Hamilton Township (Mercer County) Stormwater Basin Assessment Summary (Year 1)

Developed by the Rutgers Cooperative Extension Water Resources Program
Funded by Hamilton Township, Mercer County, New Jersey

December 6, 2012

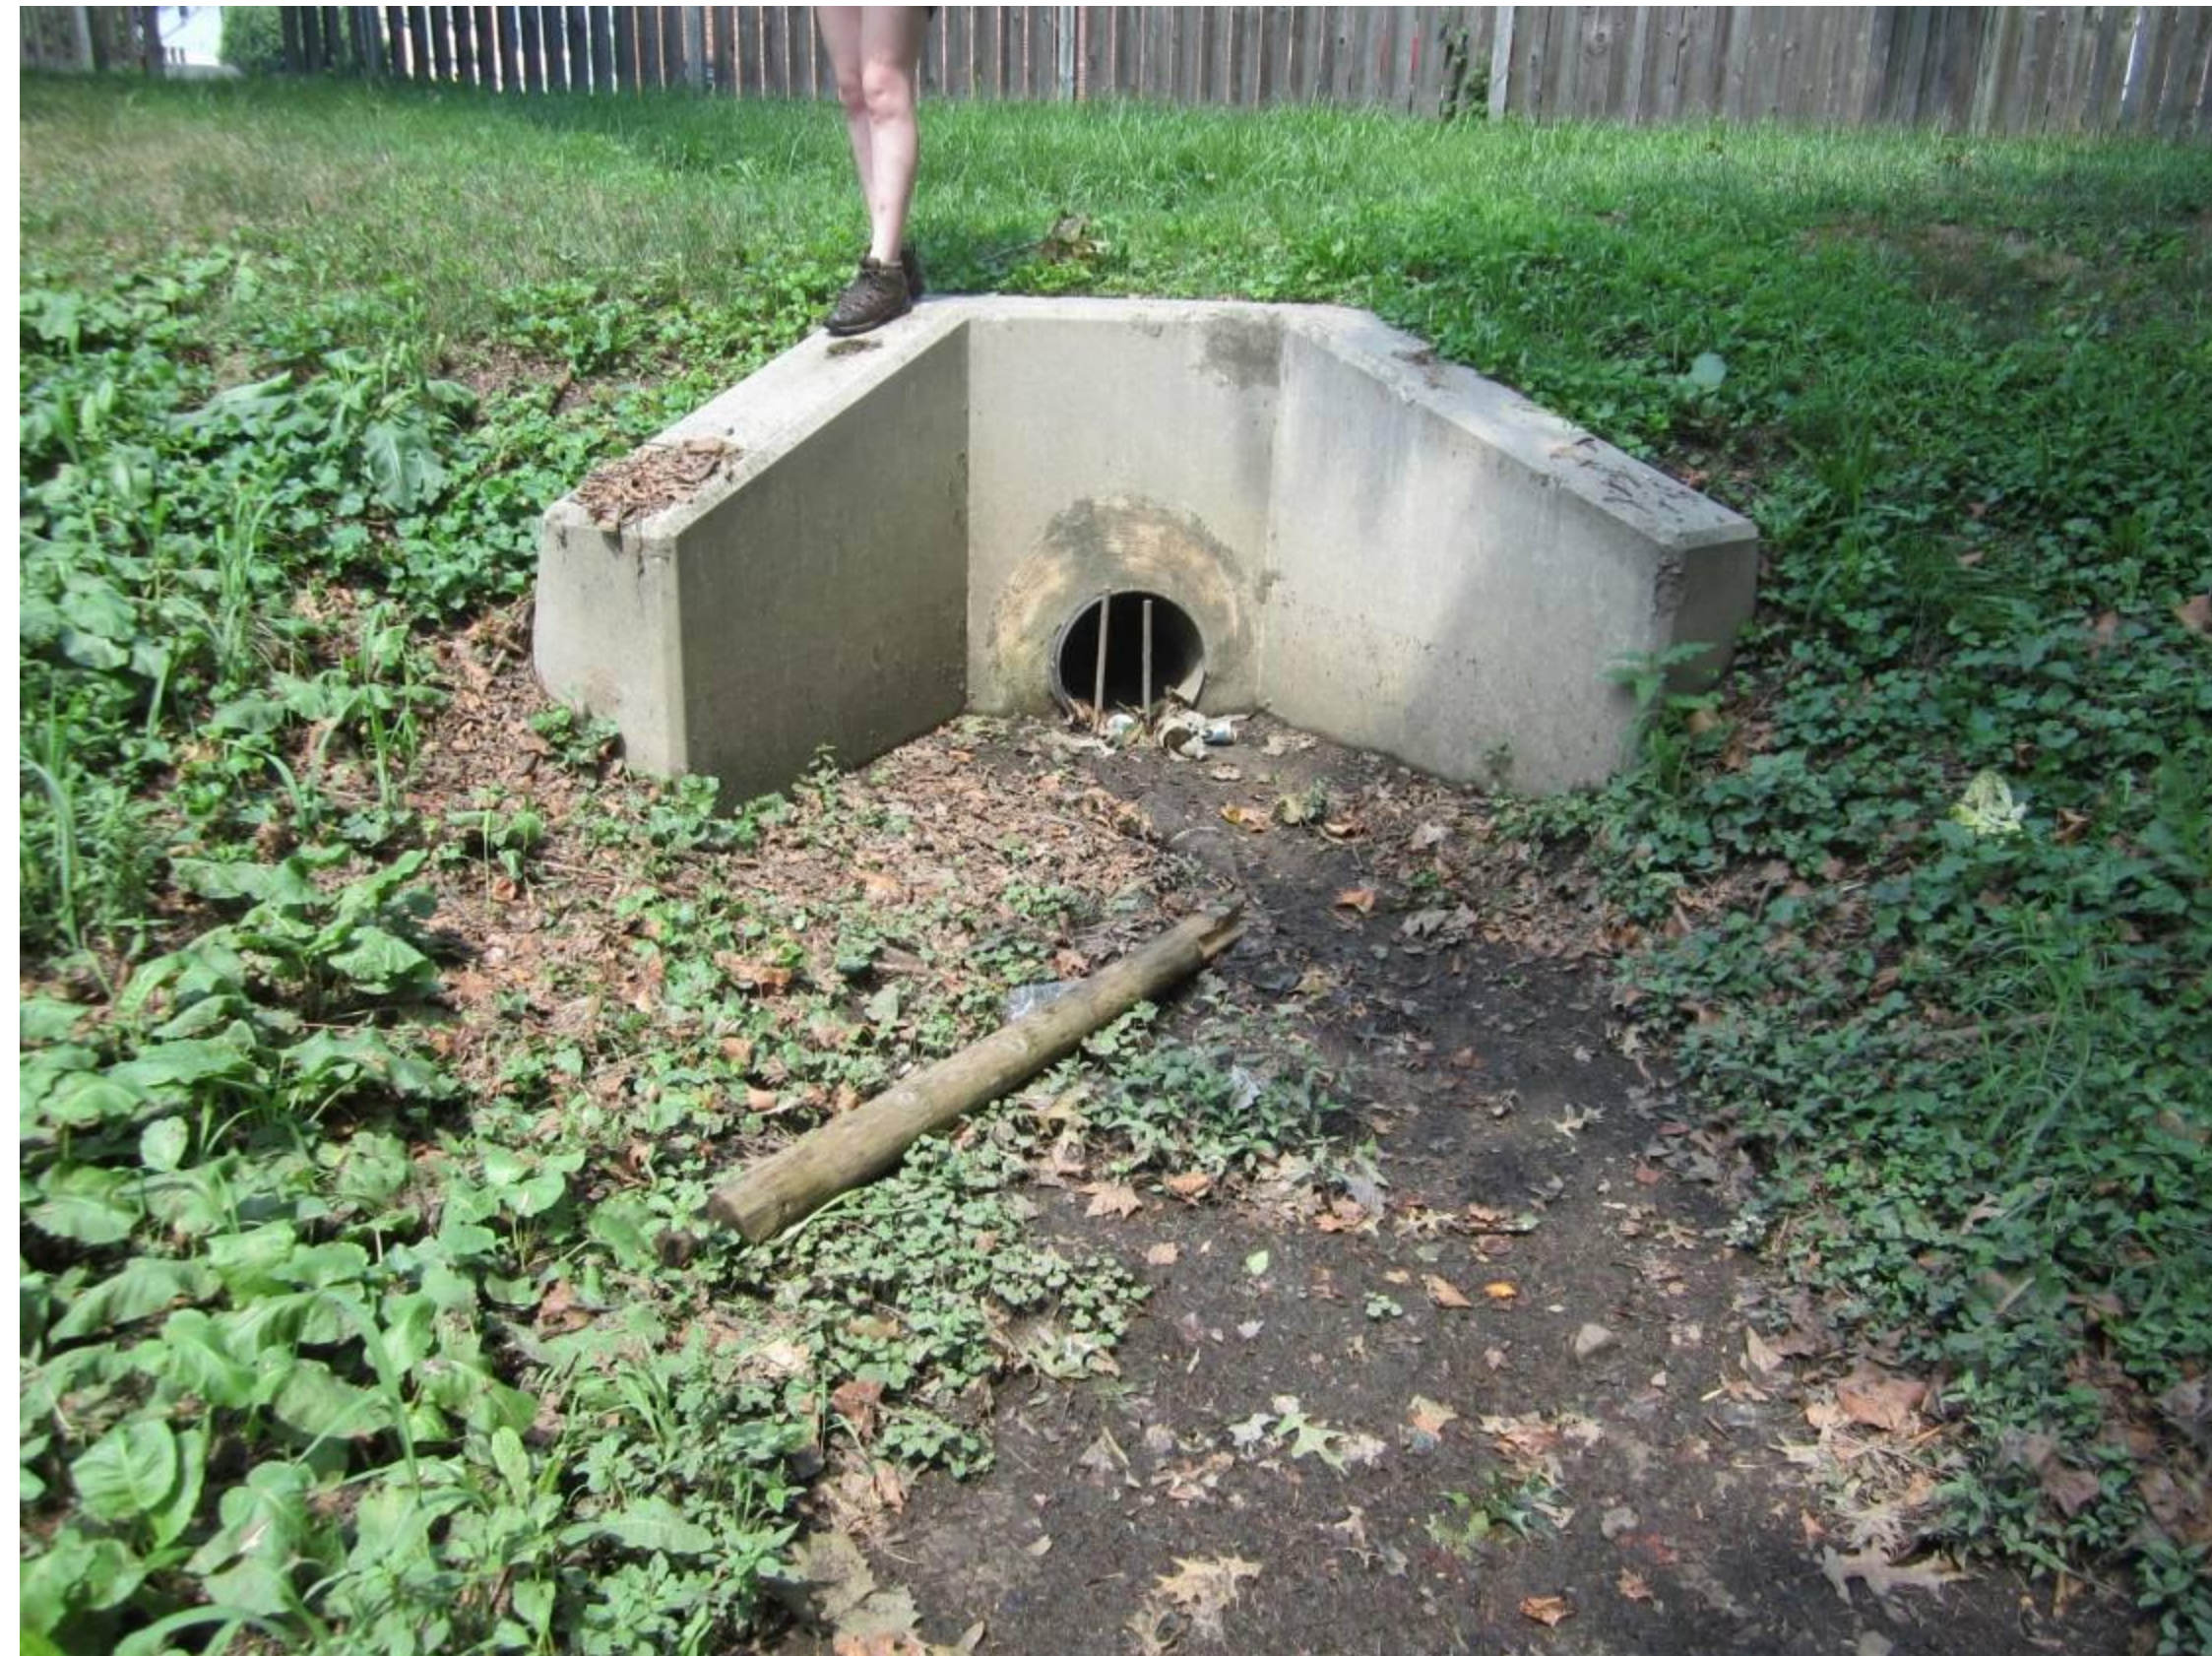
Inlet clogged with sediment

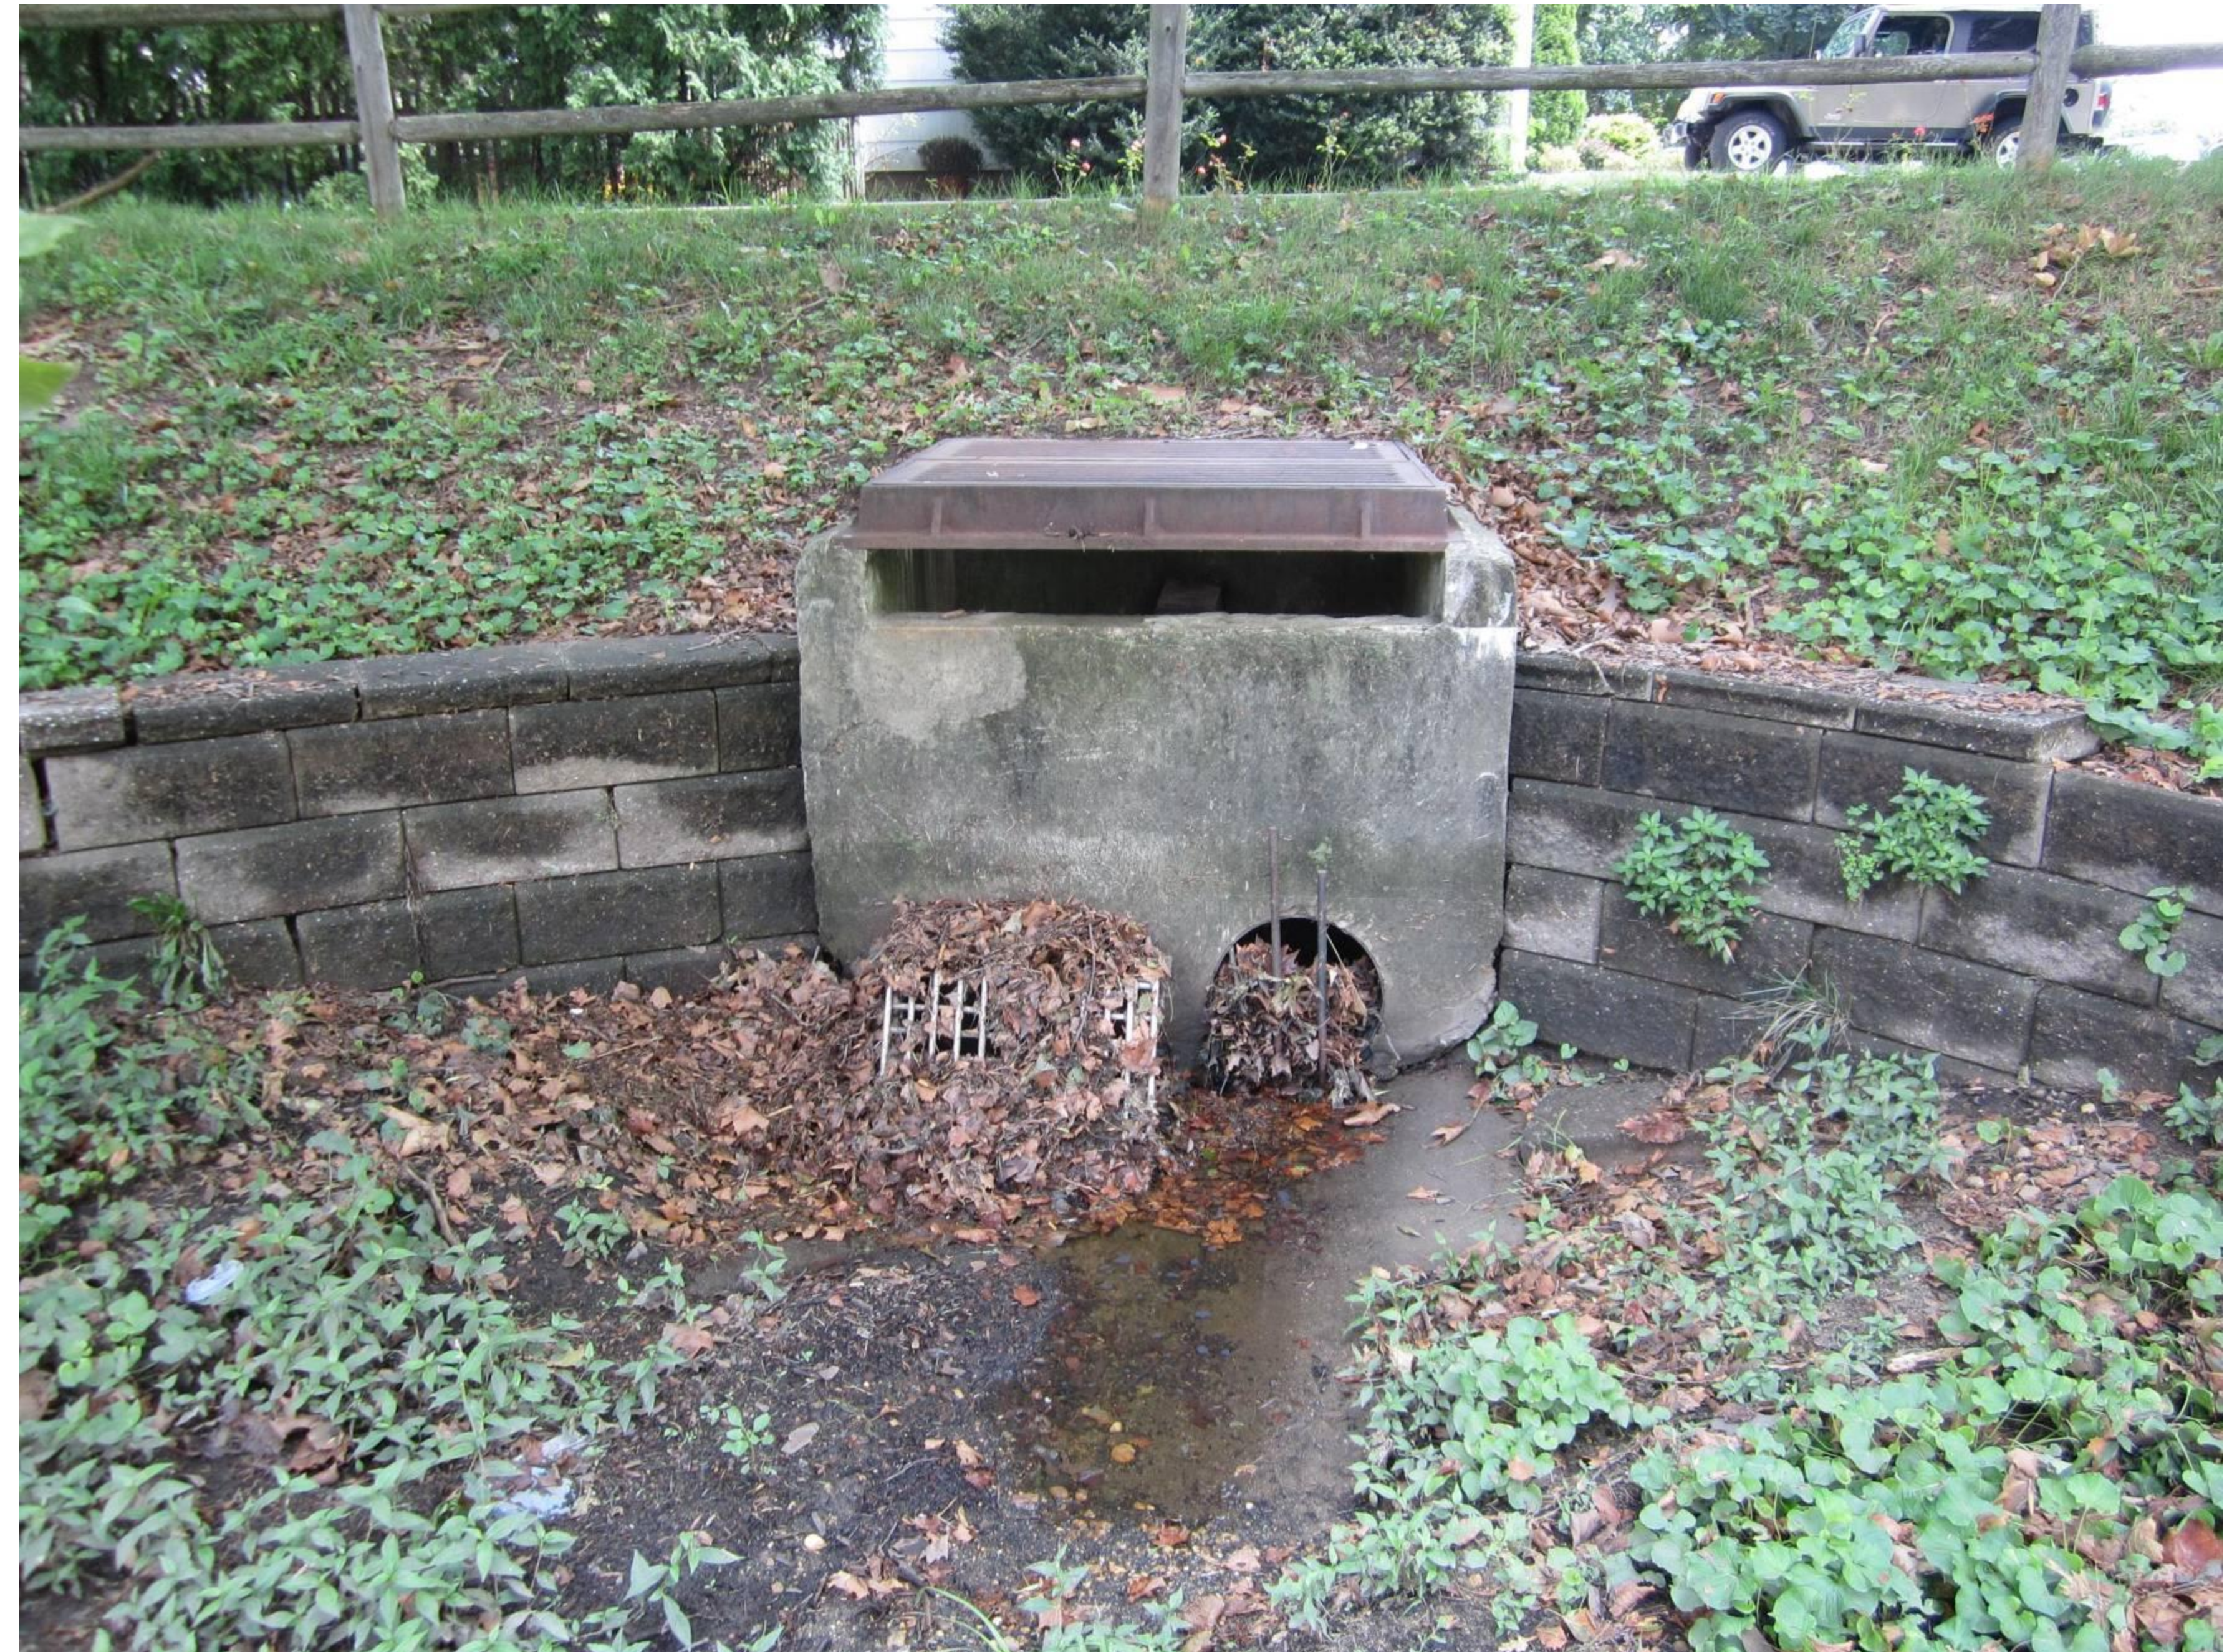
Clogged outlet structure

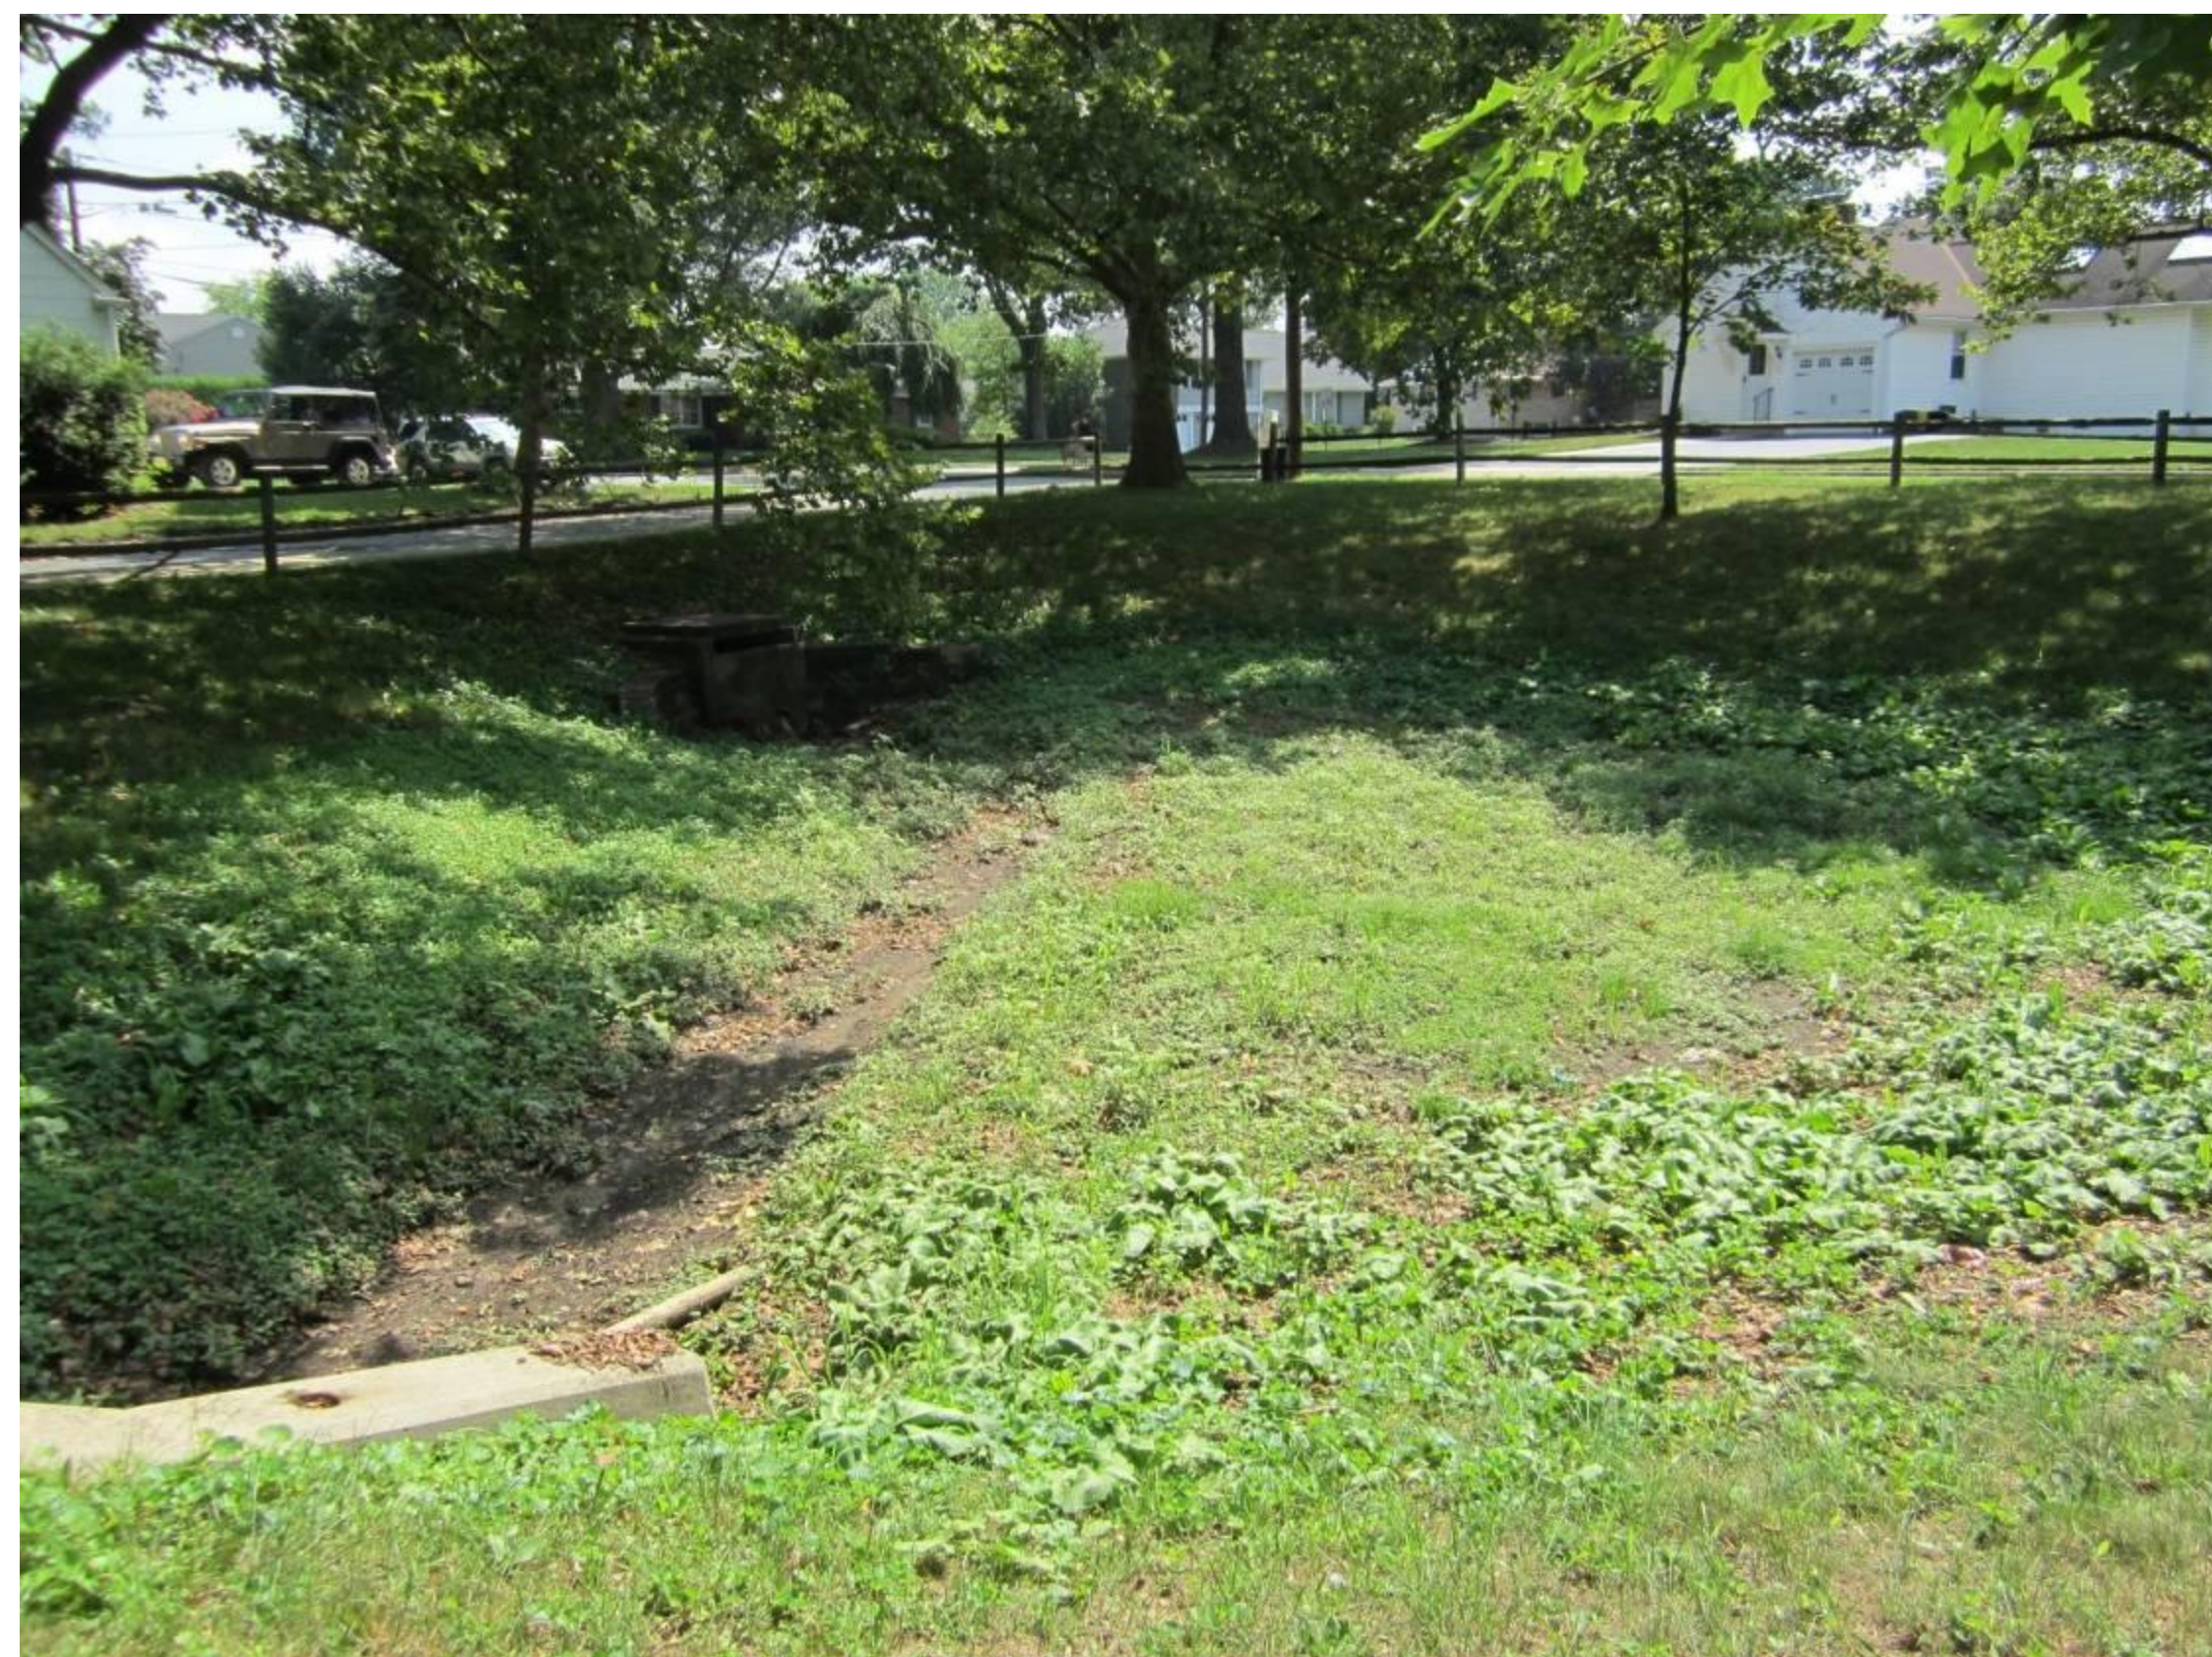
Basin bottom looking southeast

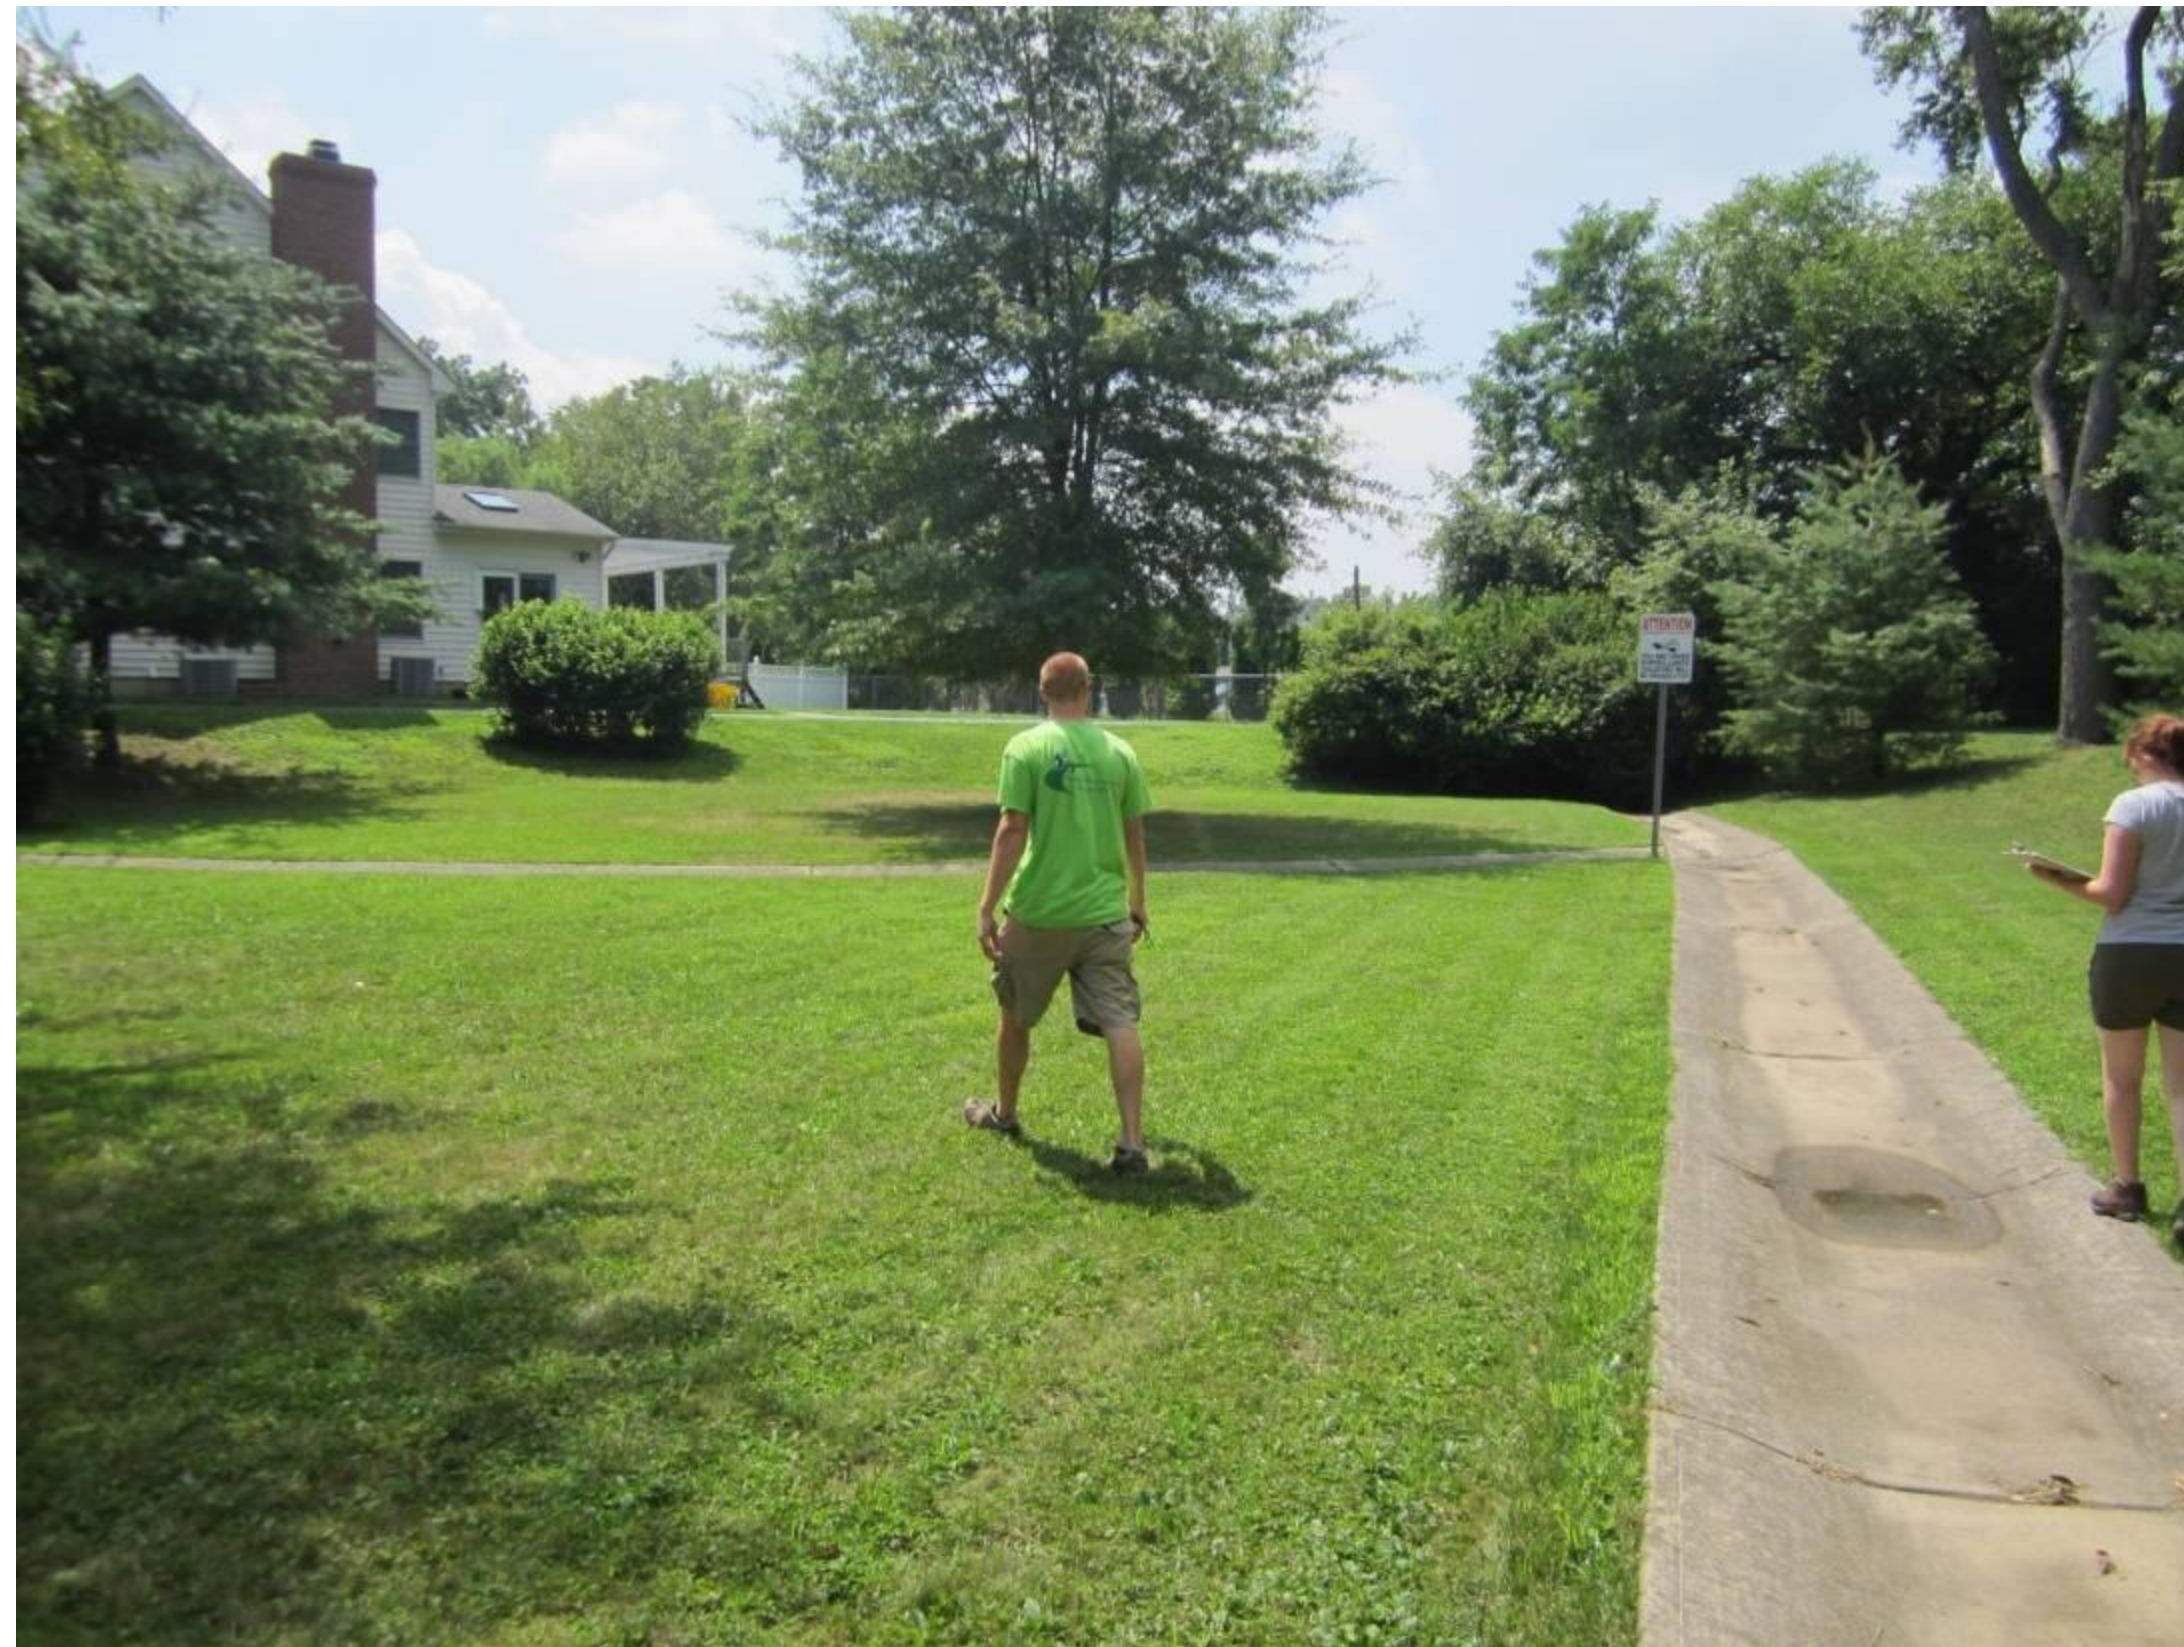
Basin bottom looking southwest

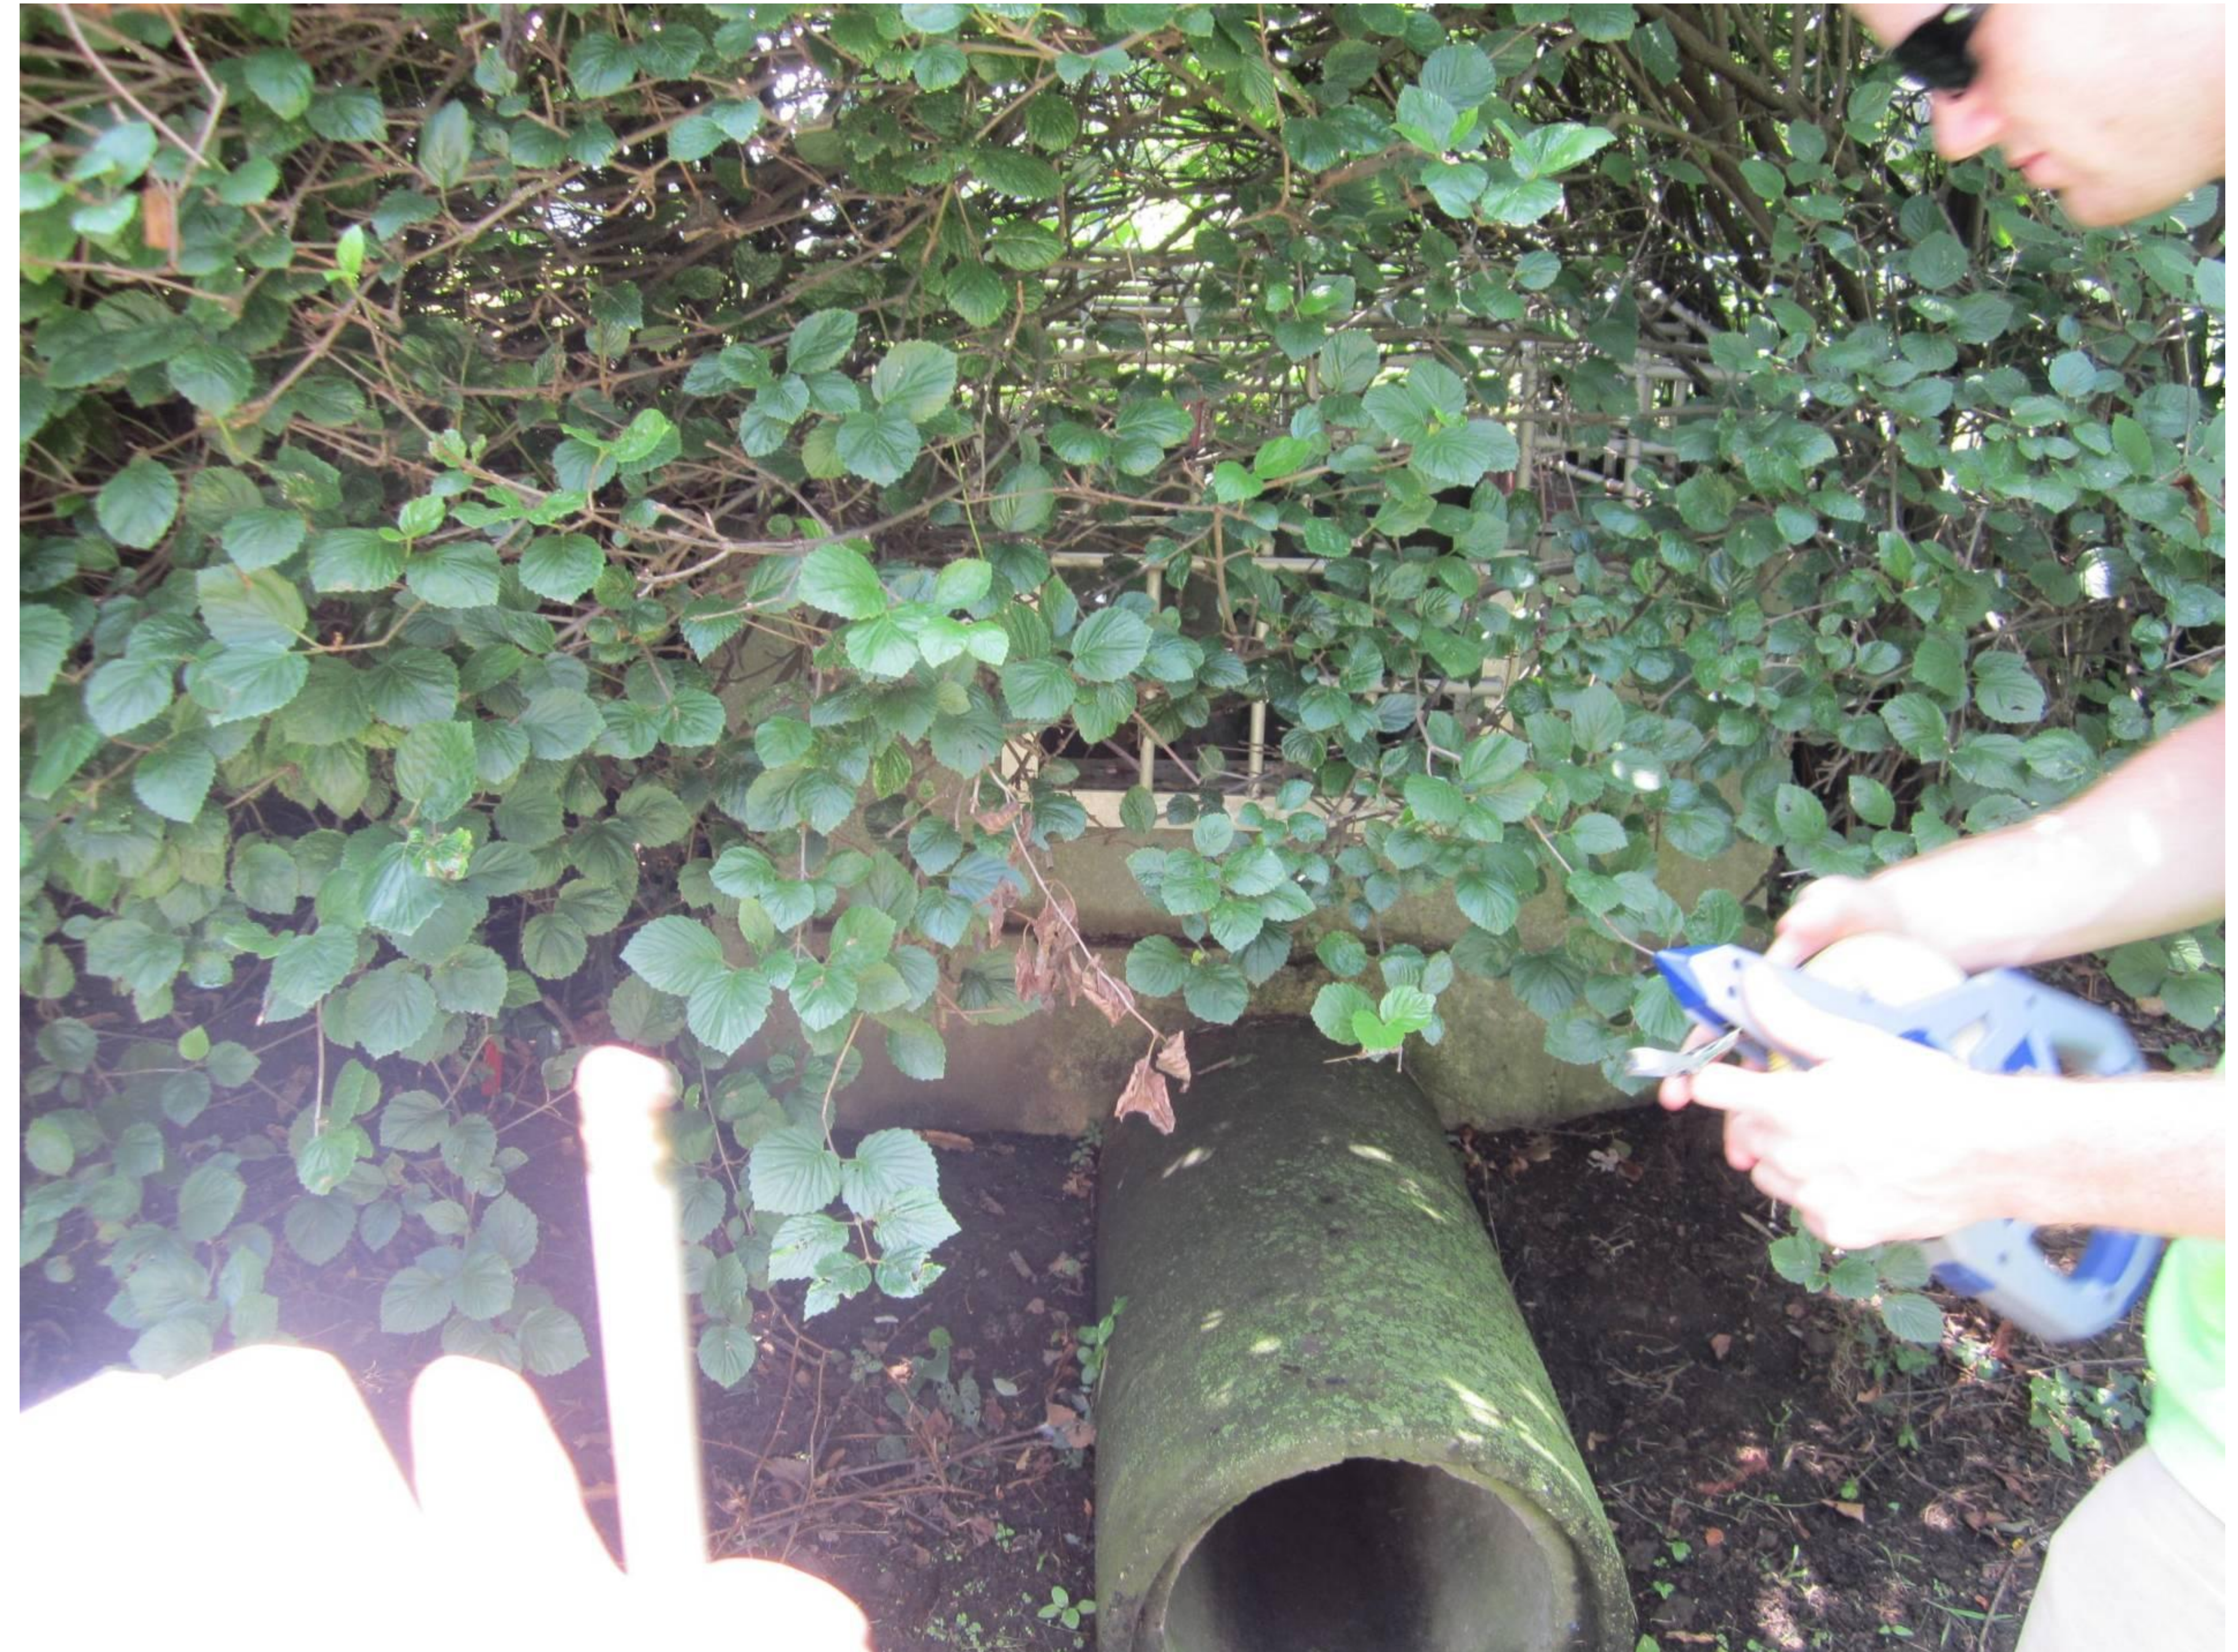
Woody vegetation growth around outlet

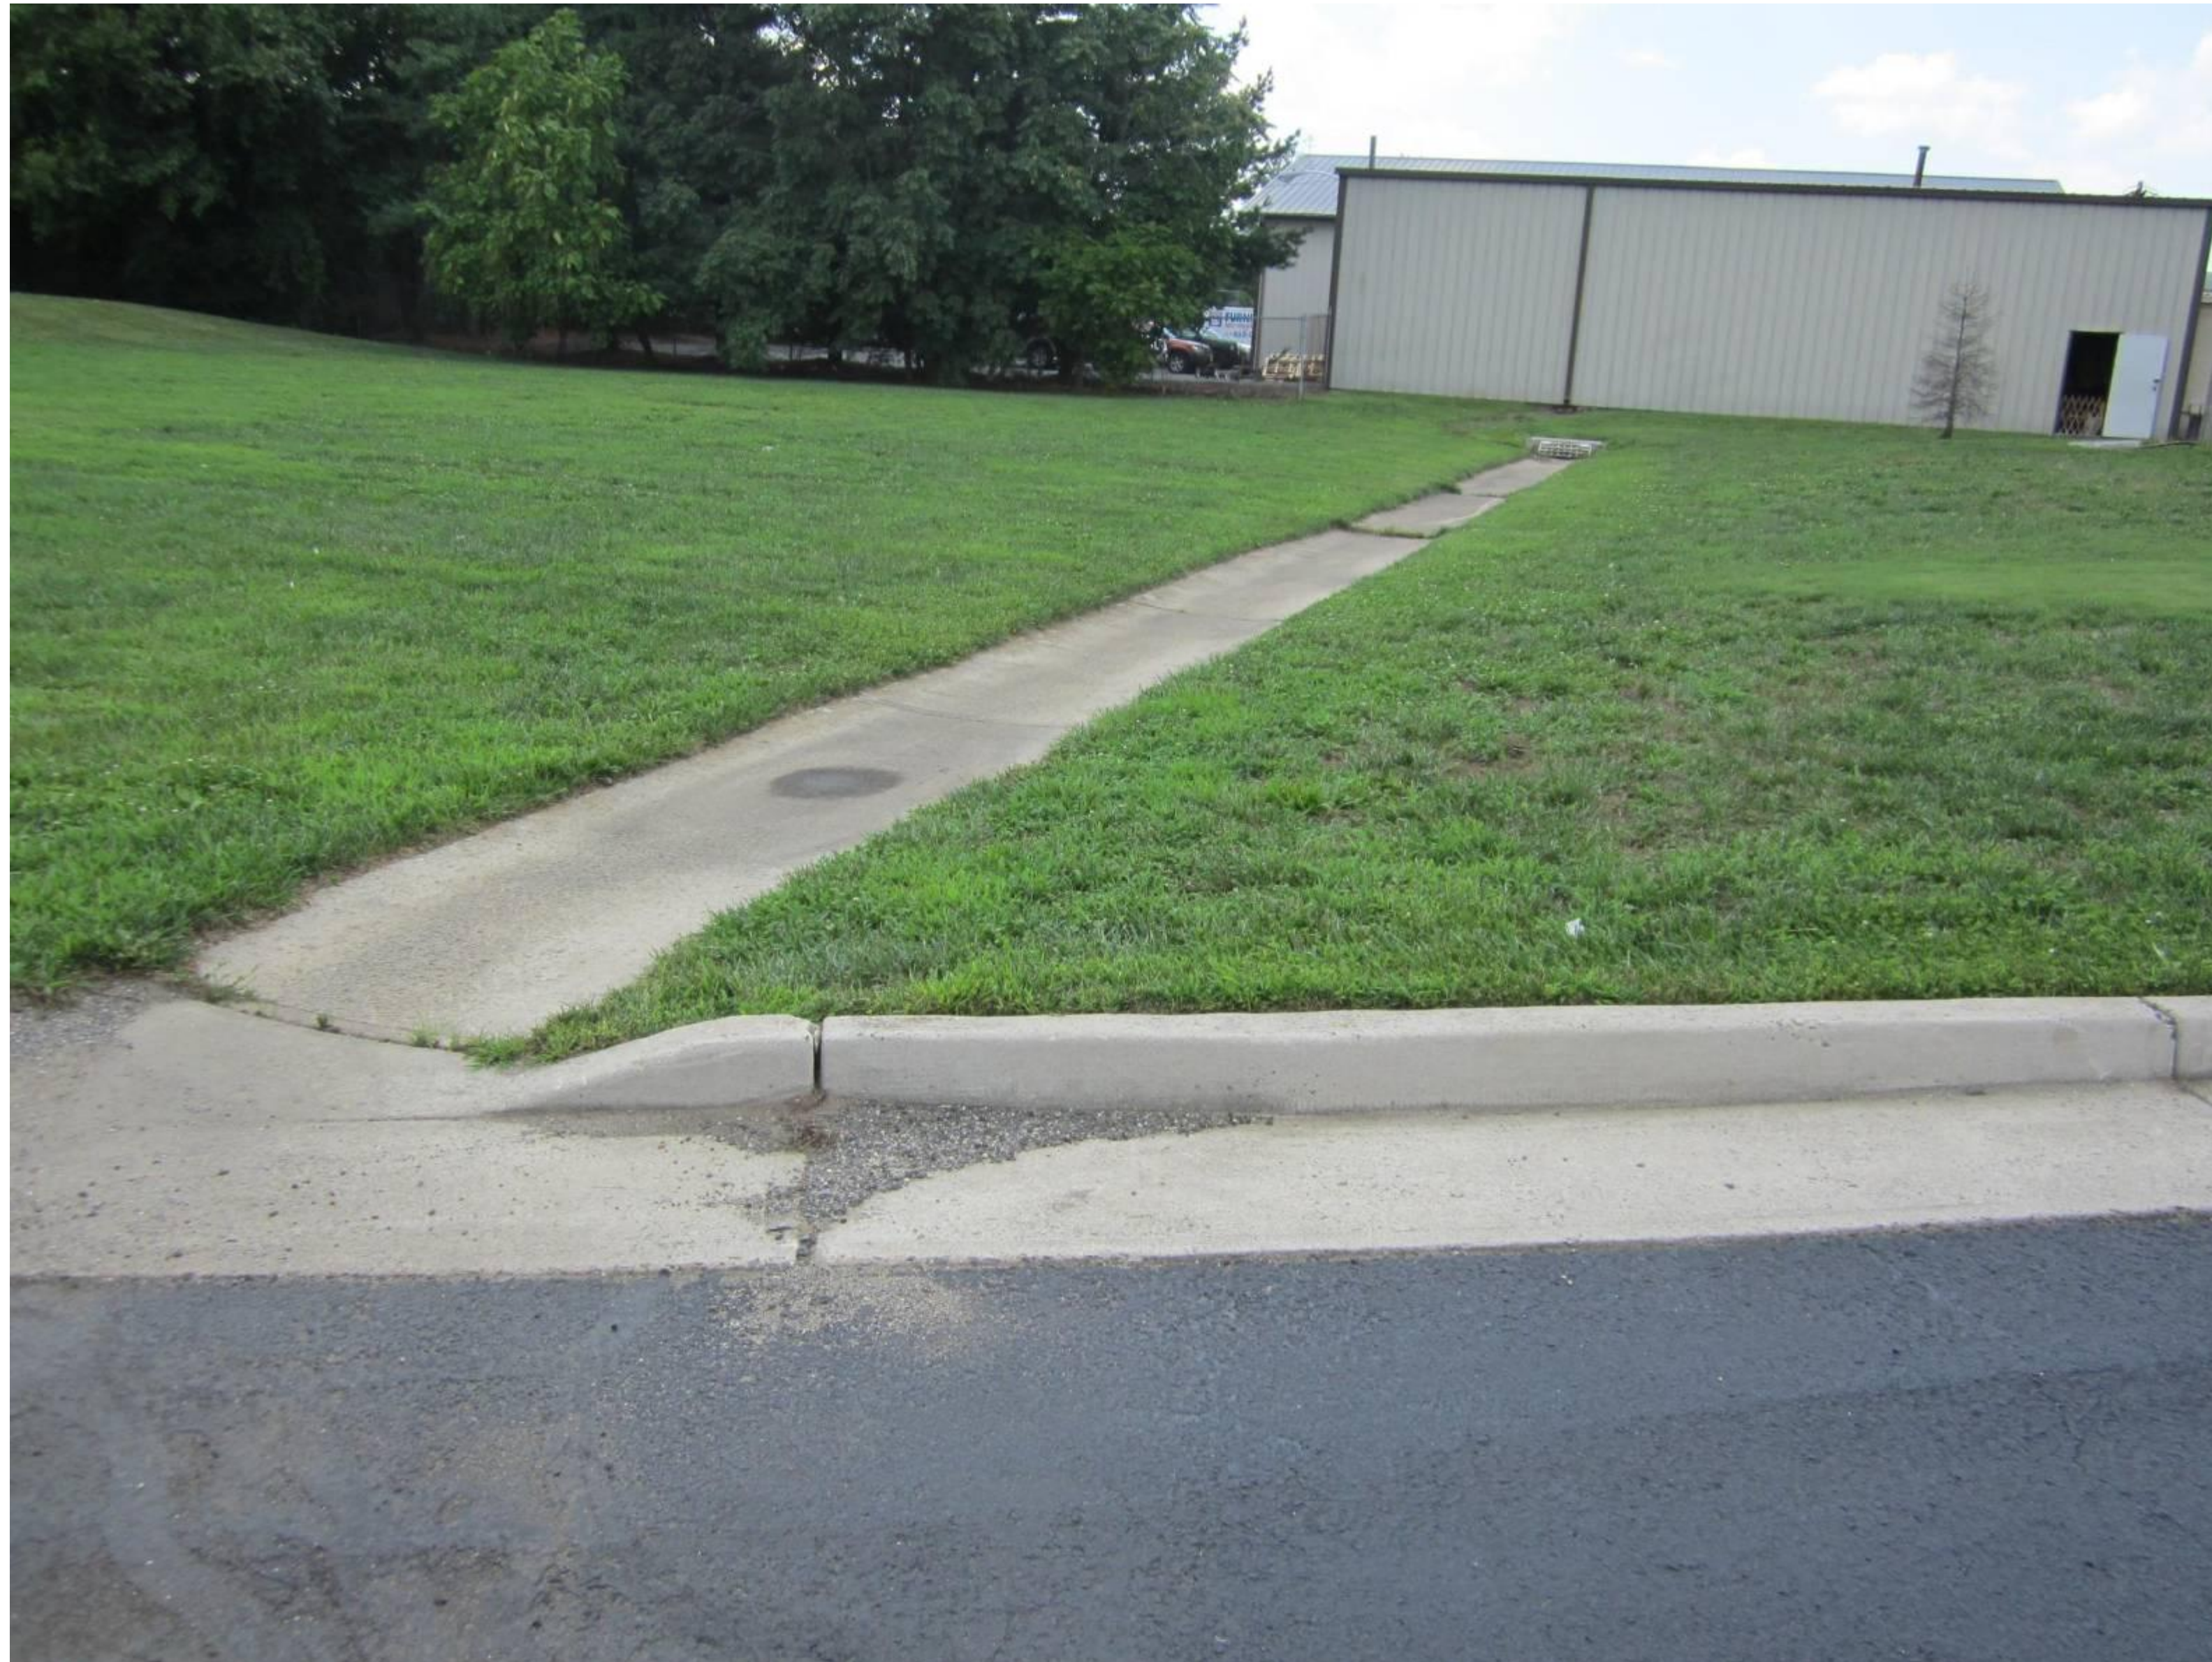
Curb cut inlet and low flow channel
