Hamilton Township (Mercer County) Stormwater Basin Assessment Summary (Year 1)

Developed by the Rutgers Cooperative Extension Water Resources Program
Funded by Hamilton Township, Mercer County, New Jersey

December 6, 2012

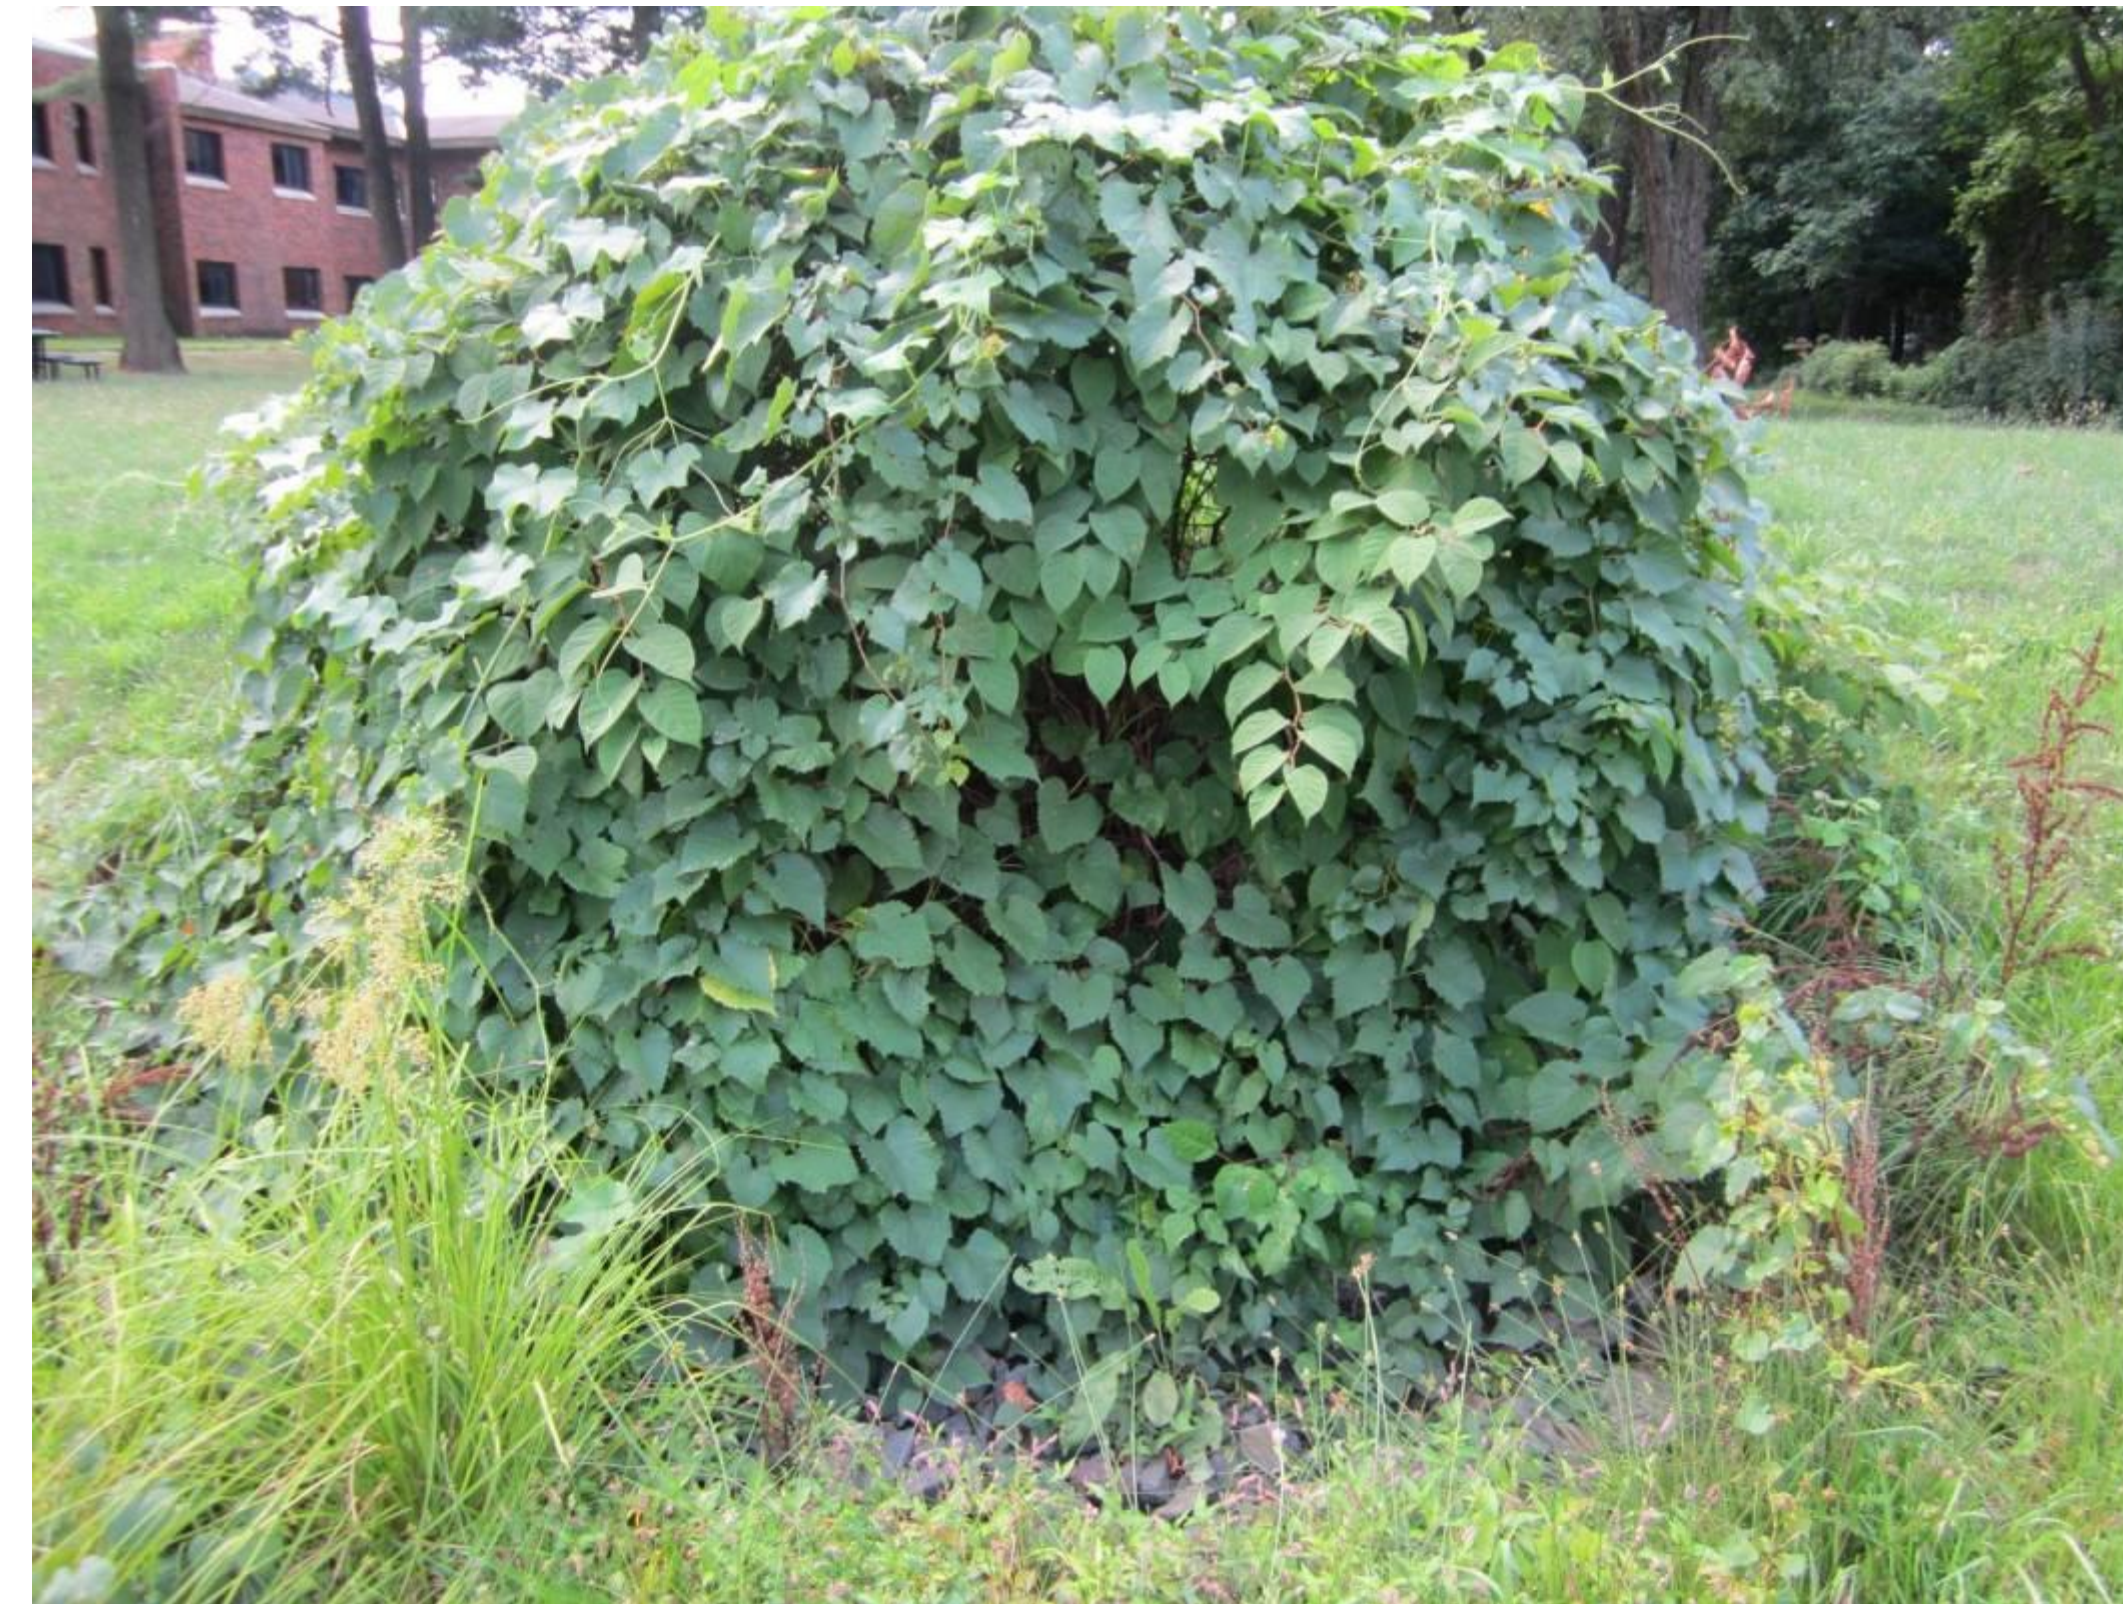
Overgrown outlet structure

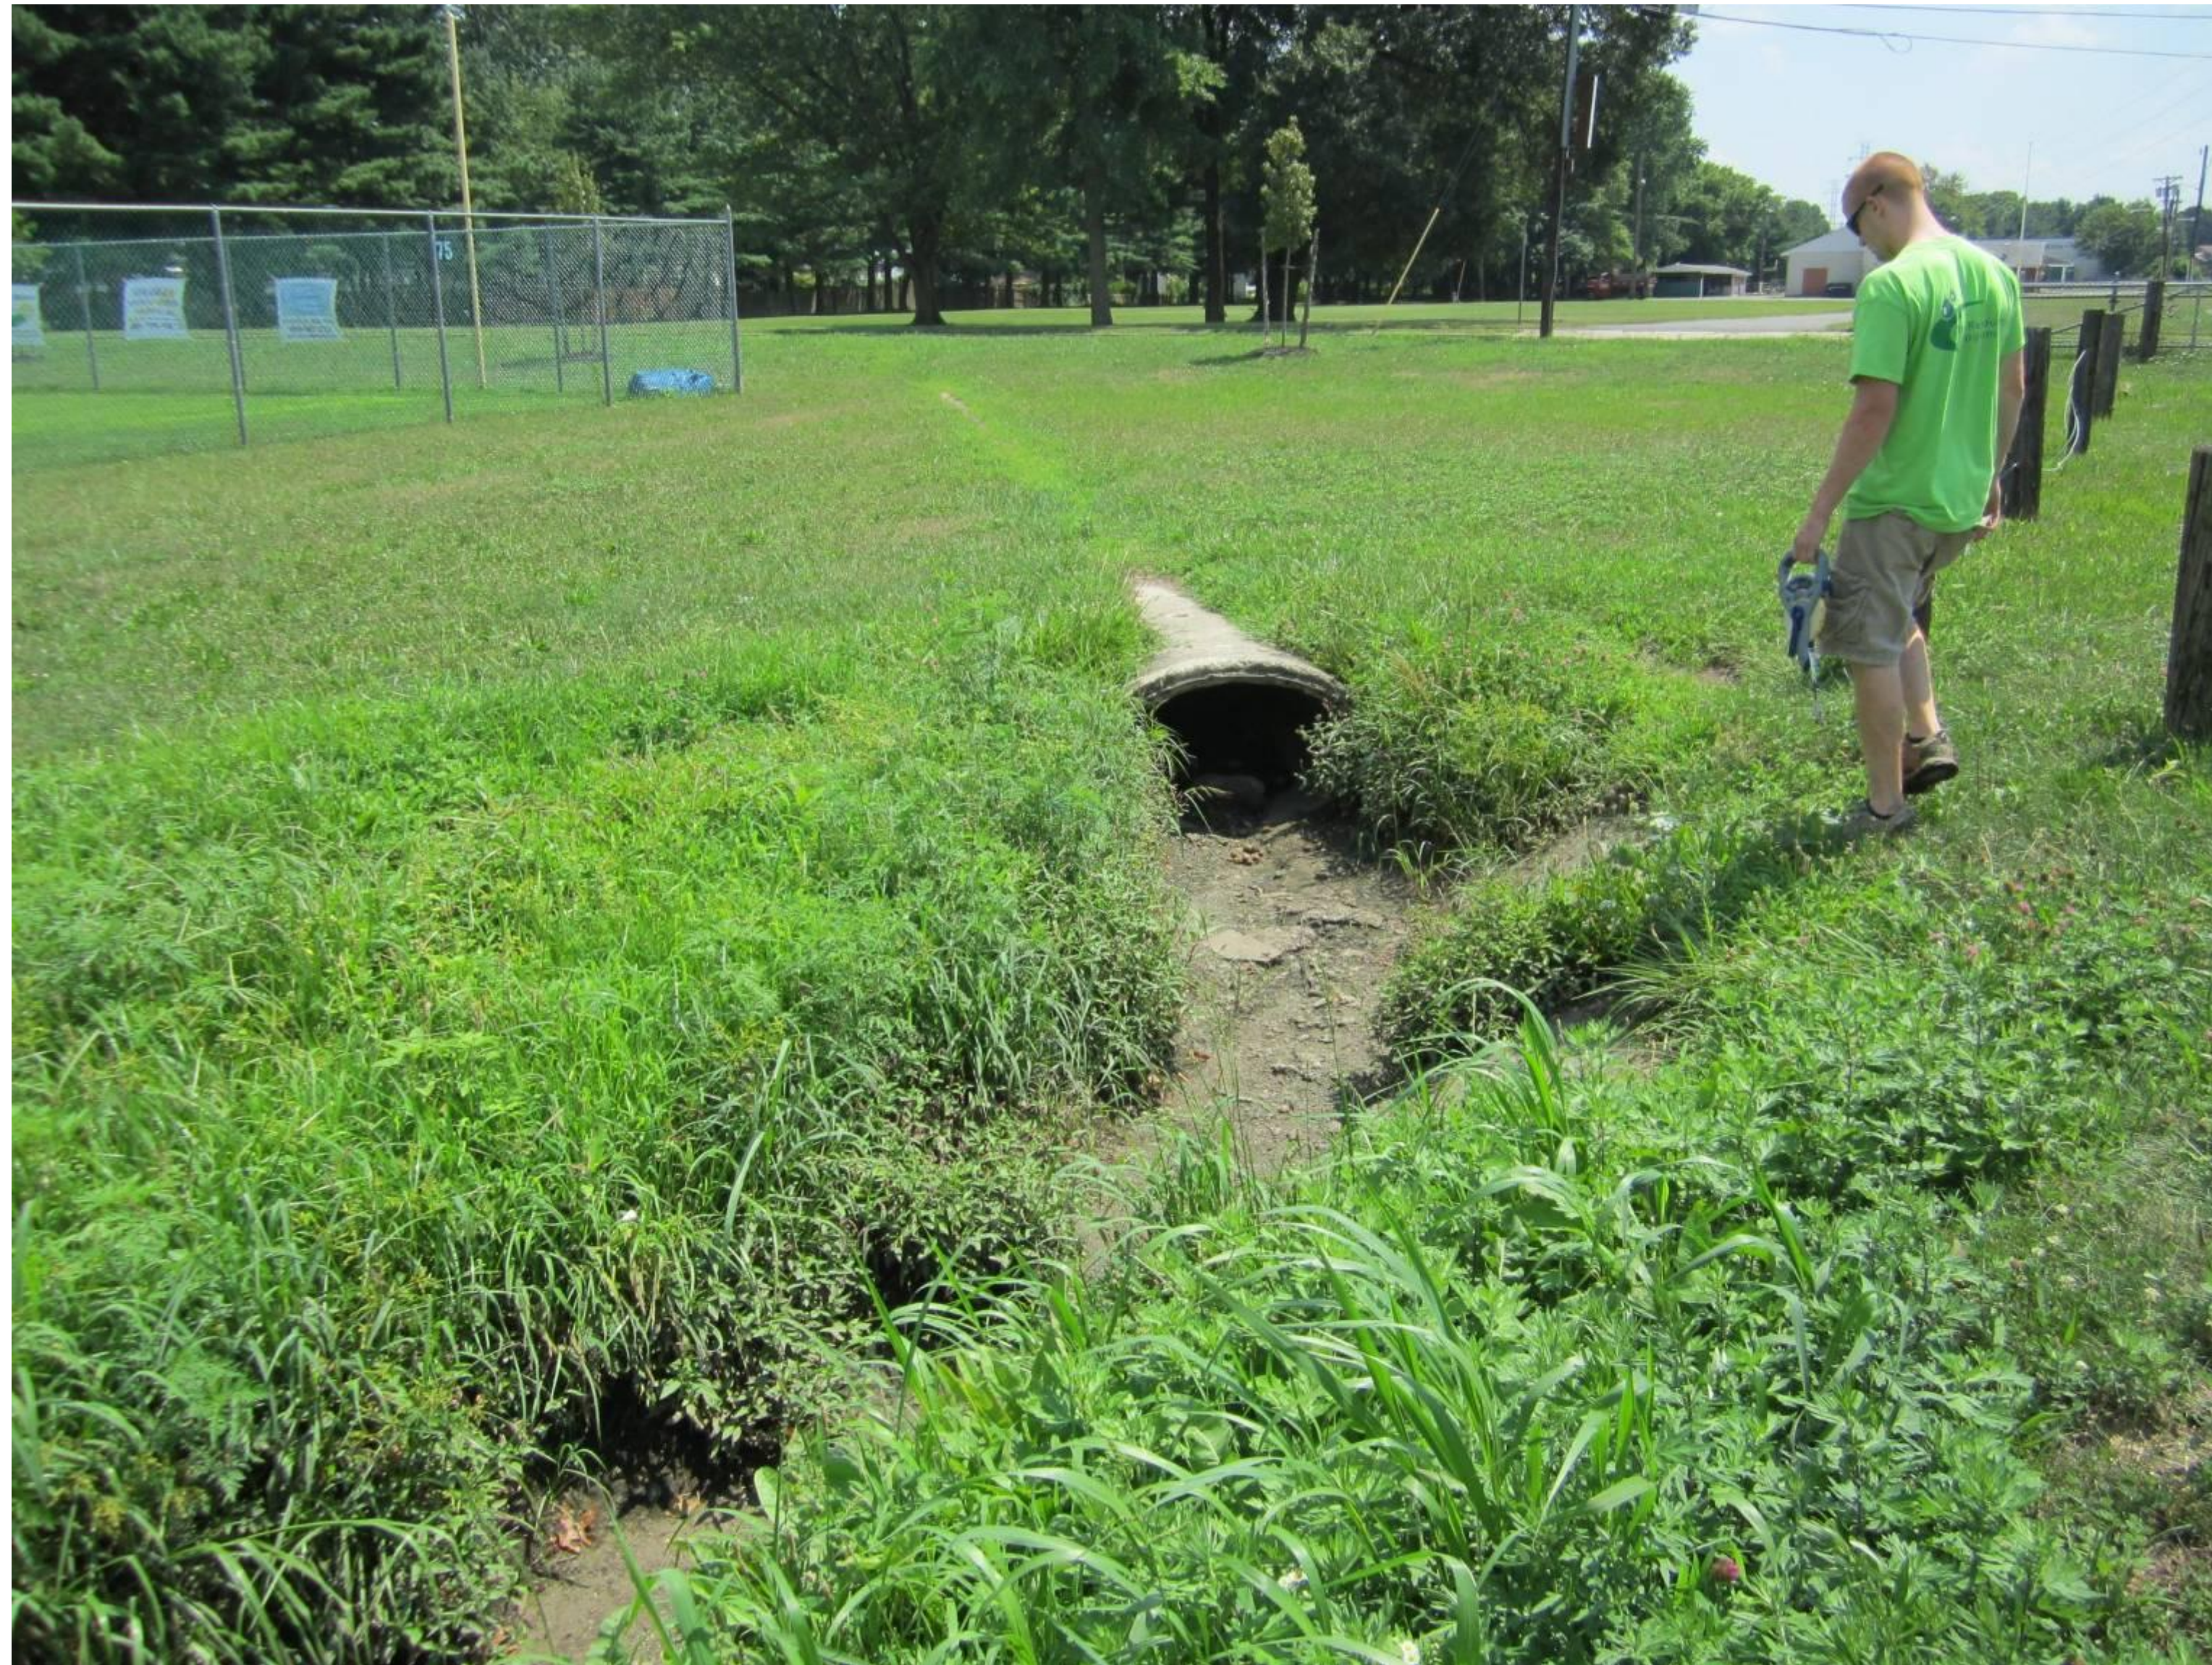
Inlet with sediment accumulation

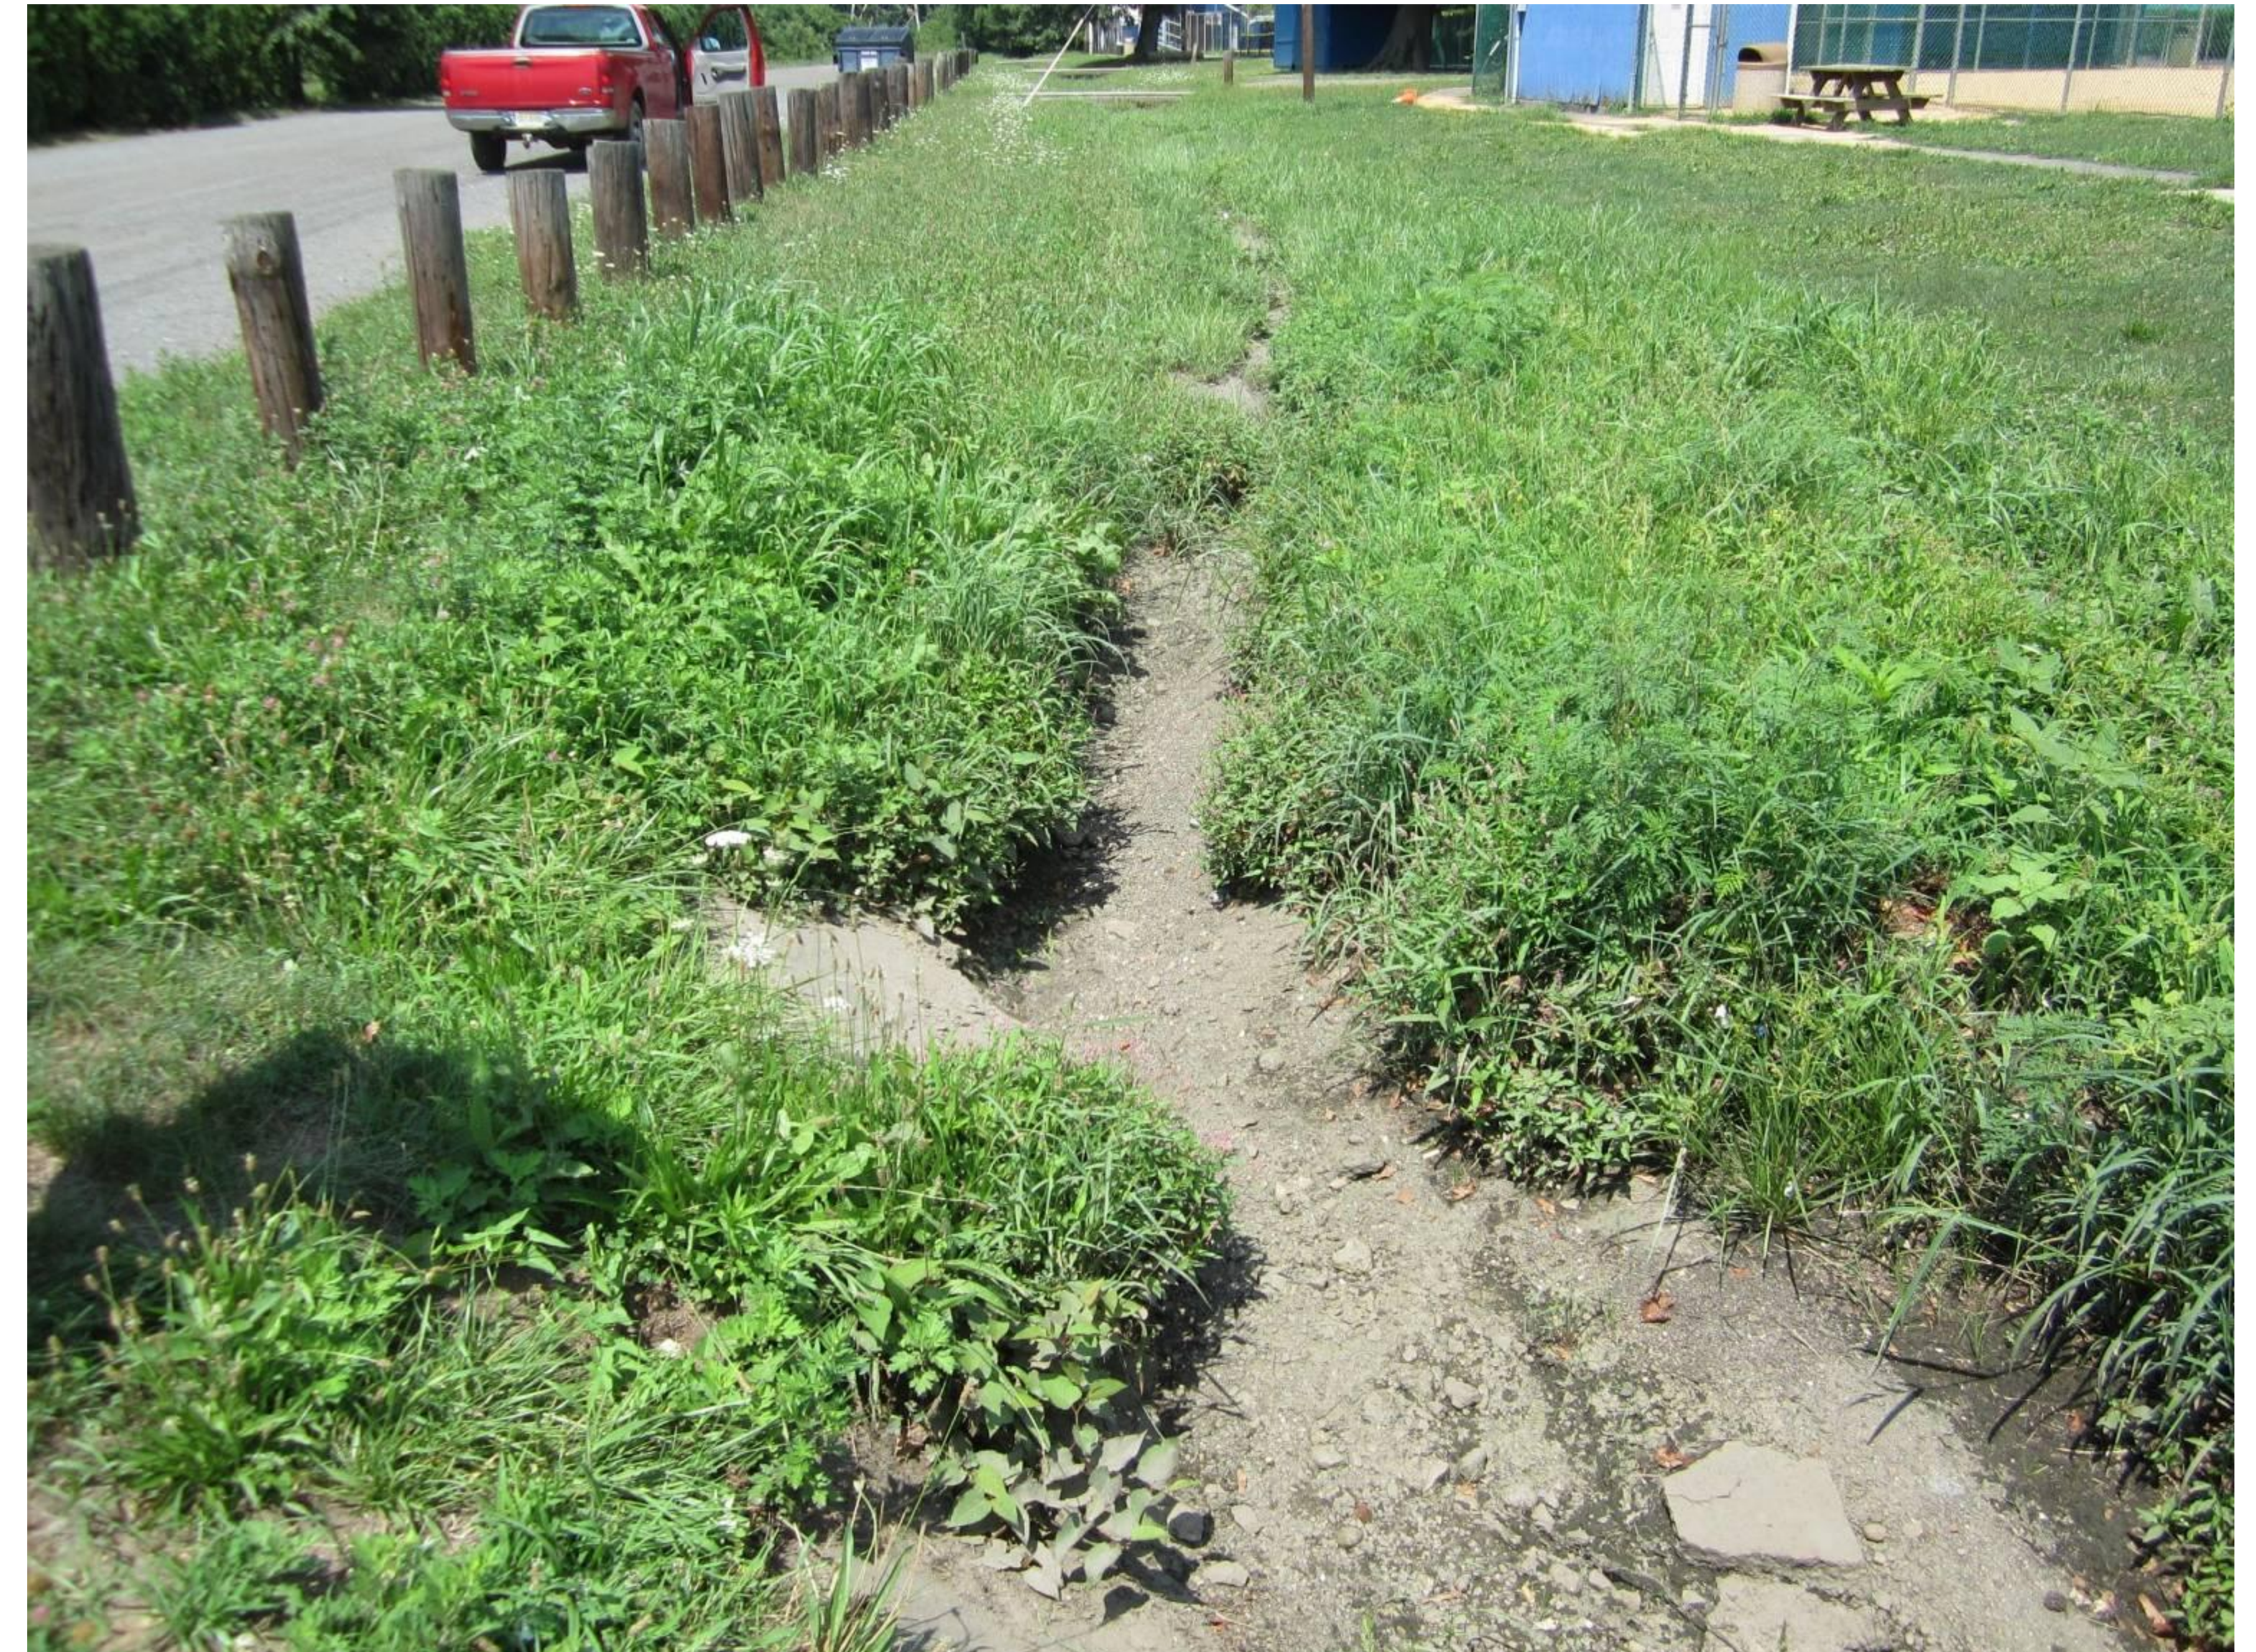
Basin bottom with erosion

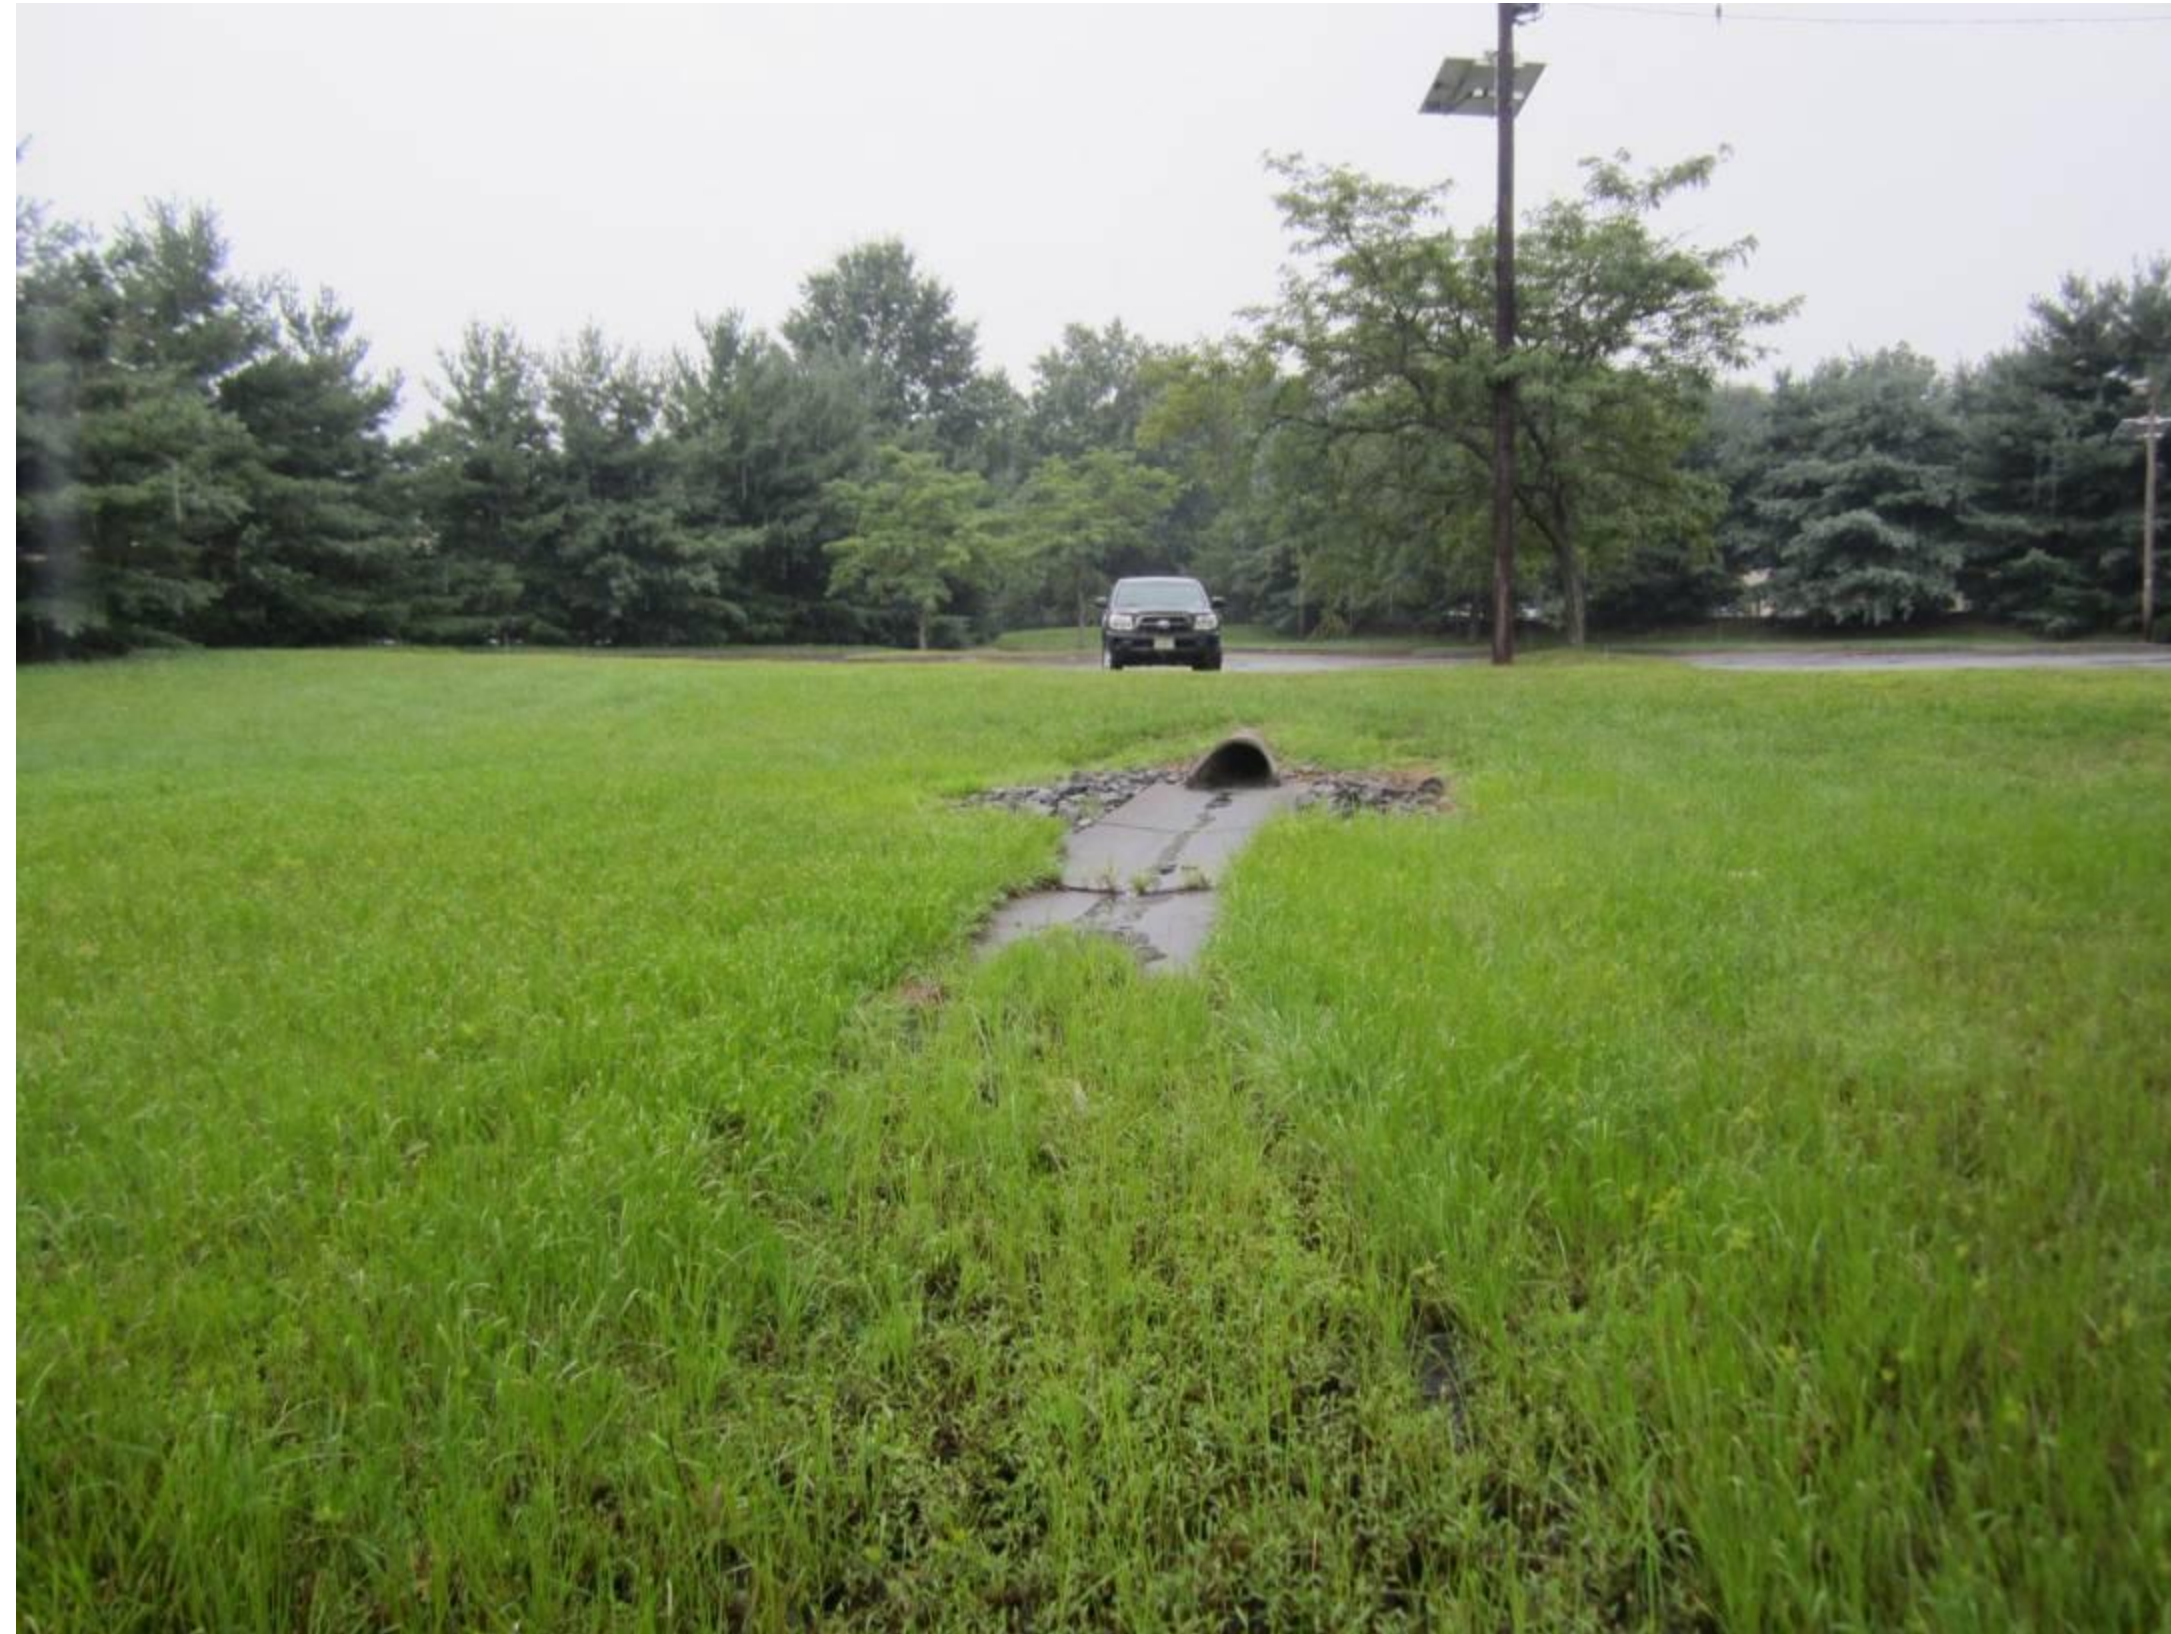
Inlet, low flow channel filled with sediment

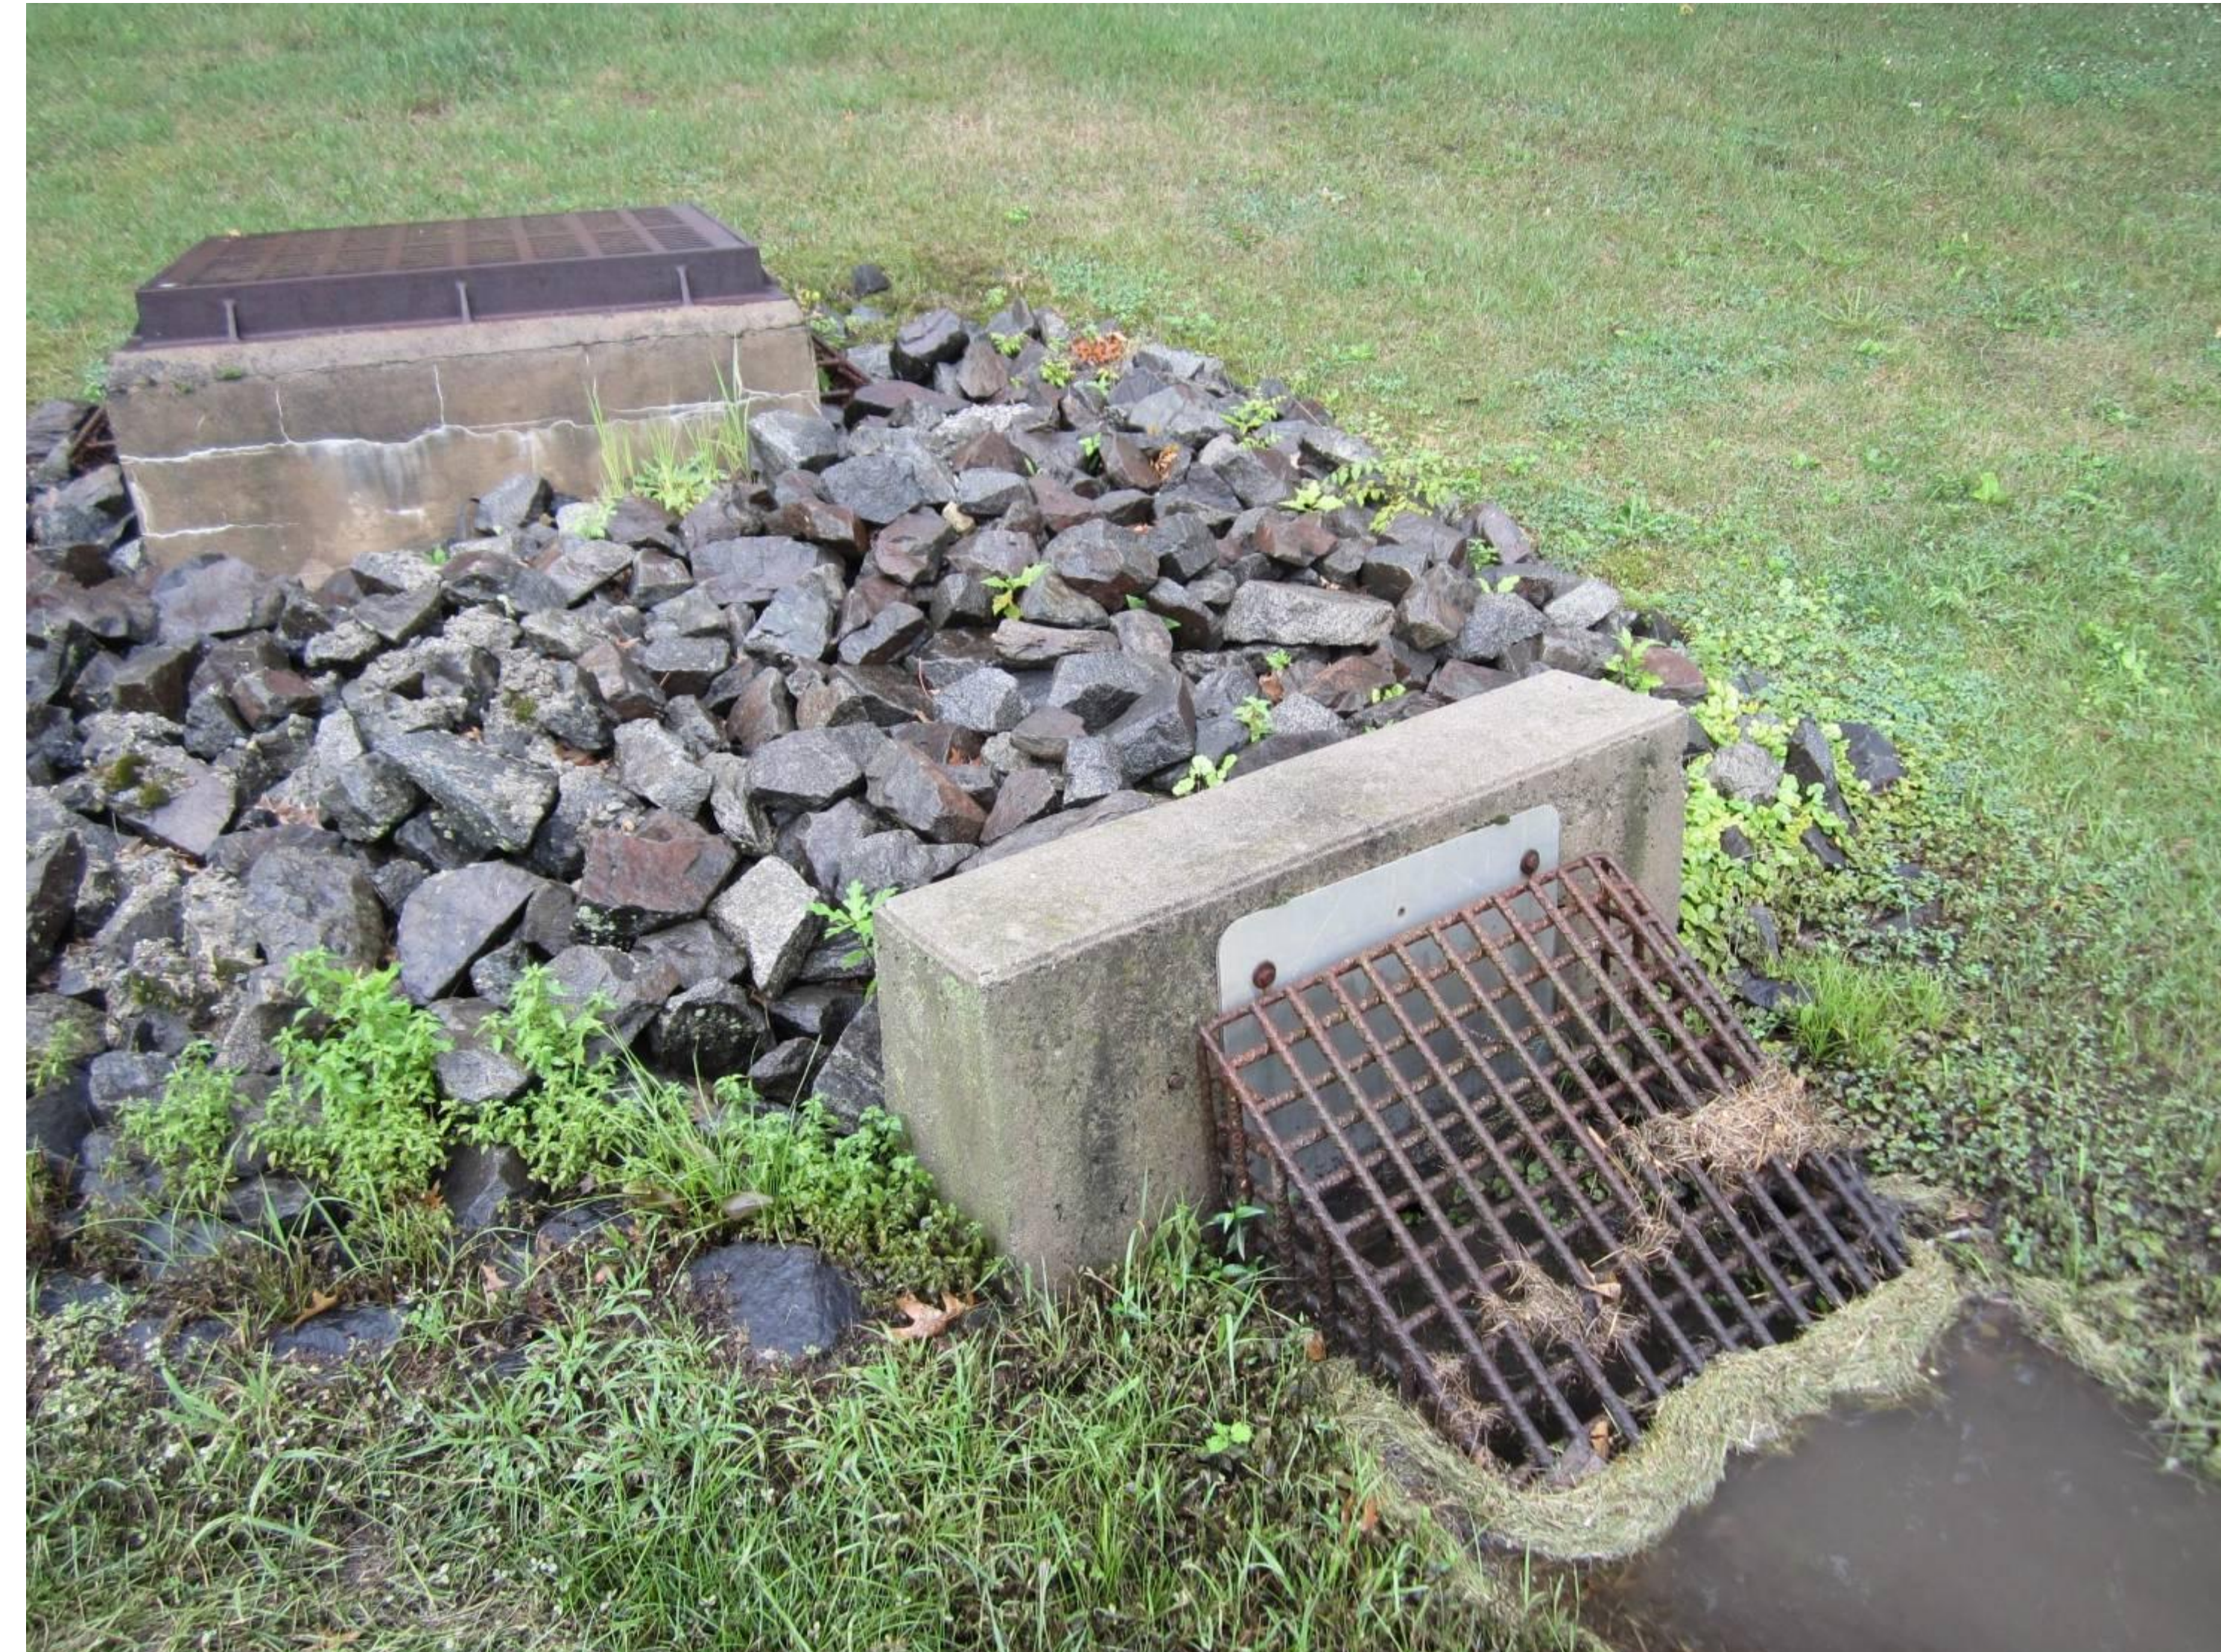
Outlet trash rack clogged with grass clippings

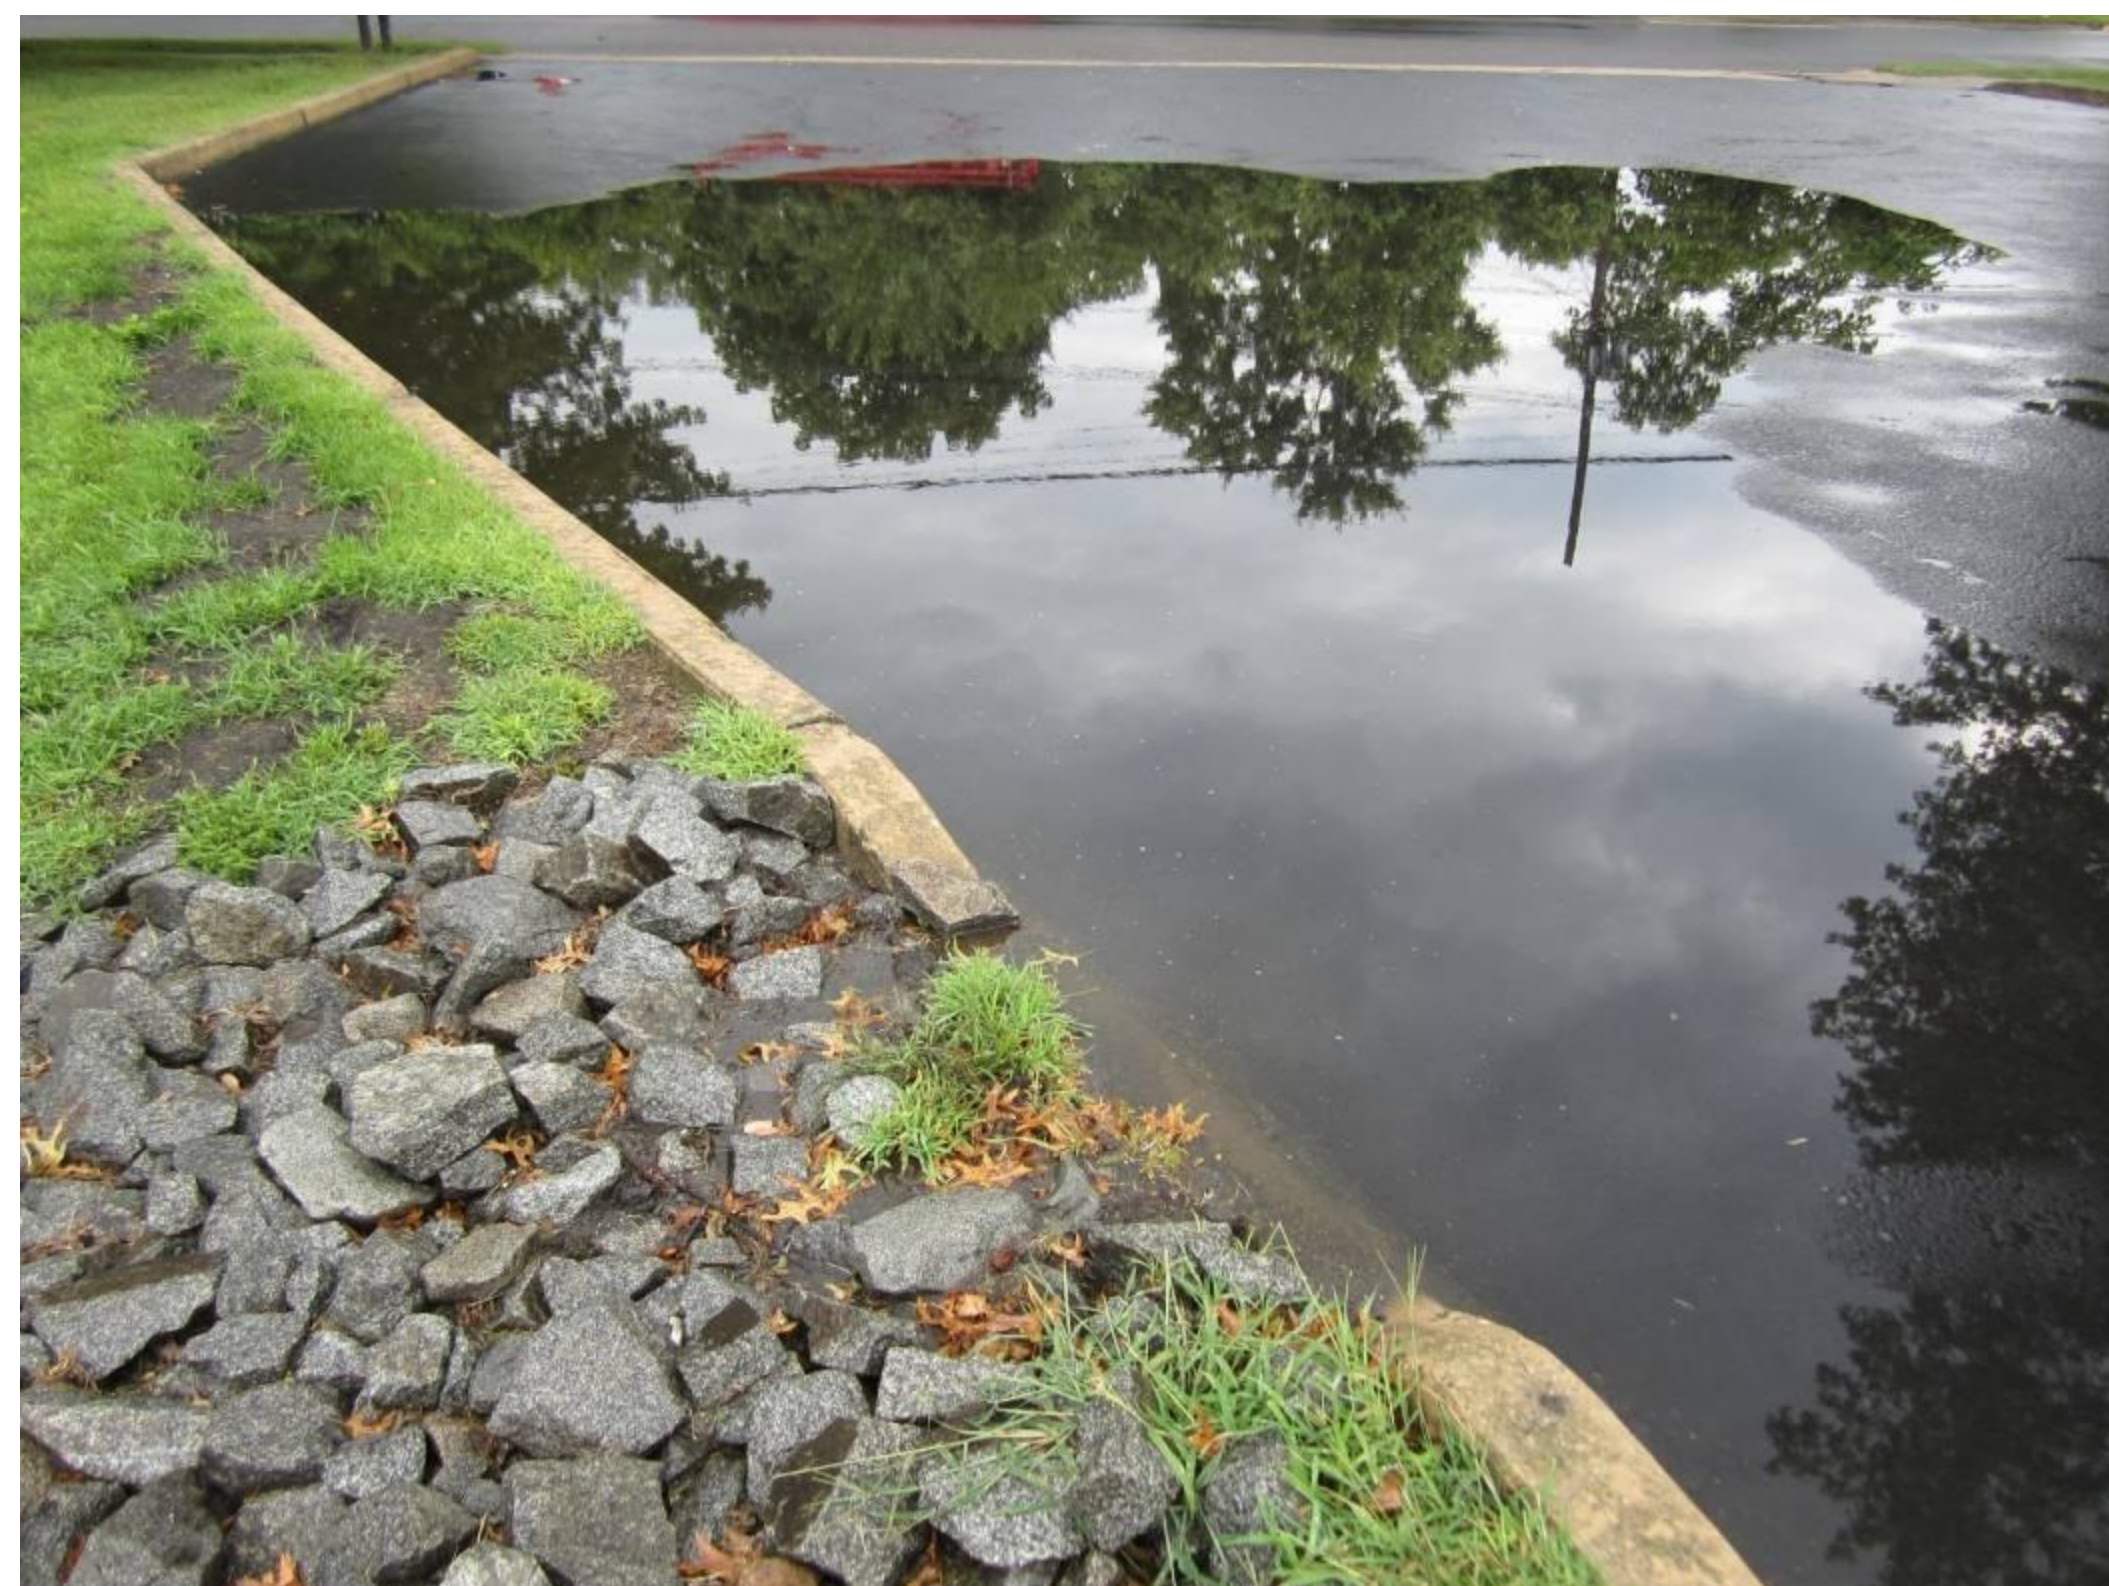
Ponding in front of curb cut
