Hamilton Township (Mercer County) Stormwater Basin Assessment Summary (Year 1)

Developed by the Rutgers Cooperative Extension Water Resources Program
Funded by Hamilton Township, Mercer County, New Jersey

December 6, 2012

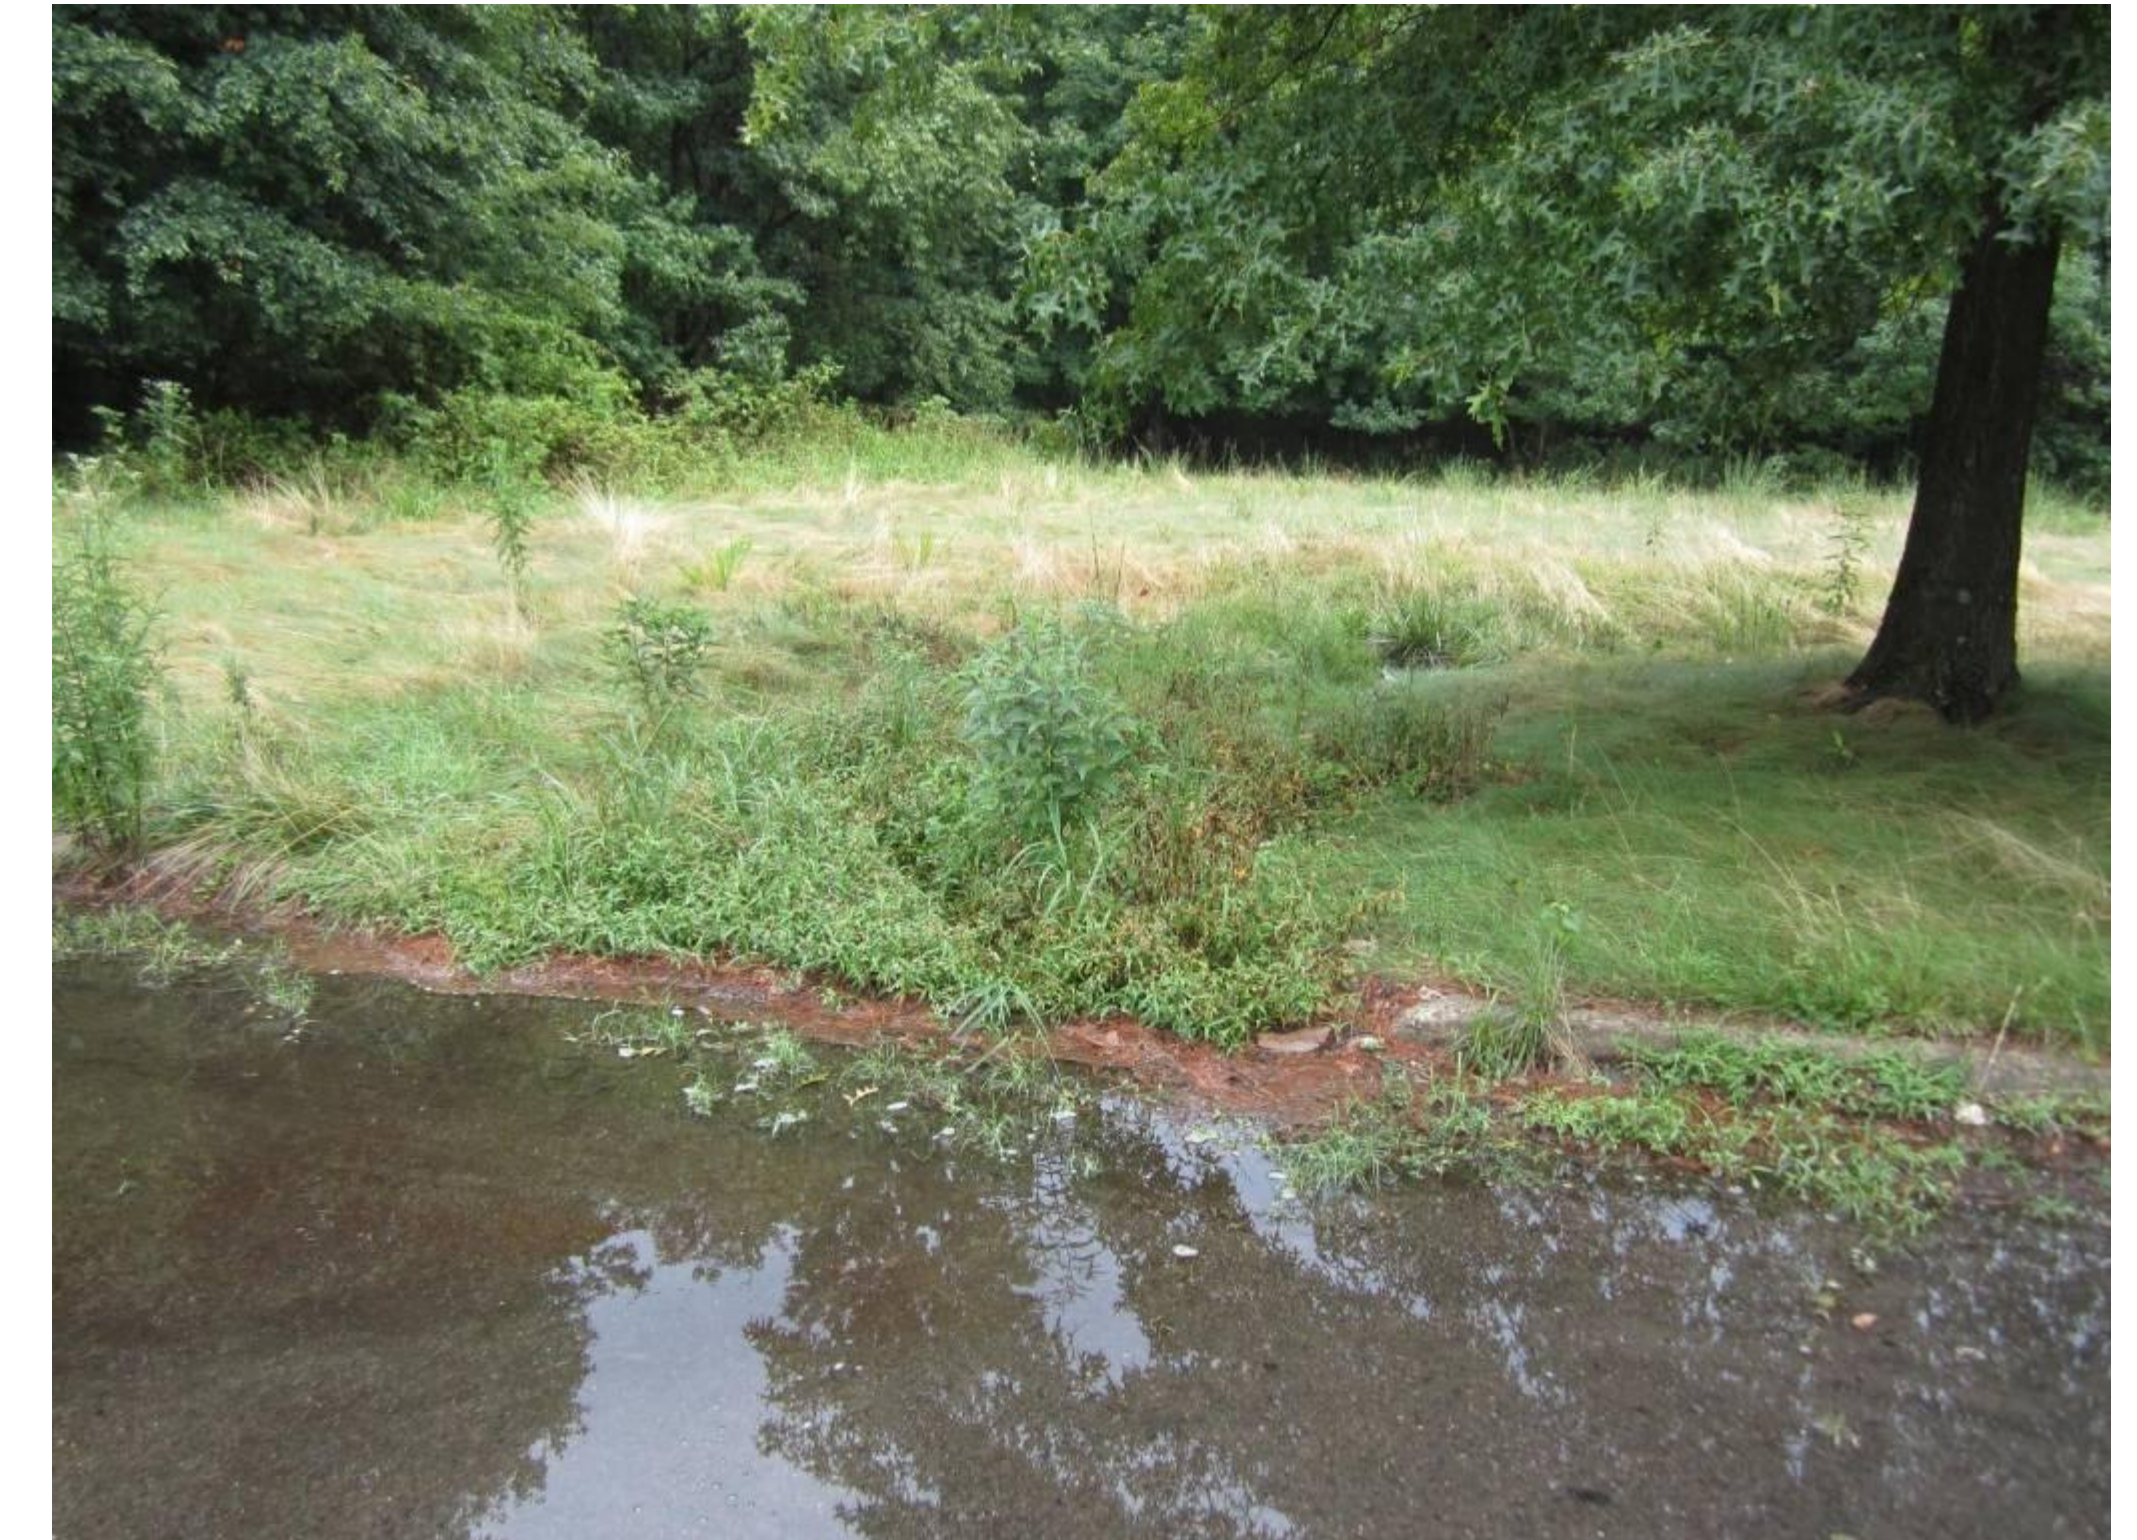
Clogged curb cut, ponding

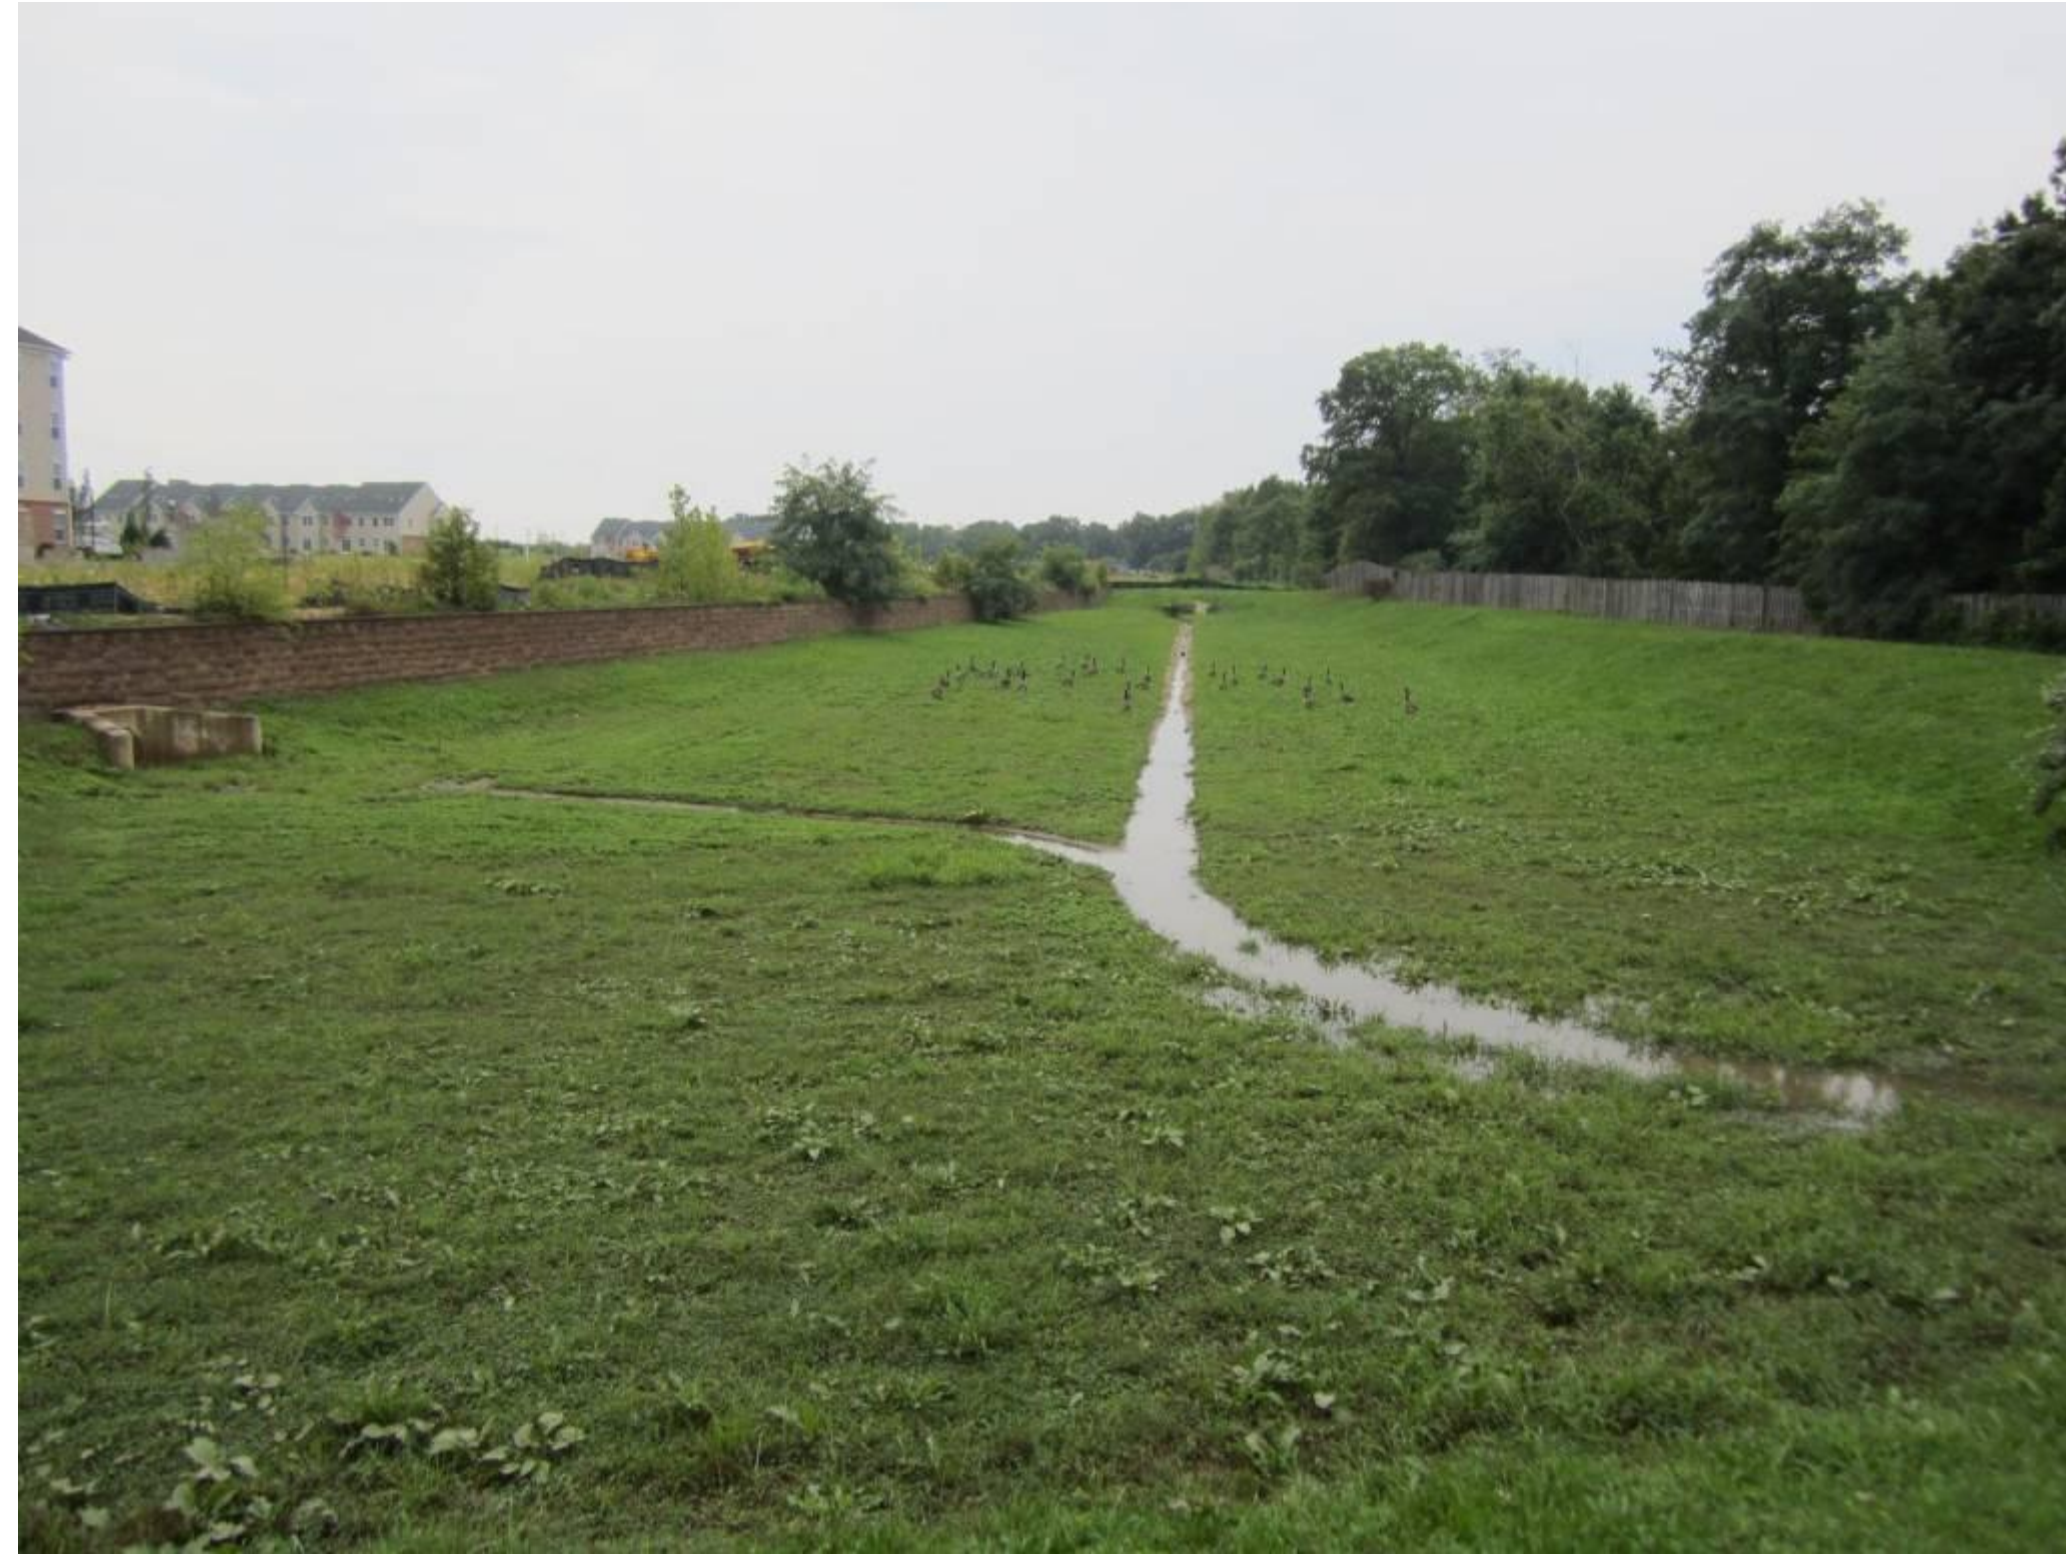
Basin bottom looking southwest

- Inlets and outlet have excess sediment accumulation obstructing flow
- Standing water in low flow channel and basin bottom
- Outlet has structural damage and missing grate

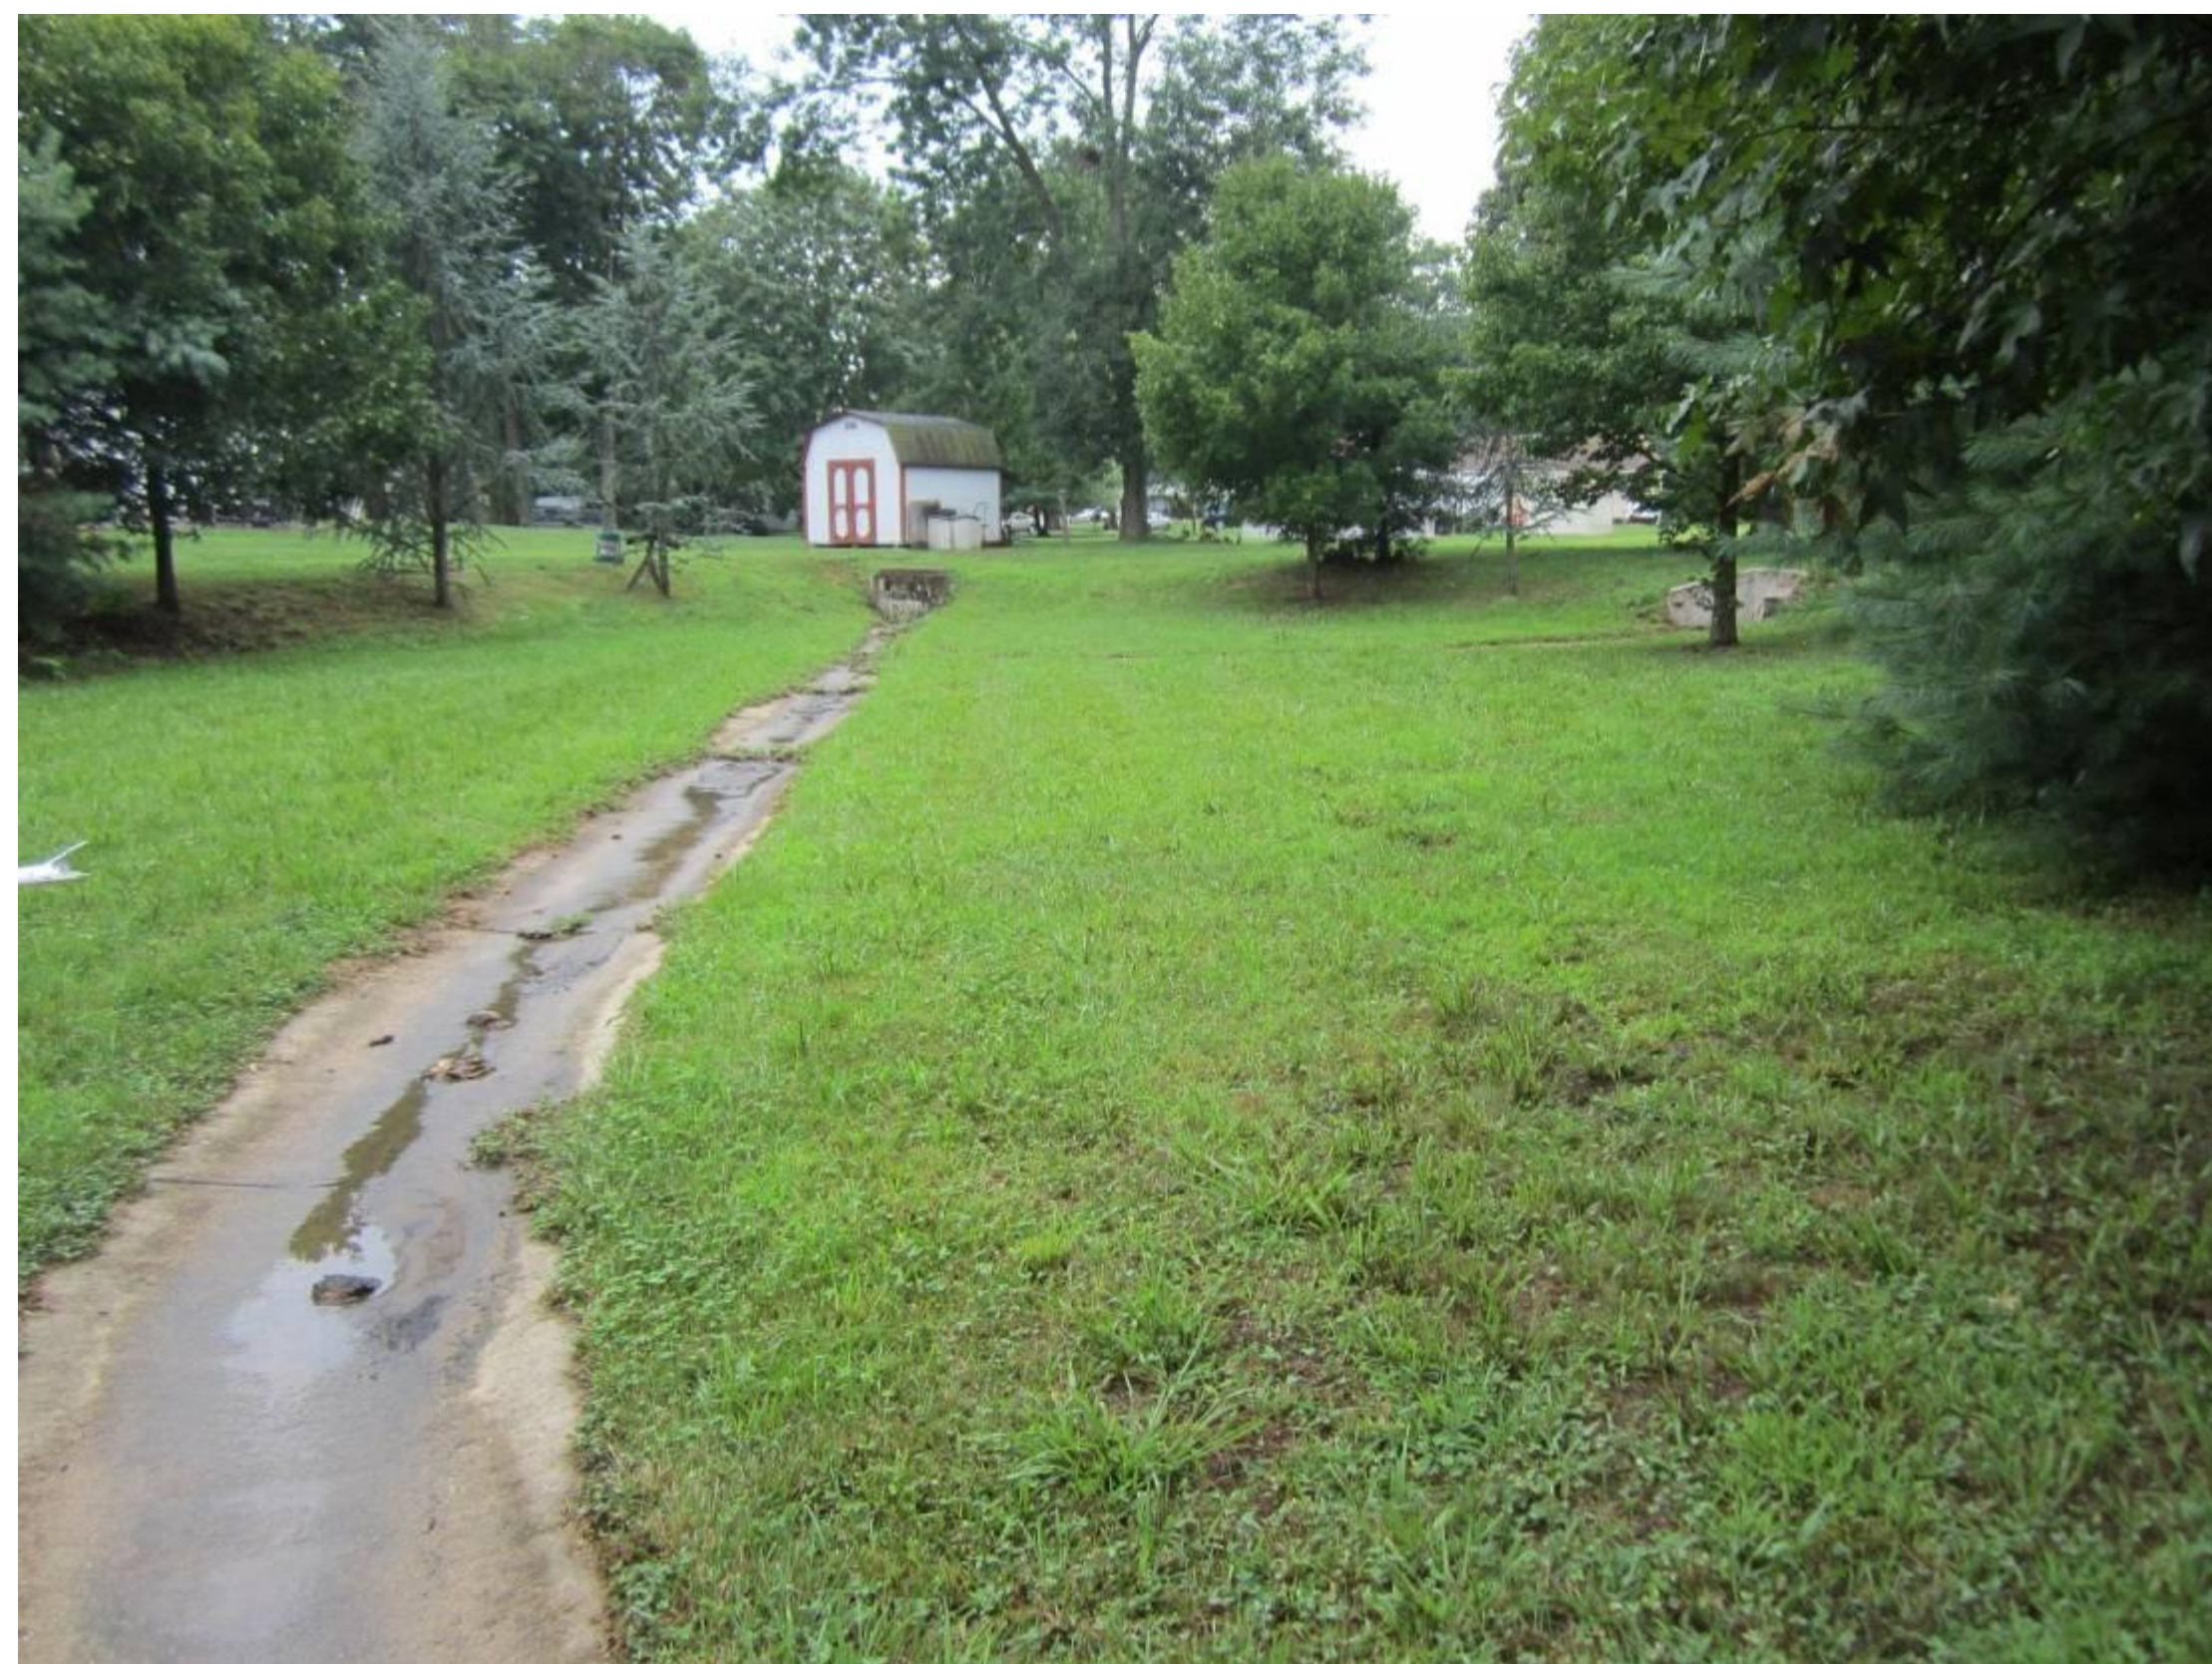
Basin bottom looking southwest

- Standing water in low flow channel
- Outlet has structural damage and trash rack is clogged with sediment/debris

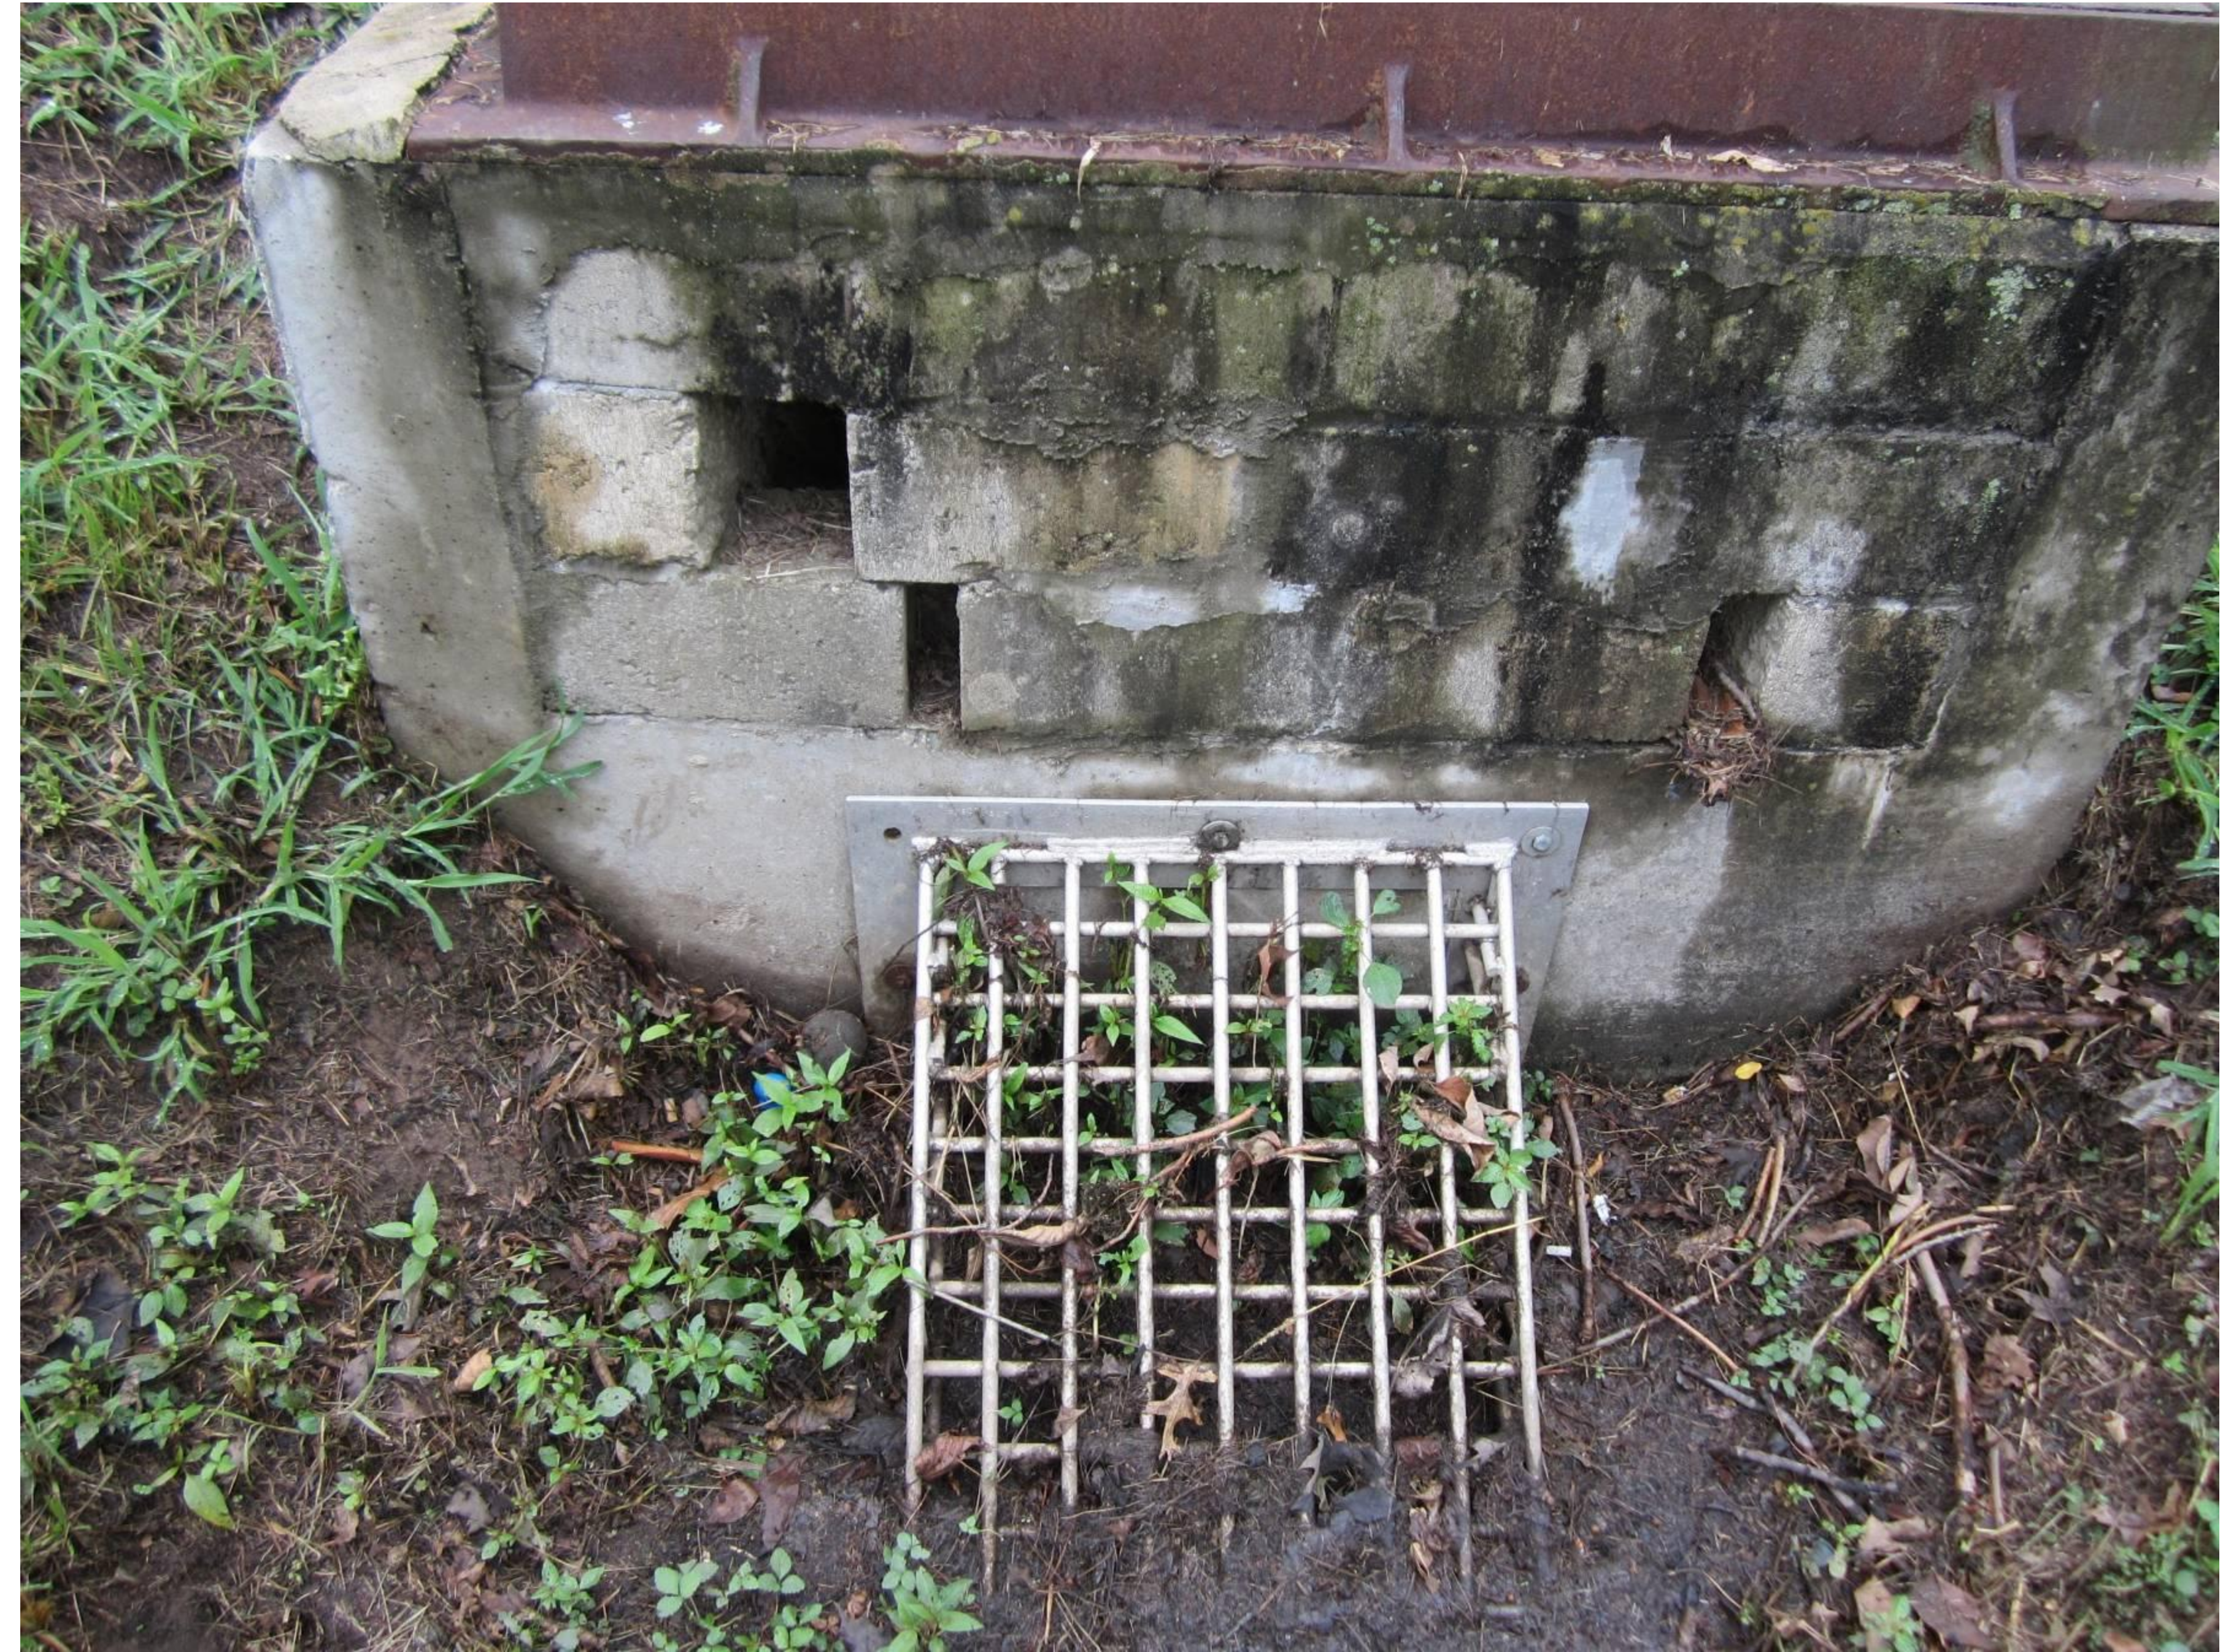
Clogged trash rack at outlet

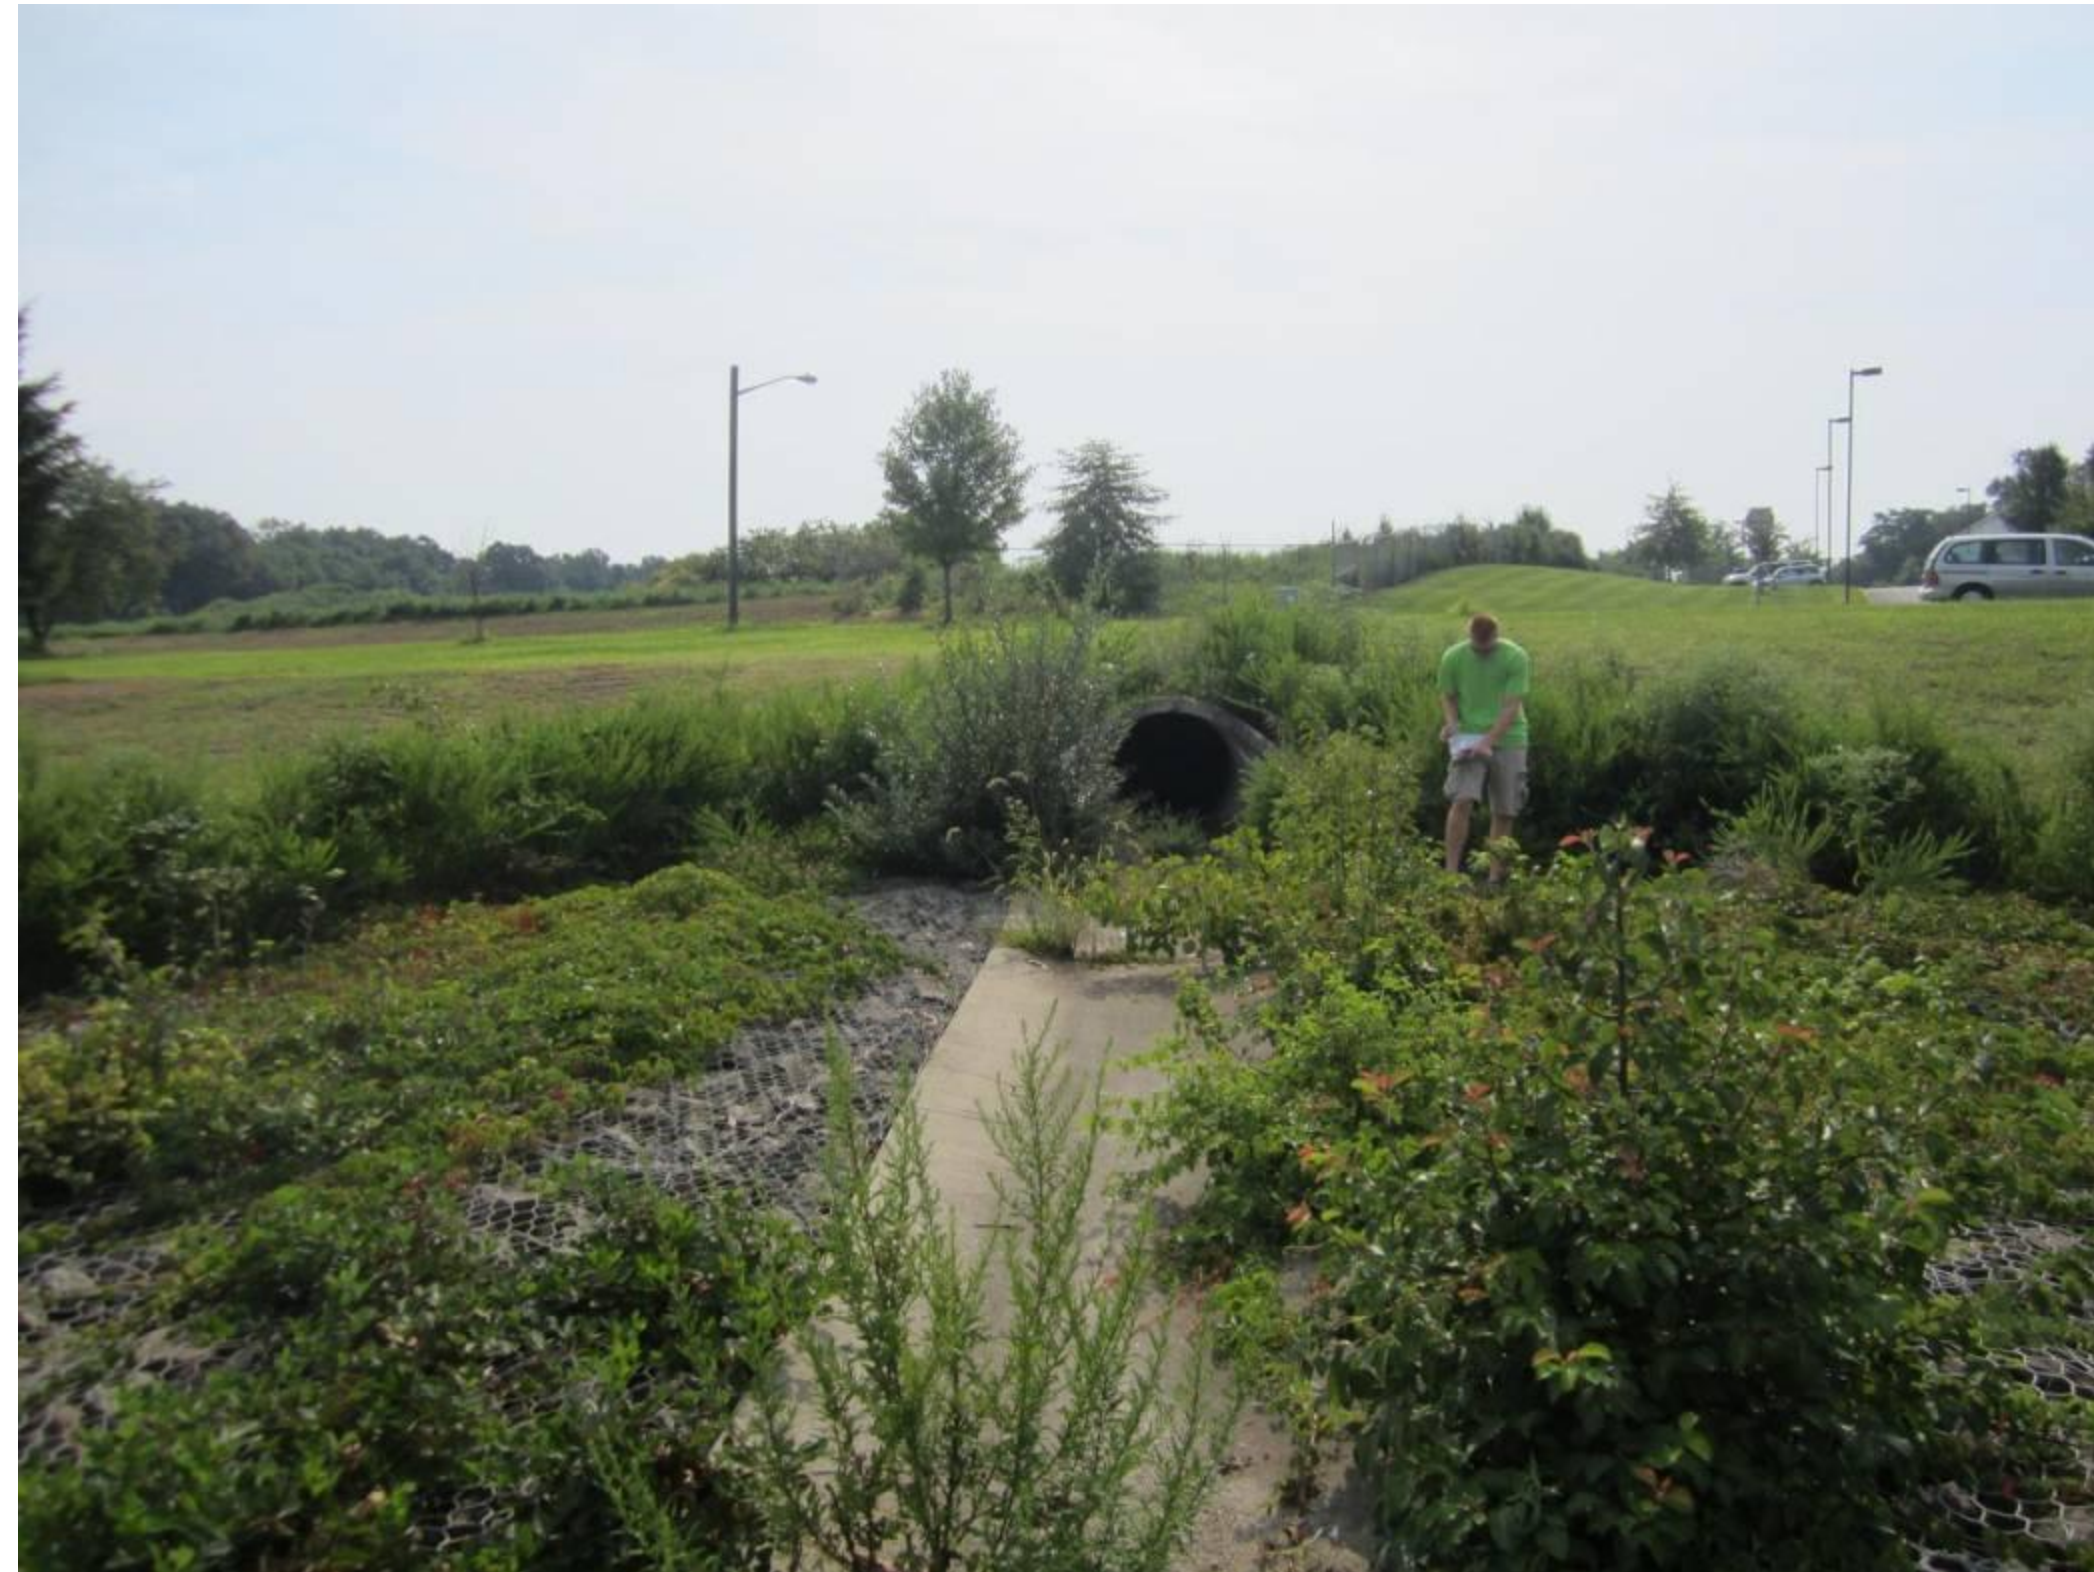
Inlet and rip rap protection

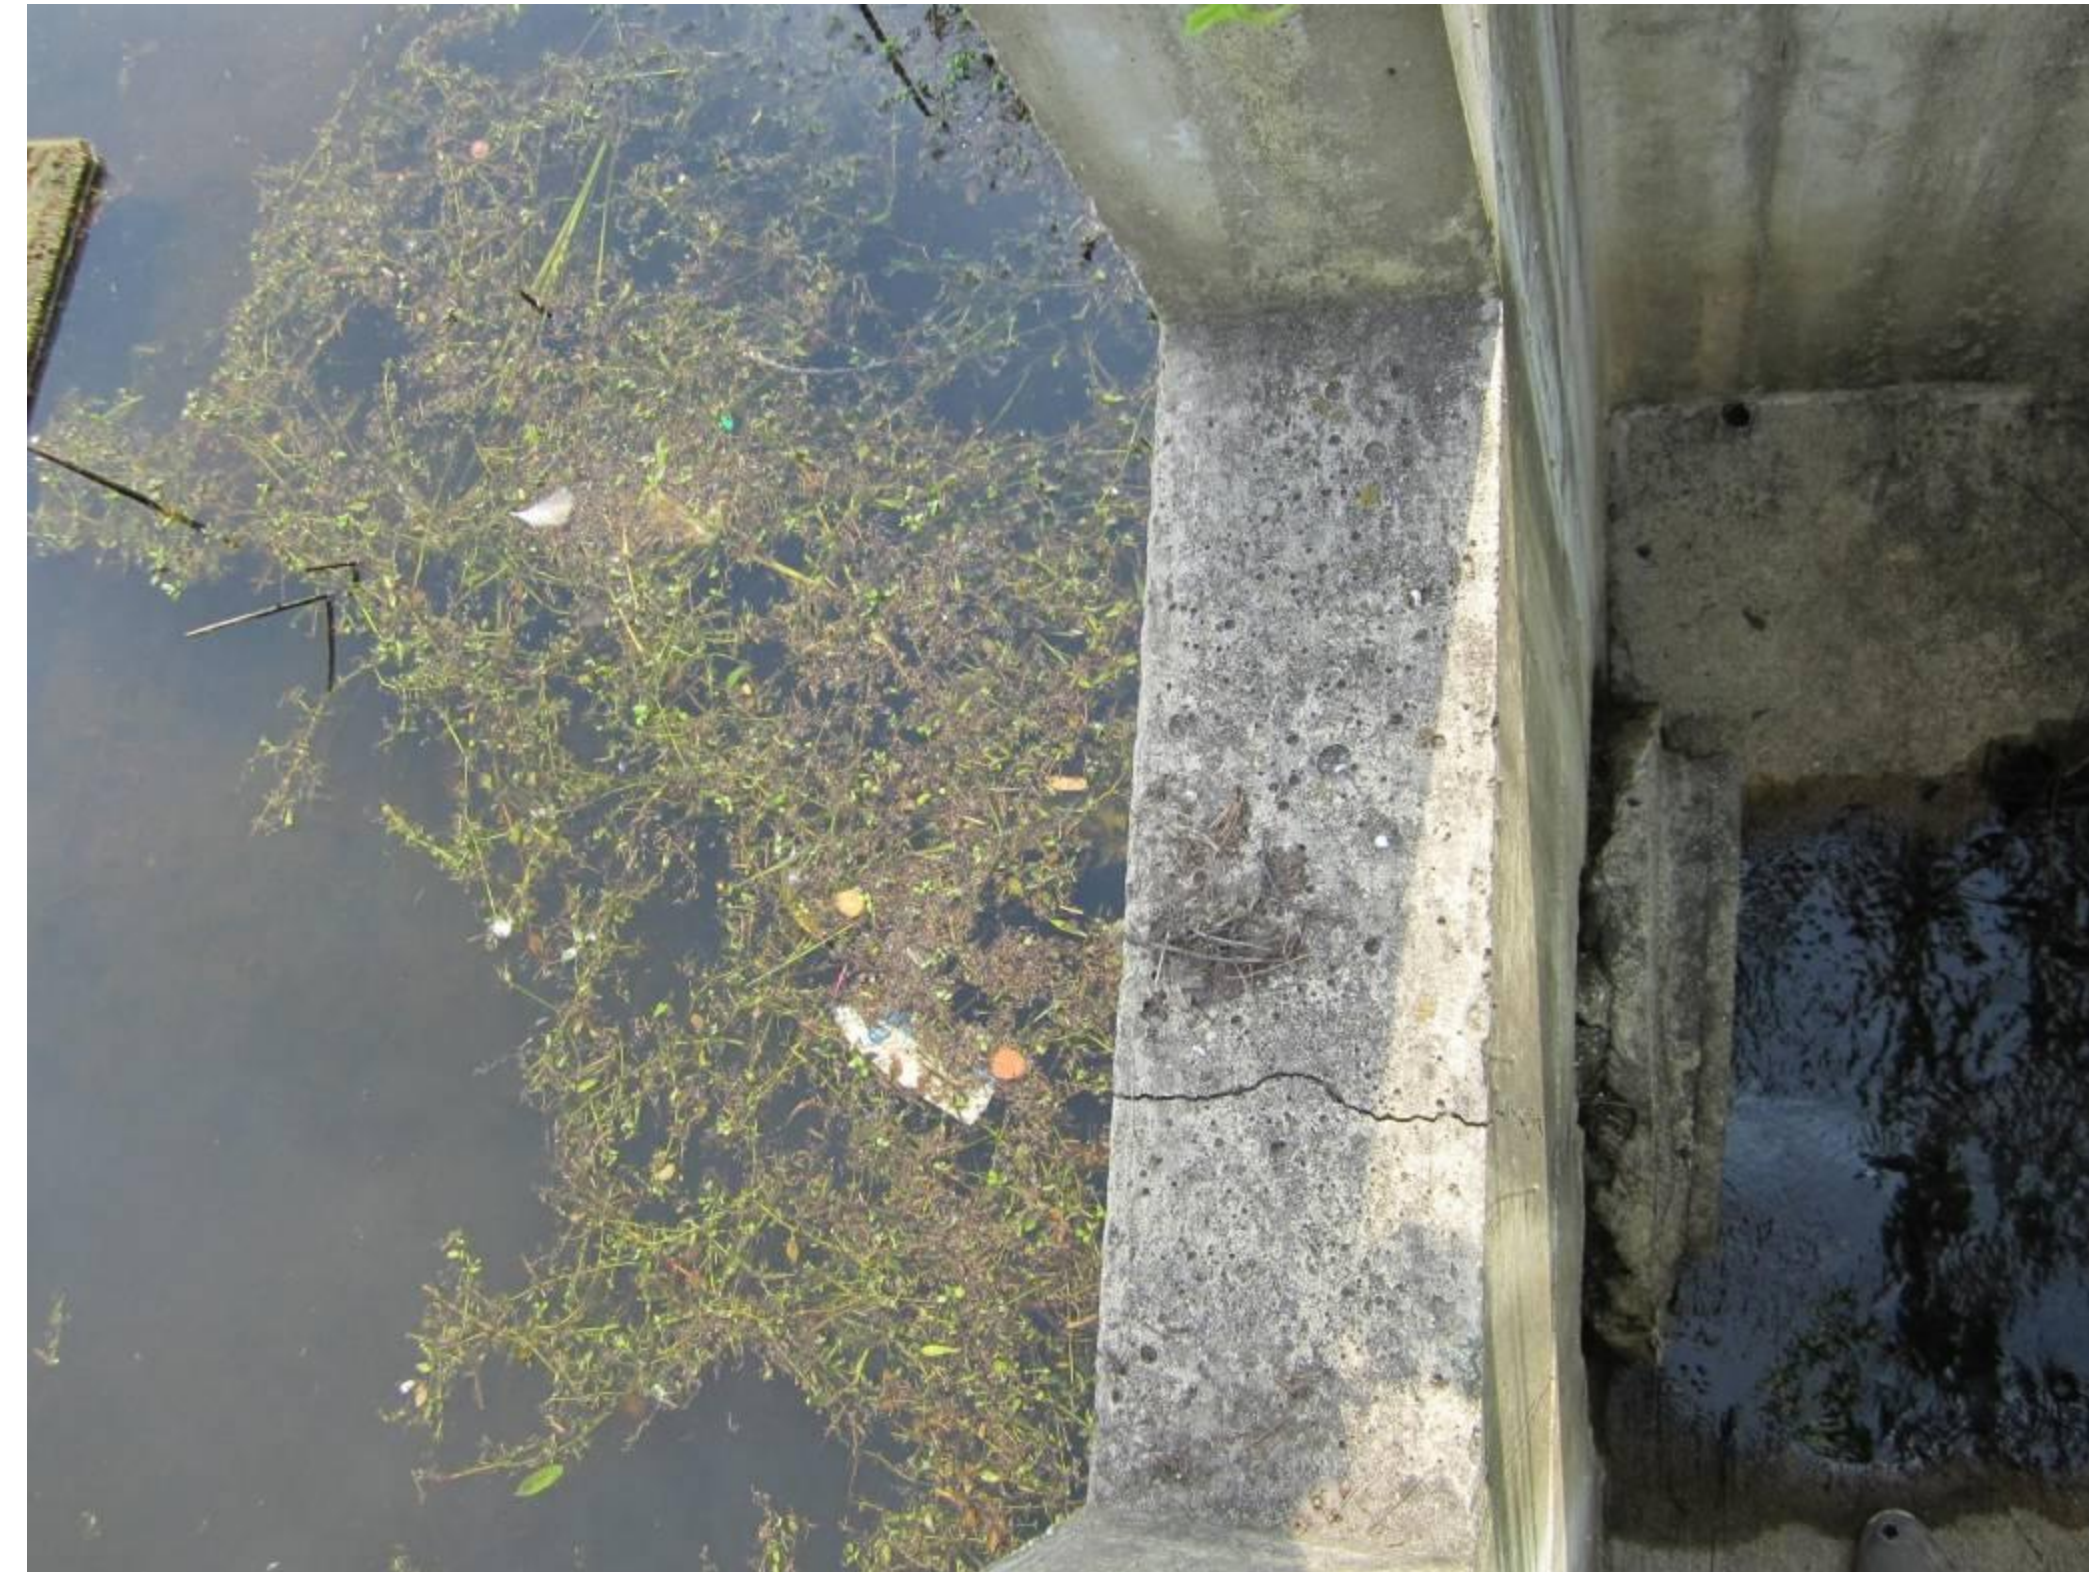
Clogged outlet structure

- Outlet has structural damage, significant debris/sediment accumulation obstructing flow
- Woody vegetation growth in and around basin
- Excessive ponding in front of outlet in entire south end of basin
- Significant mosquito population
