Hamilton Township (Mercer County) Stormwater Basin Assessment Summary (Year 1)

Developed by the Rutgers Cooperative Extension Water Resources Program
Funded by Hamilton Township, Mercer County, New Jersey

December 6, 2012

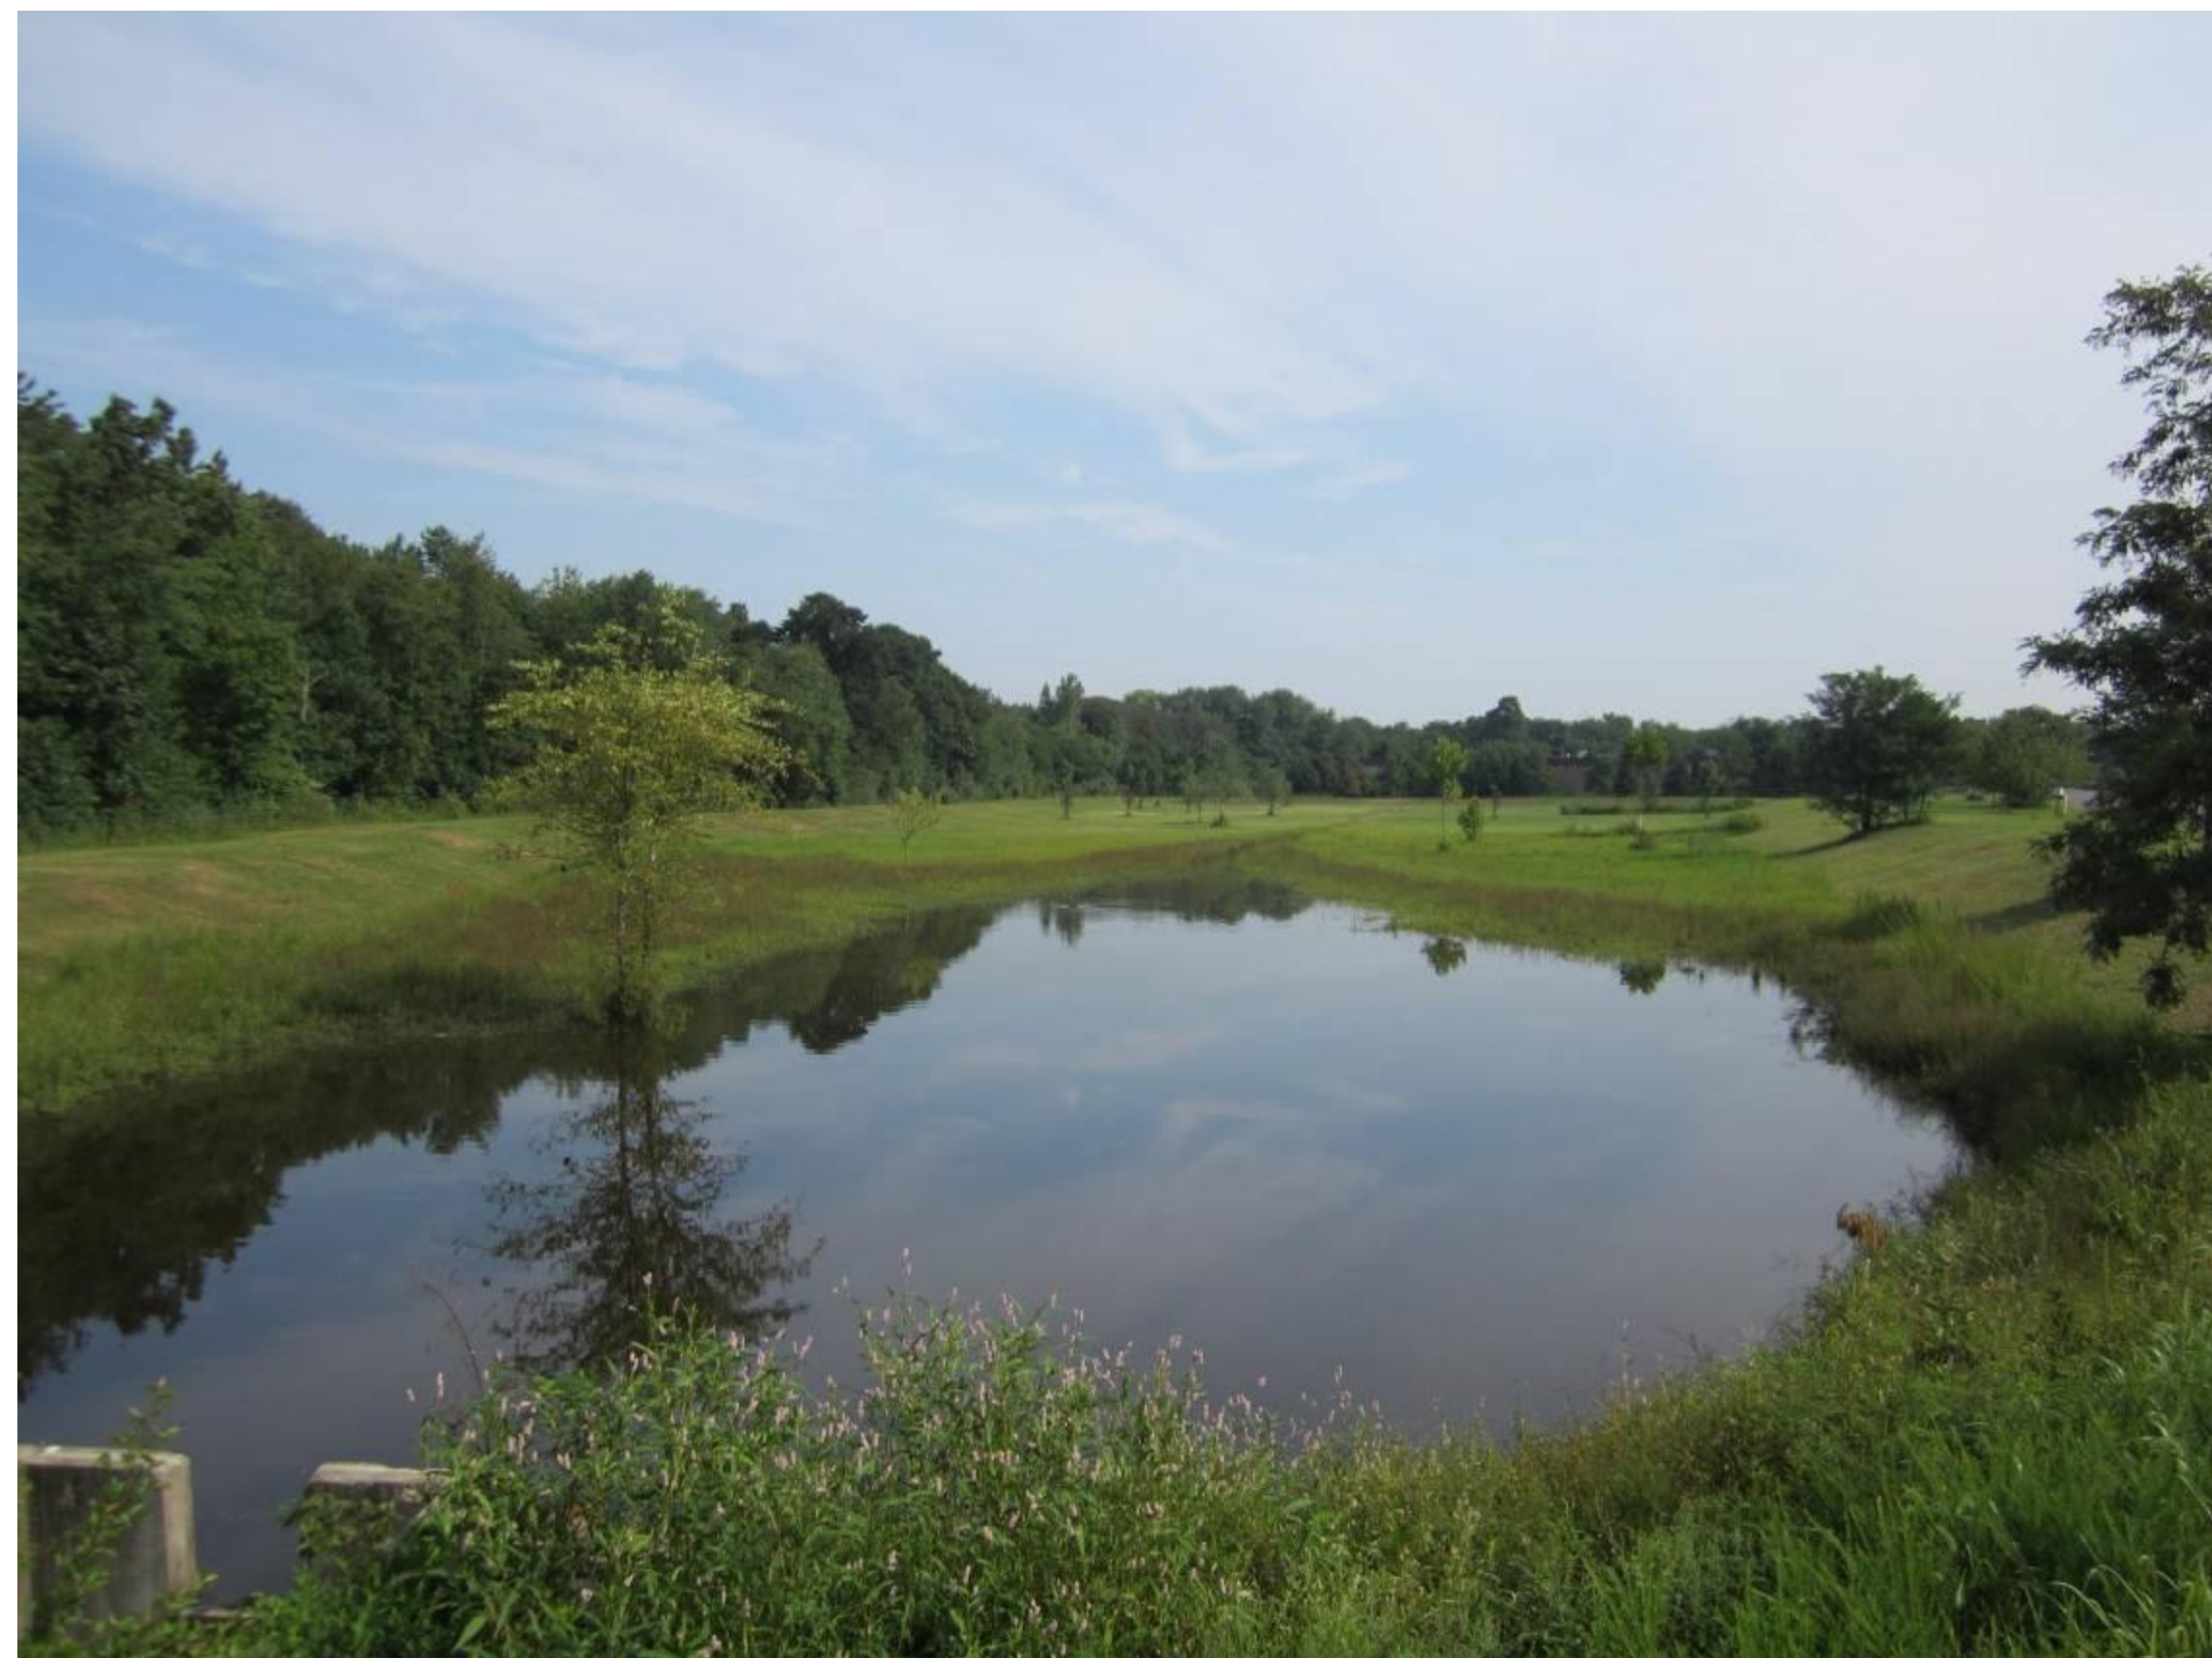
Ponding in front of outlet

- Outlet has structural damage, significant debris/sediment accumulation obstructing flow
- Woody vegetation growth in and around basin
- Excessive ponding in front of outlet in entire south end of basin
- Significant mosquito population

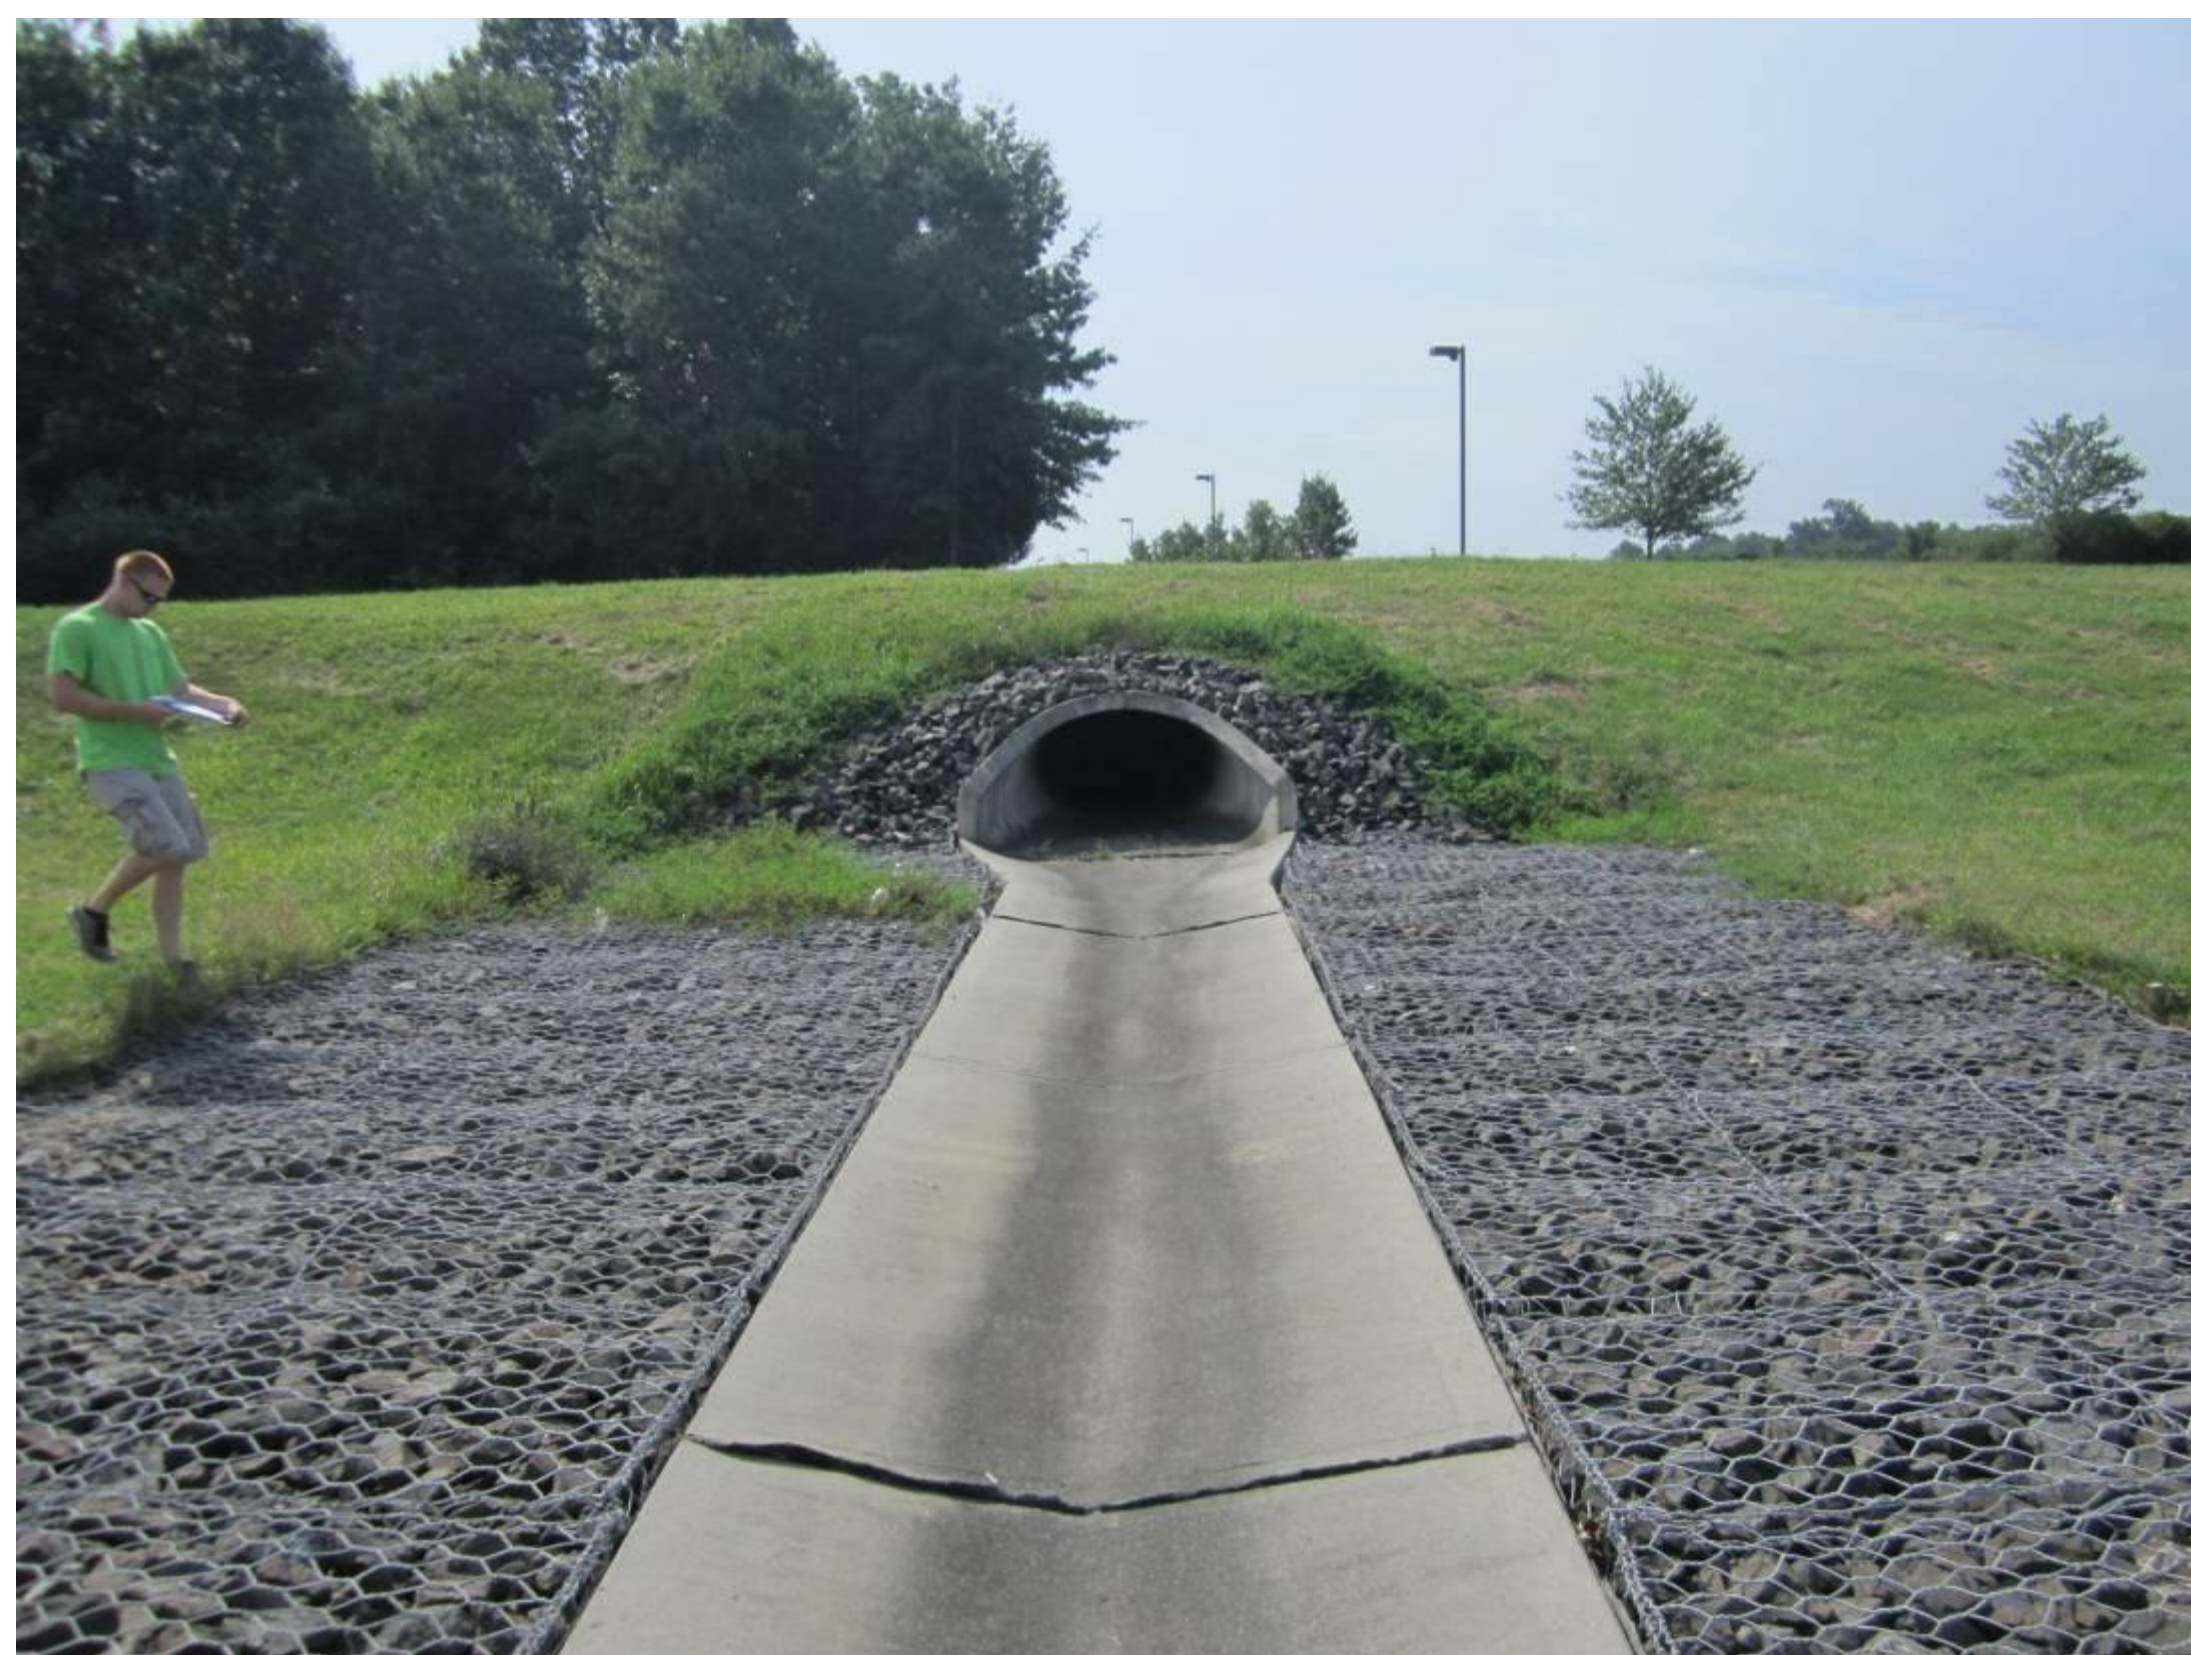
Inlet and rip rap protection

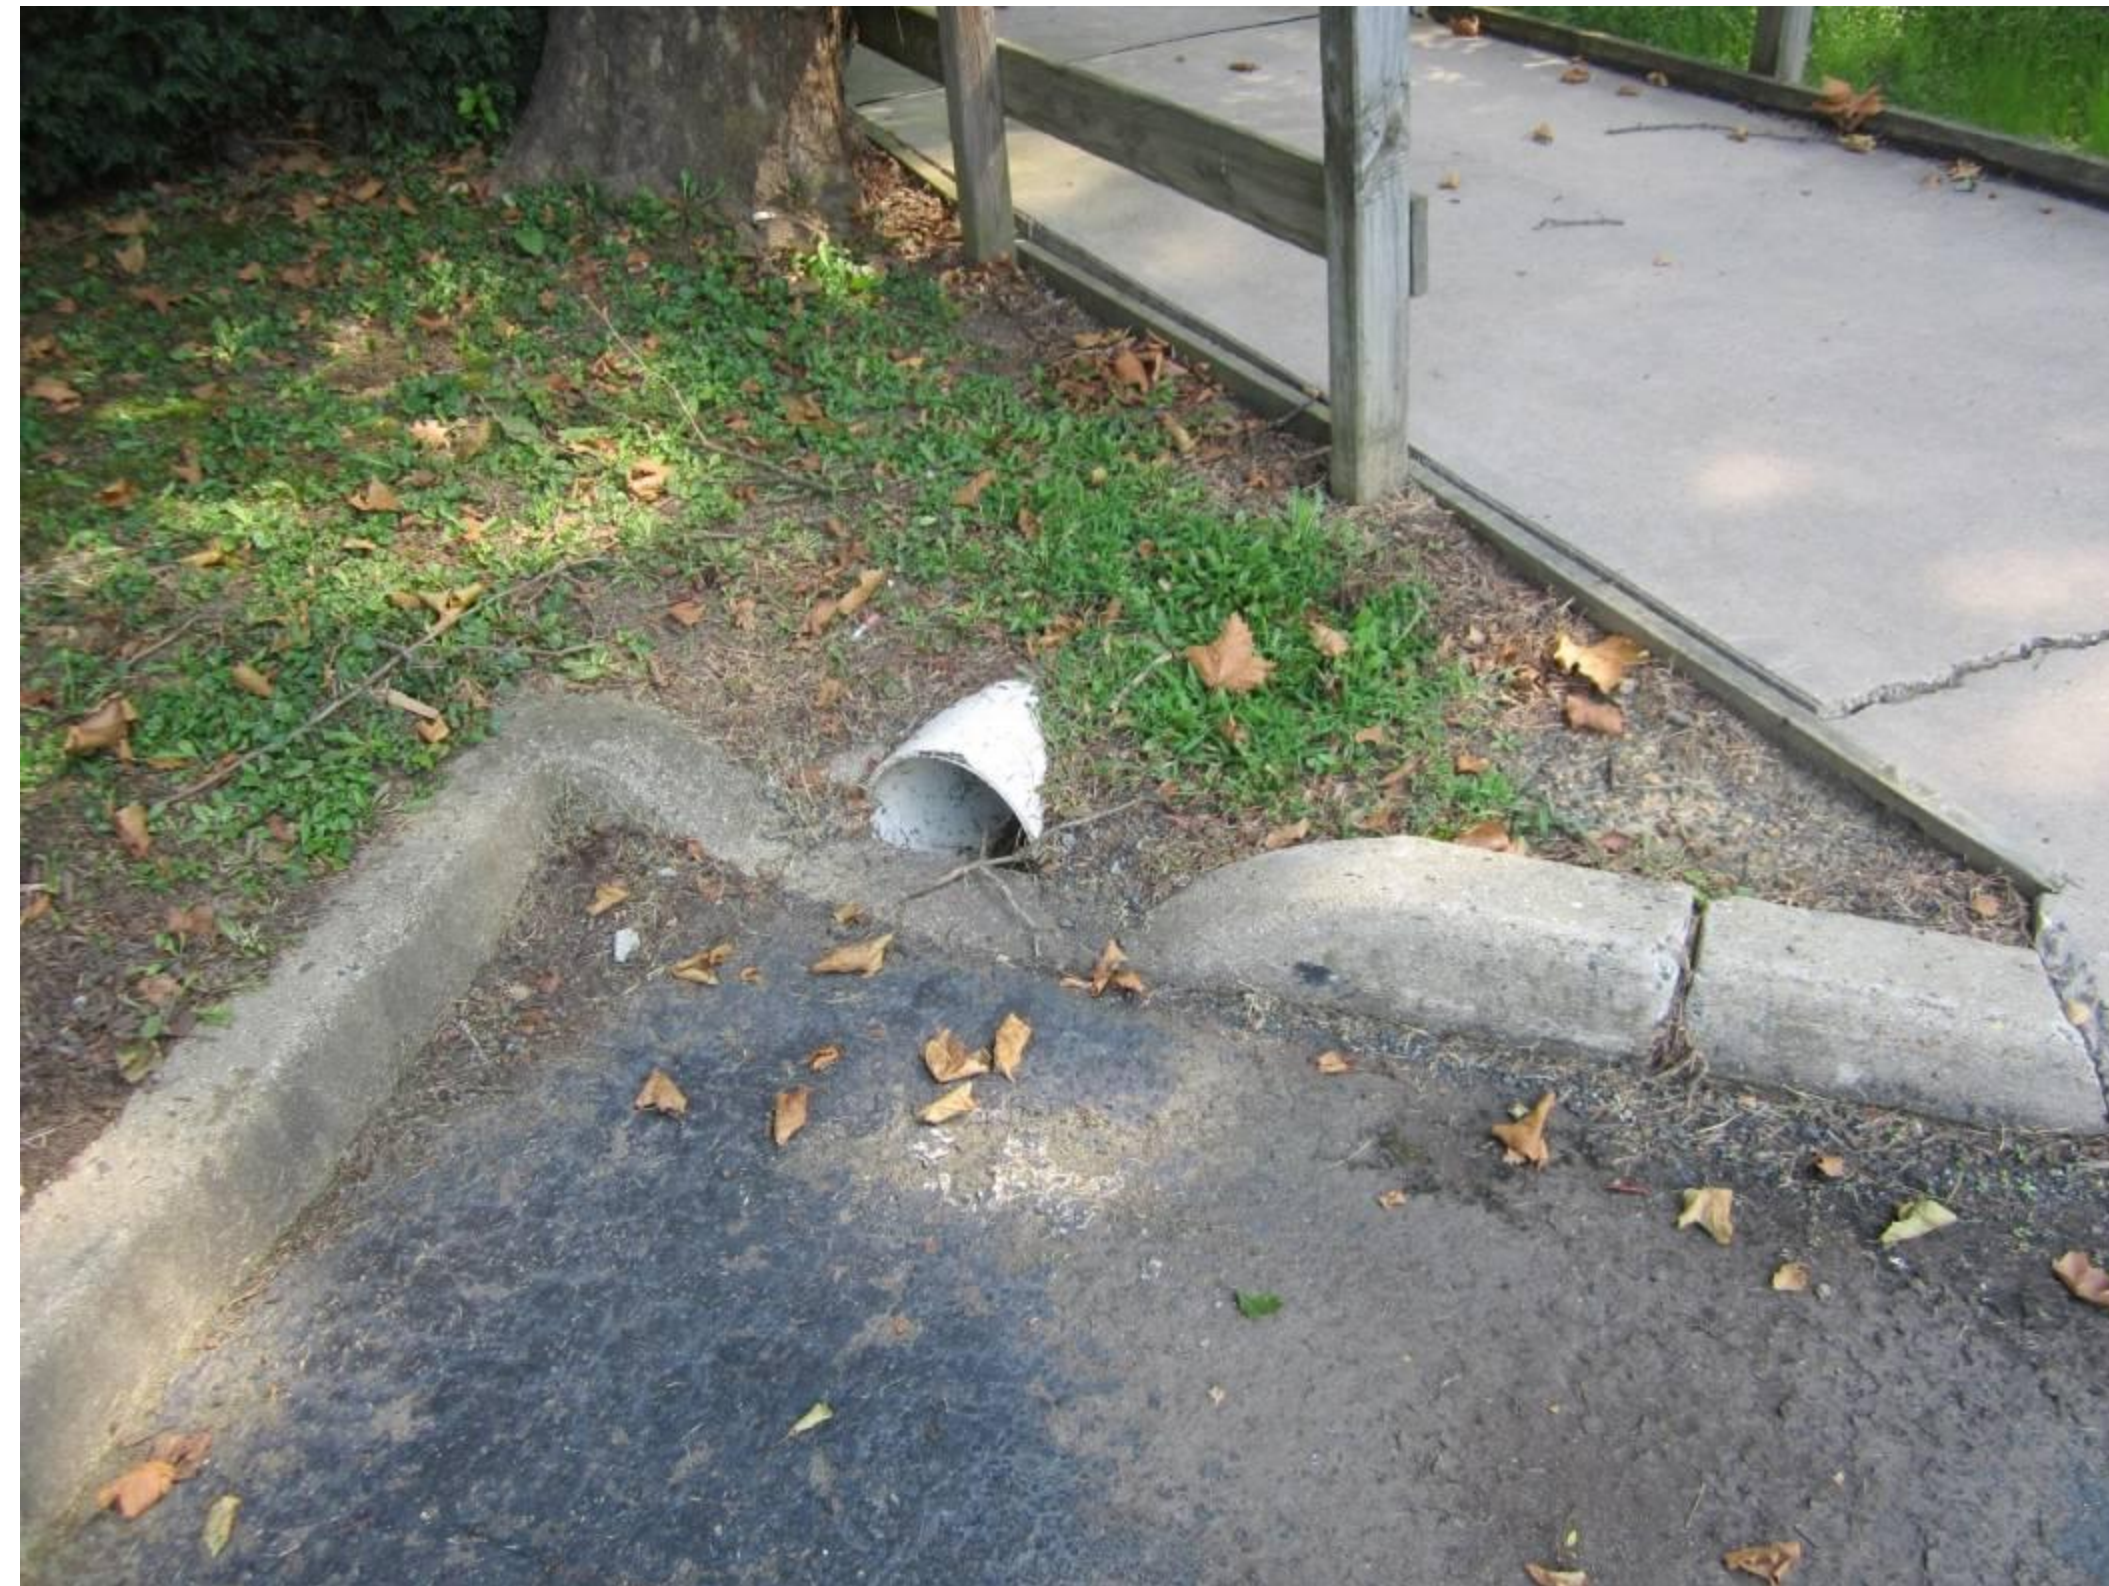
Curb cut with PVC pipe

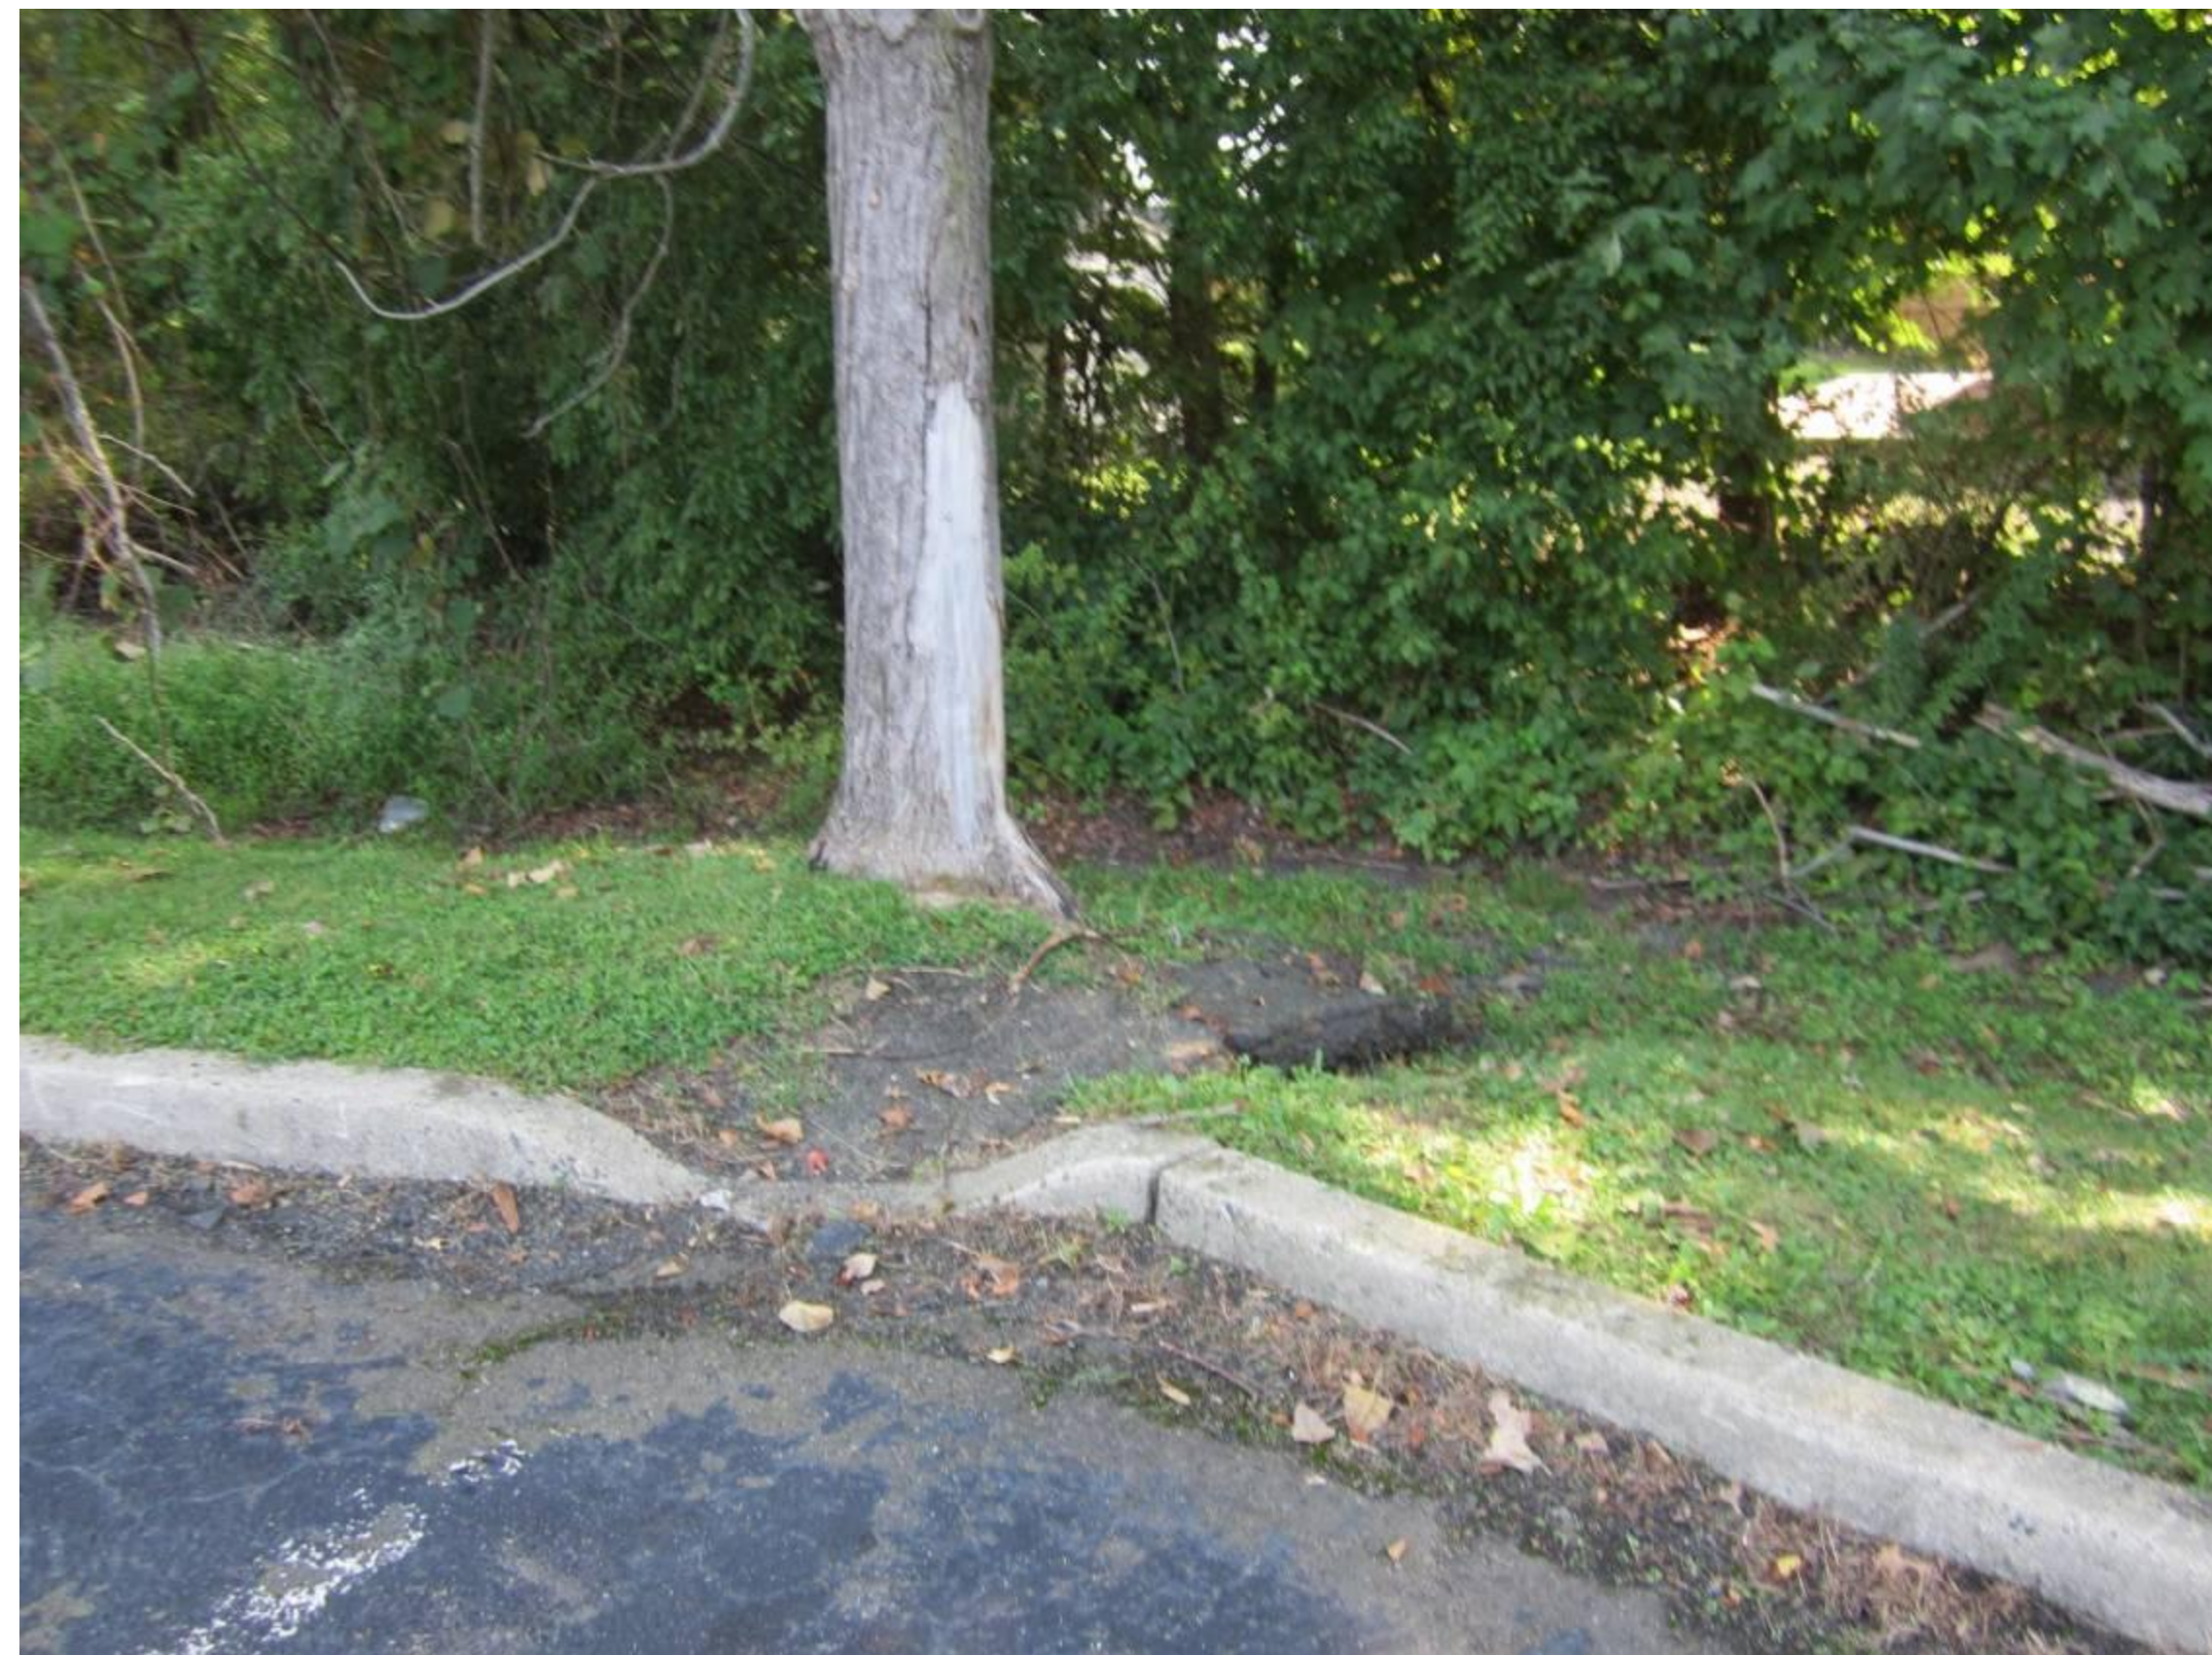
Curb cut with erosion

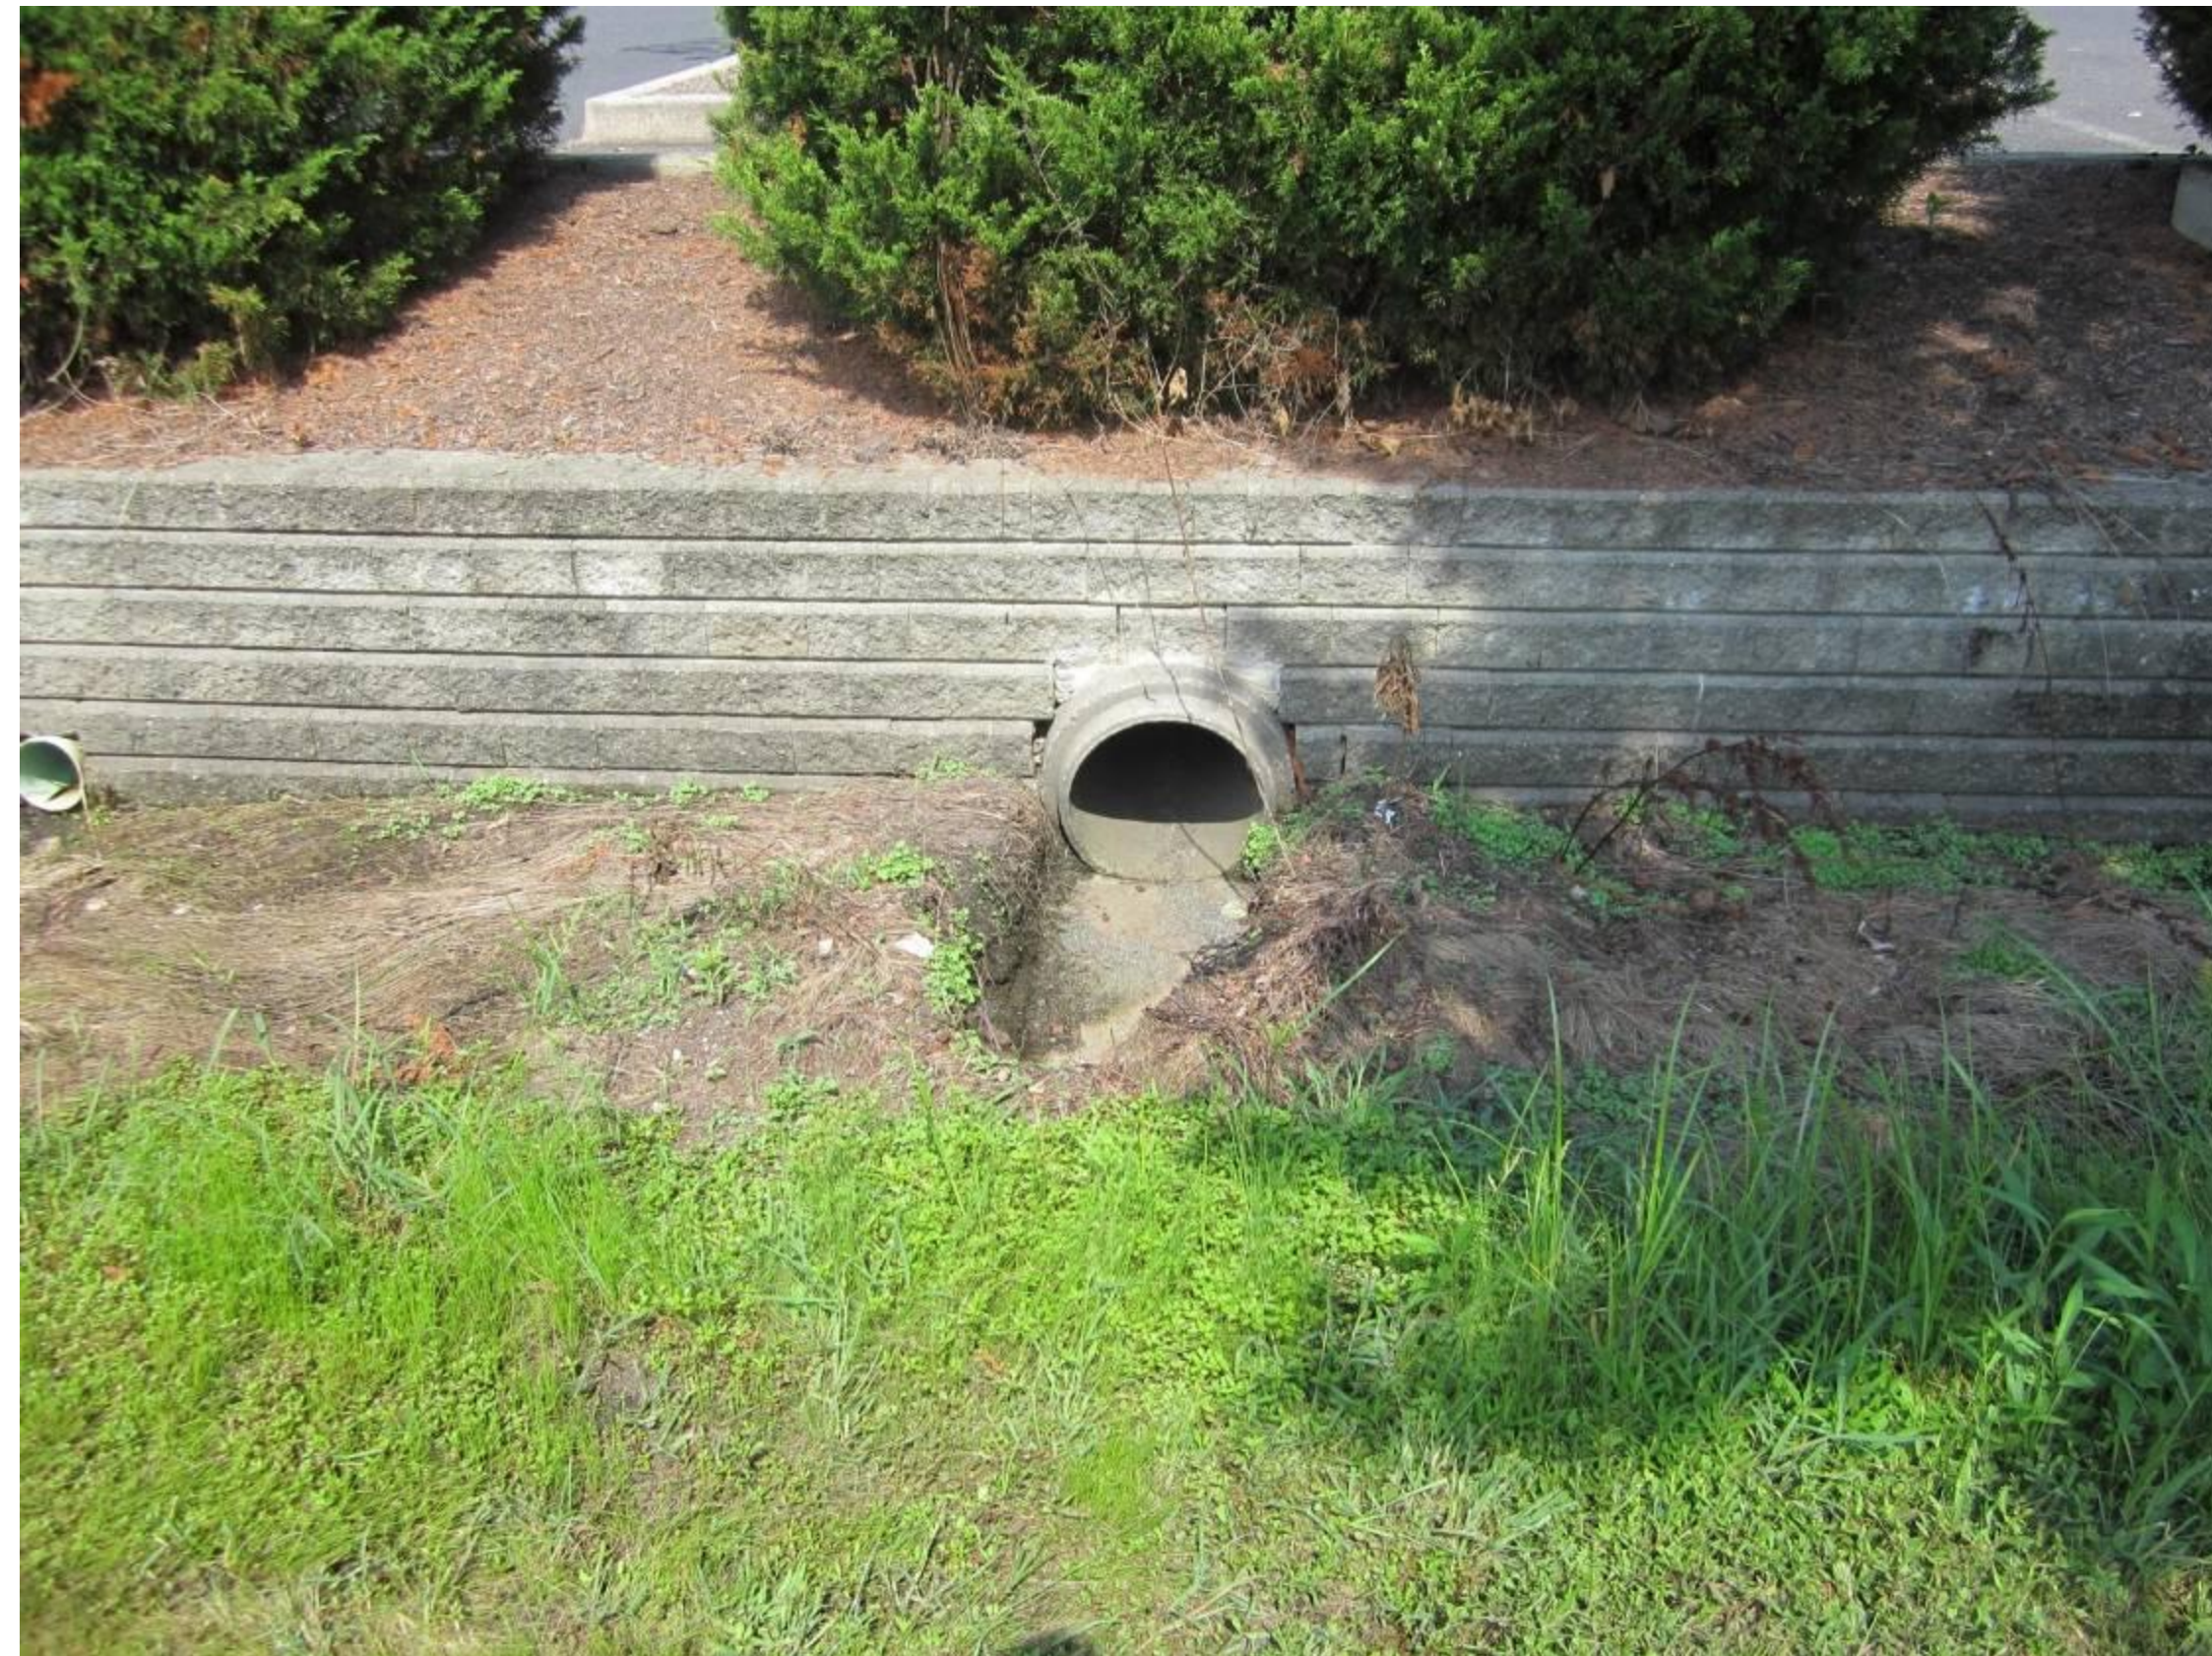
Inlet with sediment accumulation

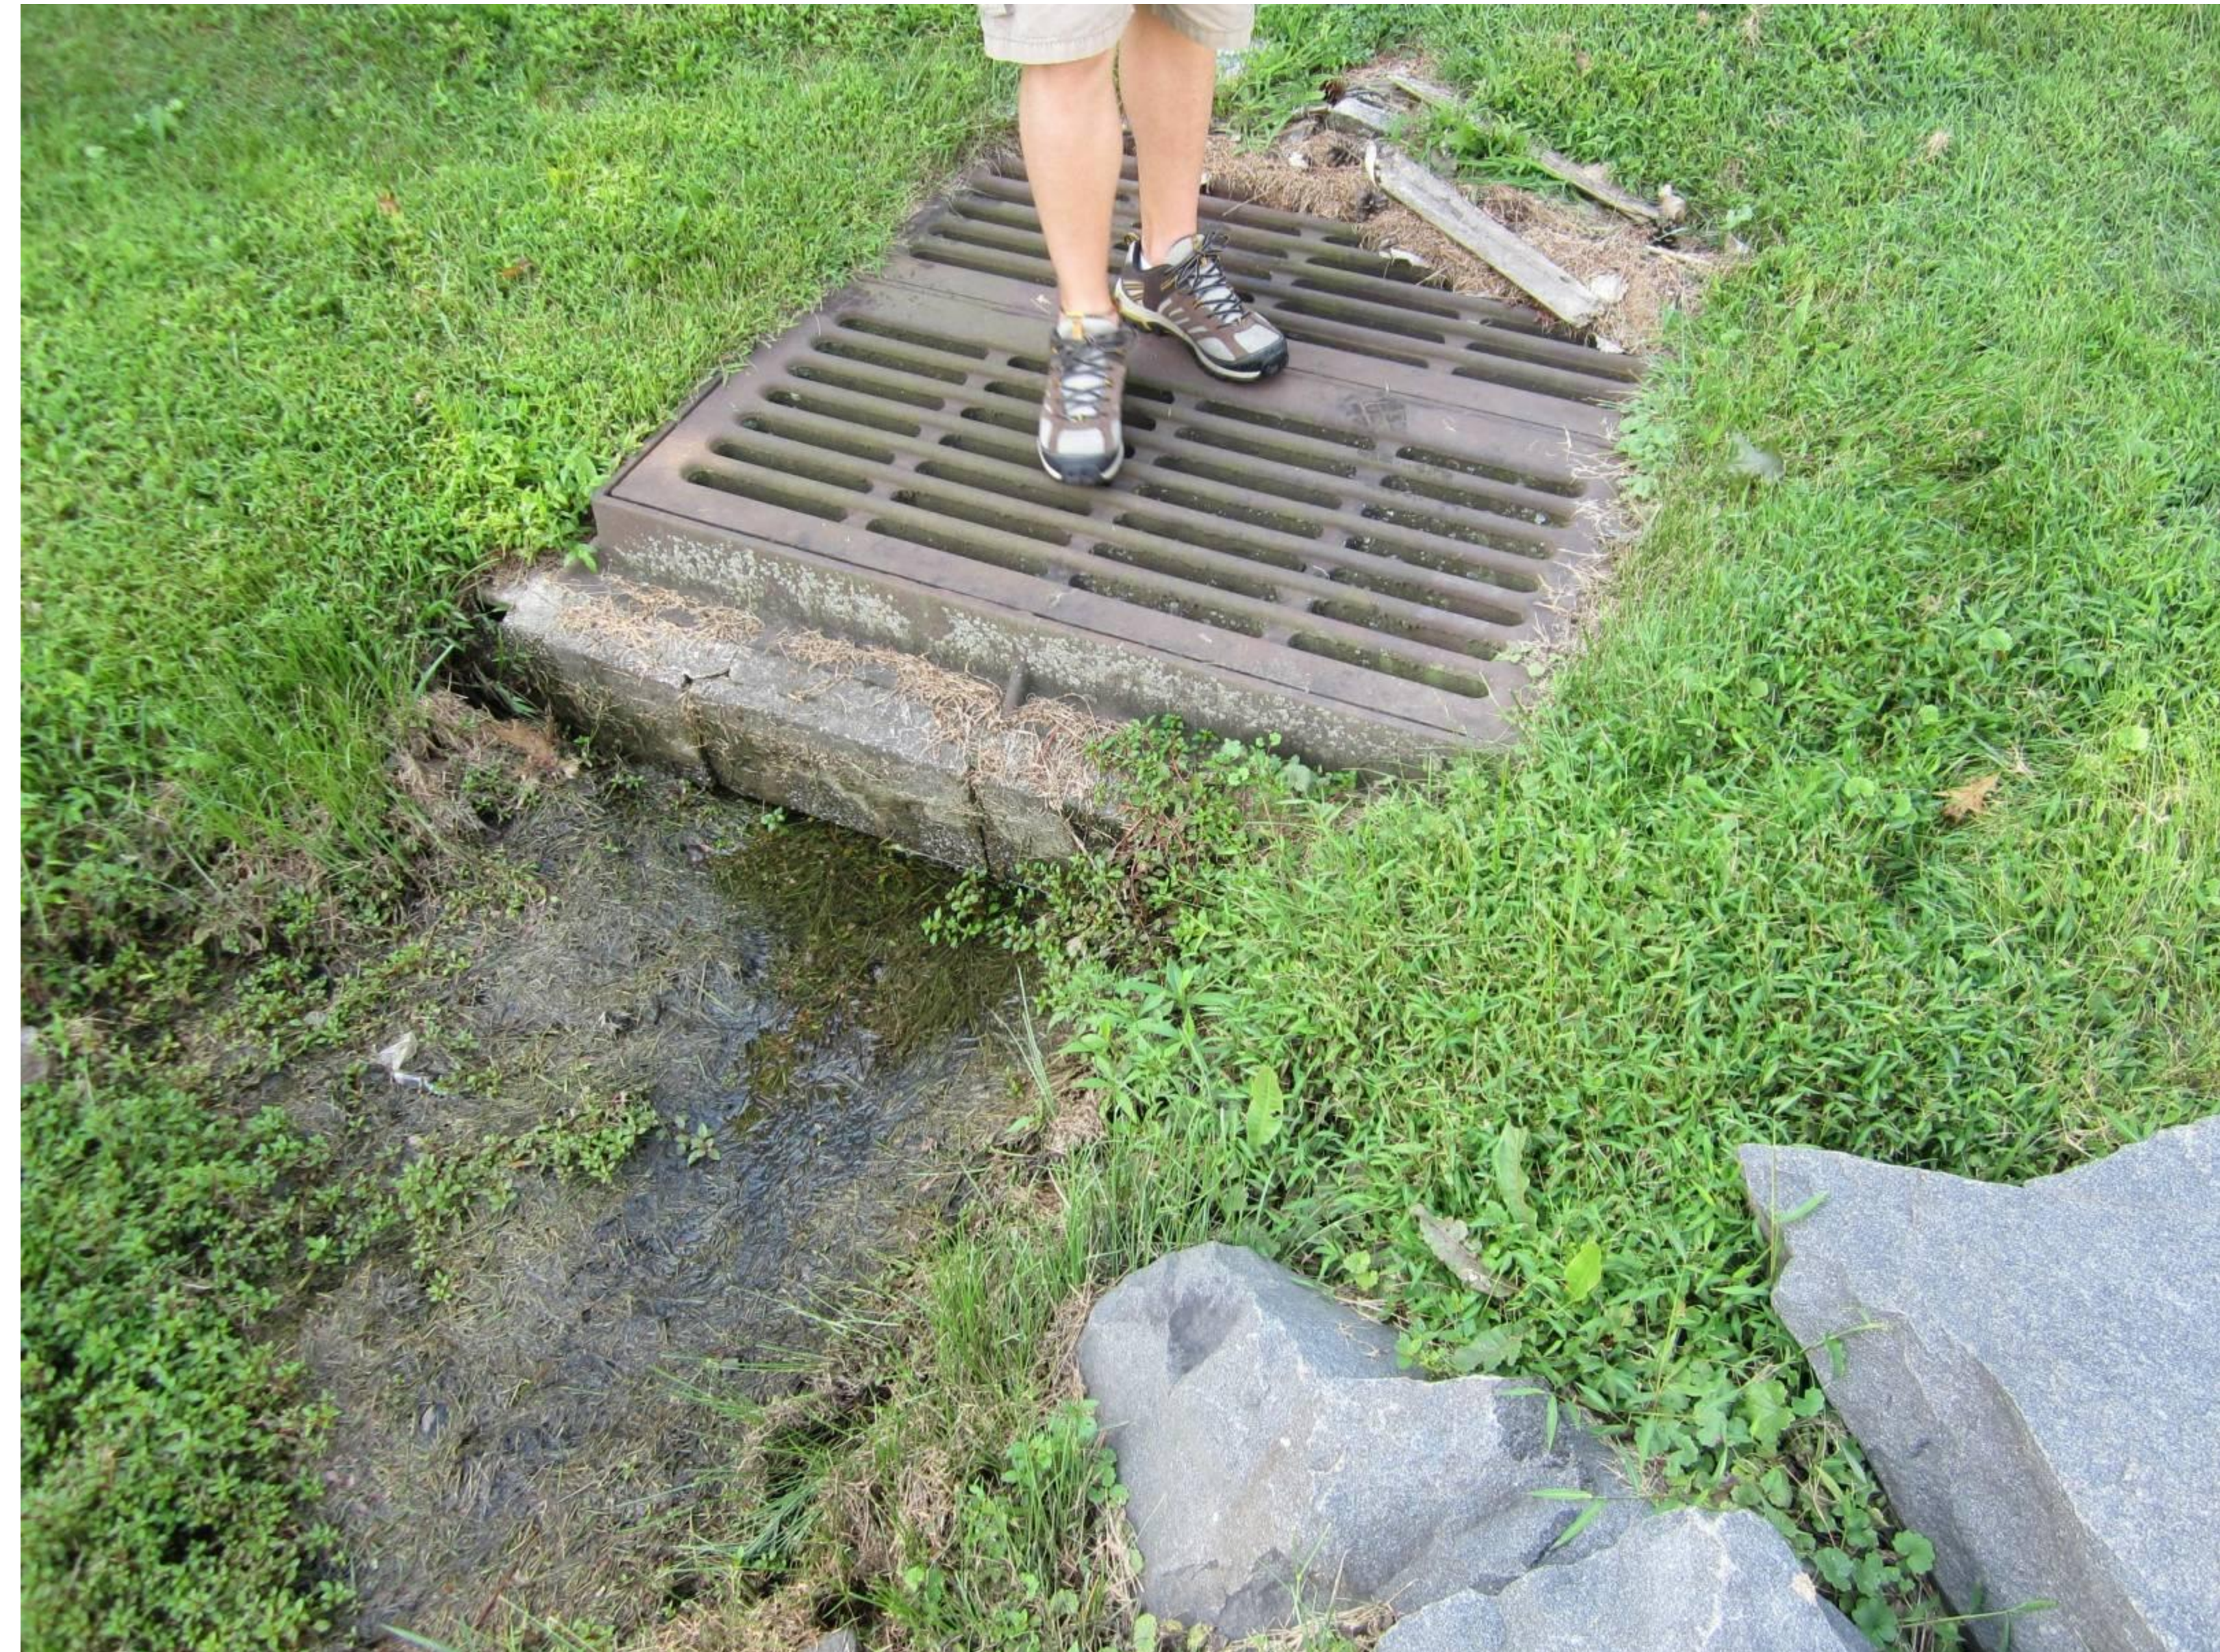
Outlet with clogged orifice
