Hamilton Township (Mercer County) Stormwater Basin Assessment Summary (Year 1)

Developed by the Rutgers Cooperative Extension Water Resources Program
Funded by Hamilton Township, Mercer County, New Jersey

December 6, 2012

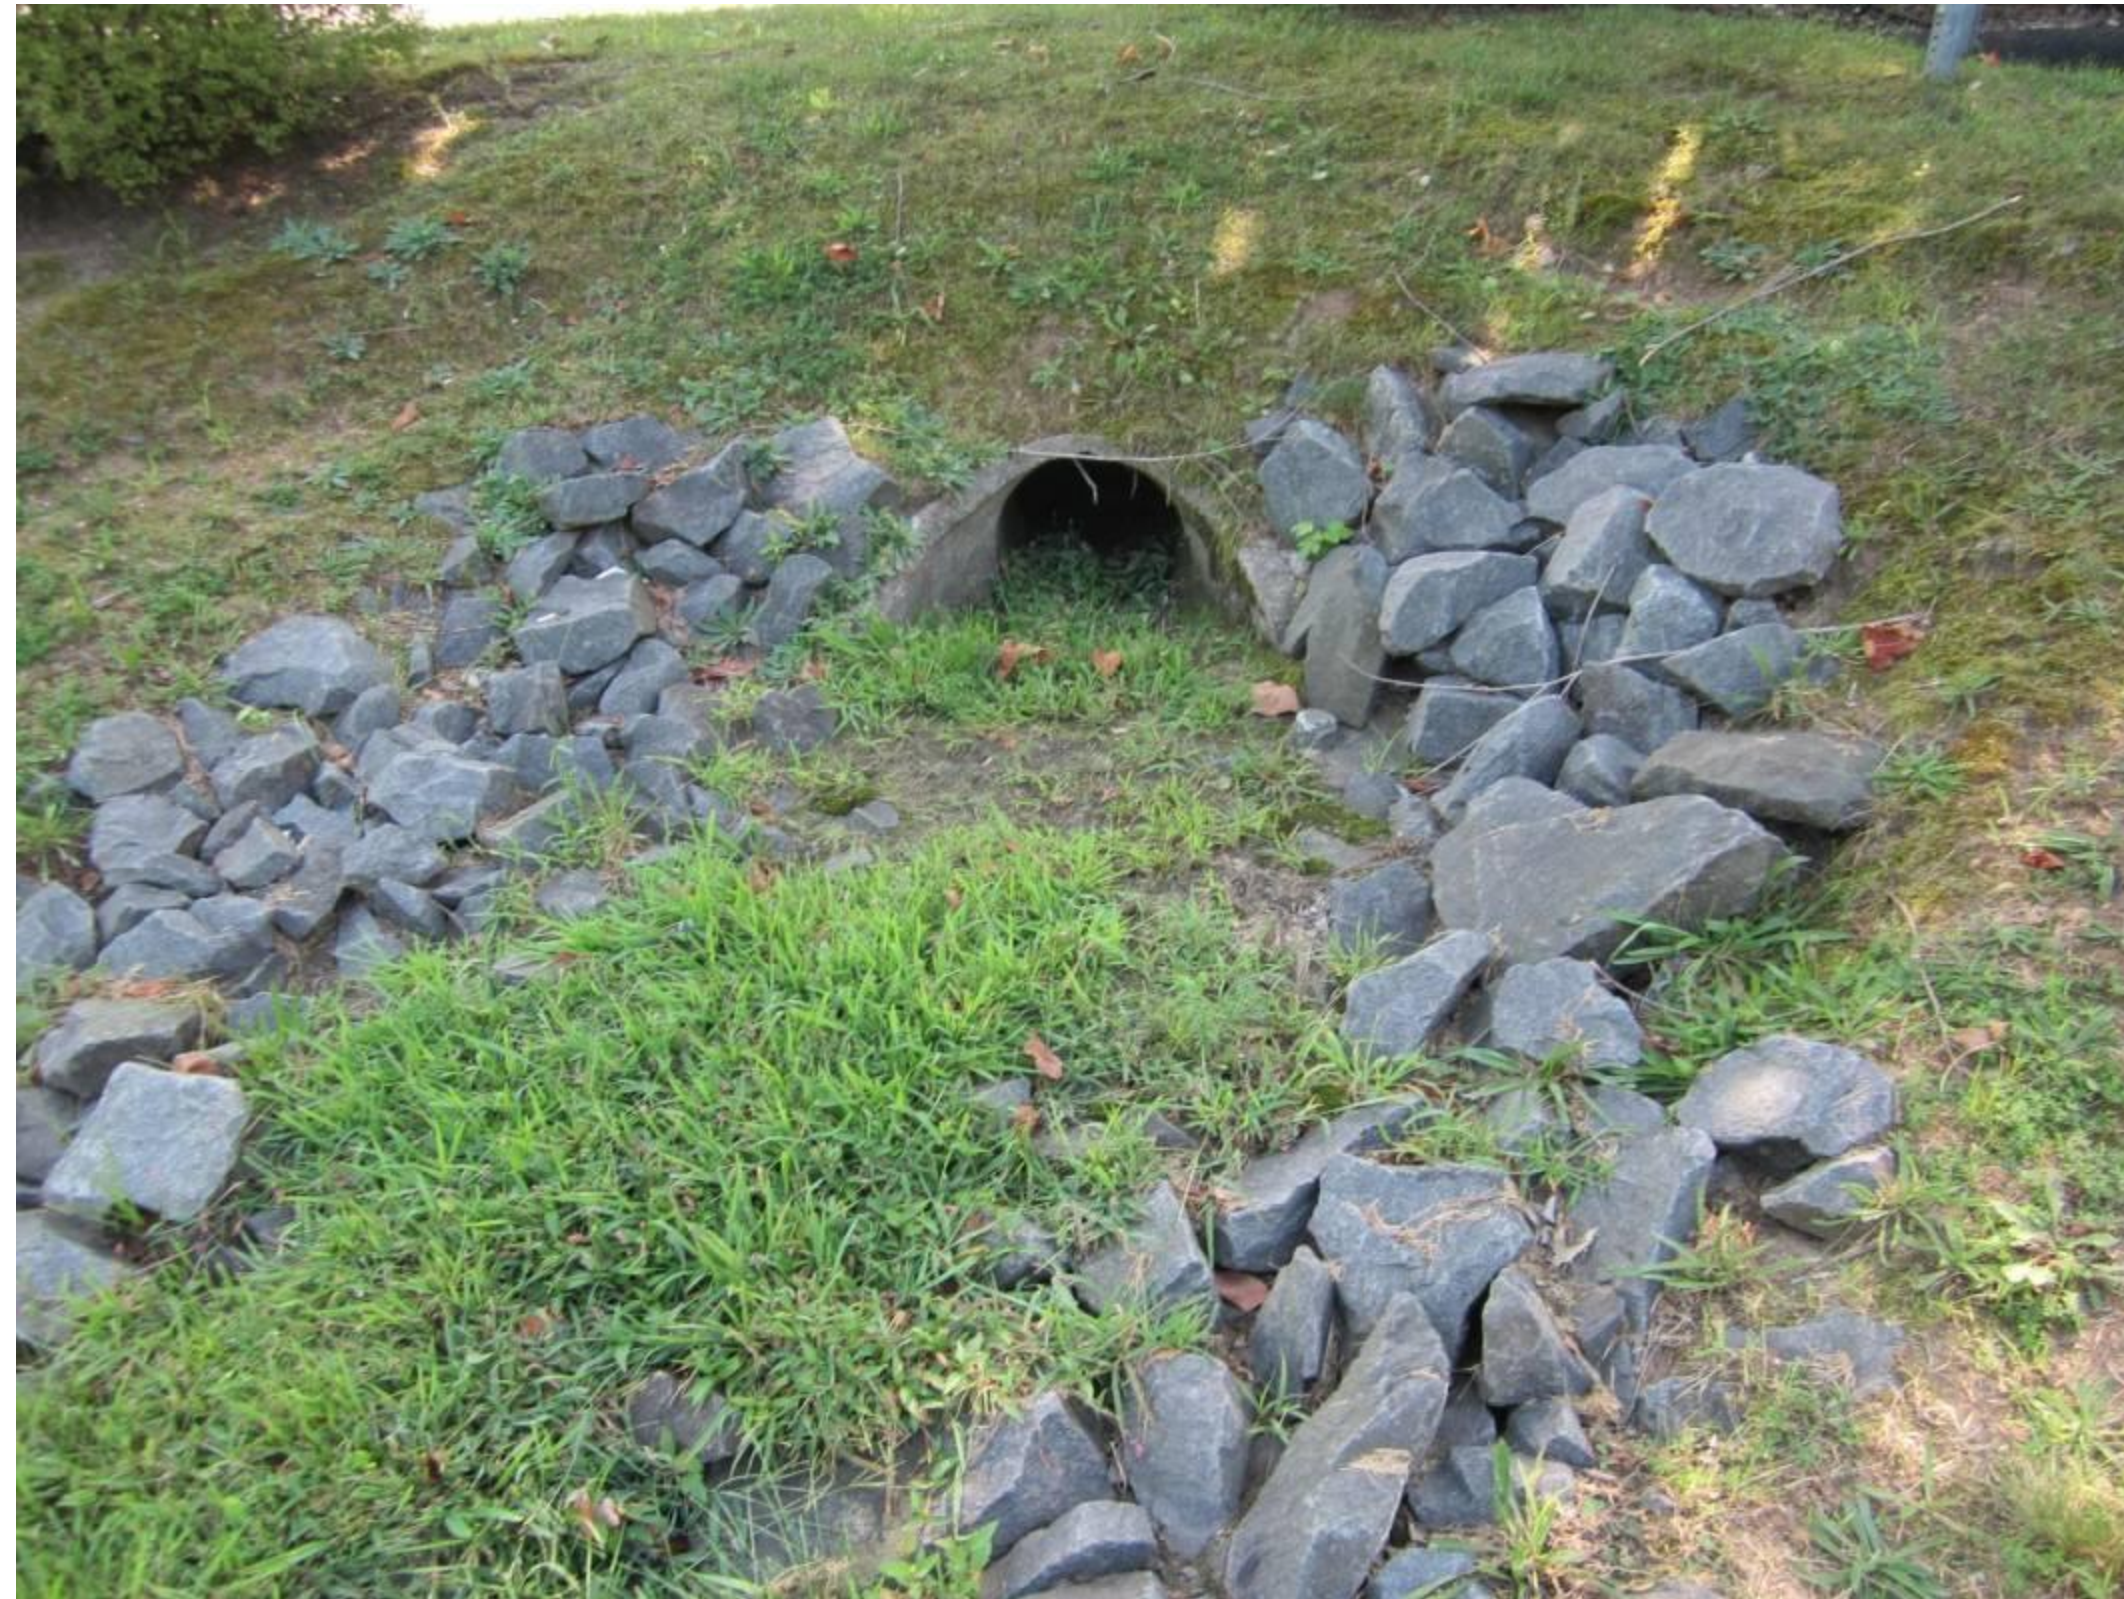
Inlet with sediment accumulation

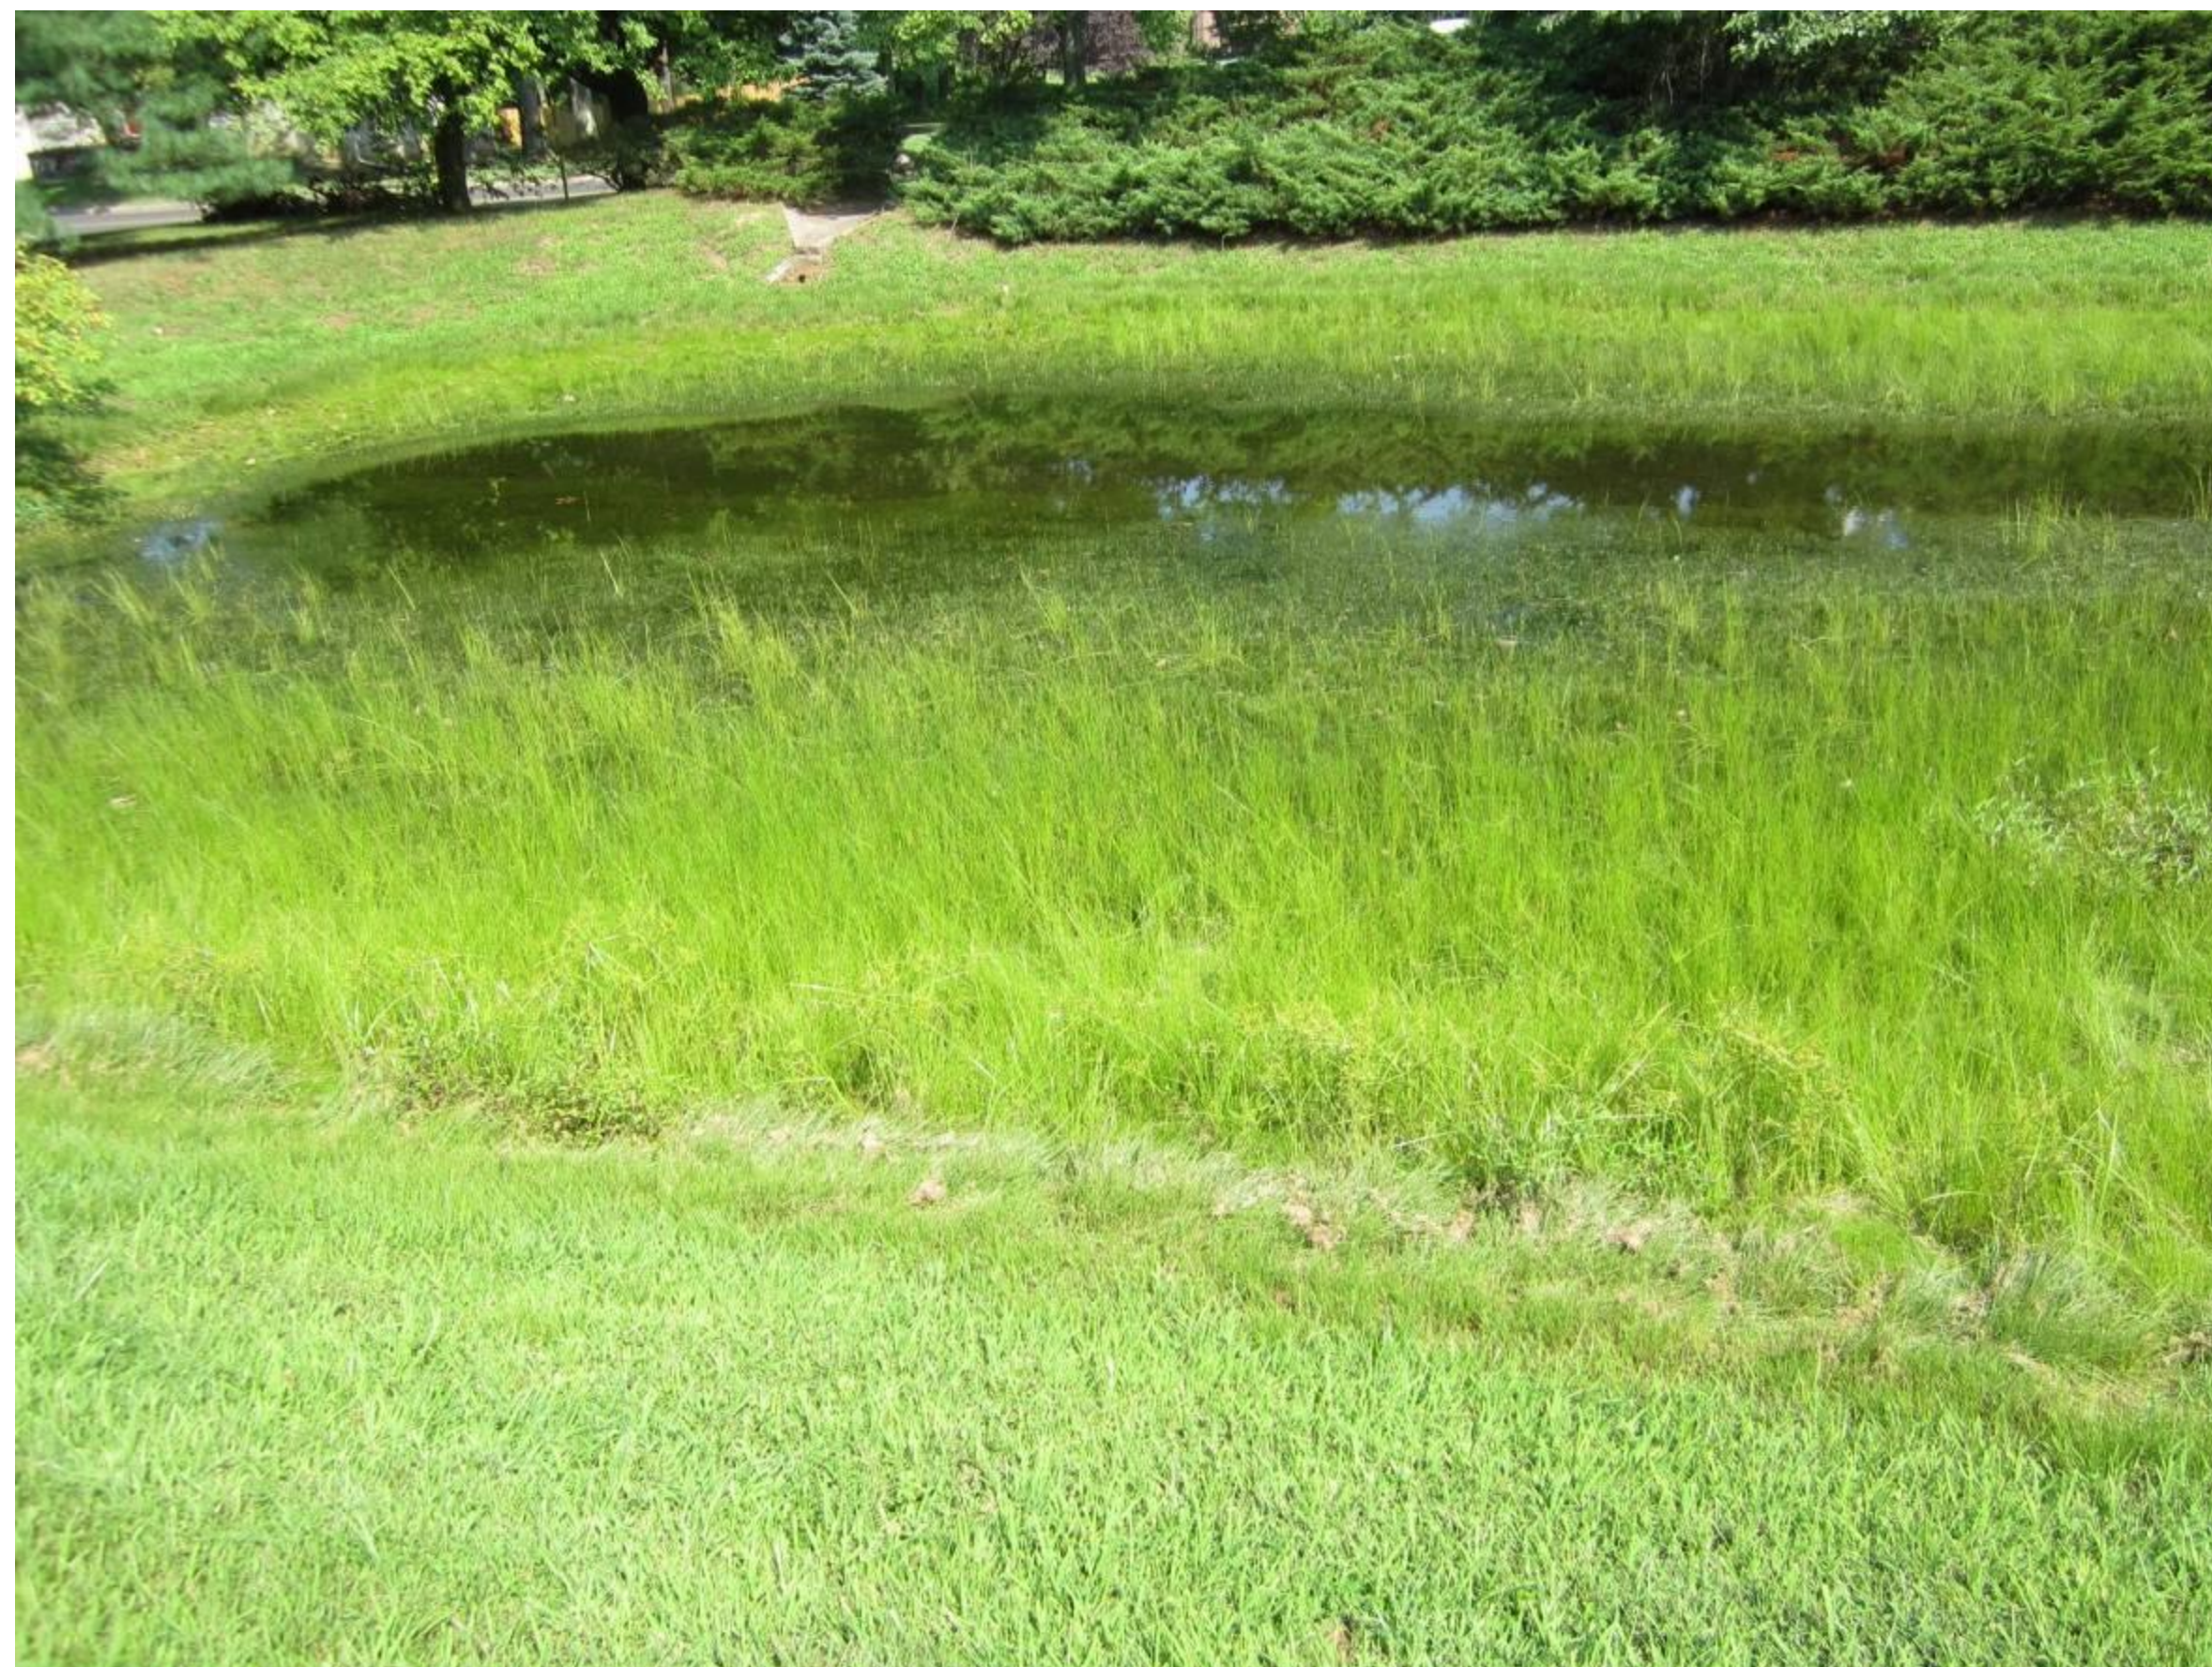
Ponding in basin bottom

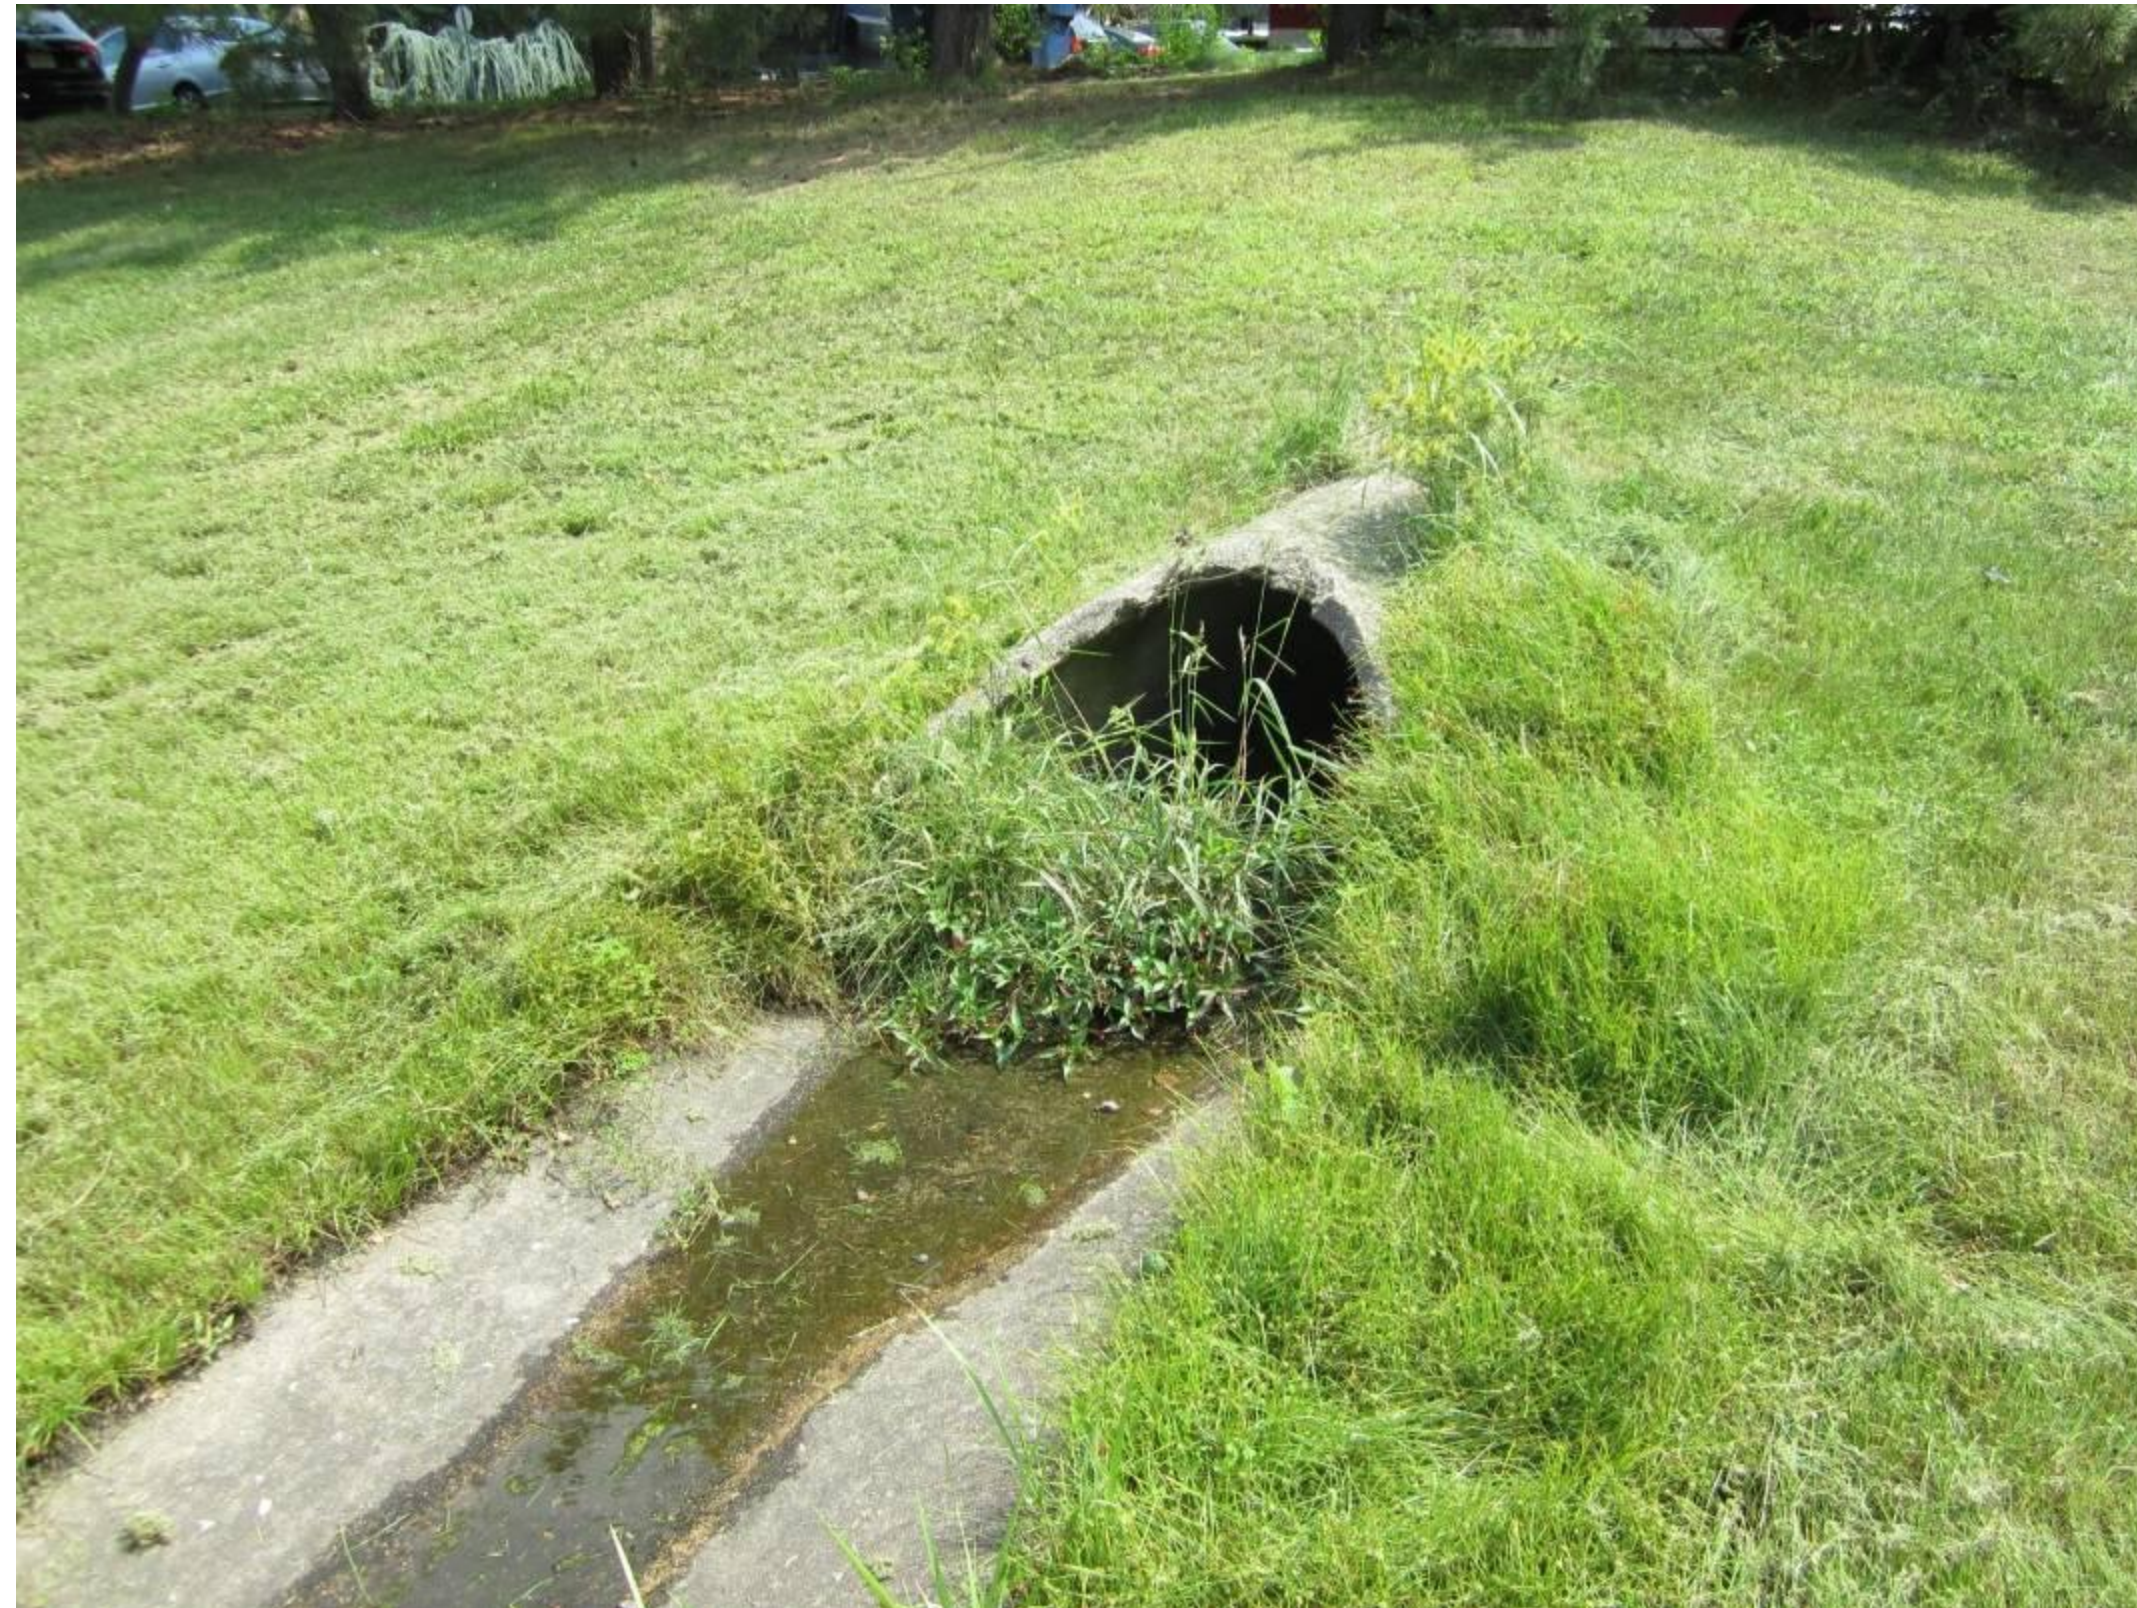
Excess sediment accumulation at inlet

- Excess sediment/grass clippings accumulating in low flow channel, inlets and outlet structure
- Visible damage at 20" diameter inlet
- Standing water remaining in low flow channel

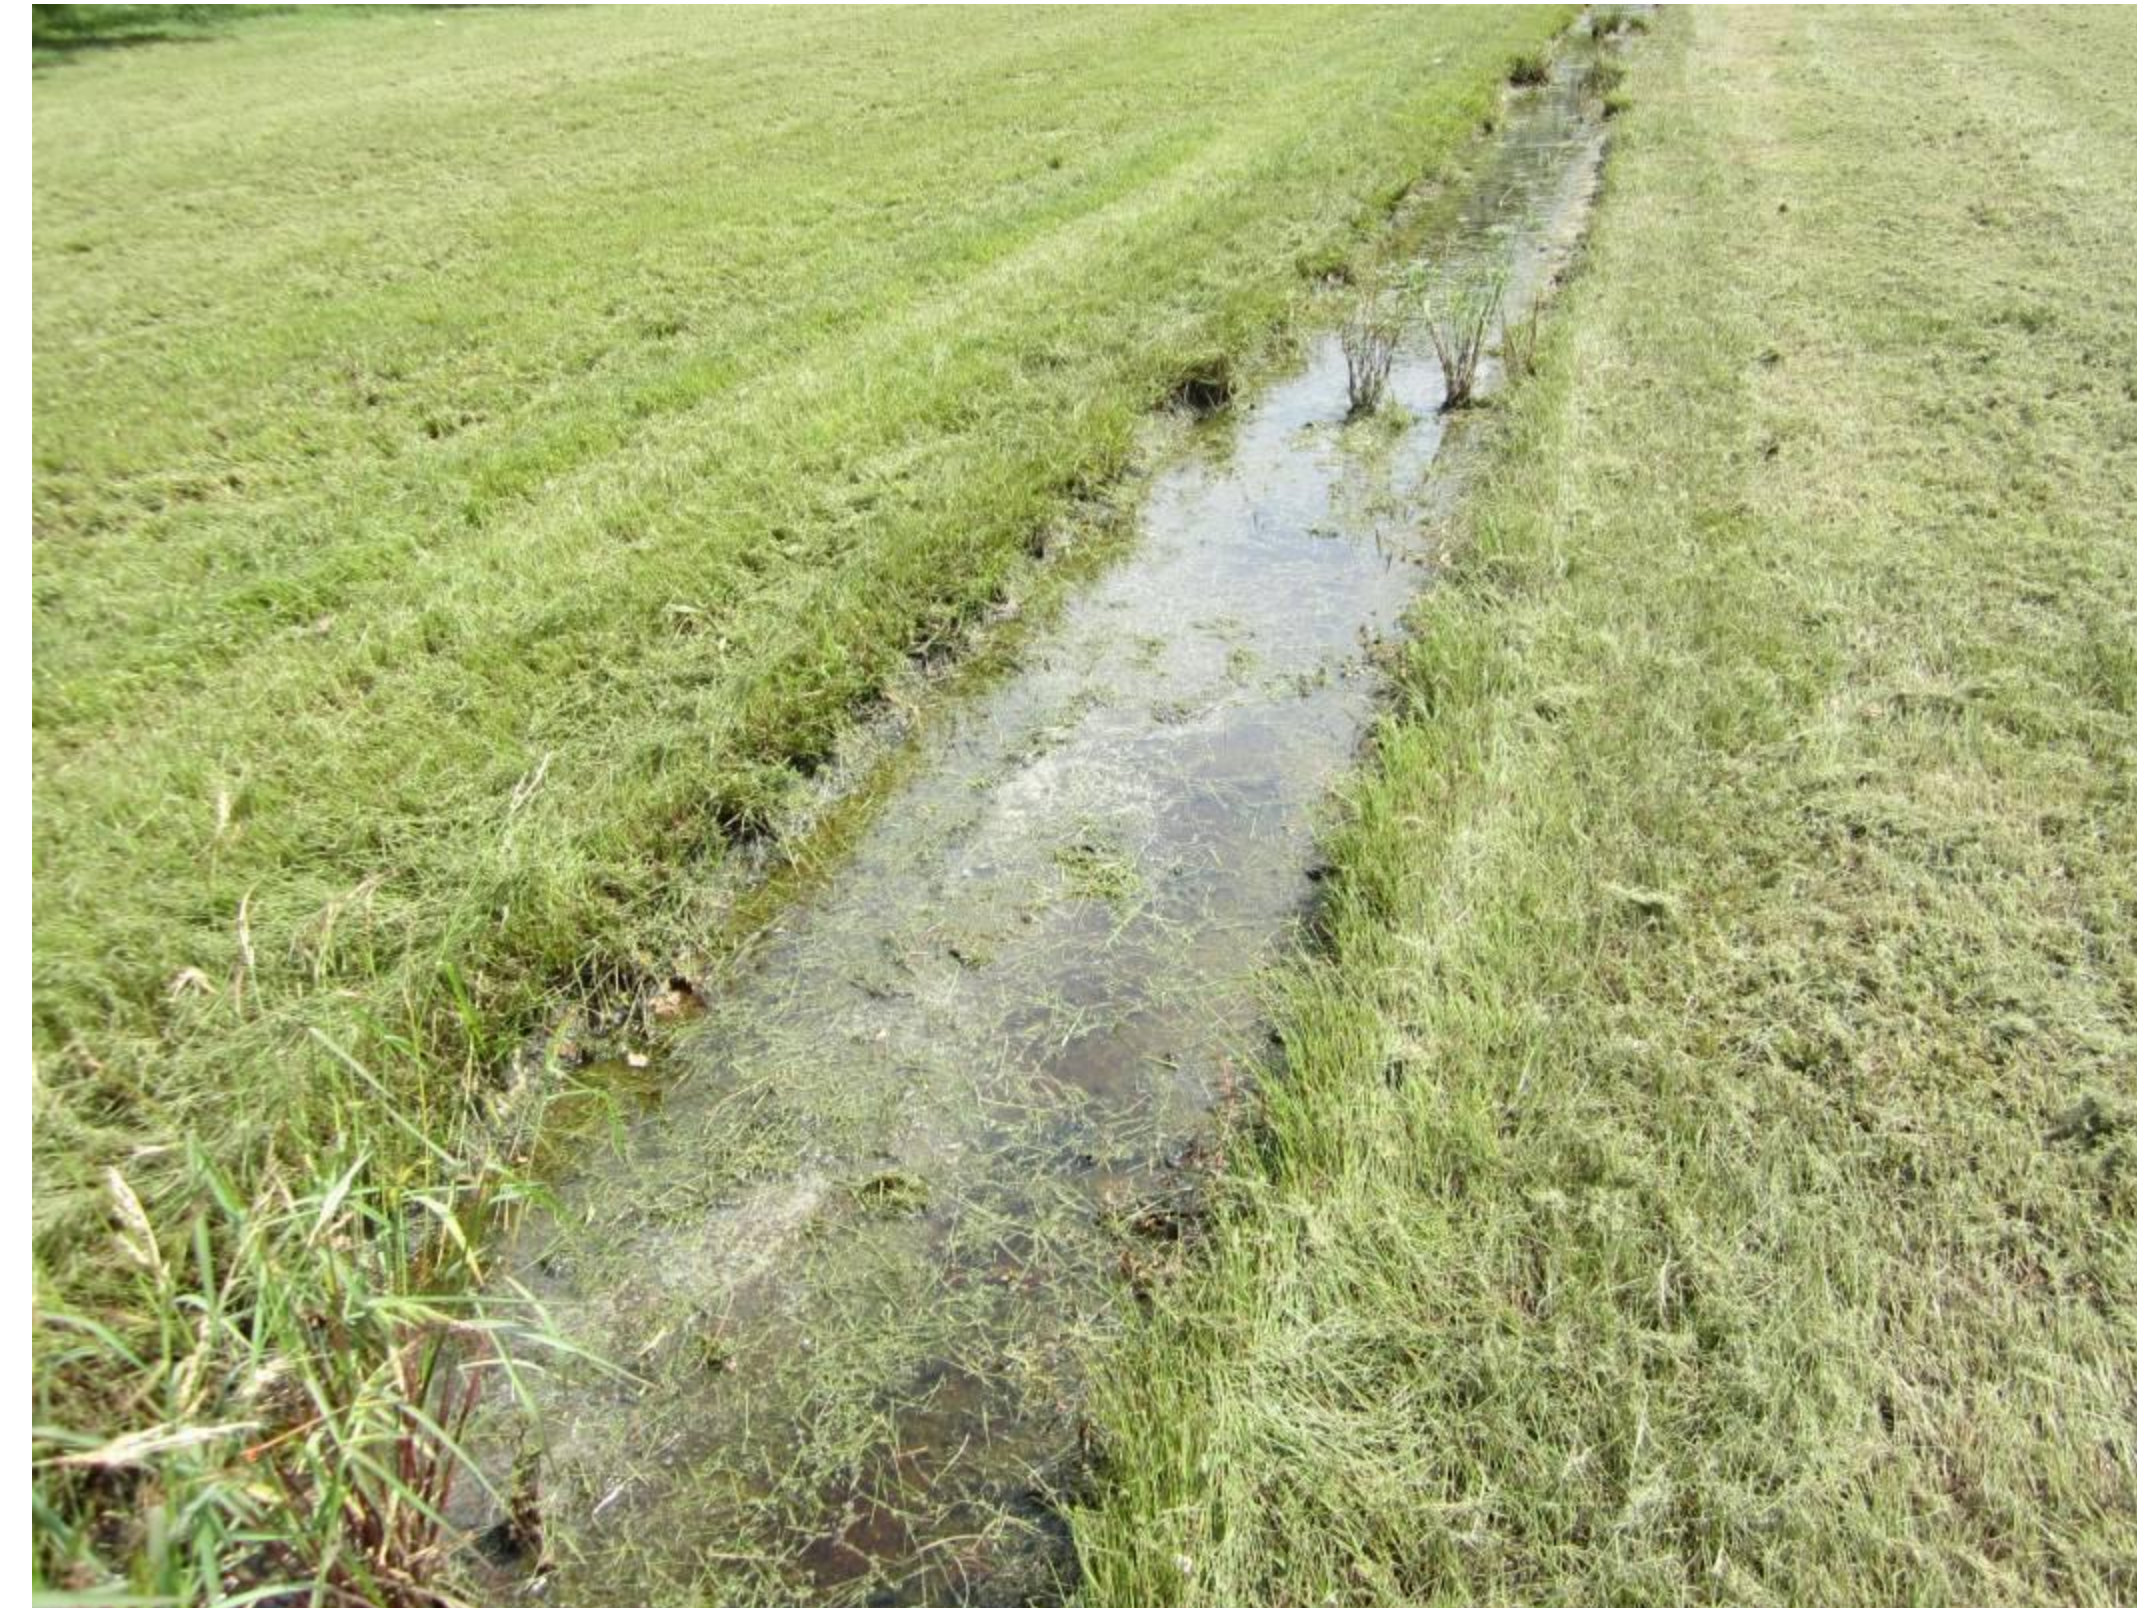
Standing water in low flow channel

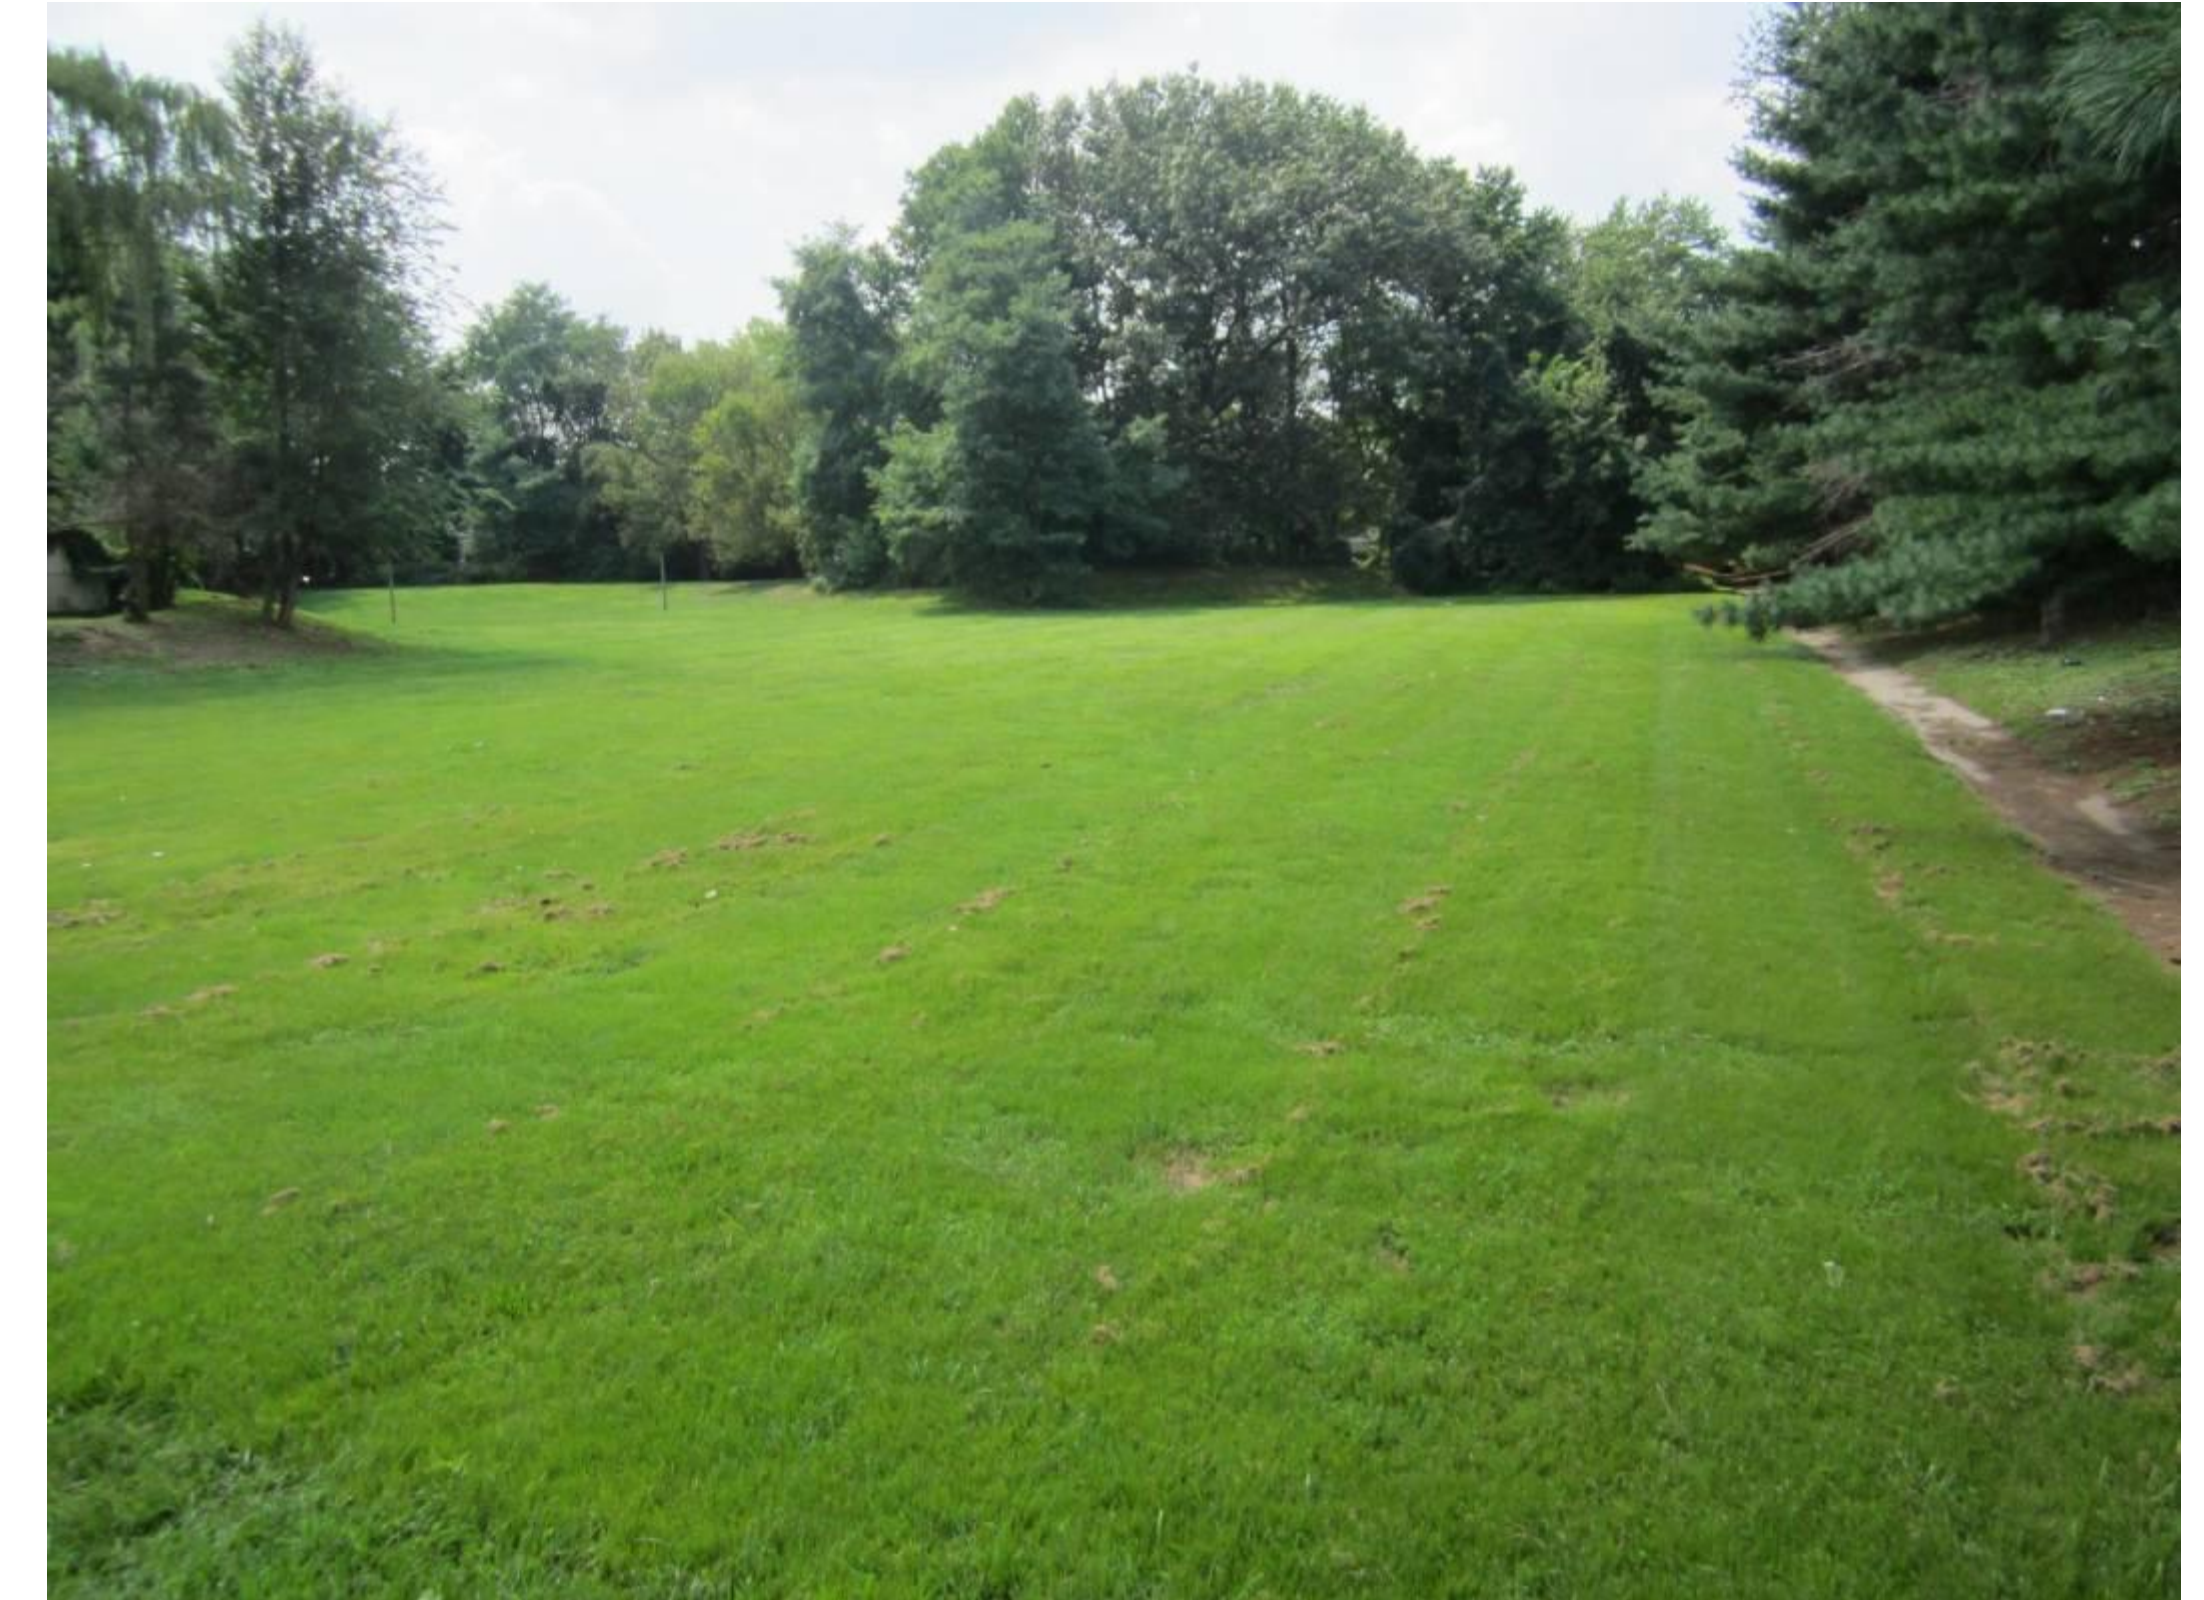
Basin bottom looking southwest

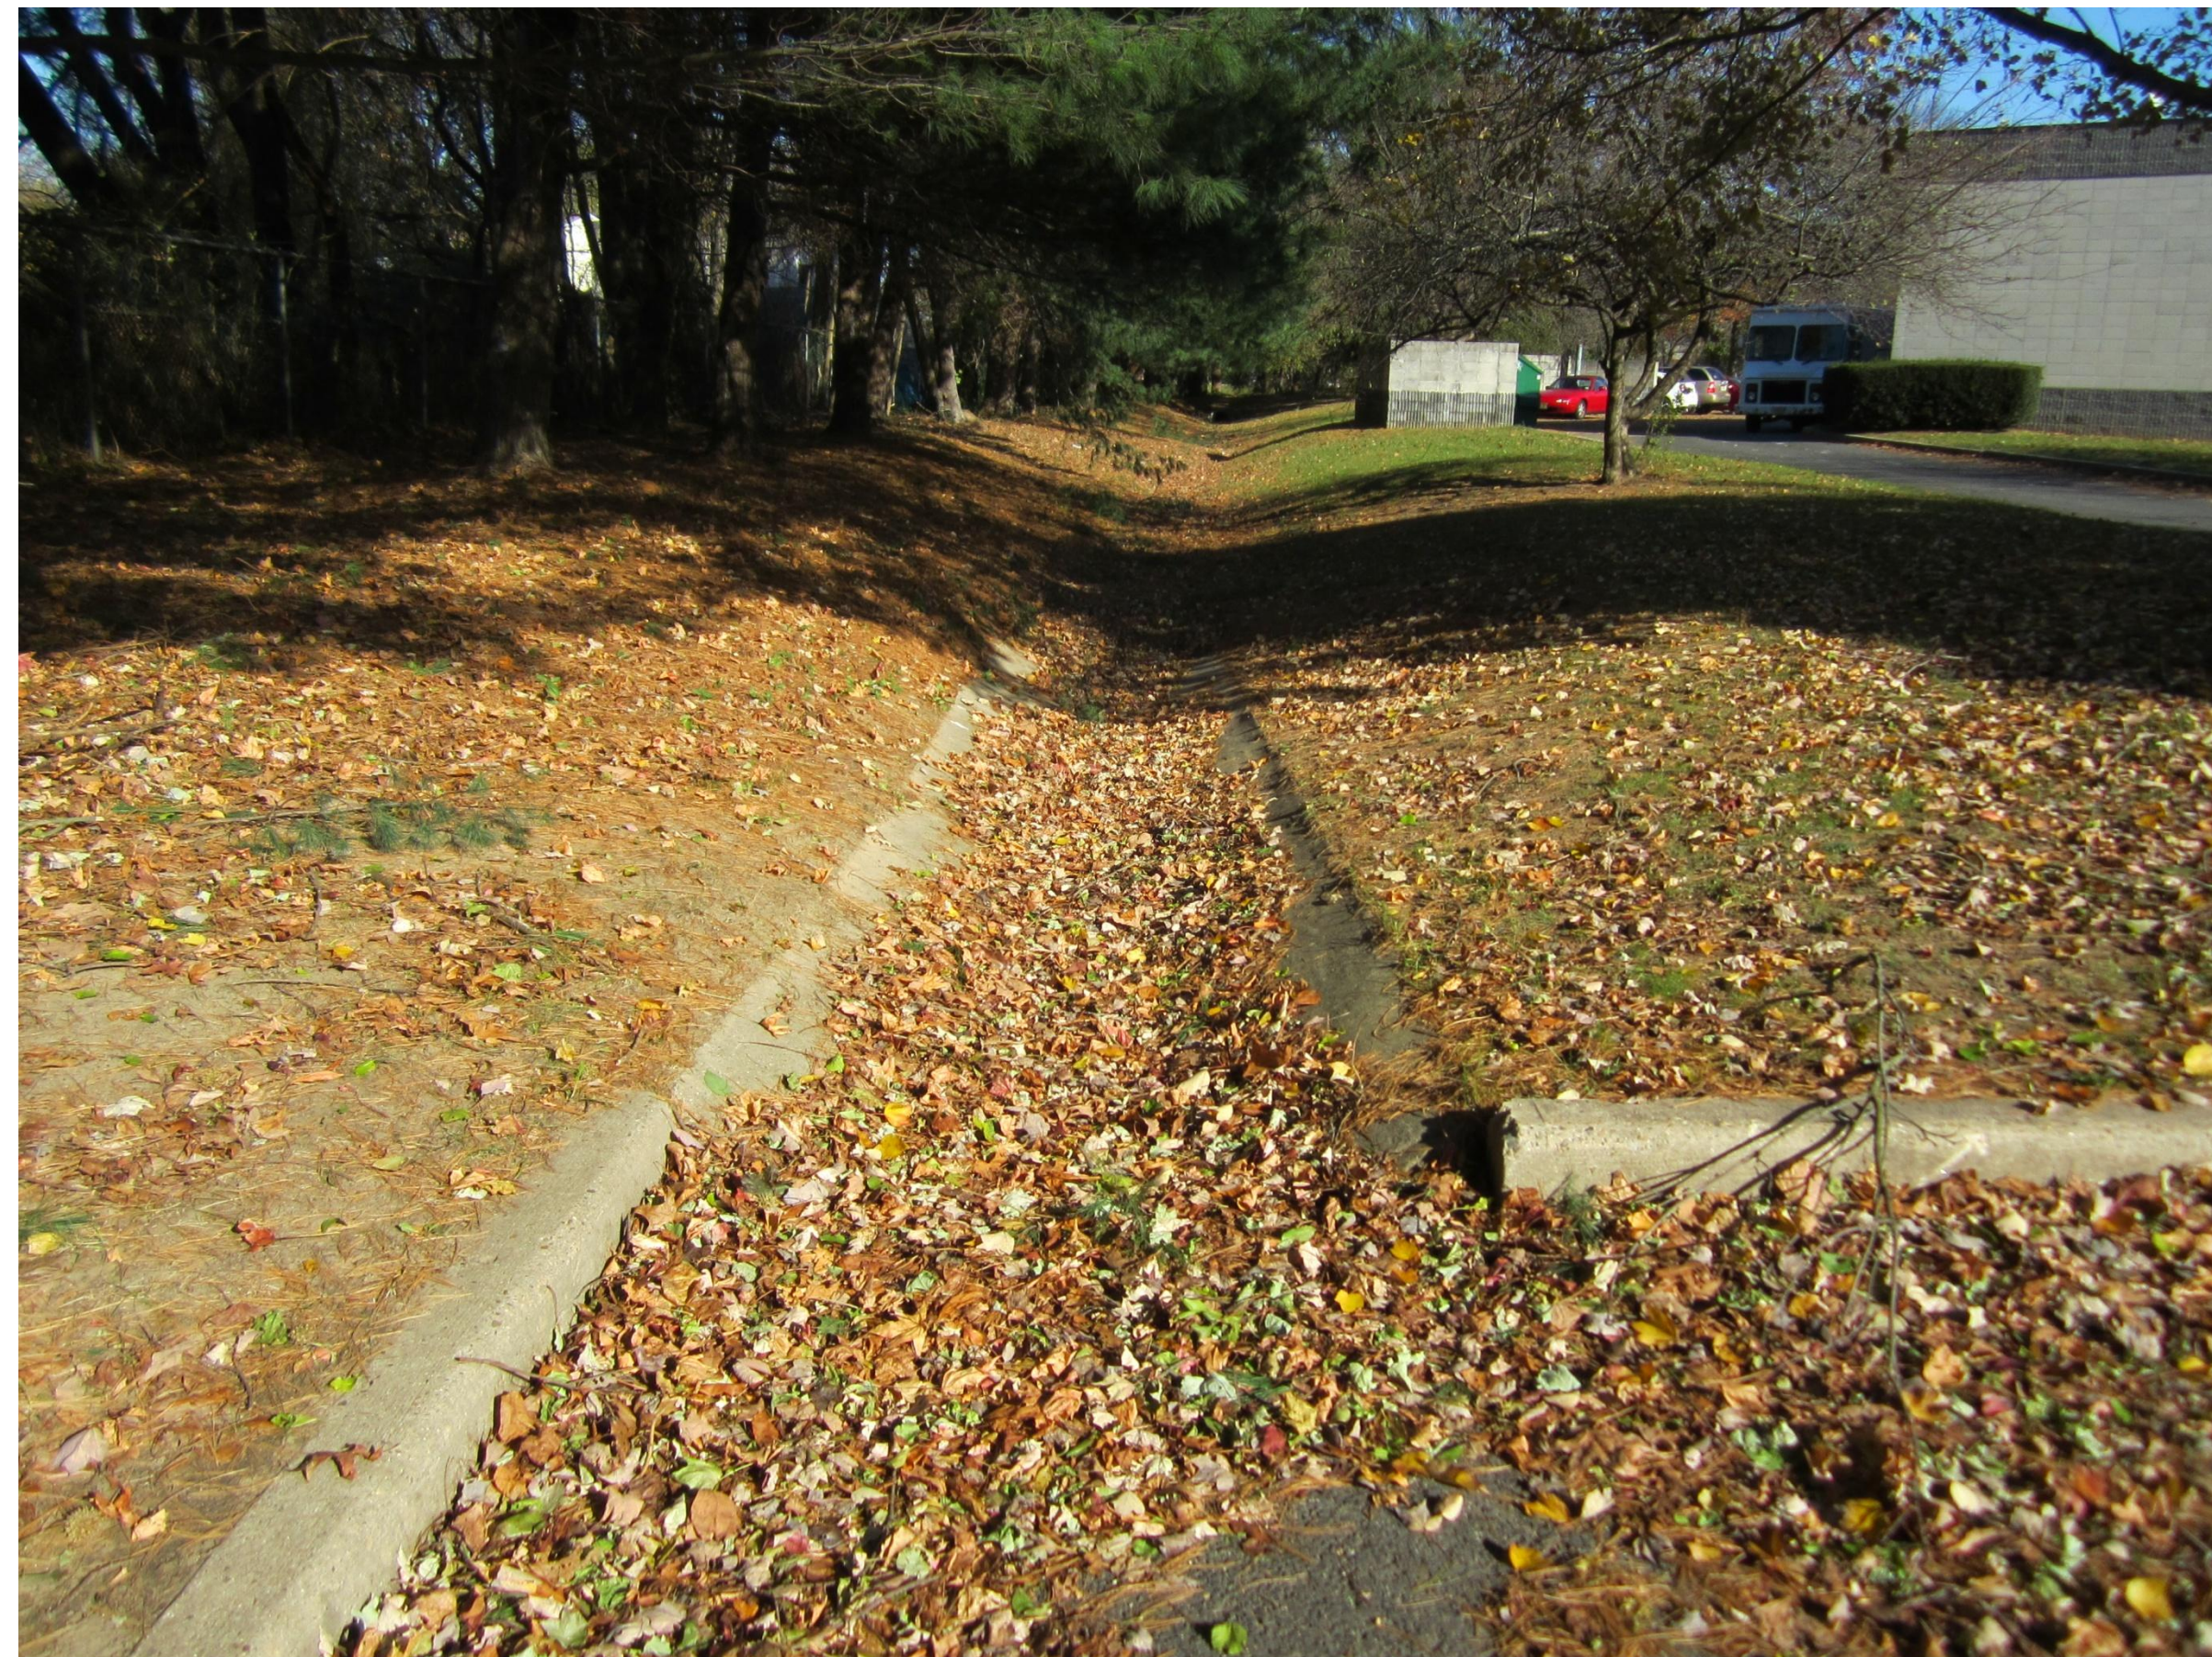
Curb cut inlet and swale
