Hamilton Township (Mercer County) Stormwater Basin Assessment Summary (Year 1)

Developed by the Rutgers Cooperative Extension Water Resources Program
Funded by Hamilton Township, Mercer County, New Jersey

December 6, 2012

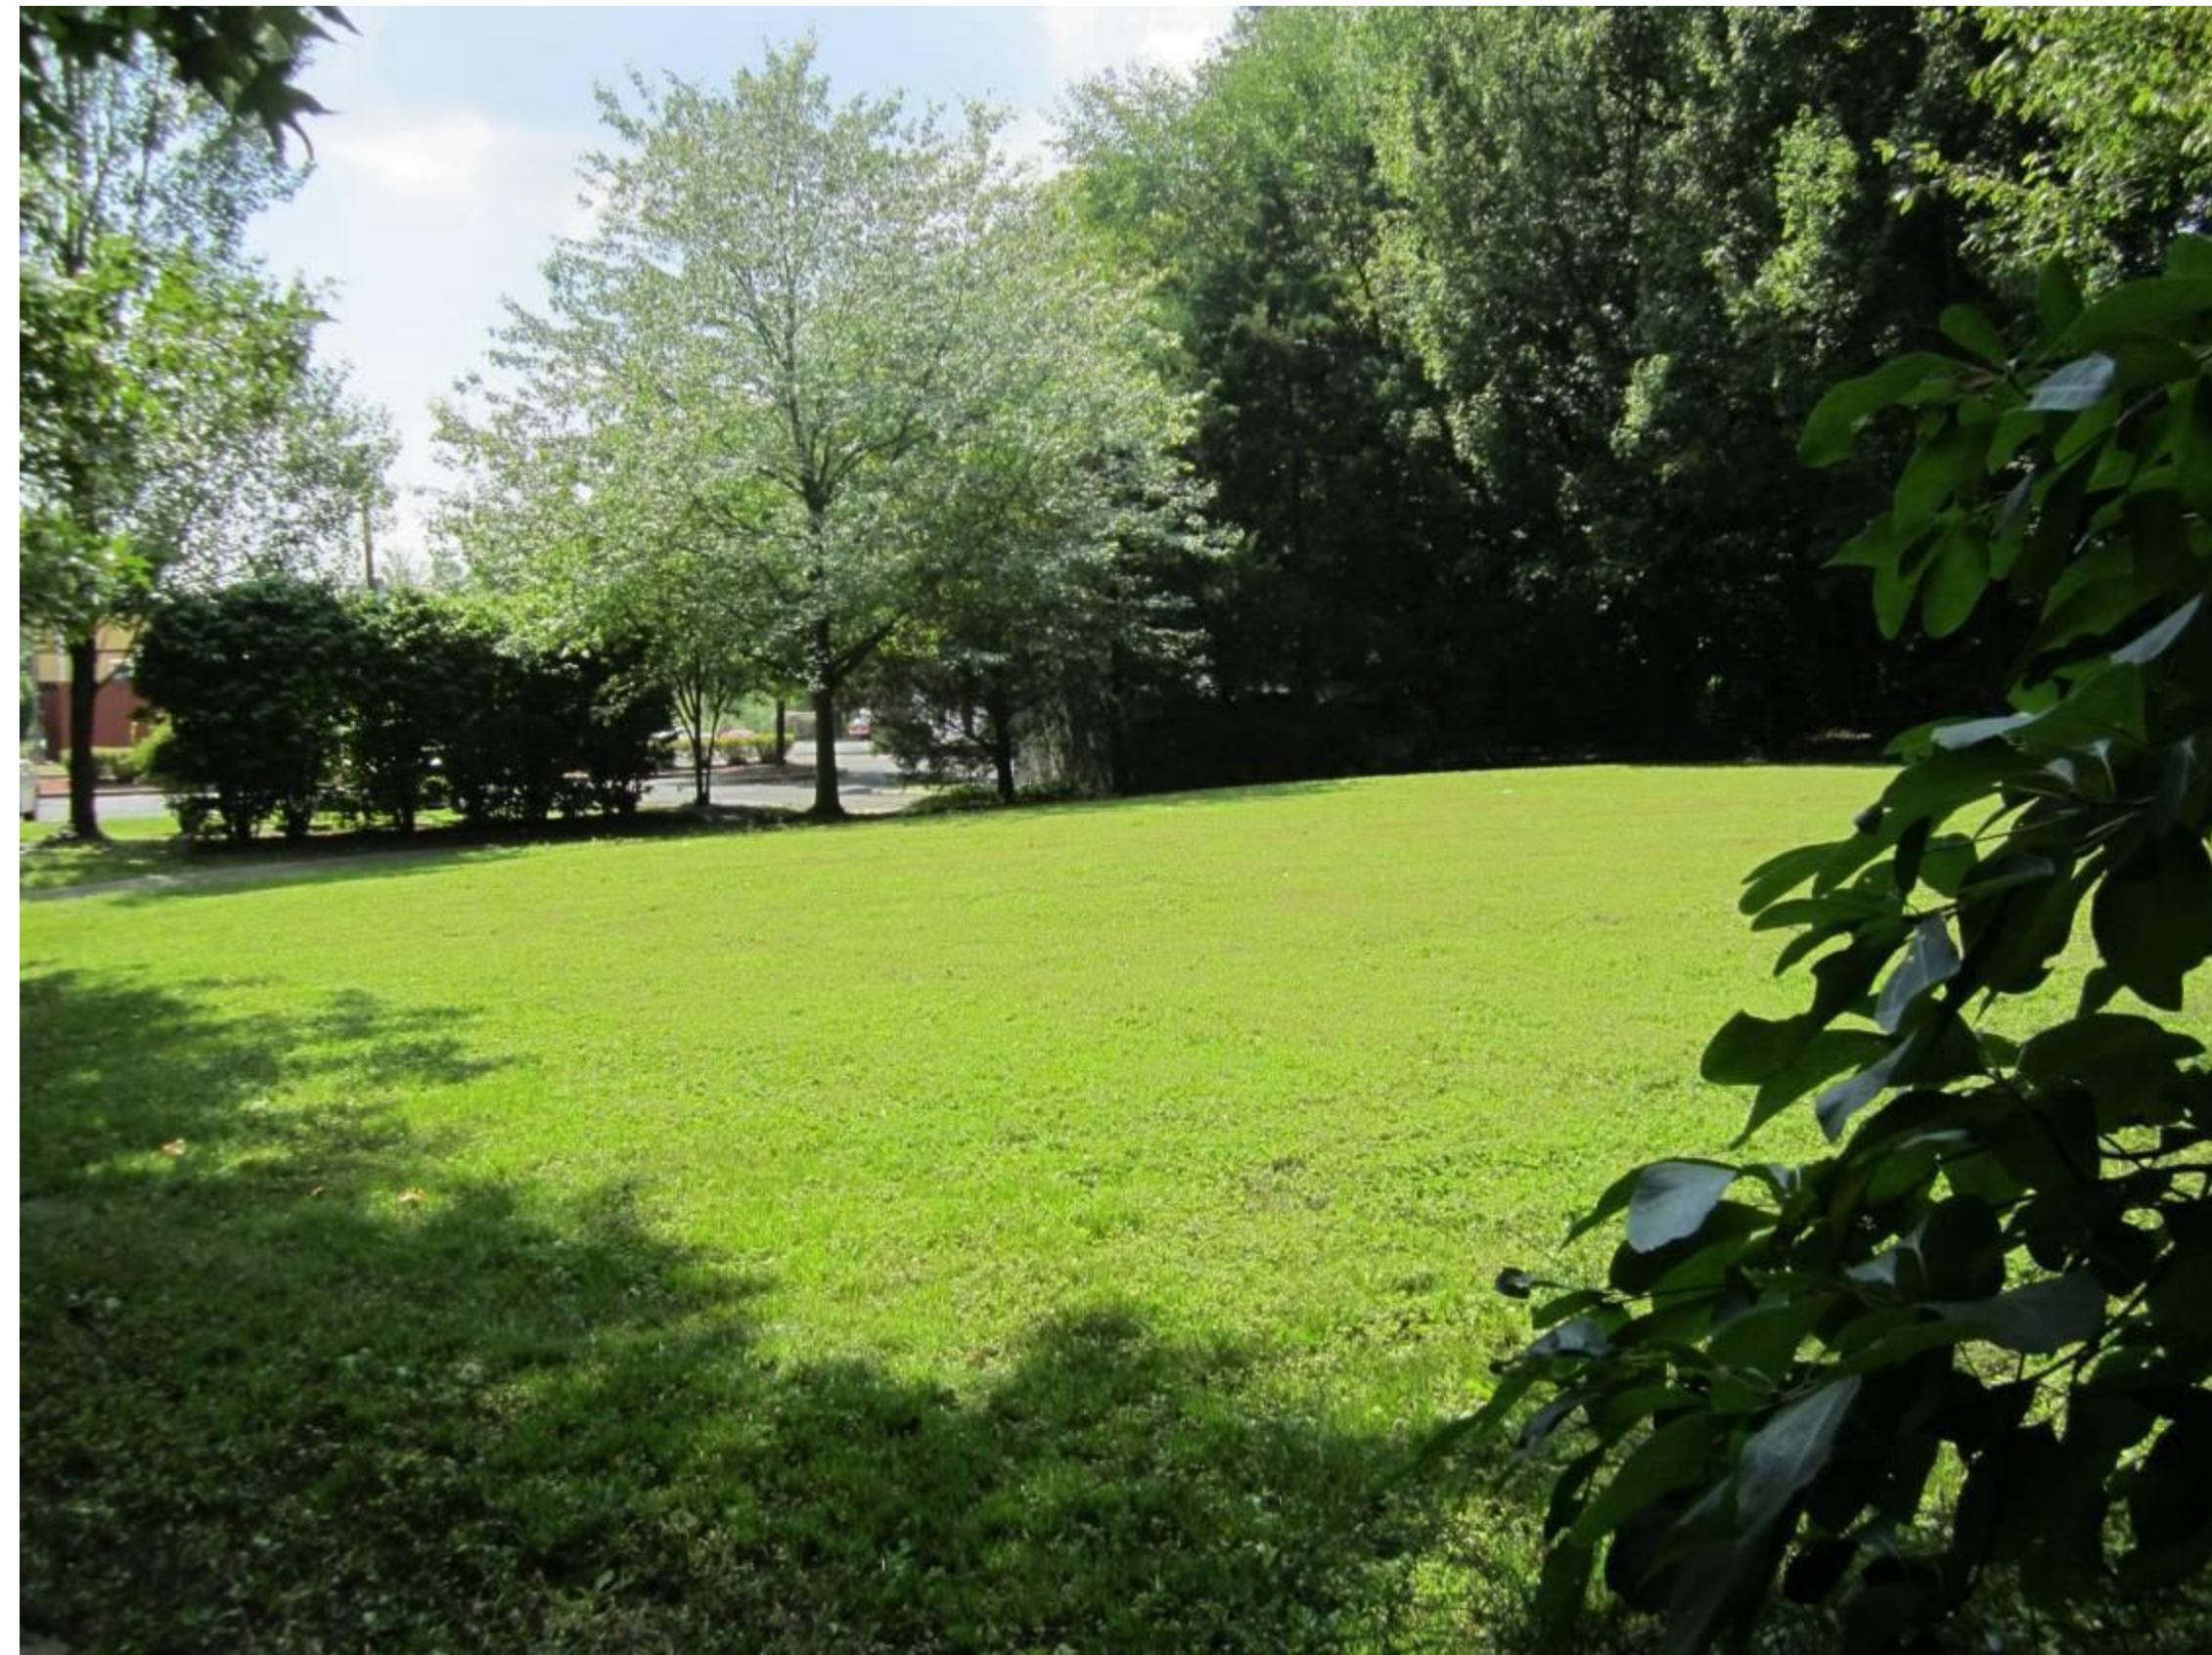
Basin bottom looking southwest

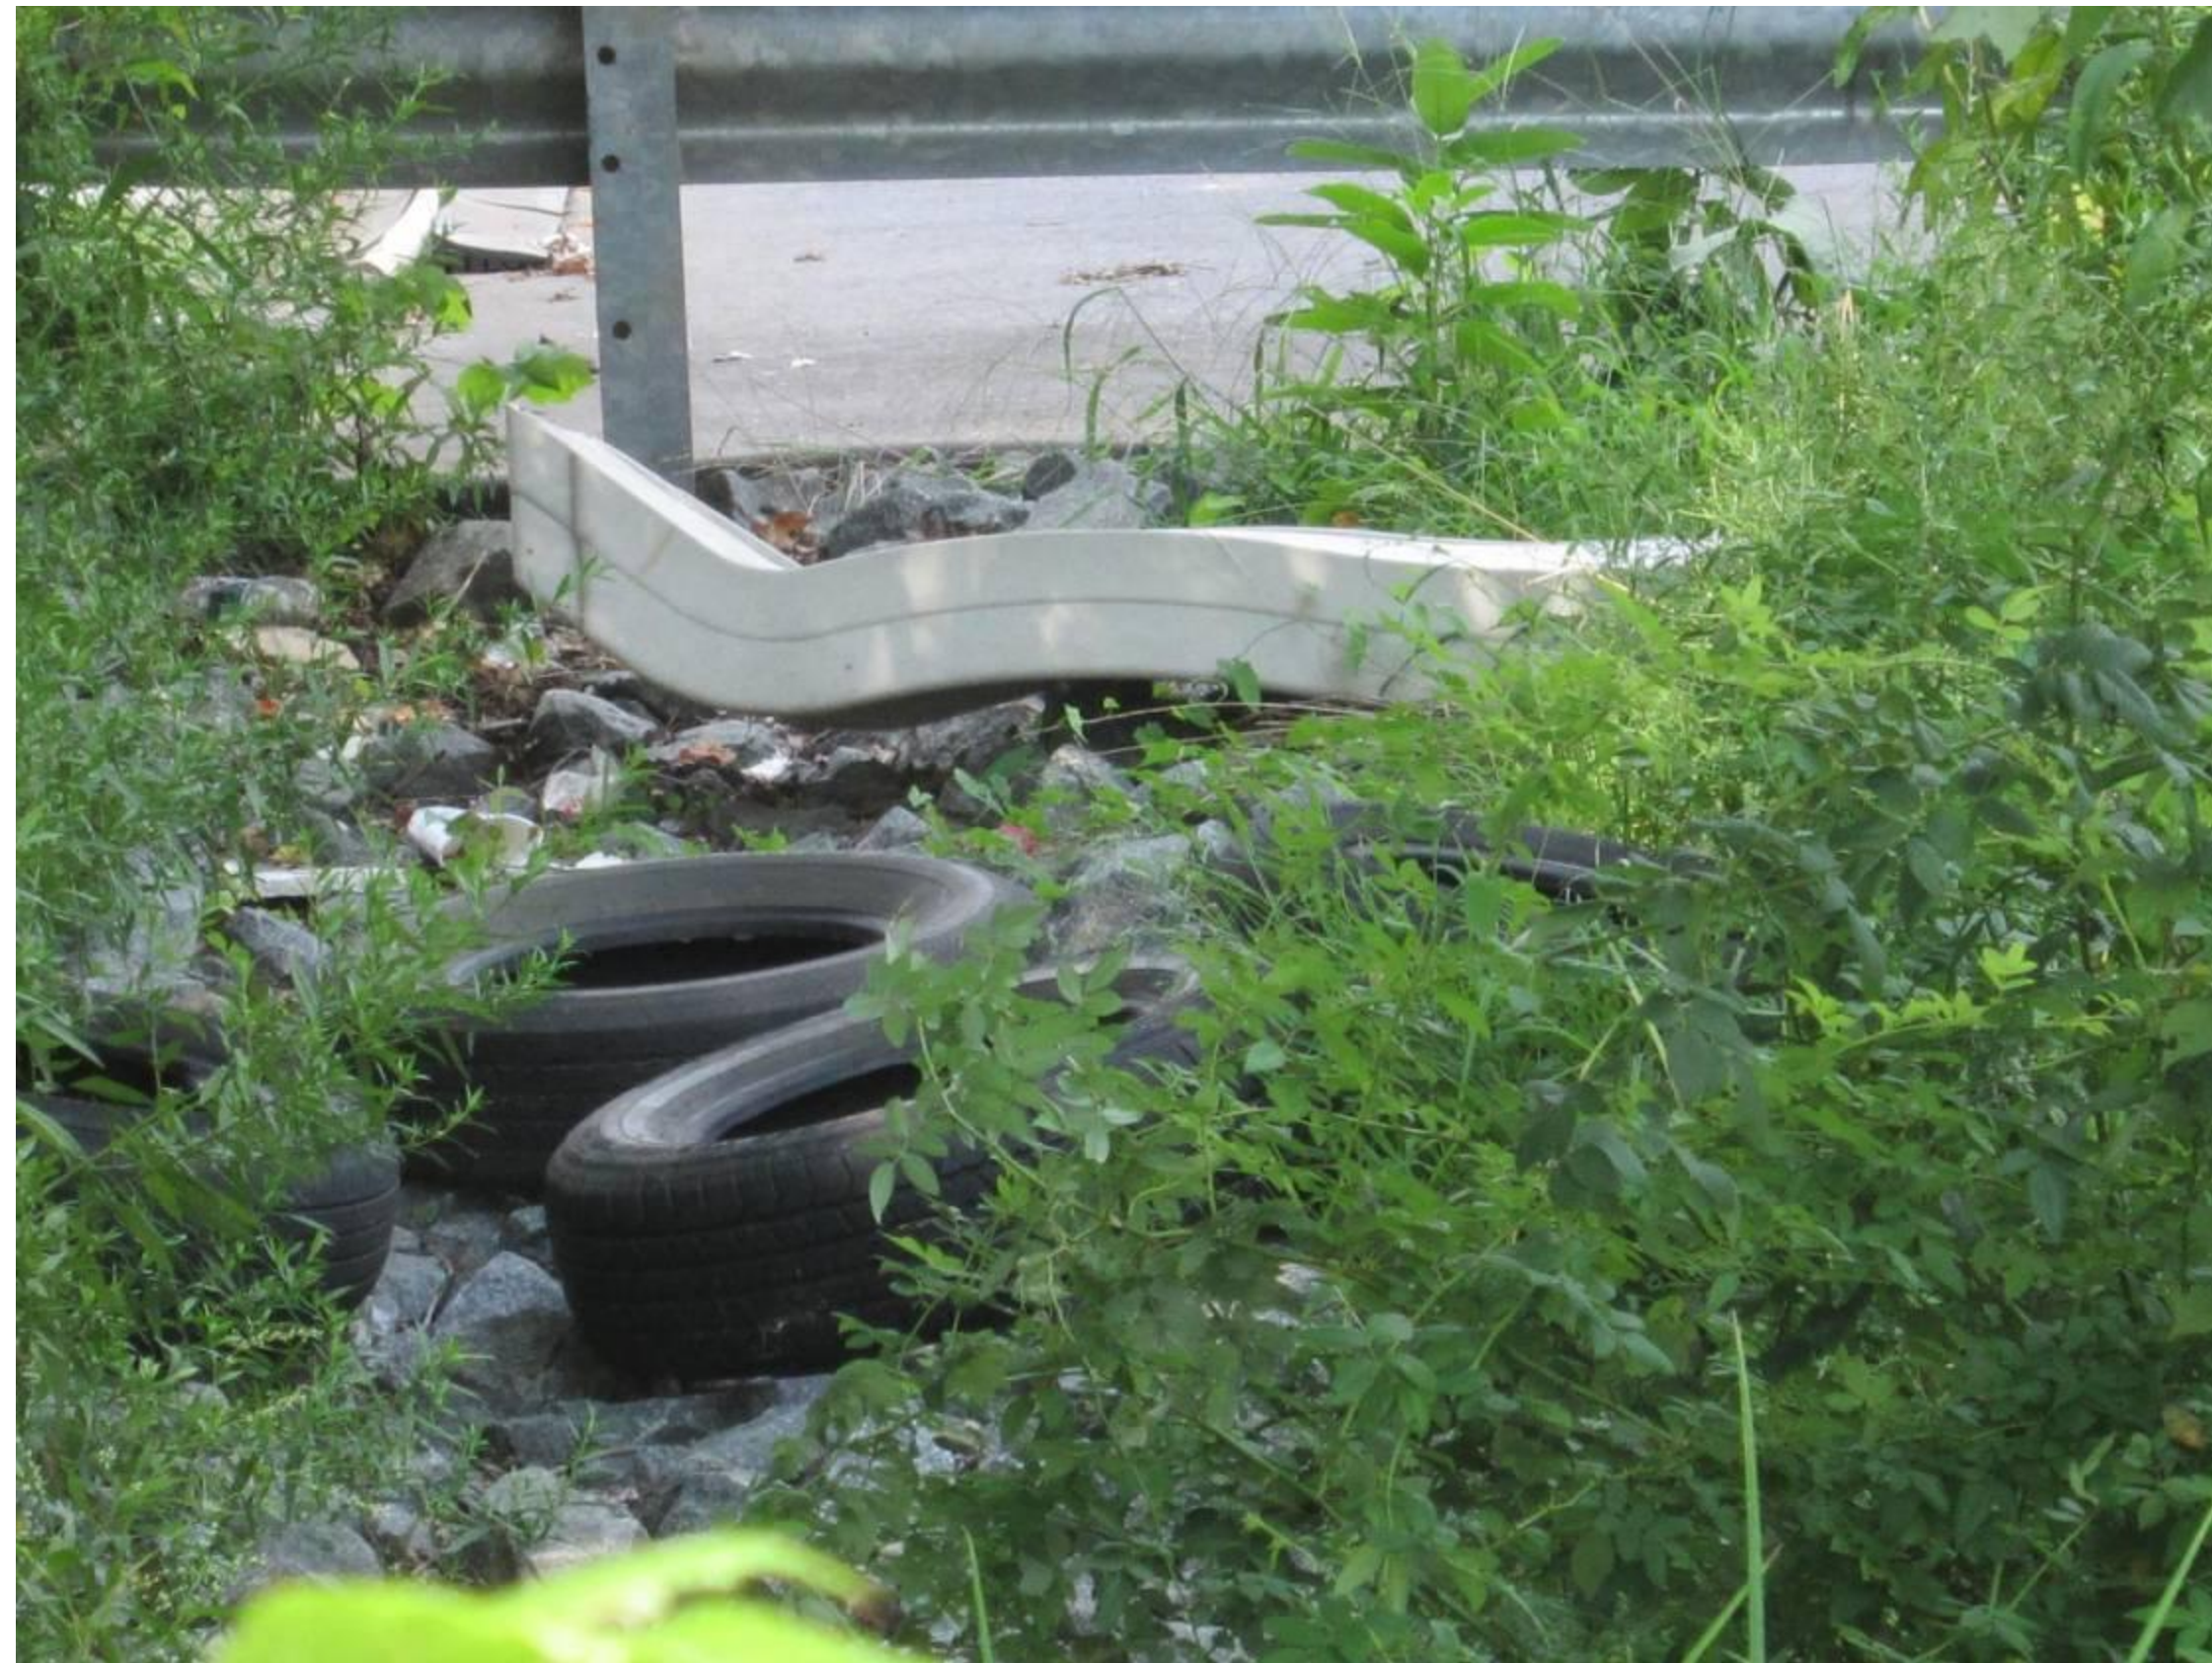
Rip rap and trash at dead end leading to basin

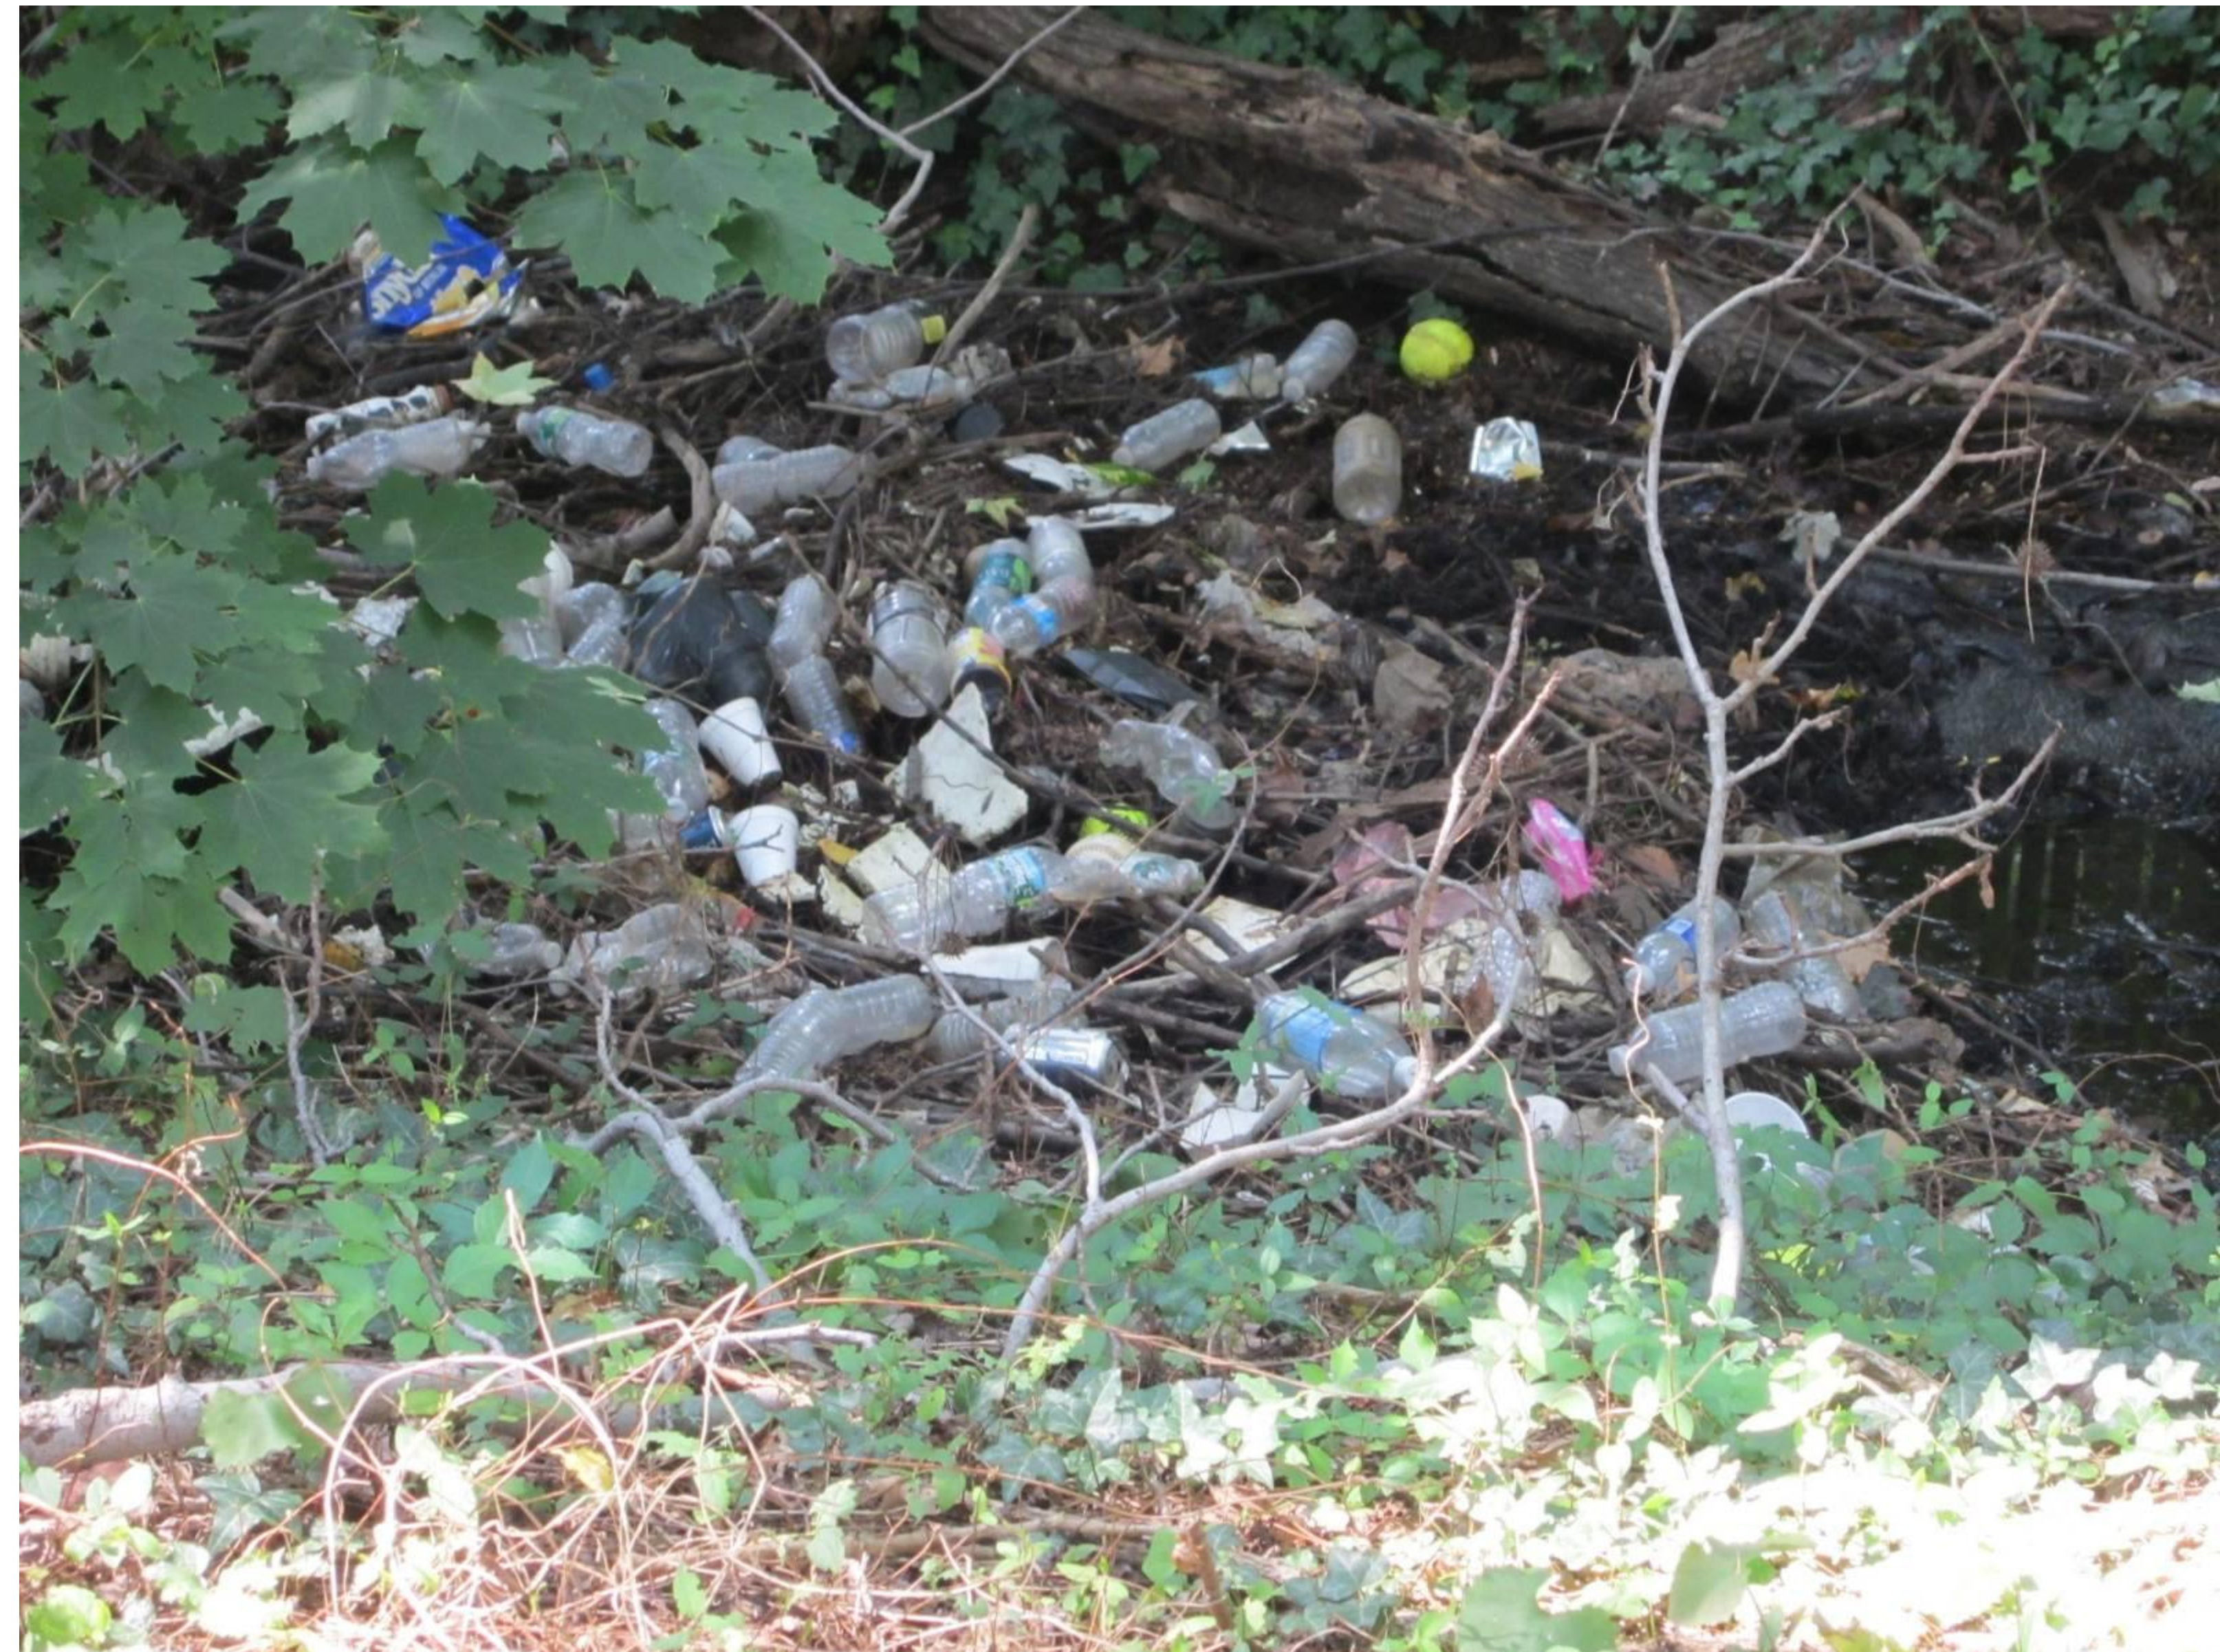
Litter and debris accumulation

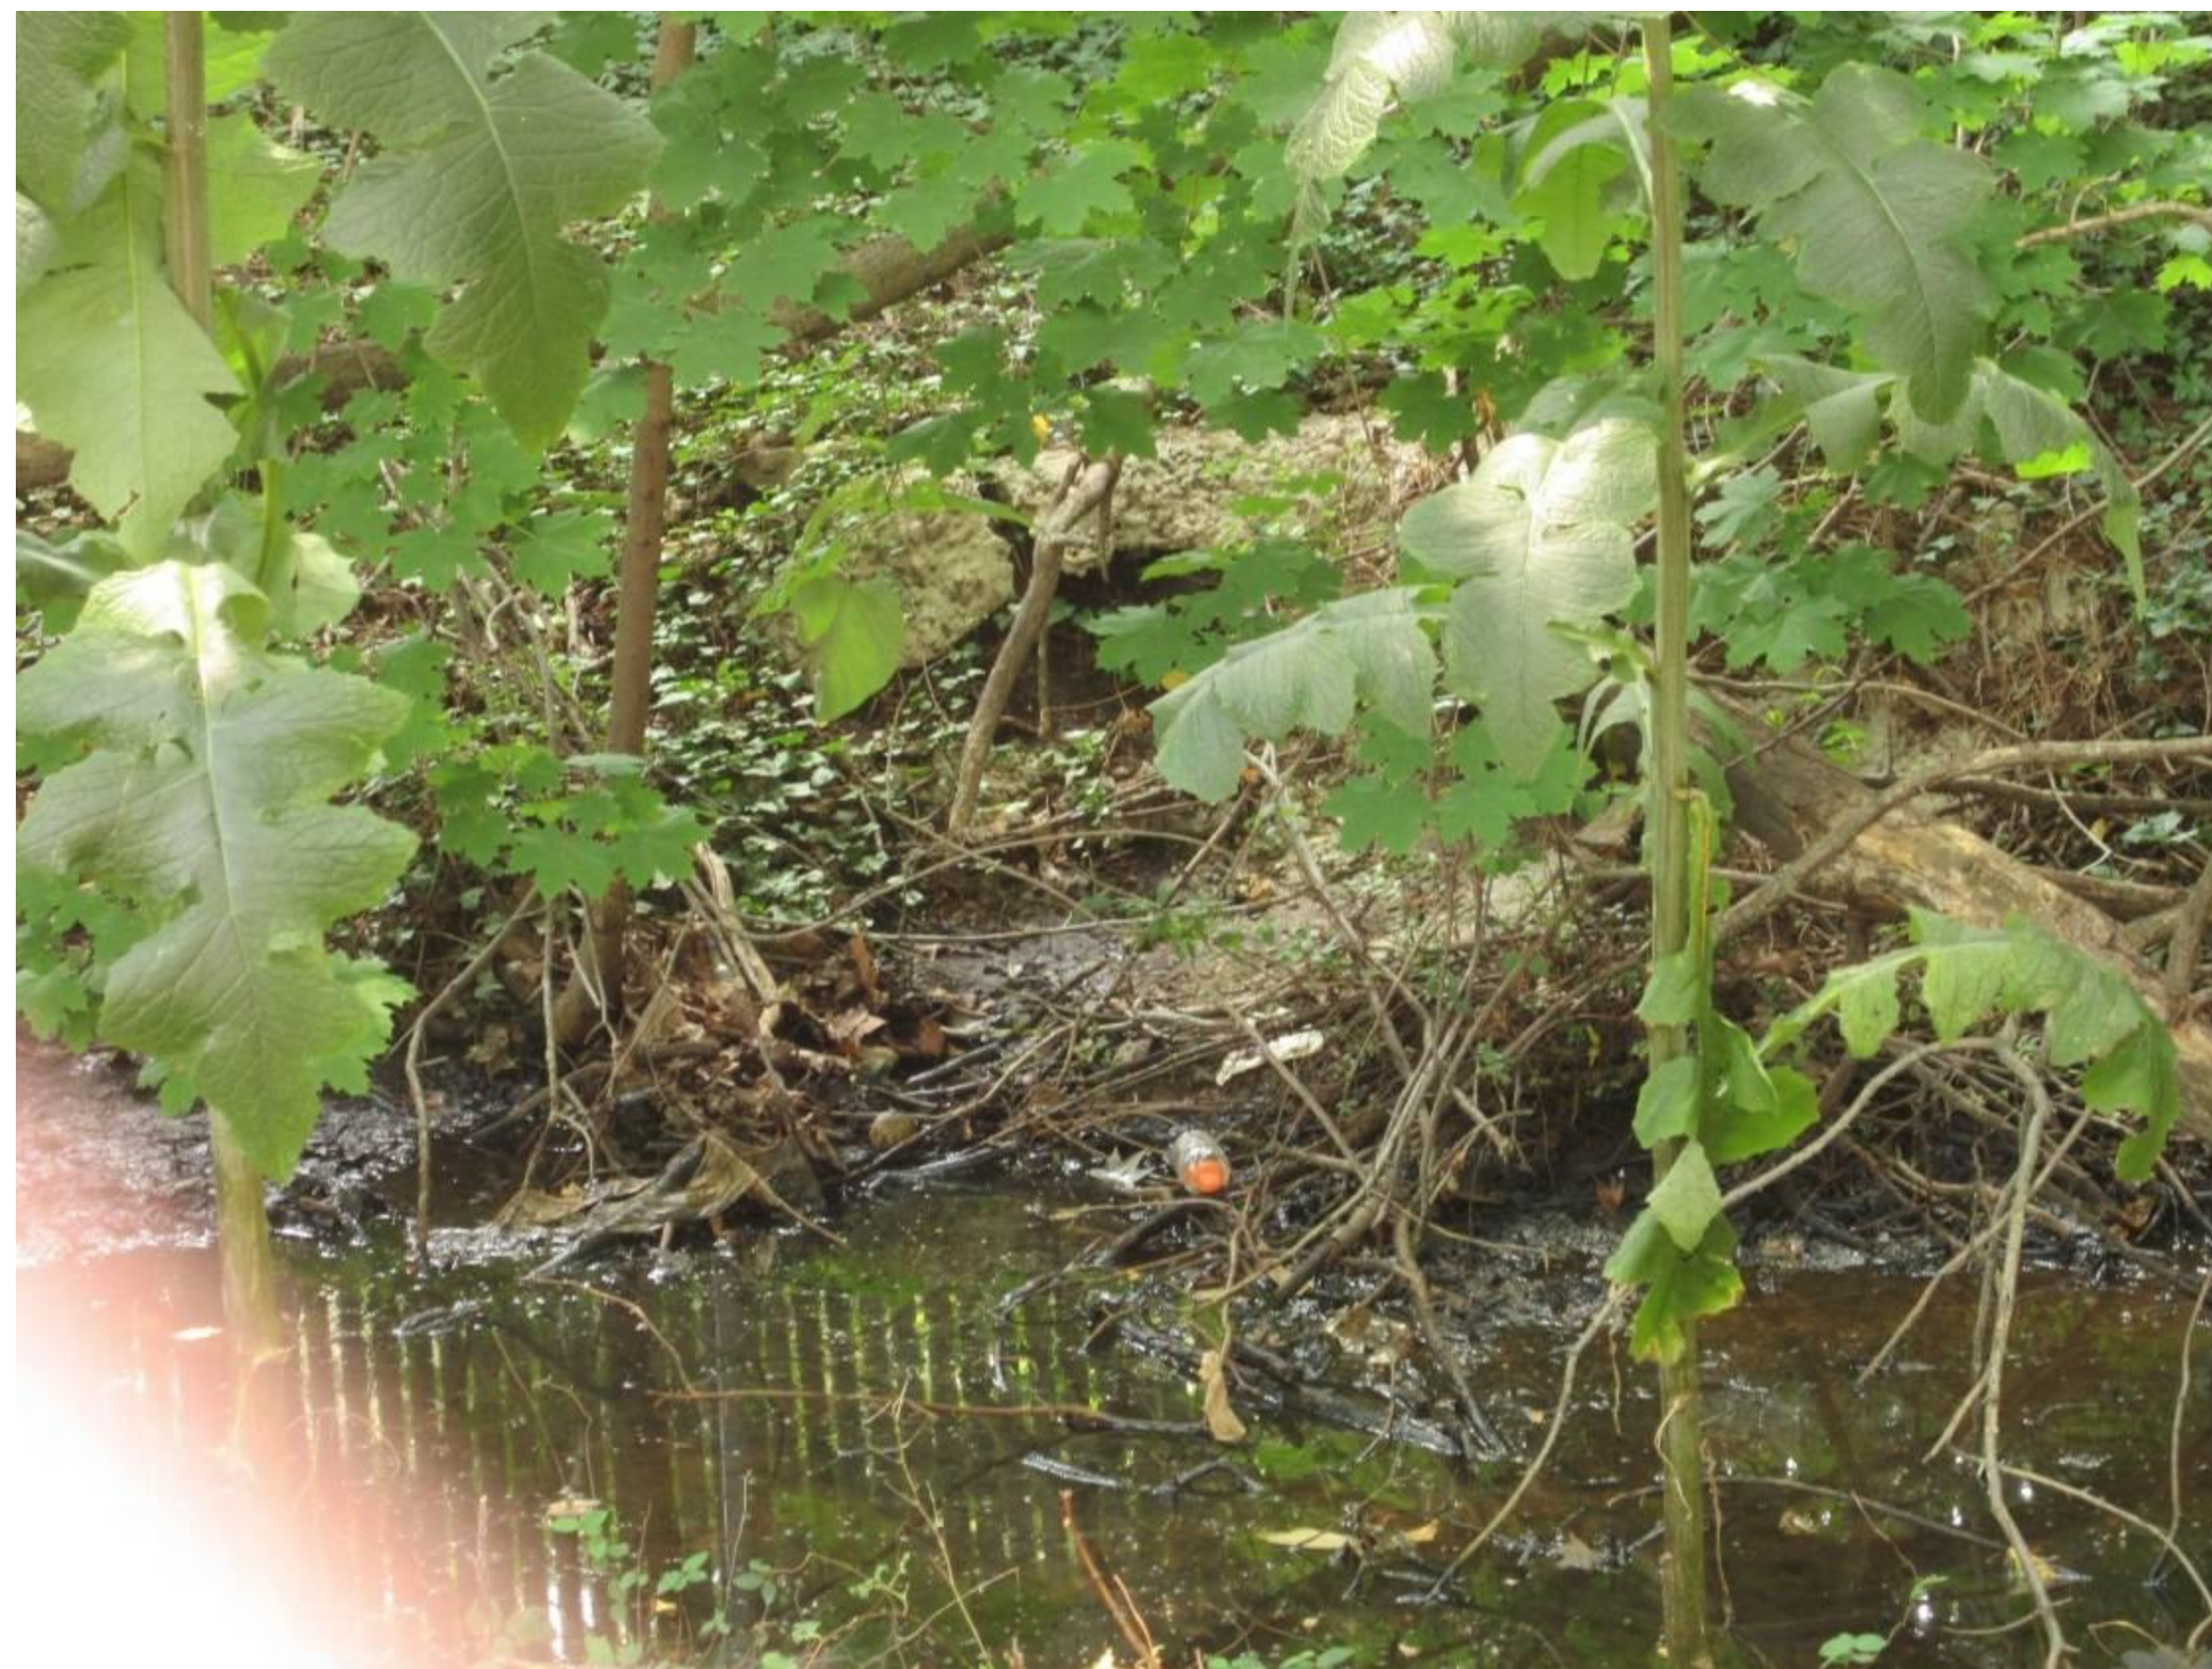
Ponding in basin bottom

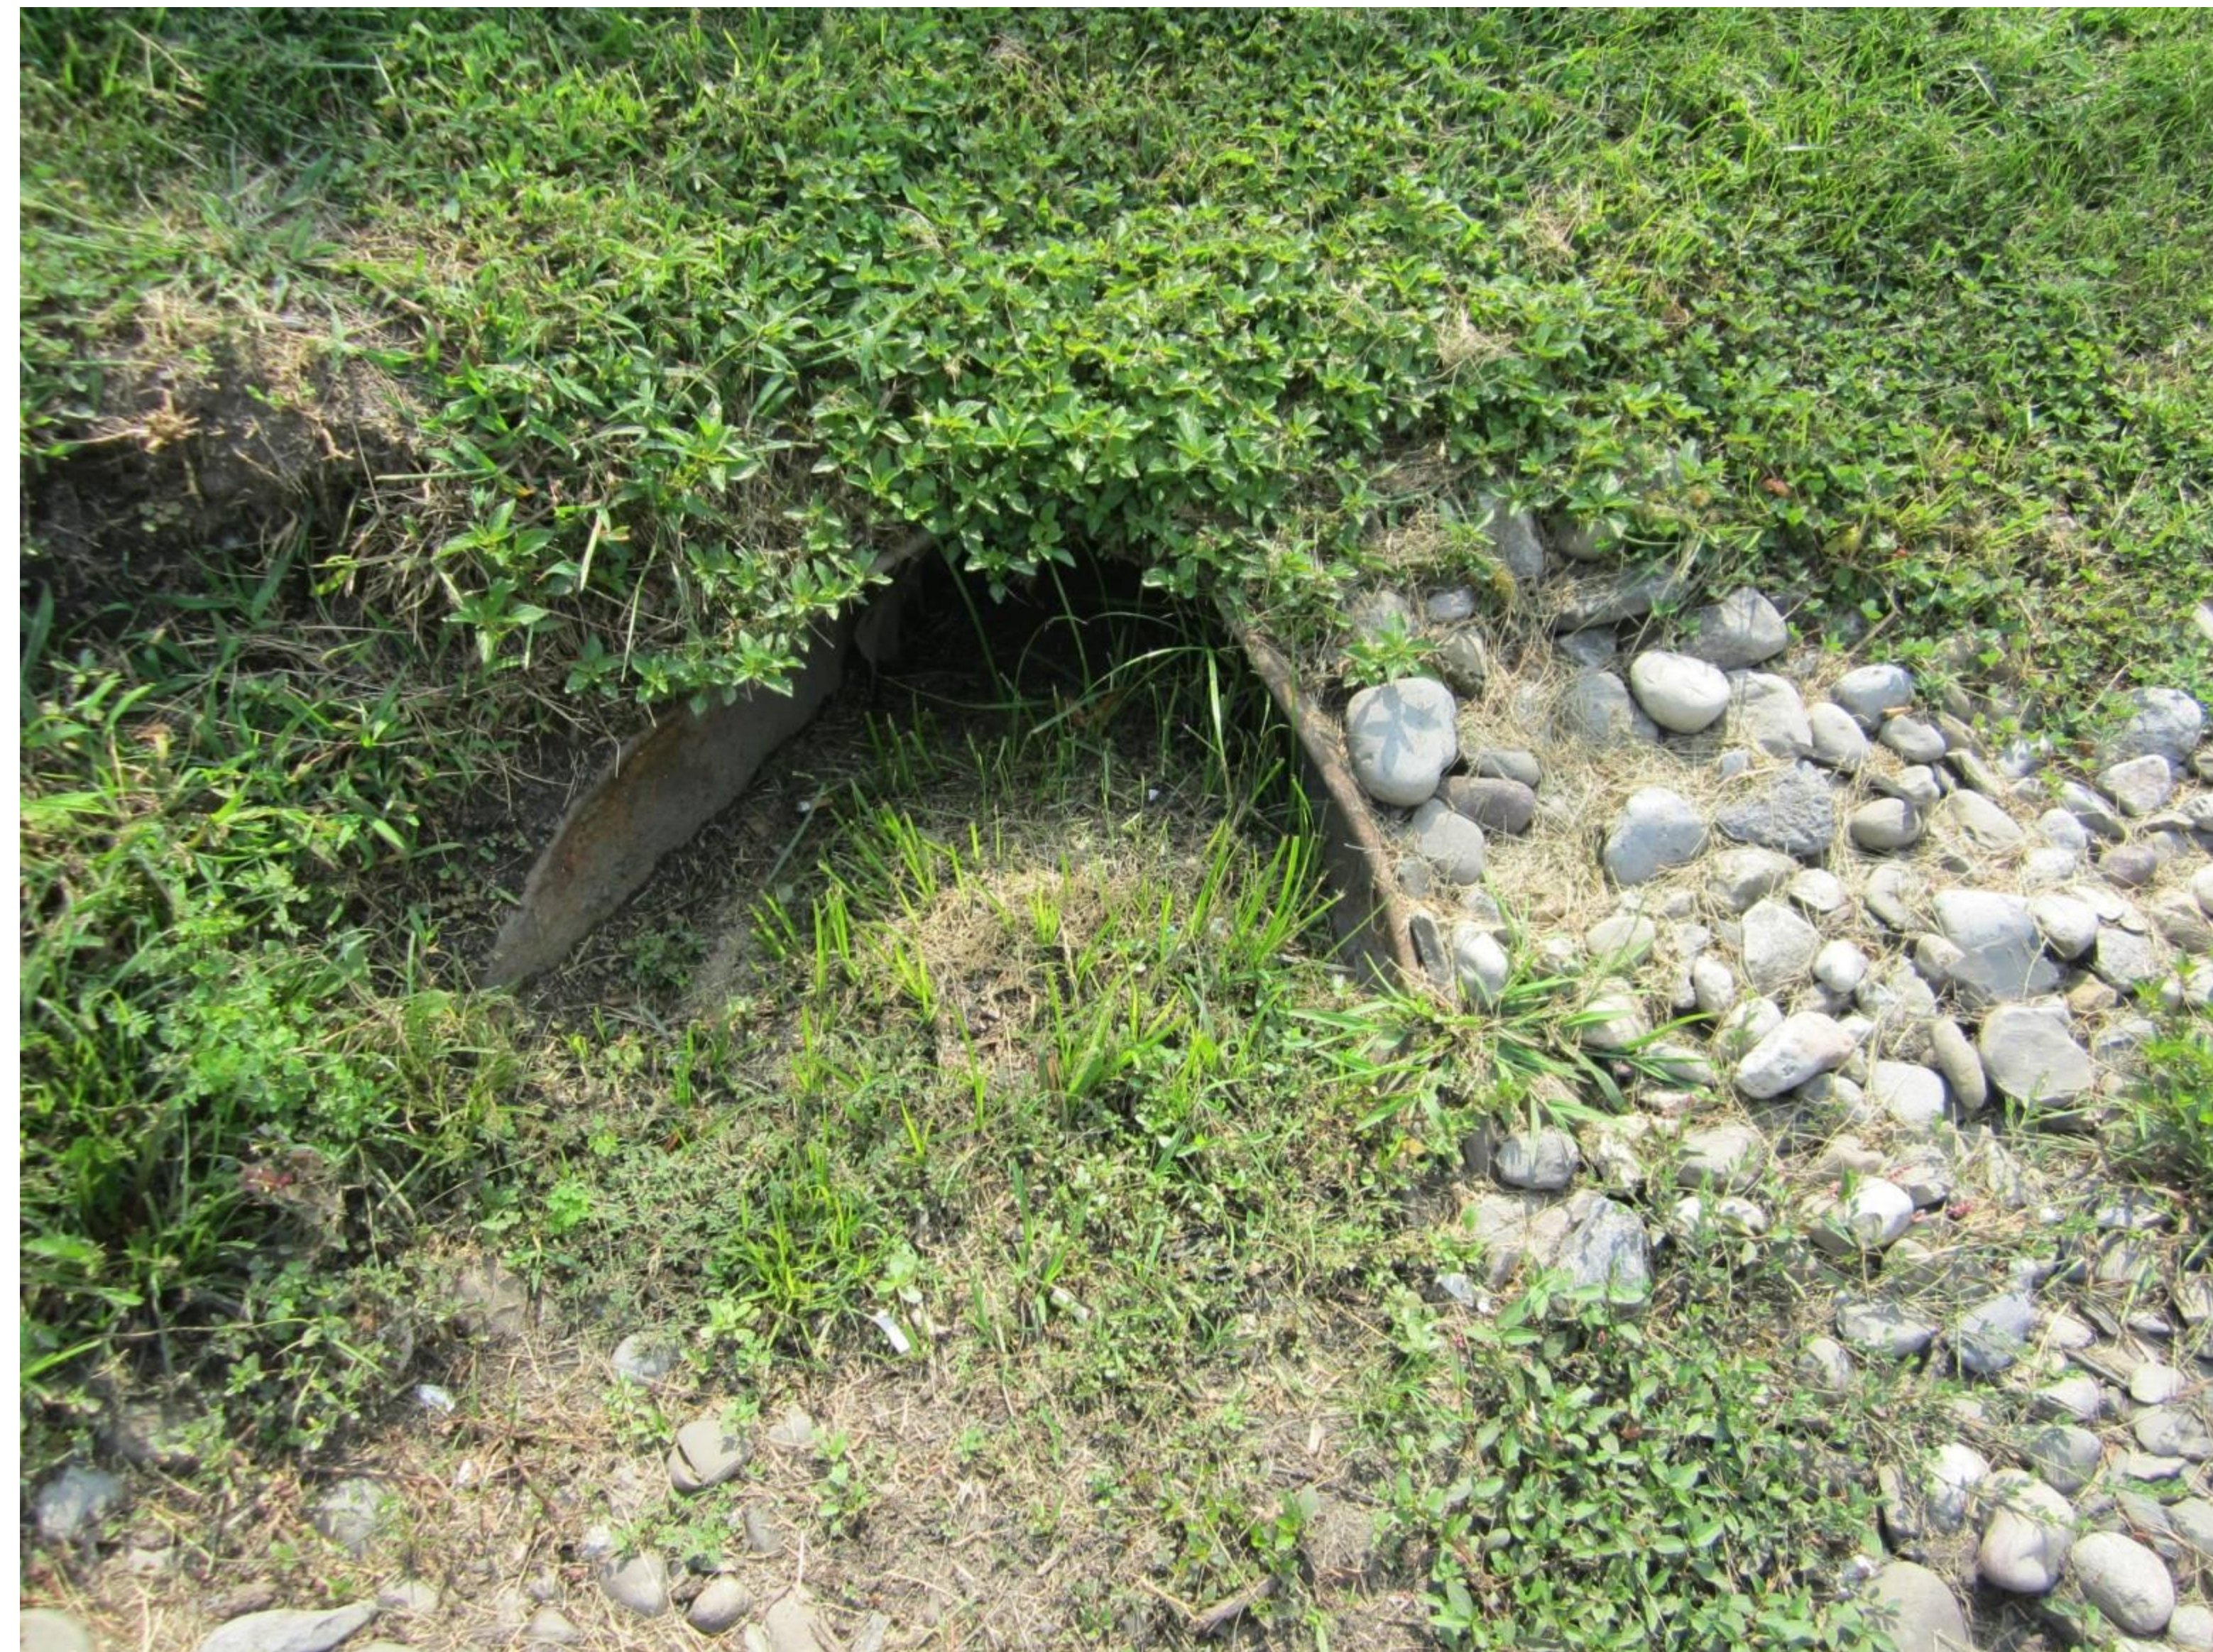
Sediment accumulation in inlet

- Excess sediment accumulation in low flow channel, outlet and inlets
- Evidence of standing water
- Corrosion and rusting at inlets

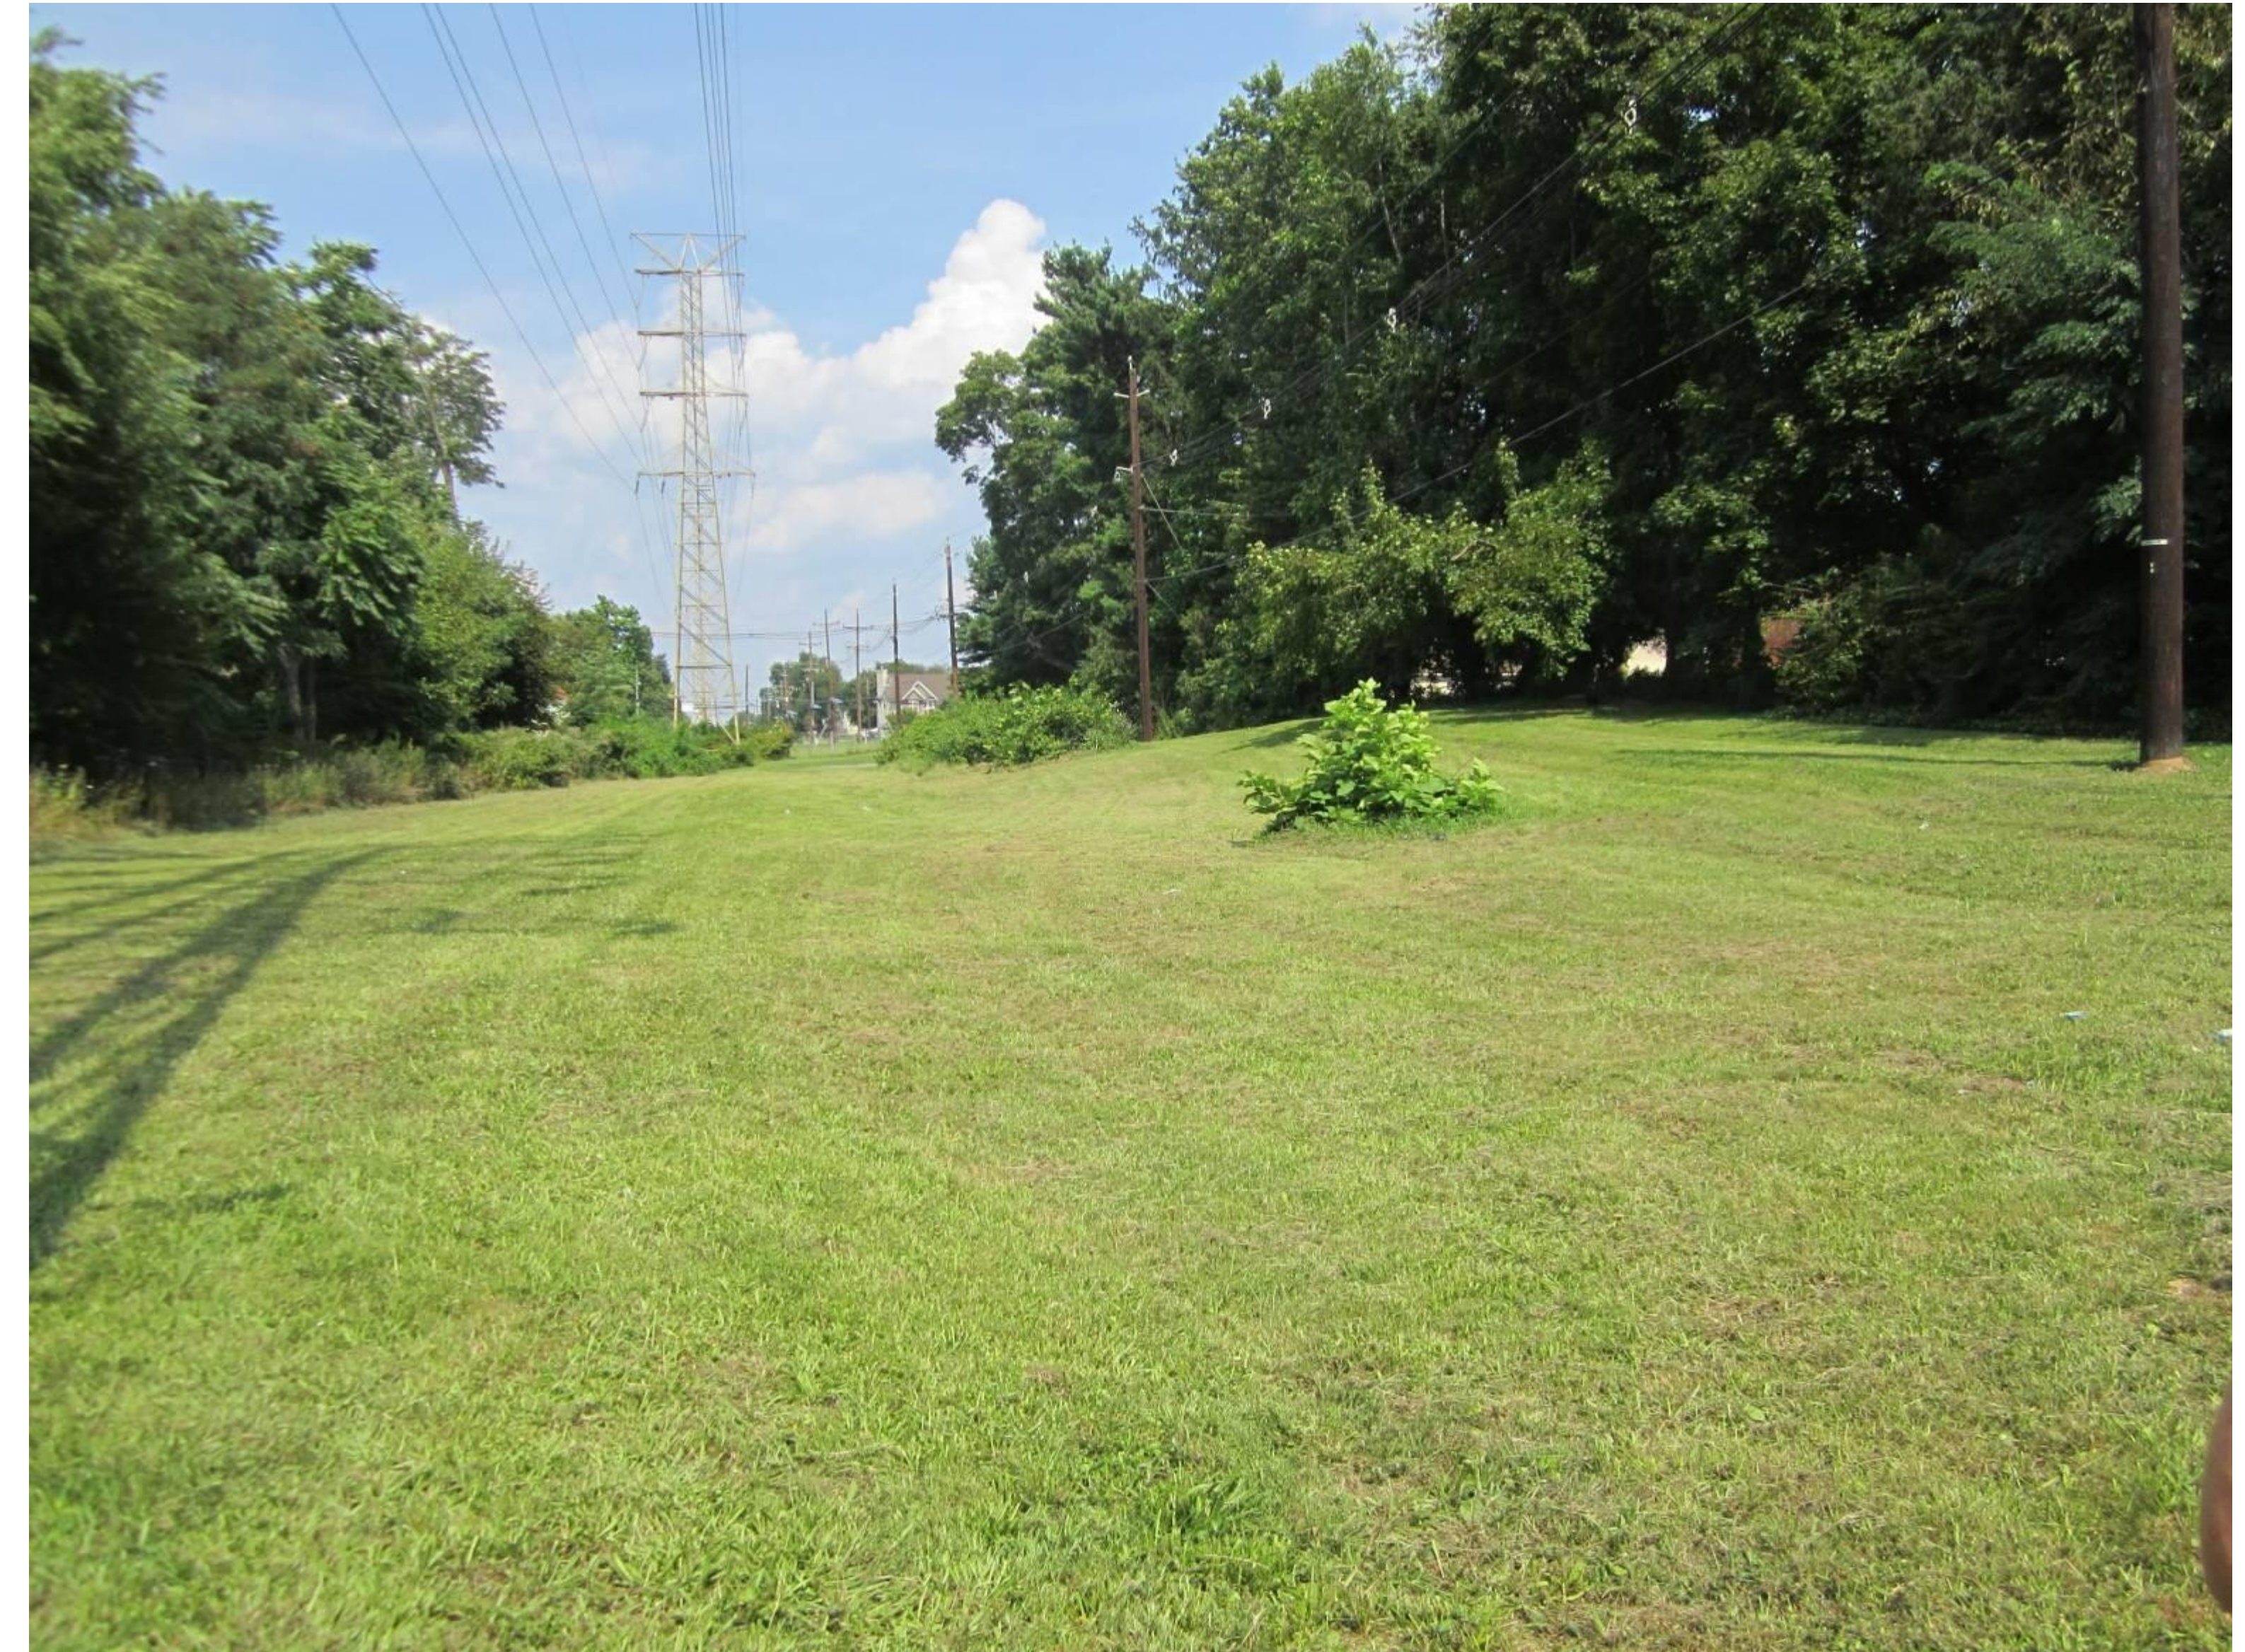
Basin bottom looking northeast
