Hamilton Township (Mercer County) Stormwater Basin Assessment Summary (Year 1)

Developed by the Rutgers Cooperative Extension Water Resources Program
Funded by Hamilton Township, Mercer County, New Jersey

December 6, 2012

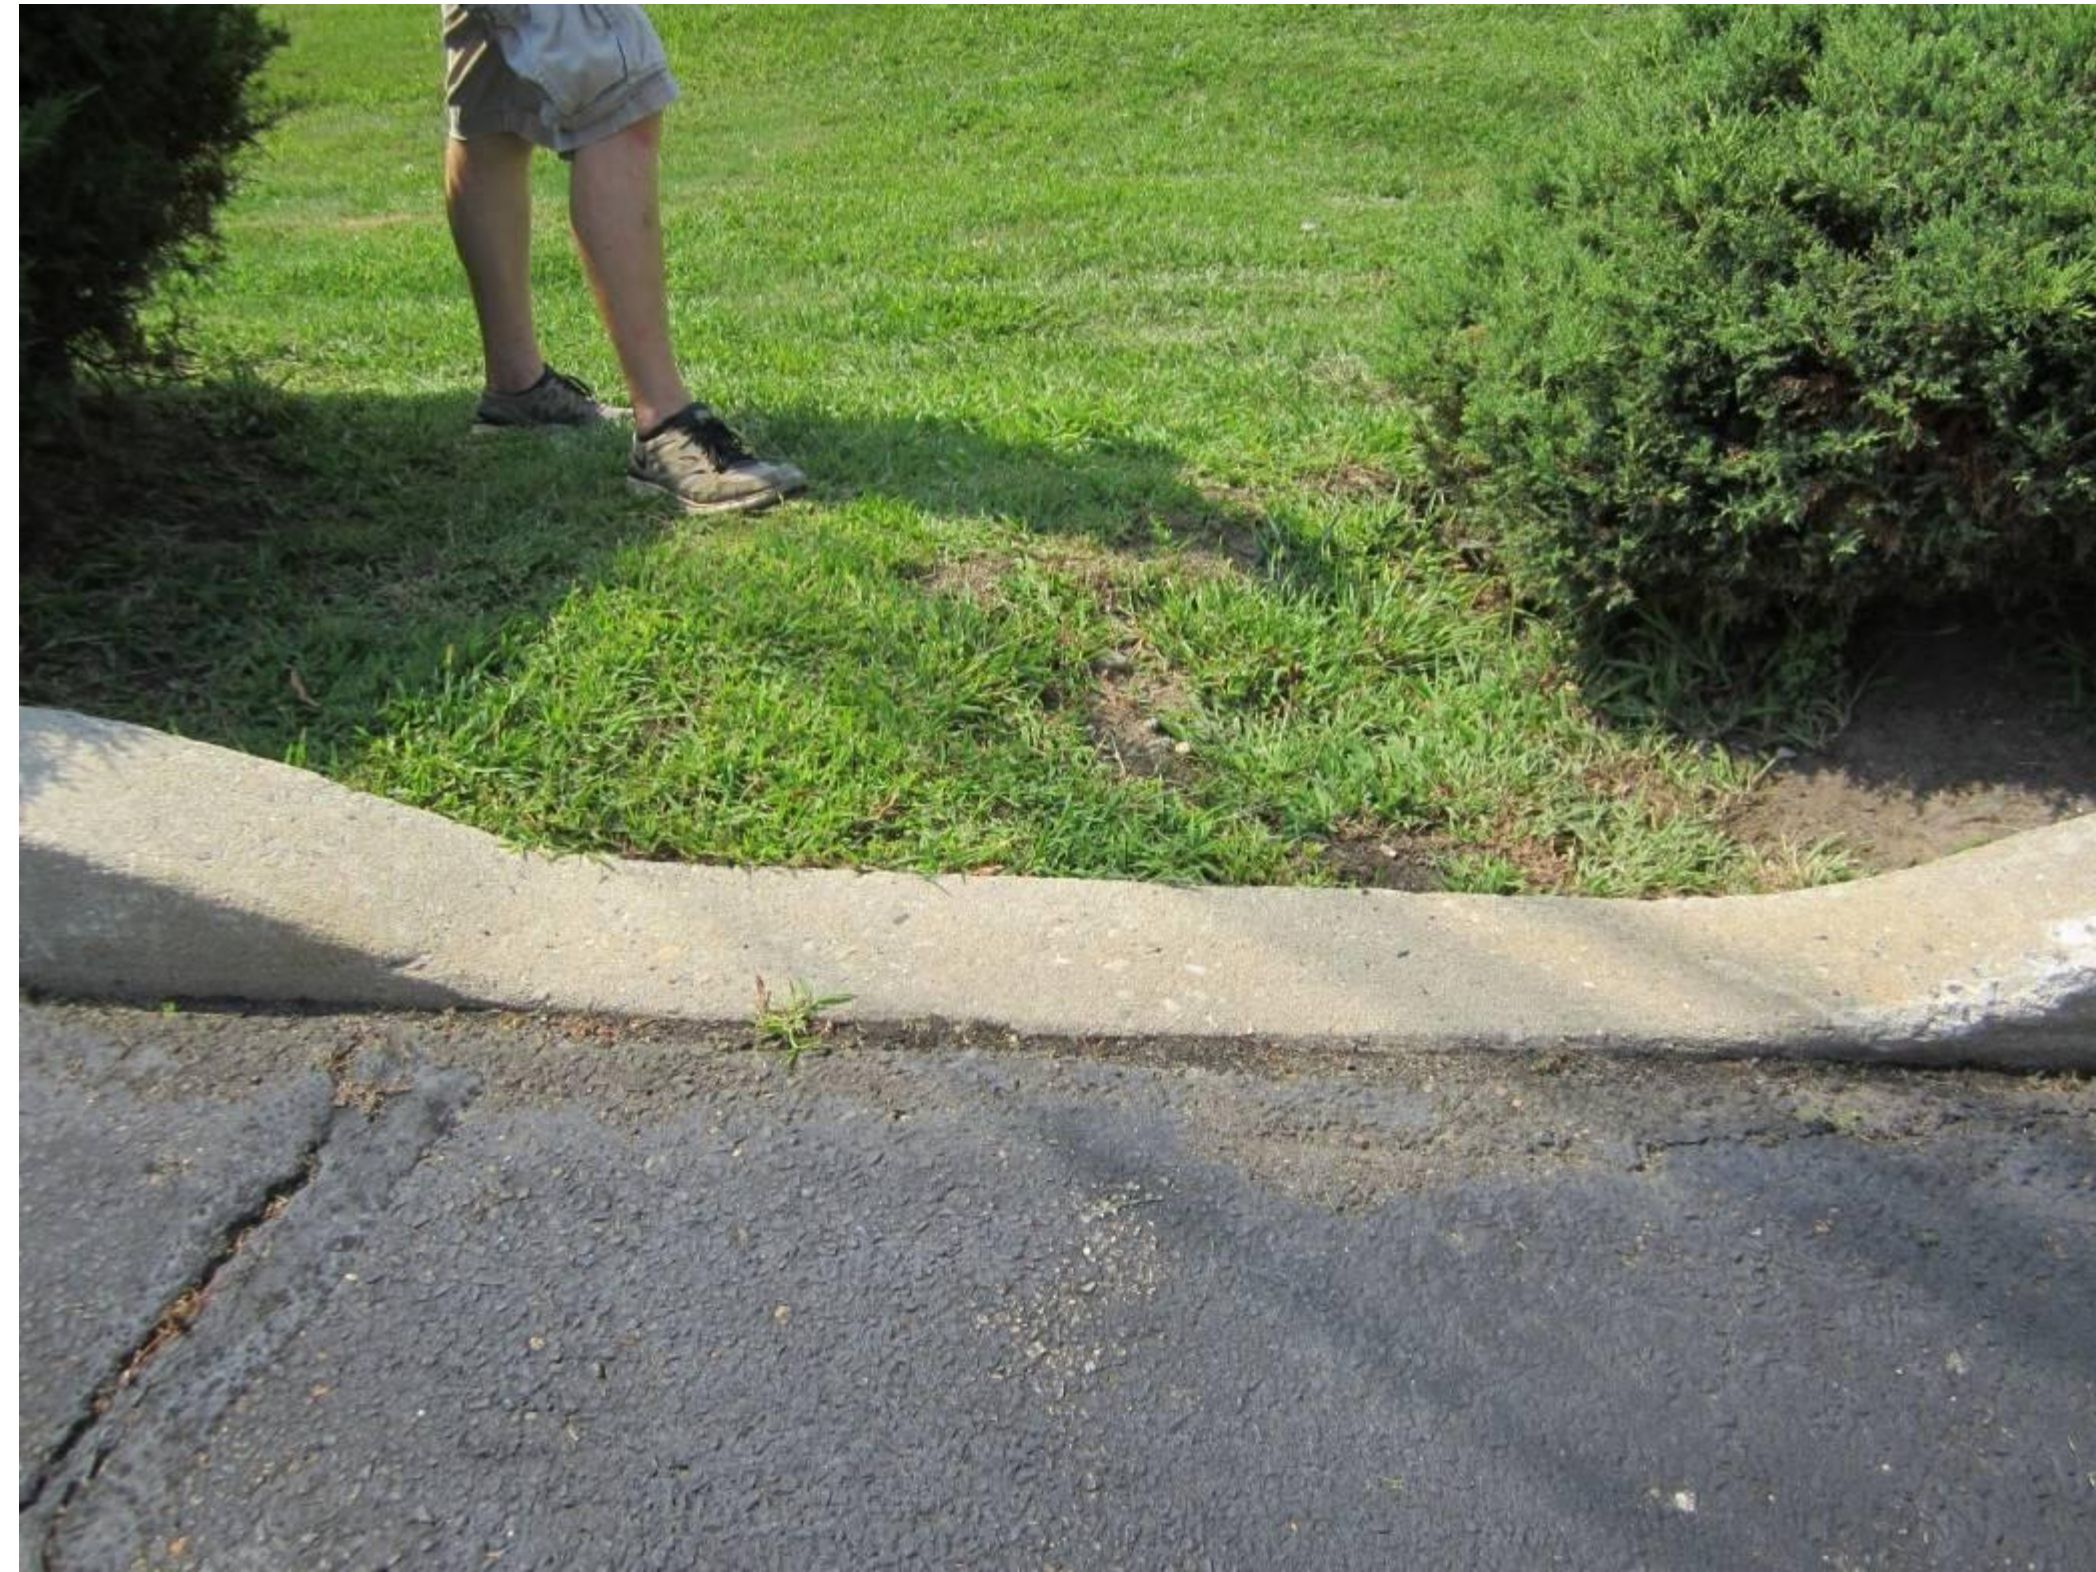
Curb cut inlet

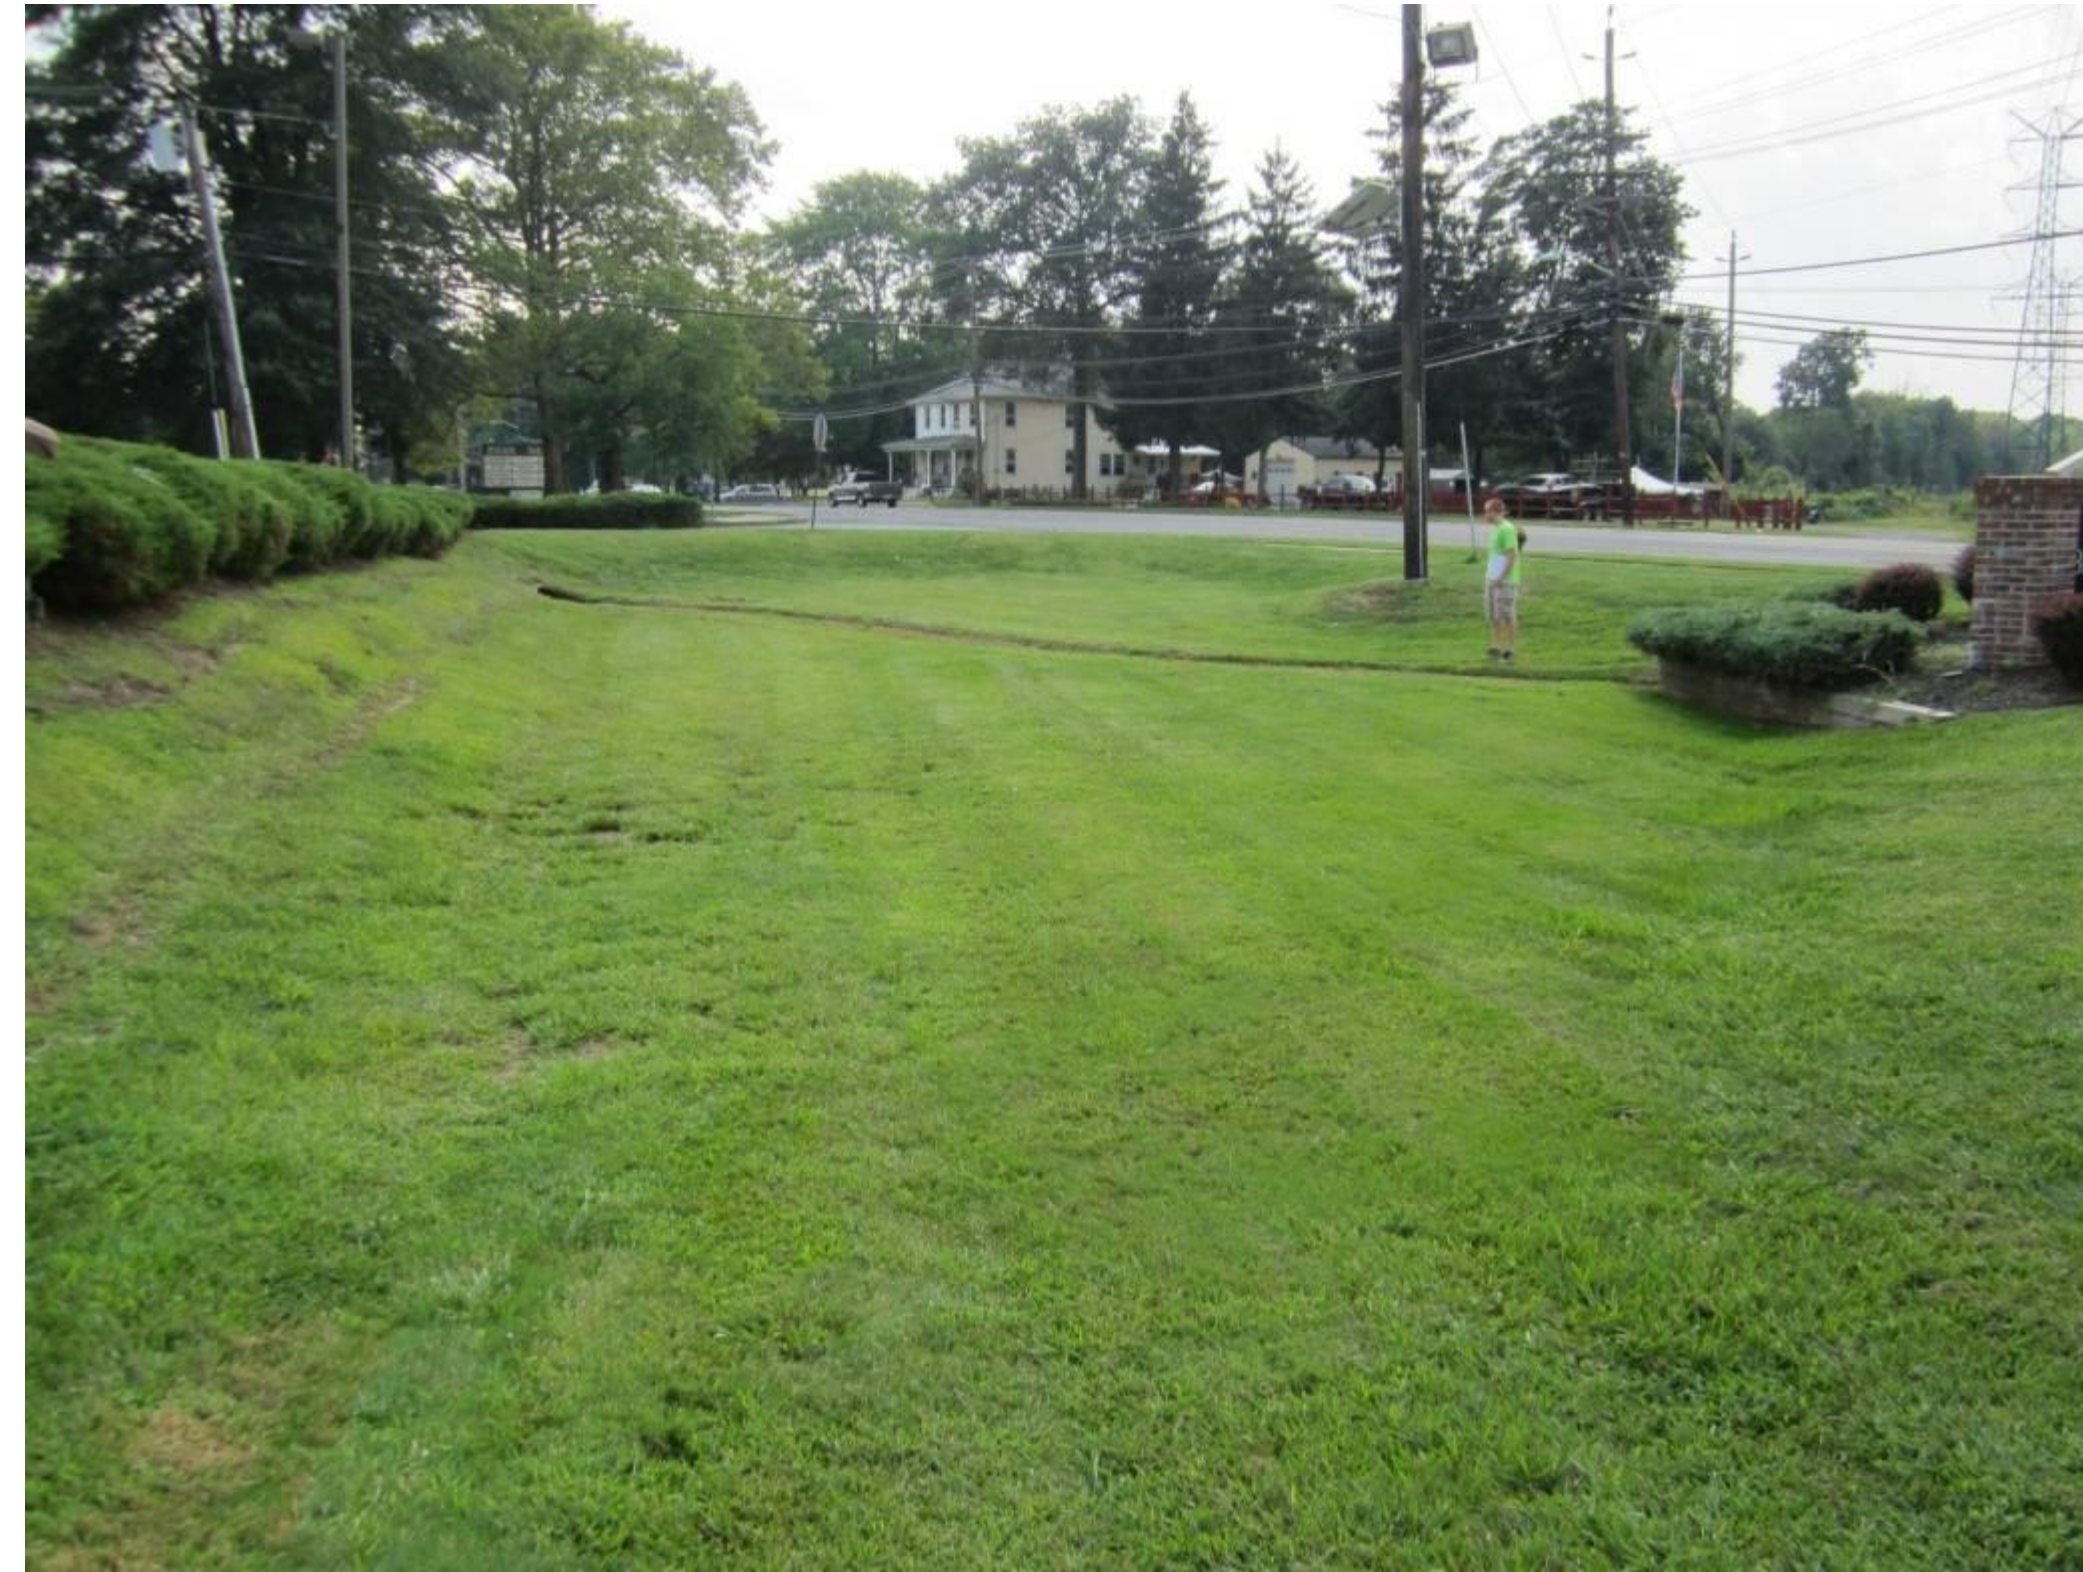
Basin bottom looking southwest

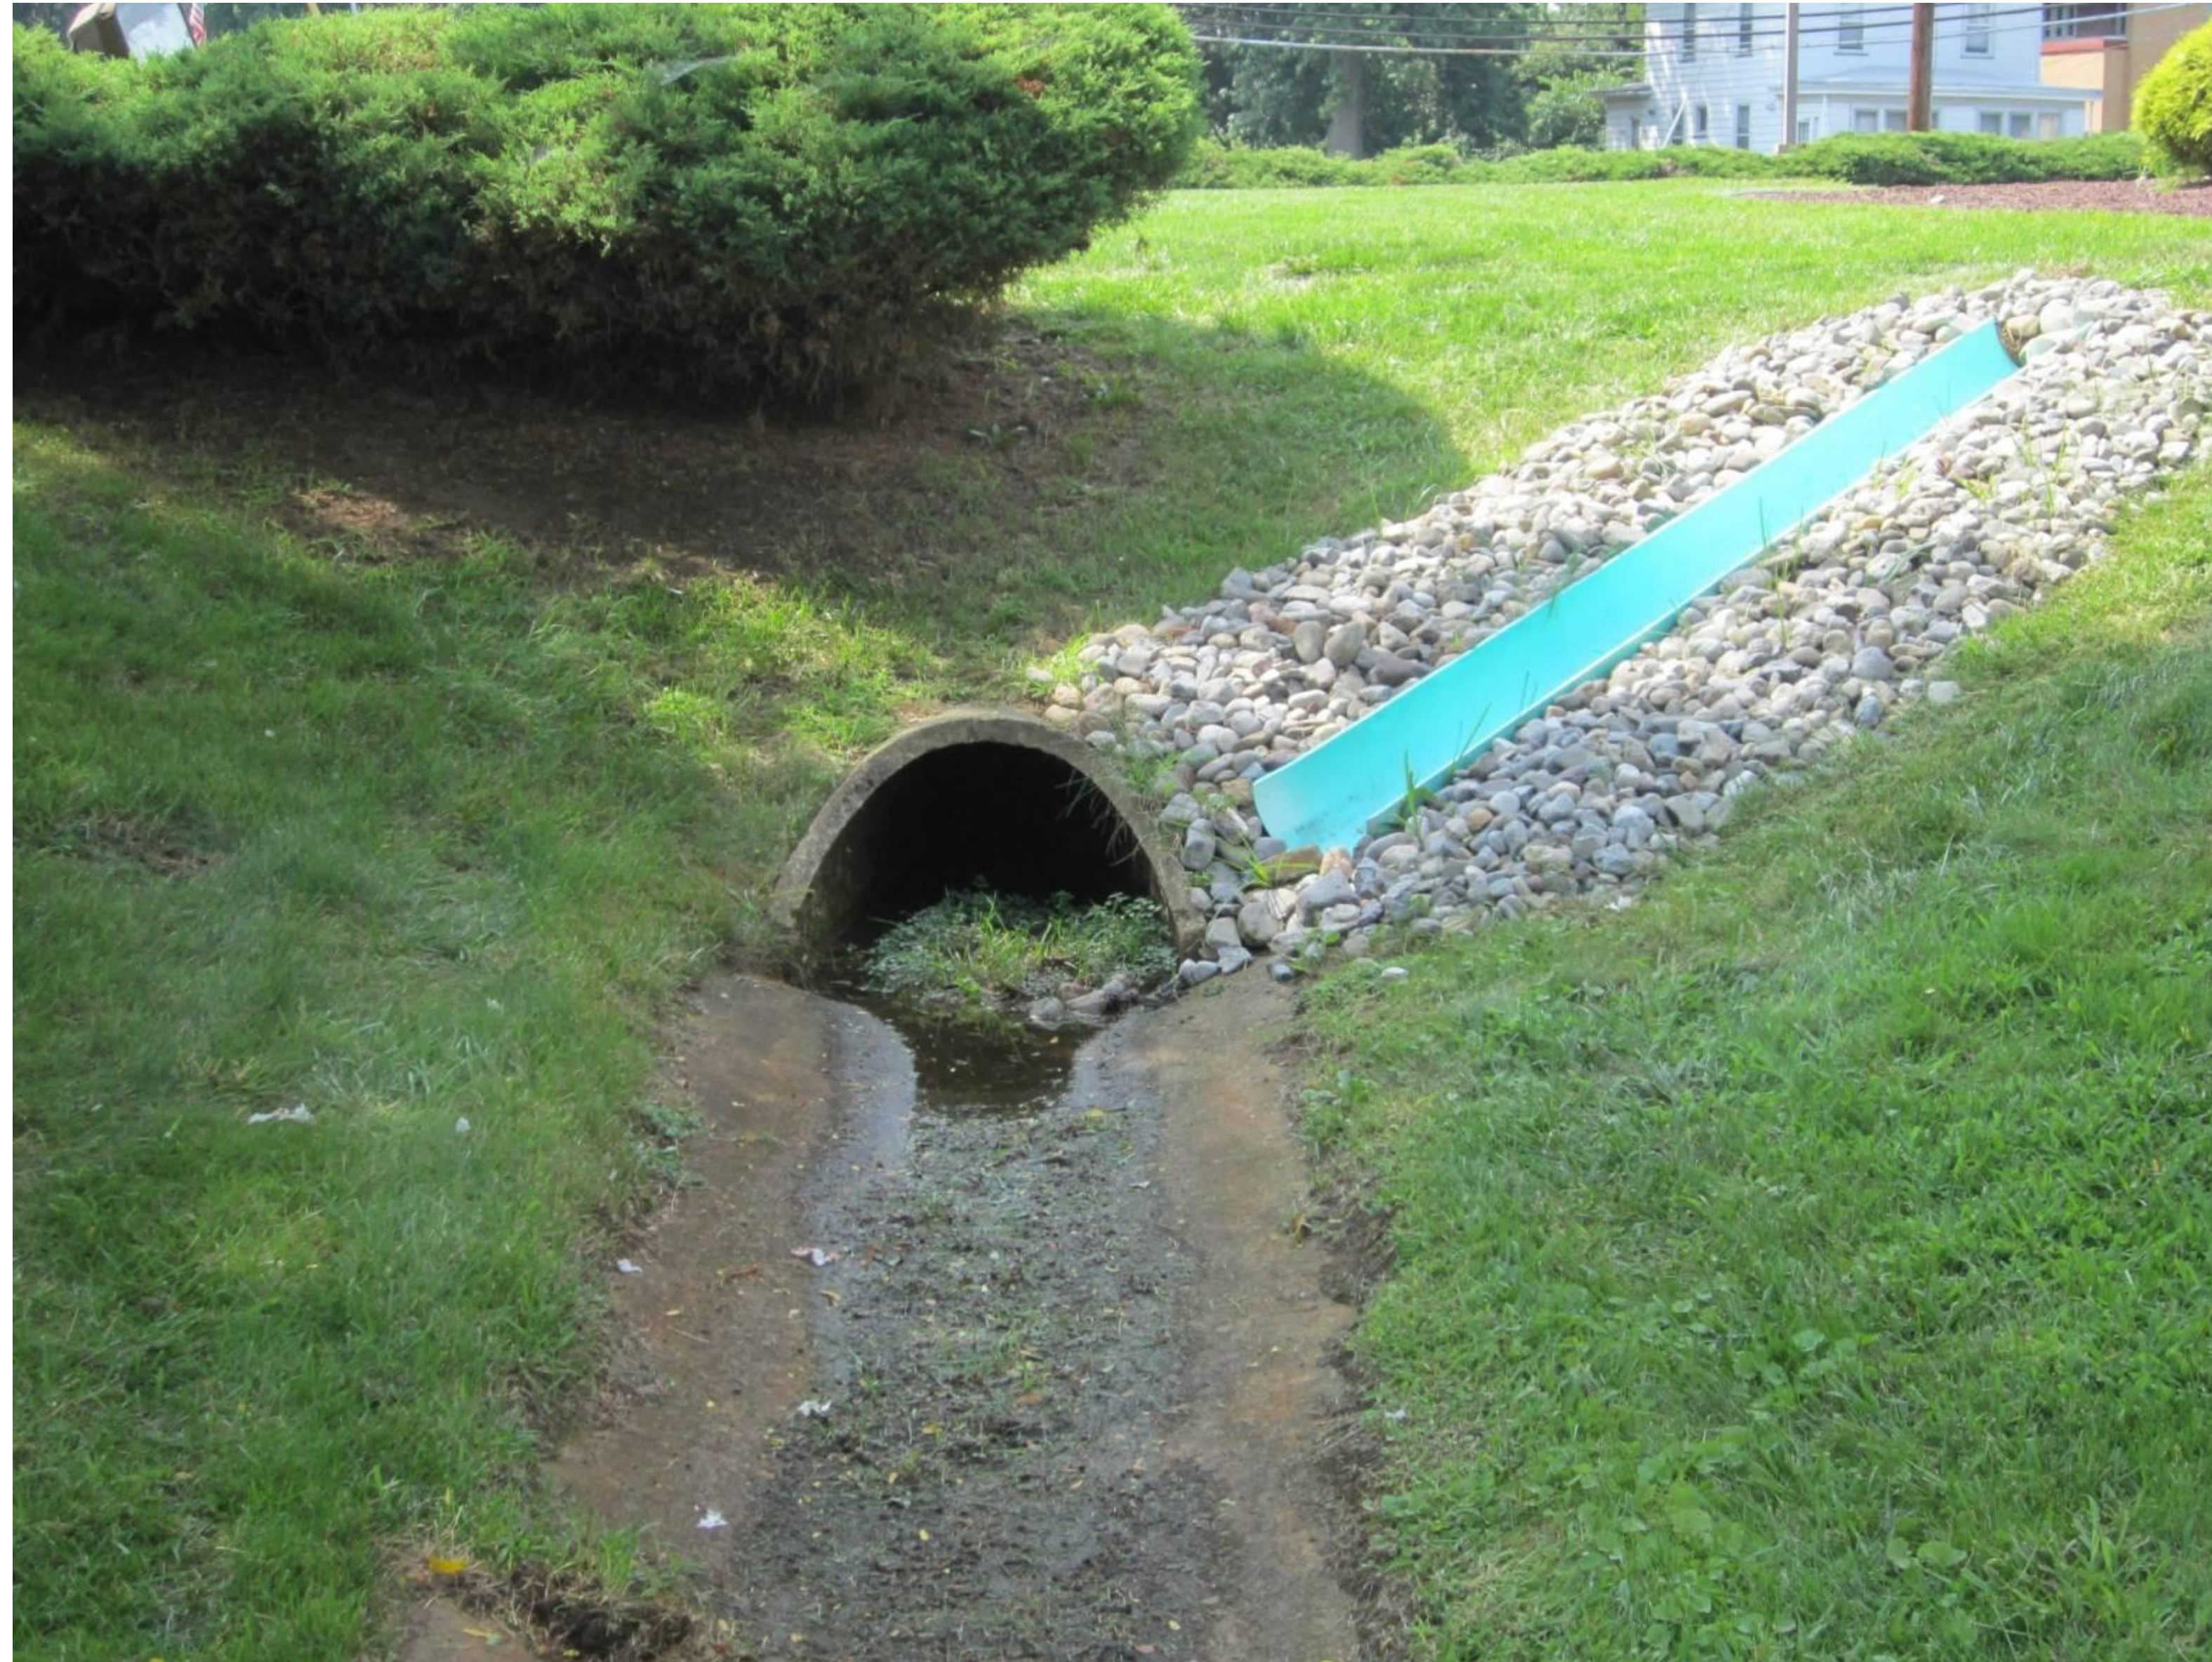
Outlet clogged with sediment

- Sediment accumulation in front of outlet
- Some corrosion from rooftop pipes

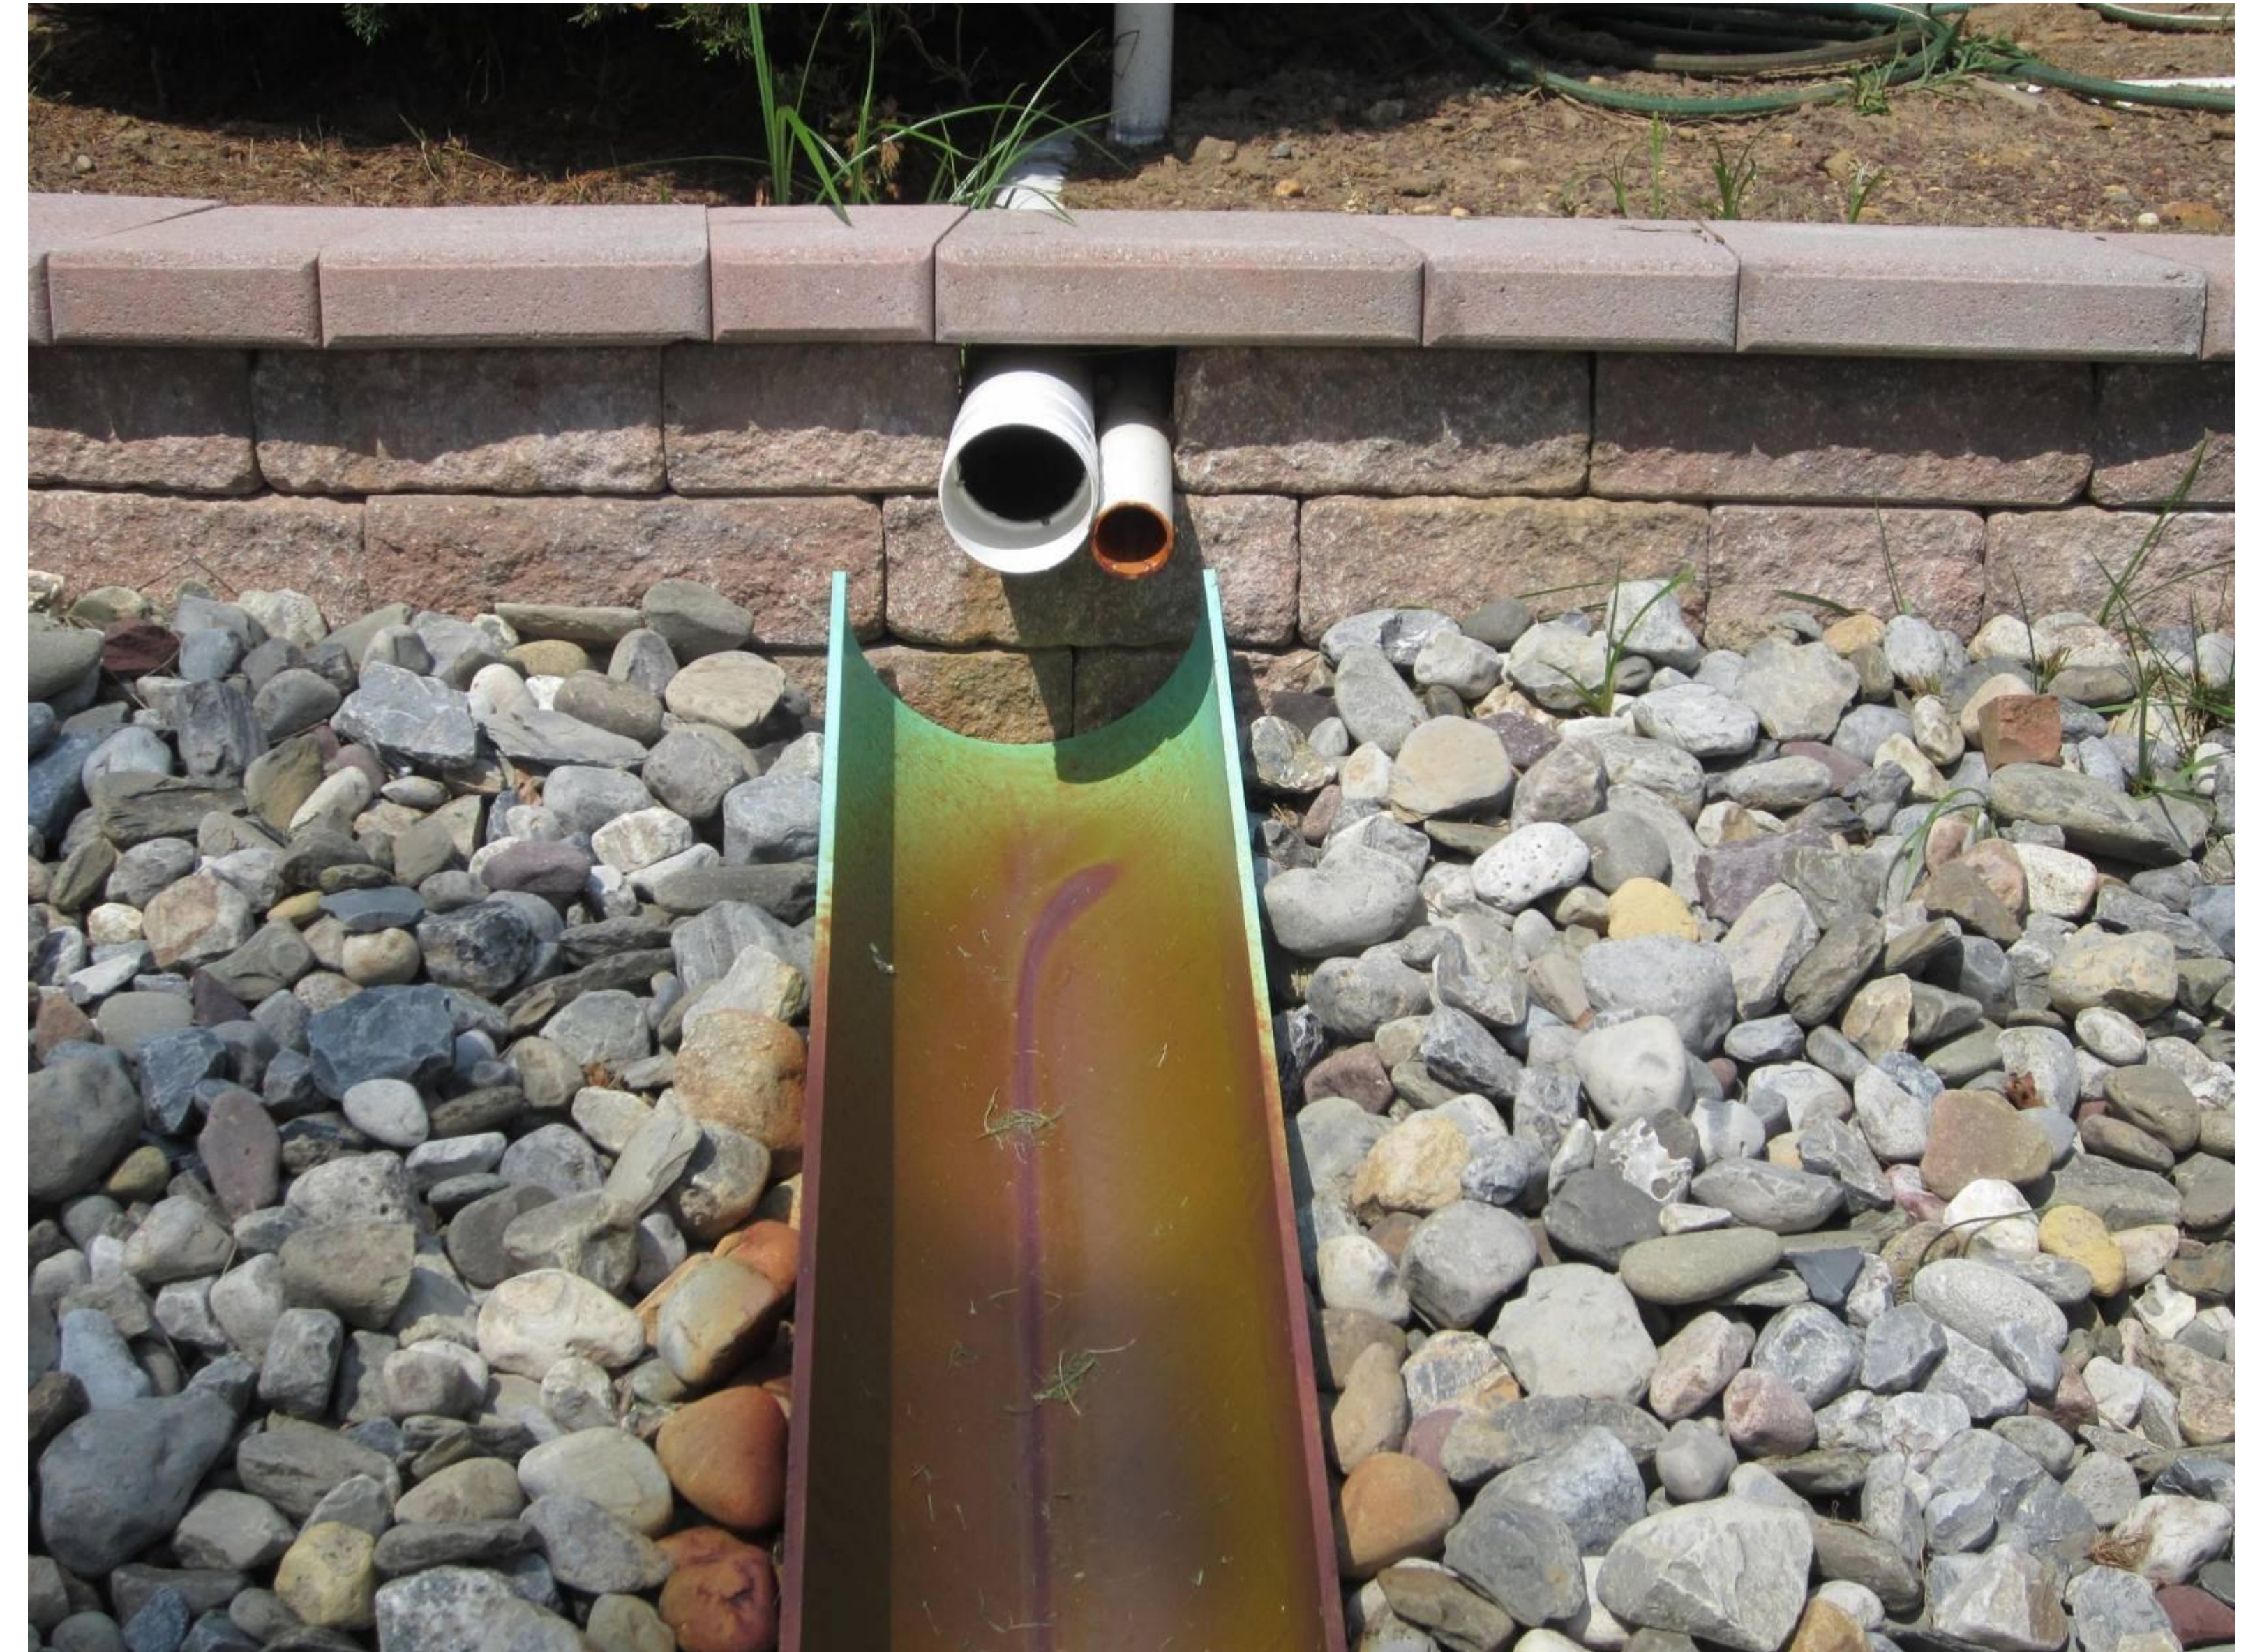
Pipe from rooftop run off

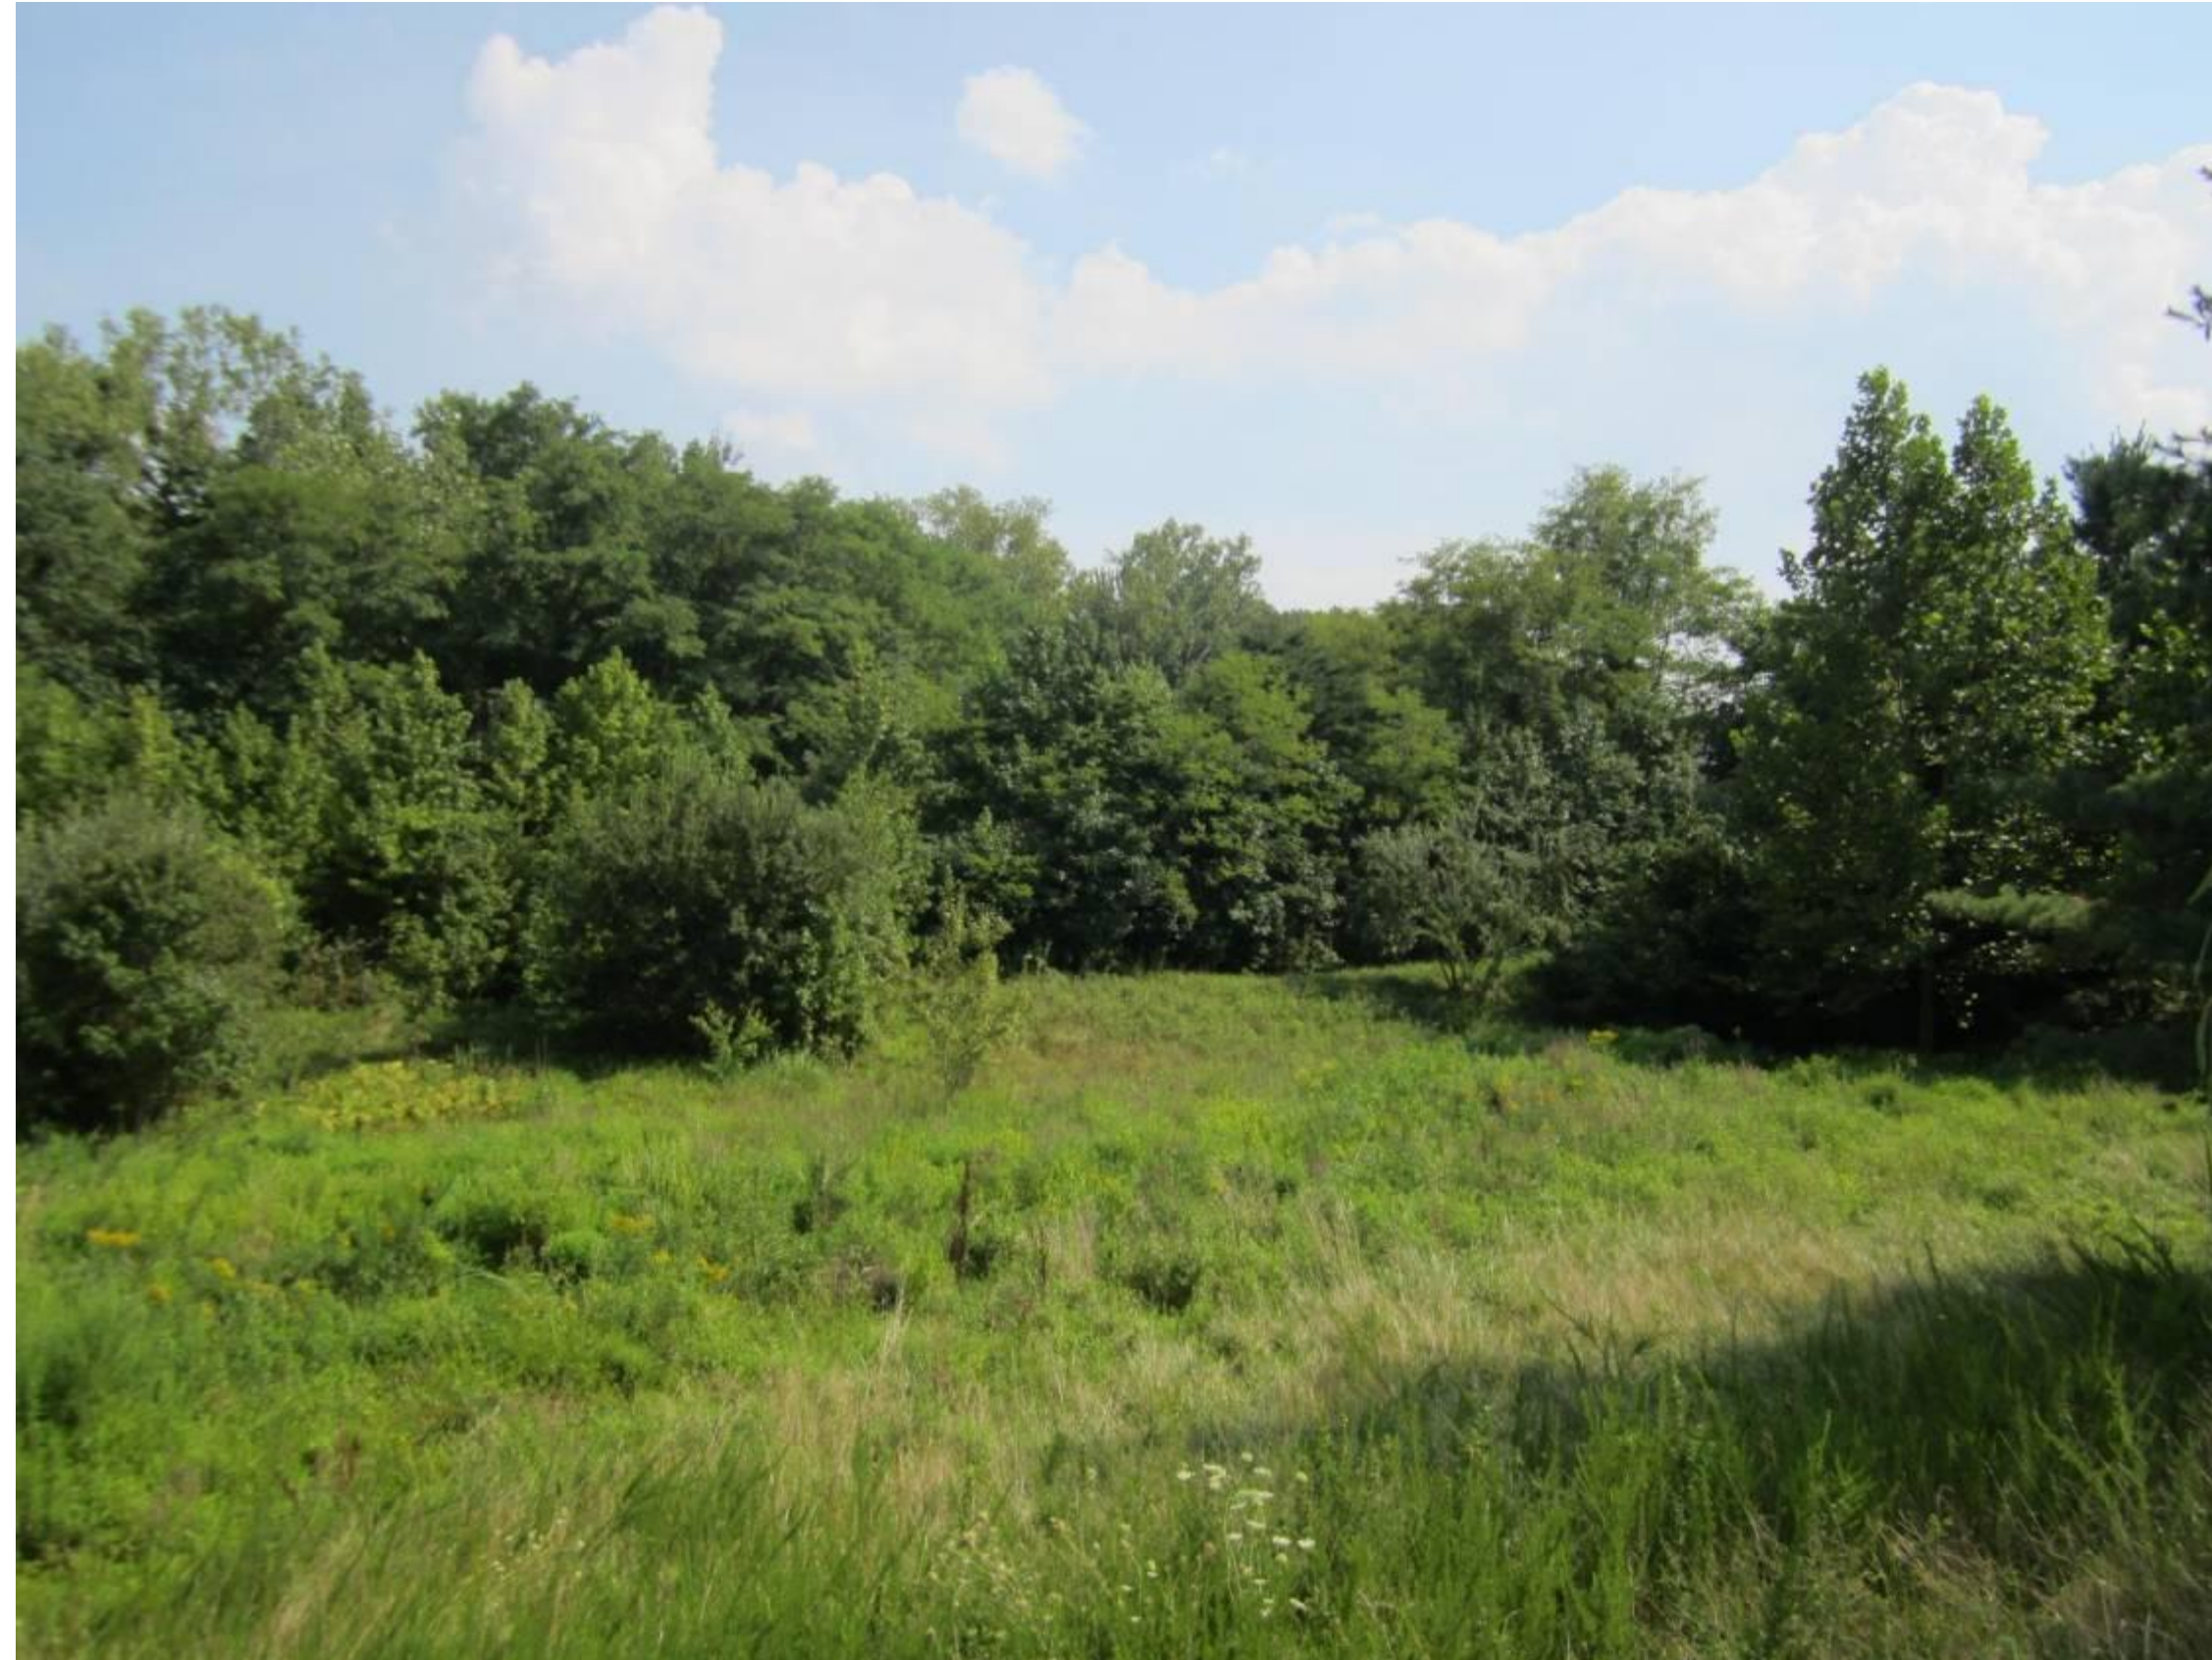
Basin bottom looking southeast

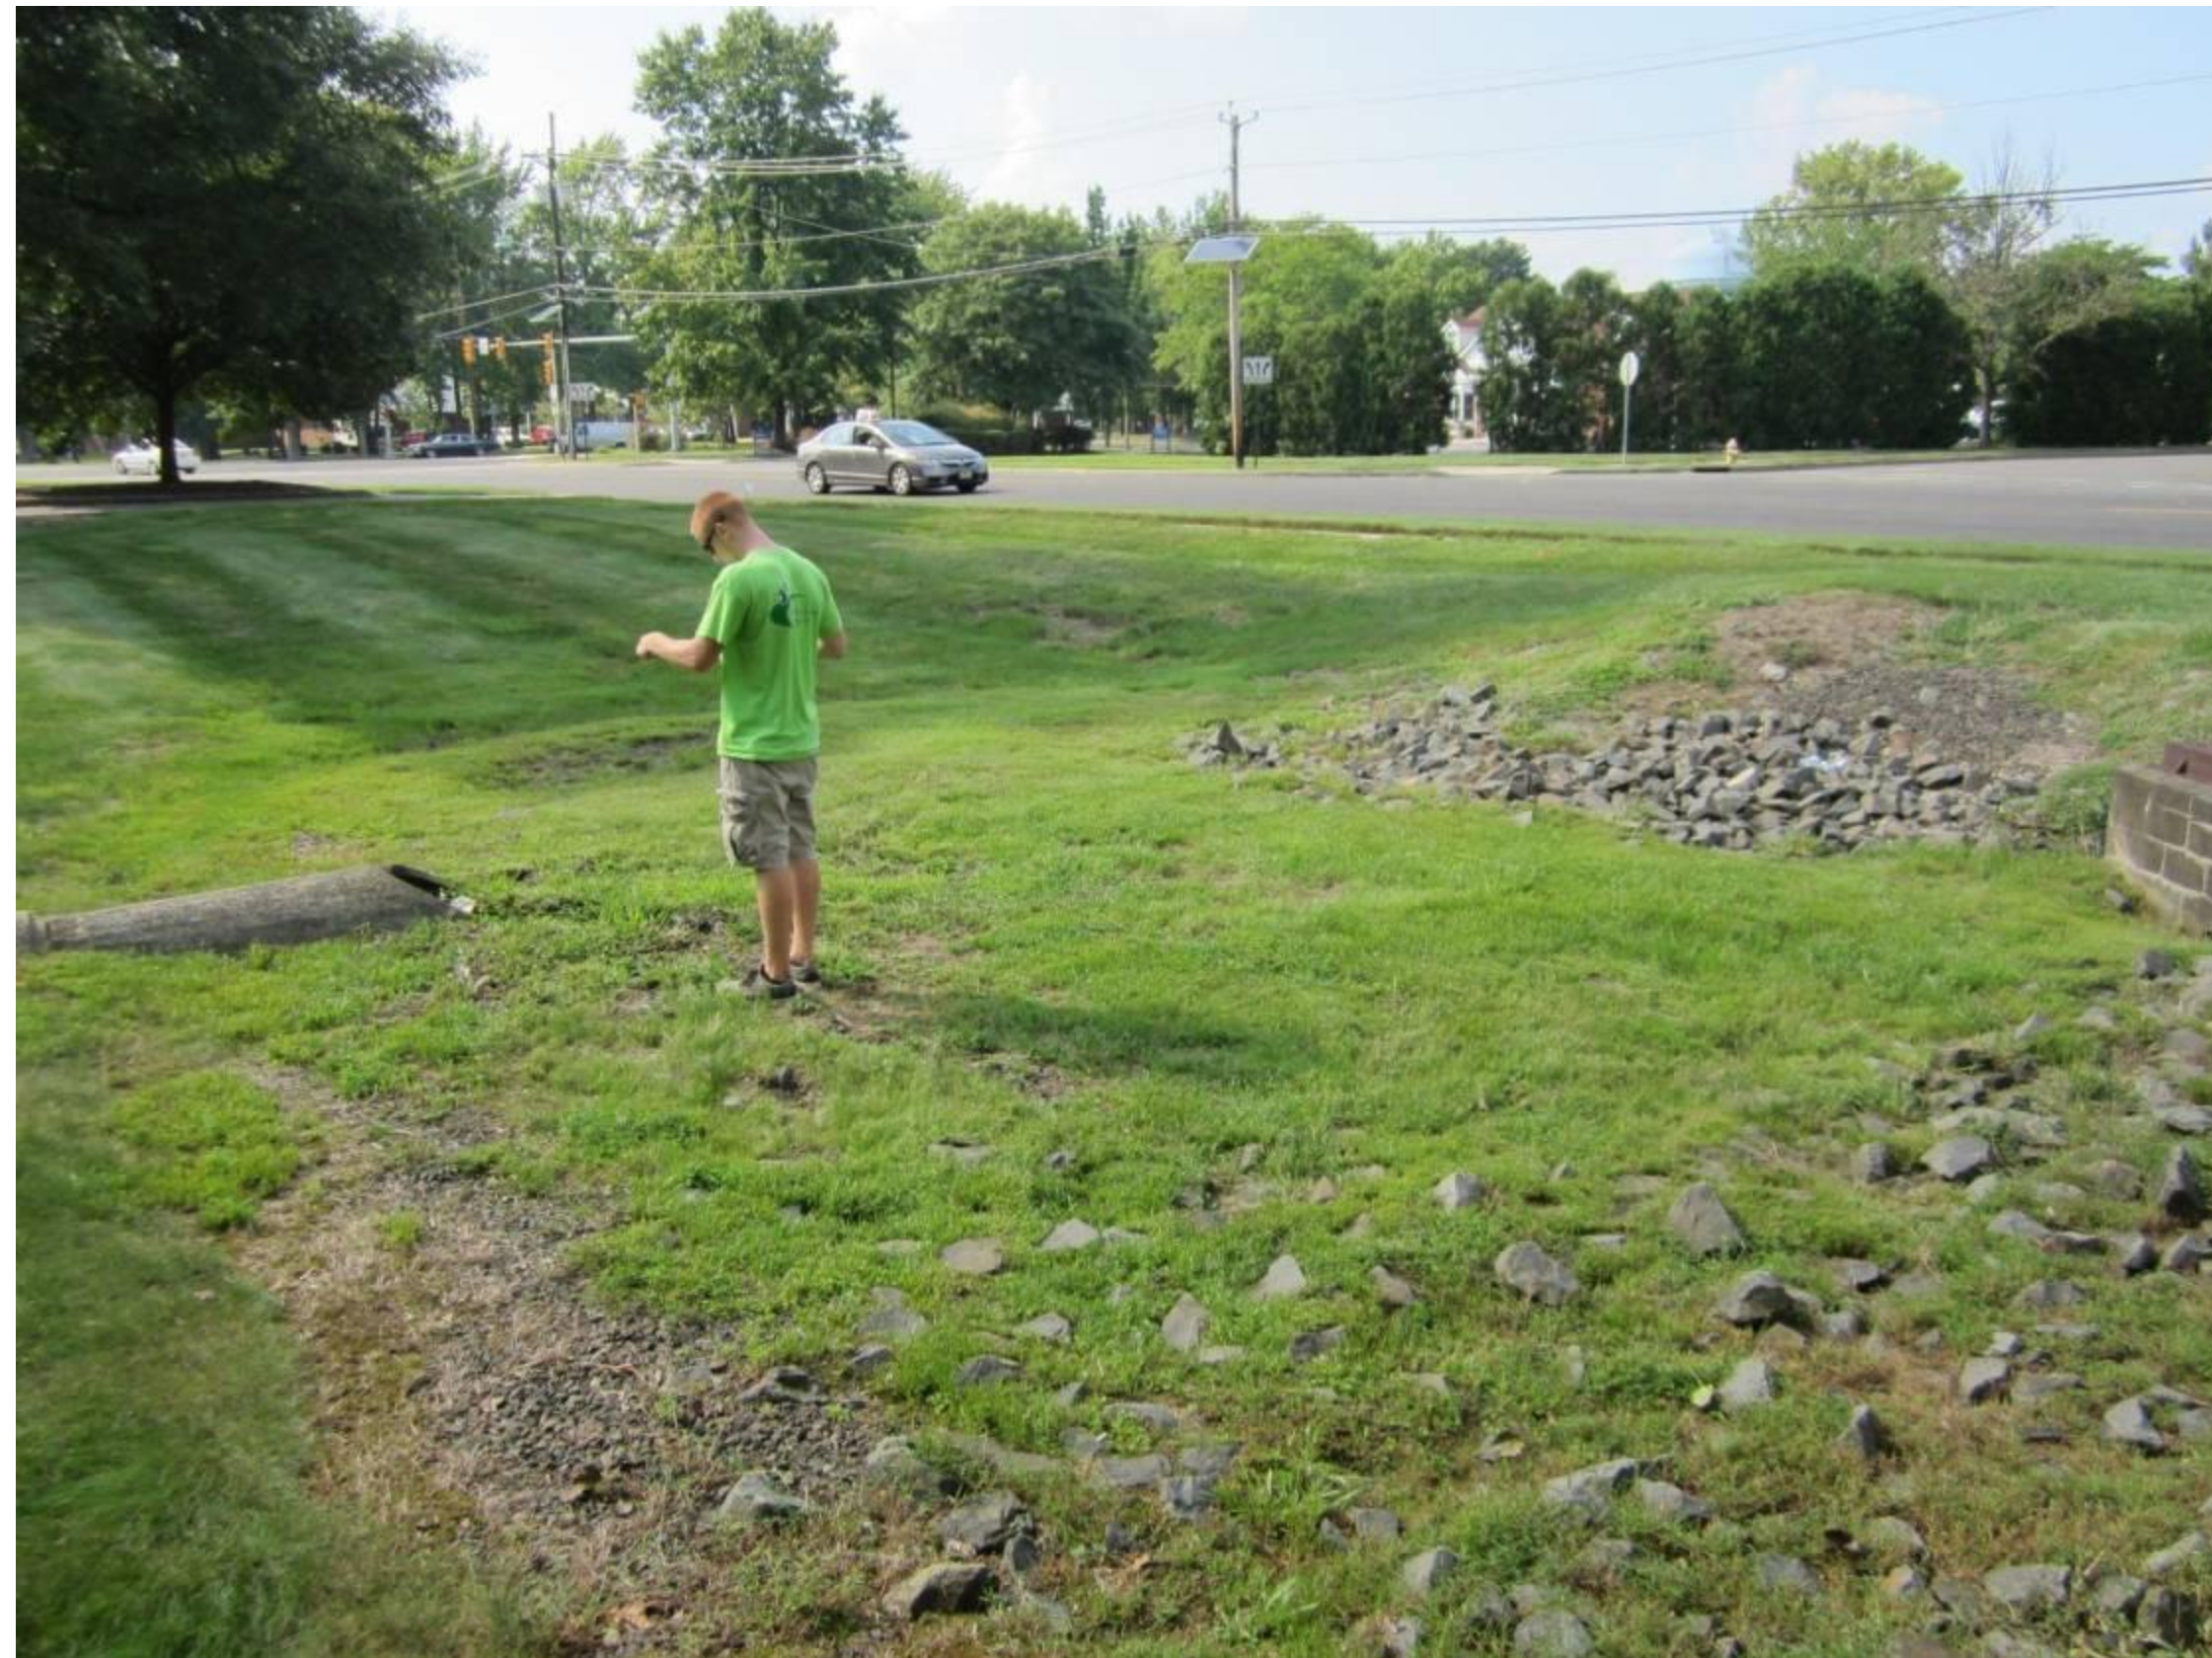
Basin bottom looking west

- Standing water in inlet
- Accumulation of litter, sediment and debris AT outlet, inlet and basin bottom
- Exposed soil in basin bottom
- Evidence of erosion in front of inlet
- Inlet shows evidence of deterioration
