Hamilton Township (Mercer County) Stormwater Basin Assessment Summary (Year 1)

Developed by the Rutgers Cooperative Extension Water Resources Program
Funded by Hamilton Township, Mercer County, New Jersey

December 6, 2012

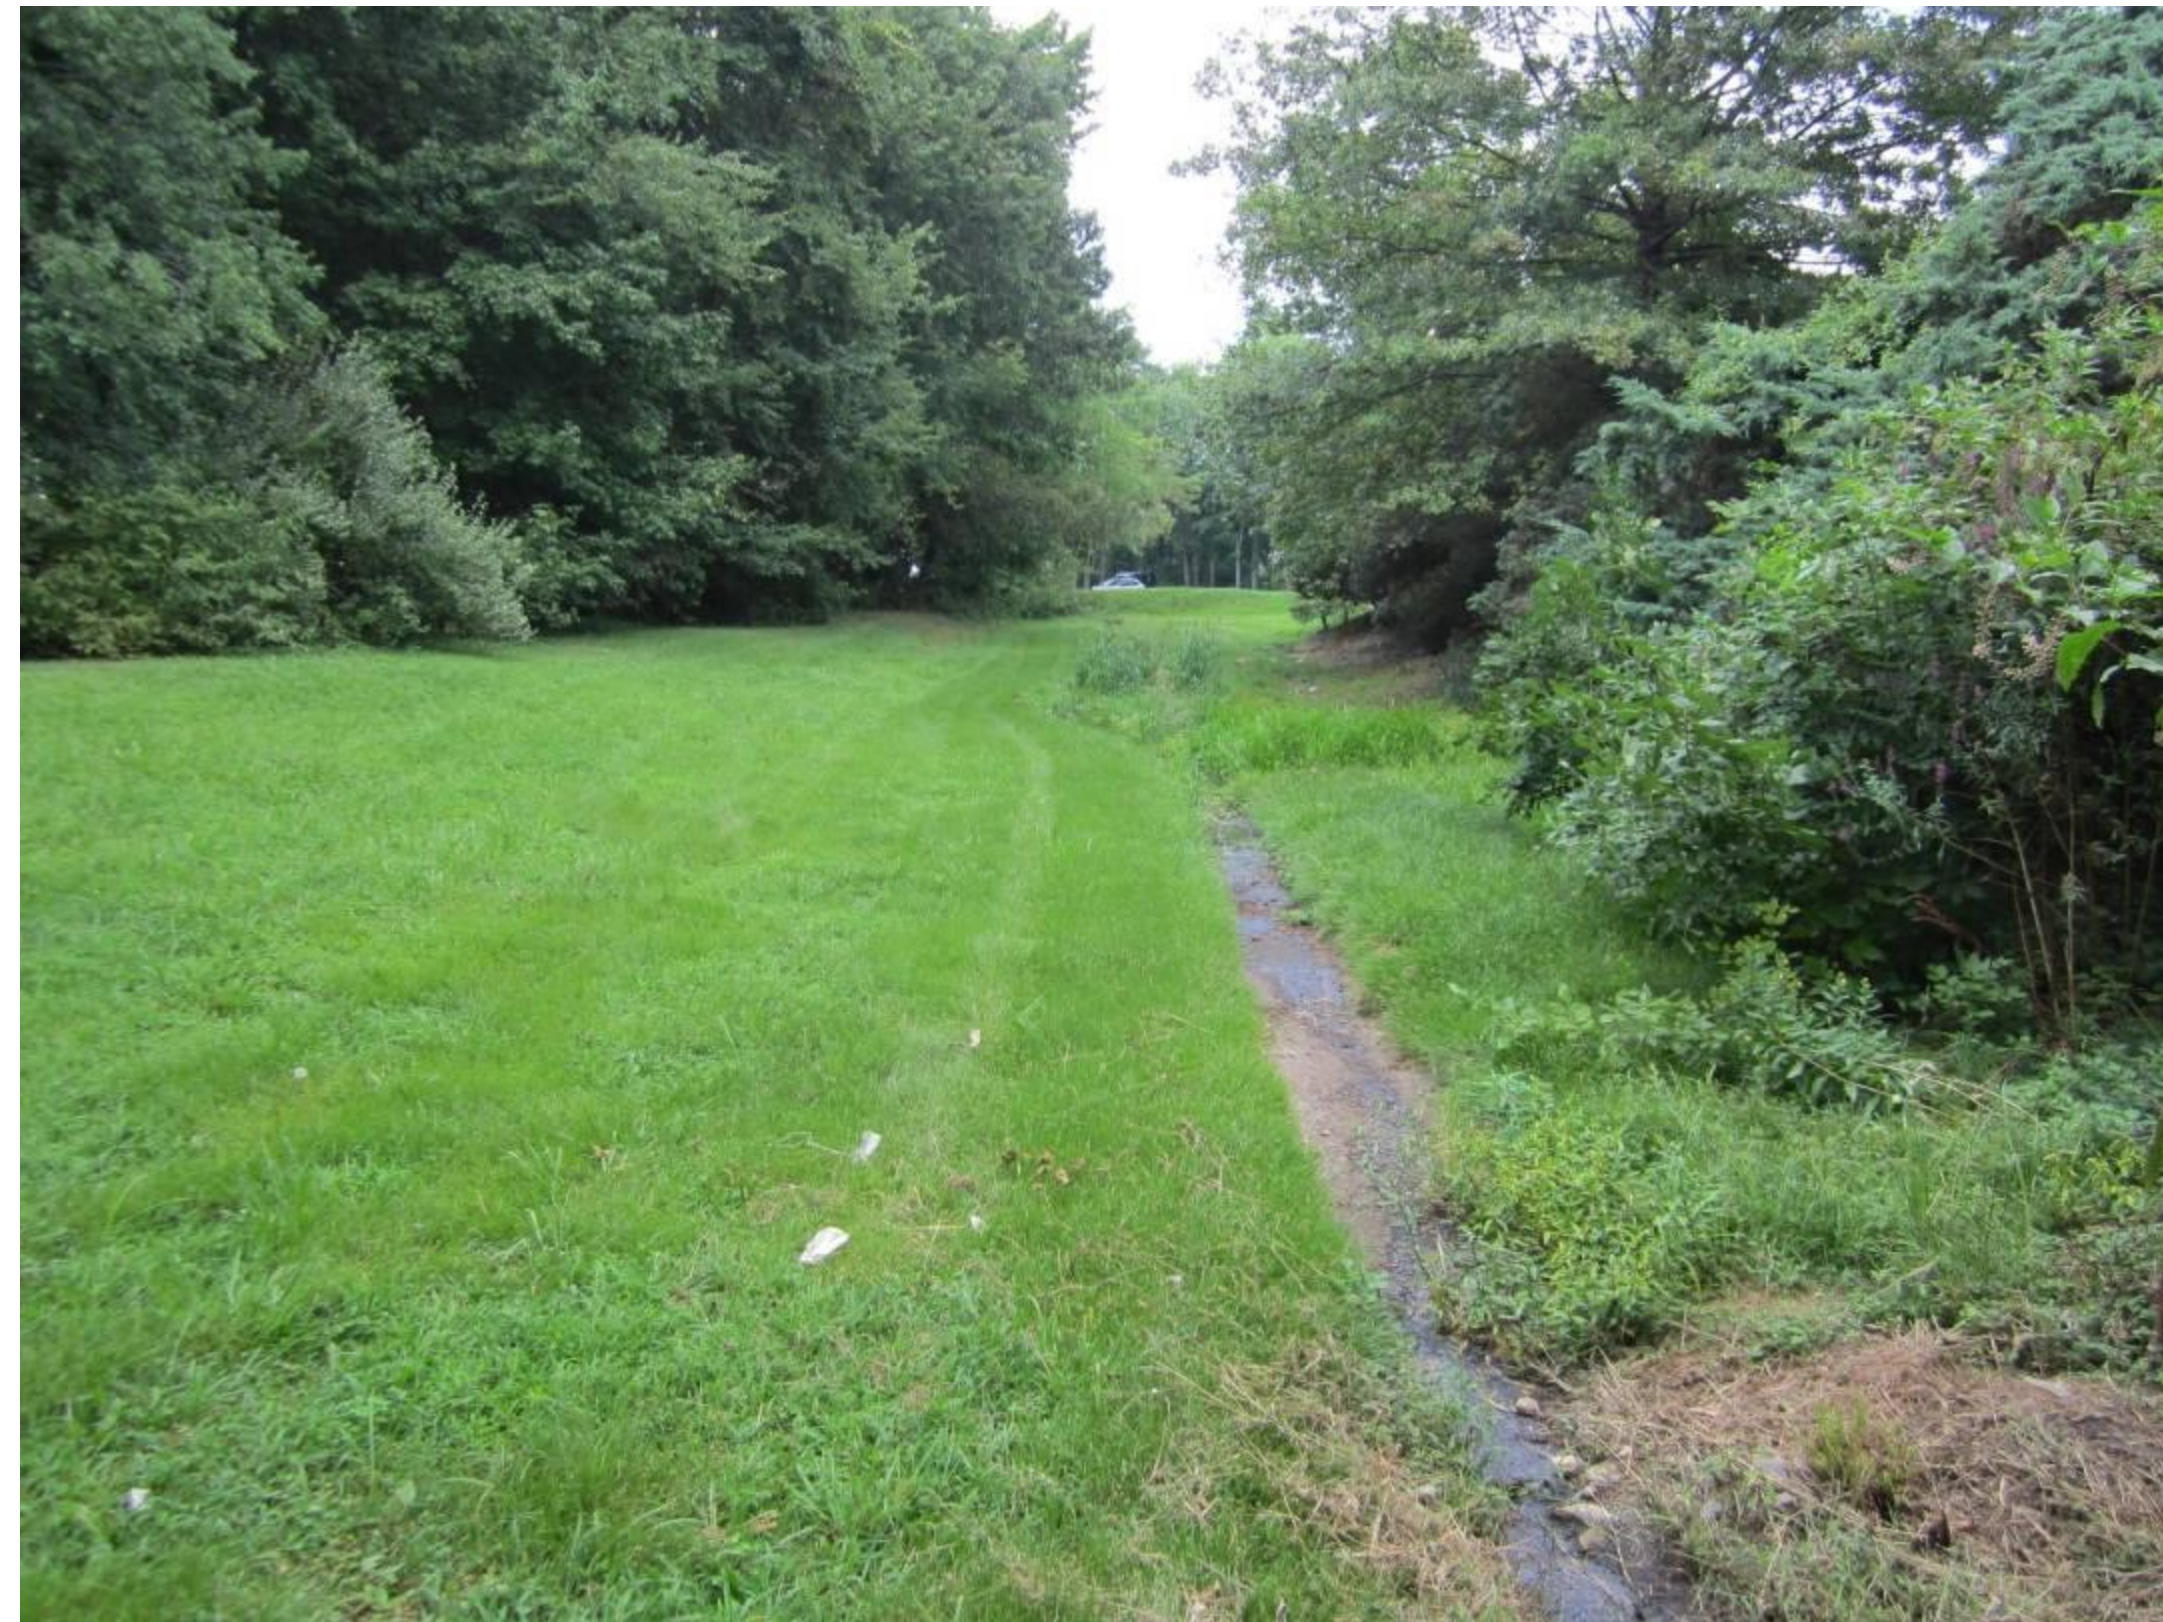
Basin bottom looking north

- Standing water in low flow channel
- Basin bottom has exposed soil
- Excessive vegetative growth at inlet and outlet structures
- Curb cut inlets have structural damage and erosion

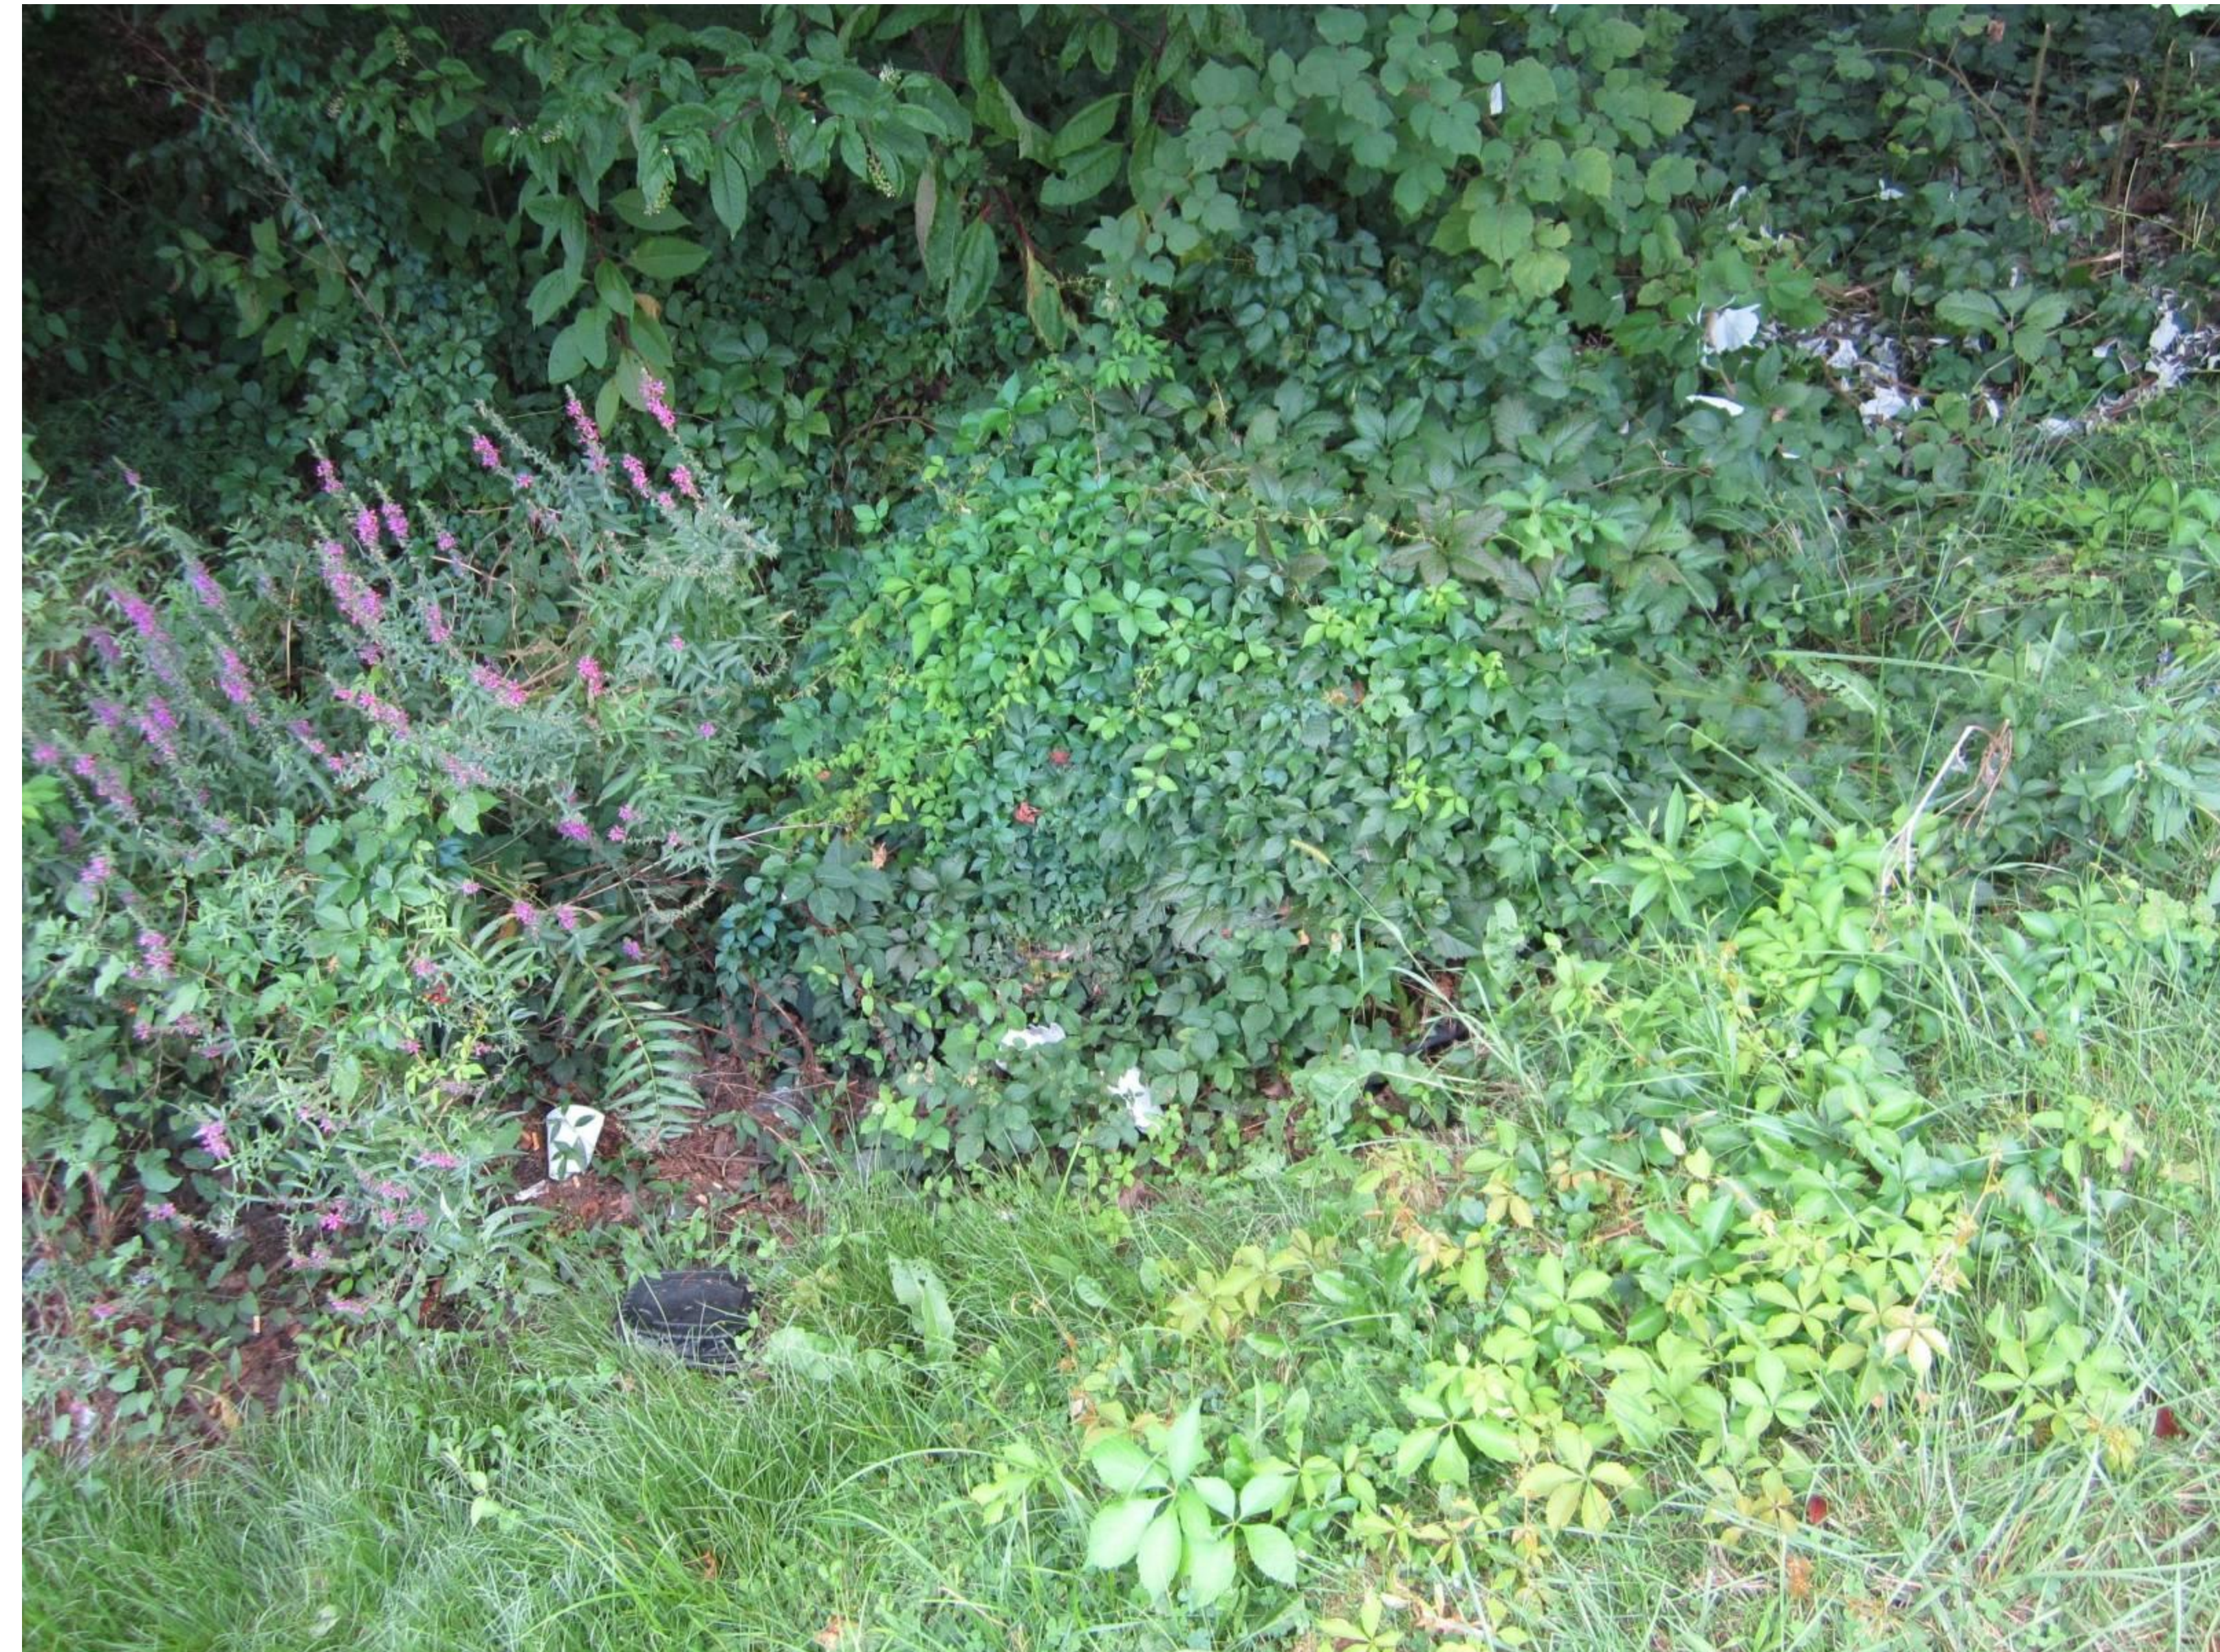
Excessive vegetative growth at outlet

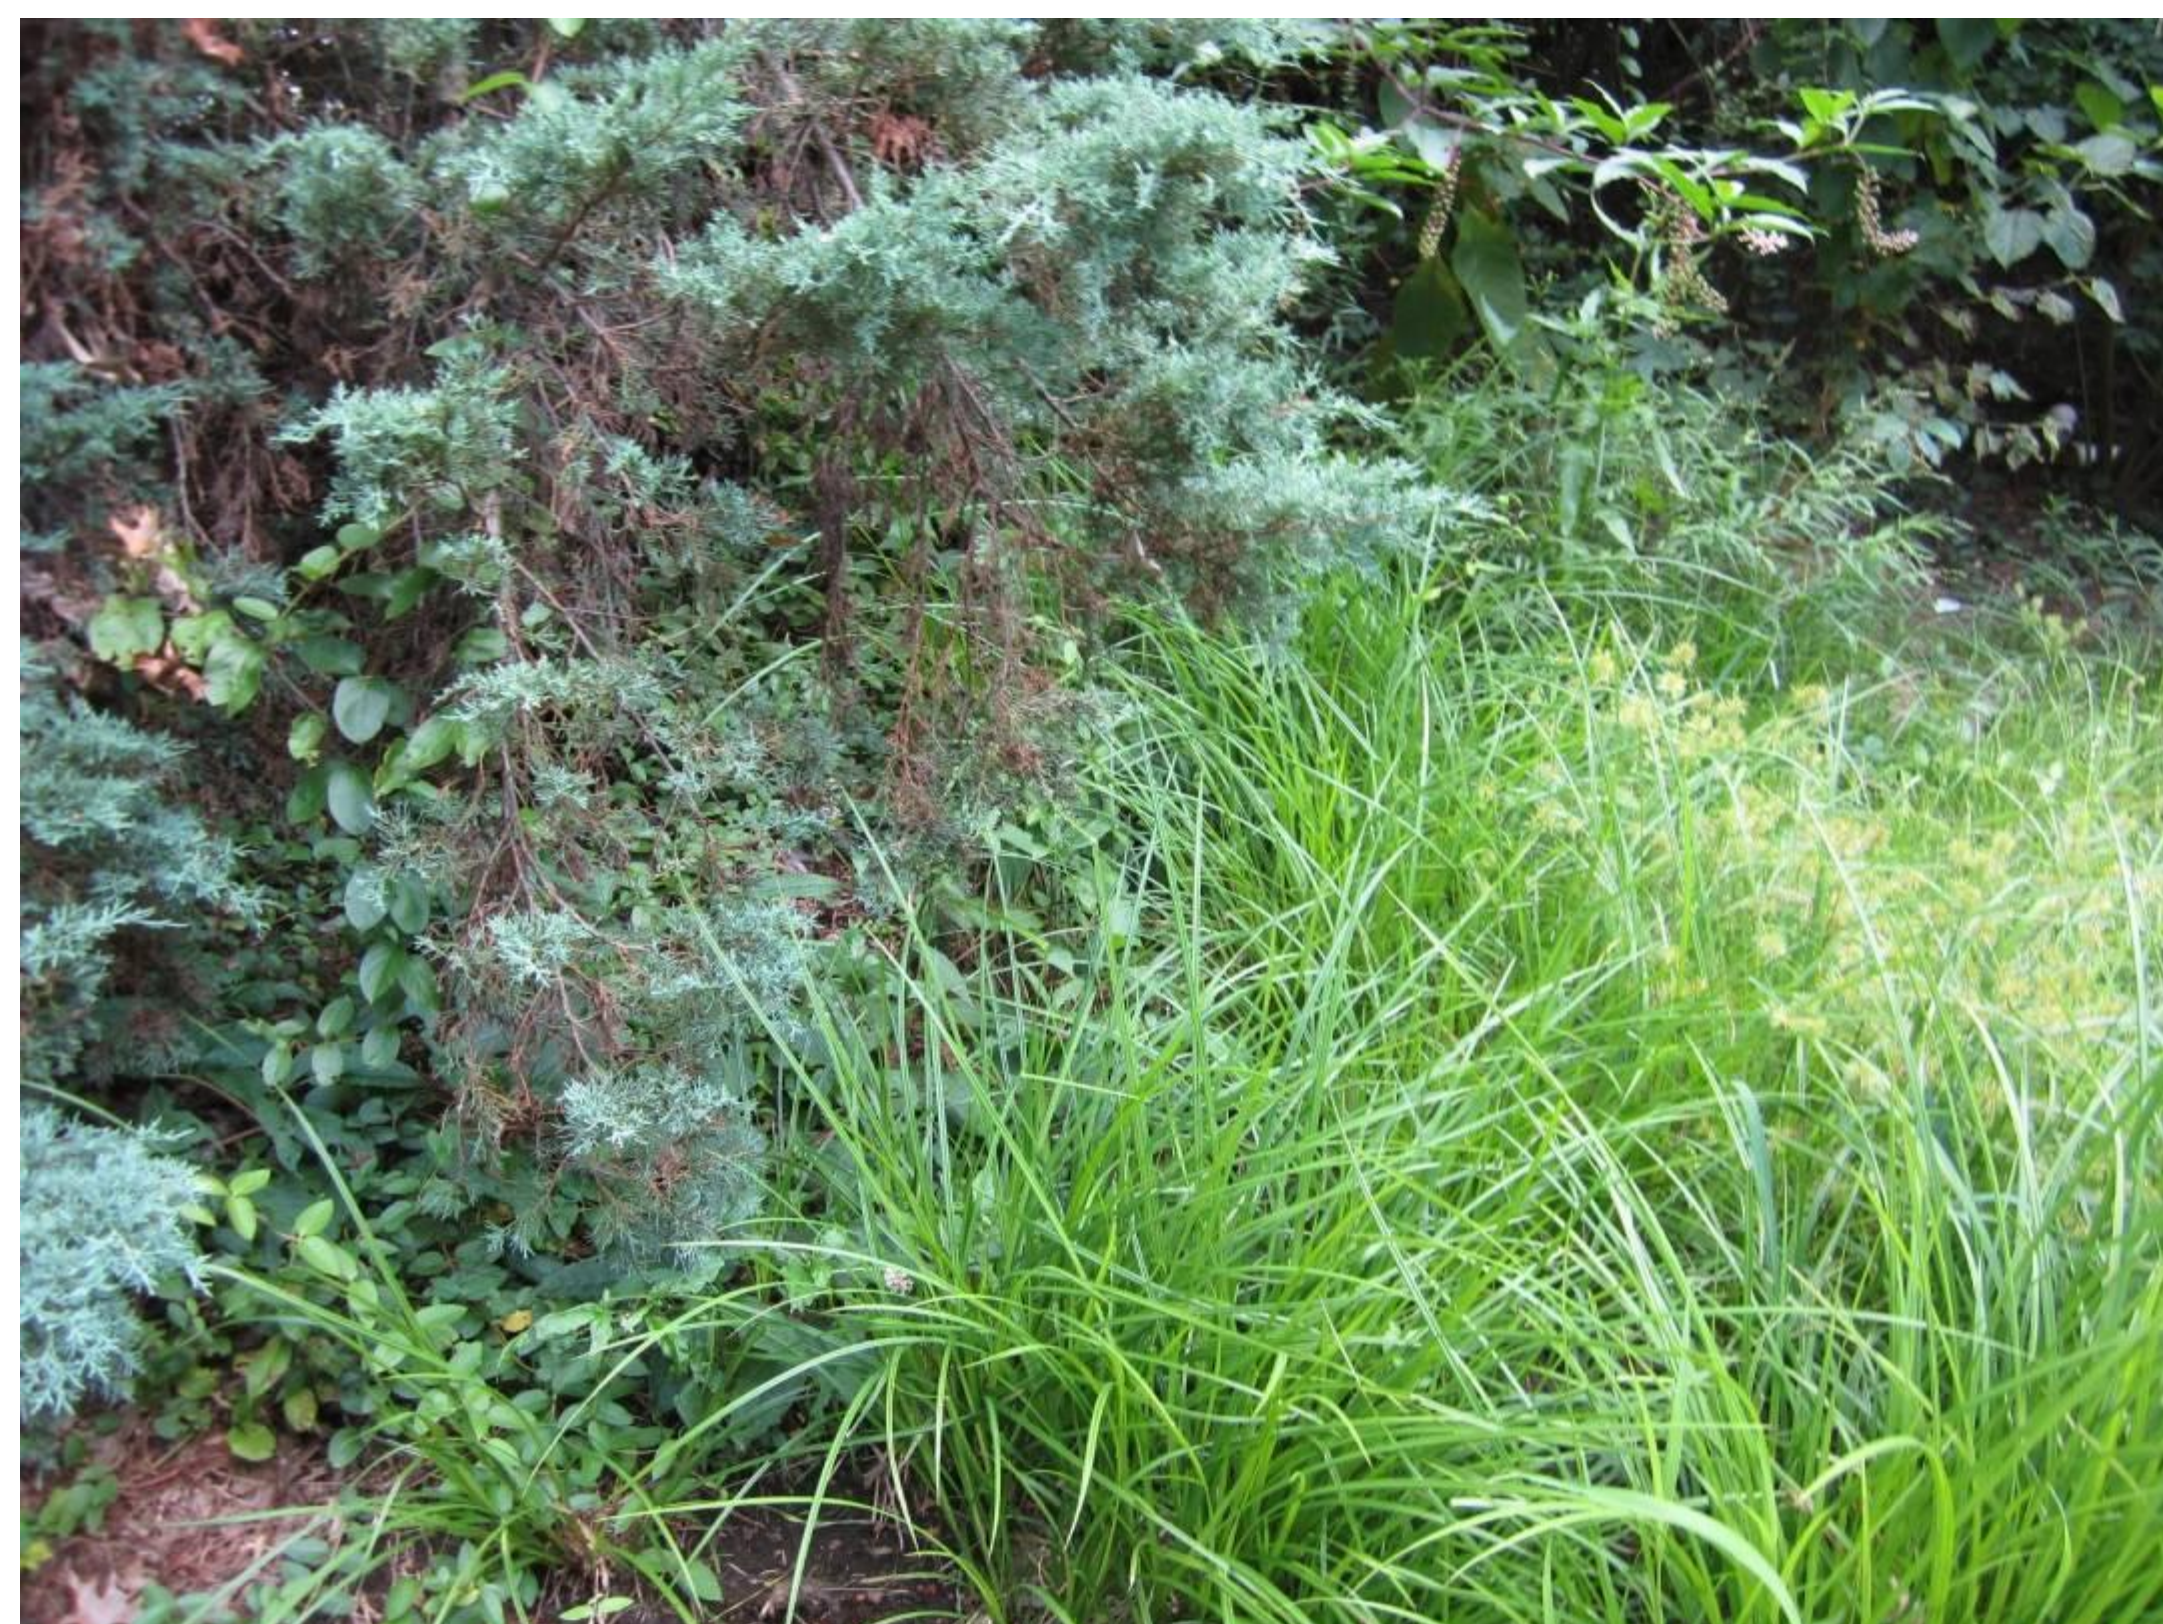
Excessive vegetative growth at inlet

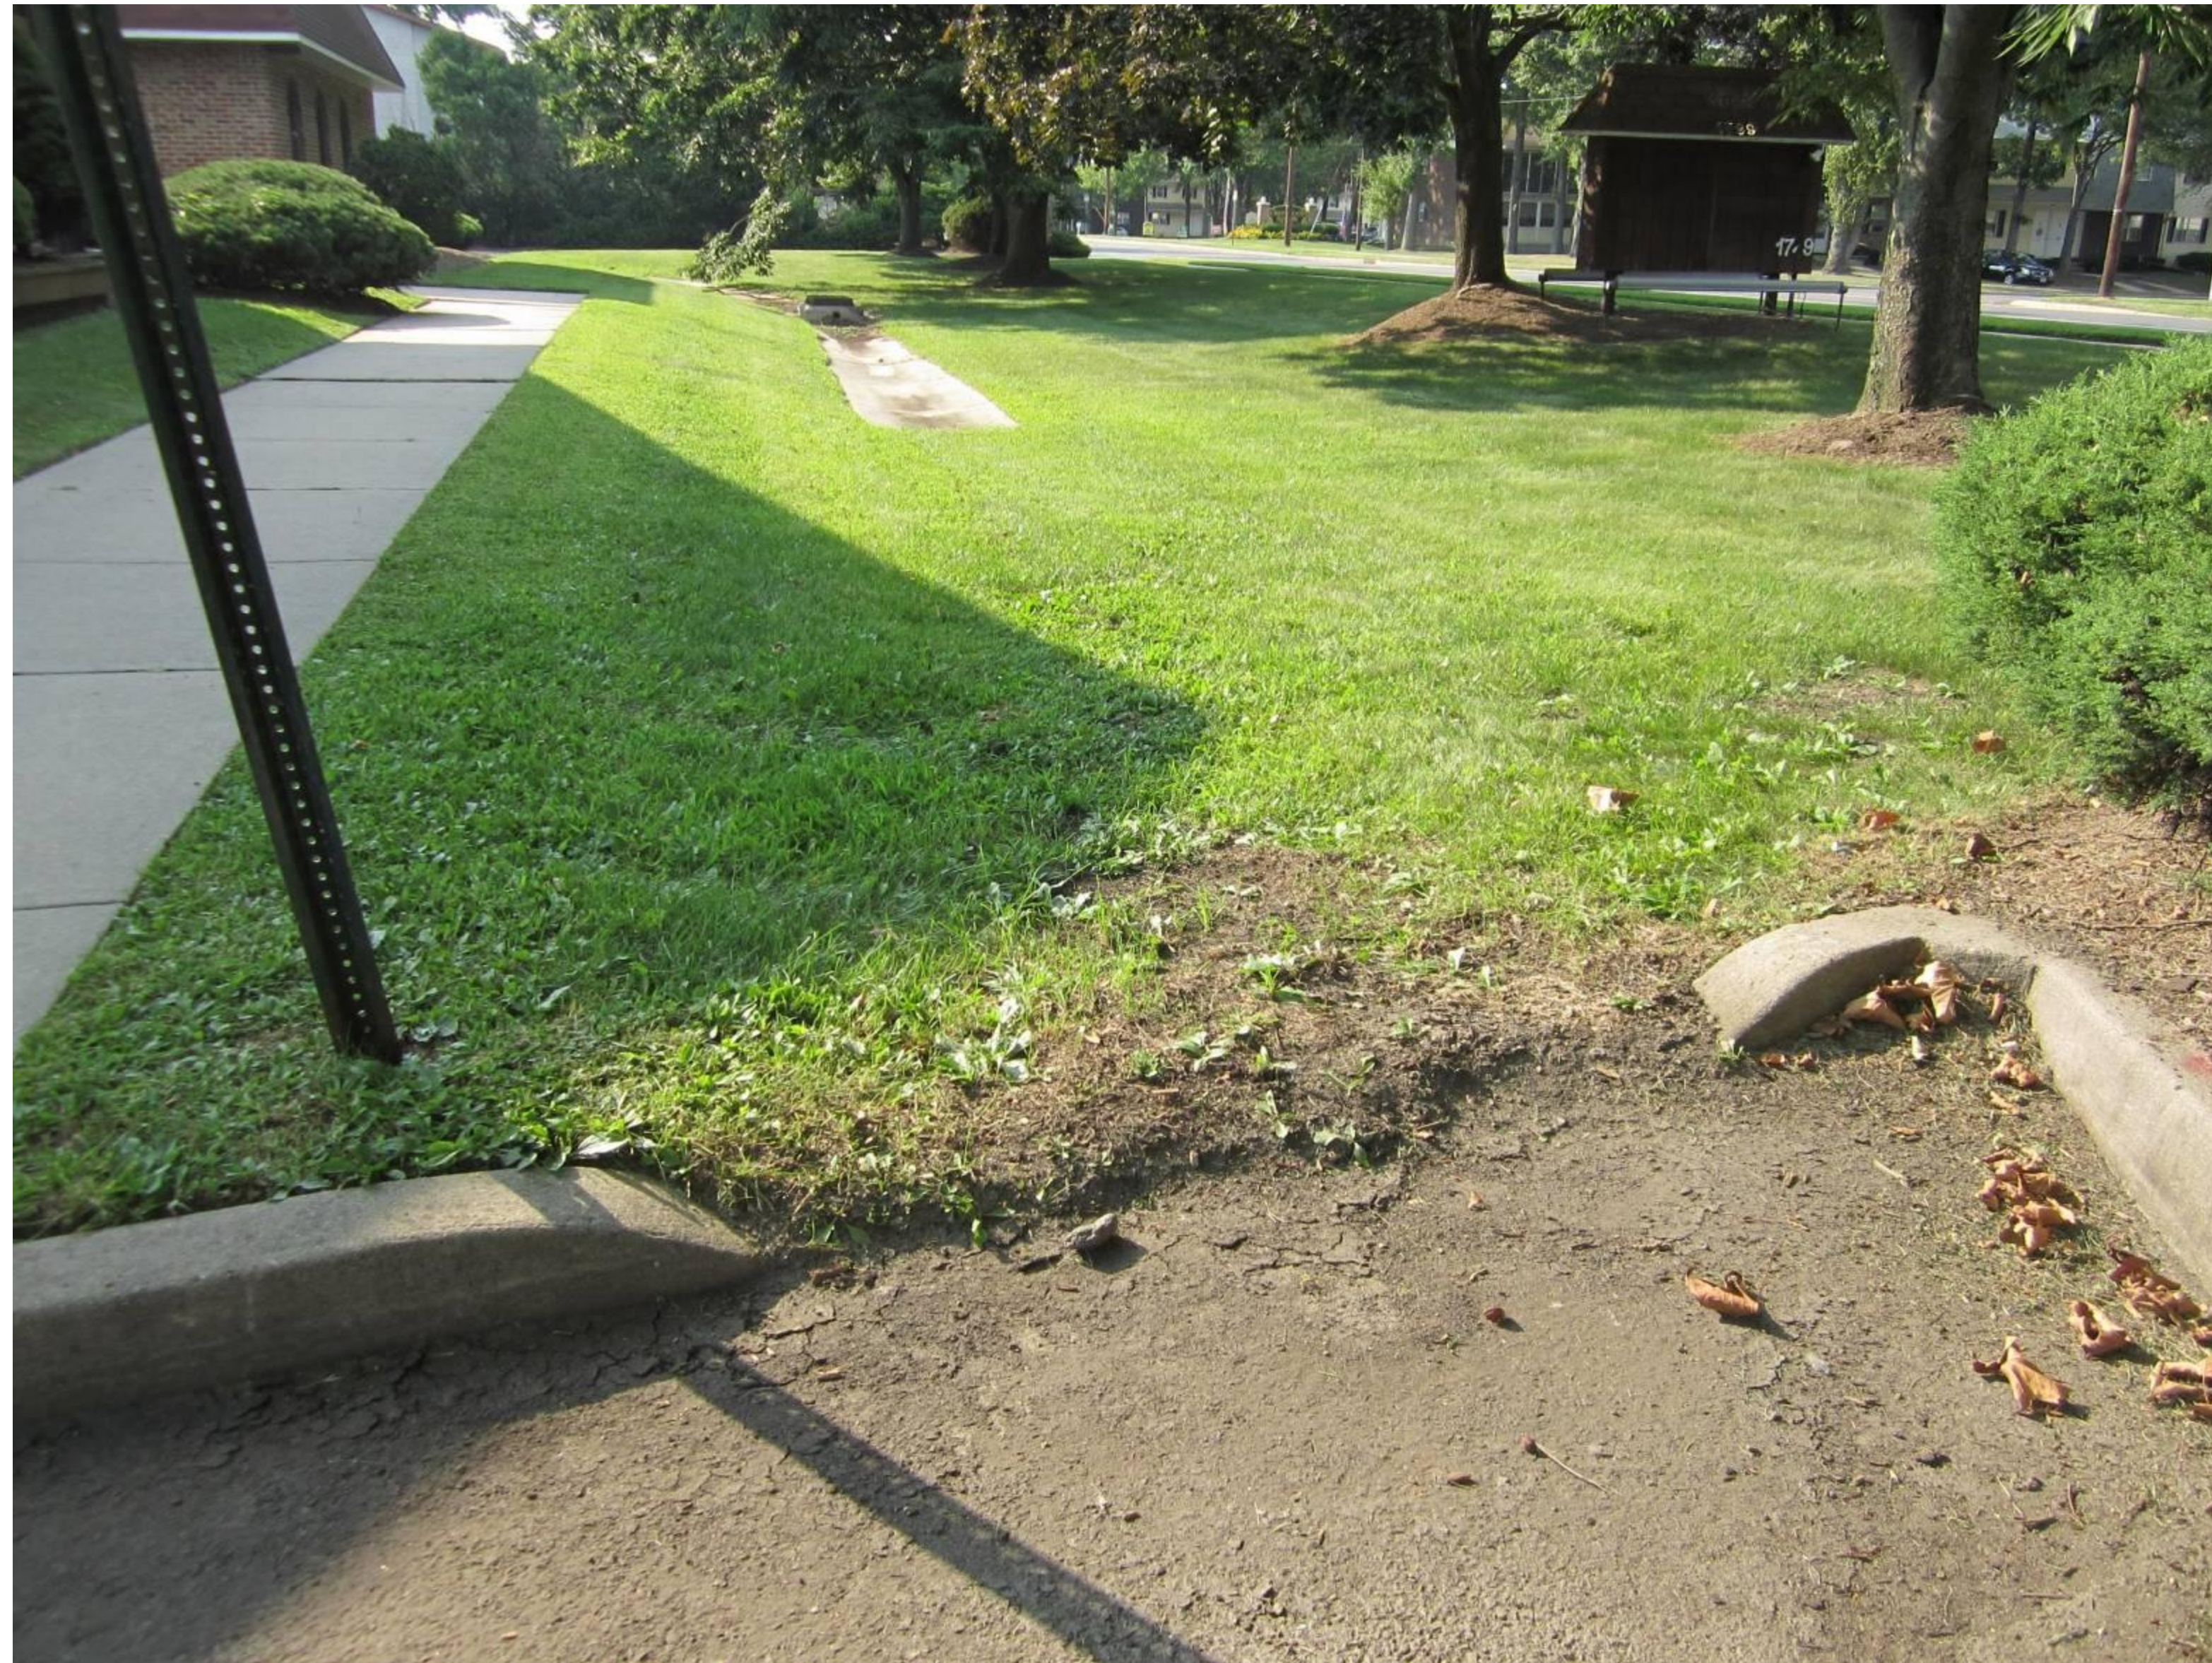
Inlet curb cut

- Sediment accumulation in low flow channel, inlet and outlet
- Outlet structure shows evidence of deterioration

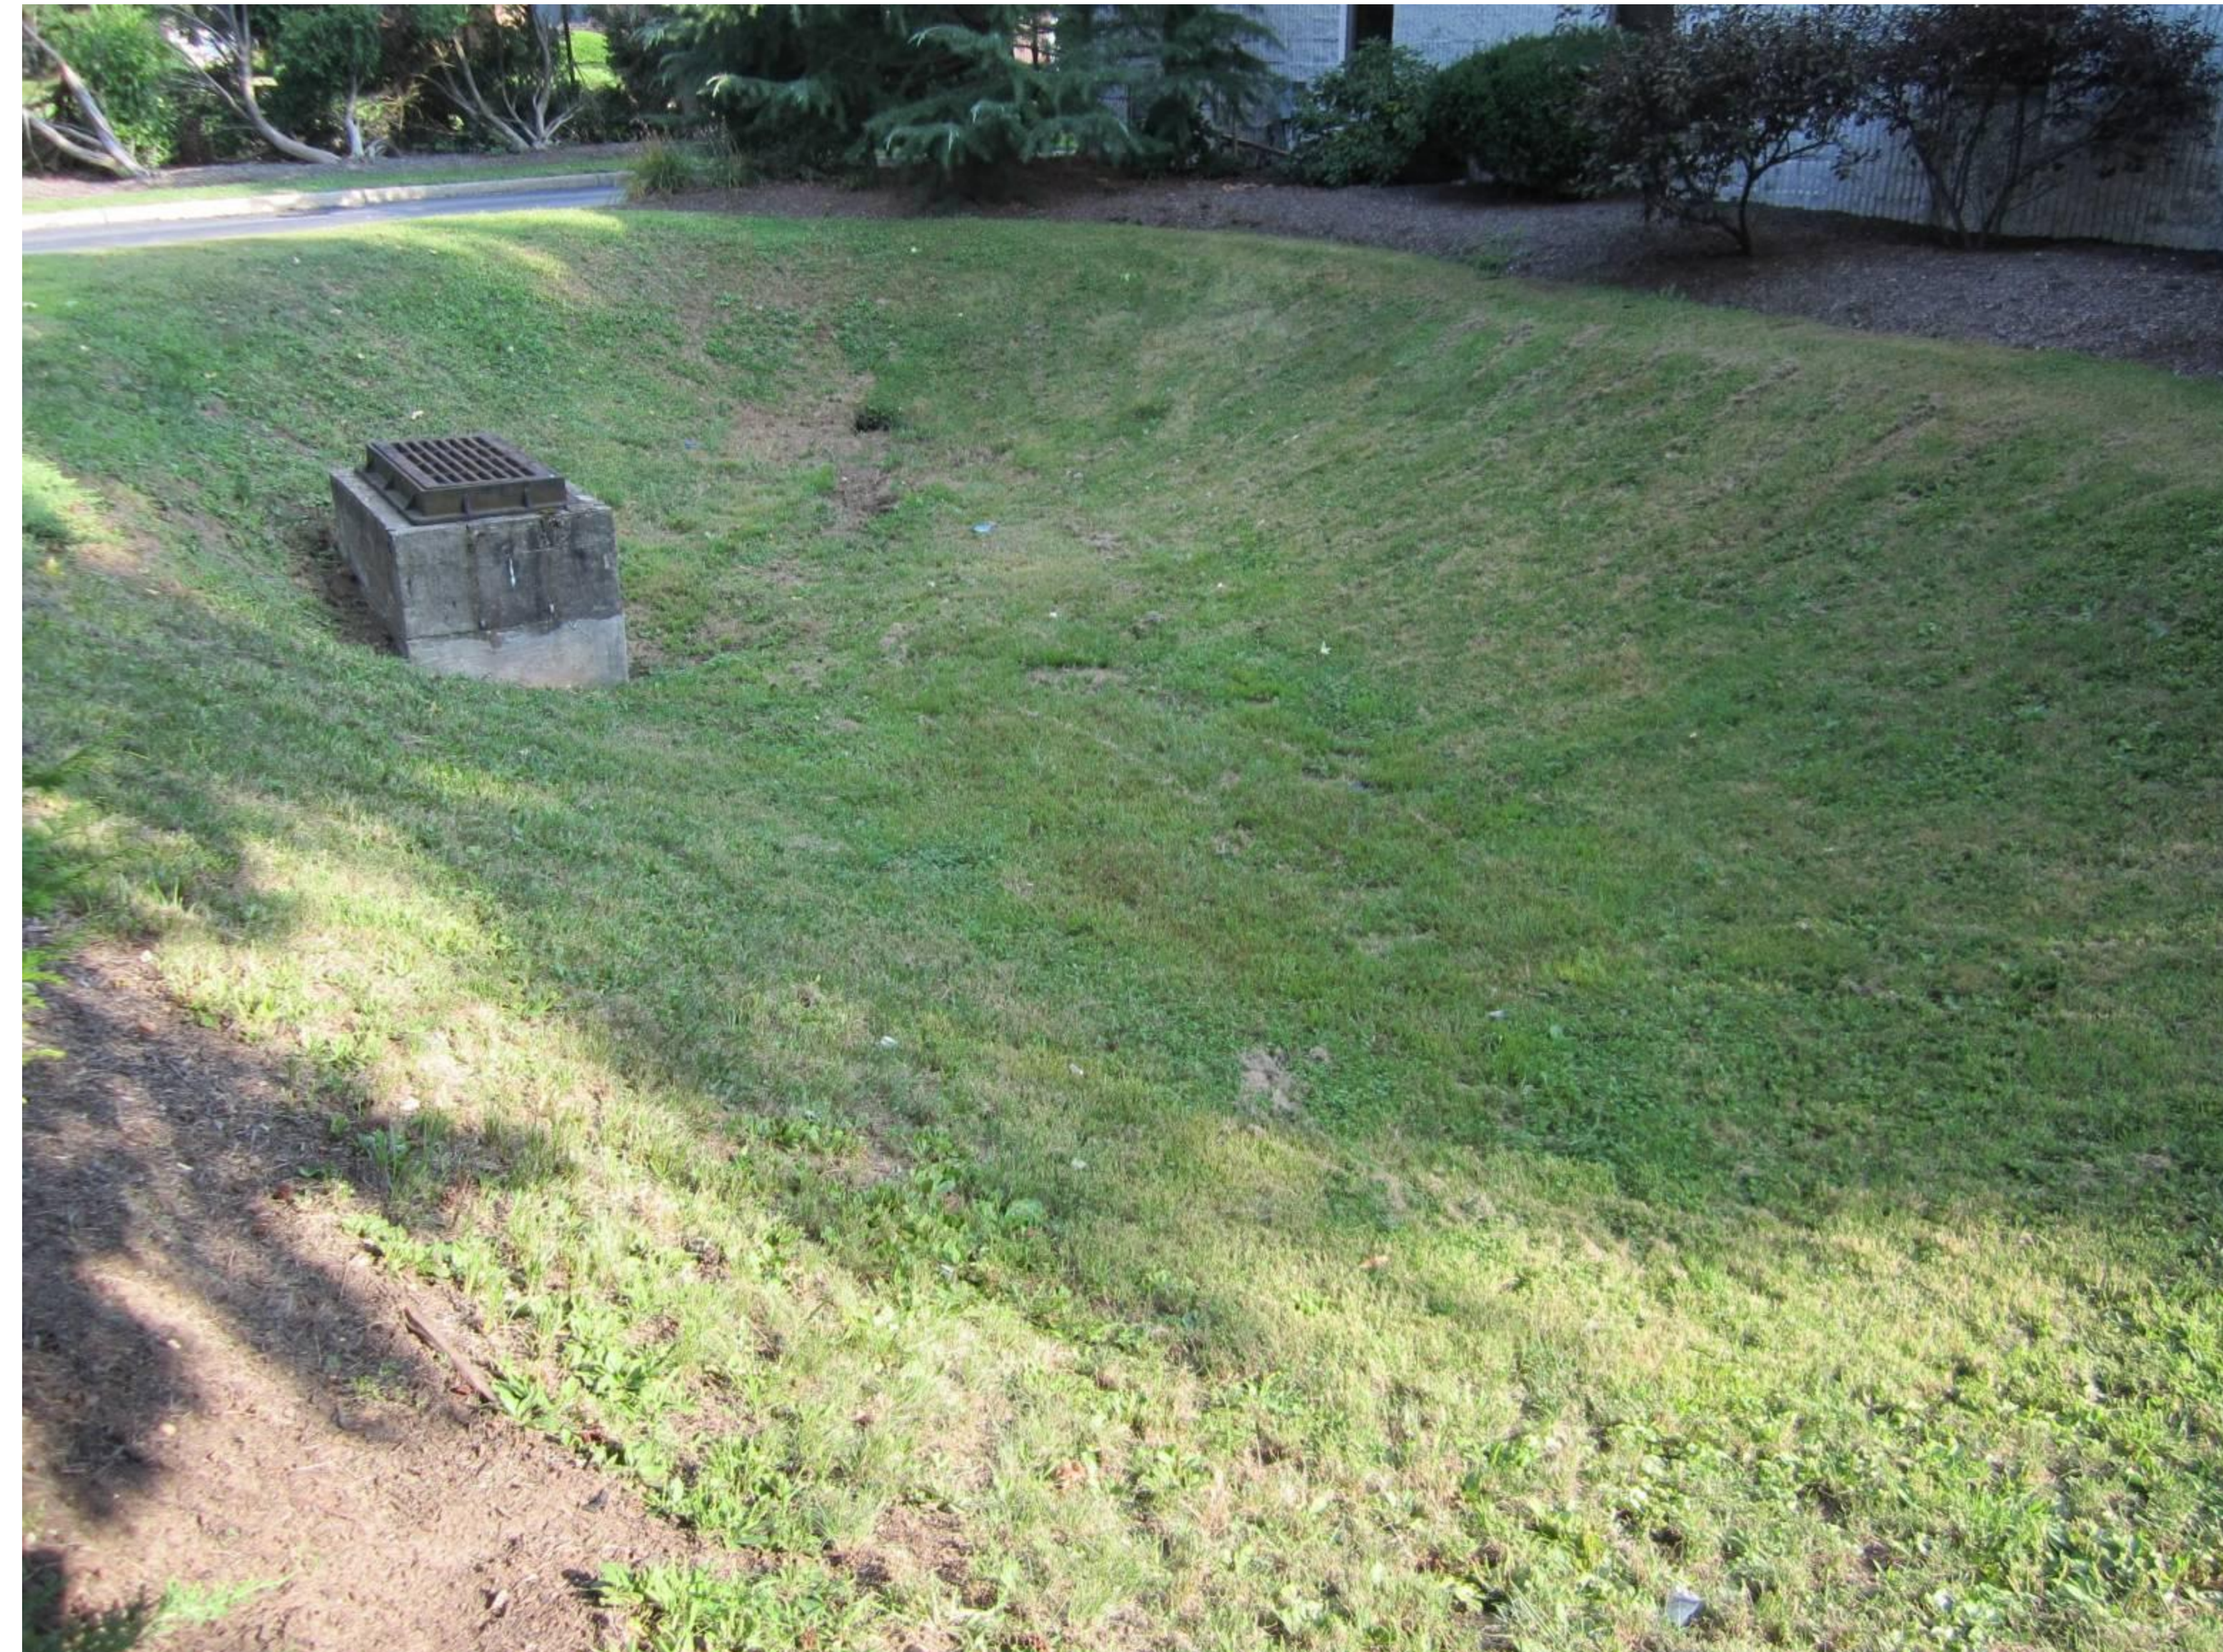
Basin bottom looking east

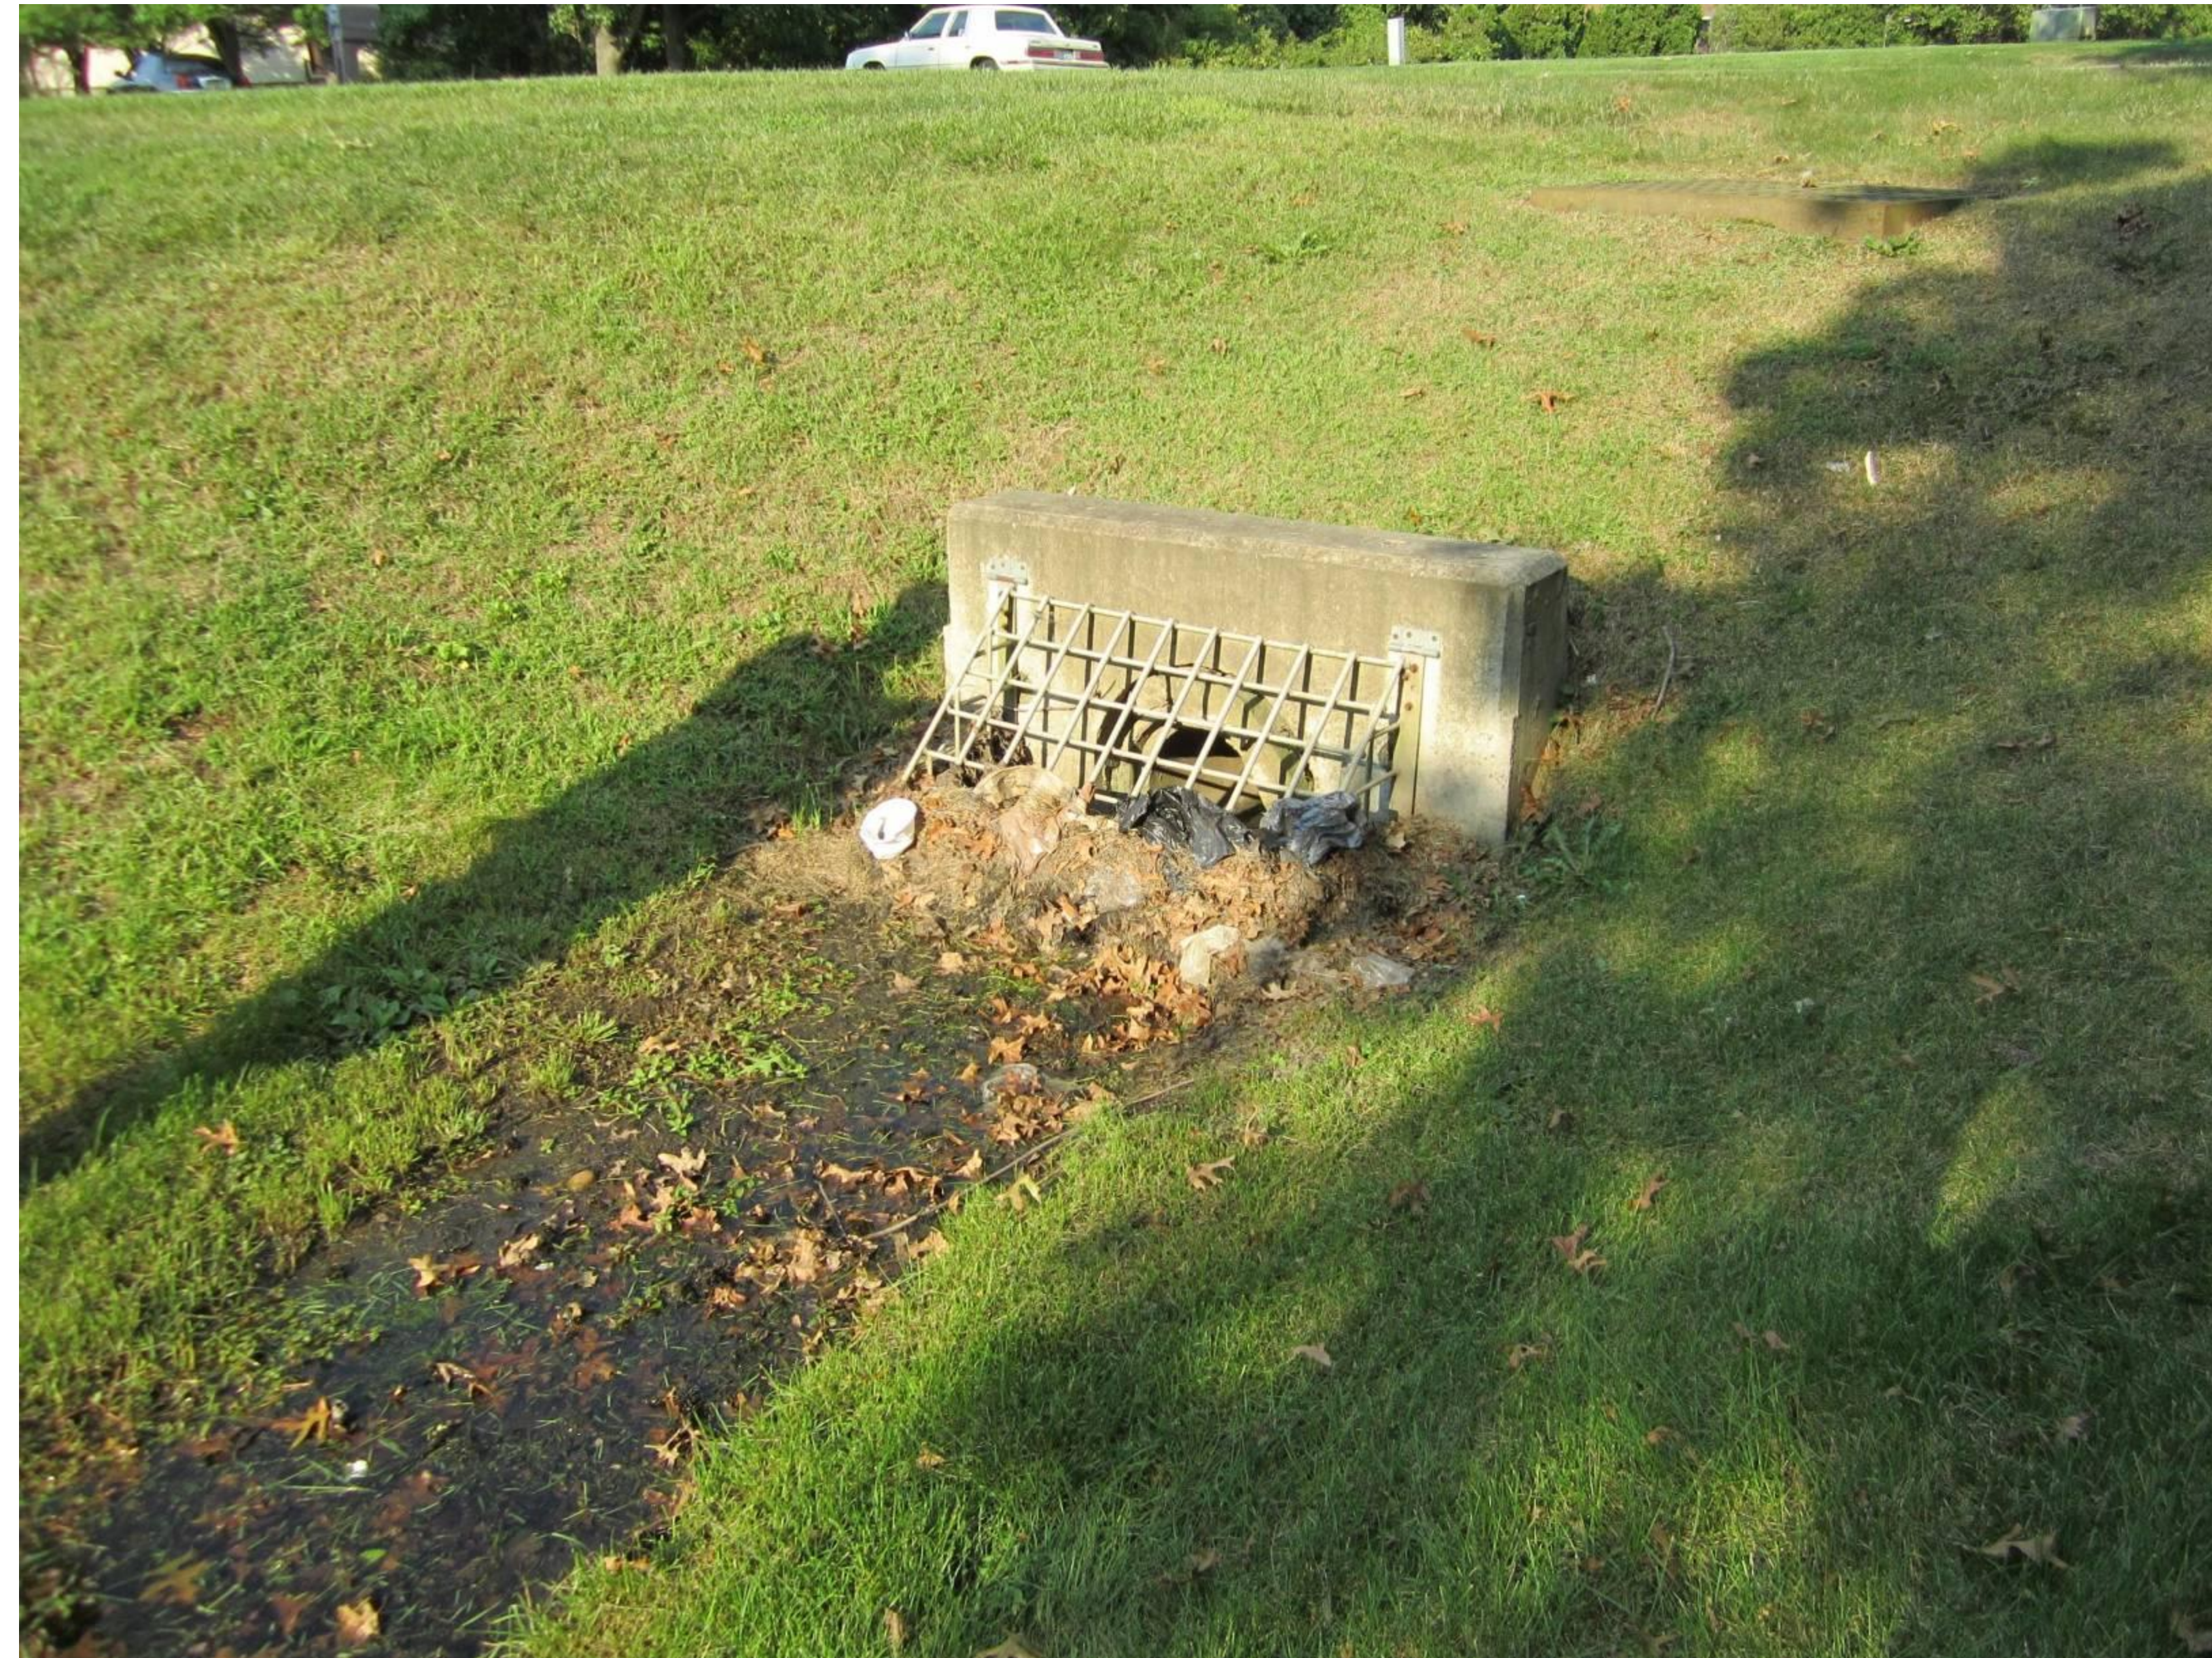
Outlet with clogged trash rack
