Hamilton Township (Mercer County) Stormwater Basin Assessment Summary (Year 1)

Developed by the Rutgers Cooperative Extension Water Resources Program
Funded by Hamilton Township, Mercer County, New Jersey

December 6, 2012

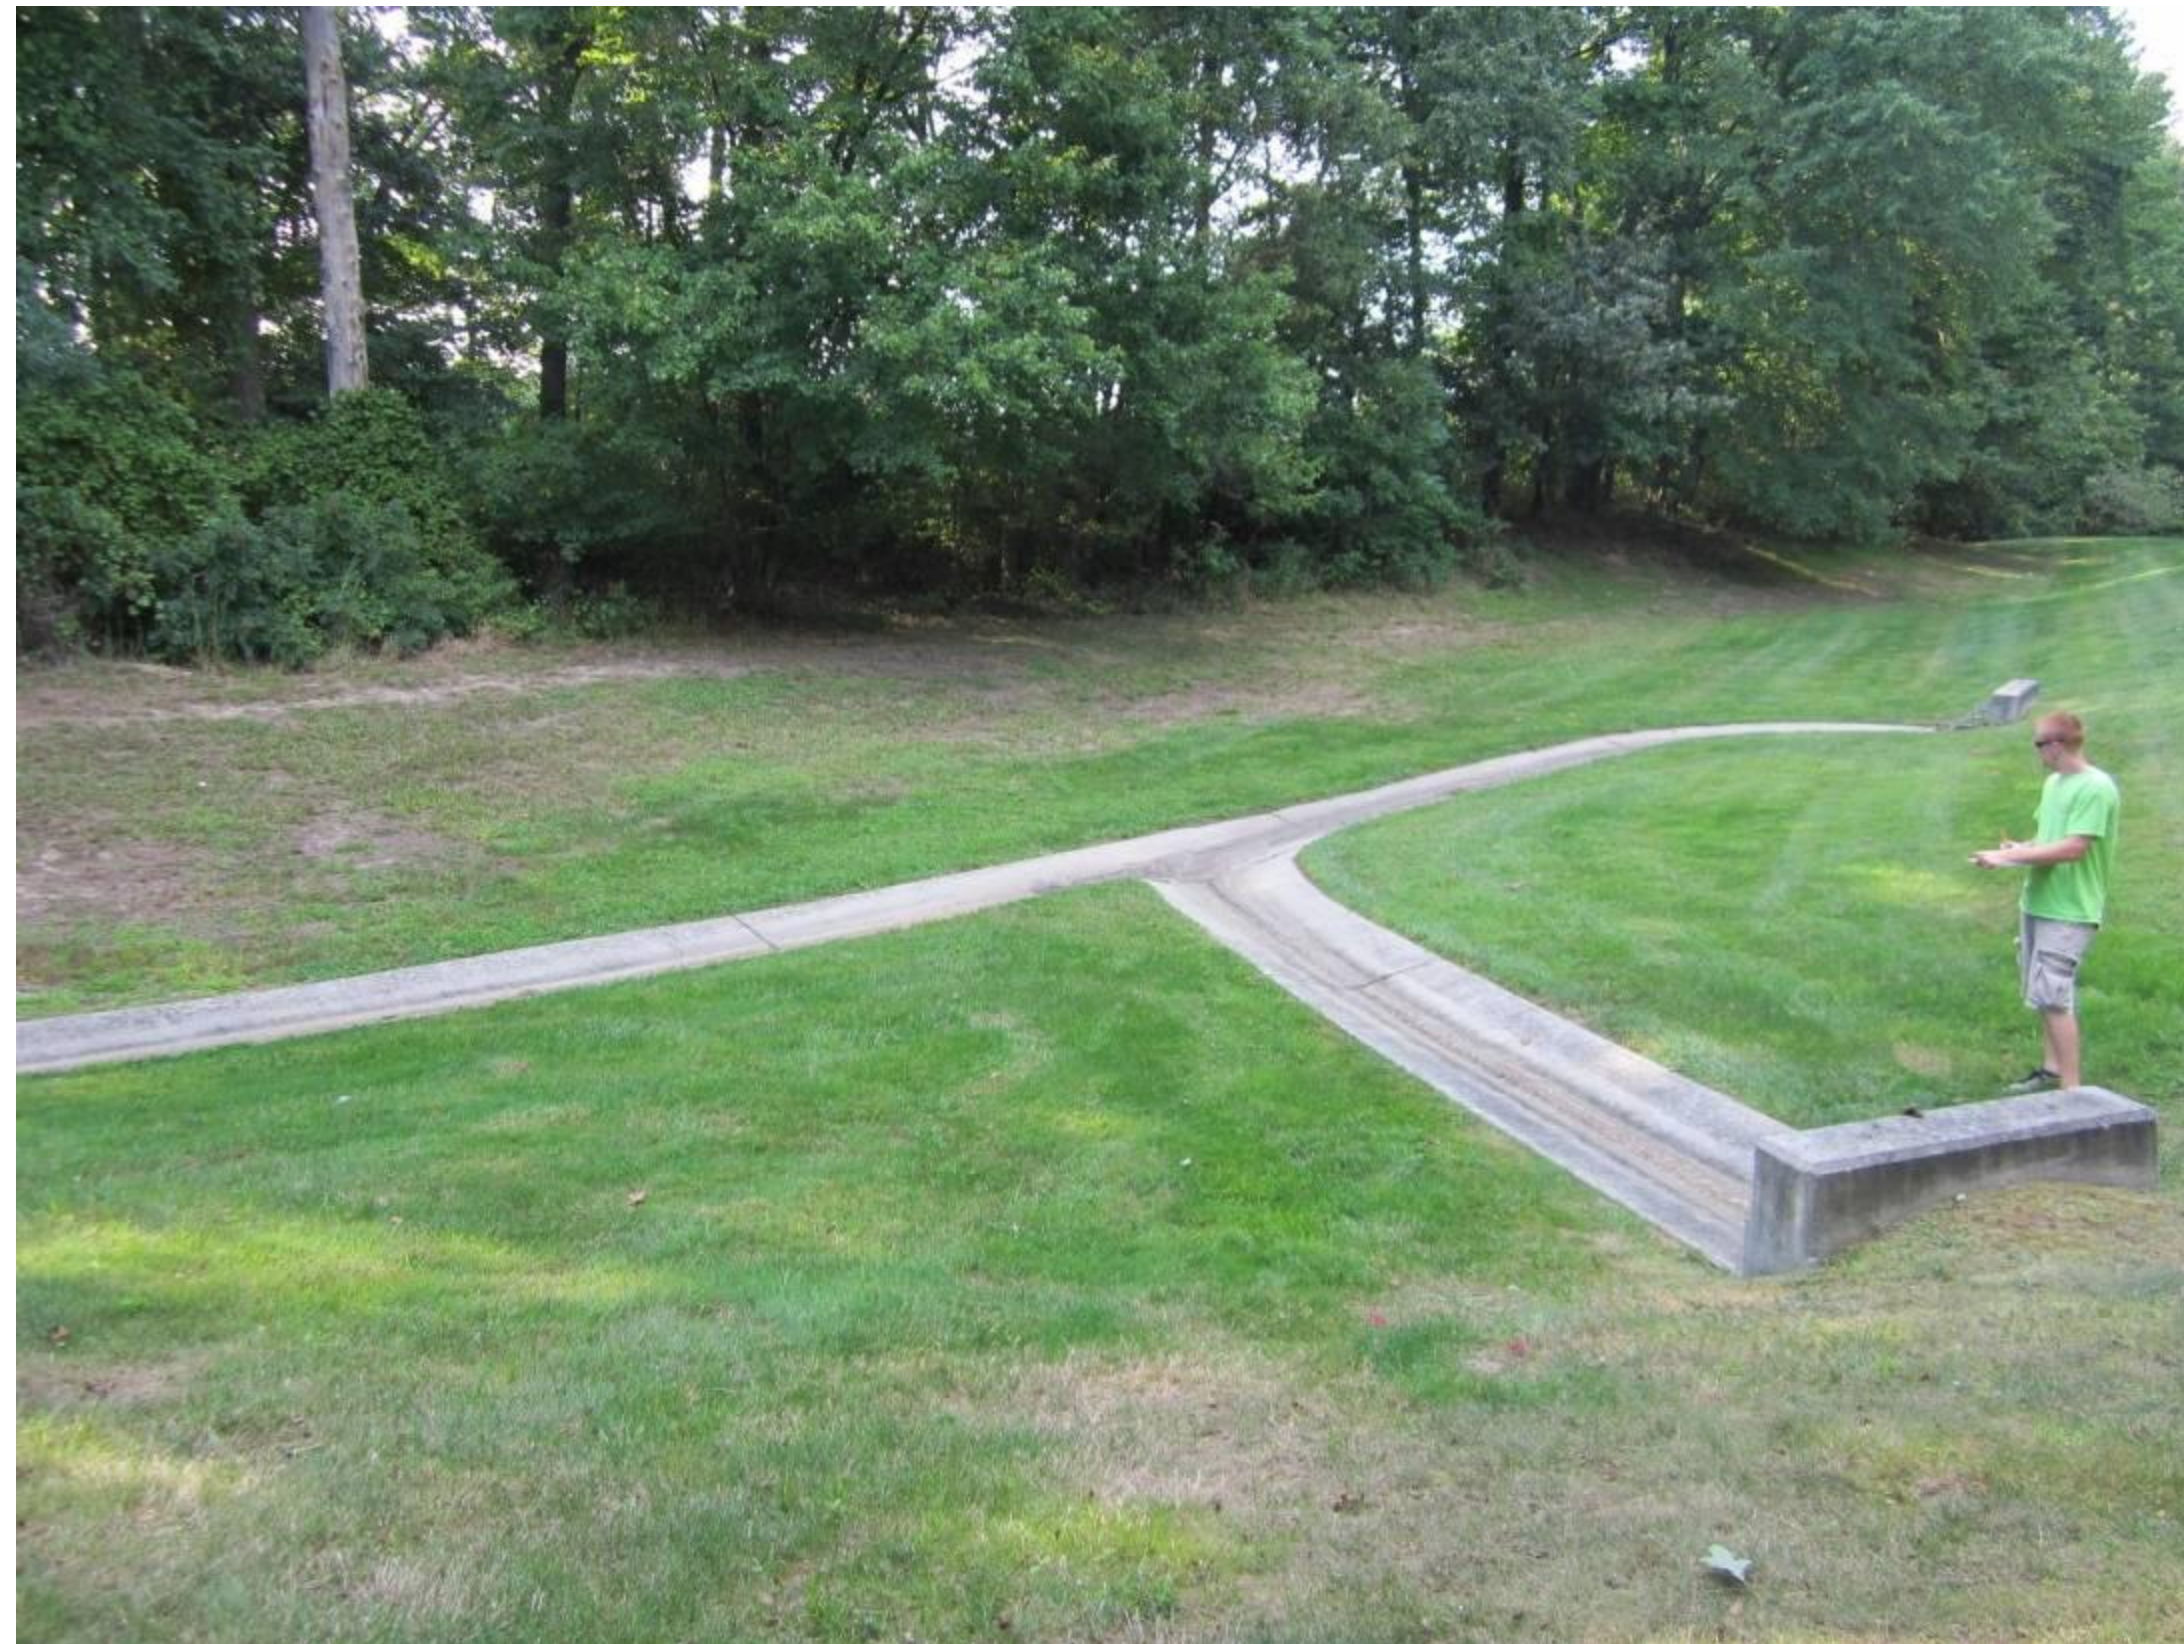
Basin bottom looking north

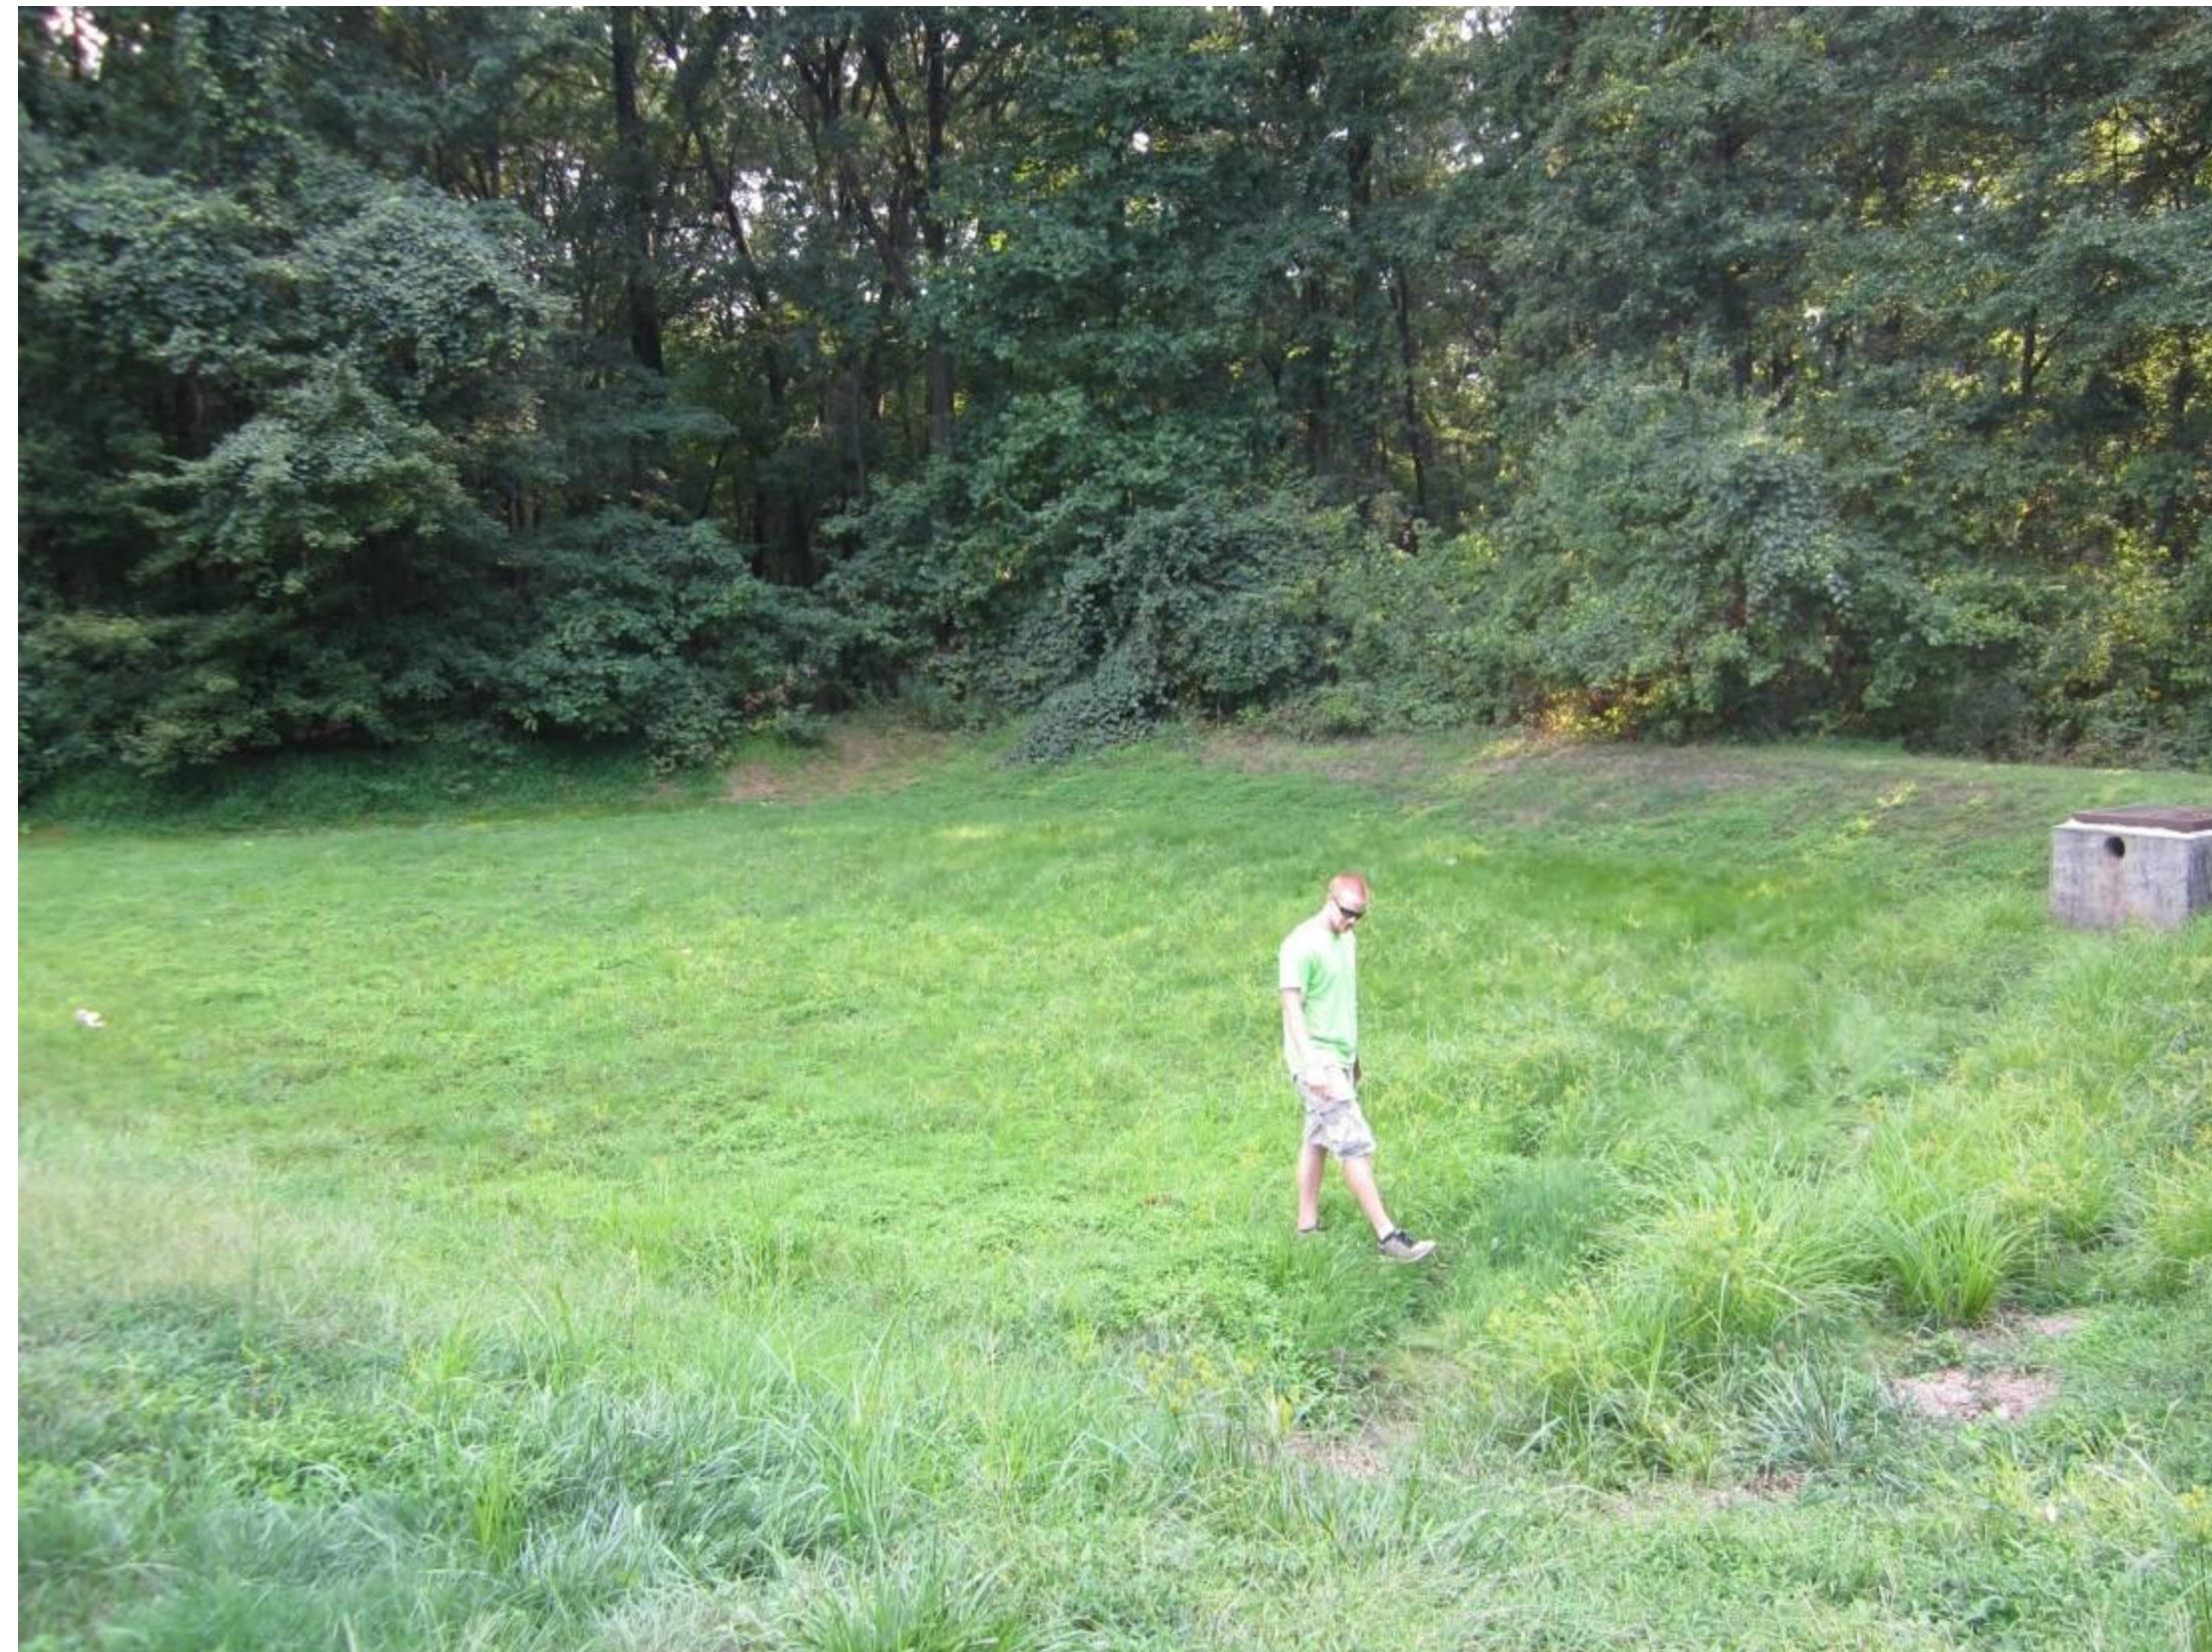
Basin bottom looking northwest

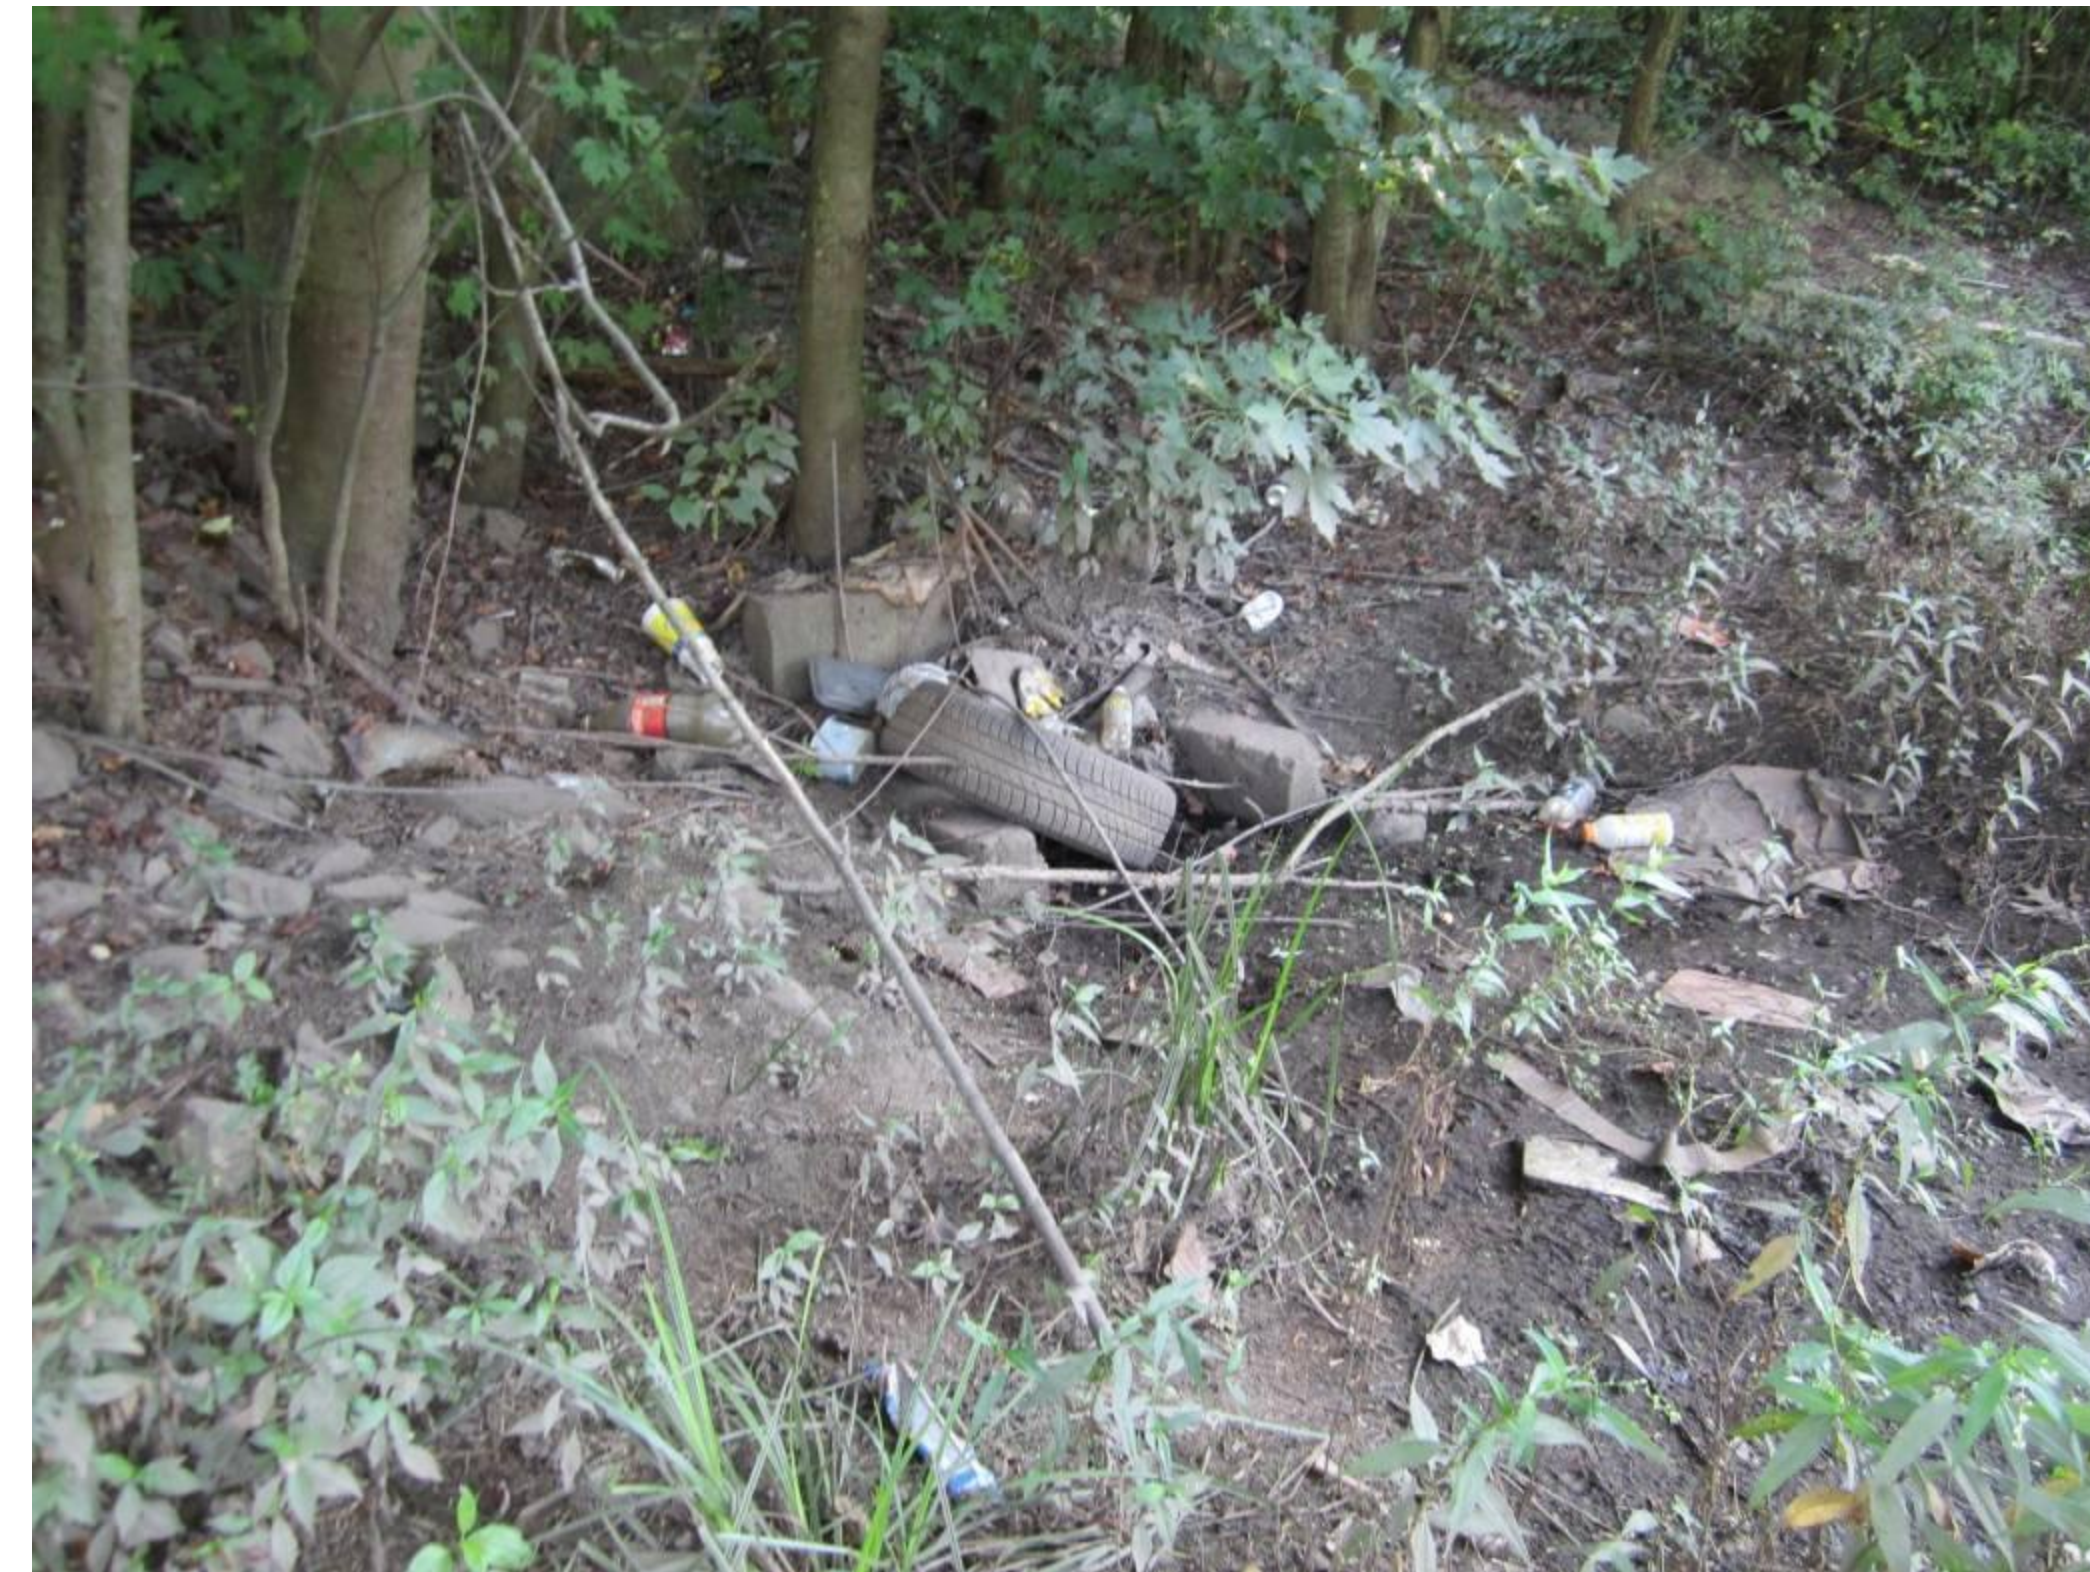
Outlet structure obstructed with litter

- Sediment, debris and litter accumulation at inlets and outlet
- Excess sediment accumulation and standing water in low flow channel with algae growth
- Northwestern basin embankment slumping/failing
- Evidence of deterioration at inlets
- Woody vegetation growth around outlet
- Basin outfall area shows evidence of erosion
