MILESTONE 4 OF REGIONAL STORMWATER MANAGEMENT PLAN FOR THE ROBINSON'S BRANCH
NEW JERSEY DEPARTMENT OF ENVIRONMENTAL PROTECTION

UNNATURAL CONSTRICTION FLOODING

JOB	CONCEPT SHEET #
BRANCH	5
B/O	TOTAL
4	7

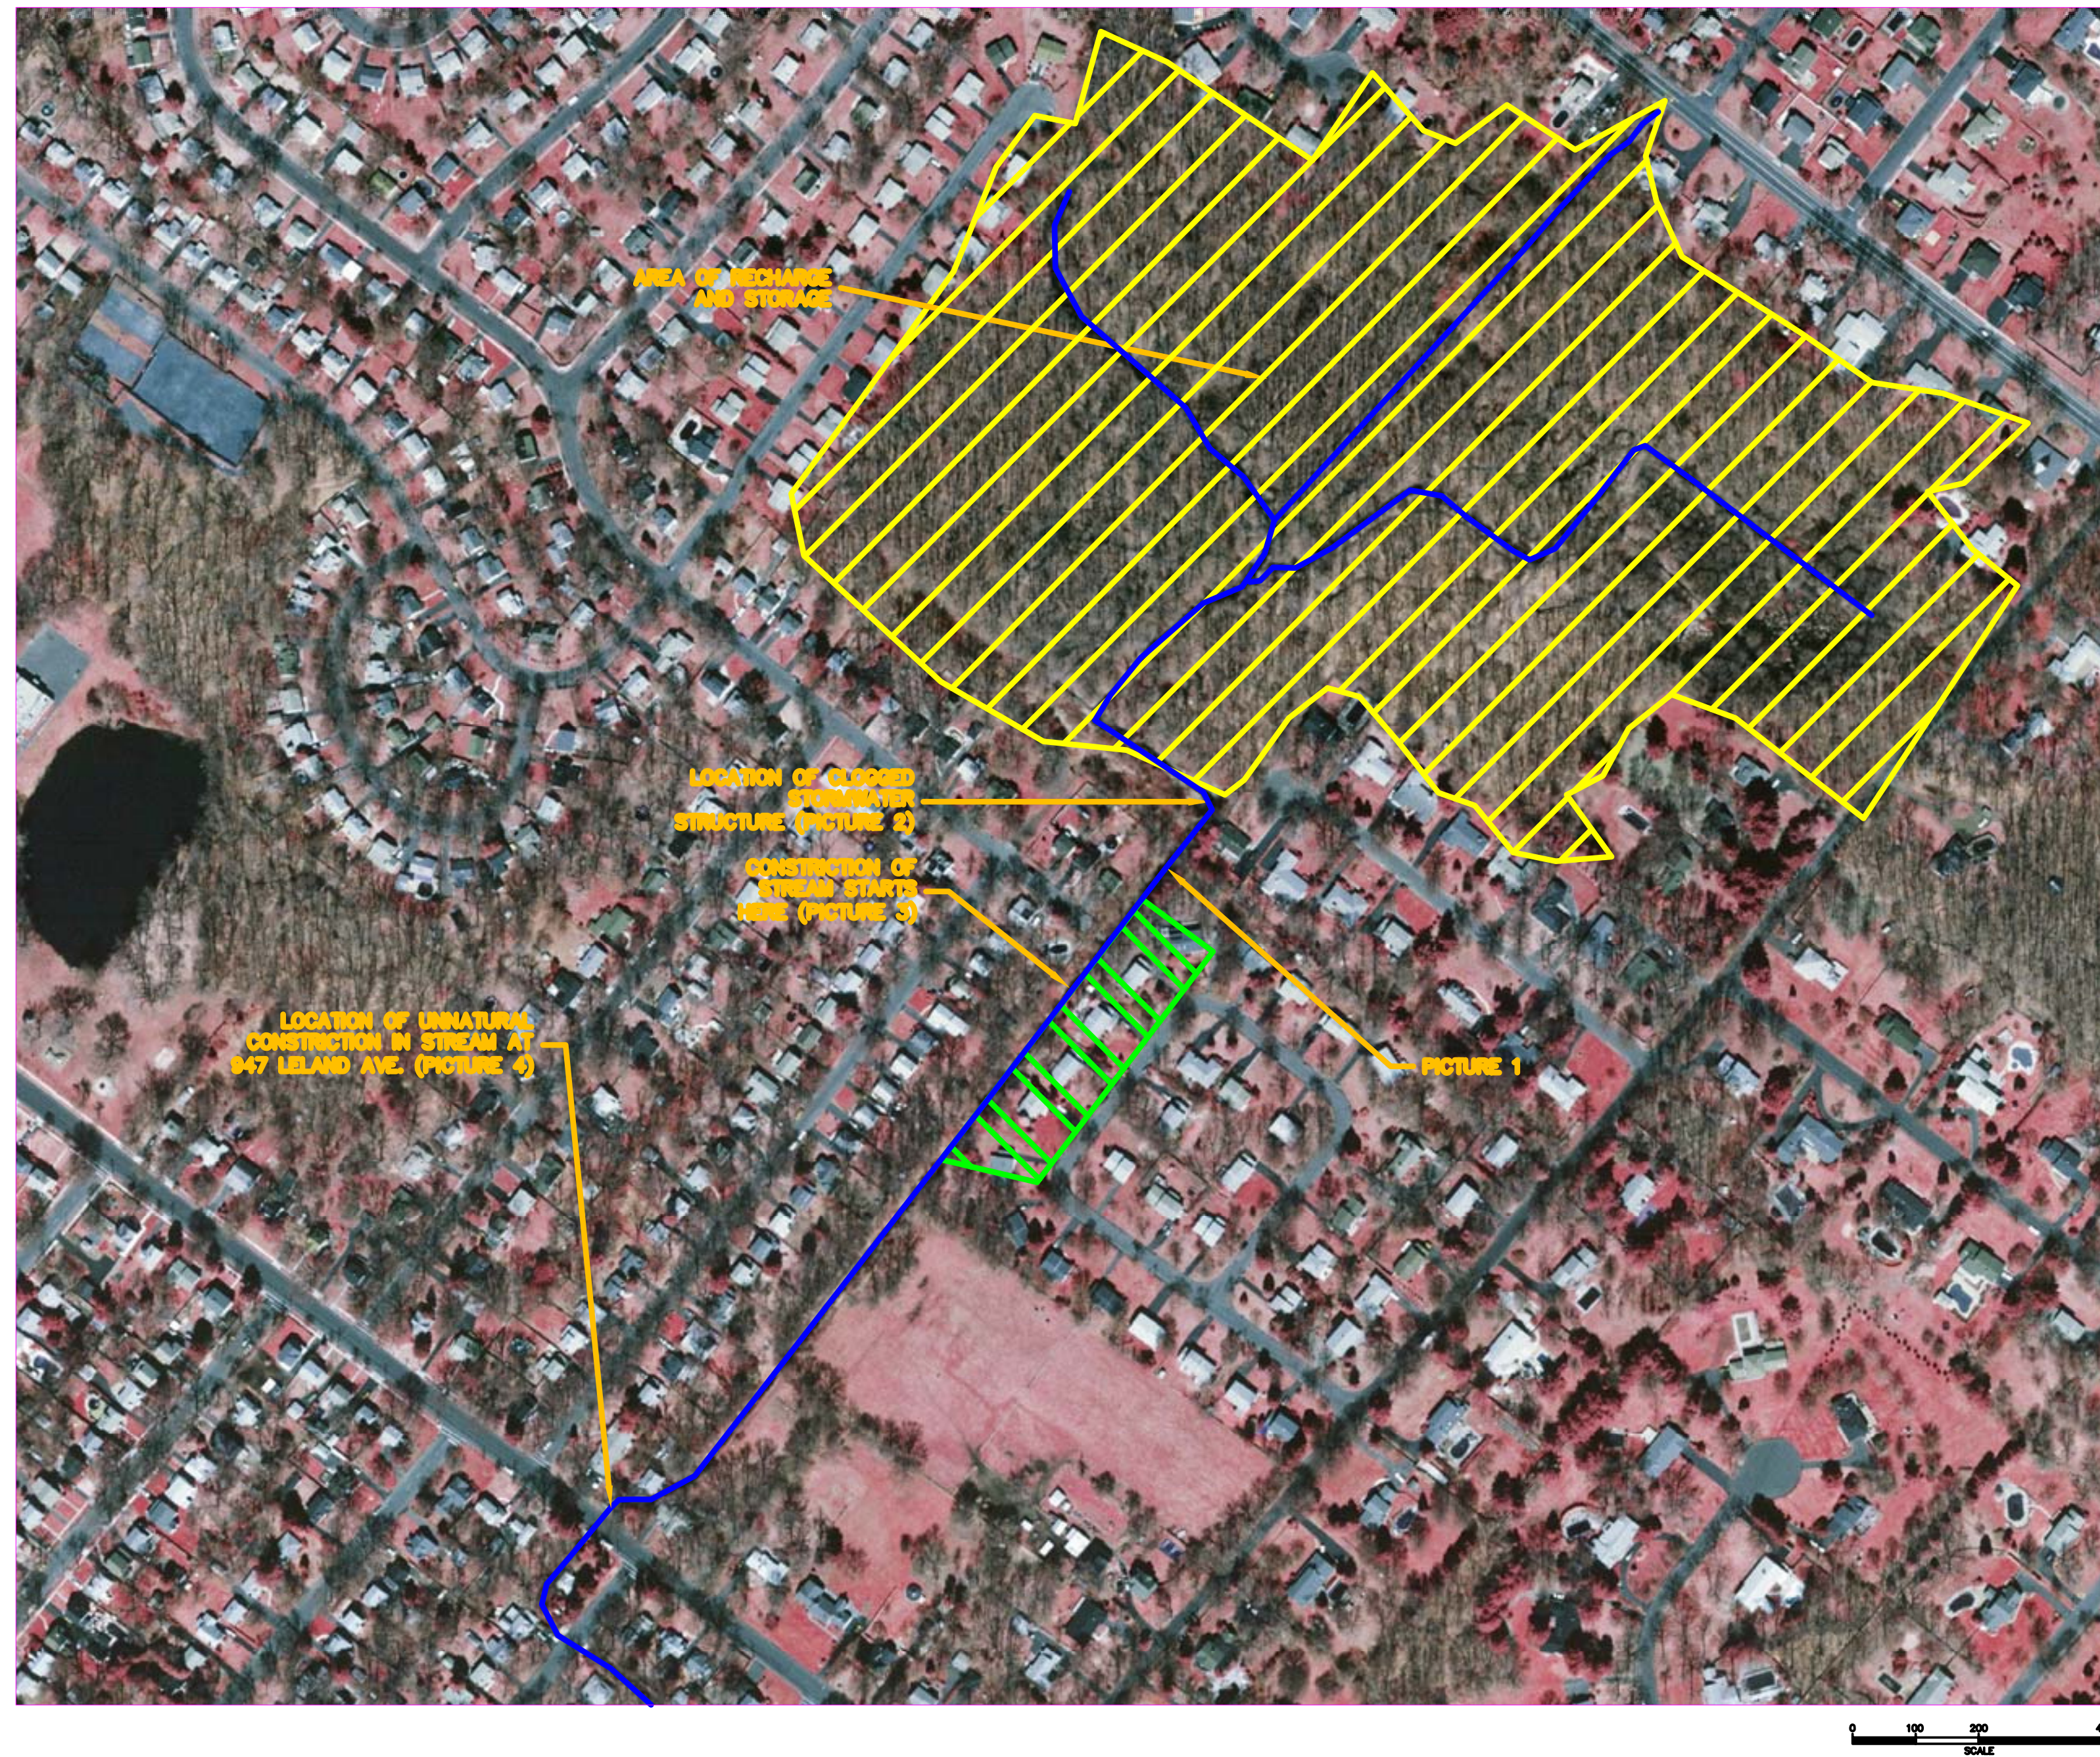
1. THE MAP ABOVE SHOWS THE LOCAL STREAMS, WHERE IT BECOMES CONSTRICTED AND WHERE FLOODING OCCURS DUE TO THIS CONSTRICTION.
2. THE CONSTRICTION BEGINS WHERE STERLING STREET DEAD ENDS AT THE STREAM BANK. THE CONSTRICTION BEGINS AS THE OCCASIONAL BUILT UP BACK YARD (SEE PICTURE 3) TO A RESIDENT OF WALD STREET BUT IT QUICKLY PROGRESSES INTO A 2 FOOT WIDE CONCRETE CHANNEL (SEE PICTURE 4). THIS CHANNEL PROVIDES VERY LITTLE ROOM FOR INCREASE FLOW DURING THE STORMS. IT IS THE UNDERSTANDING OF RUTGERS UNIVERSITY THAT THIS CONSTRICTION FORCES THE WATER TO BACK UP TO THE END OF THE CONSTRICTION BEHIND WALD STREET AND FLOOD WALD ST DURING HEAVY RAIN STORMS.

3. STORMWATER IS COLLECTED FROM THE WETLAND NORTH OF THE FLOODING AND THE SURROUNDING NEIGHBORHOODS. IT IS COLLECTED INTO THE STORMWATER SEWER SYSTEM AND PIPED INTO THE STREAM SHOWN ABOVE. PICTURE 2 SHOWS THE STORMWATER OUTFALL STRUCTURE THAT DEPOSITS THE STORMWATER FROM THE SURROUNDING NEIGHBORHOOD TO THE STREAM. IN THE INLET OF THE STRUCTURE IS OBSTRUCTED BY DEBRIS. THIS SLOWS THE FLOW FROM THE WETLAND, REDUCING THE FLOOD AT THIS POINT IS REDUCING THE FLOODING DOWNSTREAM AT WALD STREET.

4. DURING SITE VISITS, A RESIDENT INFORMED RUTGERS THAT FREQUENTLY THROUGHOUT THE STREAM OVERFLOWS. THE RESIDENT WENT ON TO SAY THAT THE OVERFLOW IS SO BAD THAT SHE FEELS THAT NEEDS EVACUATE HER HOUSE BUT SOMETIMES CANNOT DUE TO FLOODING.

1. THE FLOODING OF WALD STREET IS A SERIOUS ISSUE THAT THE MUNICIPALITY SHOULD WORK TO RESOLVE. FREQUENTLY THROUGHOUT THE YEAR THE RESIDENTS ON WALD STREET FEEL THE MUST EVACUATE THEIR HOUSE OVER RAIN THAT IS NOT AT A FLOODING VOLUME.

2. MUNICIPALITY NEEDS TO MAP OUT THE STORMWATER SEWER SYSTEM THAT FEEDS INTO THIS STREAM. FROM OUT SITE VISITS THE STORMWATER STRUCTURE IN PICTURE IS OBVIOUSLY CONNECTED TO A GREATER SYSTEM BUT IT IS UNCLER AT THIS POINT HOW EXTENSIVE THIS SYSTEM IS.

3. THE FLOODING HAD NEVER BEEN WITNESSED BY THE TEAM THAT INVESTIGATED THIS SITE. THEY ONLY HAVE THE ACCOUNTS OF ONE RESIDENT TO GO BY. THE MUNICIPAL ENGINEER NEEDS TO VISIT THE SITE AND TALK TO ALL THE RESIDENT S OF WALD STREET TO CONFIRM OR DISPROVE THE SERIOUS STATEMENT.

4. THE BEST SOLUTION TO THIS PROBLEM WOULD BE TO RELAX THE CONSTRICTION OF THE STREAM AROUND 497 LELAND AVENUE. UNFORTUNATELY, THIS WOULD MOSTLY LIKELY MEAN THAT THE MUNICIPALITY WOULD HAVE TO BUY EASEMENTS OR WHOLE PROPERTIES FROM RESIDENTS LIVING THERE NOW.

5. THIS IS A COMPLEX SYSTEM THAT HAS MASSIVE AMOUNTS OF WATER BEING DIRECTED TOWARDS IT. THE MUNICIPALITY MUST BUILD A COMPLETE STORMWATER MODEL TO CONFIRM THE FLOODING AND THAT THE SOLUTION CHOSEN FOR THIS PROJECT WILL CORRECT THE FLOODING PROBLEM.

6. PICTURE TWO SHOWS AN OBSTRUCTED INLET FOR THE STREAM. IT IS RECOMMENDED THAT THIS OBSTRUCTION BECOME PERMANENT. THE MUNICIPALITY SHOULD REDUCE THE SIZE OF THE INLET TO ENSURE THERE IS A REDUCED FLOW COMING FROM UPSTREAM TO HELP REDUCE TO PREVENT AN INCREASE IN FLOODING WALD STREET.

7. A LAND AQUISTION ACTION MAY BE REQUIRED ON THE PART OF THE MUNICIPALITY OR COUNTY TO WIDEN THE STREAM TO MEET RUNOFF CAPACITY.
