RUTGERS UNIVERSITY
Water Resources Program
New Jersey Agricultural Experiment Station

Hamilton Township (Mercer County)

Stormwater Outfall Assessment Summary

2024: South Pond Run (Region 3)

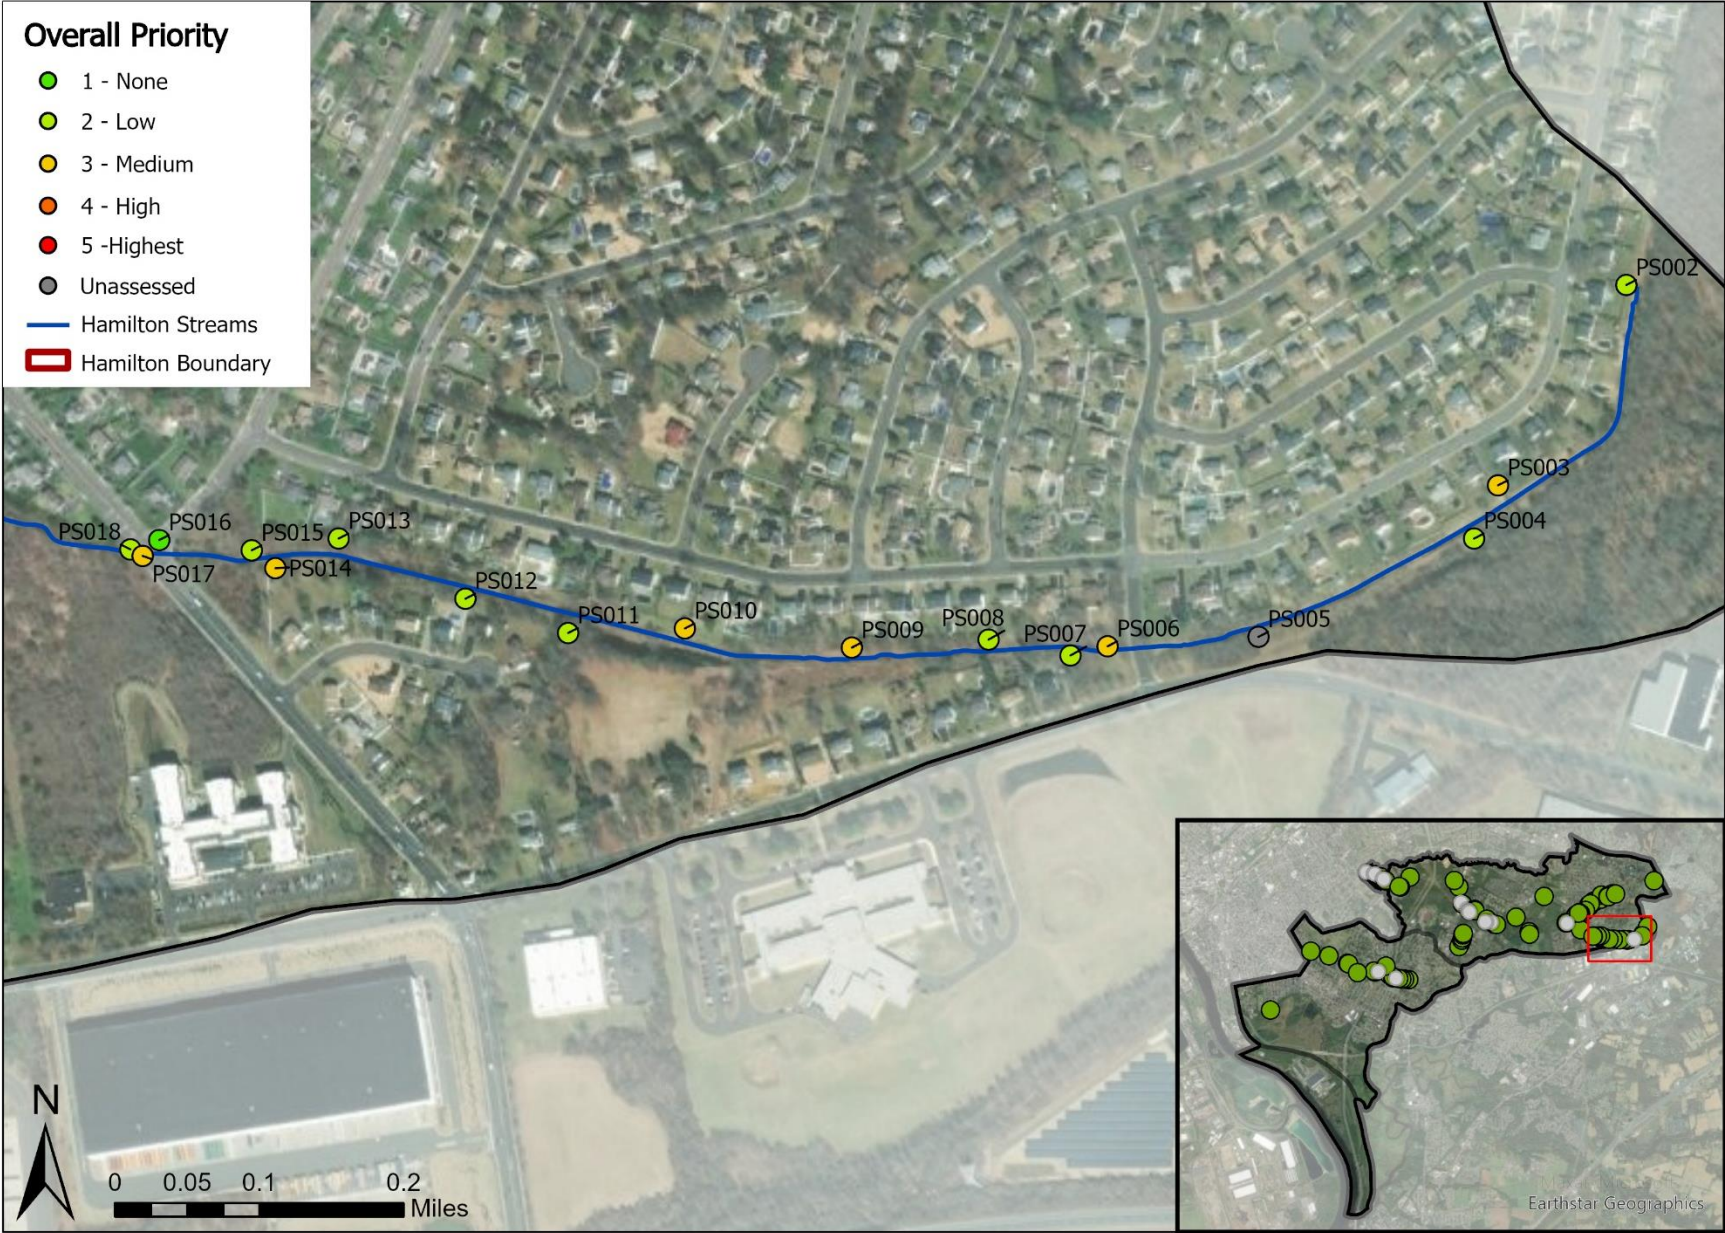
Hamilton Outfall Region 3: Overall Priority (Pond Run South)

Overall Priority in Pond Run South (1 of 7)

A prioritization was developed using the field data collected. Priority was given to outfalls that showed significant signs of deterioration, were causing downstream erosion, were unstable due to erosion, or showed signs of illicit connections. All outfalls were placed on a scale from 1 to 5 with 5 being the highest priority and needing immediate attention. Anything that has been assigned a priority level of 3 or higher should have action taken for maintenance or repair.

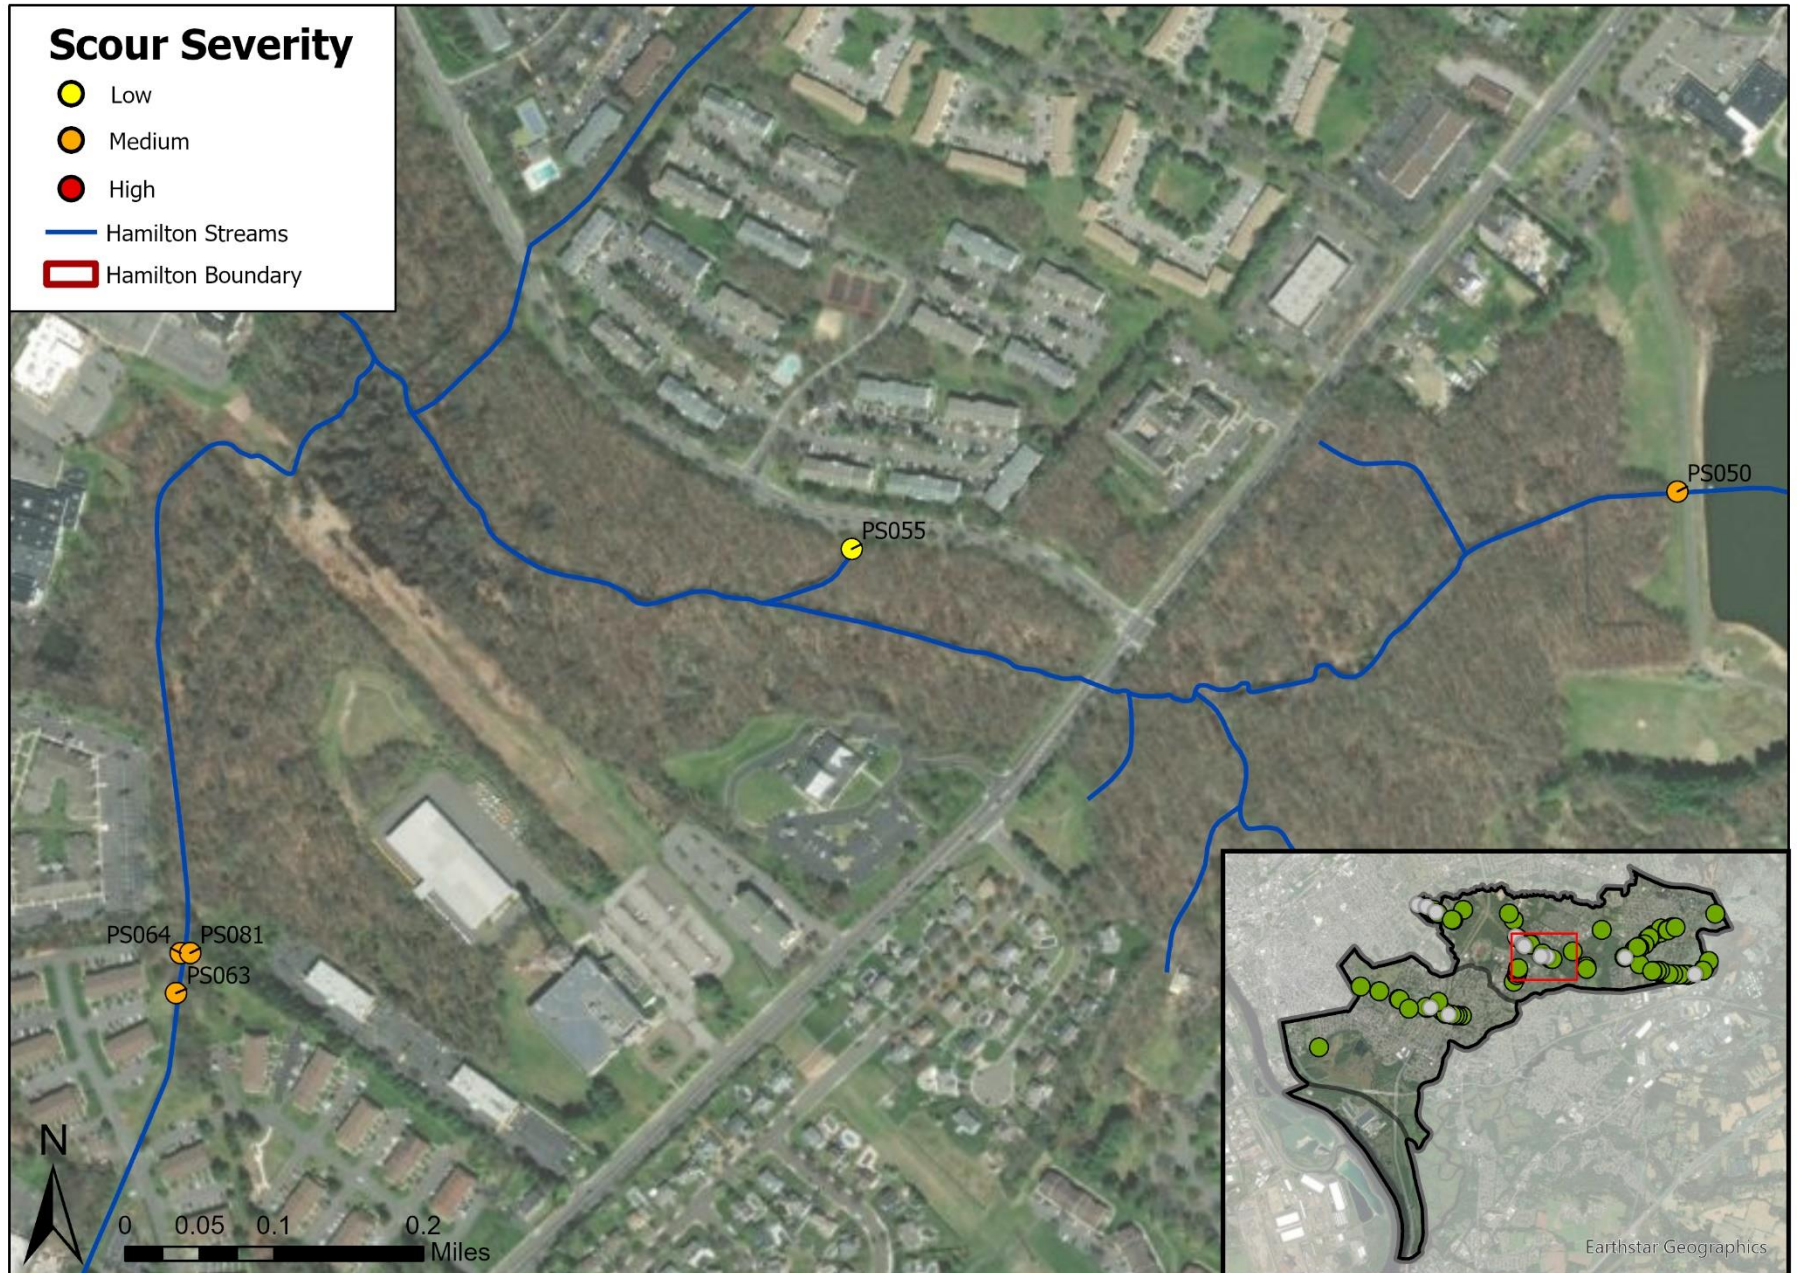
Hamilton Outfall Region 3: Erosion (Pond Run South)

Scour Severity in Pond Run South (4 of 6)

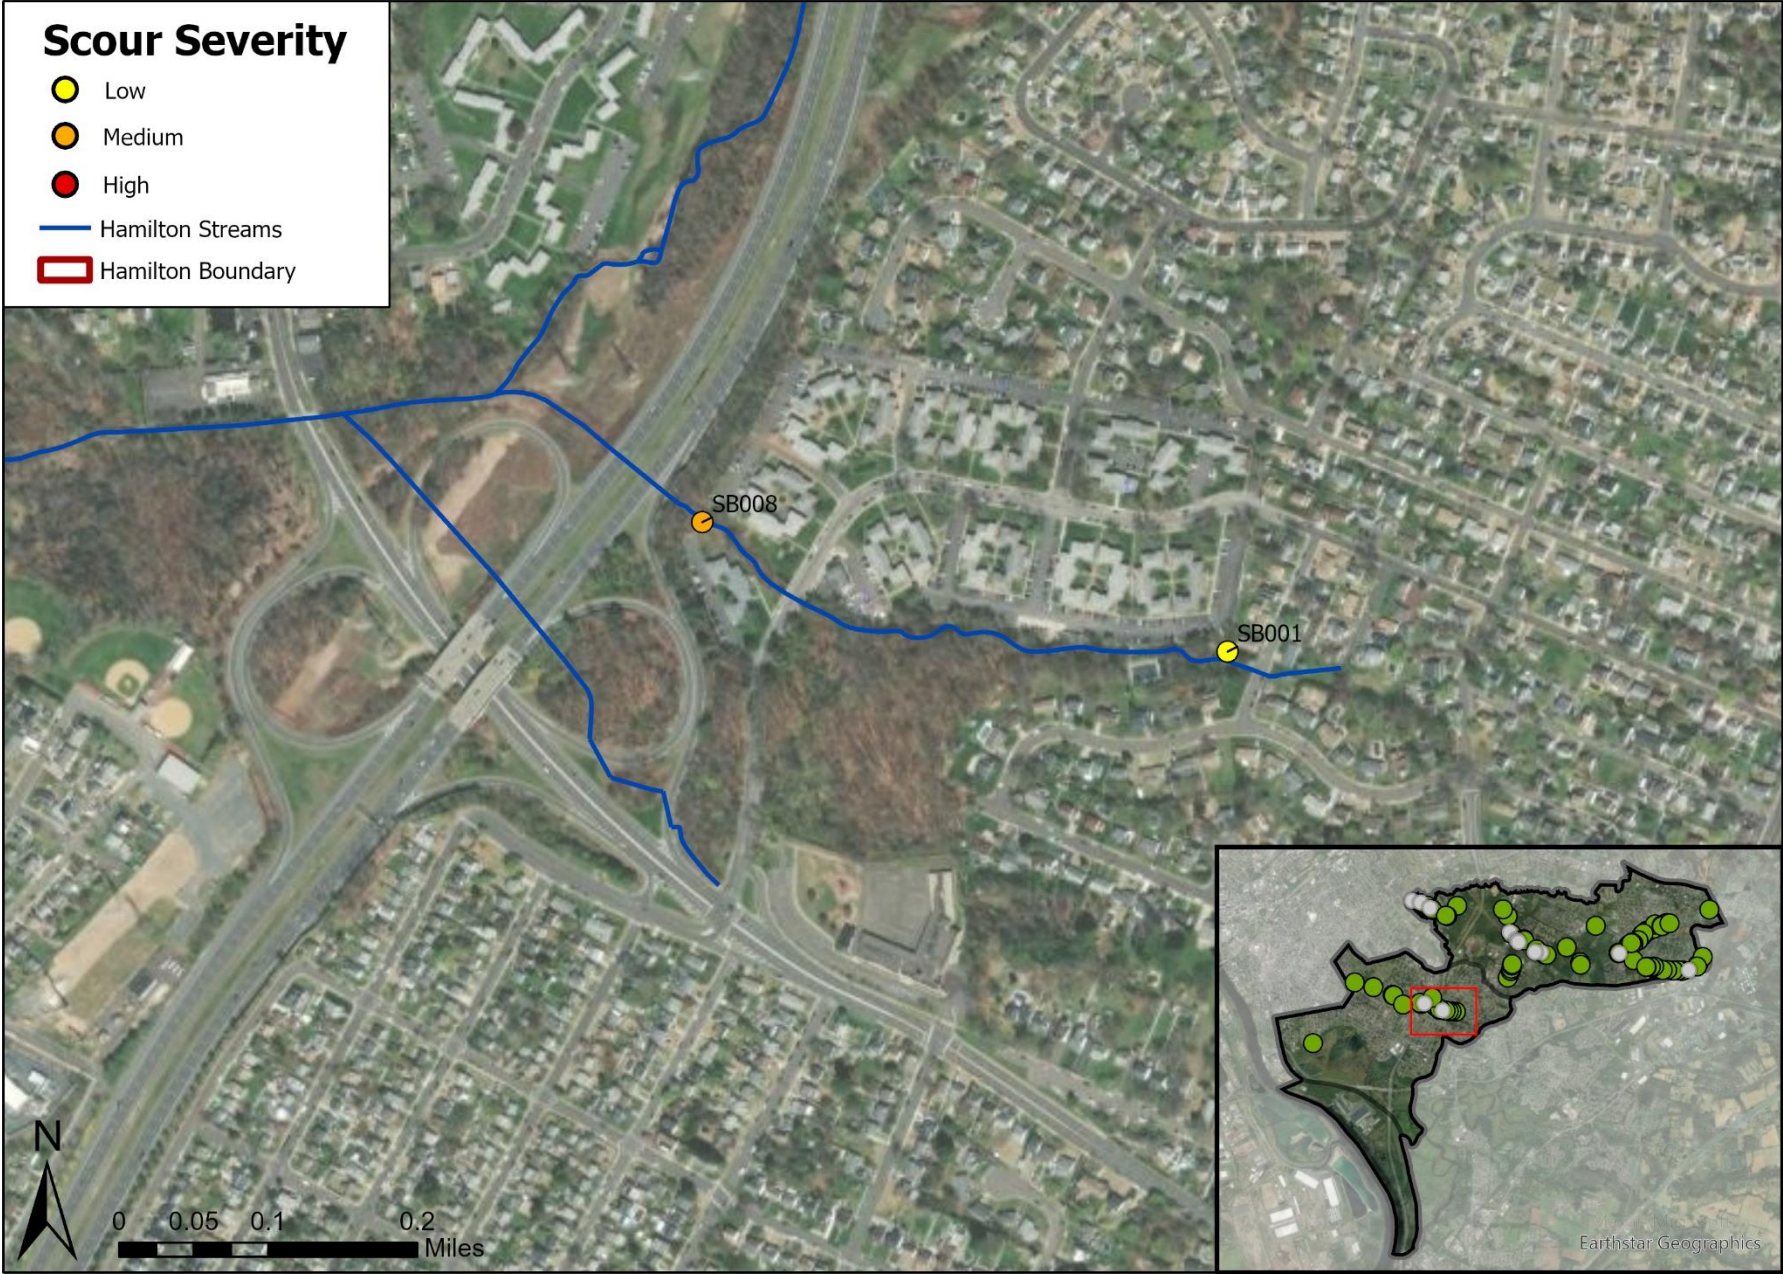
Hamilton Outfall Region 3: Erosion (Shady Brook)

Scour Severity in Shady Brook (1 of 1)

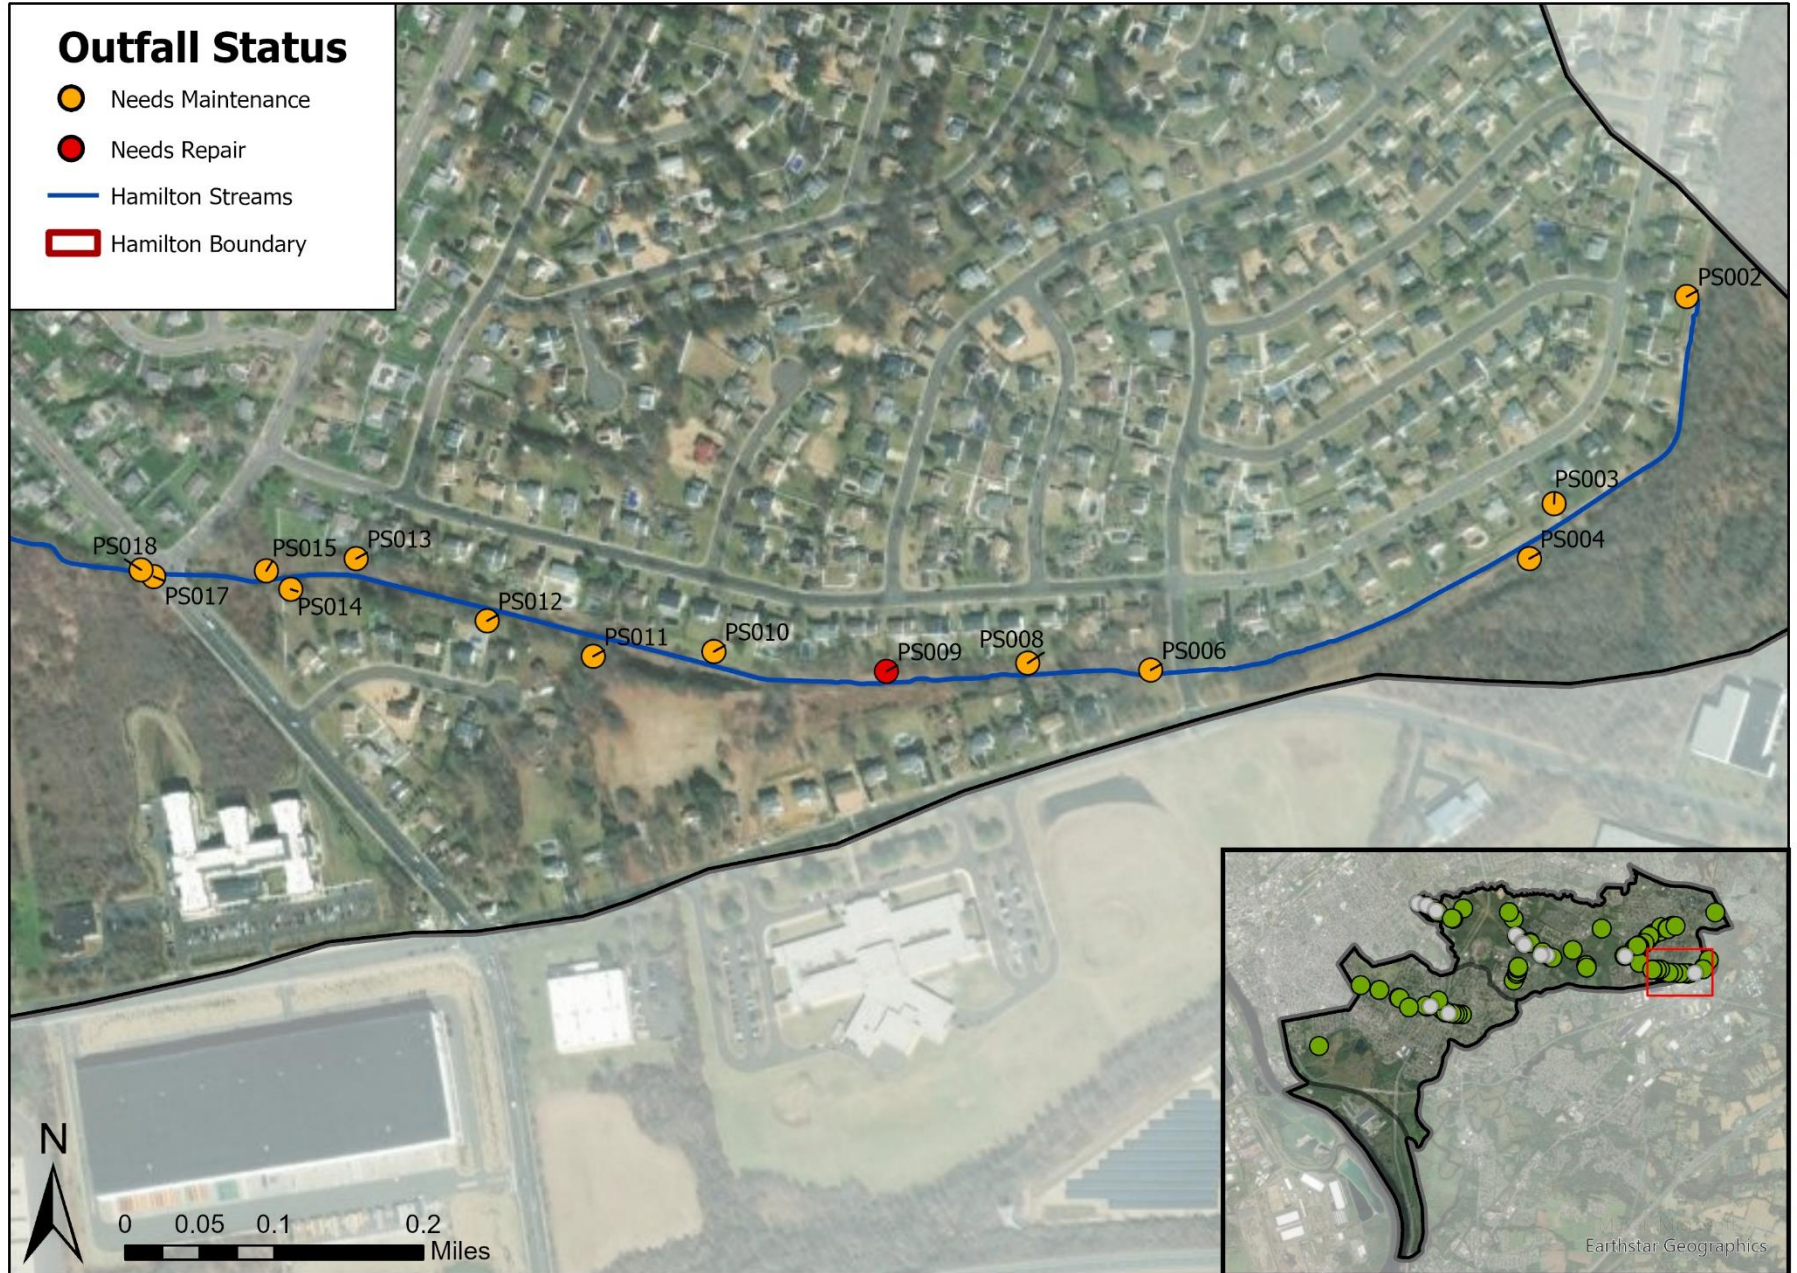
Hamilton Outfall Region 3: Outfall Maintenance & Repair (Pond Run South)

Outfall Status in Pond Run South (1 of 6)

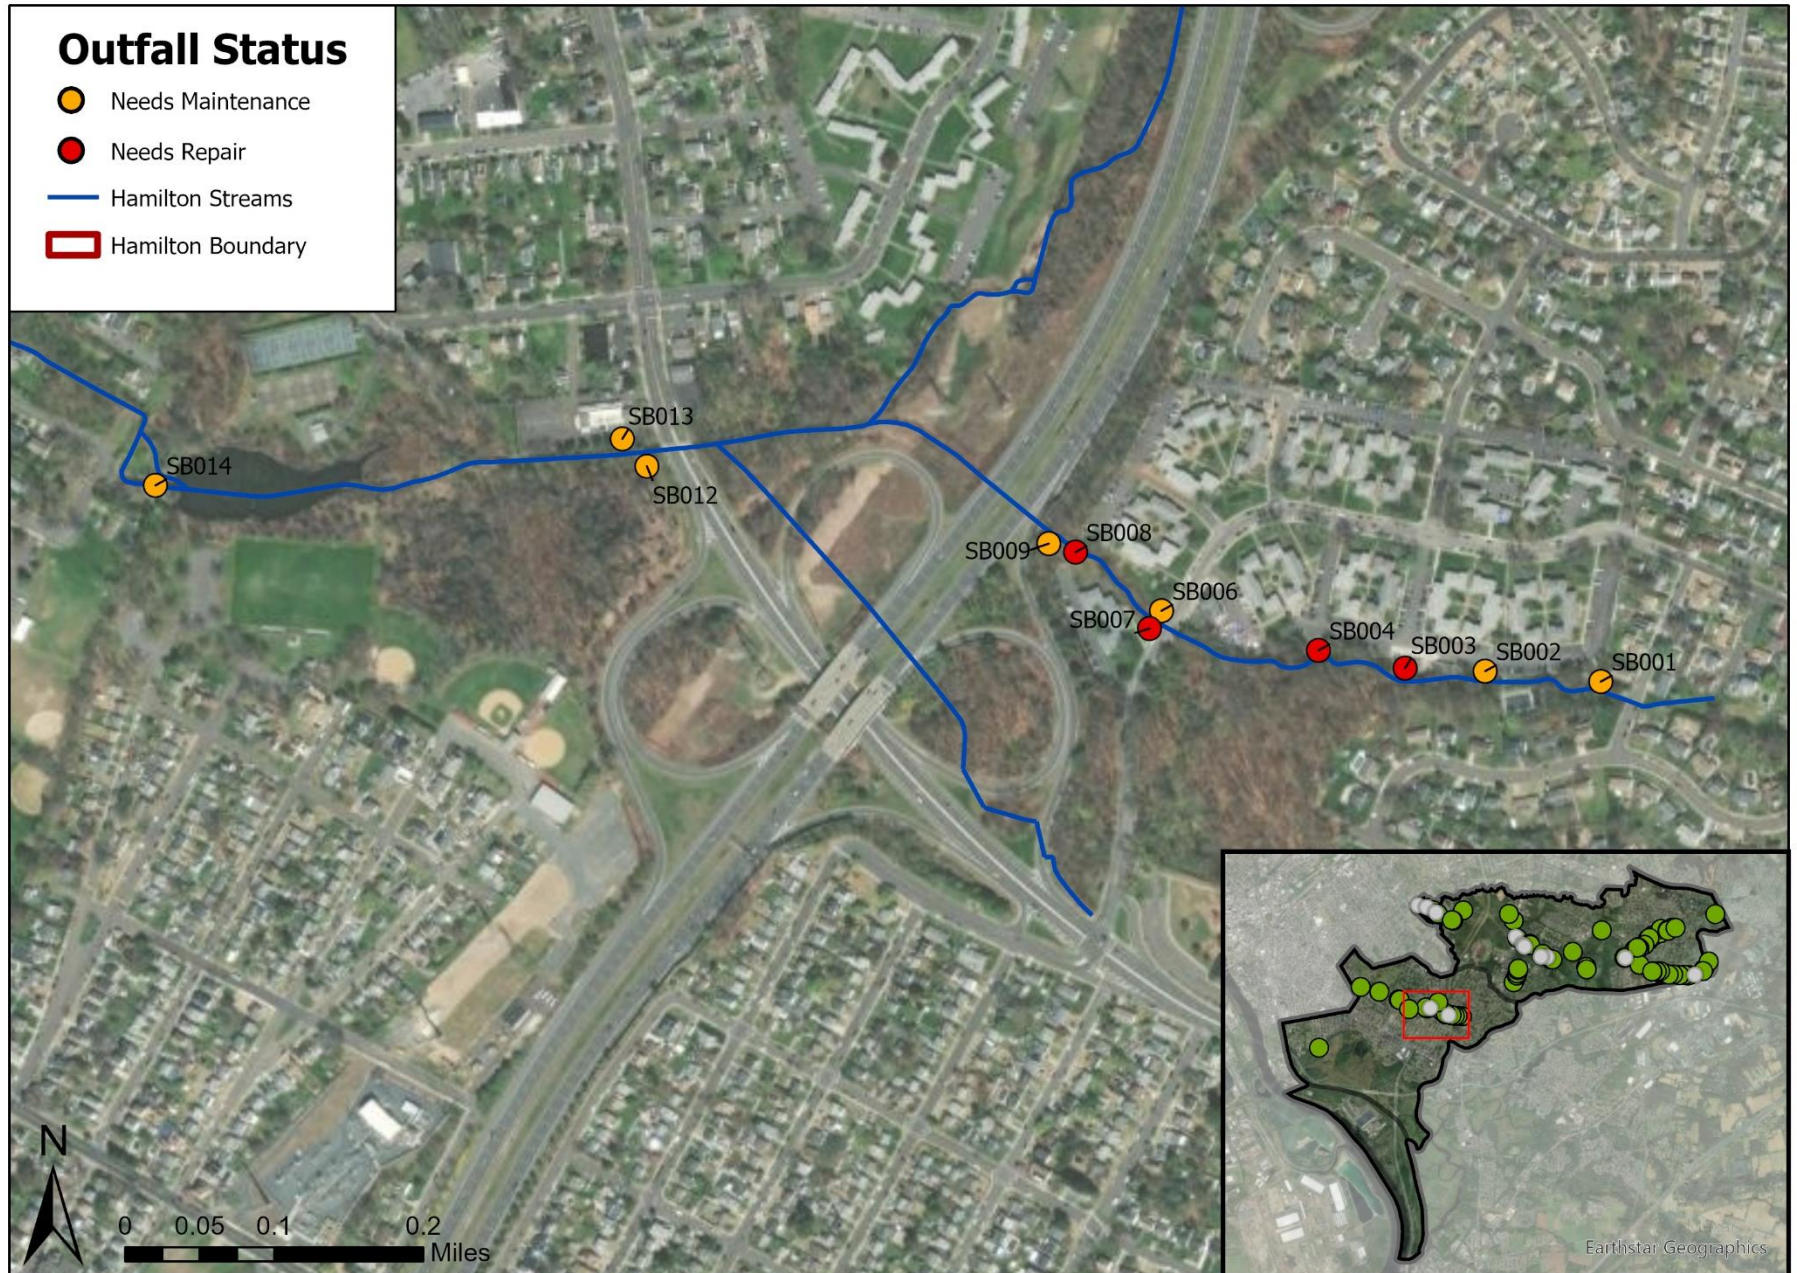
Hamilton Outfall Region 3: Outfall Maintenance & Repair (Shady Brook)

Outfall Status in Shady Brook (1 of 3)

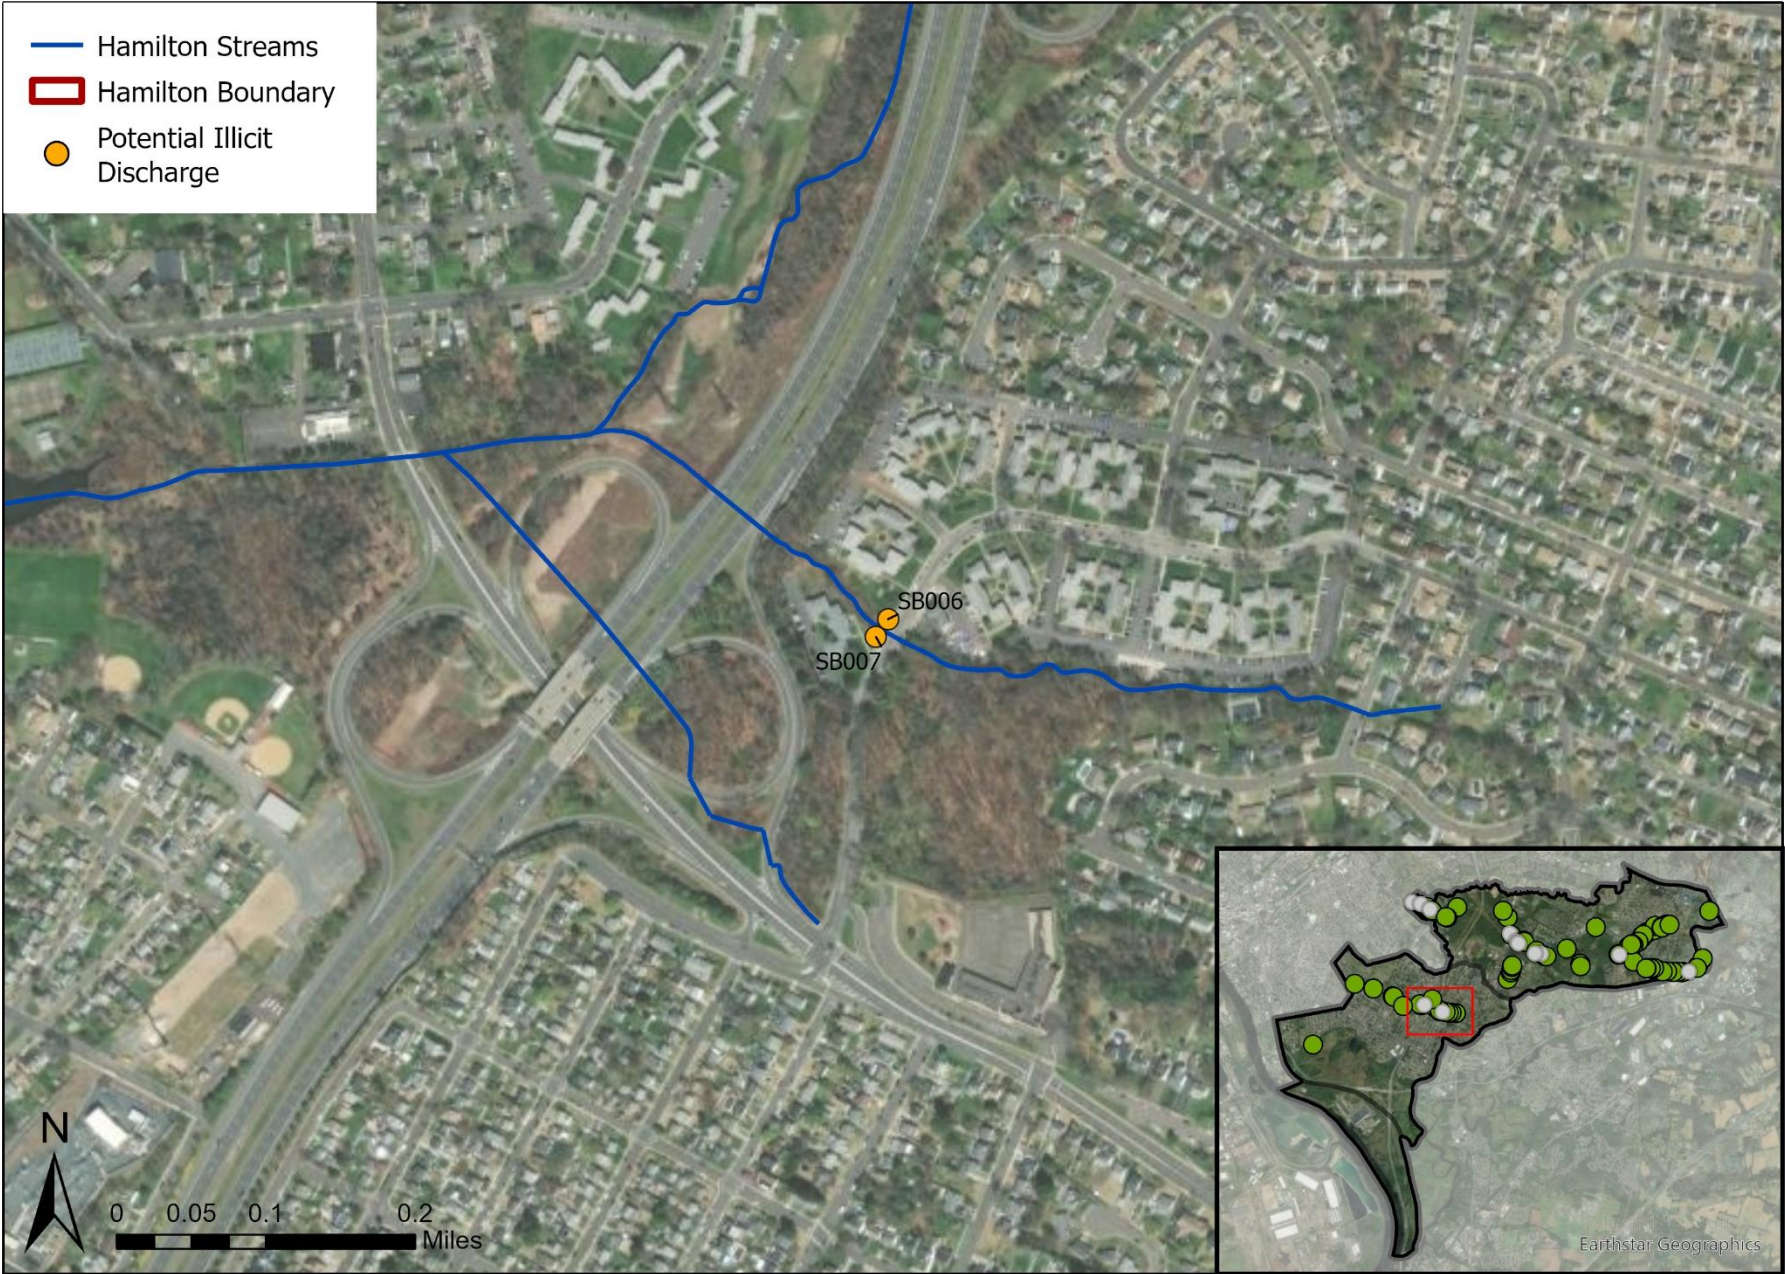
Hamilton Outfall Region 3: Potential Illicit Discharges in Shady Brook

Potential Illicit Discharge in Shady Brook (1 of 1)
