# St. Mary's Church

**Address:** 735 Union Road  
Vineland, NJ 08360

# GREEN INFRASTRUCTURE RECOMMENDATIONS

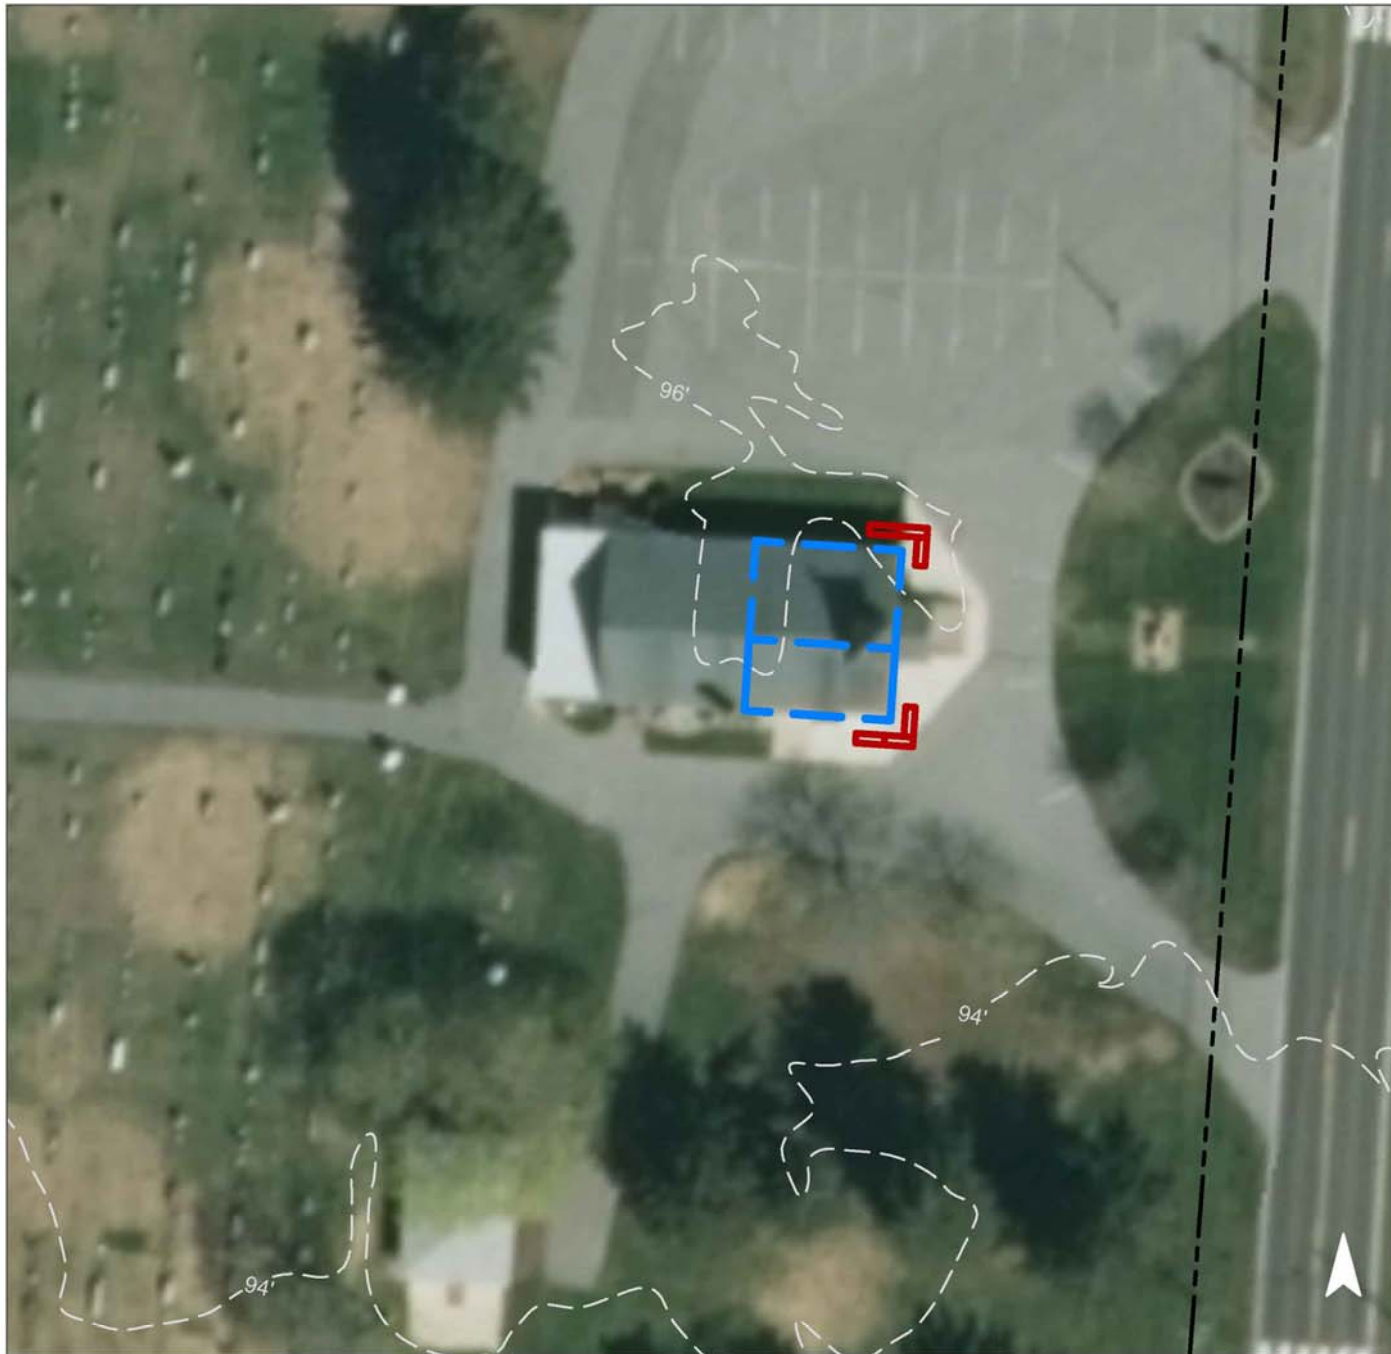
## St. Mary's Church

Downspout planter boxes can be constructed along the two corners on either side of the entrance of the building to allow roof runoff to be reused. A preliminary soil assessment suggests that the soils have suitable drainage characteristics for green infrastructure.

planter box
-

drainage area
-

property line
-
