**Impervious Cover Assessment
for
Lumberton Township, Burlington County, New Jersey**

*Prepared for Lumberton Township by the
Rutgers Cooperative Extension Water Resources Program*

August 2022

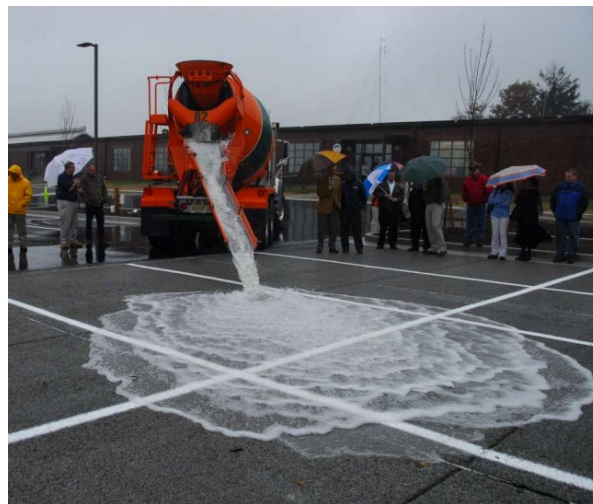
Figure 2: Rapid infiltration of water through porous pavement is demonstrated at the USEPA Edison New Jersey test site

1. ***Eliminate surfaces that are not necessary.*** For example, a paved courtyard at a public school could be converted to a grassed area.
2. ***Reduce or convert impervious surfaces.*** There may be surfaces that are required to be hardened, such as roadways or parking lots, but could be made smaller while maintaining functionality. A parking lot that has two-way car ways could be converted to one-way car ways. Permeable paving materials such as porous asphalt, pervious concrete, or permeable paving stones can be substituted for impermeable paving materials (Figure 2).

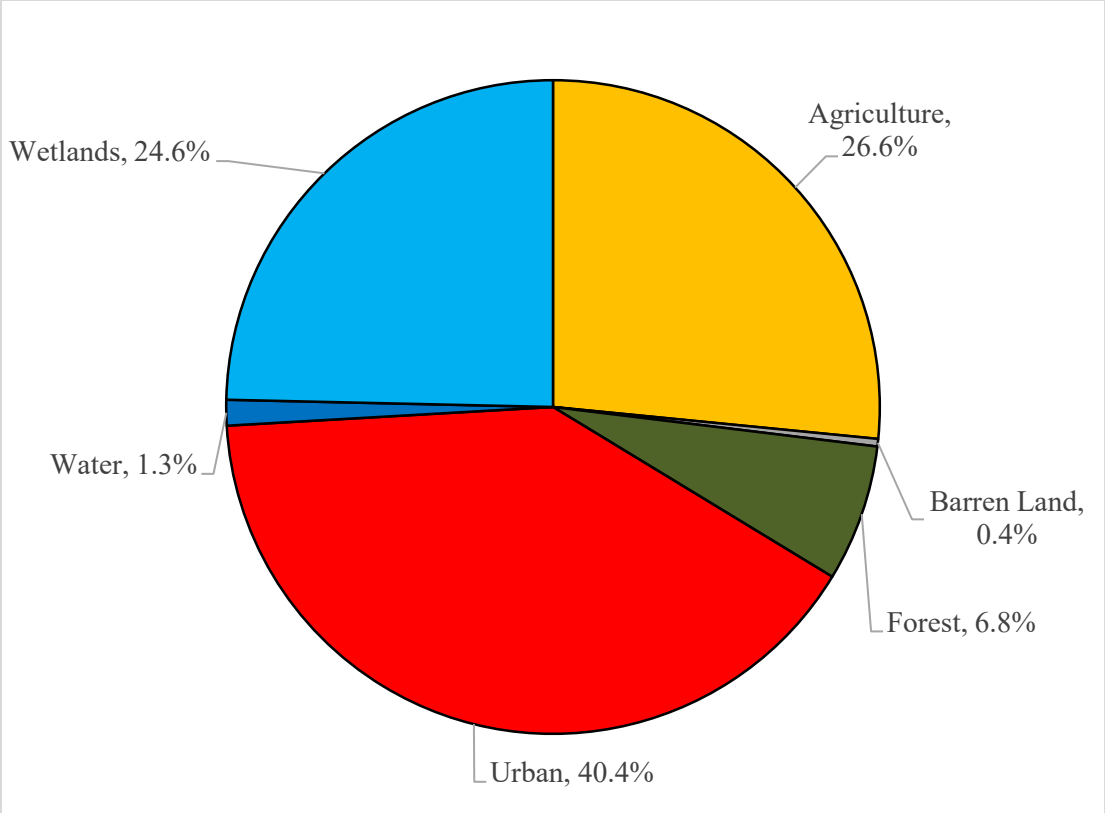
Figure 3: Pie chart illustrating the land use in Lumberton Township

Lumberton Township is located in Burlington County, New Jersey and covers approximately 13.01 square miles. Figures 3 and 4 illustrate that Lumberton Township is dominated by urban land uses. A total of 40.4% of the municipality's land use is classified as urban. Of the urban land in Lumberton Township, rural residential is the dominant land use (Figure 5).

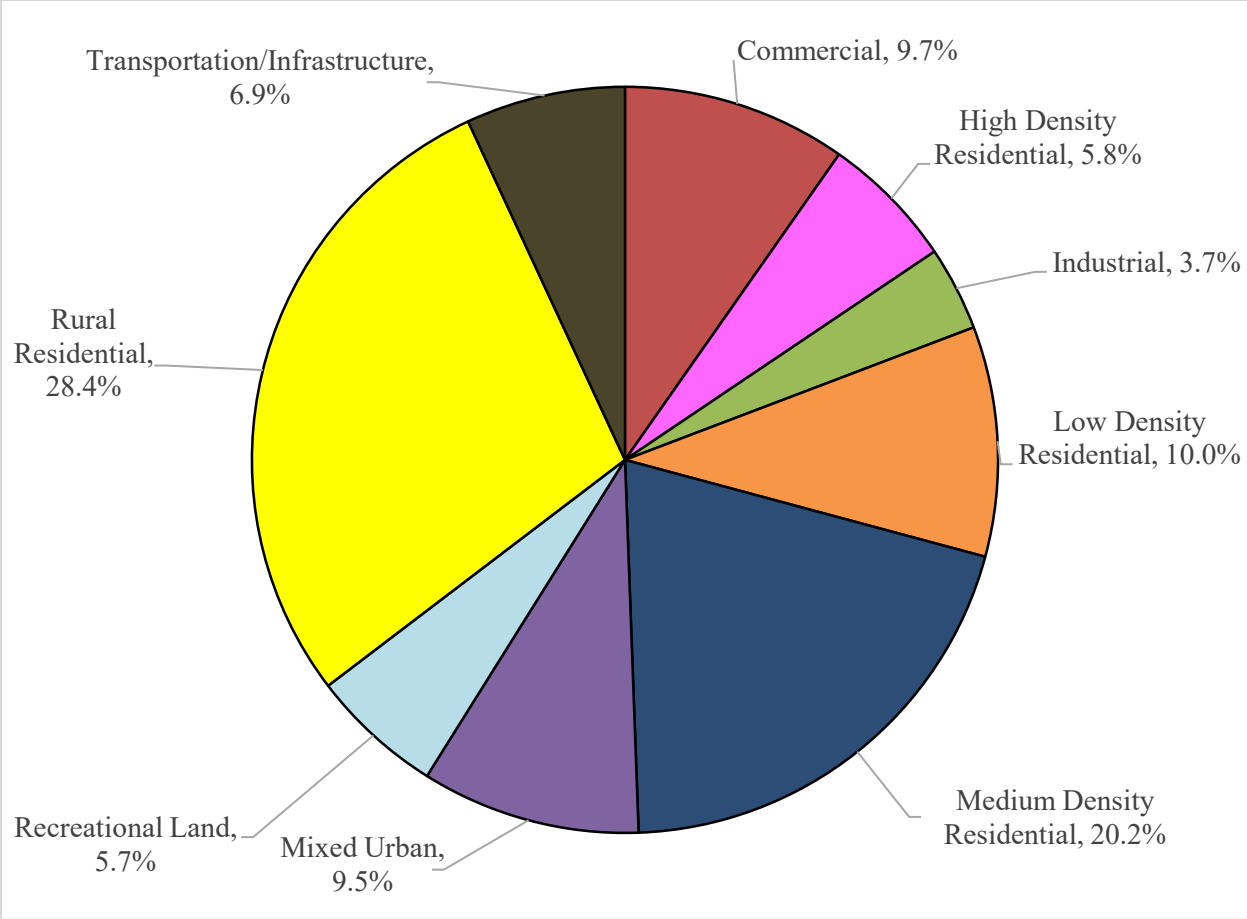
Figure 5: Pie chart illustrating the various types of urban land use in Lumberton Township

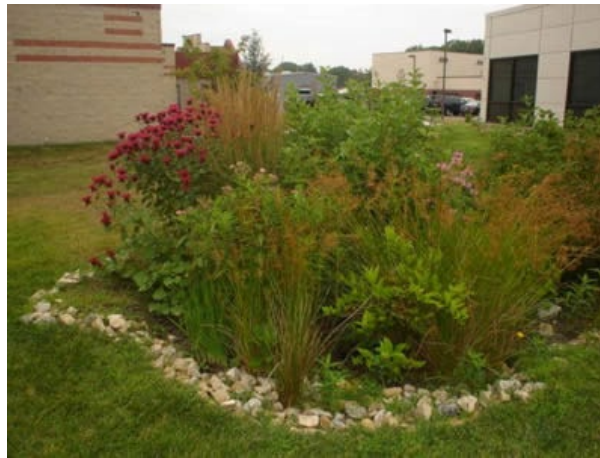
Figure 7: Rain garden outside the RCE of Gloucester County office which was designed to disconnect rooftop runoff from the local storm sewer system

- Rain Gardens: Stormwater can be diverted into shallow landscaped depressed areas (i.e., rain gardens) where the vegetation filters the water, and it is allowed to soak into the ground. Rain gardens, also known as bioretention systems, come in all shapes, sizes, and scales and can be designed to disconnect a variety of impervious surfaces (Figure 7).

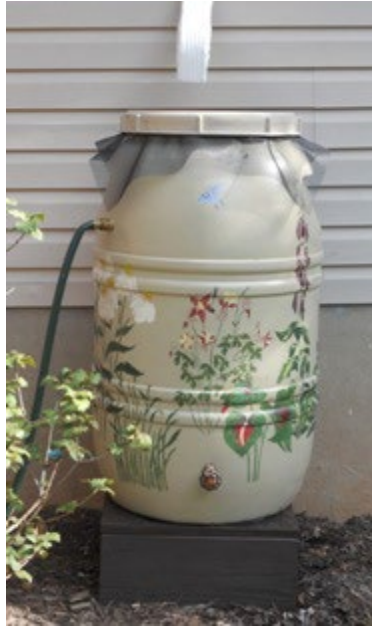
Figure 8a: Rain barrel used to disconnect a downspout with the overflow going to a flower bed

- Rainwater Harvesting: Rainwater harvesting includes the use of rain barrels and cisterns (Figures 8a and 8b). These can be installed below downspouts to collect rooftop runoff. The collected water has a variety of uses including watering plants and washing cars, ultimately reducing the use of potable water for non-drinking purposes. Rain barrels and cisterns must be designed with an overflow valve to allow excess water to be diverted to a nearby pervious area.

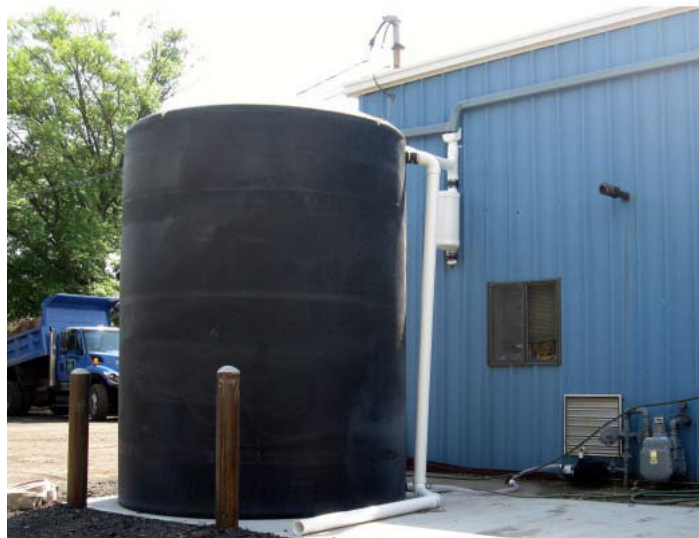
Figure 8b: A 5,000 gallon cistern used to disconnect the rooftop of the Department of Public Works in Clark Township to harvest rainwater for nonprofit car wash events

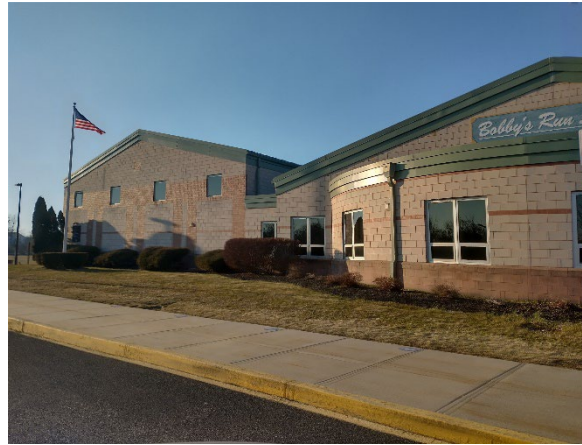
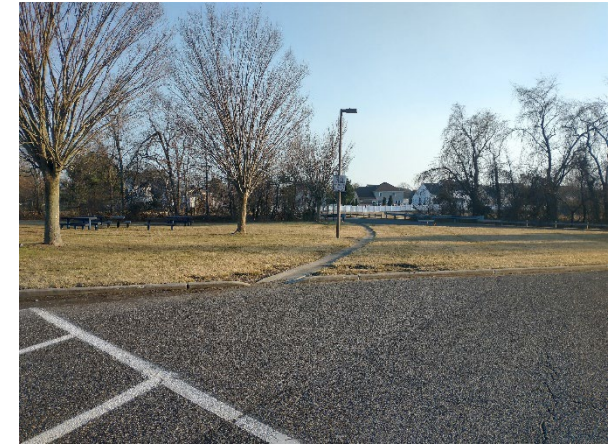
LUMBERTON MIDDLE SCHOOL

Various rain gardens can be installed south of the building to capture, treat, and infiltrate the stormwater runoff from the rooftops. Patches of parking areas can be converted to pervious pavement to help infiltrate the stormwater from the parking lots. An existing concrete flow channel can be removed and replaced with a bioswale to help slow and detain the stormwater.

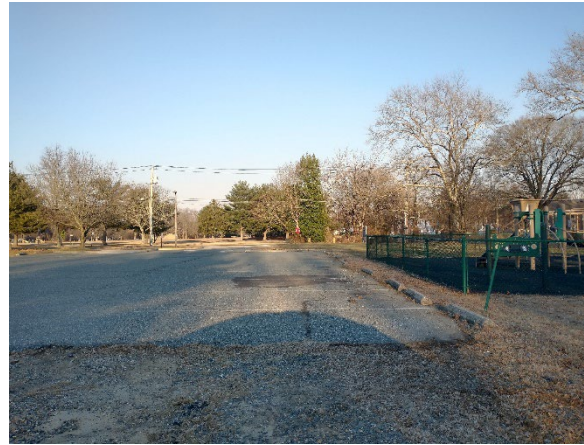
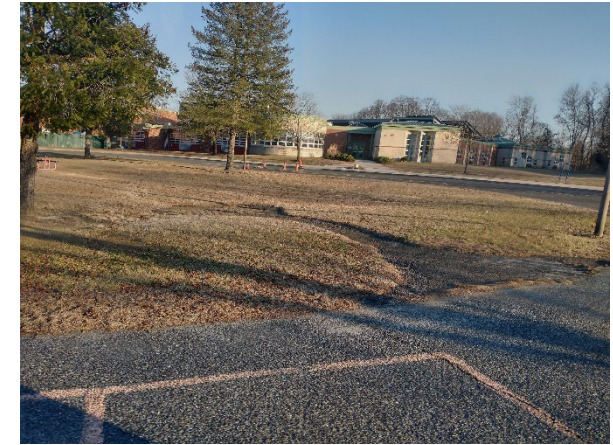
FLORENCE L. WALTHER ELEMENTARY SCHOOL

Various rain gardens can be placed around the building and off the roadways in low lying areas to help capture, treat, and infiltrate the stormwater runoff from the rooftops and paved areas. Parking spots in the southern parking lot can be converted to pervious pavement to infiltrate the stormwater runoff from the parking lot. A cistern can be installed south of the building nearby the existing planting beds for stormwater reuse.

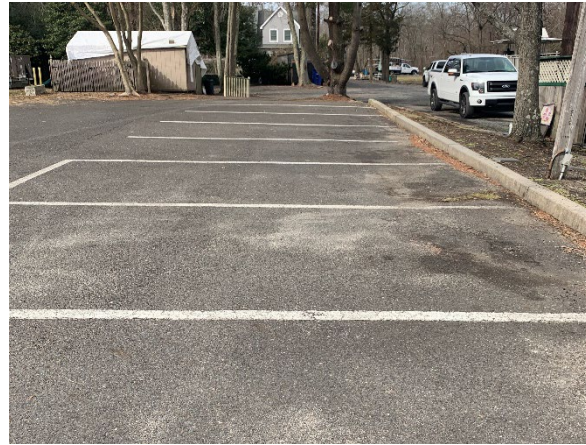
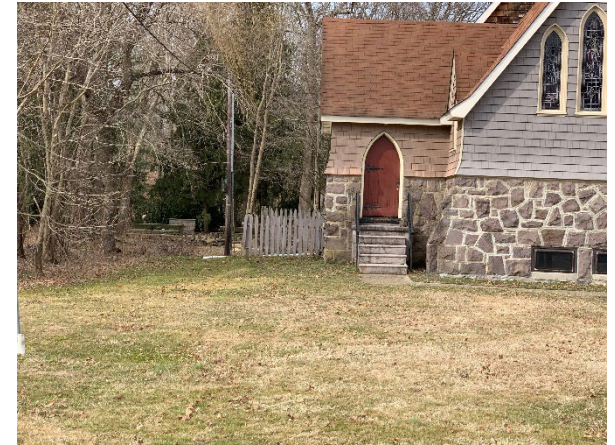
ST. MARTIN-IN-THE-FIELDS EPISCOPAL CHURCH

A rain garden can be installed south of the building to capture, treat, and infiltrate the stormwater from the rooftop. The parking spaces in the north section of the parking lot can be converted to pervious pavement to allow the stormwater runoff from the parking lot to infiltrate. A cistern can be installed east of the building to allow for non-potable stormwater reuse from the rooftop.
