**Impervious Cover Assessment  
for  
Franklin Township, Hunterdon County, New Jersey**

*Prepared for Franklin Township by the  
Rutgers Cooperative Extension Water Resources Program*

August 6, 2021

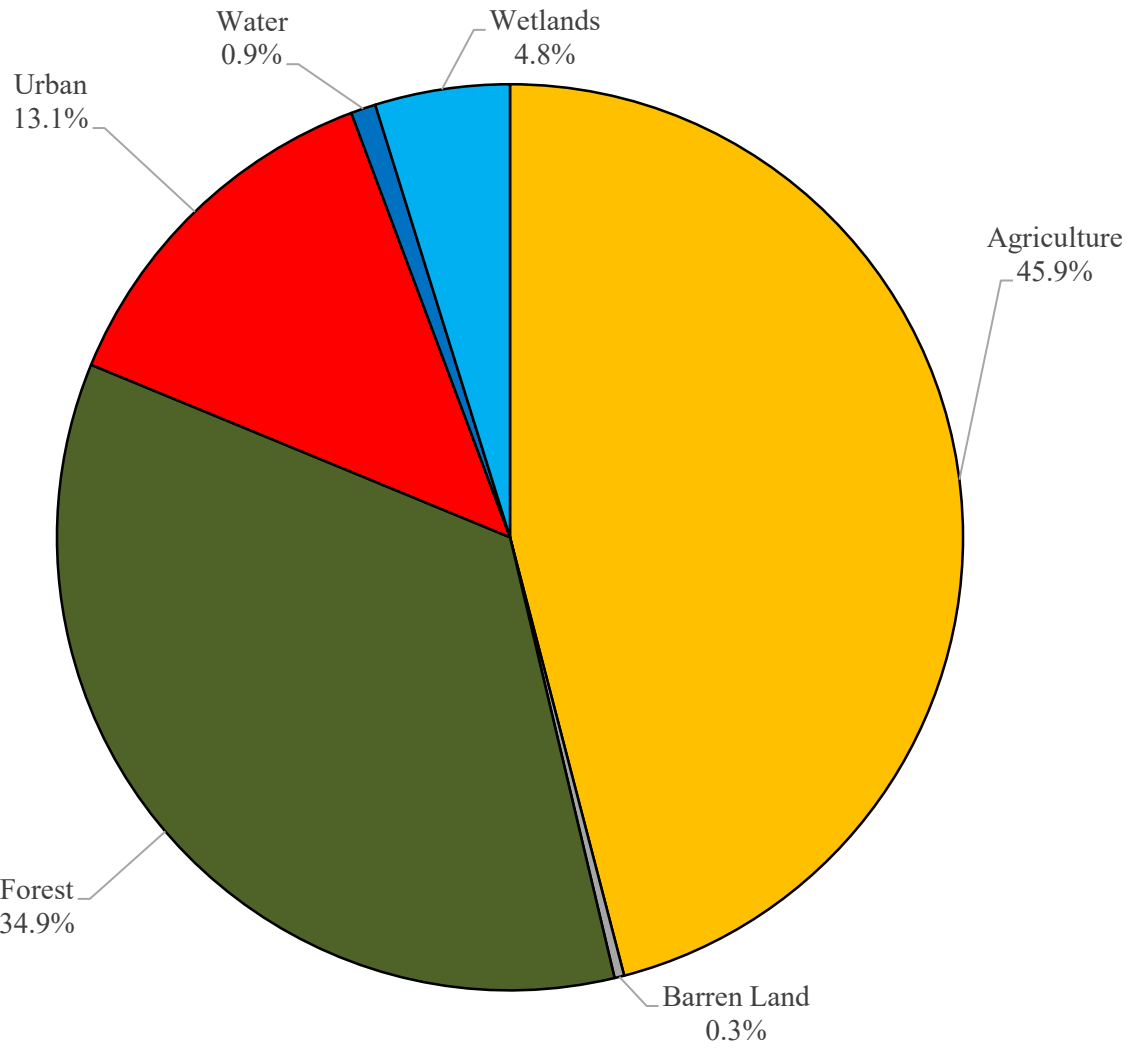
Figure 3: Pie chart illustrating the land use in Franklin Township

Franklin Township is located in Warren County, New Jersey and covers approximately 23.30 square miles. Figures 3 and 4 illustrate that Franklin Township is dominated by agriculture land uses. A total of 13.1% of the municipality's land use is classified as urban. Of the urban land in Franklin Township, rural residential is the dominant land use (Figure 5).

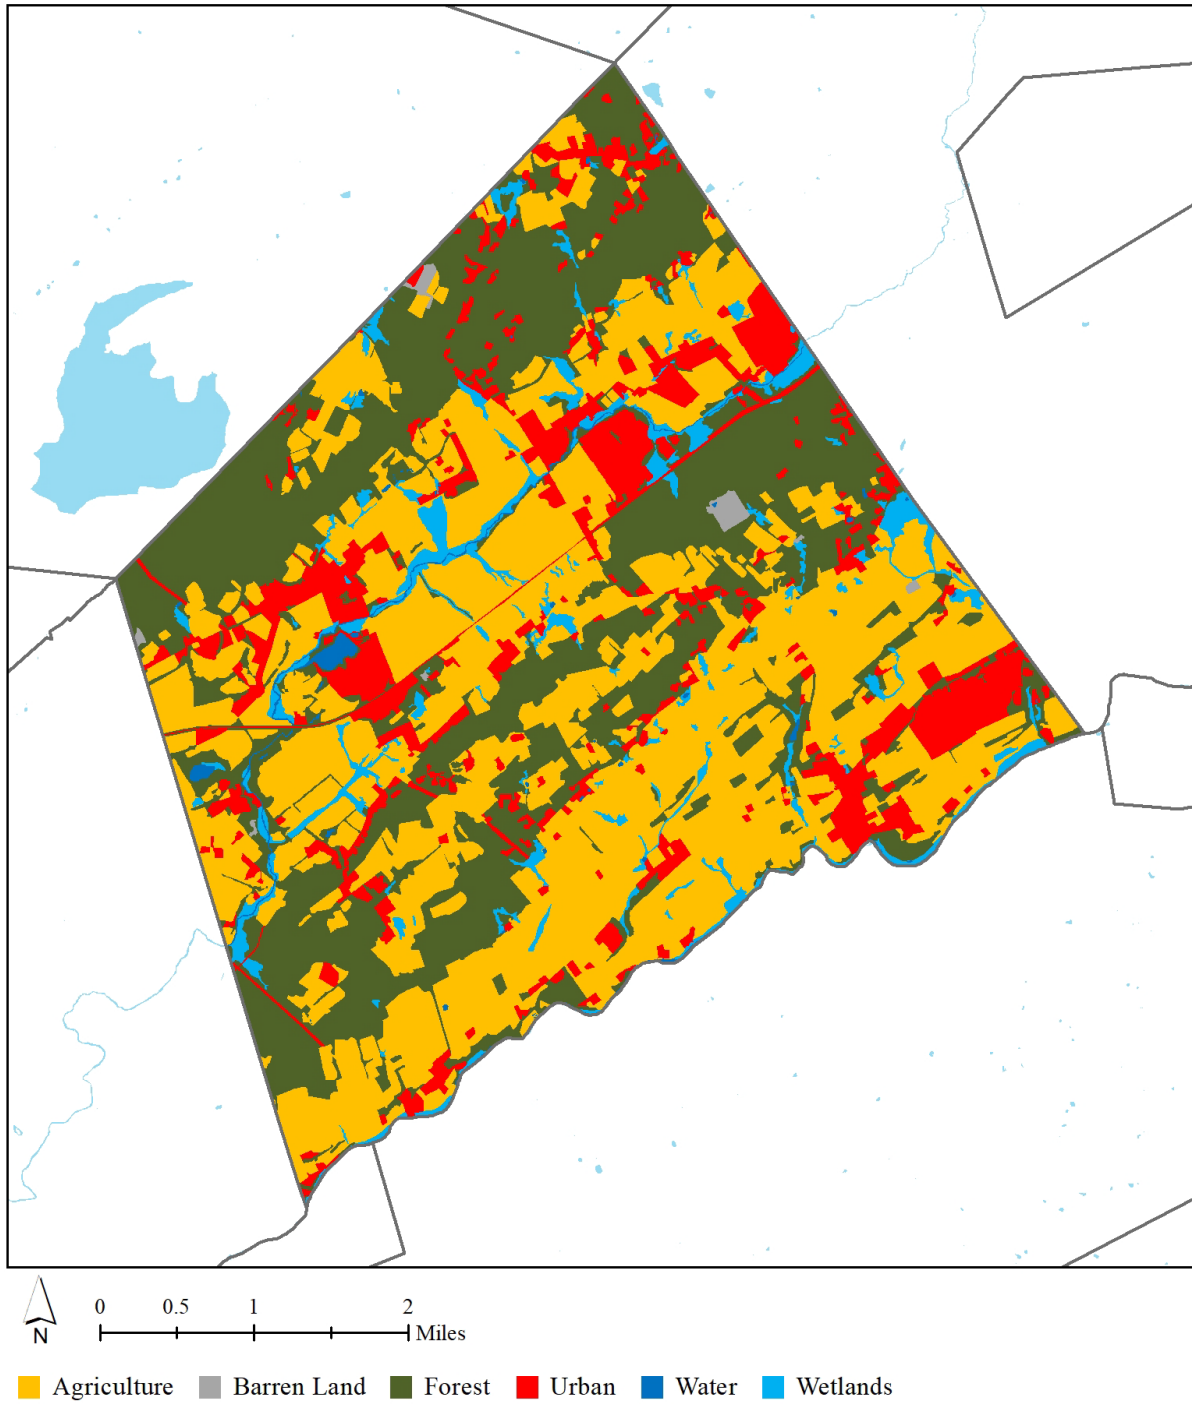
Figure 4: Map illustrating the land use in Franklin Township

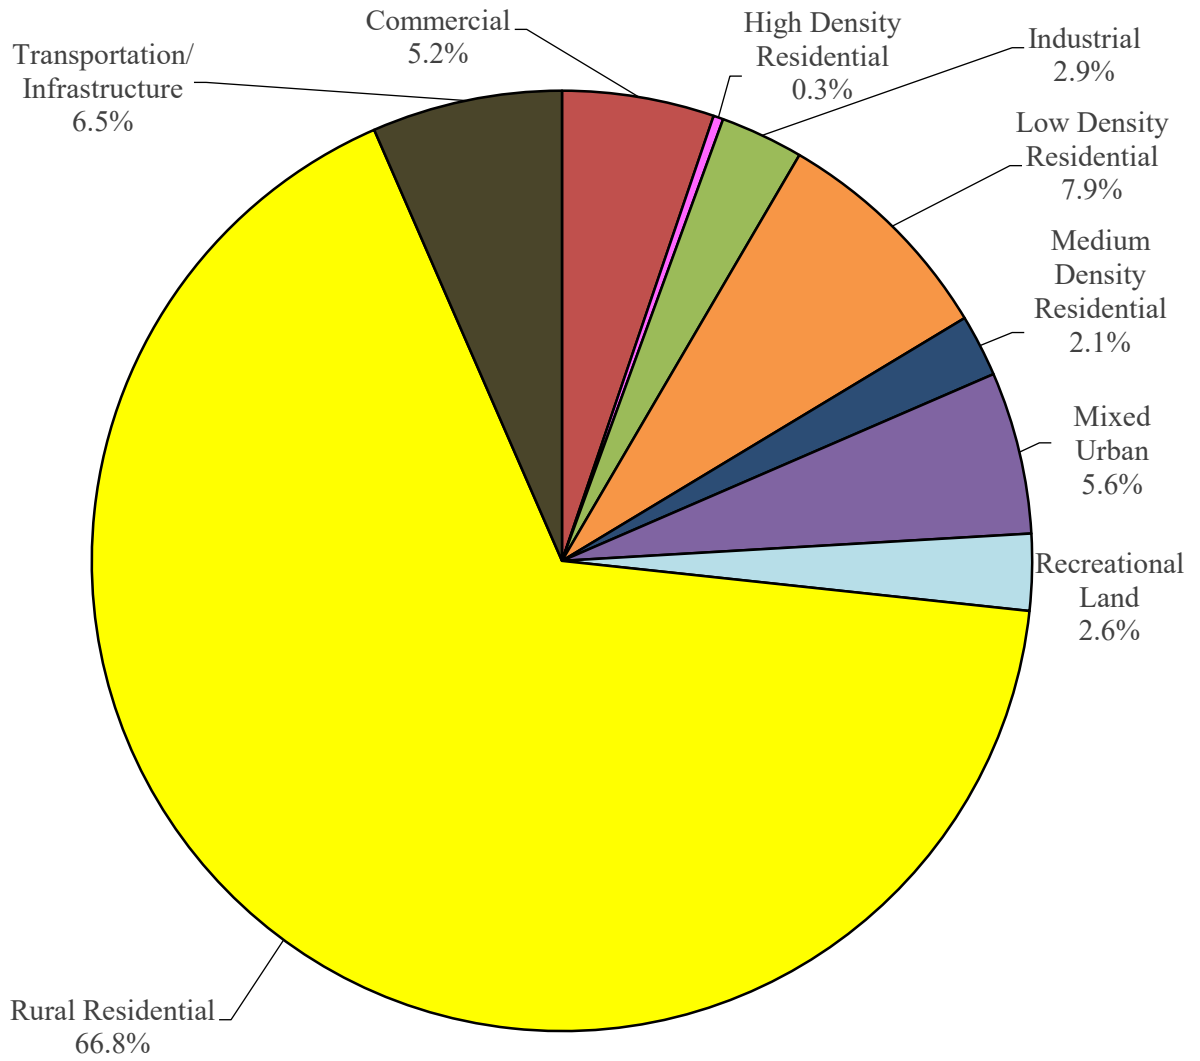
Figure 5: Pie chart illustrating the various types of urban land use in Franklin Township

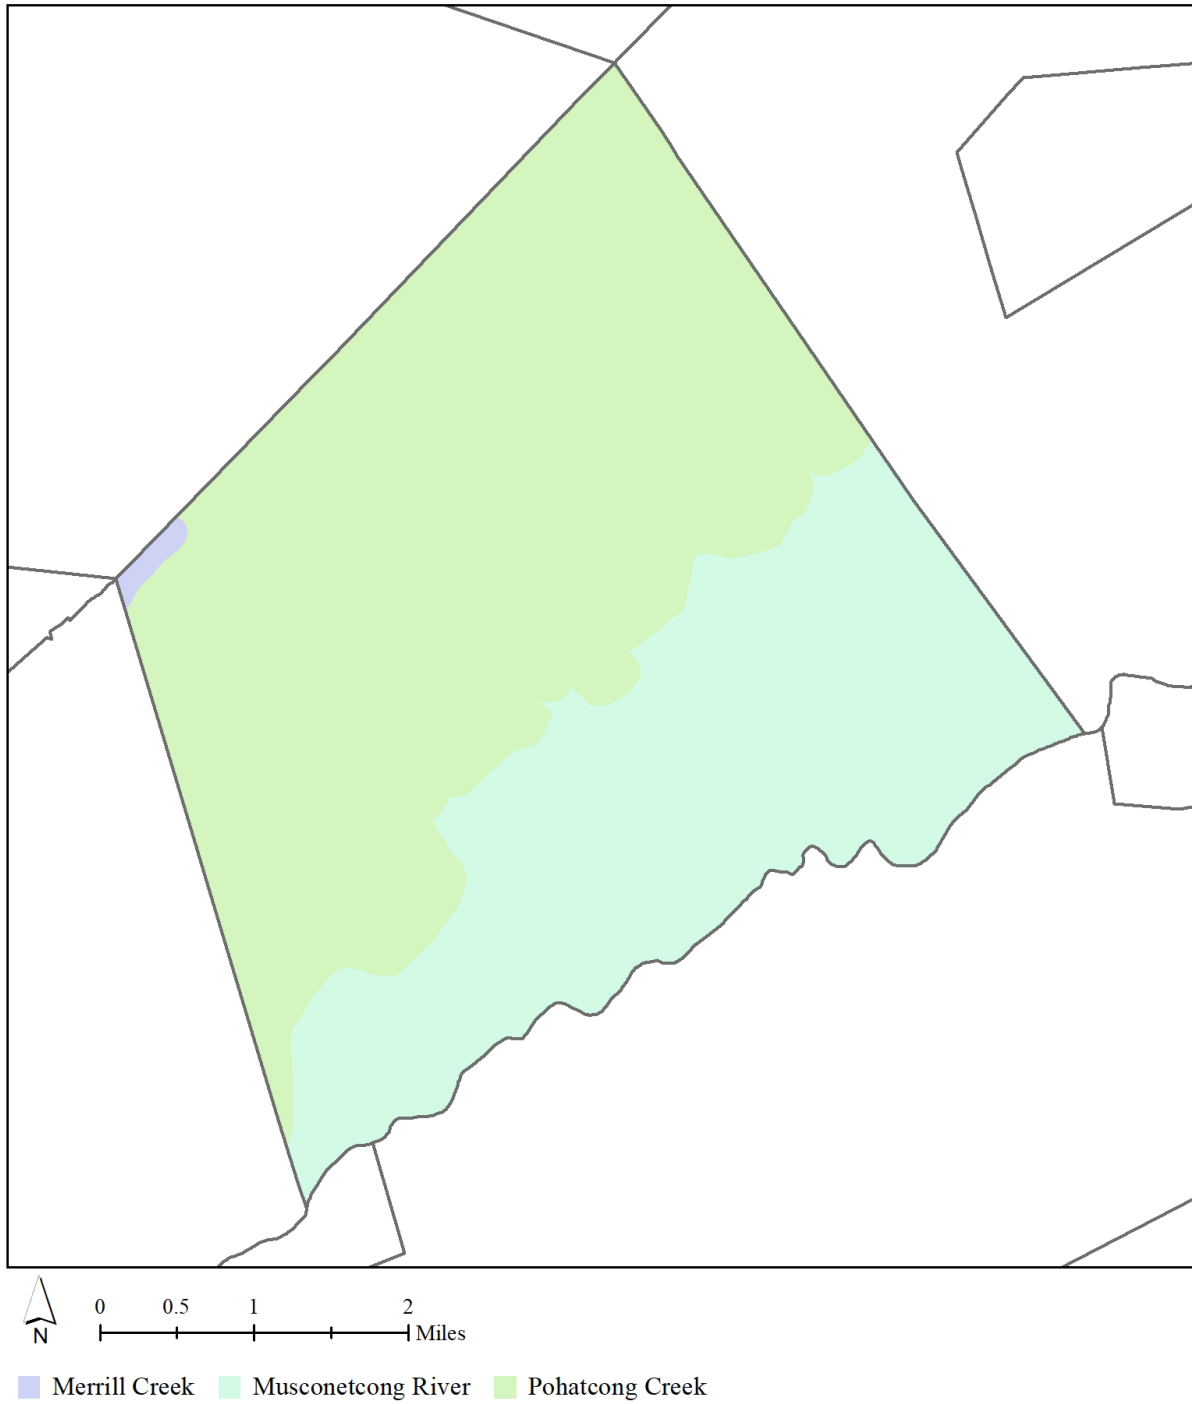
Figure 6: Map of the subwatersheds in Franklin Township

Water resources are typically managed on a watershed/subwatershed basis; therefore, an impervious cover analysis was performed for each subwatershed within Franklin Township (Table 1 and Figure 6). On a subwatershed basis, impervious cover ranges from 1.7% in the Merrill Creeek subwatershed to 5.1% in the Pohatcong Creek subwatershed. Evaluating impervious cover on a subwatershed basis allows the municipality to focus impervious cover reduction or disconnection efforts in the subwatersheds where frequent flooding occurs.

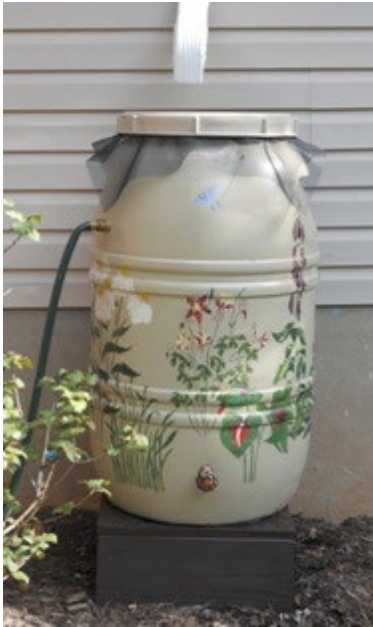
Figure 8a: Rain barrel used to disconnect a downspout with the overflow going to a flower bed

- Rainwater Harvesting: Rainwater harvesting includes the use of rain barrels and cisterns (Figures 8a and 8b). These can be placed below downspouts to collect rooftop runoff. The collected water has a variety of uses including watering plants and washing cars. This practice also helps cut down on the use of potable water for nondrinking purposes. It is important to divert the overflow from the rainwater harvesting system to a pervious area.

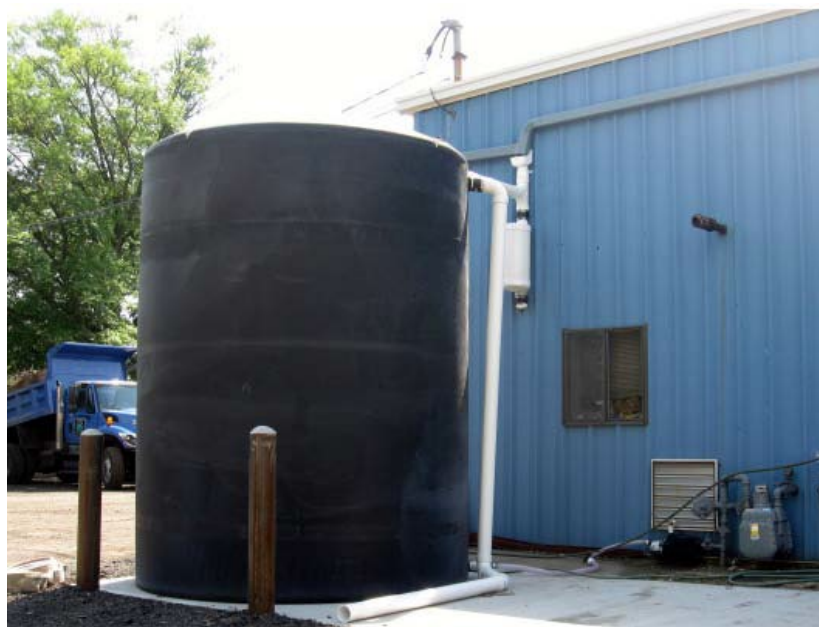
Figure 8b: A 5,000 gallon cistern used to disconnect the rooftop of the Department of Public Works in Clark Township to harvest rainwater for nonprofit car wash events

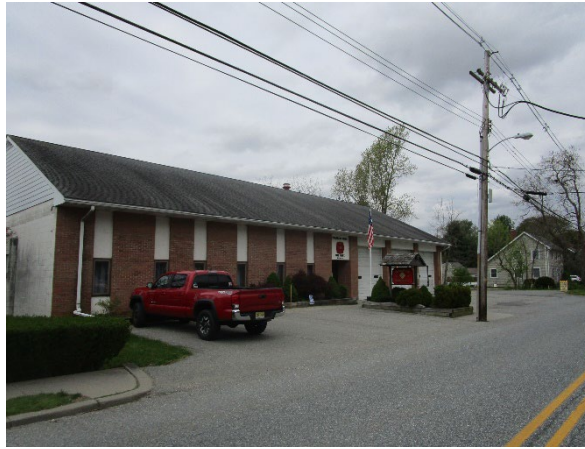
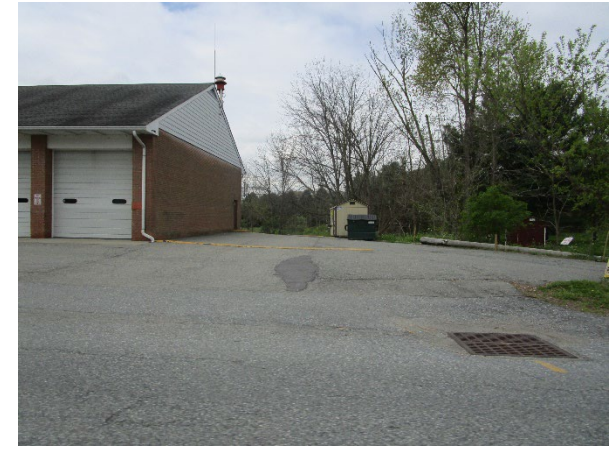
# FRANKLIN TOWNSHIP FIRE DEPARTMENT STATION 3

A bioretention system can be installed in the turfgrass area at the back of the building. Pervious pavement can be installed in the parking spaces to manage runoff from the rooftop by redirecting downspouts into it. A cistern can be installed to capture stormwater for reuse in washing vehicles or watering landscaping.

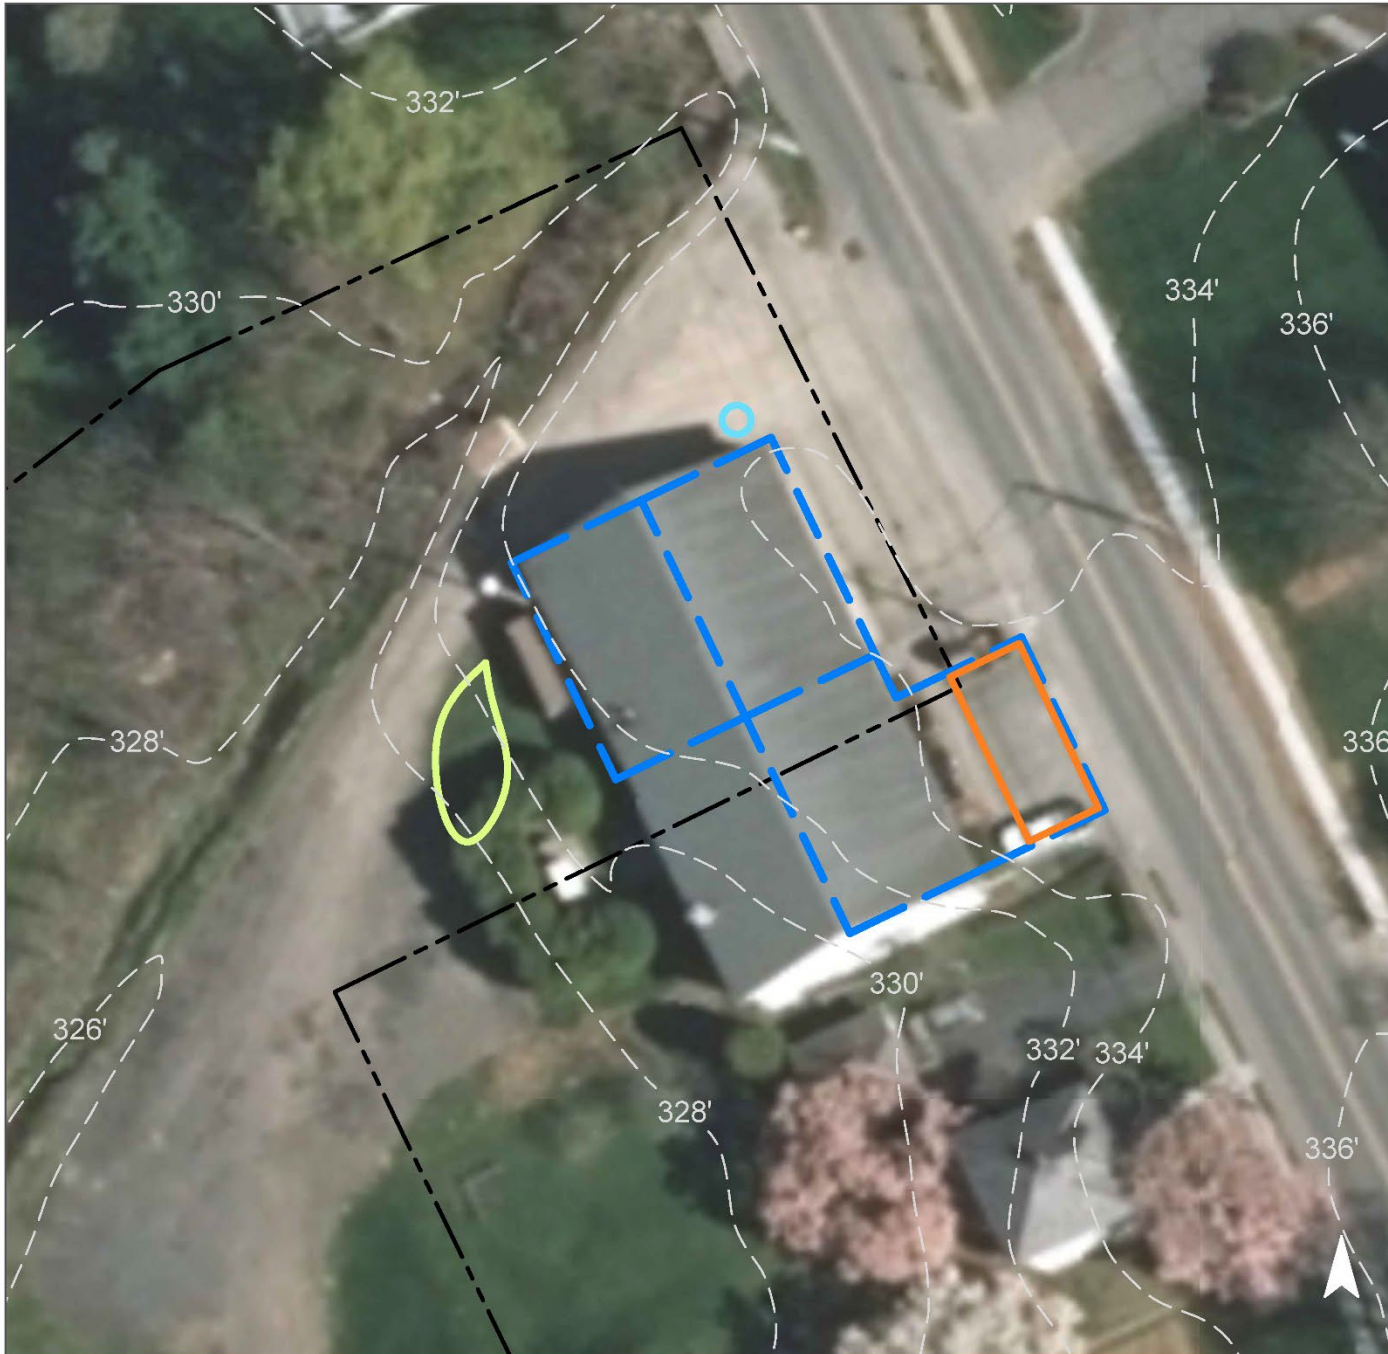
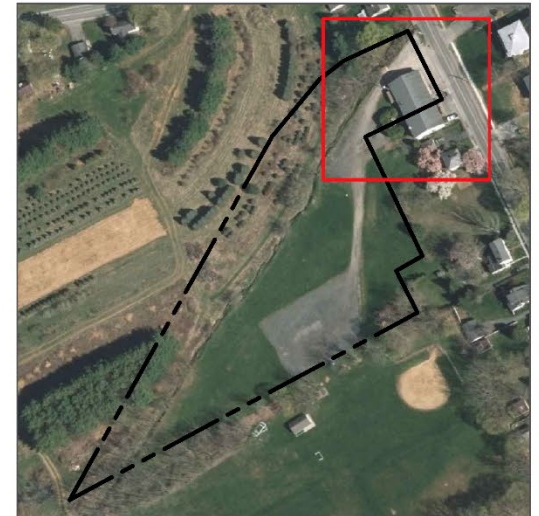
## Franklin Township Fire Department Station 3

bioretention system
-

pervious pavement
-

rainwater harvesting
-

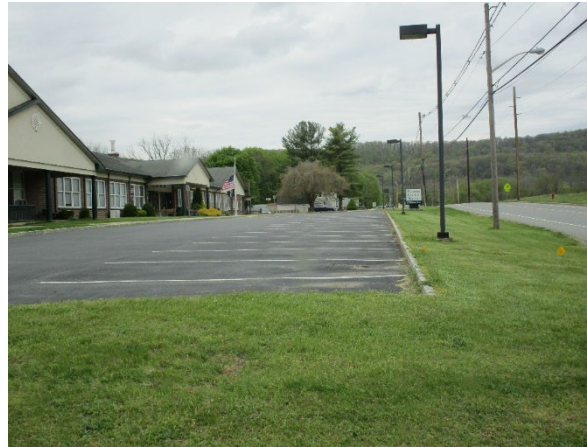
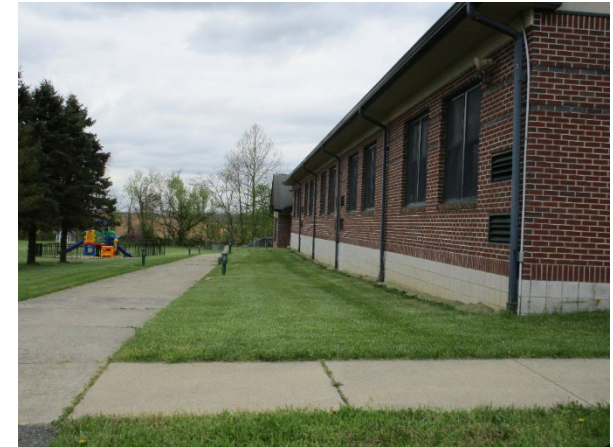
# FRANKLIN TOWNSHIP ELEMENTARY SCHOOL

Pervious pavement strips can be installed in the parking areas of the property to help infiltrate stormwater from the parking lot. Additionally, bioretention systems can be installed along the eastern and southern sides of the building to accumulate stormwater runoff from the rooftops.

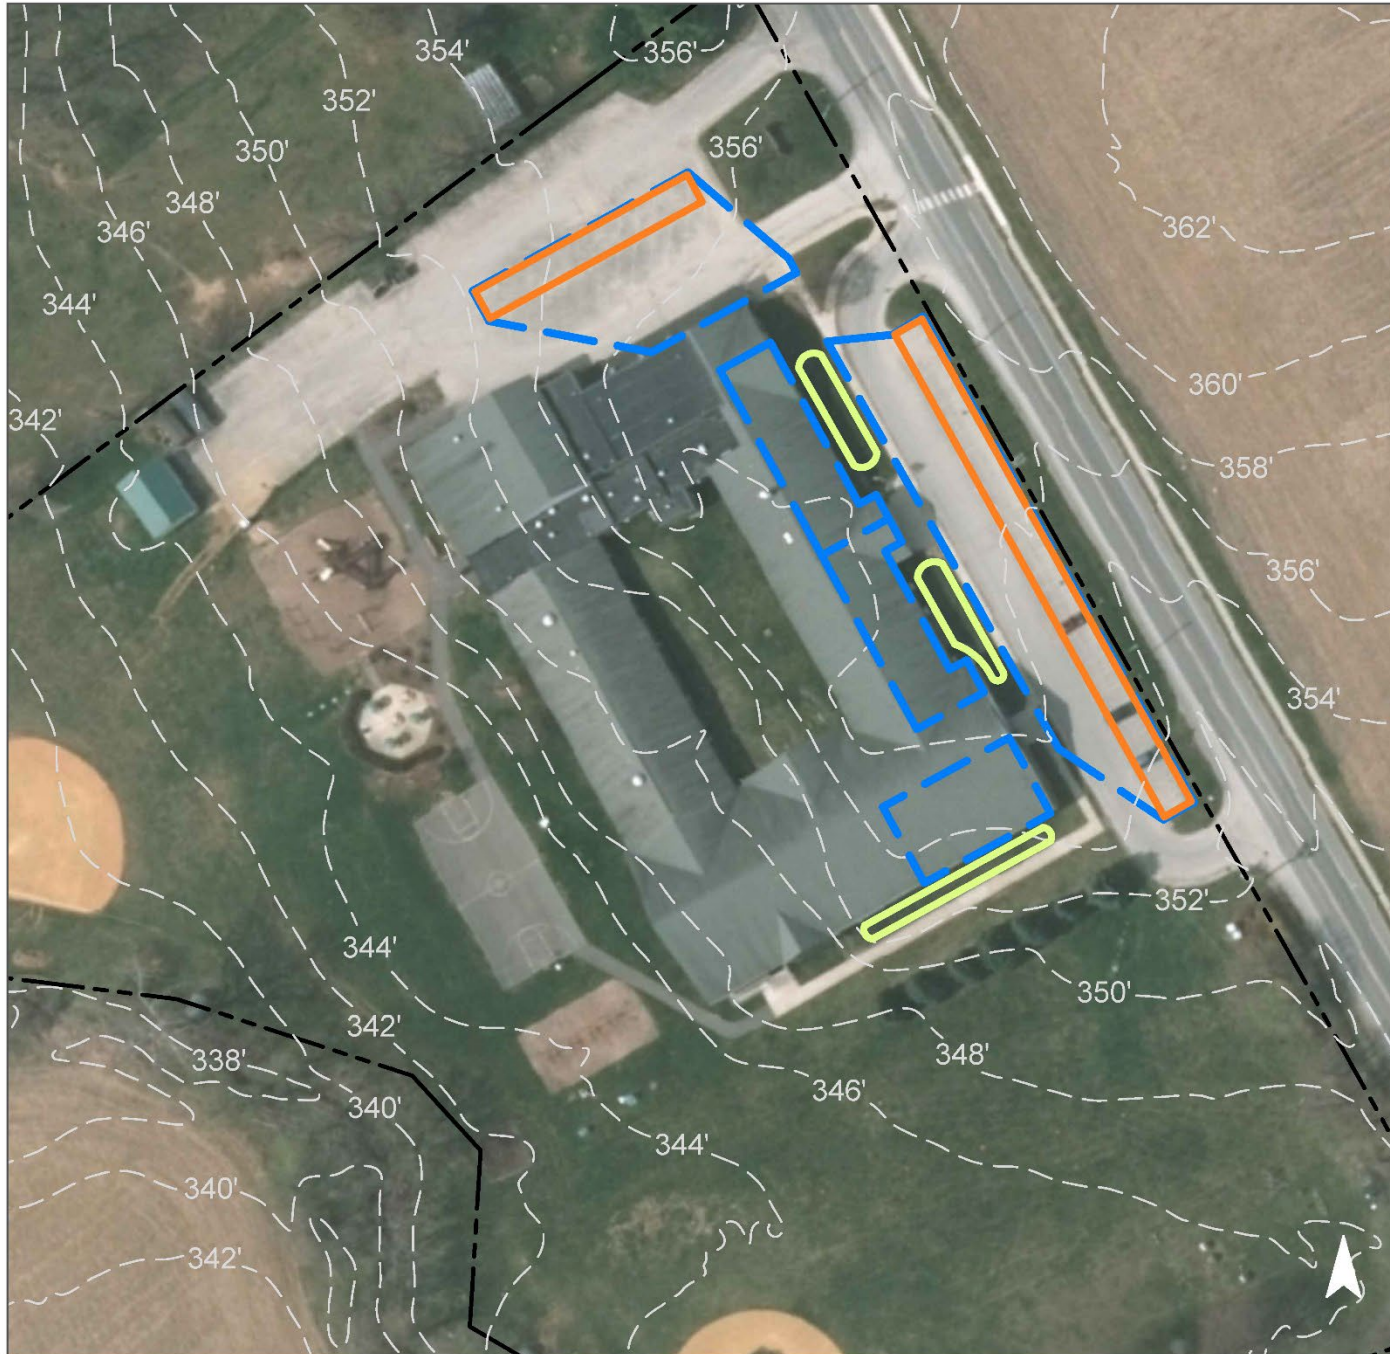
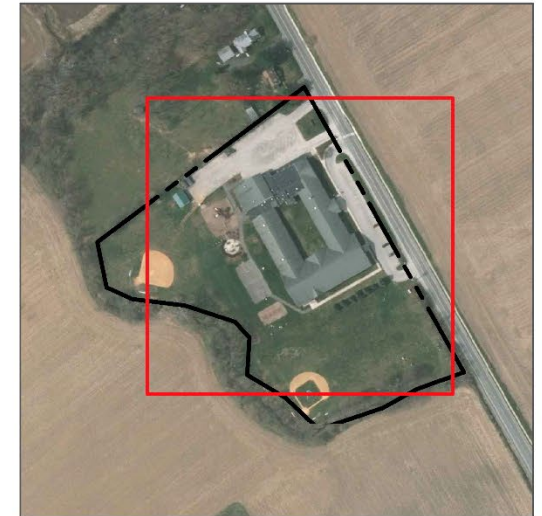
## Franklin Township Elementary School

bioretention system
-

pervious pavement
-

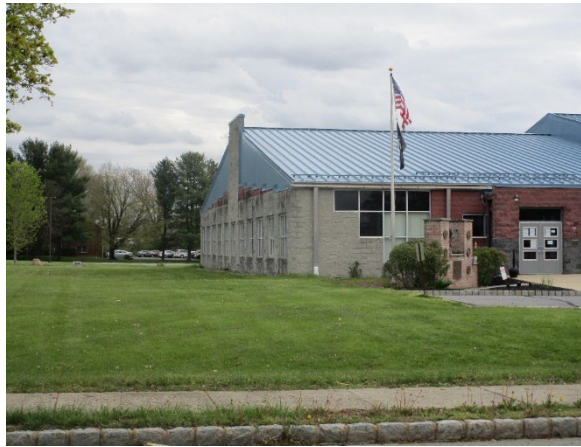
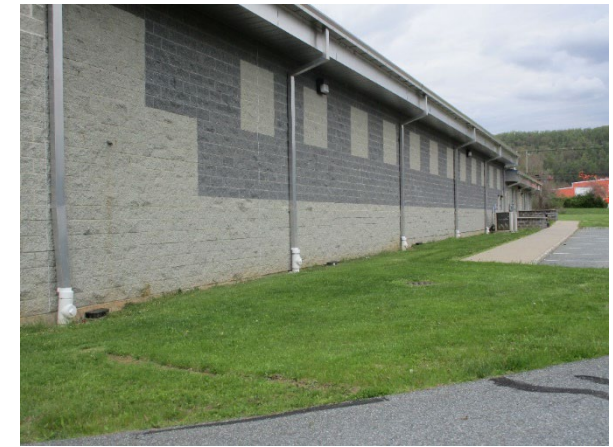
# FRANKLIN TOWNSHIP MUNICIPAL BUILDING

Bioretention systems can be installed near three corners of the building. Additionally, pervious pavement sections can be installed to capture stormwater from the parking lots. A bioswale can be added to further manage stormwater from the parking lots as well as act as an overflow for the western pervious pavement strip.

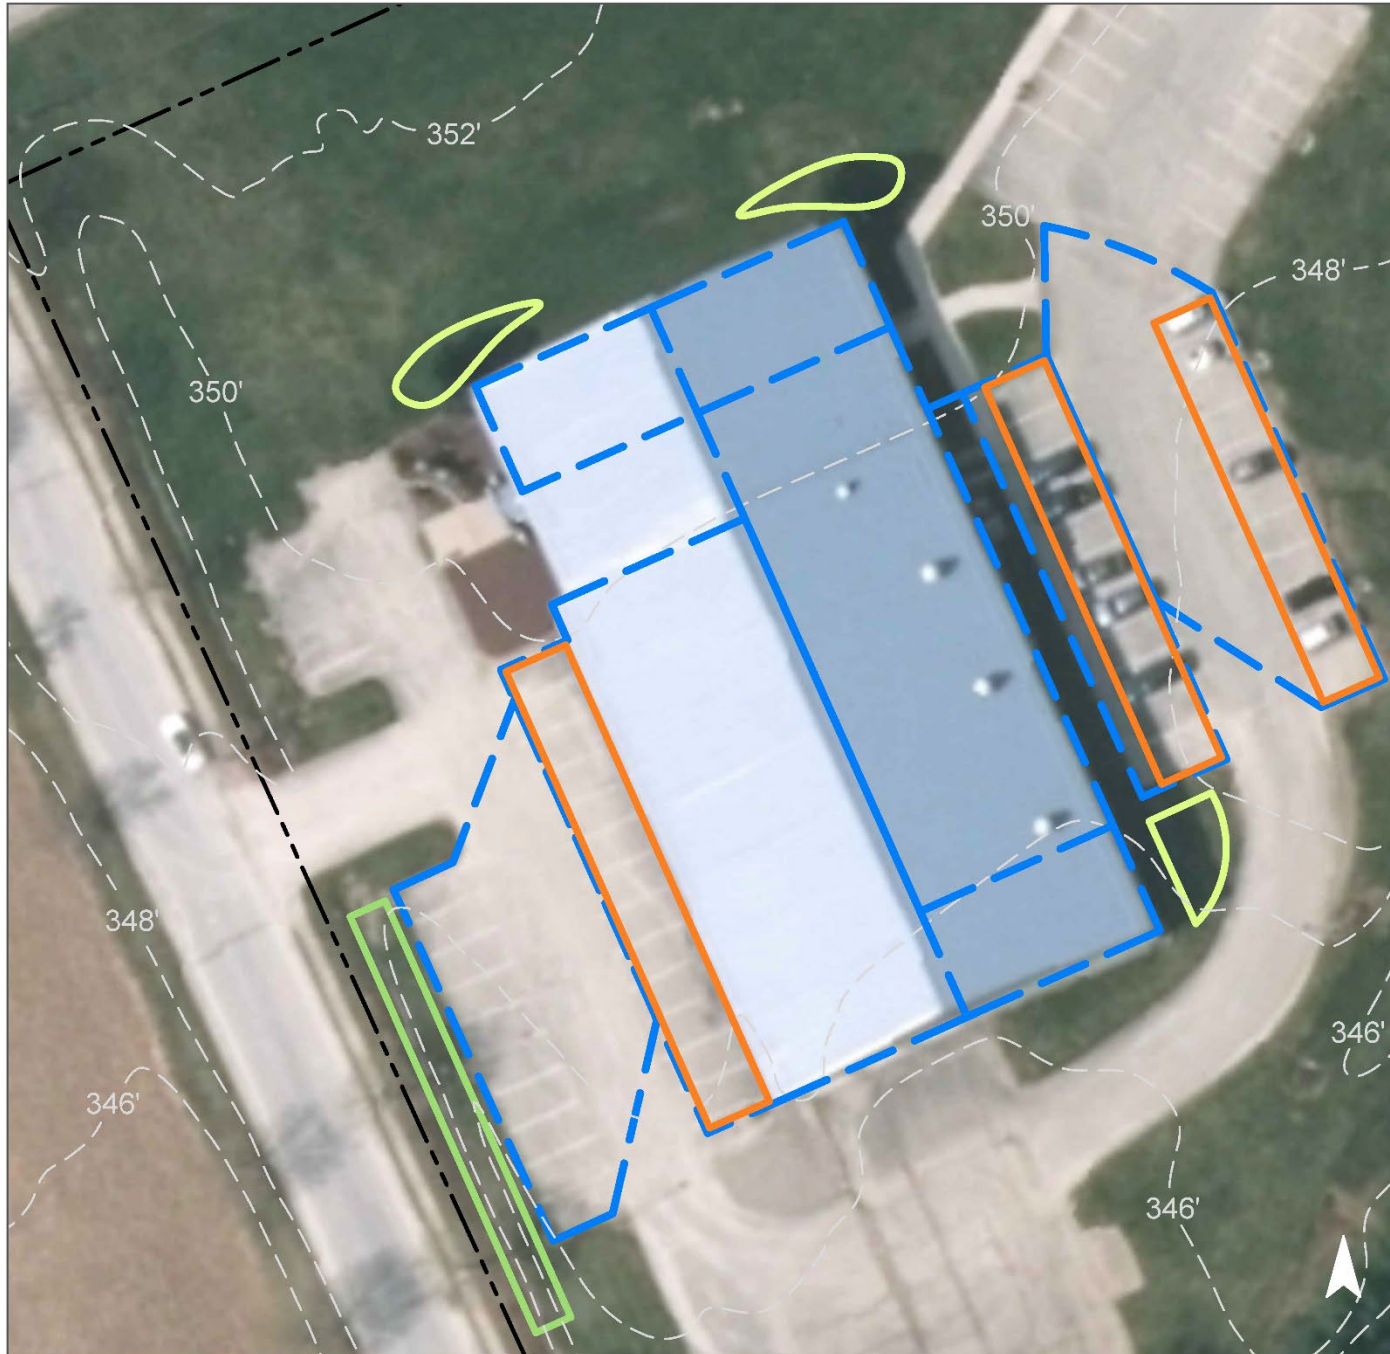
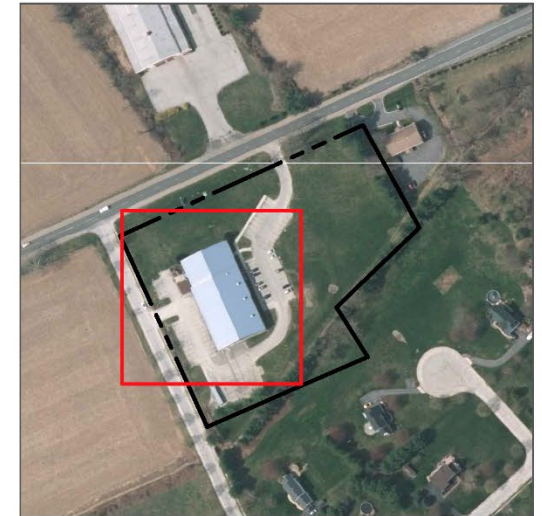
## Franklin Township Municipal Building

bioretention system
-

bioswale
-

pervious pavement
-
