**Impervious Cover Assessment  
for  
Liberty Township, Warren County, New Jersey**

*Prepared for Liberty Township by the  
Rutgers Cooperative Extension Water Resources Program*

August 6, 2021

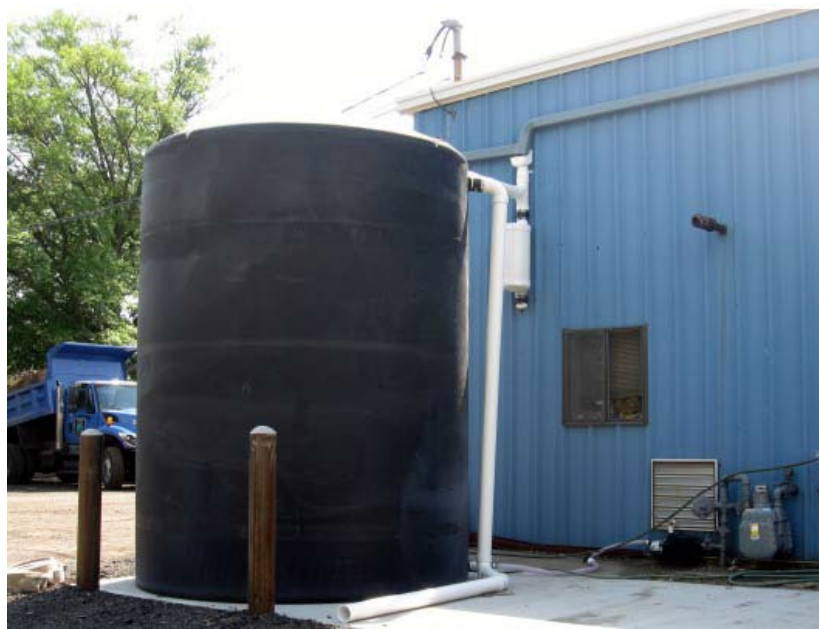
Figure 8b: A 5,000 gallon cistern used to disconnect the rooftop of the Department of Public Works in Clark Township to harvest rainwater for nonprofit car wash events

- Rainwater Harvesting: Rainwater harvesting includes the use of rain barrels and cisterns (Figures 8a and 8b). These can be placed below downspouts to collect rooftop runoff. The collected water has a variety of uses including watering plants and washing cars. This practice also helps cut down on the use of potable water for nondrinking purposes. It is important to divert the overflow from the rainwater harvesting system to a pervious area.

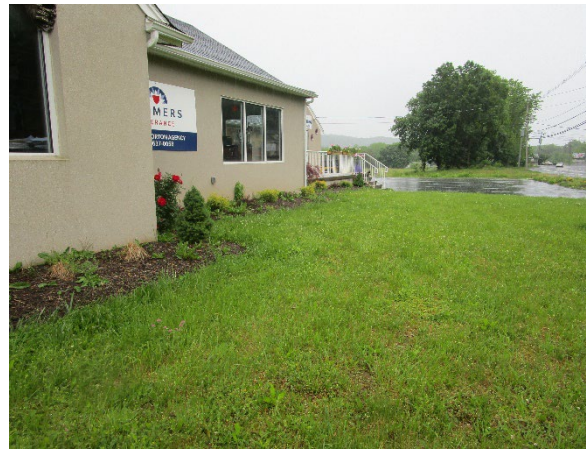
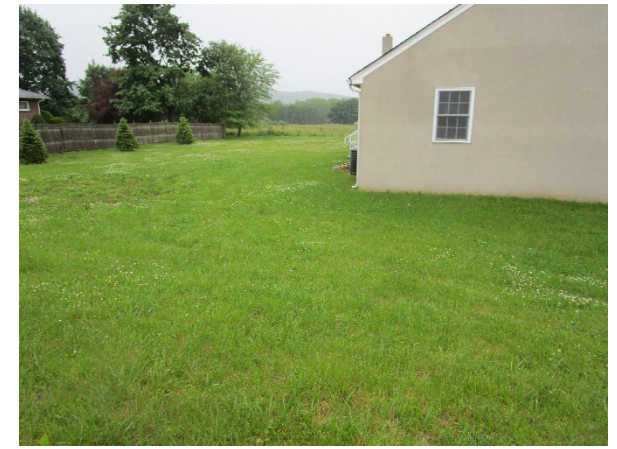
# FARMERS INSURANCE

Rain gardens can be installed in multiple locations around the building to collect stormwater runoff from the downspouts of the building. Additionally, a downspout planter box can be installed by the entrance of the building.

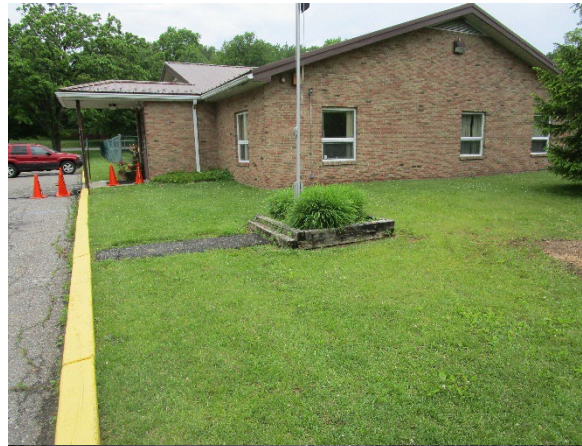
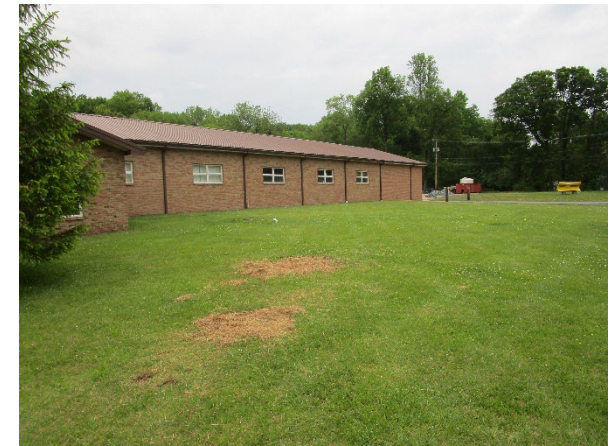
# LIBERTY TOWNSHIP MUNICIPAL COMPLEX

Multiple locations were identified as being suitable for rain garden implementation. Rain gardens can be installed along the south side of the building to accumulate stormwater runoff from the roof of the building. Additionally, a downspout planter box can be installed by the entrance of the building.

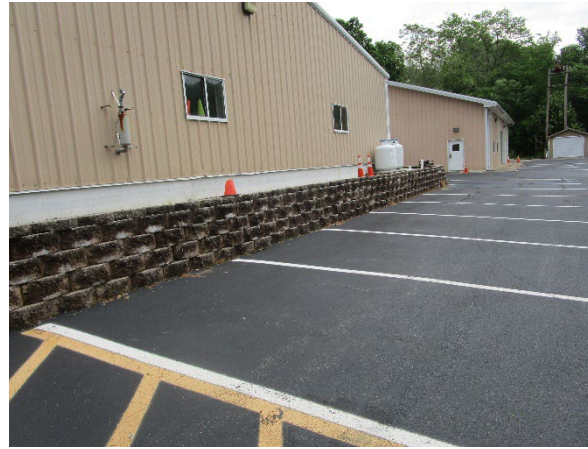
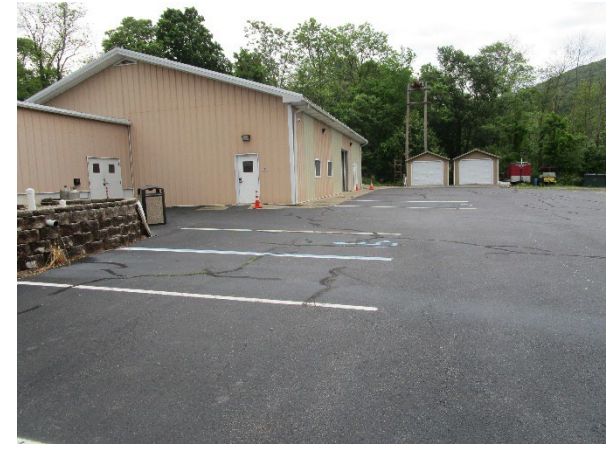
# MOUNTAIN LAKE FIRE COMPANY

A rain garden can be installed in the turfgrass area to the left of the main entrance. A rain garden and pervious pavement can be installed along the back parking lot to accumulate and infiltrate stormwater runoff from the large pavement area. Additionally, a cistern can be installed to repurpose stormwater runoff from the rooftop of the building.
