**Impervious Cover Assessment
for
Raritan Borough, Somerset County, New Jersey**

*Prepared for Raritan Borough by the
Rutgers Cooperative Extension Water Resources Program*

February 4, 2015

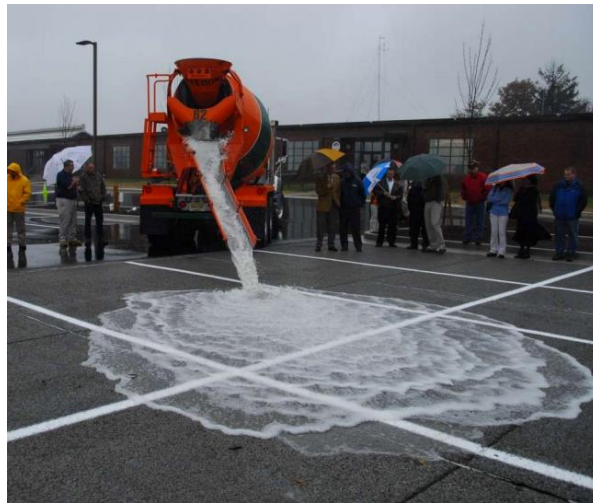
Figure 2: Rapid infiltration of water through porous pavement is demonstrated at the USEPA Edison New Jersey test site

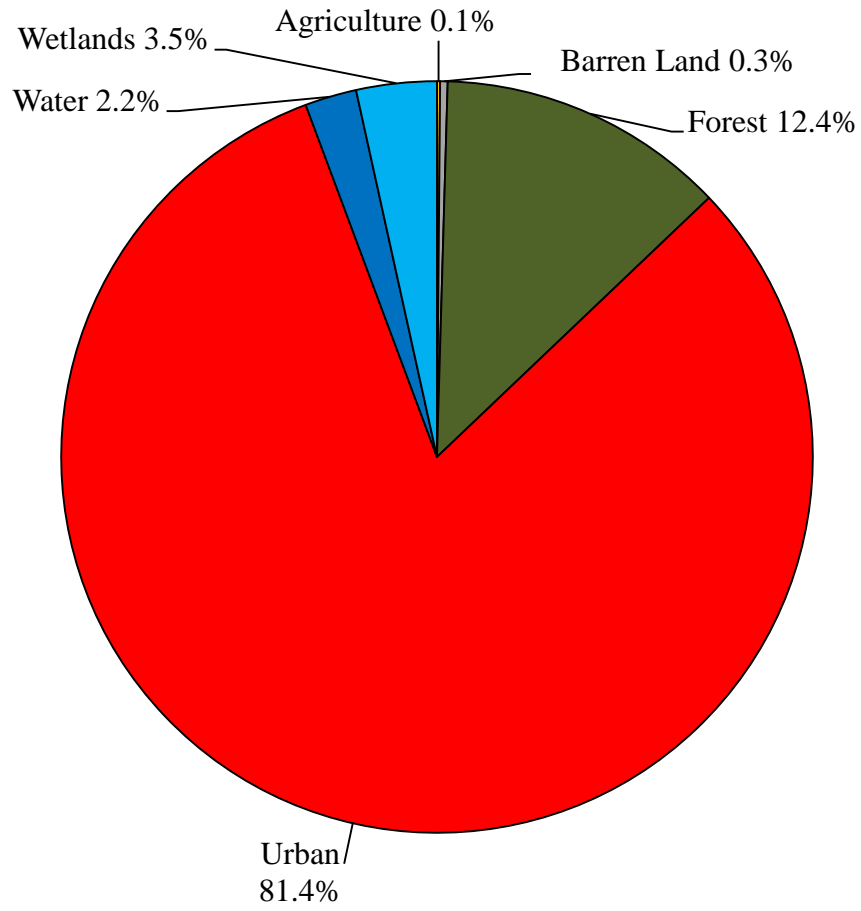
Figure 3: Pie chart illustrating the land use in Raritan Borough

Located in Somerset County in central New Jersey, Raritan Borough covers approximately 2.0 square miles west of Somerville Borough. Figures 3 and 4 illustrate that Raritan Borough is dominated by urban land uses. A total of 81.4% of the municipality's land use is classified as urban. Of the urban land in Raritan Borough, medium density residential is the dominant land use (Figure 5).

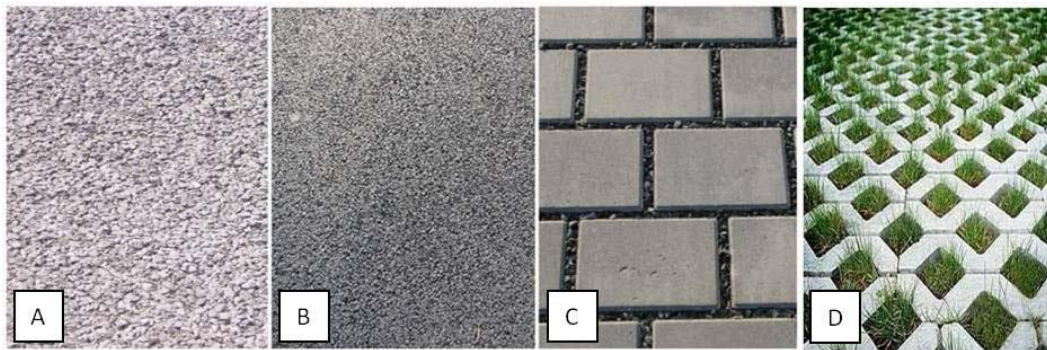
Permeable surfaces: (A) pervious concrete, (B) porous asphalt, (C) interlocking concrete pavers, (D) grid pavers (Rowe, 2012)

Pervious concrete and porous asphalt are the most common of the permeable surfaces. They are similar to regular concrete and asphalt but without the fine materials. This allows water to quickly pass through the material into an underlying layered system of stone that holds the water allowing it to infiltrate into the underlying uncompacted soil.

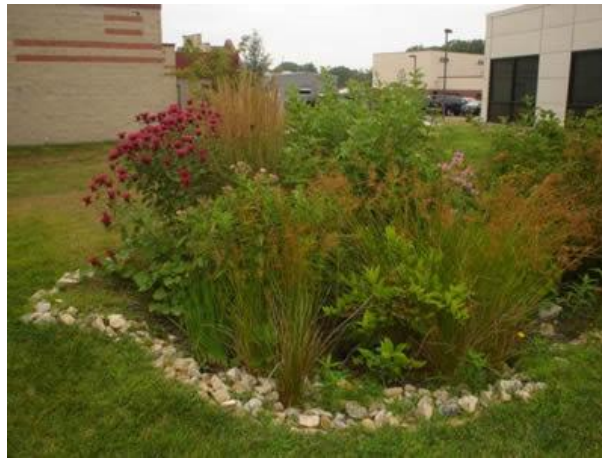
Figure 7: Rain garden outside the RCE of Gloucester County office which was designed to disconnect rooftop runoff from the local storm sewer system

- Rain Gardens: Stormwater can be diverted into shallow landscaped depressed areas (i.e., rain gardens) where the vegetation filters the water, and it is allowed to soak into the ground. Rain gardens, also known as bioretention systems, come in all shapes and sizes and can be designed to disconnect a variety of impervious surfaces (Figure 7).

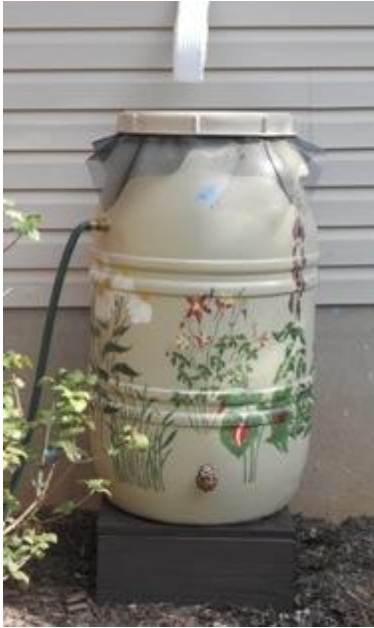
Figure 8a: Rain barrel used to disconnect a downspout with the overflow going to a flower bed

- Rainwater Harvesting: Rainwater harvesting includes the use of rain barrels and cisterns (Figures 8a and 8b). These can be placed below downspouts to collect rooftop runoff. The collected water has a variety of uses including watering plants and washing cars. This practice also helps cut down on the use of potable water for nondrinking purposes. It is important to divert the overflow from the rainwater harvesting system to a pervious area.

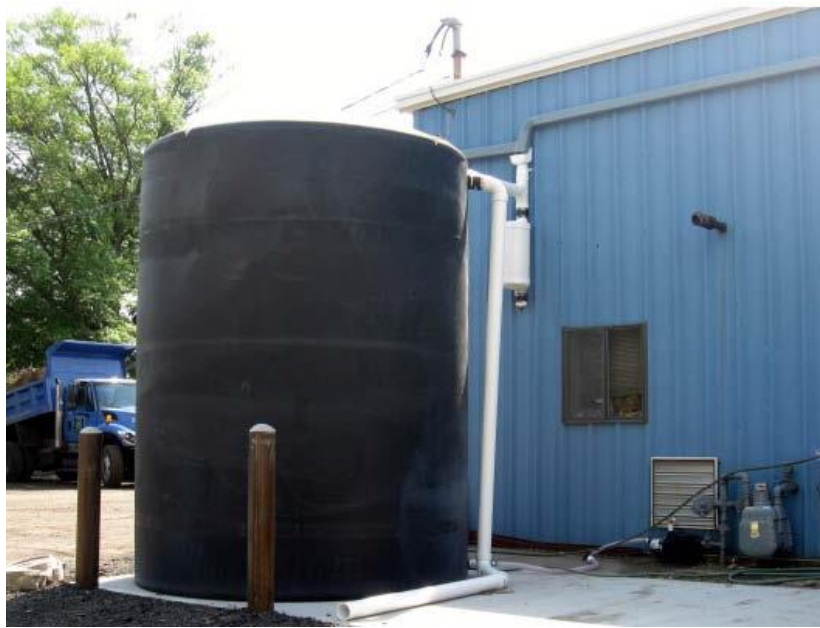
Figure 8b: A 5,000 gallon cistern used to disconnect the rooftop of the Department of Public Works in Clark Township to harvest rainwater for nonprofit car wash events

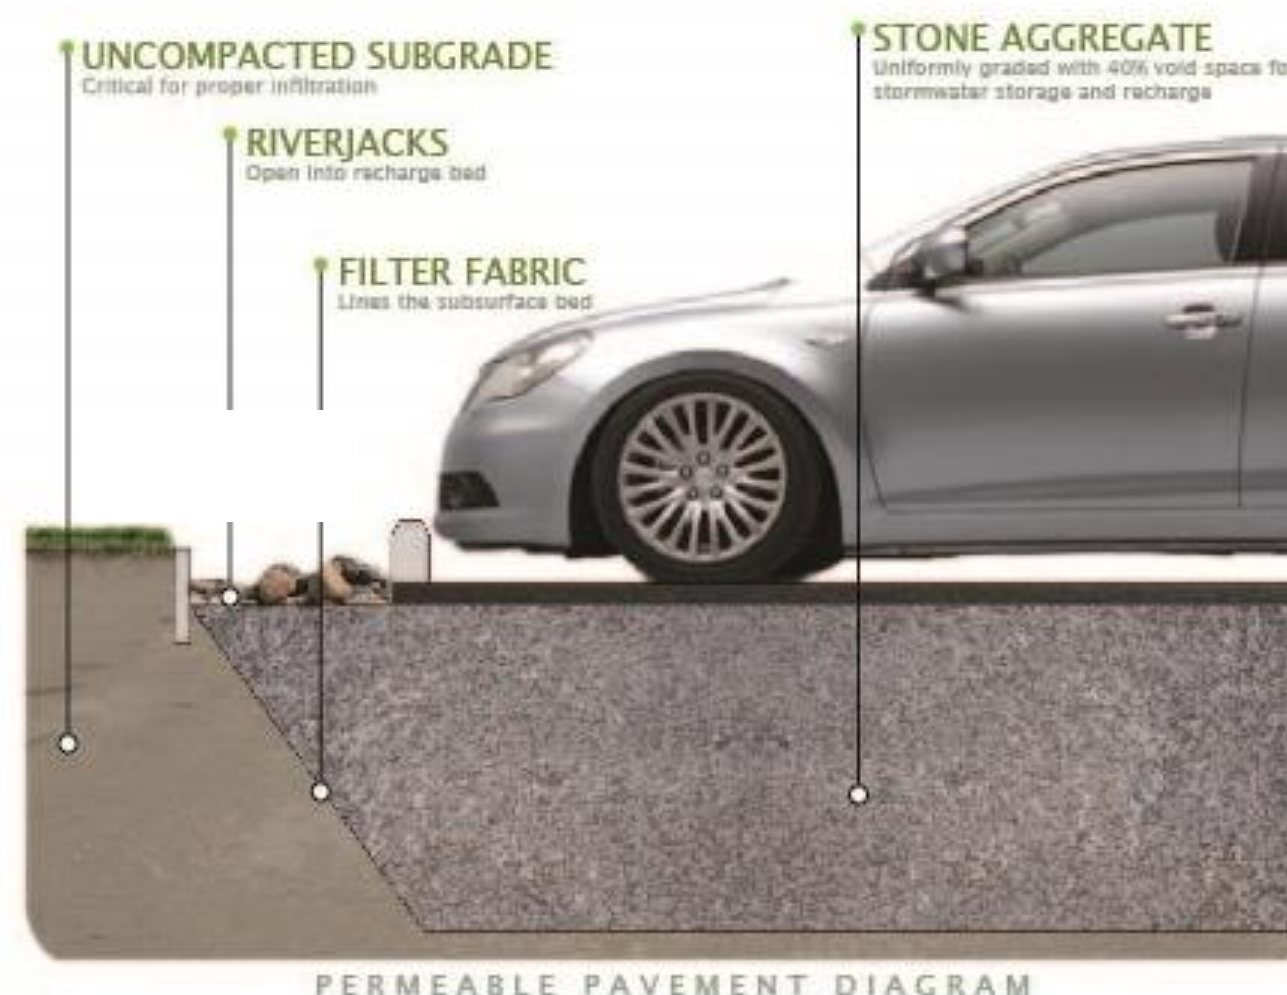
PERMEABLE PAVEMENT DIAGRAM

2 POROUS PAVEMENT
