**Impervious Cover Assessment
for
South Bound Brook Borough, Somerset County, New Jersey**

*Prepared for South Bound Brook Borough by the
Rutgers Cooperative Extension Water Resources Program*

February 4, 2015

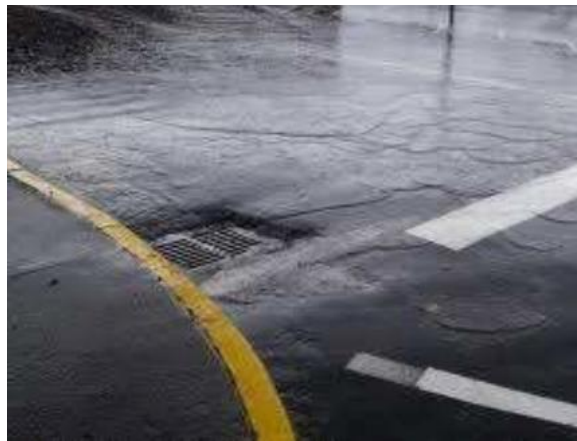
Figure 1: Stormwater draining from a parking lot

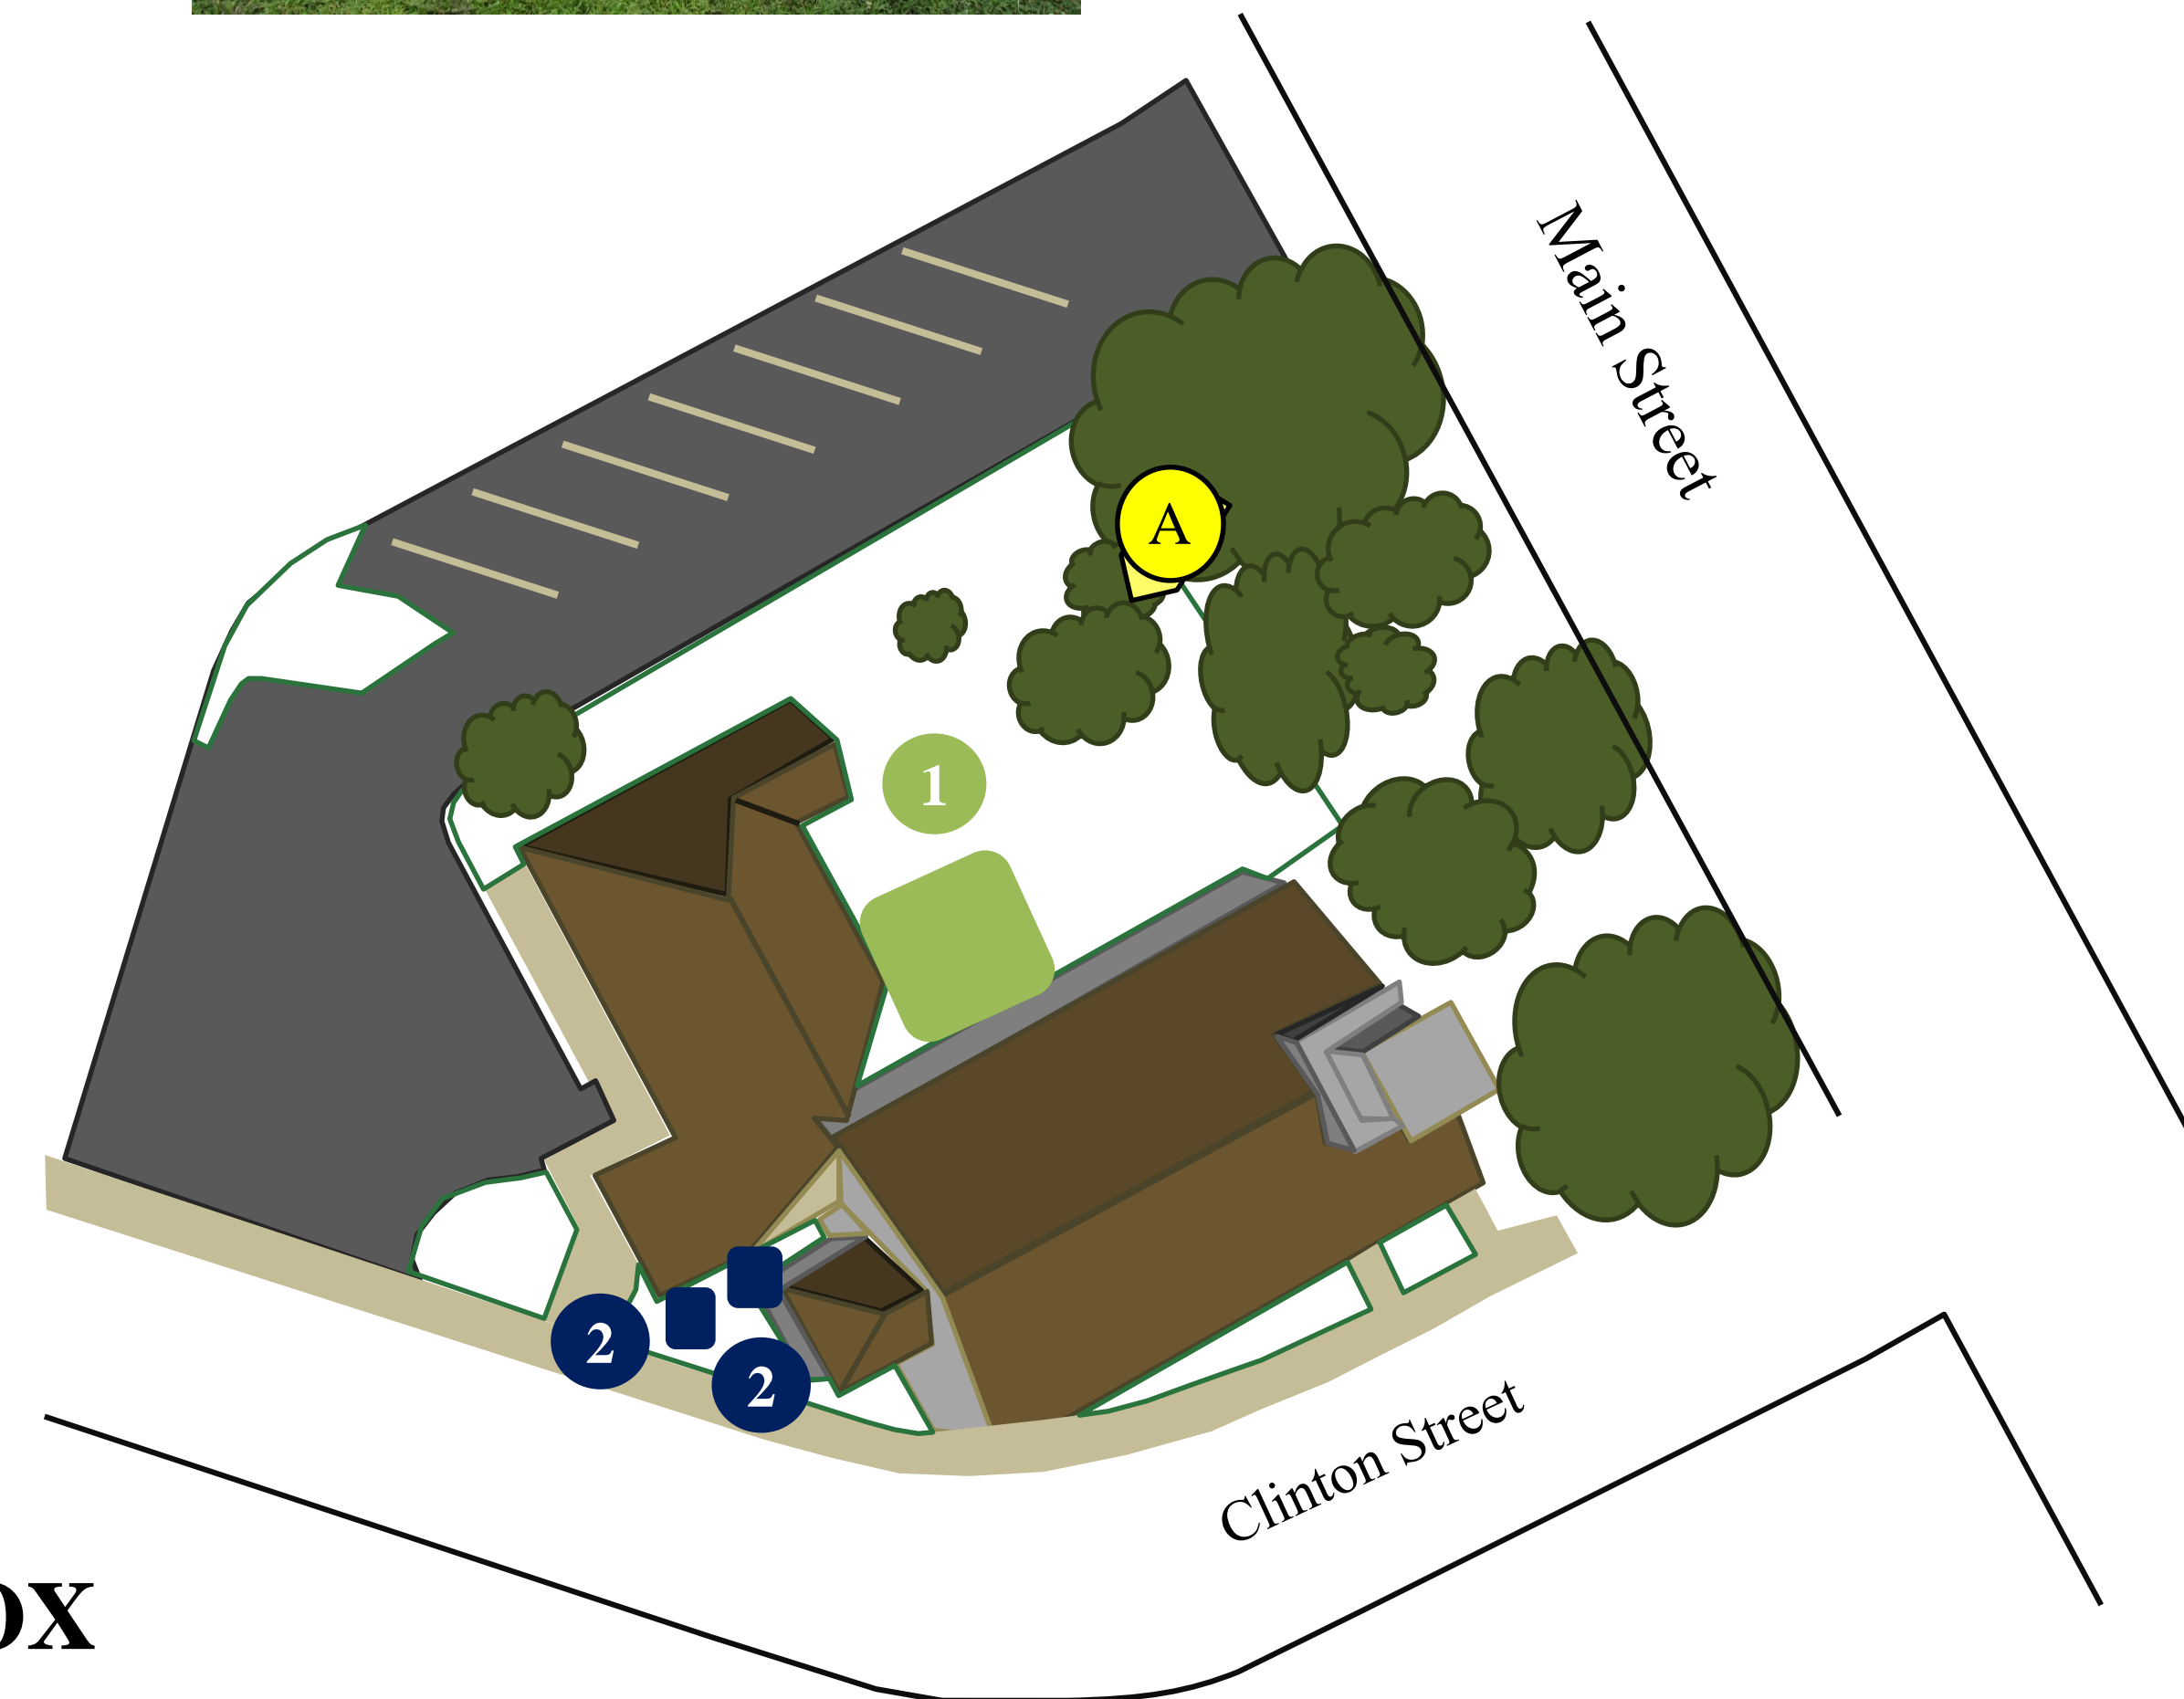
SITE PLAN:

1 BIORETENTION SYSTEM: A bioretention system could be installed in the back of the building along the side of the church. Disconnecting the downspouts will allow stormwater runoff to flow into the bioretention system. Stormwater runoff will be captured, filtered, and prevented from entering directly into the storm sewer system.

2 DOWNSPOUT PLANTER BOX: Downspout planter boxes could be installed to the right of the entrance on Clinton Street to intercept, treat, and filter a portion of the water coming from the roof.

<p>Proposed Solution(s): The downspouts on the right side of the entrance on Clinton Street can be disconnected and redirected into downspout planter boxes. In the back of the building near where the two sides intersect, a bioretention system can be installed to collect runoff from four already disconnected downspouts.</p>	
<p>Anticipated Benefits: Since the bioretention systems would be designed to capture, treat, and infiltrate the entire 2-year design storm (3.3 inches of rain over 24 hours), these systems are estimated to achieve a 95% pollutant load reduction for TN, TP, and TSS. The downspout planters would minimize and filter stormwater runoff. A bioretention system and downspout planter boxes would also provide ancillary benefits such as enhanced wildlife habitat and aesthetic appeal.</p>	
<p>Possible Funding Sources: mitigation funds from local developers NJDEP grant programs</p>	
<p>Partners/Stakeholders: South Bound Brook residents local community groups (Boy Scouts, Girl Scouts, etc.) Rutgers Cooperative Extension</p>

The rain garden would need to be approximately 450 square feet. At \$5 per square foot, the estimated cost of the rain garden is \$2,250. The two downspout planters would cost approximately \$600. The total cost of the project would be \$2,850.
