**Impervious Cover Reduction Action Plan
for
Readington Township, Hunterdon County, New Jersey**

*Prepared for Readington Township by the
Rutgers Cooperative Extension Water Resources Program*

November 16, 2015

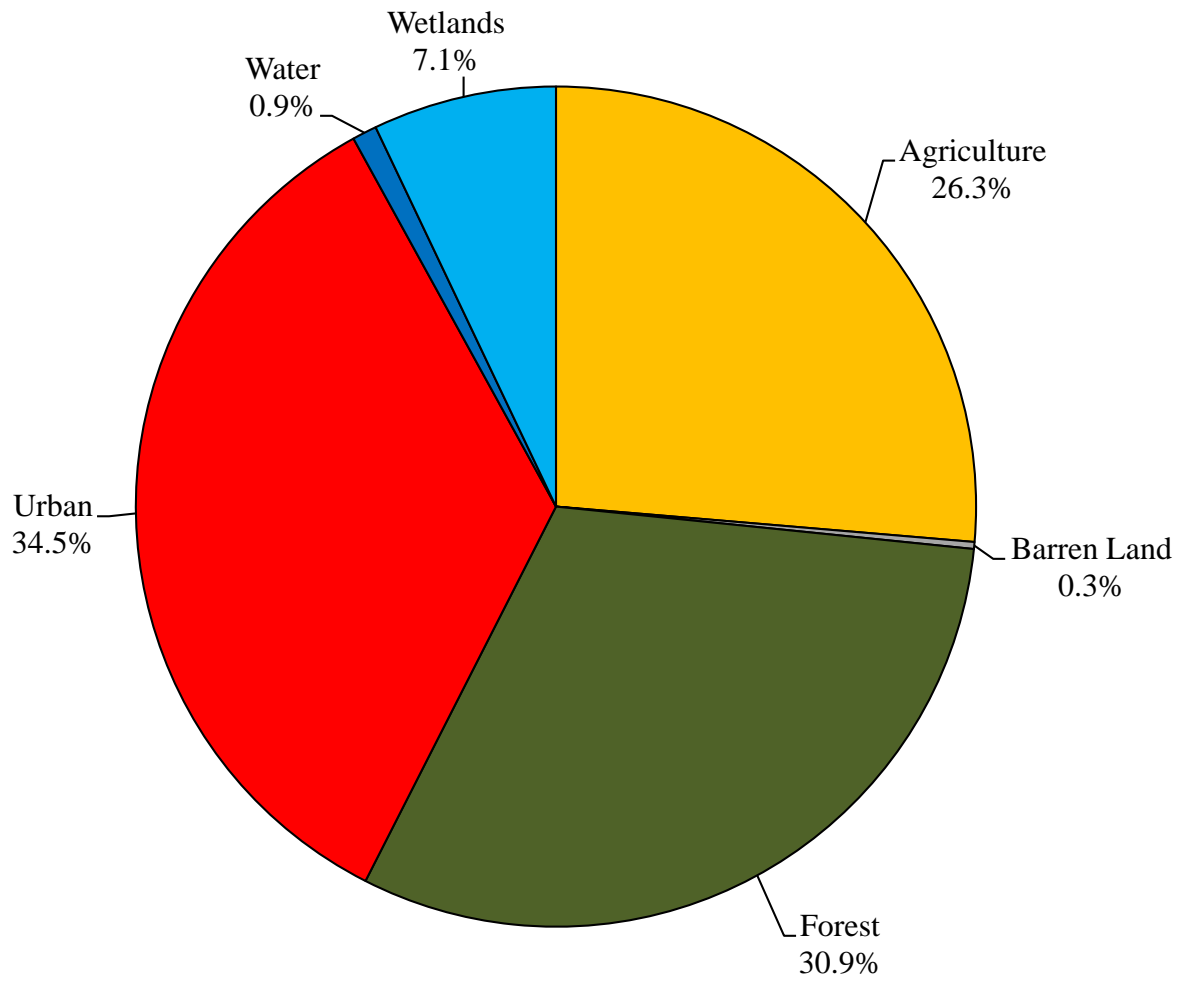
Figure 2: Pie chart illustrating the land use in Readington Township

Located in Hunterdon County in central New Jersey, Readington Township covers approximately 47.8 square miles. Figures 1 and 2 illustrate that Readington Township is dominated by urban land uses. Approximately 34.5% of the municipality's land use is classified as urban. Of the urban land in Readington Township, rural residential development is the dominant land use (Figure 3).

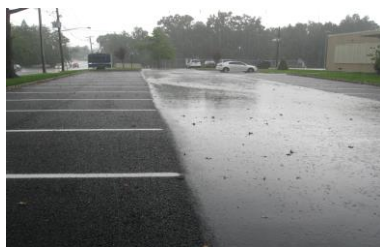
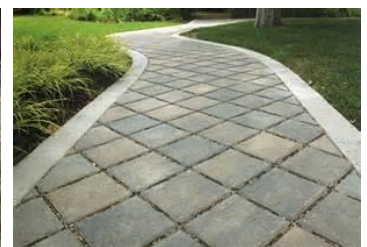
Pervious pavements

There are several types of permeable pavement systems including porous asphalt, pervious concrete, permeable pavers, and grass pavers. These surfaces are hard and support vehicle traffic but also allow water to infiltrate through the surface. They have an underlying stone layer to store stormwater runoff and allow it to slowly seep into the ground.

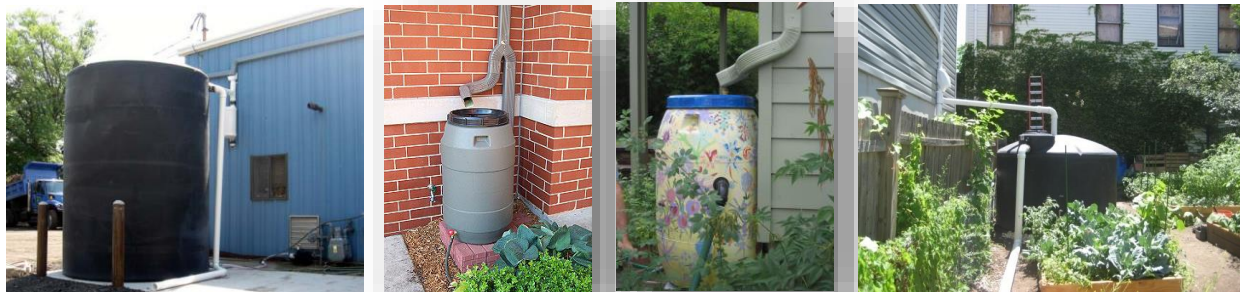
Rainwater harvesting systems (cistern or rain barrel)

These systems capture rainwater, mainly from rooftops, in cisterns or rain barrels. The water can then be used for watering gardens, washing vehicles, or for other non-potable uses.

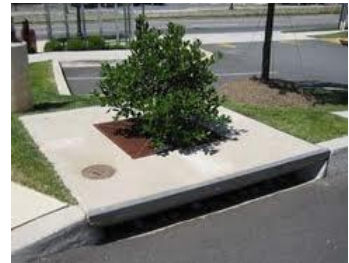
Tree filter boxes

These are pre-manufactured concrete boxes that contain a special soil mix and are planted with a tree or shrub. They filter stormwater runoff but provide little storage capacity. They are typically designed to quickly filter stormwater and then discharge it to the local sewer system.

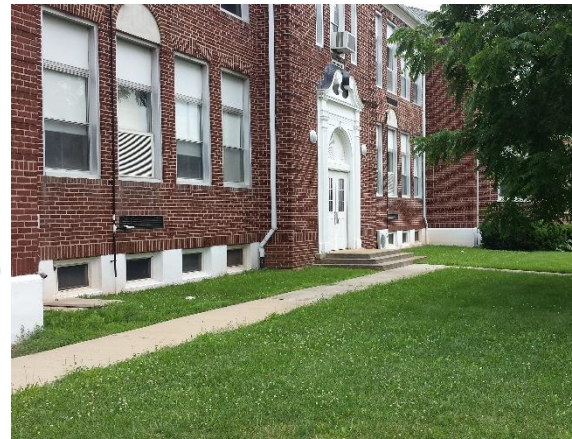
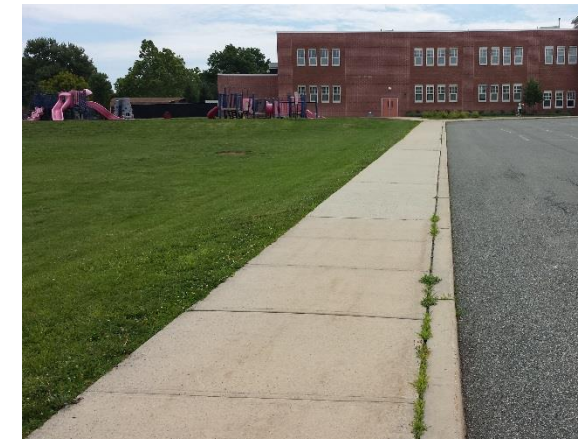
WHITEHOUSE SCHOOL

On the east side of the school a bioretention system can be installed to capture, treat, and infiltrate roof runoff by disconnecting and redirecting the nearby downspouts. A second rain garden can be built on the south side to treat roof runoff as well. Runoff from the play area can be captured by making curb cuts and constructing a rain garden in the turf grass area adjacent to it. Parking spaces can be replaced with pervious pavement to infiltrate additional stormwater. A preliminary soil assessment suggests that the soils have suitable drainage characteristics for green infrastructure.

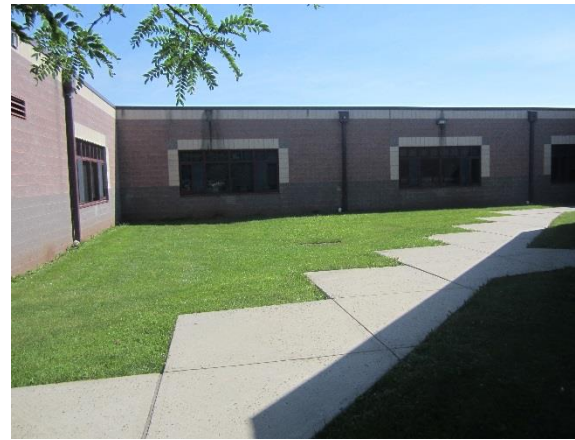
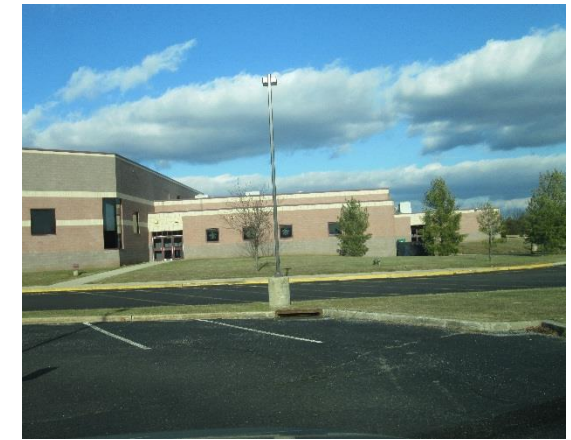
The school's stormwater appears to drain primarily through connected downspouts with some disconnected downspouts flowing into turf grass. There are multiple locations where rain gardens can be installed to capture, treat, and infiltrate roof runoff by disconnecting and redirecting downspouts. Runoff from the parking lot can be infiltrated by using pervious pavement. A preliminary soil assessment suggests that more soil testing would be required before determining the soil's suitability for green infrastructure.

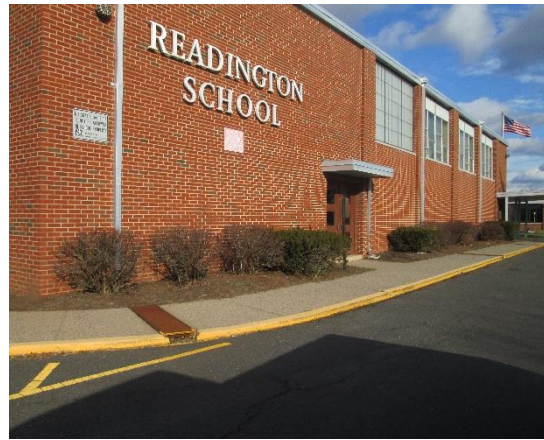
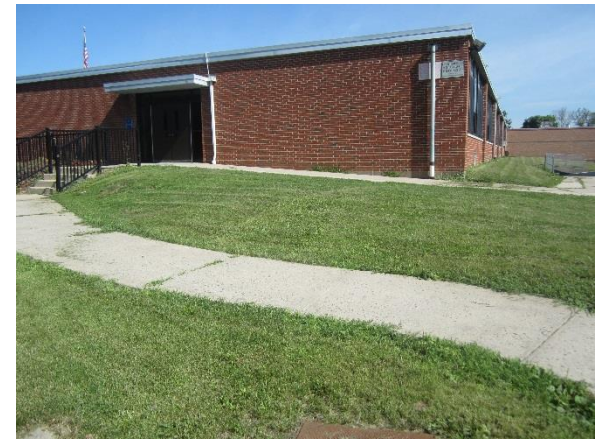
There are several locations where rain gardens can be installed to capture, treat, and infiltrate roof runoff. The parking lot runoff can be treated by creating curb cuts to direct rainwater into rain gardens using the detention basin as an overflow. A preliminary soil assessment suggests that more soil testing would be required before determining the soil's suitability for green infrastructure.

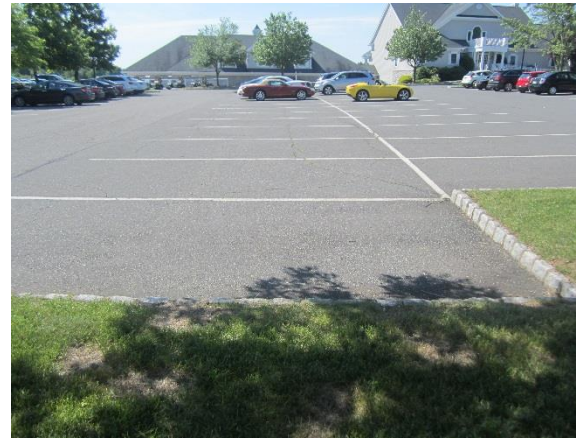
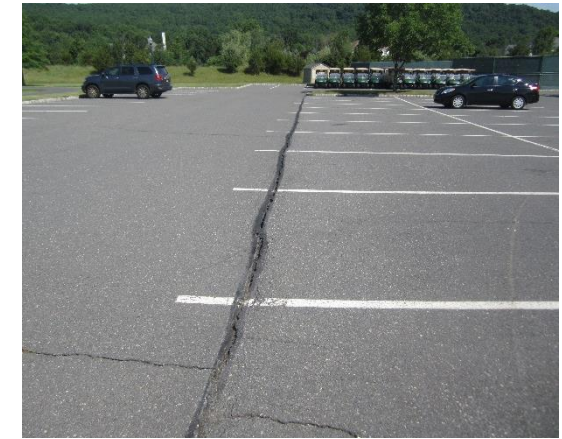
The country club's parking lot runoff flows toward the northeast and into catch basins along the way. Strips of pervious pavement can replace the existing asphalt to capture this runoff and allow it to infiltrate. A preliminary soil assessment suggests that the soils have suitable drainage characteristics for green infrastructure.

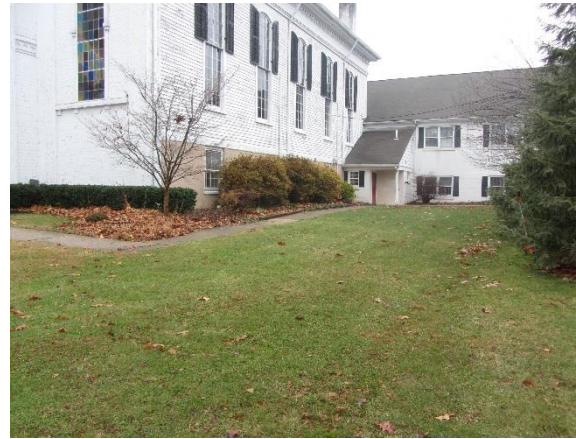
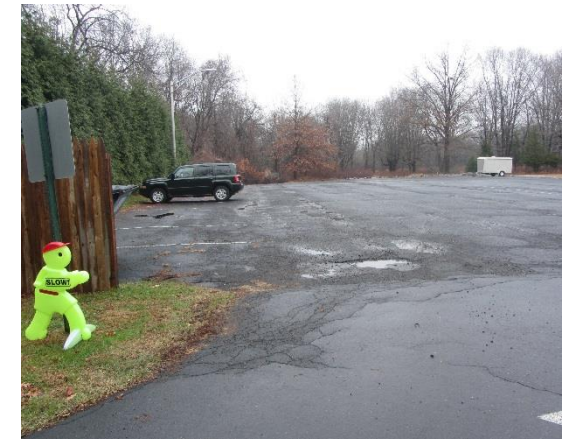
The church's stormwater comes from the roof which flows down primarily disconnected downspouts, and the parking lot that drains into the neighboring woods. Bioretention systems can be installed on the south and east sides of the building to capture, treat, and infiltrate roof runoff. The parking lot runoff can be captured by replacing parking spaces with pervious pavement. A preliminary soil assessment suggests that the soils have suitable drainage characteristics for green infrastructure.

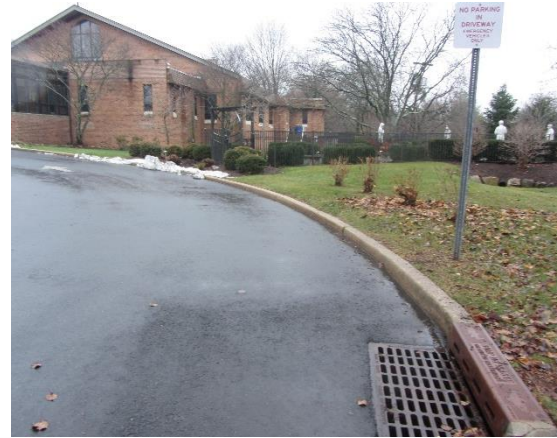
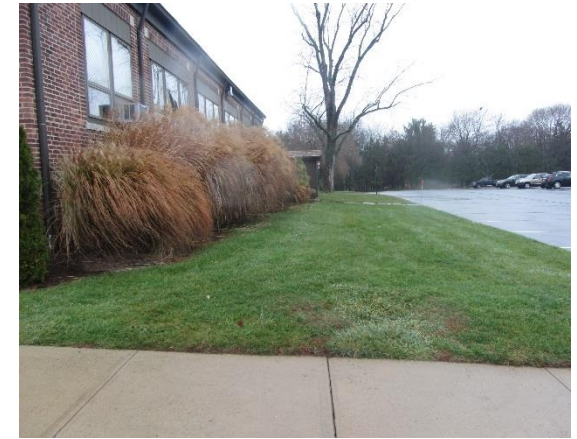
The parking lot runoff currently drains into a detention basin at the south end. Parking spaces can be replaced with pervious pavement to capture and infiltrate stormwater. Additional runoff from the parking lot can be captured, treated, and infiltrated by installing rain gardens. The roof runoff flows down connected downspouts, which can be disconnected into rain gardens. A preliminary soil assessment suggests that the soils have suitable drainage characteristics for green infrastructure.

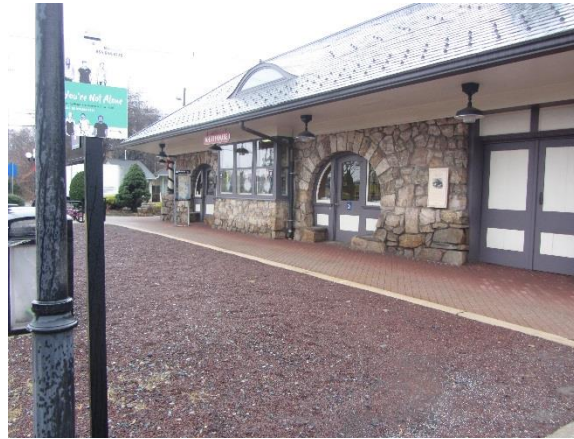
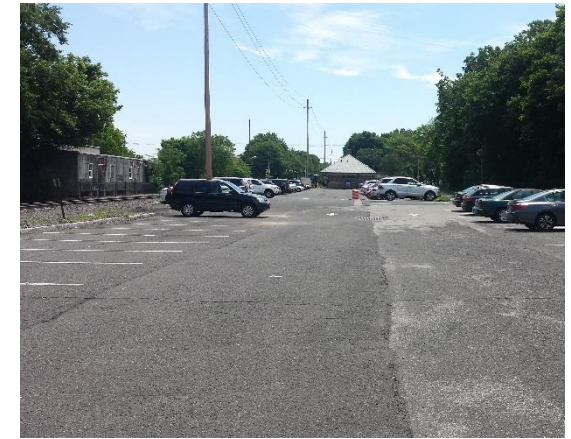
The library runoff drains into connected downspouts. The runoff from the parking lot flows primarily toward the railroad tracks although some is caught by catch basins. Parking spaces can be replaced with pervious pavement to capture and infiltrate stormwater. A preliminary soil assessment suggests that the soils have suitable drainage characteristics for green infrastructure.

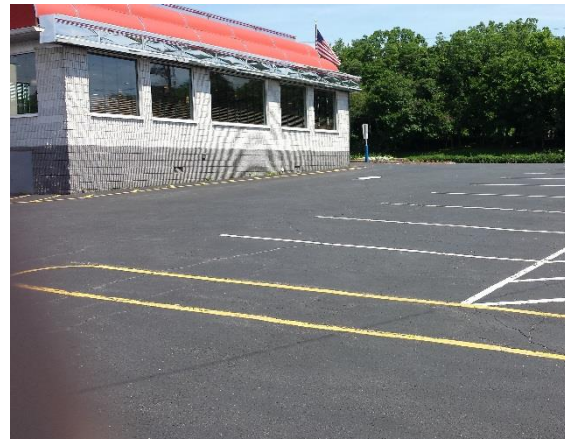
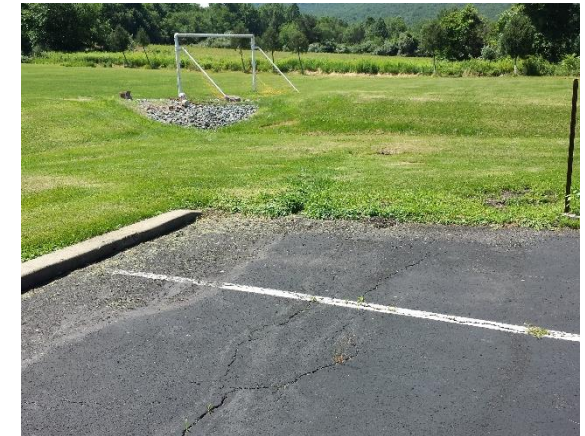
The diner’s stormwater primarily comes from the parking lot, which flows into the surrounding field and gravel area at the east end. The runoff from the east area can be captured by replacing parking spaces with pervious pavement. Runoff from the southeast area can be captured, treated, and infiltrated by installing a bioretention system. A preliminary soil assessment suggests that the soils have suitable drainage characteristics for green infrastructure.

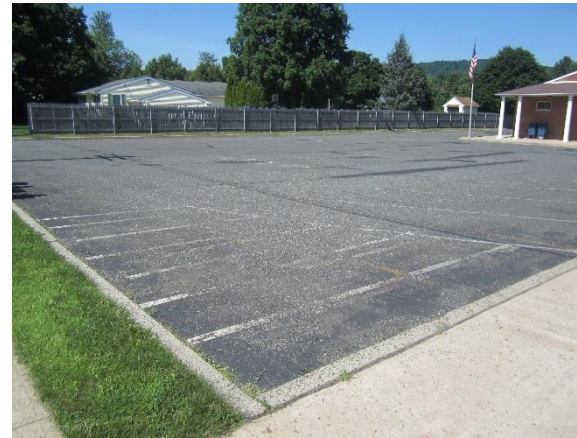
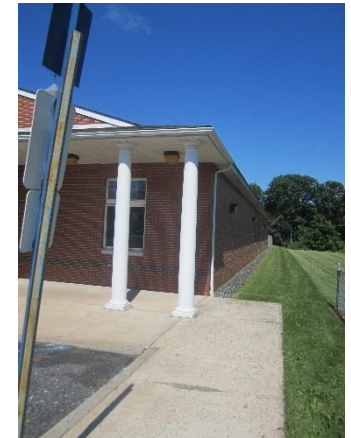
The parking lots drain to catch basins. The rooftop runoff from the north side can be treated by adding gutters and directing water into a rain garden on the fire department's property if permission was granted. The south side roof runoff can be treated by replacing the sidewalk with pervious pavement. Parking spaces can be replaced with pervious pavement to capture and infiltrate stormwater. A preliminary soil assessment suggests that the soils have suitable drainage characteristics for green infrastructure.

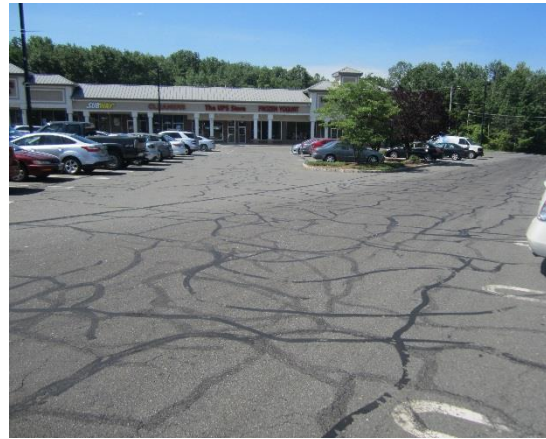
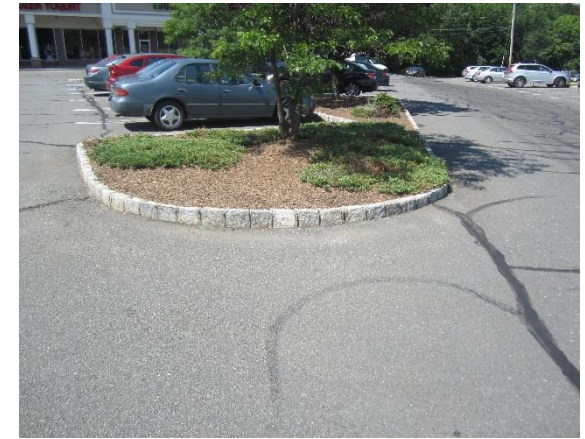
Parking spaces can be replaced with pervious pavement to capture and infiltrate stormwater. A preliminary soil assessment suggests that the soils have suitable drainage characteristics for green infrastructure.

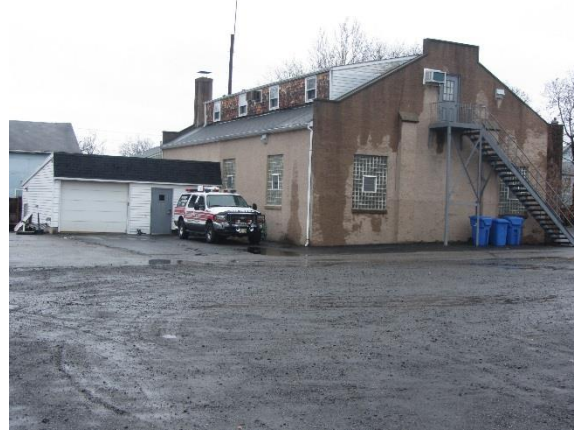
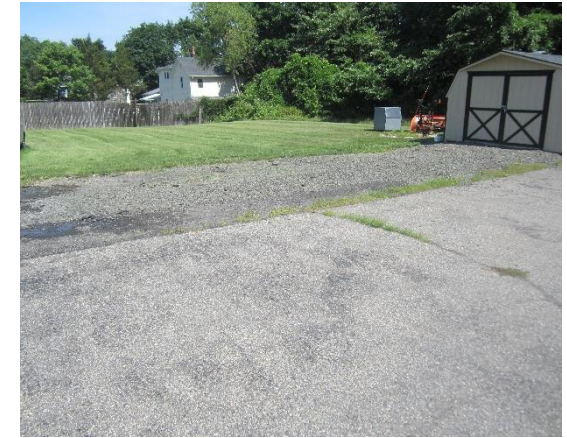
The rescue squad's stormwater comes from its paved areas, which drain toward the northwest turf grass area. The rooftop runoff flows down disconnected downspouts. The paved runoff in the front can be infiltrated by replacing parking spaces with pervious pavement. The runoff from the building can be harvested inside a cistern, which can be used for washing vehicles. A bioretention system can be constructed in the turf grass behind the building to capture, treat, and infiltrate runoff. A preliminary soil assessment suggests that the soils have suitable drainage characteristics for green infrastructure.

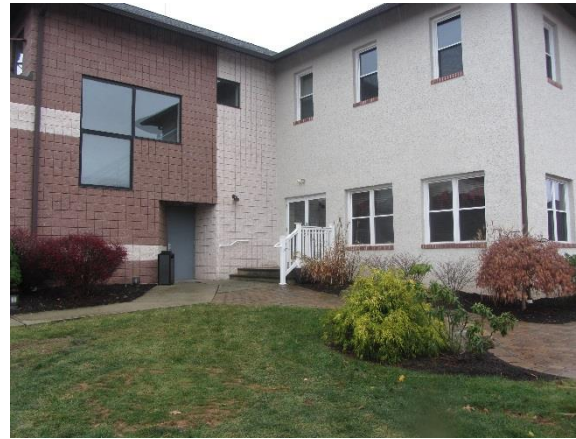
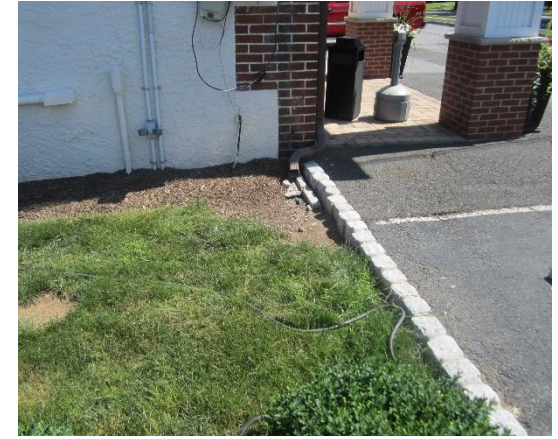
The fire station primarily has internal drainage with connected downspouts on the south and east sides. The paved areas drain either toward the street, the northern turf grass and wooded area, or to the neighboring rescue squad. A bioretention system can be built on the south face where the nearby downspouts can be disconnected and redirected into it to capture, treat and infiltrate roof runoff. A preliminary soil assessment suggests that the soils have suitable drainage characteristics for green infrastructure.

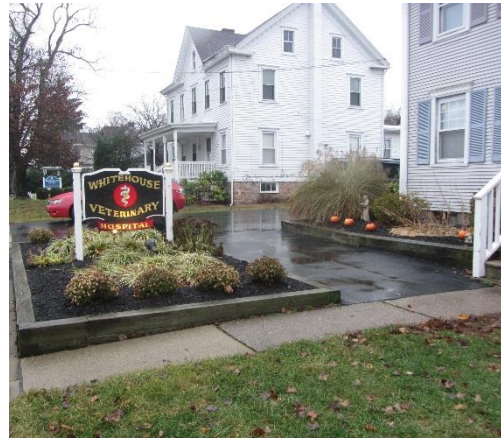
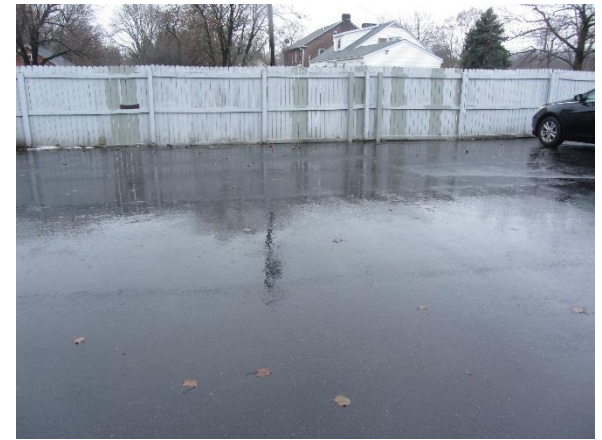
The runoff from the building flows down disconnected downspouts onto the driveway and turf grass. The parking lot and driveway runoff drain into the roadways. A bioretention system can be constructed on the south face to capture, treat, and infiltrate rooftop runoff. Parking spaces can be replaced with pervious pavement to capture and infiltrate stormwater. A preliminary soil assessment suggests that the soils have suitable drainage characteristics for green infrastructure.
