**Impervious Cover Assessment  
for  
Bedminster Township, Somerset County, New Jersey**

*Prepared for Bedminster Township by the  
Rutgers Cooperative Extension Water Resources Program*

January 7, 2020

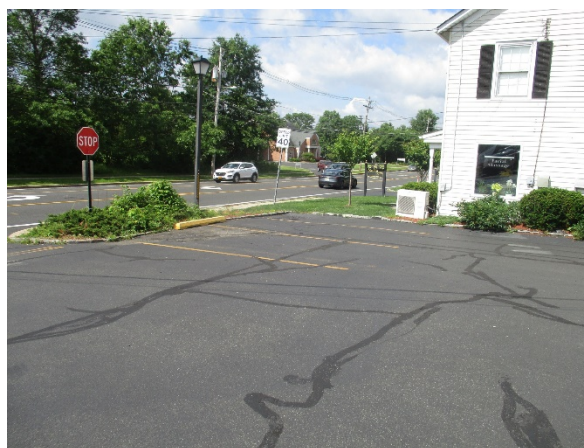
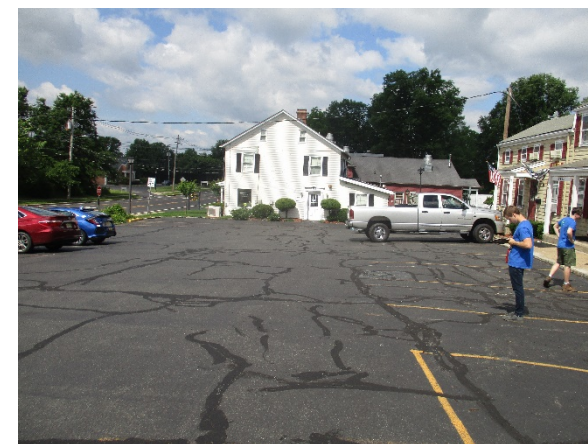
# ANNIE'S DELI

Parking spaces located in the southeast corner of parking lot (shown here adjacent to white building and stop sign) can be replaced with pervious pavement to capture and infiltrate stormwater. Downspouts at Annie's Deli can be disconnected and directed into downspout planter boxes to capture and filter rooftop runoff.

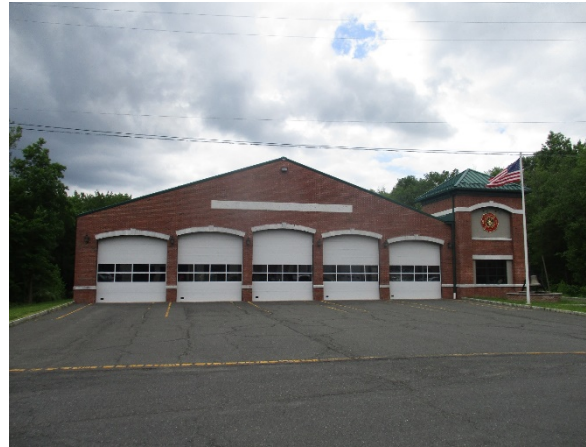
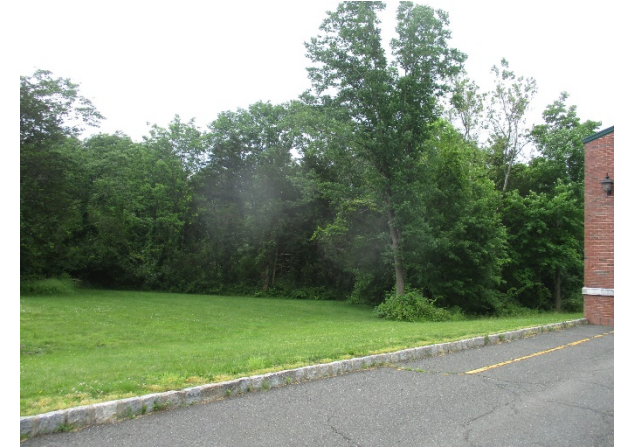
# FARHILLS BEDMINSTER FIRE DEPARTMENT

Cisterns can be installed in the southeast or southwest rear corners of the building to allow roof runoff to be reused. A bioretention system can be installed at the northeast corner of the building to capture, treat, and infiltrate rooftop runoff. Pervious pavement can be installed in the parking spaces behind and south of the building to filter and infiltrate pavement runoff.

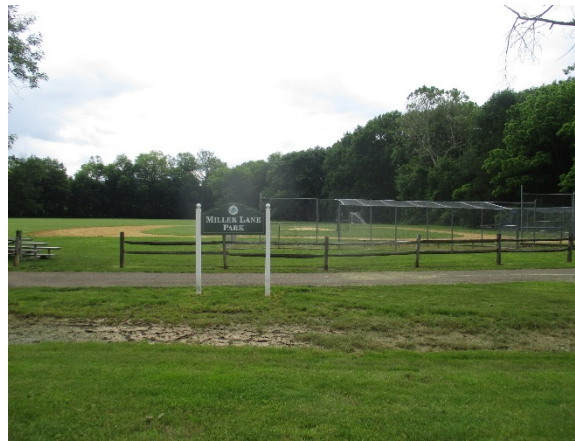
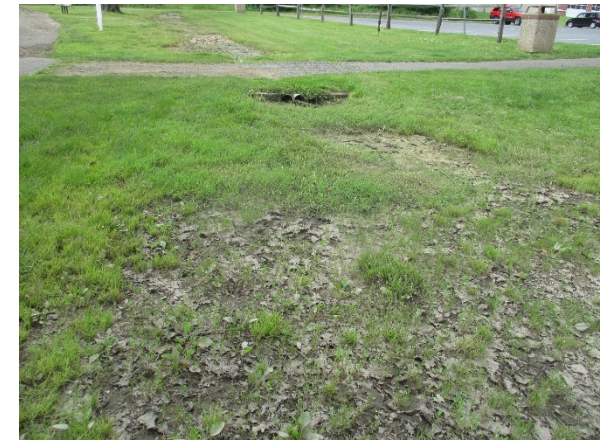
# MILLER LANE PARK

Adjacent, connected bioretention systems can be installed on the eastern edge of the parking lot to capture, treat, and infiltrate runoff. The systems will be linked by pipes (already installed) shown in the above image. Pervious pavement can be installed in the parking spaces on the southern edge of the parking lot to filter and infiltrate pavement runoff.
