**Impervious Cover Assessment
for
Bernards Township, Somerset County, New Jersey**

*Prepared for Bernards Township by the
Rutgers Cooperative Extension Water Resources Program*

January 7, 2020

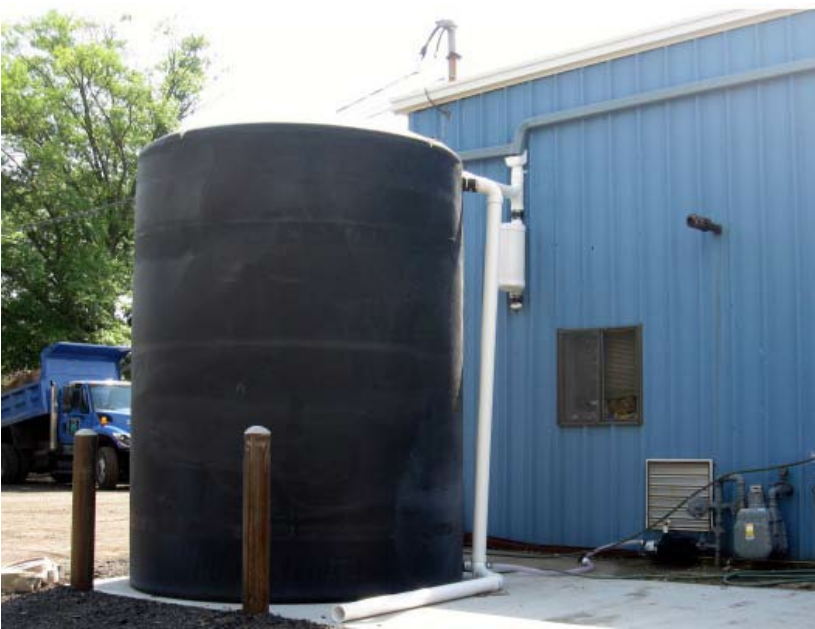
Figure 8b: A 5,000 gallon cistern used to disconnect the rooftop of the Department of Public Works in Clark Township to harvest rainwater for nonprofit car wash events

- Rainwater Harvesting: Rainwater harvesting includes the use of rain barrels and cisterns (Figures 8a and 8b). These can be placed below downspouts to collect rooftop runoff. The collected water has a variety of uses including watering plants and washing cars. This practice also helps cut down on the use of potable water for nondrinking purposes. It is important to divert the overflow from the rainwater harvesting system to a pervious area.

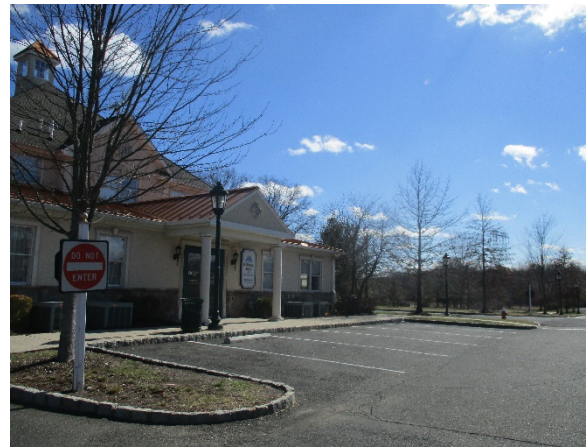
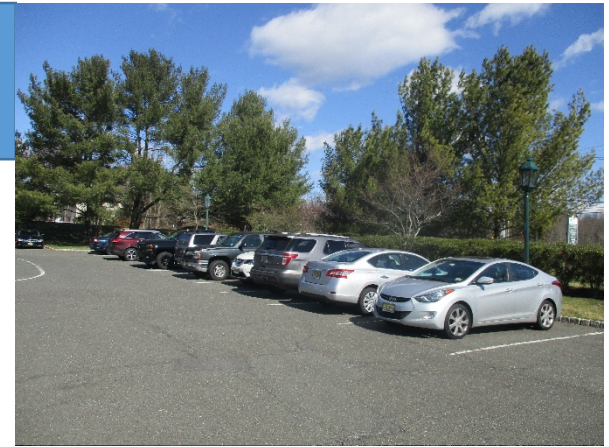
MILLINGTON BANK

Parking spaces in the parking lot to the east and west of the building can be converted to porous pavement to capture and infiltrate stormwater runoff from the parking lot. Porous pavement comes in different forms such as porous asphalt, pervious concrete, permeable pavers, and grass pavers. These are sturdy materials that allow for vehicles to pass over but still allow water to infiltrate into the ground.

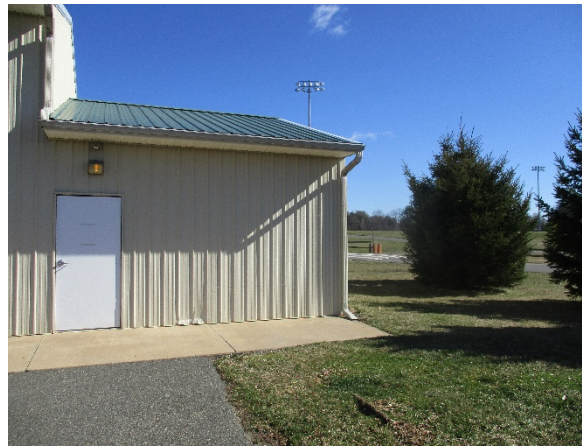
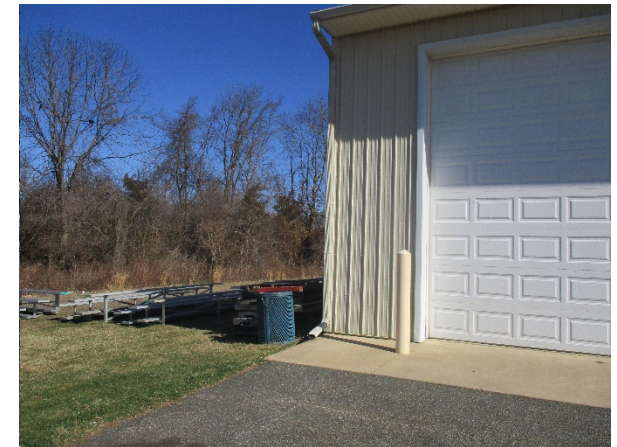
MOUNTAIN PARK BASEBALL AND SOCCER FIELDS

A cistern can be placed adjacent to the building to capture stormwater runoff from the roof. The captured water can then be used for non-potable uses such as washing vehicles.

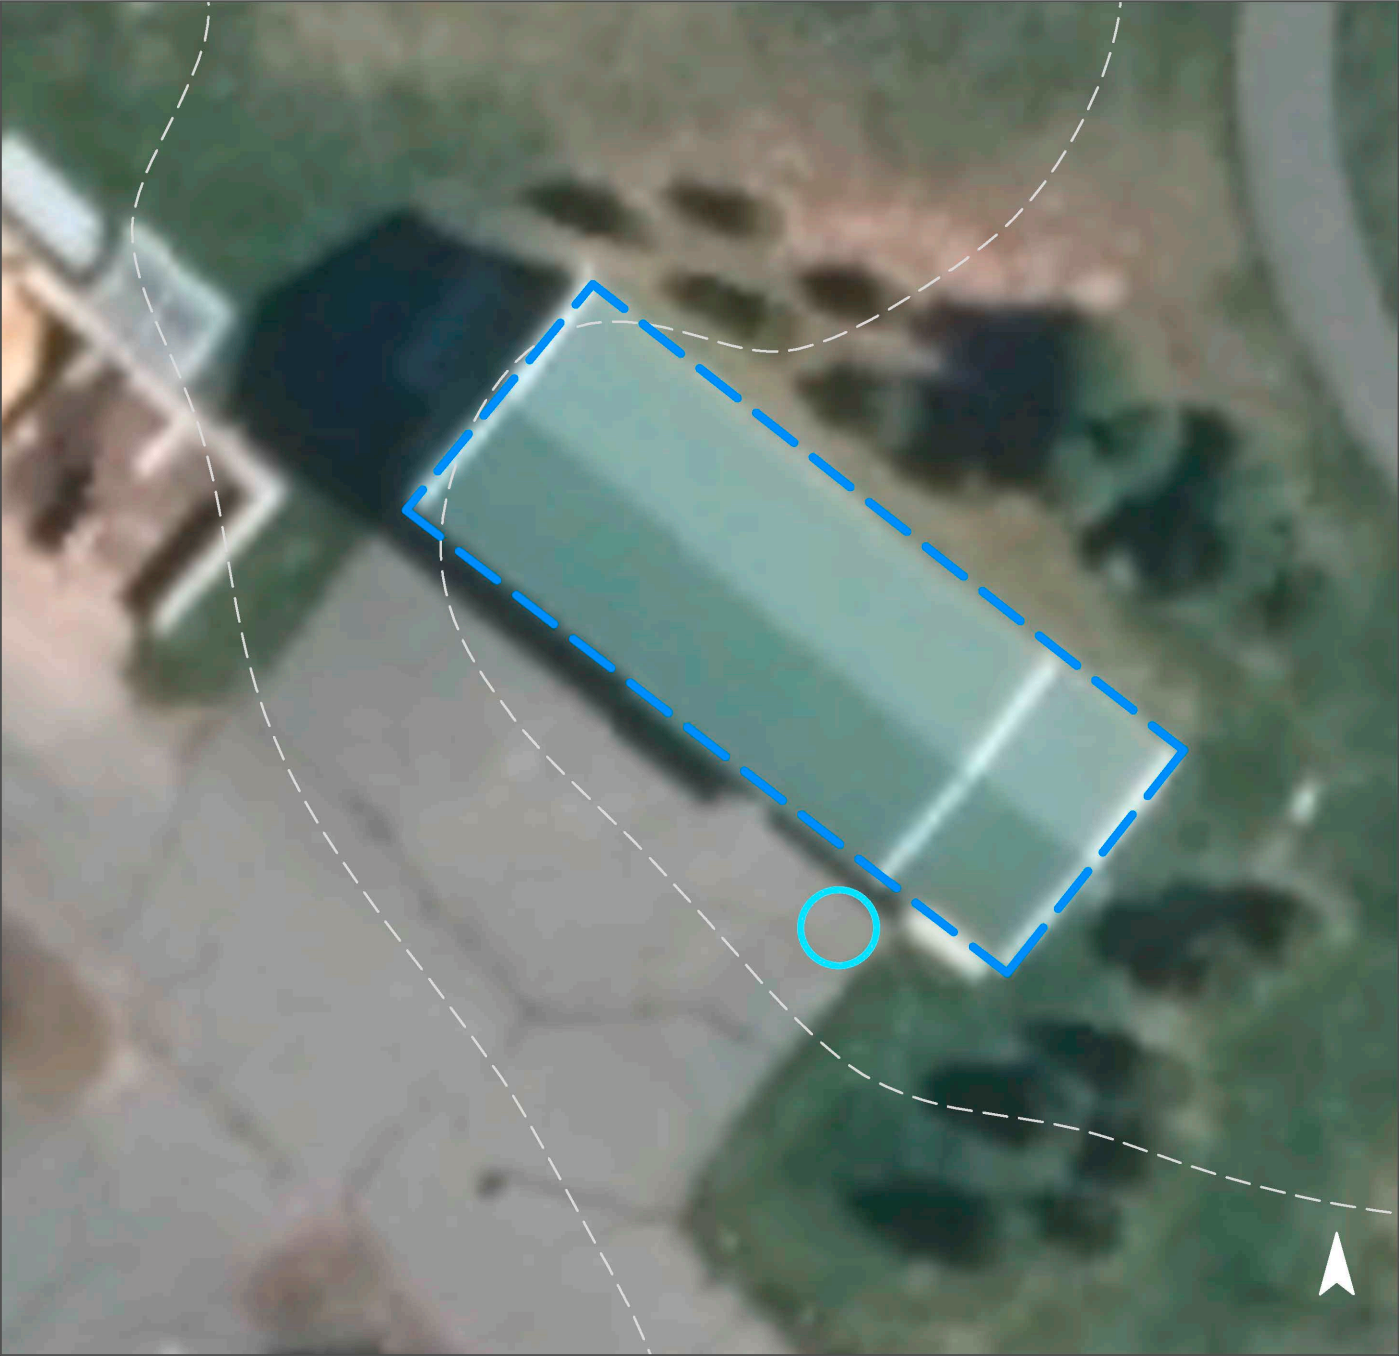
Mountain Park Baseball and Soccer Fields

rainwater harvesting
-

drainage area
-

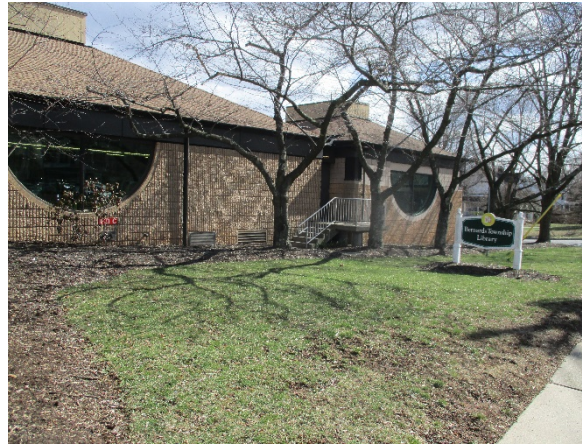
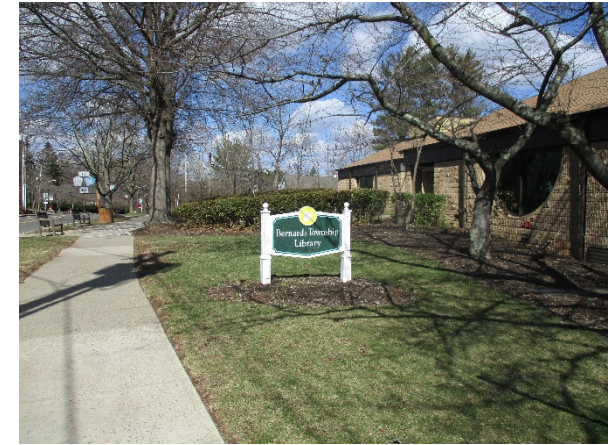
BERNARDS TOWNSHIP LIBRARY

A rain garden can be planted in front of the library entrance to capture, treat, and infiltrate stormwater runoff from the roof. A rain garden features many native flowering plants that beautify the landscape while providing habitat for wildlife. With its environmental and ecological importance, this installation could serve as a great educational tool as well.
