**Impervious Cover Assessment
for
Chester Township, Morris County, New Jersey**

*Prepared for Chester Township by the
Rutgers Cooperative Extension Water Resources Program*

January 7, 2020

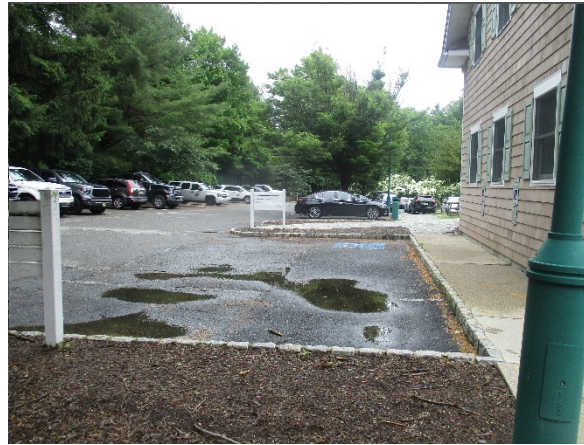
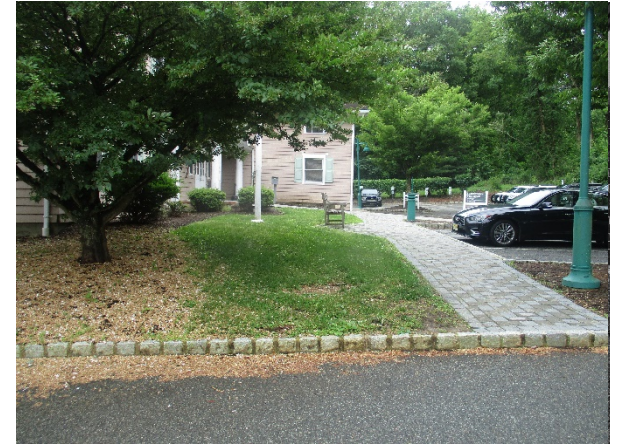
CHESTER TOWNSHIP MUNICIPAL BUILDING

Parking spaces can be replaced with pervious pavement to capture and infiltrate stormwater. A rain garden can also be installed to capture, treat, and infiltrate rooftop runoff.

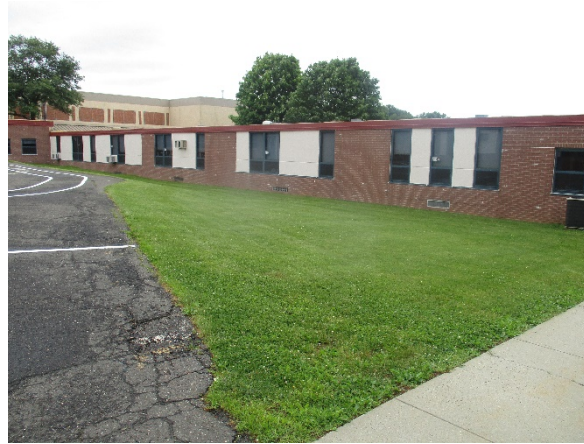
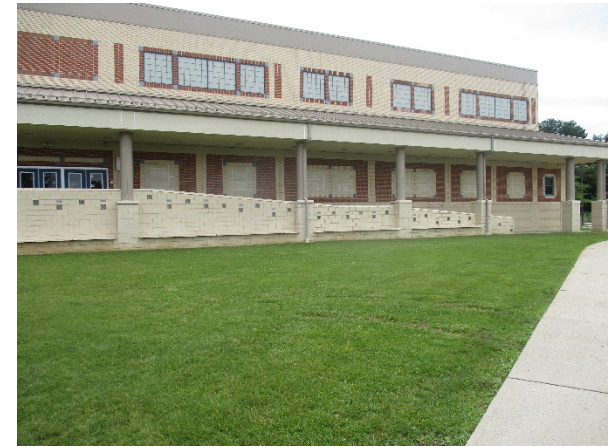
DICKERSON SCHOOL

Rain gardens can be added in three locations as specified in the aerial to capture rainwater from the rooftops of the school buildings. Pervious pavement can also be installed in the school parking lot to infiltrate stormwater.

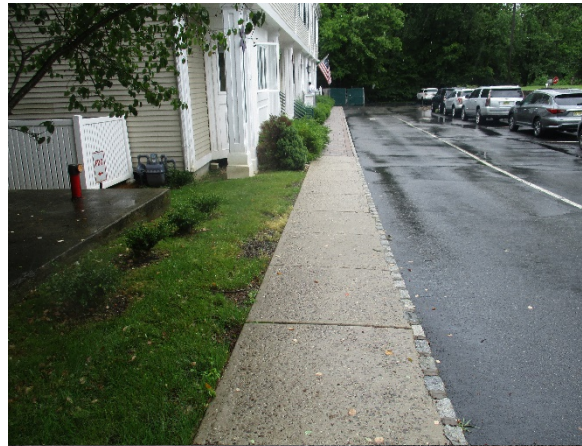
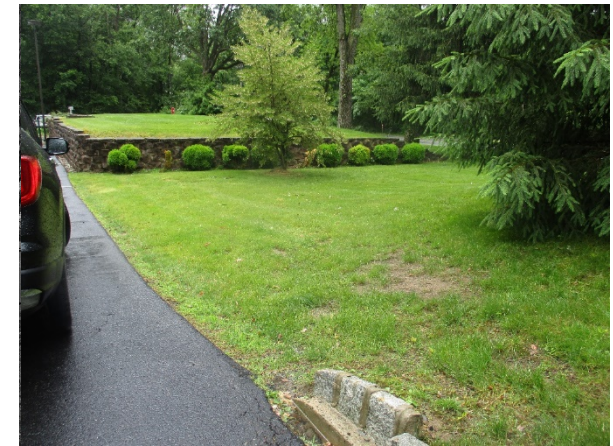
WESTMONT MONTESSORI SCHOOL

A rain garden can be installed adjacent to the lowest point in the driveway to capture stormwater runoff. Several downspout planter boxes are also recommended for installation along the school building to capture and reuse rooftop runoff.
