**Impervious Cover Assessment
for
Mendham Township, Morris County, New Jersey**

*Prepared for Mendham Township by the
Rutgers Cooperative Extension Water Resources Program*

January 7, 2020

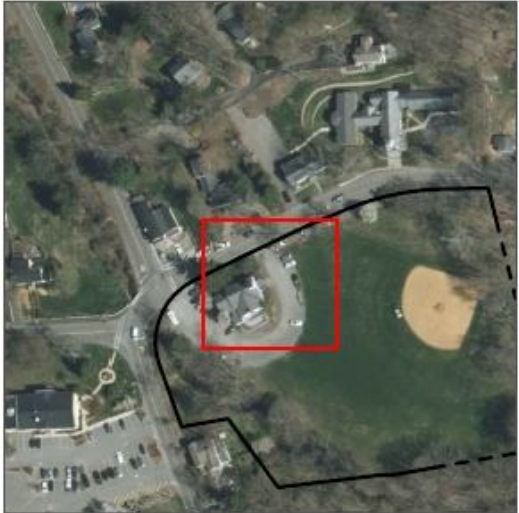
Brookside Community Club

Bioretention systems can be installed on the north side of the building to capture, treat, and infiltrate rooftop runoff. Parking spaces can be replaced with pervious pavement to capture and infiltrate stormwater. A downspout planter box should also be considered for installation along the east side of the building.

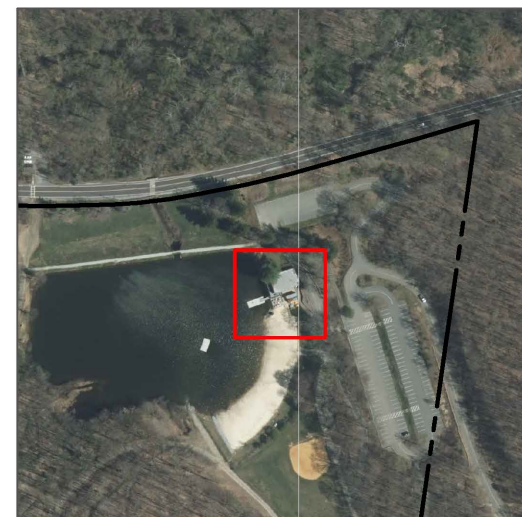
Parque

Bioretention systems can be installed on the east side of the building to capture, treat, and infiltrate rooftop runoff. Downspout planter boxes can be constructed along the south side of the building to allow roof runoff to be reused and to spread awareness about green infrastructure programs.
