**Impervious Cover Assessment
for
Randolph Township, Morris County, New Jersey**

*Prepared for Randolph Township by the
Rutgers Cooperative Extension Water Resources Program*

January 7, 2020

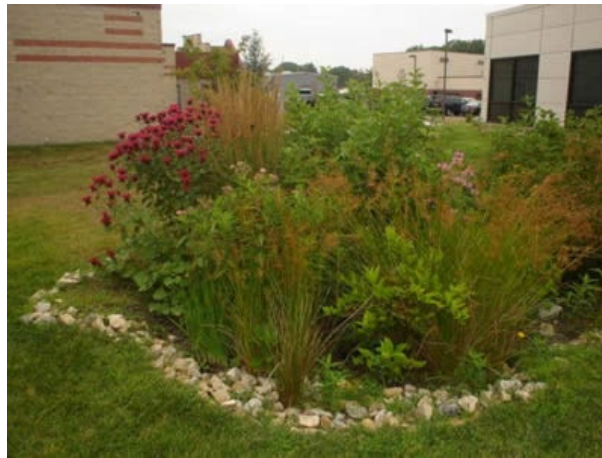
Figure 7: Rain garden outside the RCE of Gloucester County office which was designed to disconnect rooftop runoff from the local storm sewer system

- Rain Gardens: Stormwater can be diverted into shallow landscaped depressed areas (i.e., rain gardens) where the vegetation filters the water, and it is allowed to soak into the ground. Rain gardens, also known as bioretention systems, come in all shapes and sizes and can be designed to disconnect a variety of impervious surfaces (Figure 7).

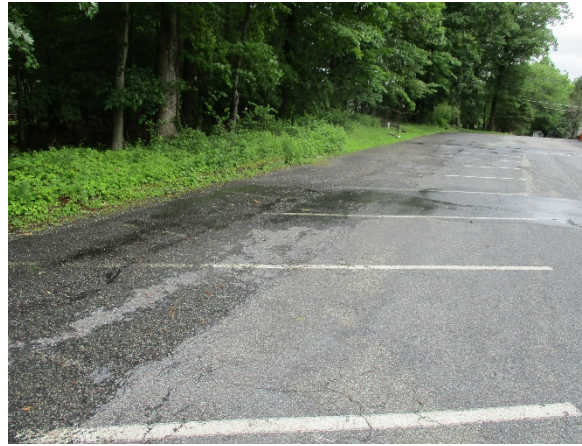
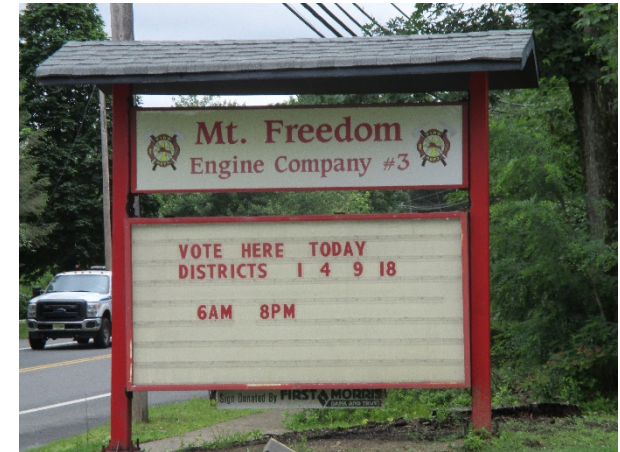
MT. FREEDOM FIRE CO. 3 RTFD

Parking spaces in the parking lot south of the building near multiple disconnected downspouts can be converted to pervious pavement to capture and infiltrate stormwater runoff from the parking lot. A cistern can be installed on the north side of the building near a disconnected downspout to capture rainwater that can be used for watering gardens, washing vehicles, or for other non-potable uses.

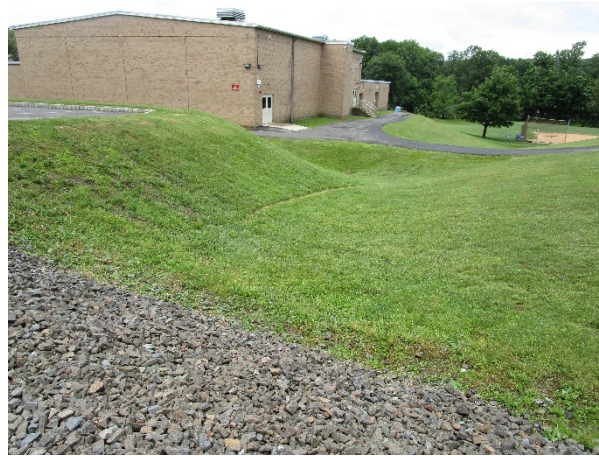
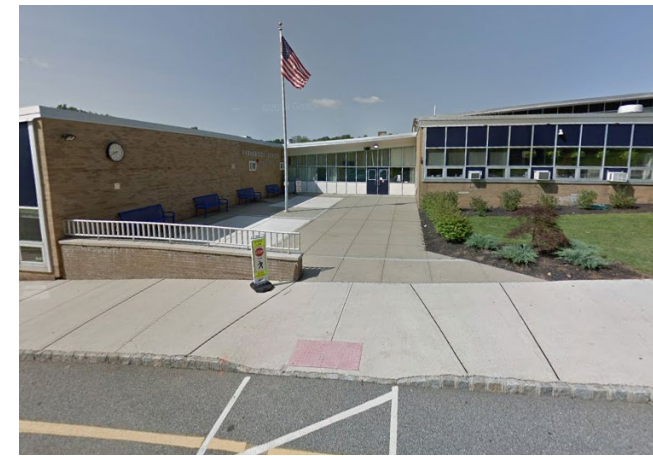
FERNBROOK ELEMENTARY SCHOOL

A bioretention system can be installed north of the building near the playground to capture, treat, and infiltrate rooftop runoff.

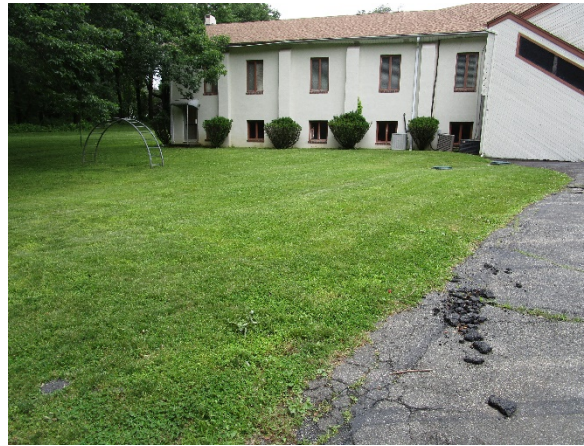
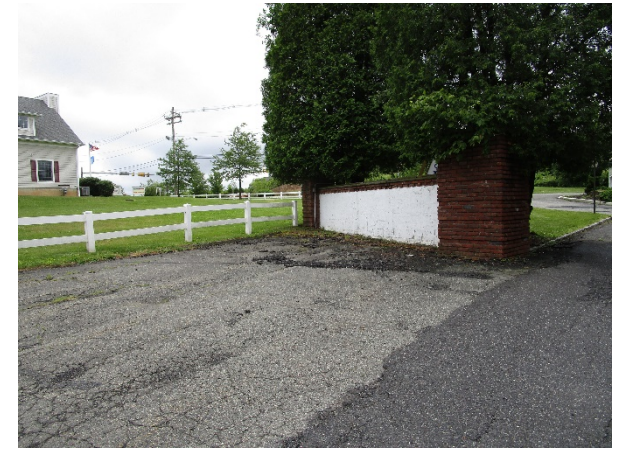
MAR THOMA CHURCH OF NEW JERSEY

Parking spaces in the parking lot to the south of the building can be converted to pervious pavement to capture and infiltrate stormwater runoff from the parking lot. A rain garden can be installed in the turfgrass area west of the building to capture, treat, and infiltrate stormwater runoff from the roof.
