**Impervious Cover Assessment
for
Union Township, Hunterdon County, New Jersey**

*Prepared for Union Township by the
Rutgers Cooperative Extension Water Resources Program*

January 7, 2020

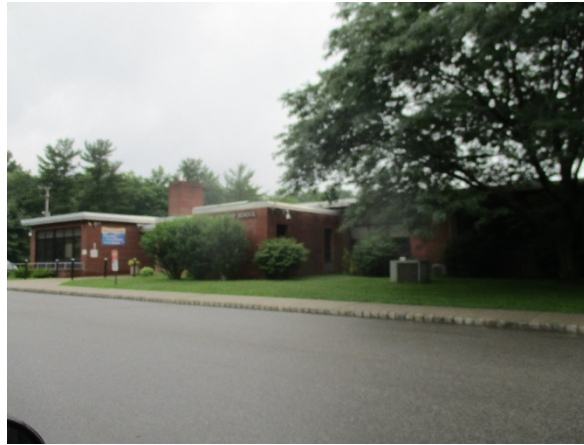
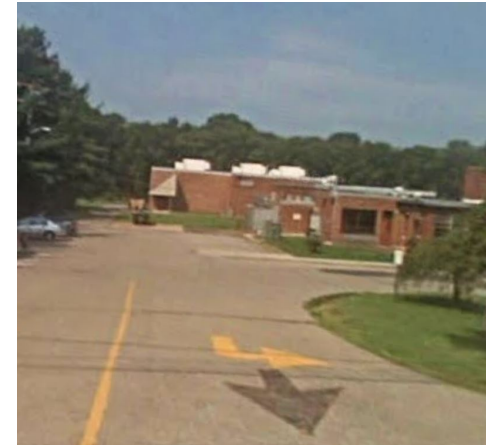
UNION TOWNSHIP MIDDLE SCHOOL

Parking spaces to the south of the school can be converted to pervious pavement to capture and infiltrate stormwater runoff from the street and parking lot. A rain garden can be installed in the front lawn to capture, filter, and infiltrate roof runoff if the front downspouts are disconnected and redirected.

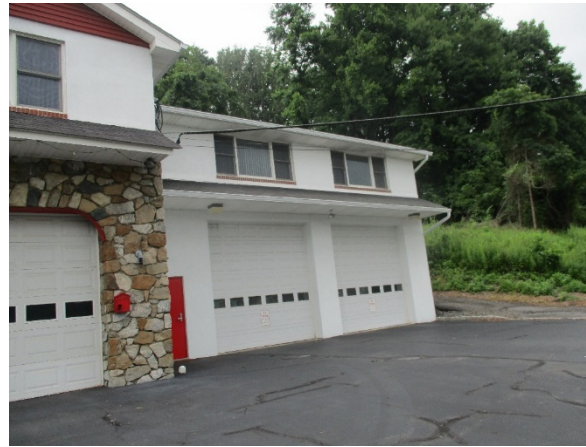
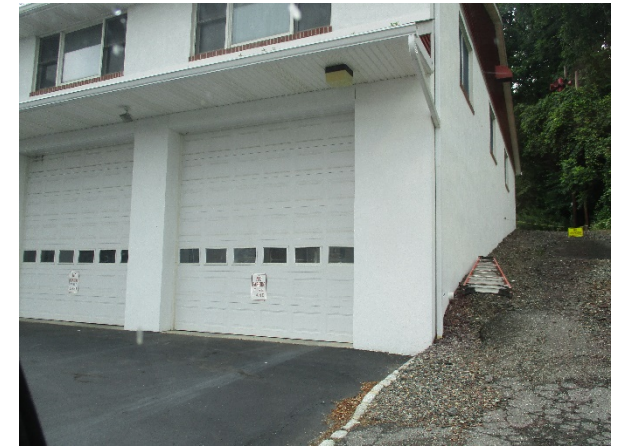
PATTENBURG VOLUNTEER FIRE COMPANY

A cistern can be installed at the southeast downspout of the building to harvest rainwater from the roof. Captured rainwater can be used for washing vehicles among other non-potable uses.

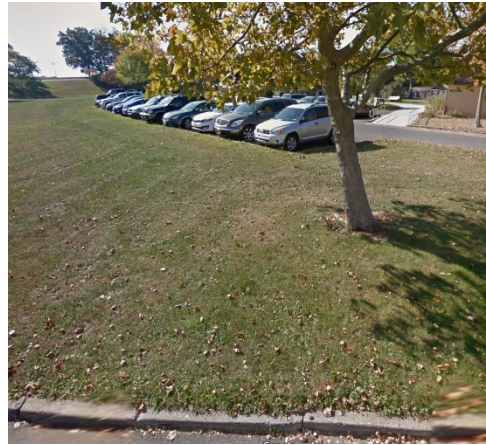
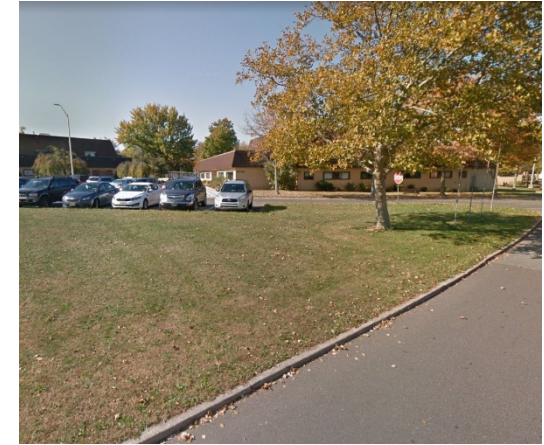
HUNTERDON STATE SCHOOL

A rain garden can be installed in the turfgrass area near the entrance of the school to capture, treat, and infiltrate stormwater runoff from the front parking lot and to divert it from entering the nearby storm drain.
