**Impervious Cover Assessment
for
Washington Township, Morris County, New Jersey**

*Prepared for Washington Township by the
Rutgers Cooperative Extension Water Resources Program*

January 7, 2020

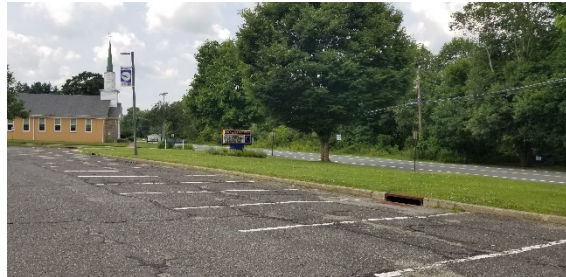
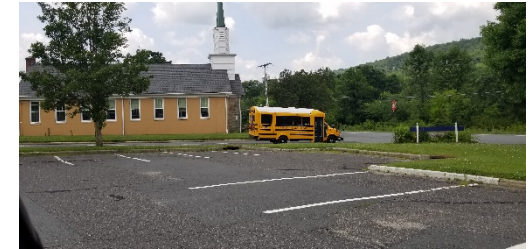
LONG VALLEY MIDDLE SCHOOL

Pervious pavement is proposed to decrease the amount of surface runoff contamination from the parking lot to the subwatershed as well as to remediate the erosion. A bioretention system is proposed in the north turfgrass area to treat the northwest drainage area of the school. Downspout planter boxes are another option to serve the same purpose.
