**Impervious Cover Assessment
for
Buena Borough, Atlantic County, New Jersey**

*Prepared for Buena Borough by the
Rutgers Cooperative Extension Water Resources Program*

March 27, 2018

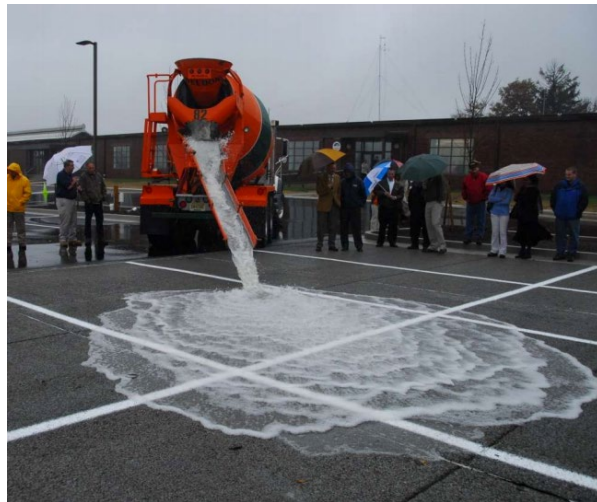
Figure 2: Rapid infiltration of water through porous pavement is demonstrated at the USEPA Edison New Jersey test site

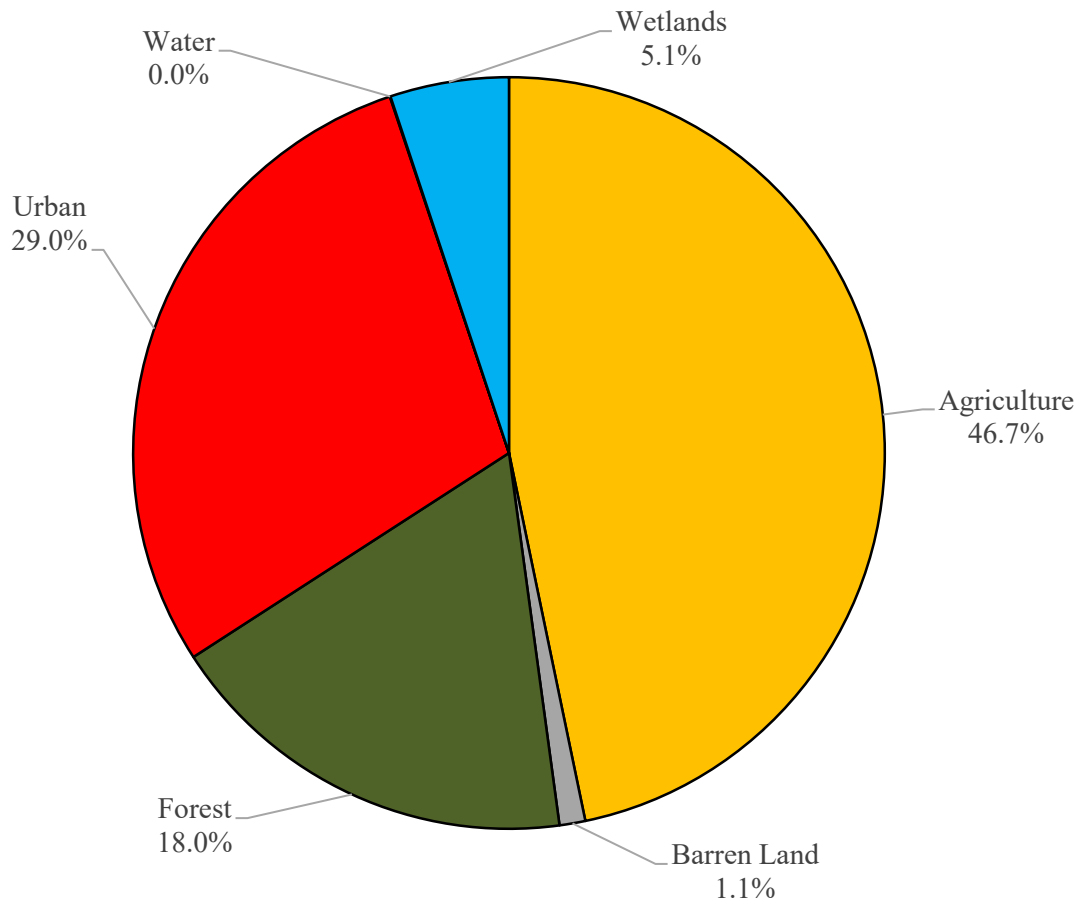
Figure 3: Pie chart illustrating the land use in Buena Borough

Buena Borough is located in Atlantic County, New Jersey and covers approximately 7.6 square miles south of Monroe Township. Figures 3 and 4 illustrate that Buena Borough is dominated by agriculture land uses. A total of 29.0% of the municipality's land use is classified as urban. Of the urban land in Buena Borough, rural residential is the dominant land use (Figure 5).

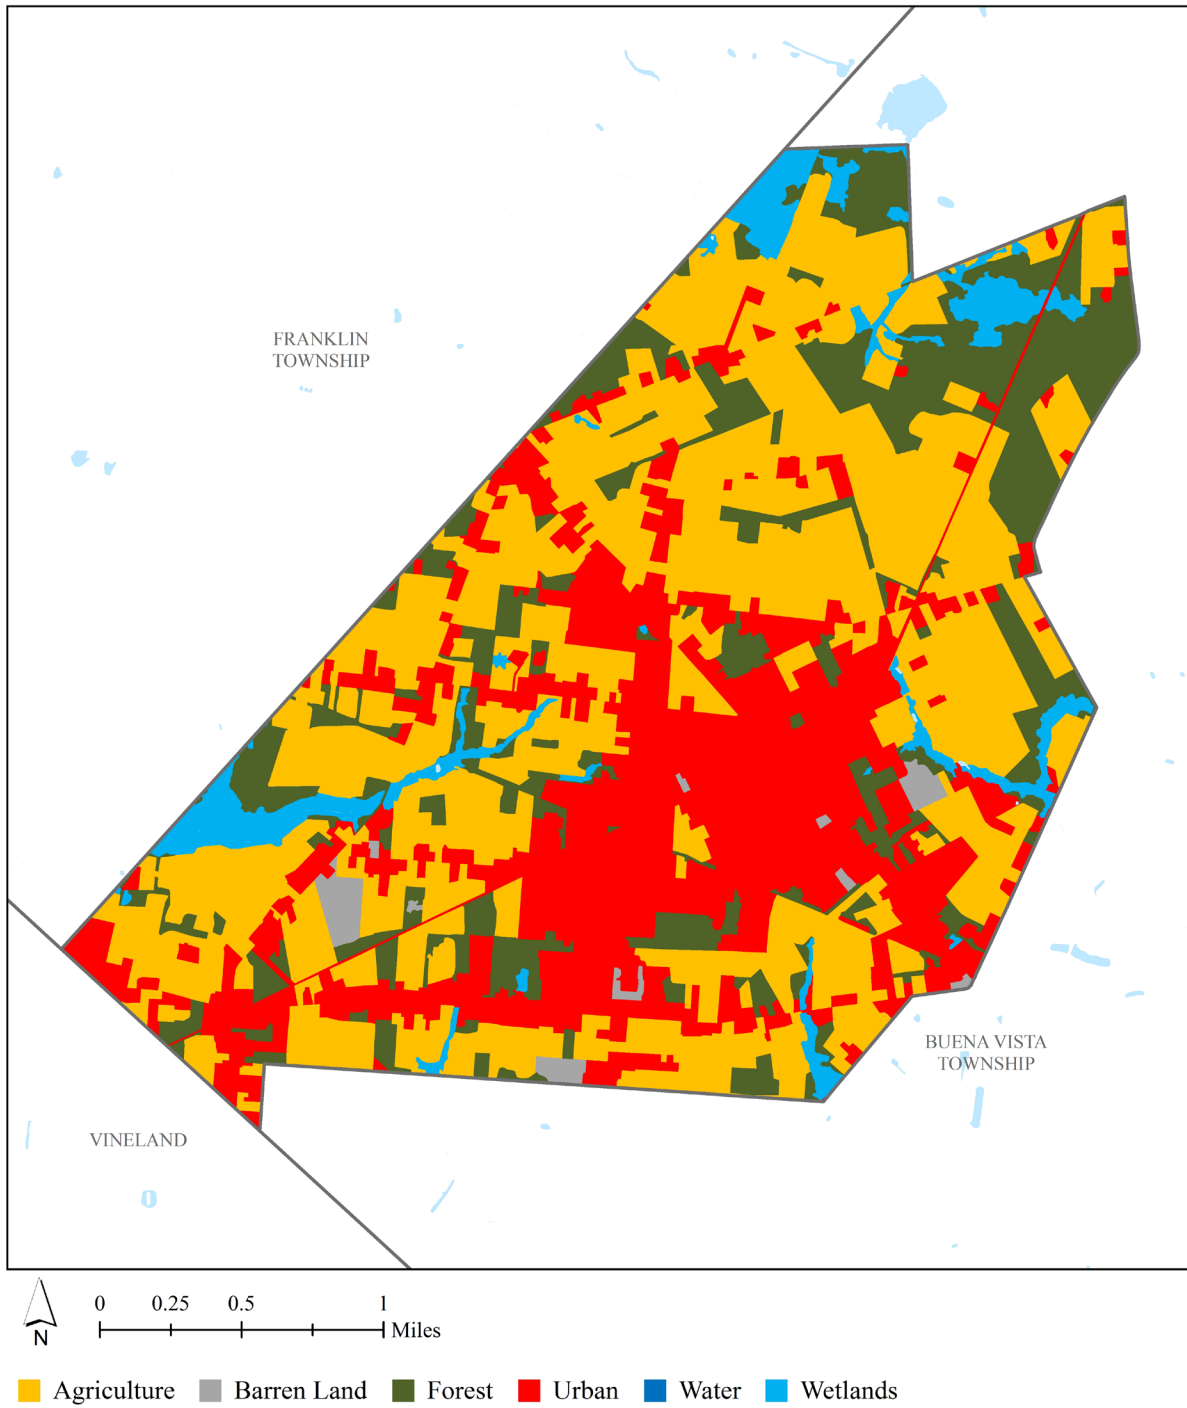
Figure 4: Map illustrating the land use in Buena Borough

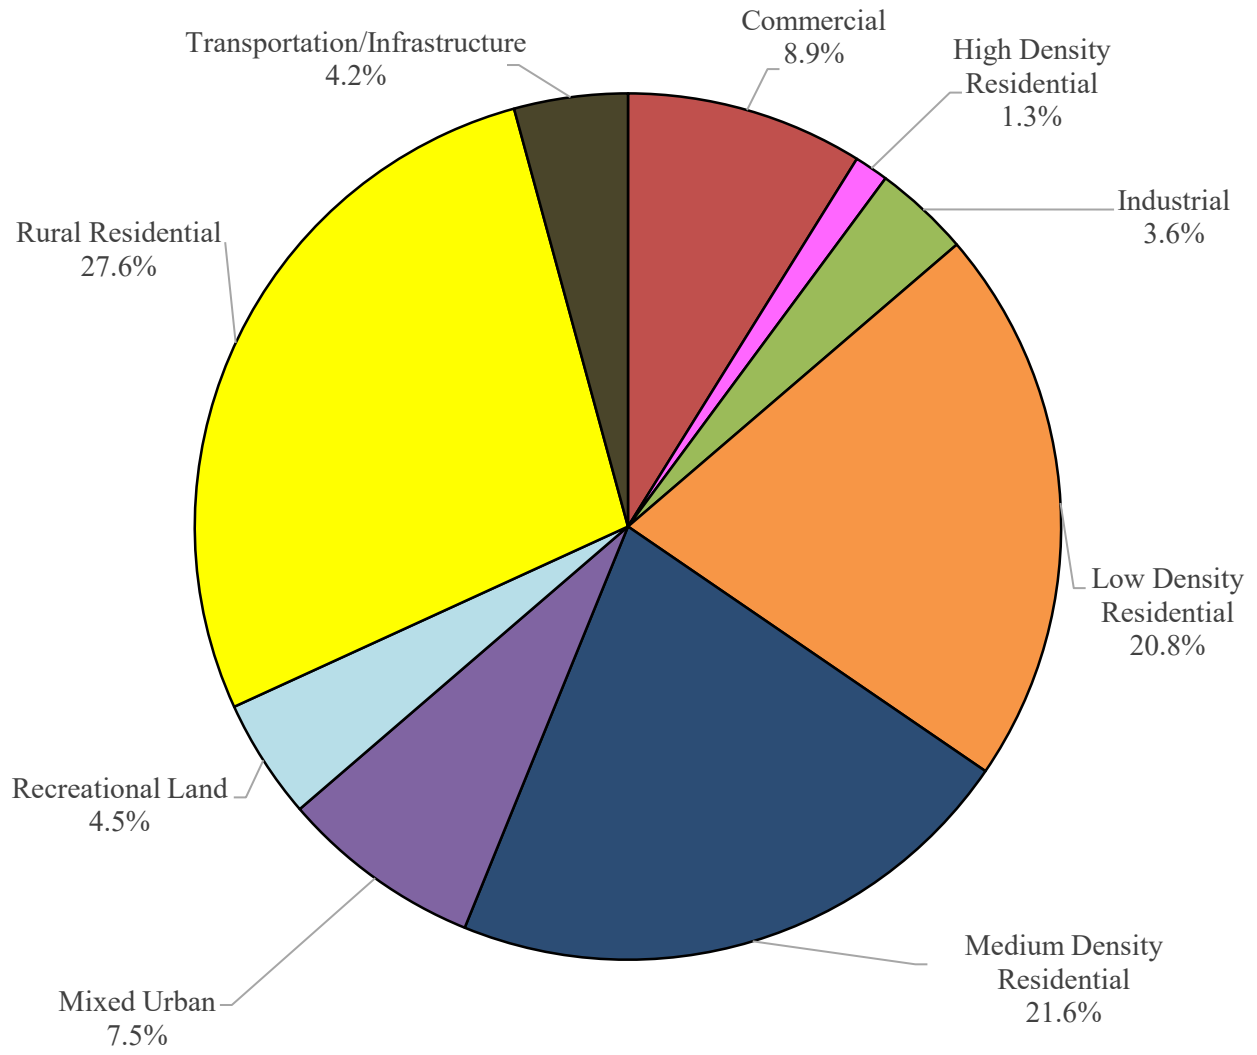
Figure 5: Pie chart illustrating the various types of urban land use in Buena Borough

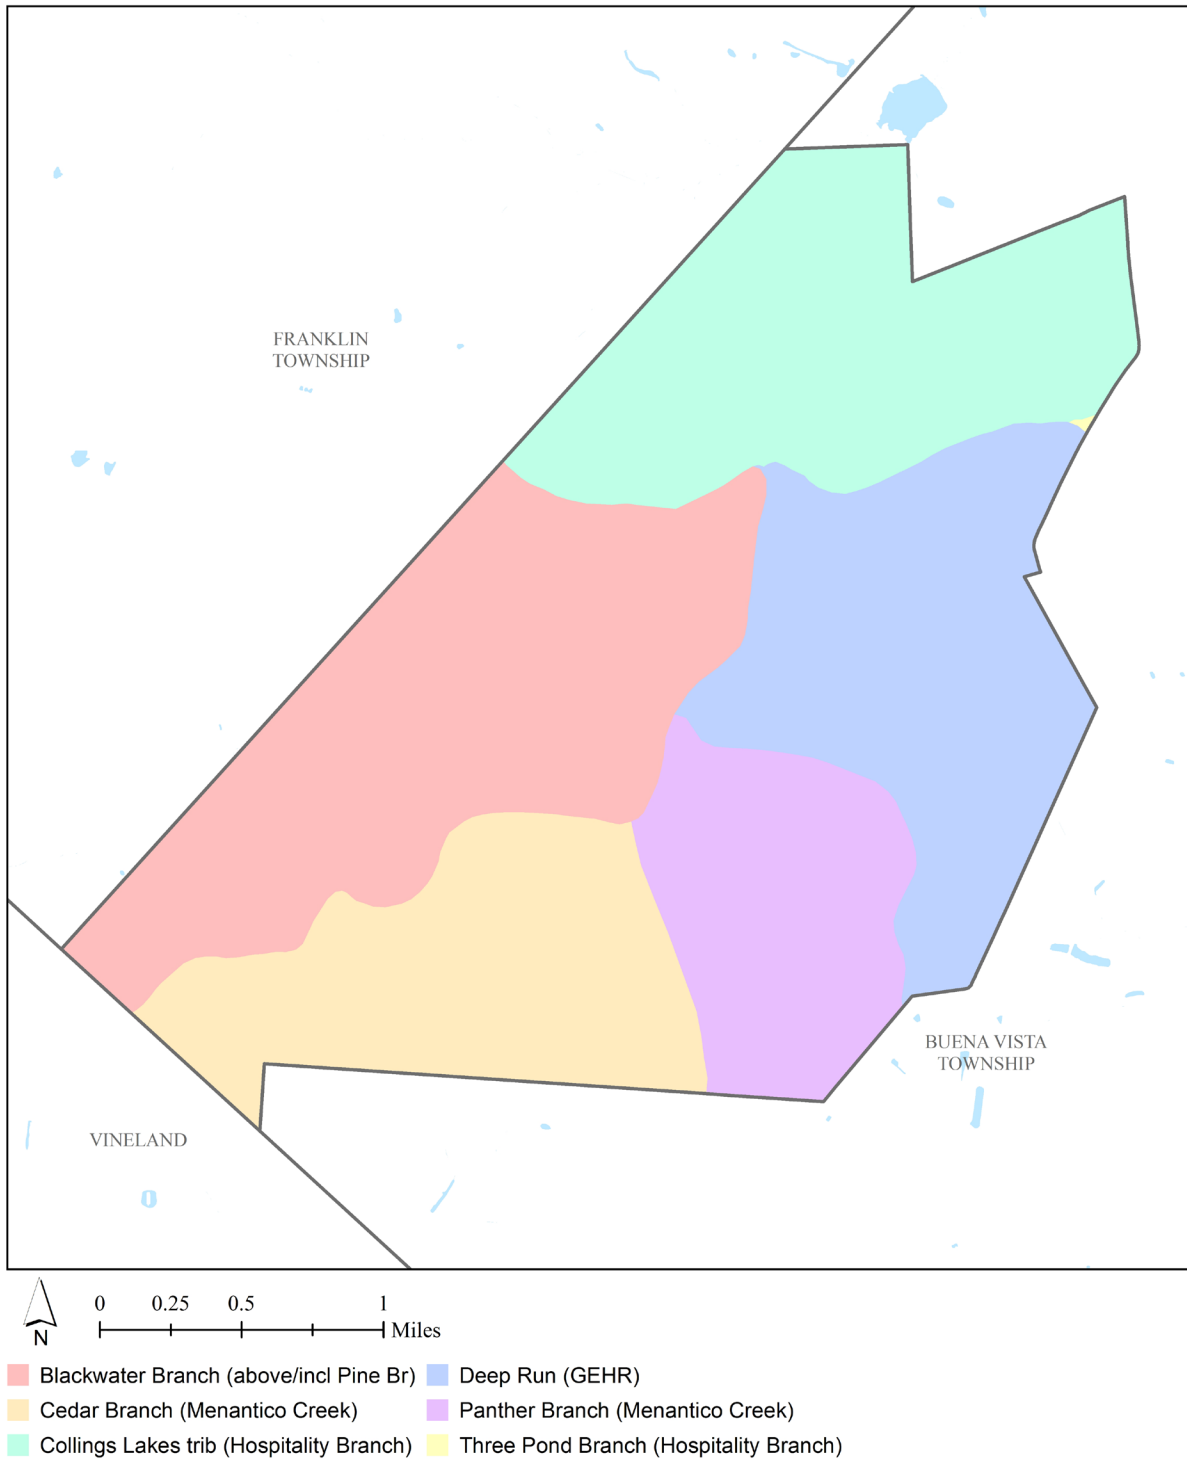
Figure 6: Map of the subwatersheds in Buena Borough

Water resources are typically managed on a watershed/subwatershed basis; therefore, an impervious cover analysis was performed for each subwatershed within Buena Borough (Table 1 and Figure 6). On a subwatershed basis, impervious cover ranges from 0% in the Three Pond Branch subwatershed to 69.9% in the Cedar Branch subwatershed. Evaluating impervious cover on a subwatershed basis allows the municipality to focus impervious cover reduction or disconnection efforts in the subwatersheds where frequent flooding occurs.

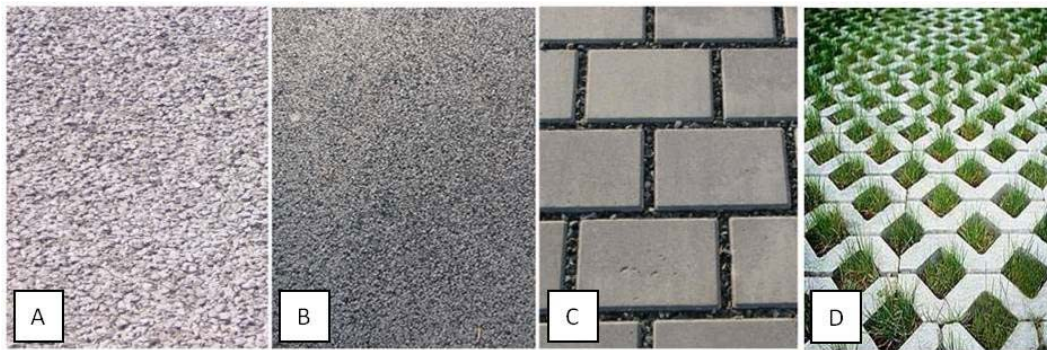
Permeable surfaces: (A) pervious concrete, (B) porous asphalt, (C) interlocking concrete pavers, (D) grid pavers (Rowe, 2012)

Pervious concrete and porous asphalt are the most common of the permeable surfaces. They are similar to regular concrete and asphalt but without the fine materials. This allows water to quickly pass through the material into an underlying layered system of stone that holds the water, allowing it to infiltrate into the underlying uncompacted soil.

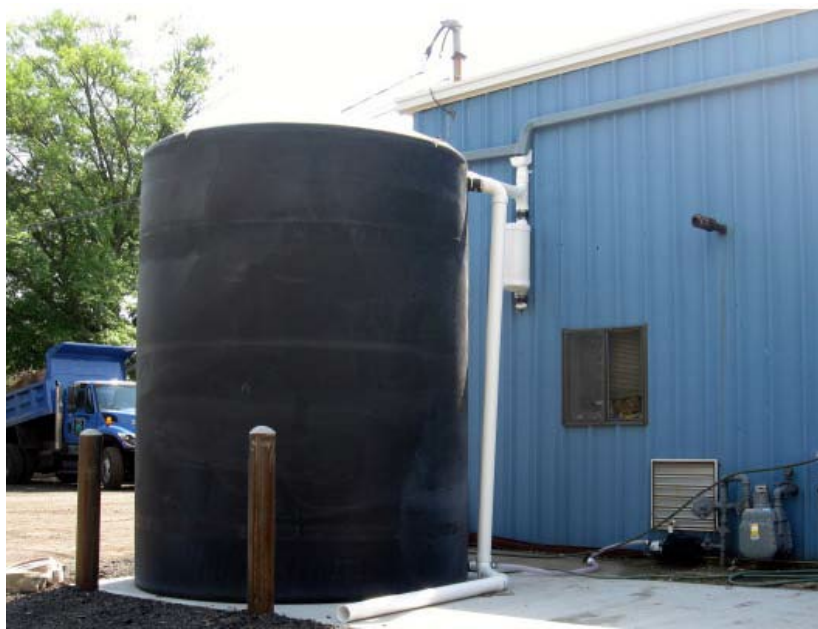
Figure 8b: A 5,000 gallon cistern used to disconnect the rooftop of the Department of Public Works in Clark Township to harvest rainwater for nonprofit car wash events

- Rainwater Harvesting: Rainwater harvesting includes the use of rain barrels and cisterns (Figures 8a and 8b). These can be placed below downspouts to collect rooftop runoff. The collected water has a variety of uses including watering plants and washing cars. This practice also helps cut down on the use of potable water for nondrinking purposes. It is important to divert the overflow from the rainwater harvesting system to a pervious area.

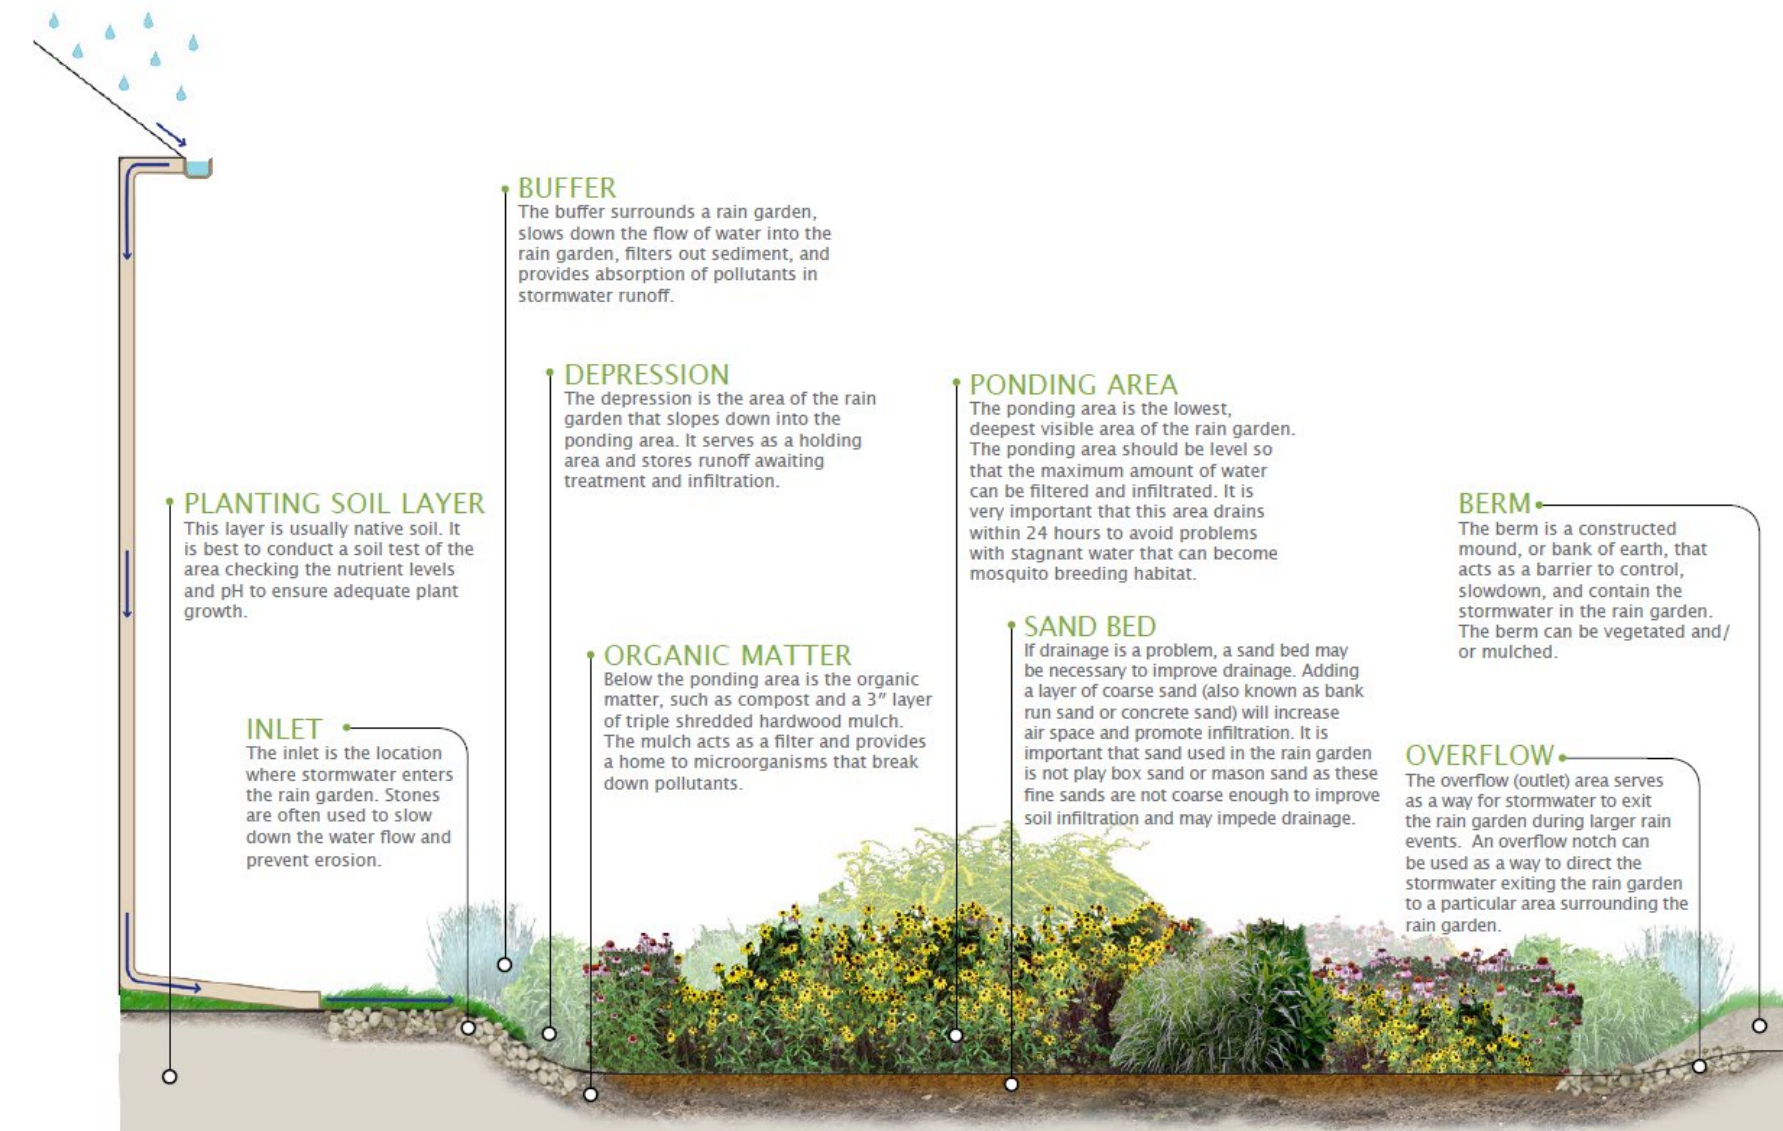
1 BIORETENTION SYSTEM

- 1 BIORETENTION SYSTEM:** Rain gardens can be installed in the turfgrass areas alongside the chapel and south of the parking lot. Rain gardens can be used to reduce sediment and nutrient loading to the local waterway and increase groundwater recharge.
- 2 DISCONNECTED DOWNSPOUTS:** Also referred to as simple disconnection, downspouts are simply disconnected and prevented from draining directly to the roadway or storm sewer system and are directed to discharge water to a pervious area (i.e., lawn).
- 3 BIOSWALE:** Bioswales are landscape features that convey stormwater from one location to another while removing pollutants and providing water an opportunity to infiltrate.

Rain garden #1 would need to be approximately 500 square feet. At \$5 per square foot, the estimated cost is \$2,500.

Rain garden #2 would need to be approximately 2,322 square feet. At \$5 per square foot, the estimated cost is \$11,610.

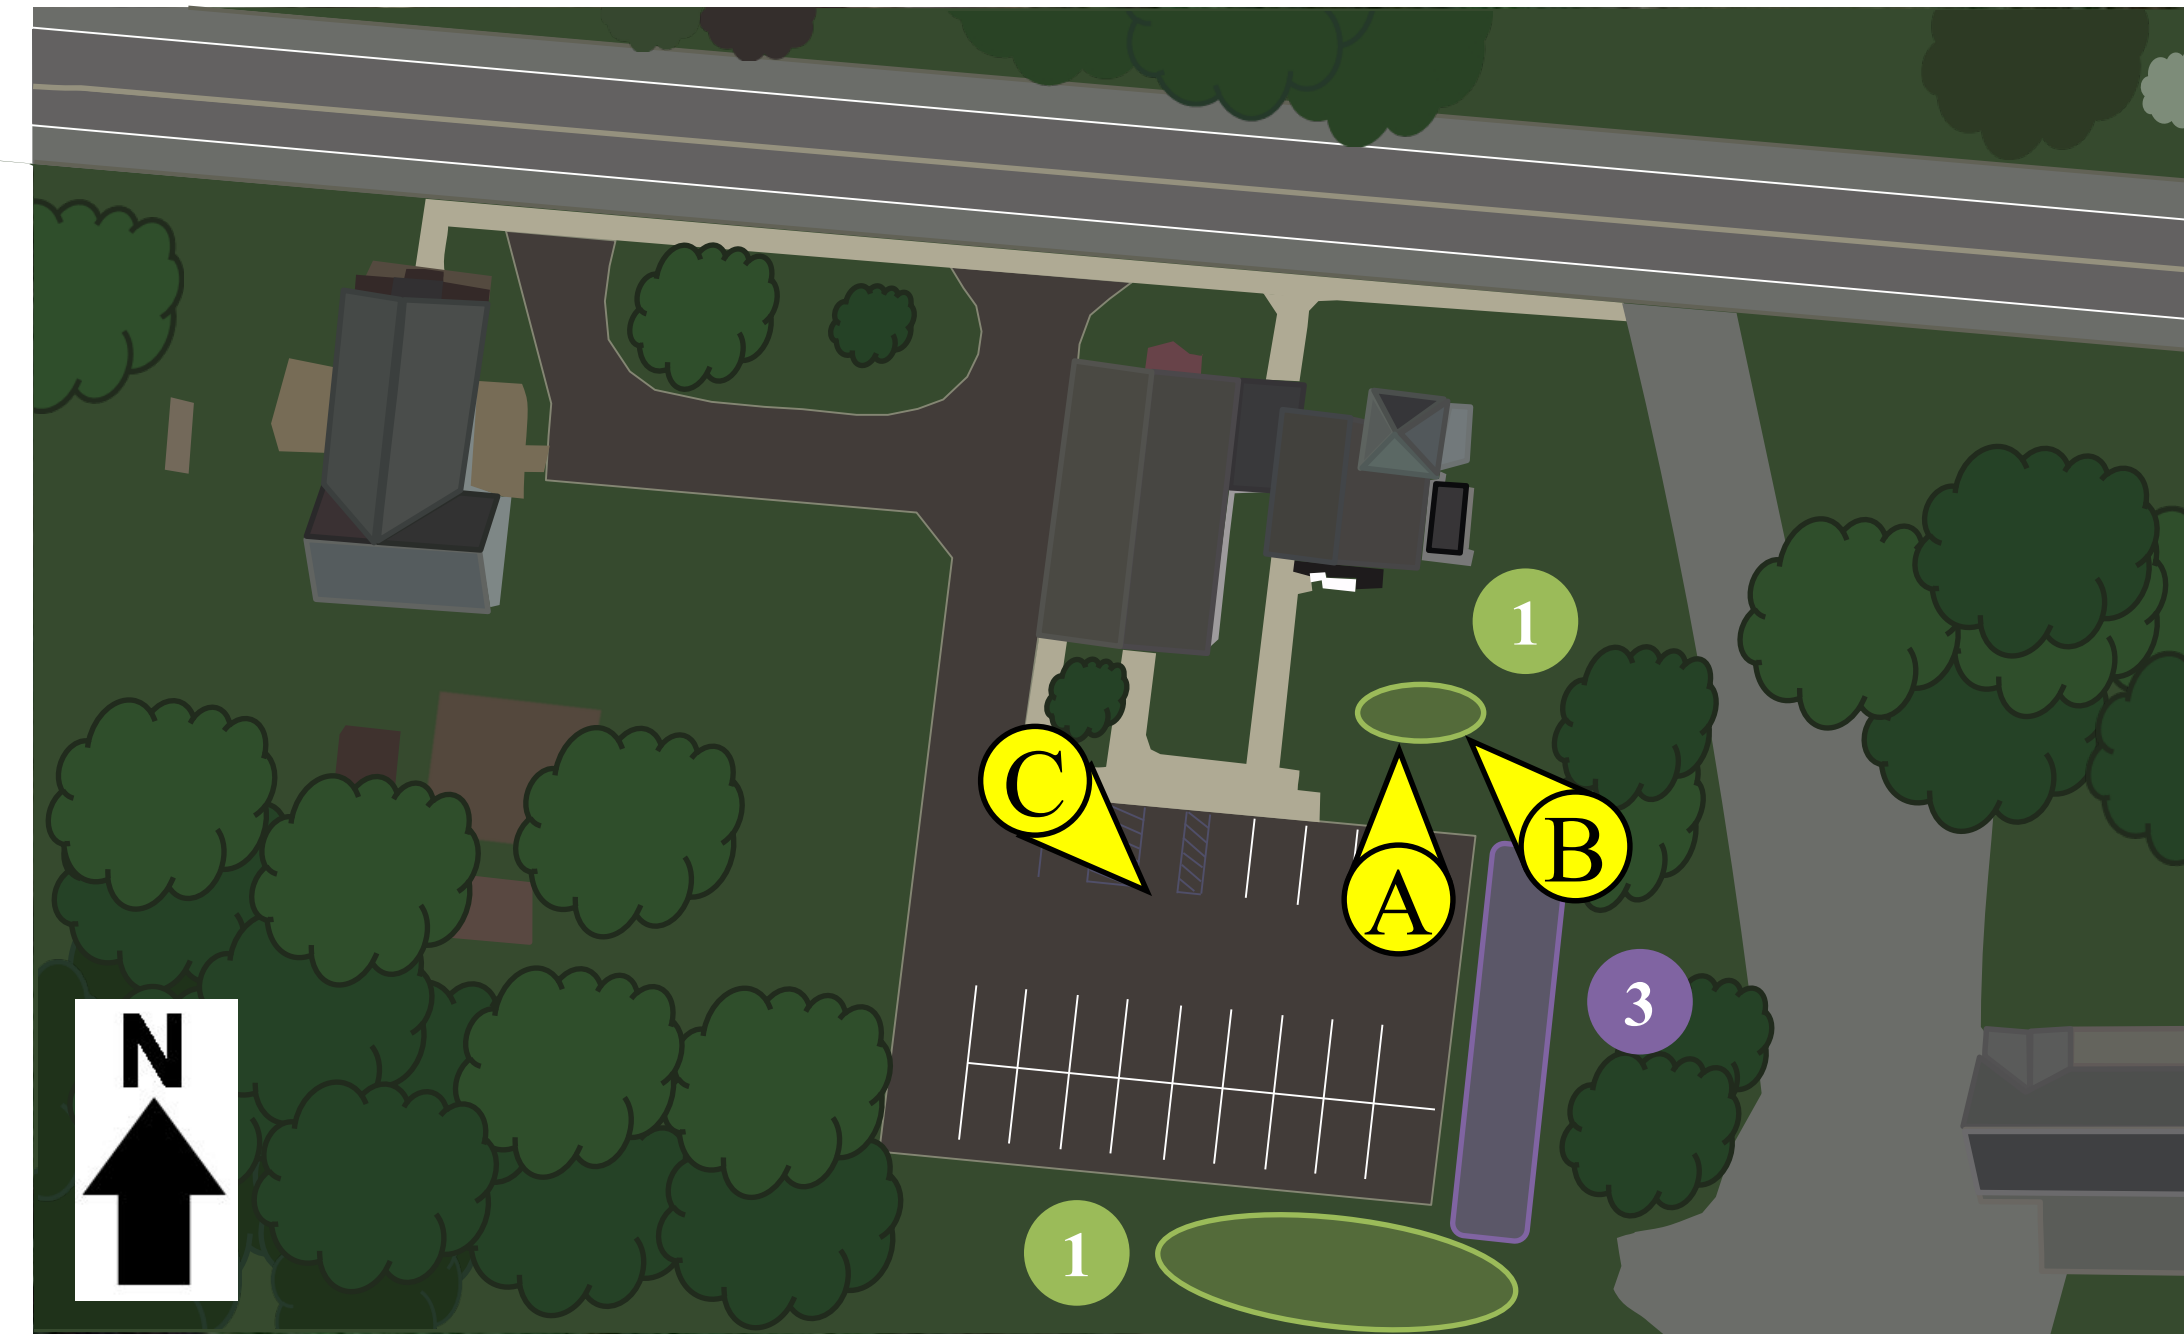
SITE PLAN:

<p>Proposed Solution(s): A rain garden could be placed near the disconnected downspouts southeast of the church to manage runoff from the roof. A bioswale could be placed along the parking lot to redirect water towards another rain garden, placed southeast of the lot.</p>	
<p>Anticipated Benefits: Since the bioretention systems would be designed to capture, treat, and infiltrate the entire 2-year design storm (3.3 inches of rain over 24 hours), these systems are estimated to reduce TN by 30%, TP by 60%, and TSS by 90%. A bioretention system would also provide ancillary benefits, such as enhanced wildlife and aesthetic appeal to nearby residents and to parishioners of Truth Bible Church.</p> <p>The bioswale will capture, treat, and infiltrate stormwater reducing TN by 30%, TP by 60%, and TSS by 90%.</p>	
<p>Possible Funding Sources: mitigation funds from local developers NJDEP grant programs Alloway Township local social and community groups</p>

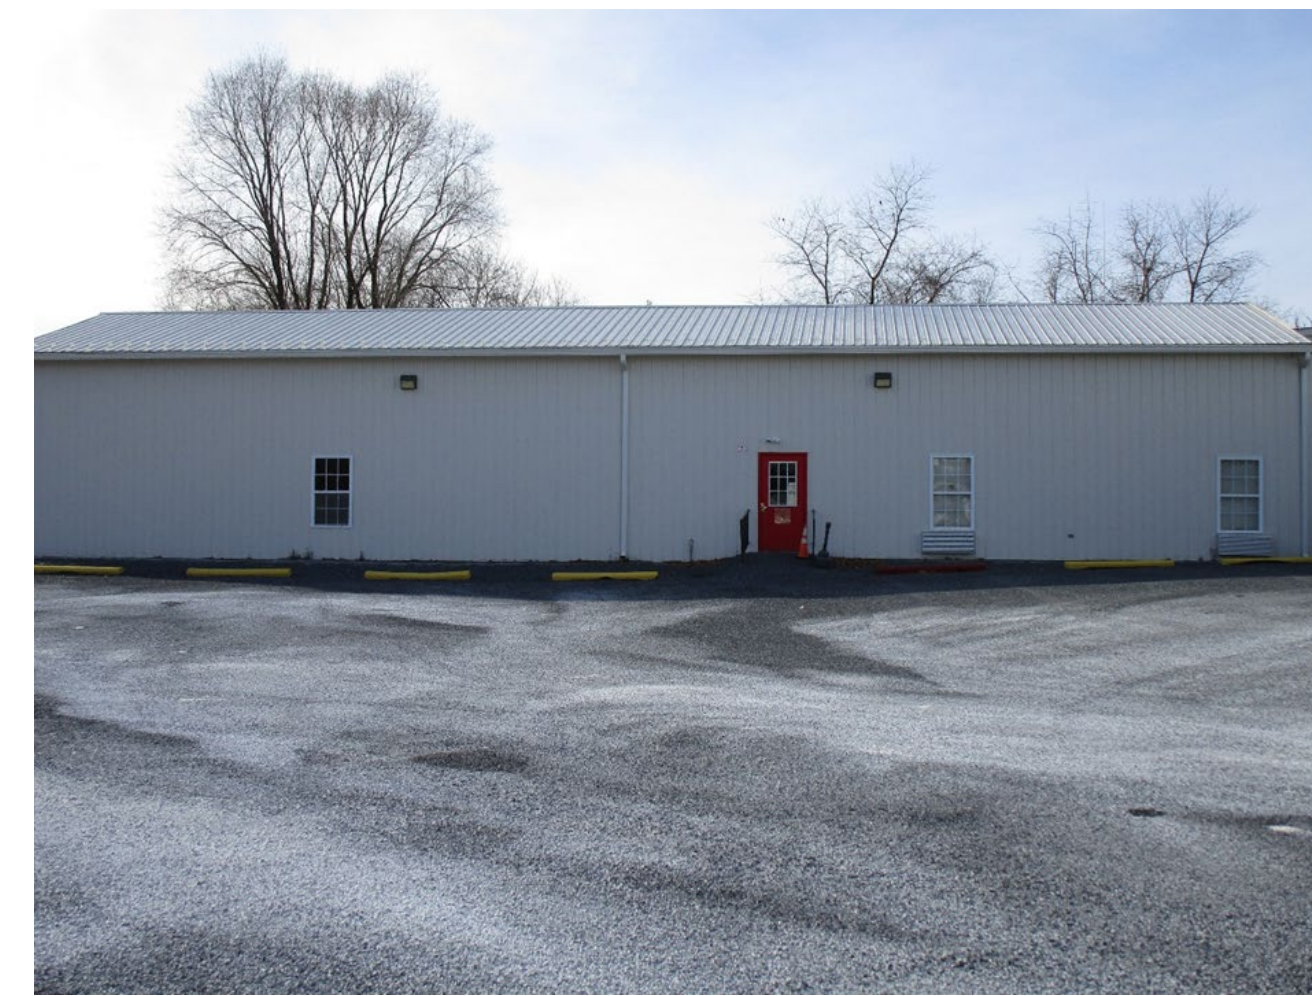
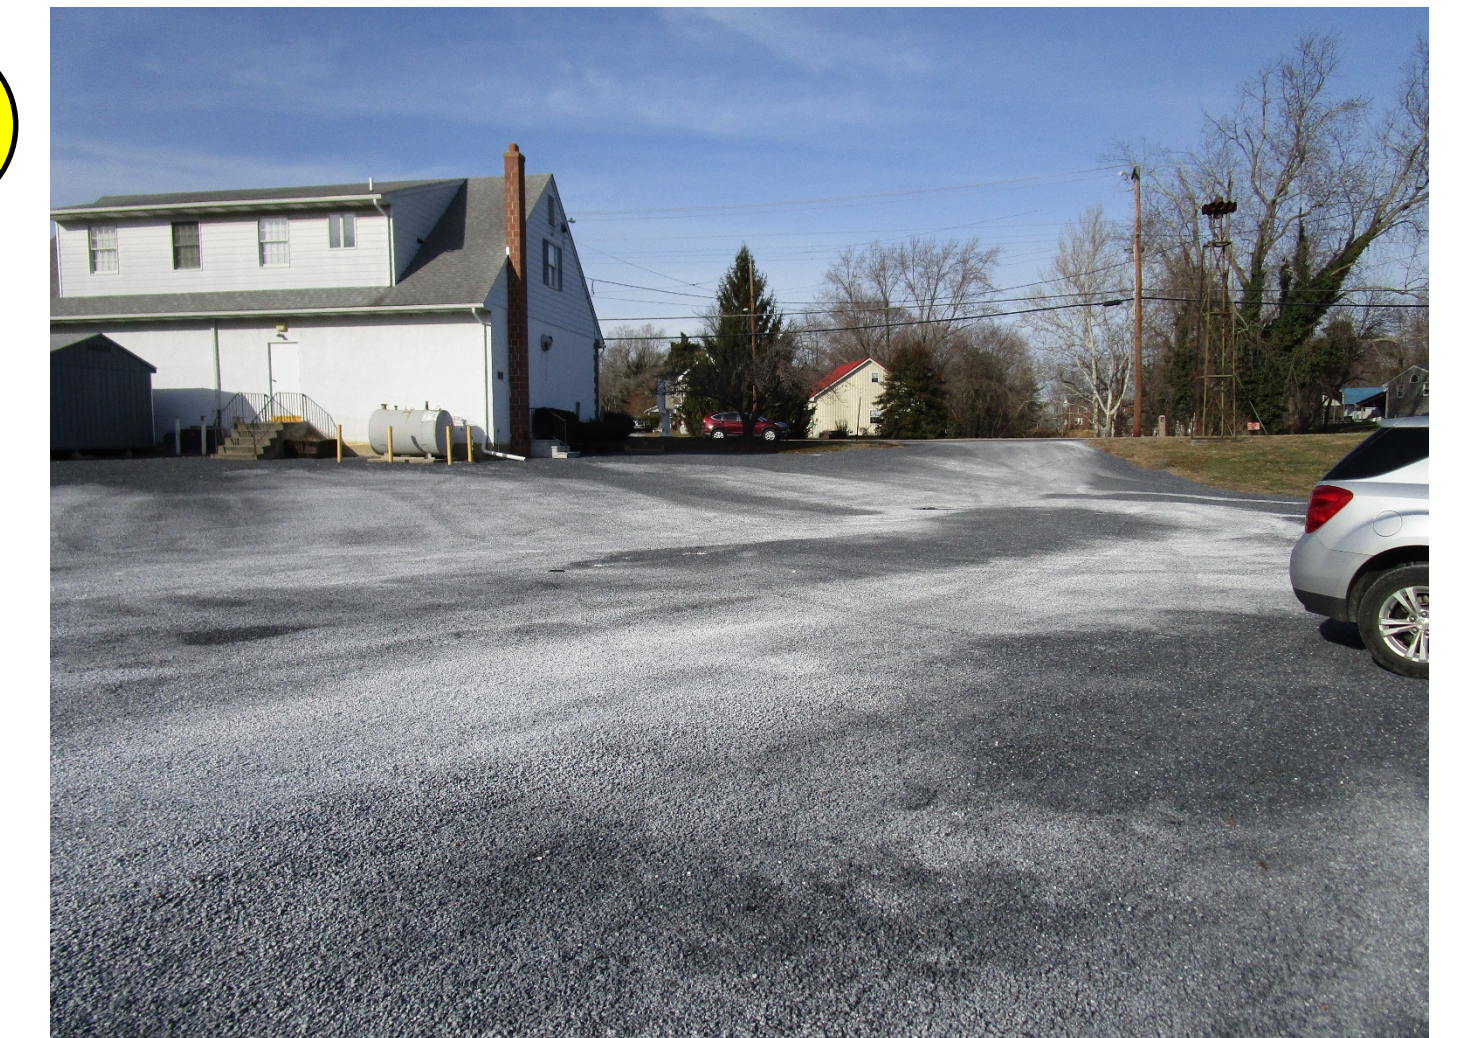
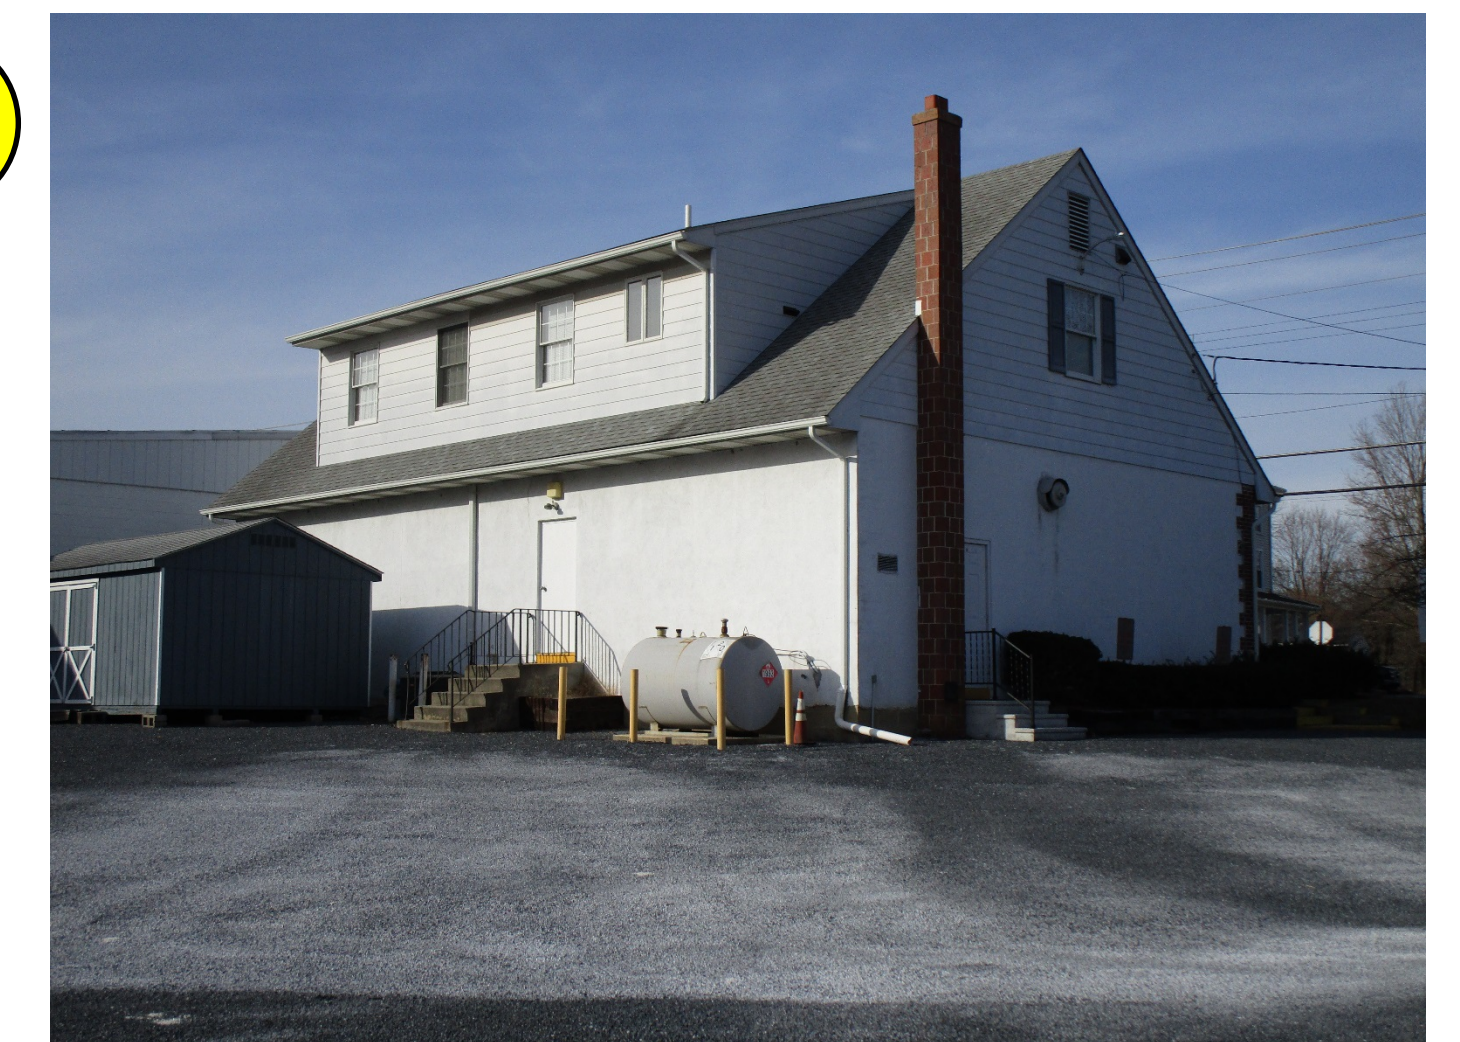
SITE PLAN:

1 RAINWATER HARVESTING SYSTEM: These systems capture rainwater, mainly from rooftops, in cisterns or rain barrels. The water can then be used for watering gardens, washing vehicles, or for other non-potable uses.

2 PERVIOUS PAVEMENT: There are several types of permeable pavement systems including porous asphalt, pervious concrete, permeable pavers, and grass pavers. These surfaces are hard and support vehicle traffic but also allow water to infiltrate through the surface. They have an underlying stone layer to store stormwater runoff and allow it to slowly seep into the ground.

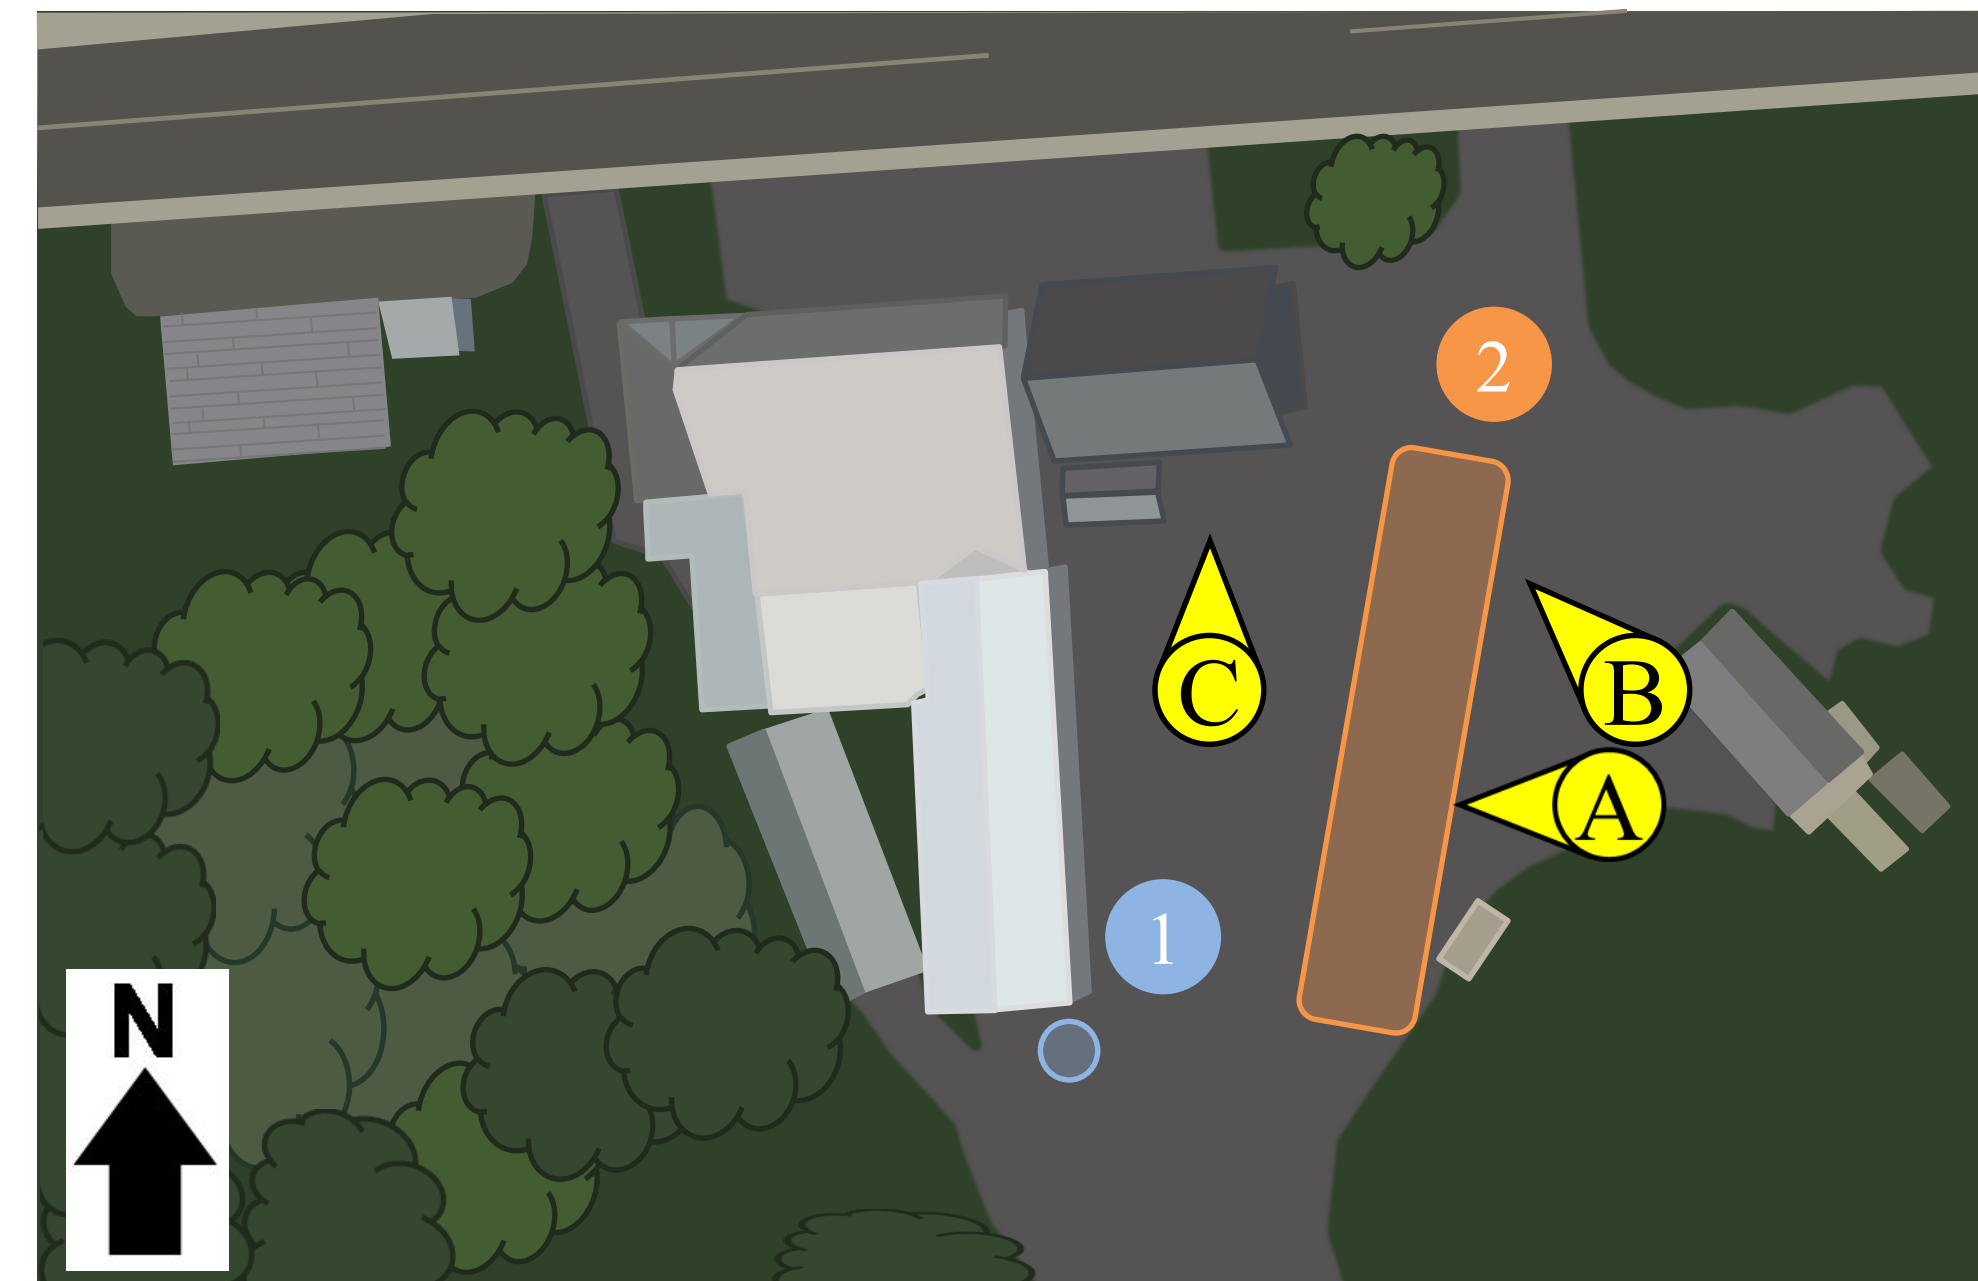
<p>Proposed Solution(s): Cisterns could be placed south of the building, with gutters pitched such that roof runoff is redirected from the downspouts and towards the rainwater harvesting systems. The rainwater in the cisterns can be used to wash the fire trucks. To capture stormwater runoff from the parking lot and from the roof of the Ambulance Corp building, a porous pavement system could be installed east of the building.</p>	
<p>Anticipated Benefits: Porous pavement allows stormwater to penetrate through to soil layers which will promote groundwater recharge as well as intercept and filter stormwater runoff.</p> <p>Cisterns can harvest stormwater which can be used for watering plants or other purposes, which cuts back on the use of potable water for nondrinking purposes. Since the rainwater harvesting system would be designed to capture the first 1.25 inches of rain, it would reduce the pollutant loading by 90% during the periods it is operational (i.e., it would not be used in the winter when there is a chance of freezing).</p>

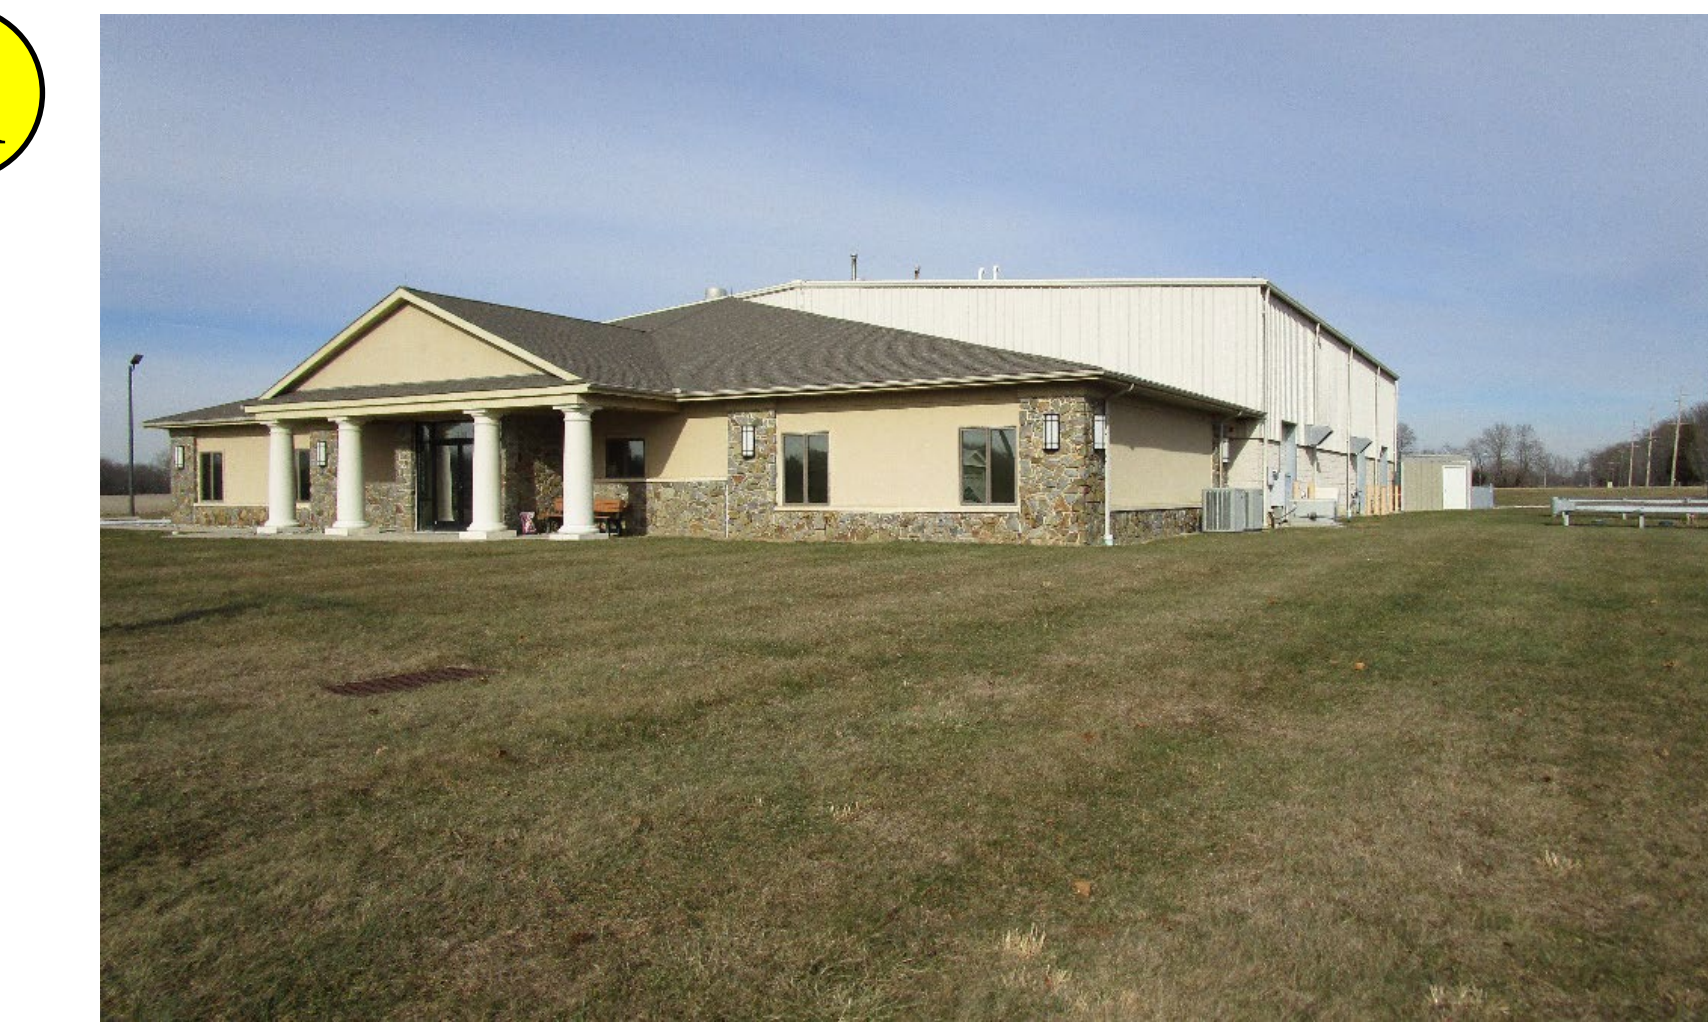
SITE PLAN:

<p>Proposed Solution(s): Porous pavement can be installed in both of the northernmost sets of parking spaces to capture runoff from the parking lot. In the turfgrass area south of the building, a rain garden could be installed to capture roof runoff and mitigate water flow through the clearing. A bioswale can be placed east of the main entrance to direct roof runoff towards the rain garden. The downspouts can then be disconnected so roof runoff flows into the bioswale, rain garden, and permeable pavement rather than into the sewer system.</p>	
<p>Anticipated Benefits: Since the bioretention systems would be designed to capture, treat, and infiltrate the entire 2-year design storm (3.3 inches of rain over 24 hours), these systems are estimated to reduce TN by 30%, TP by 60%, and TSS by 90%. A bioretention system would also provide ancillary benefits, such as enhanced wildlife and aesthetic appeal to local residents and patrons of the Glass Center.</p> <p>The bioswale will capture, treat, and infiltrate stormwater, reducing TN by 30%, TP by 60%, and TSS by 90%.</p> <p>Porous pavement allows stormwater to penetrate through to soil layers, which will promote groundwater recharge as well as intercept and filter stormwater runoff. The porous pavement system will achieve the same level of pollutant load reduction for TN, TP, and TSS as the bioretention system.</p>
