**Impervious Cover Assessment
for
Buena Borough, Atlantic County, New Jersey**

*Prepared for Buena Borough by the
Rutgers Cooperative Extension Water Resources Program*

March 27, 2018

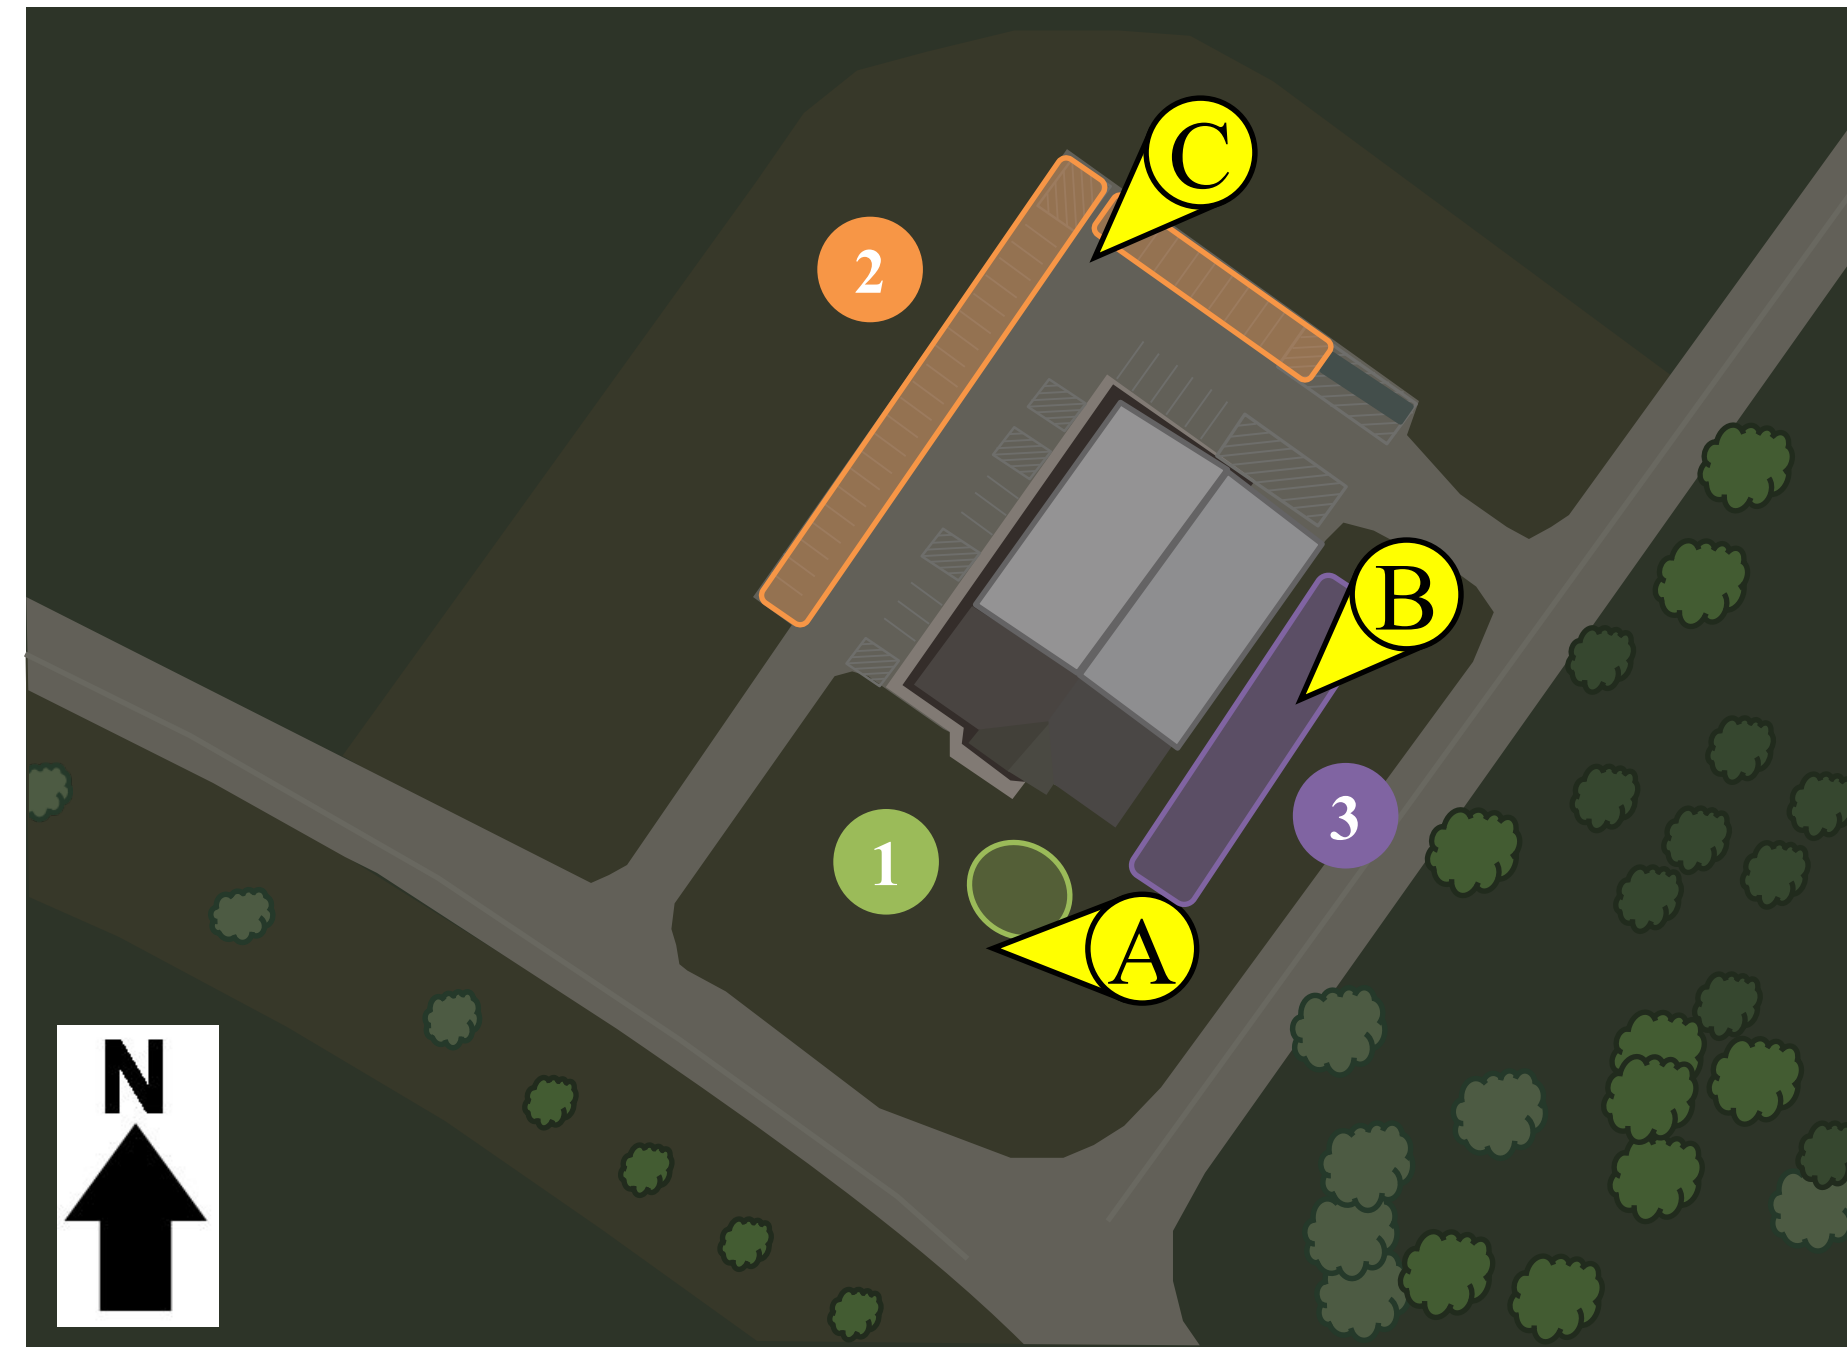
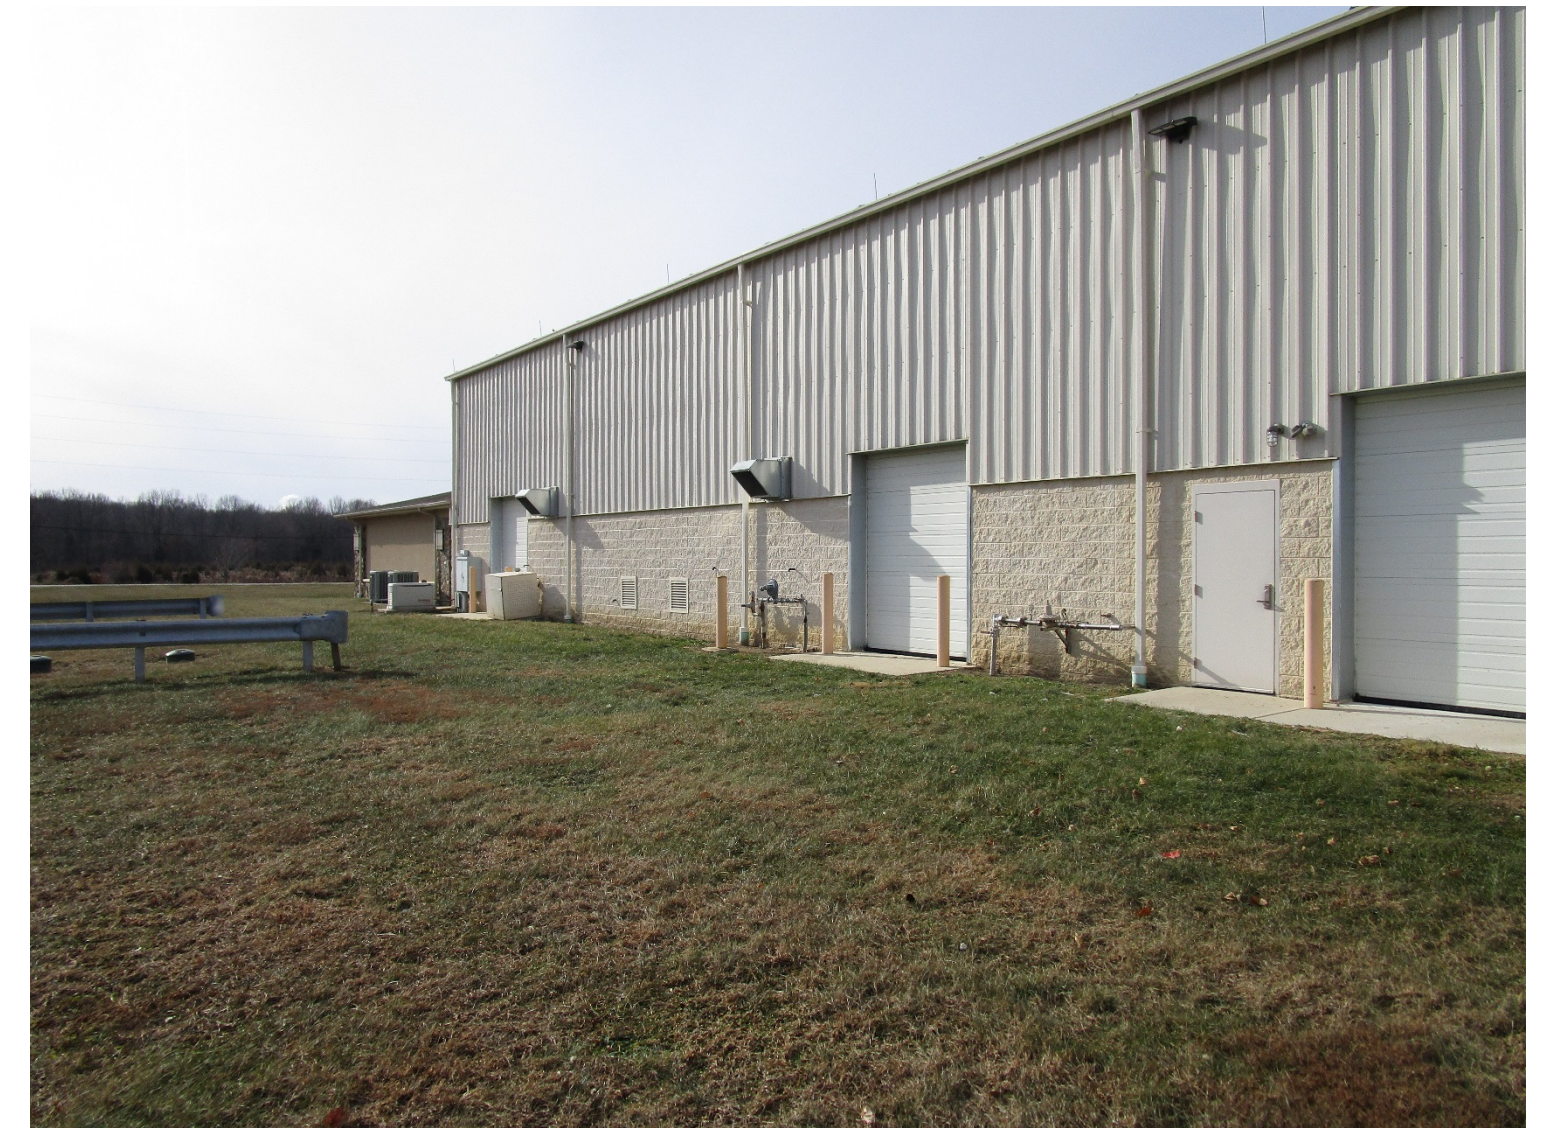
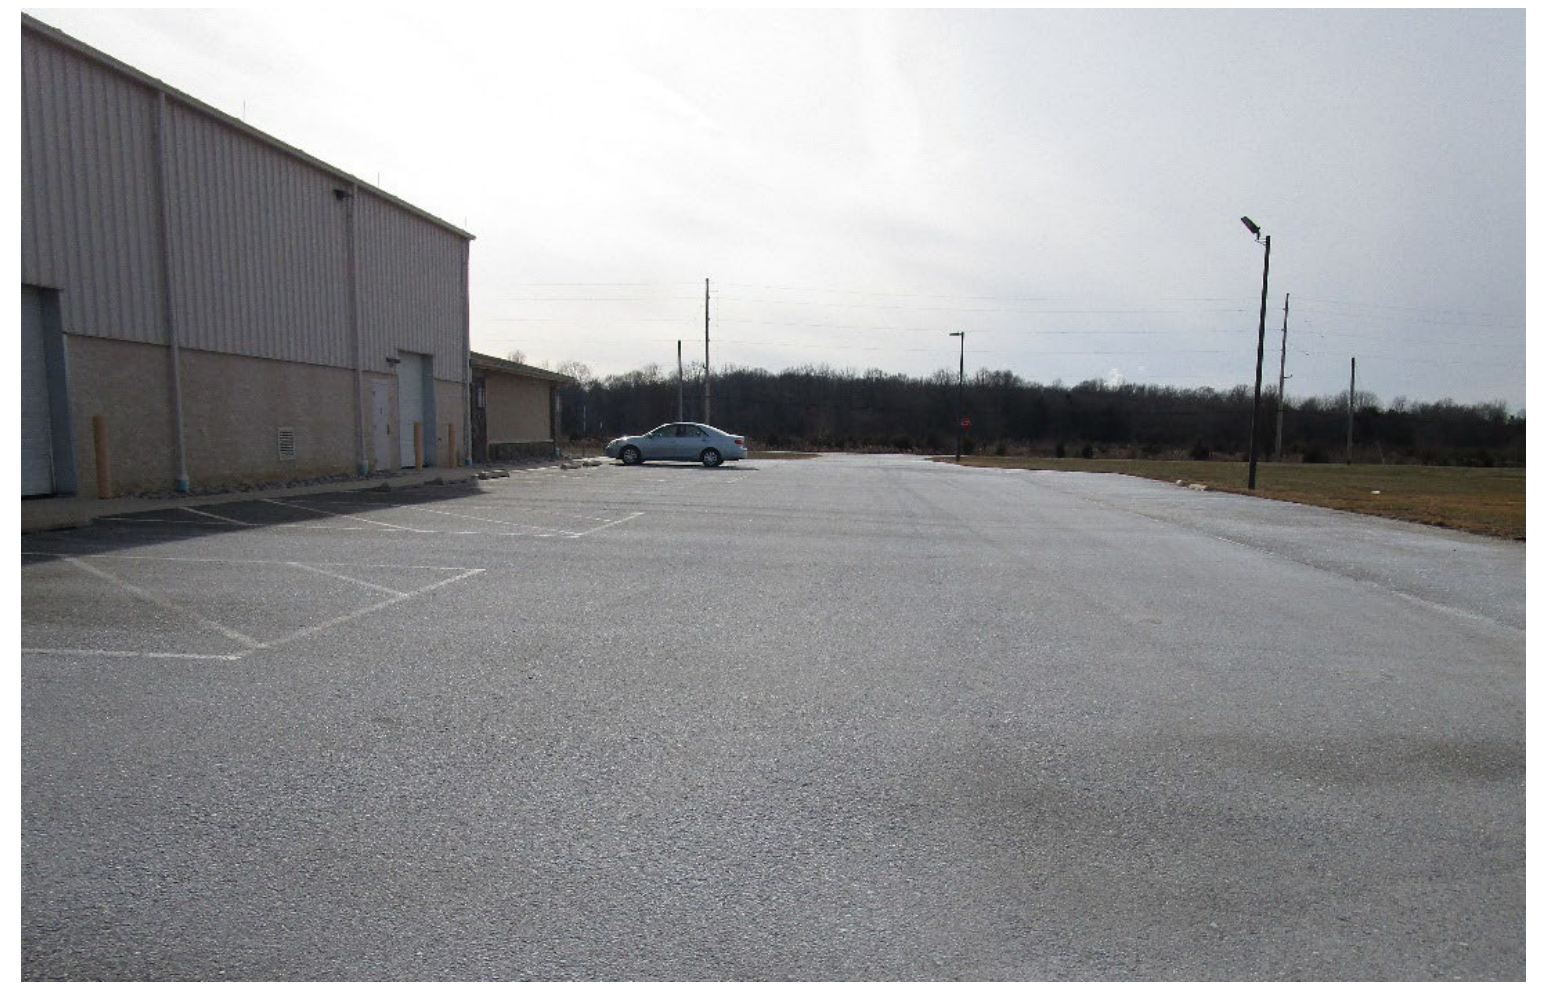
SITE PLAN:

- 1 BIORETENTION SYSTEM:** A rain garden can be installed in the turfgrass area alongside the building. Rain gardens can be used to reduce sediment and nutrient loading to the local waterway and increase groundwater recharge.
- 2 PERVIOUS PAVEMENT:** Porous pavement promotes groundwater recharge and filters stormwater.
- 3 BIOSWALE:** Bioswales are landscape features that convey stormwater from one location to another while removing pollutants and providing water an opportunity to infiltrate.
