**Impervious Cover Assessment
for
Manchester Township, Ocean County, New Jersey**

*Prepared for Manchester Township by the
Rutgers Cooperative Extension Water Resources Program*

March 26, 2020

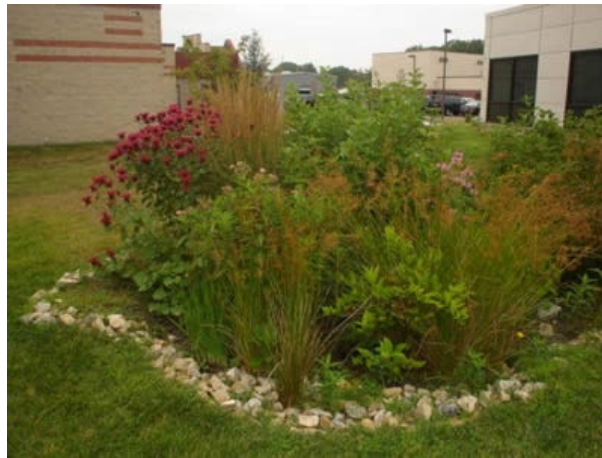
Figure 7: Rain garden outside the RCE of Gloucester County office which was designed to disconnect rooftop runoff from the local storm sewer system

- Rain Gardens: Stormwater can be diverted into shallow landscaped depressed areas (i.e., rain gardens) where the vegetation filters the water, and it is allowed to soak into the ground. Rain gardens, also known as bioretention systems, come in all shapes and sizes and can be designed to disconnect a variety of impervious surfaces (Figure 7).

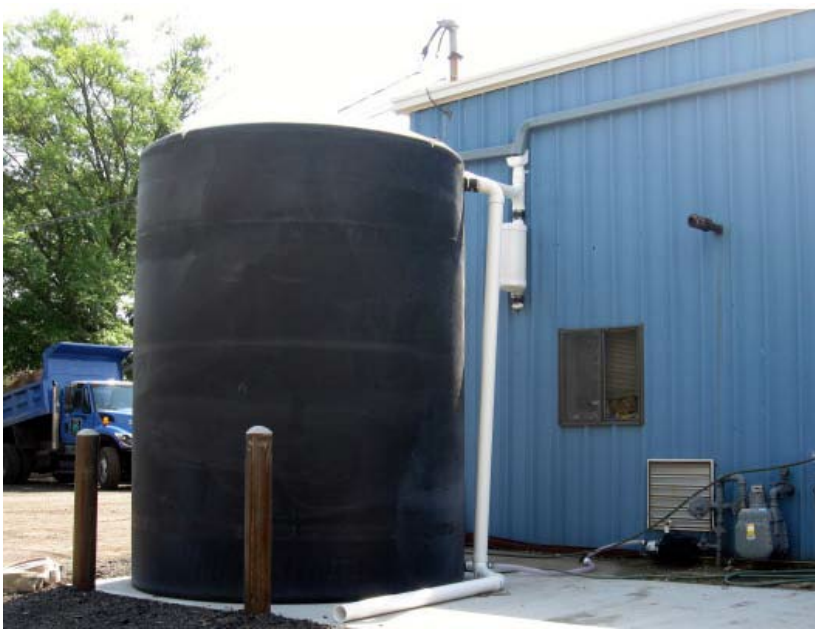
Figure 8b: A 5,000 gallon cistern used to disconnect the rooftop of the Department of Public Works in Clark Township to harvest rainwater for nonprofit car wash events

- Rainwater Harvesting: Rainwater harvesting includes the use of rain barrels and cisterns (Figures 8a and 8b). These can be placed below downspouts to collect rooftop runoff. The collected water has a variety of uses including watering plants and washing cars. This practice also helps cut down on the use of potable water for nondrinking purposes. It is important to divert the overflow from the rainwater harvesting system to a pervious area.

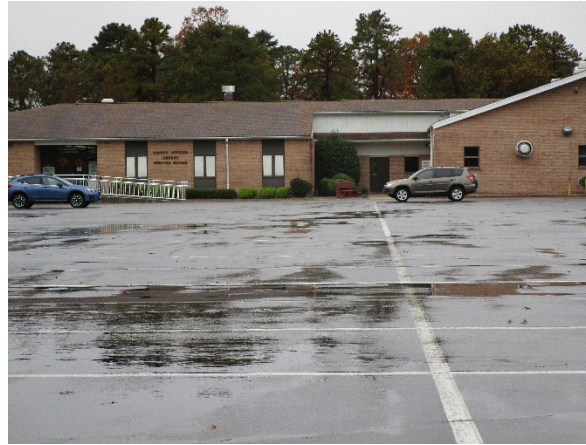
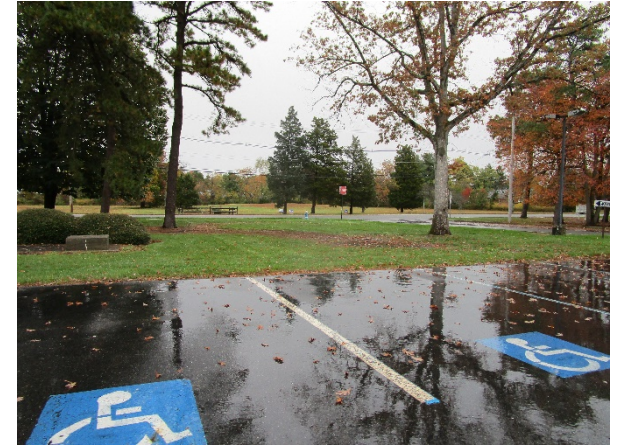
SAINT ELIZABETH ANN SETON CHURCH

Parking spaces can be converted to porous pavement to capture and infiltrate stormwater runoff from the parking lot. Rain gardens can be installed in the turfgrass area on the eastern corner to capture, treat, and infiltrate stormwater runoff from the lot and in front of the building to capture rooftop runoff.

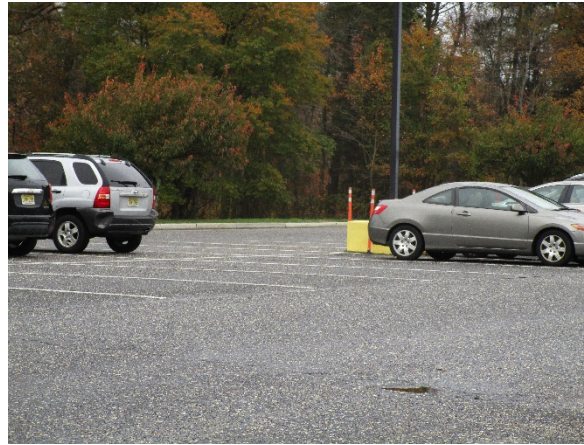
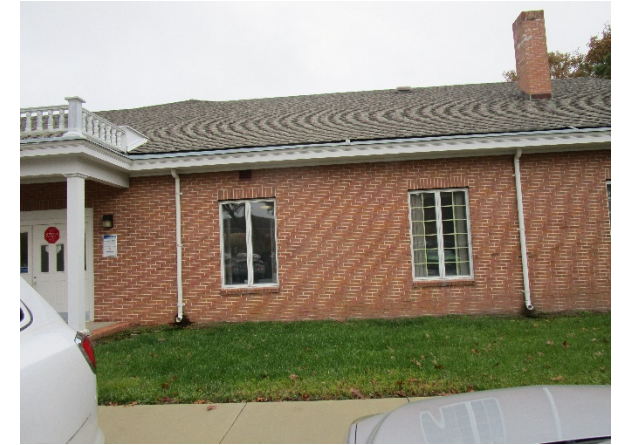
OCEAN COUNTY LIBRARY

Parking spaces in the parking lot can be converted to porous pavement to capture and infiltrate stormwater runoff from the parking lot. Rain gardens can be installed in the turfgrass areas around the building to capture, treat, and infiltrate stormwater runoff from the roof.
