Irrigation Efficiency Study in Belmar

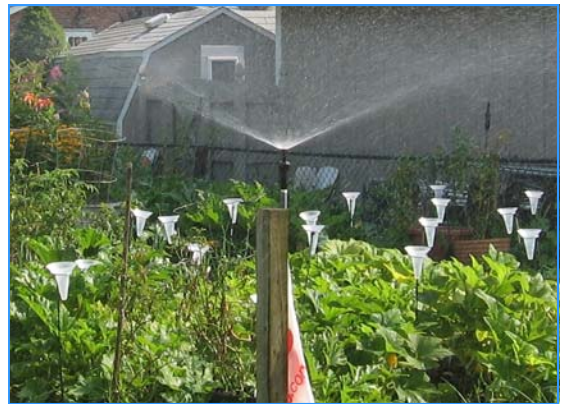
Irrigation efficiency audit conducted at the Magical Garden co-op, Belmar, N.J.

The audit revealed that the existing irrigation system was inefficient with a Distribution Uniformity (DU_{LQ}) of 38.31%. By replacing the sprinkler heads with new MP Rotator nozzles, the Magical Garden now properly irrigates the garden on forty-two percent (42%) of the water that was required with the old nozzles.
