**Impervious Cover Assessment
for
Franklin Township, Somerset County, New Jersey**

*Prepared for Franklin Township by the
Rutgers Cooperative Extension Water Resources Program*

Updated February 24, 2021

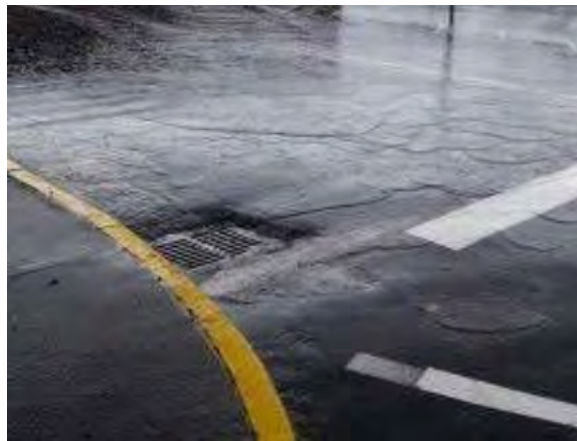
Figure 1: Stormwater draining from a parking lot

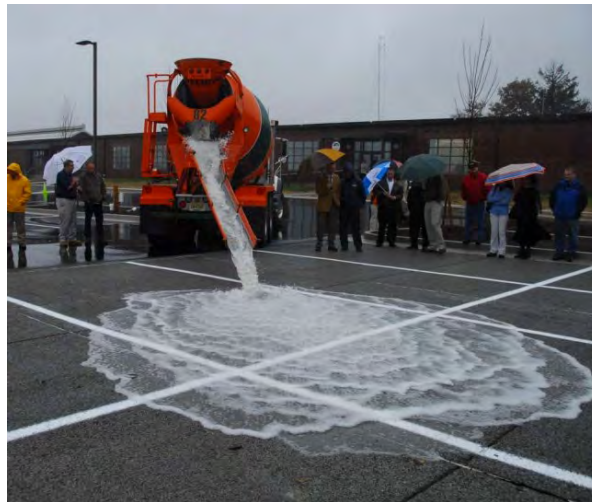
Figure 2: Rapid infiltration of water through porous pavement is demonstrated at the USEPA Edison New Jersey test site

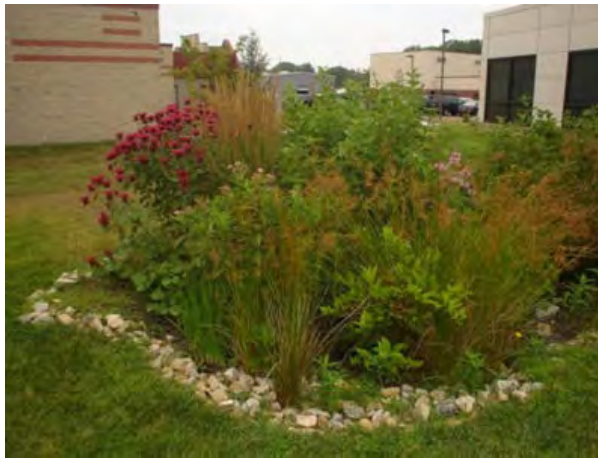
Figure 7: Rain garden outside the RCE of Gloucester County office which was designed to disconnect rooftop runoff from the local storm sewer system

- Rain Gardens: Stormwater can be diverted into shallow landscaped depressed areas (i.e., rain gardens) where the vegetation filters the water, and it is allowed to soak into the ground. Rain gardens, also known as bioretention systems, come in all shapes and sizes and can be designed to disconnect a variety of impervious surfaces (Figure 7).

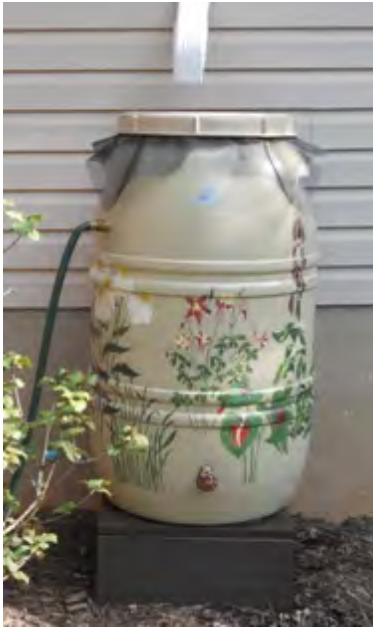
Figure 8a: Rain barrel used to disconnect a downspout with the overflow going to a flower bed

- Rainwater Harvesting: Rainwater harvesting includes the use of rain barrels and cisterns (Figures 8a and 8b). These can be placed below downspouts to collect rooftop runoff. The collected water has a variety of uses including watering plants and washing cars. This practice also helps cut down on the use of potable water for nondrinking purposes. It is important to divert the overflow from the rainwater harvesting system to a pervious area.

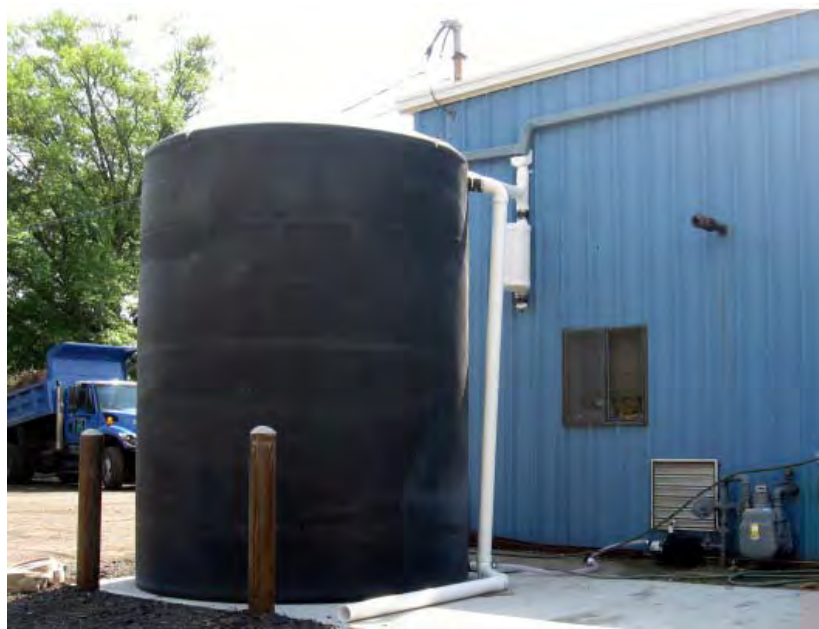
Figure 8b: A 5,000 gallon cistern used to disconnect the rooftop of the Department of Public Works in Clark Township to harvest rainwater for nonprofit car wash events

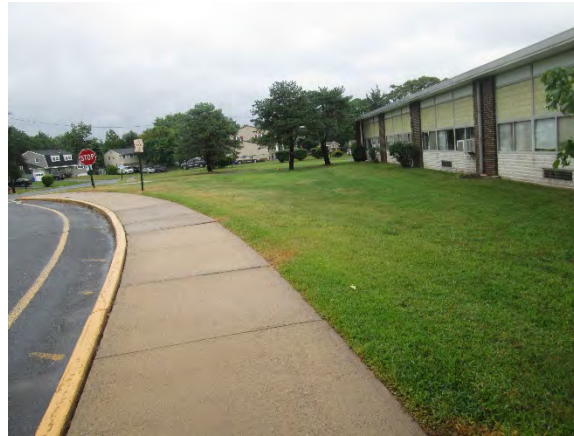
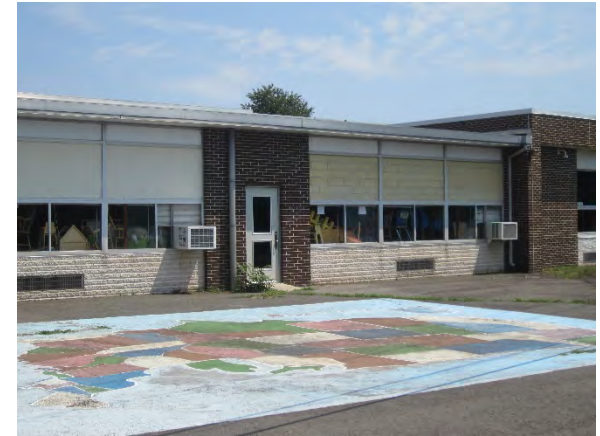
CONERLY ROAD SCHOOL

Rain gardens can be installed to capture, treat, and infiltrate roof runoff by disconnecting and redirecting nearby downspouts. These rain gardens can serve as an educational tool for students to learn about stormwater management using green infrastructure. The two play areas at the back of the school are suitable for replacement with porous asphalt. In addition, parking spaces can also be replaced with pervious pavement to capture and infiltrate stormwater.

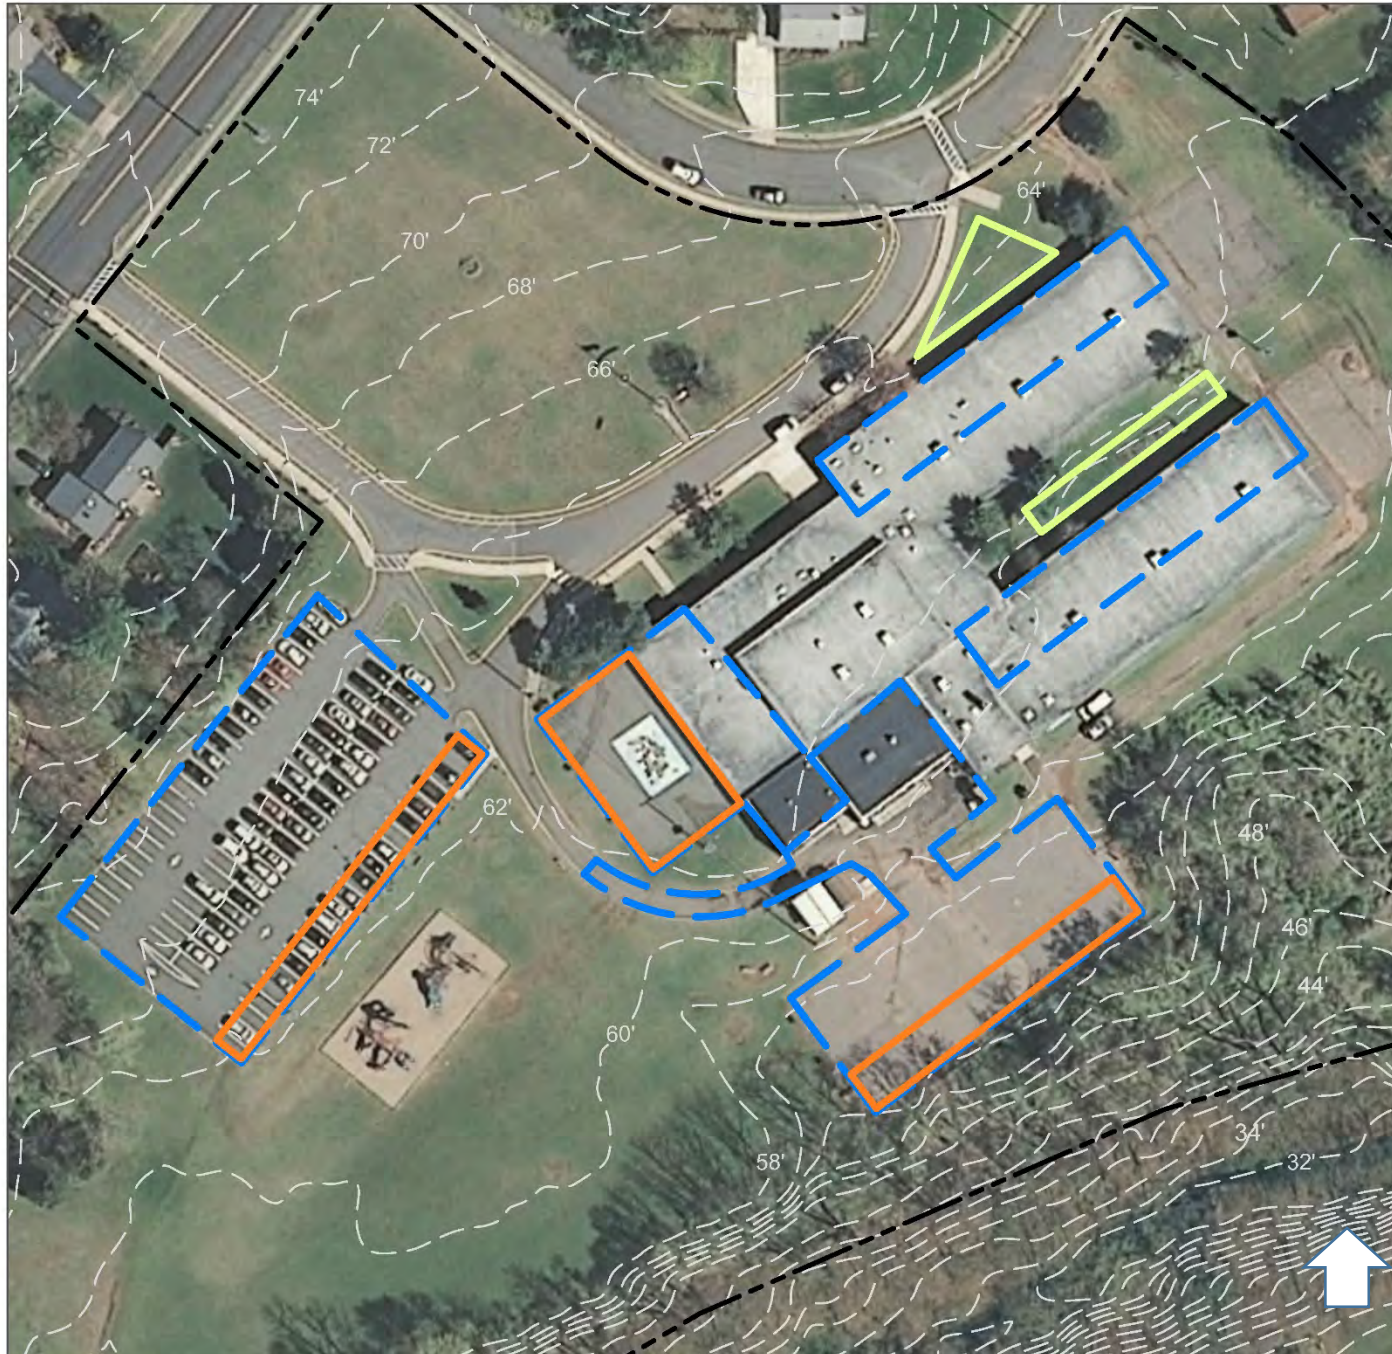
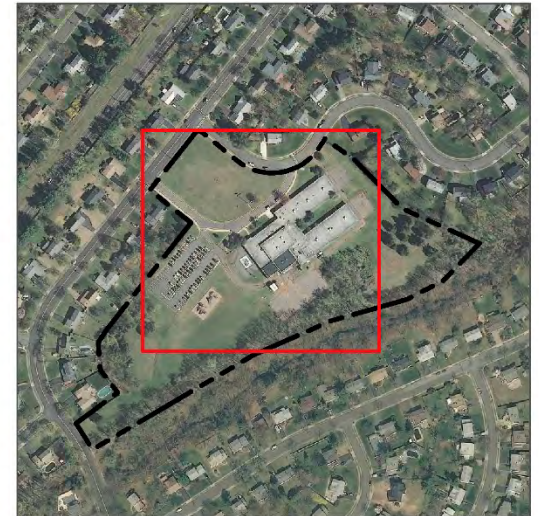
Conerly Road School

pervious pavement
-

bioretention system
-

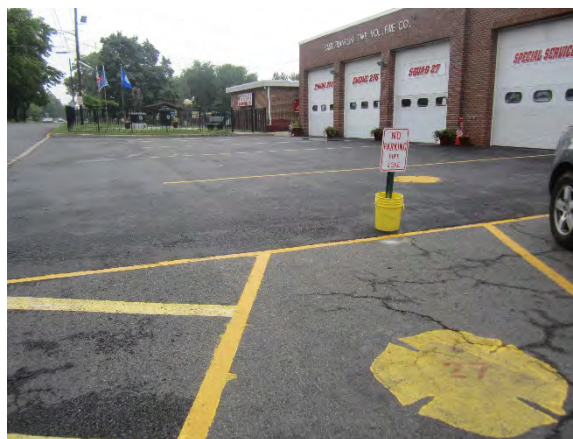
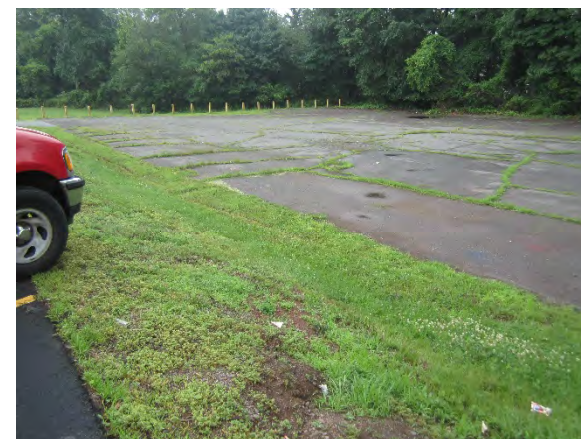
EAST FRANKLIN FIRE COMPANY

A rain garden can be installed in the turfgrass area to the south of the parking area to capture, treat, and infiltrate stormwater runoff from a portion of the parking lot. Another rain garden can also be installed to capture rooftop runoff from the downspouts on the building.

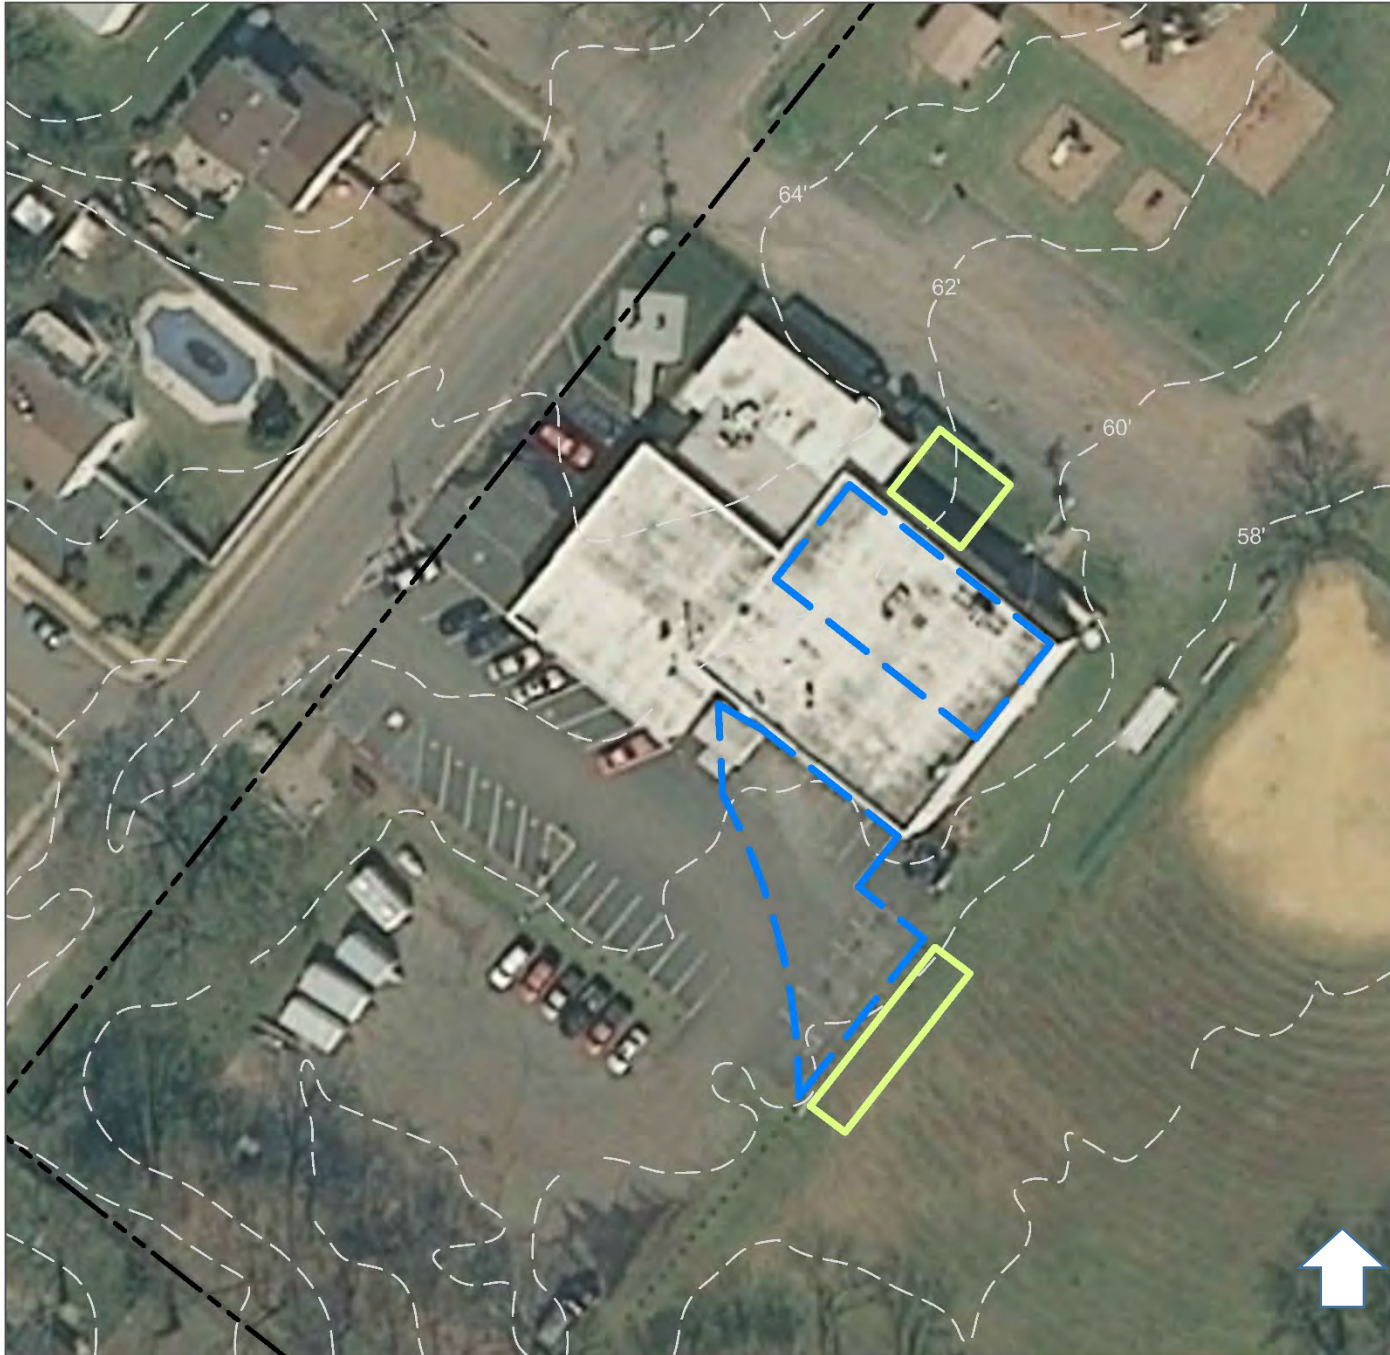
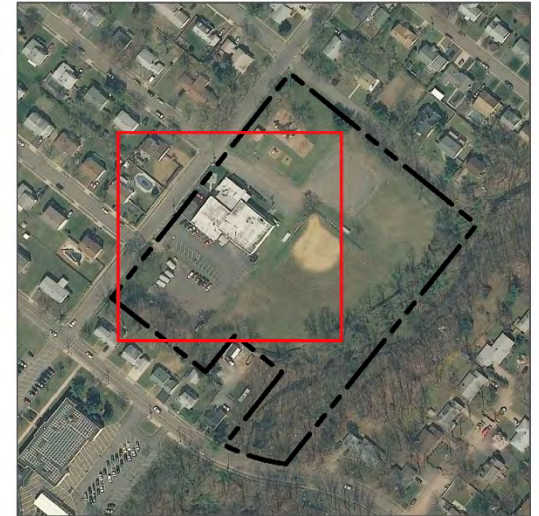
East Franklin Firehouse Company

bioretention system
-

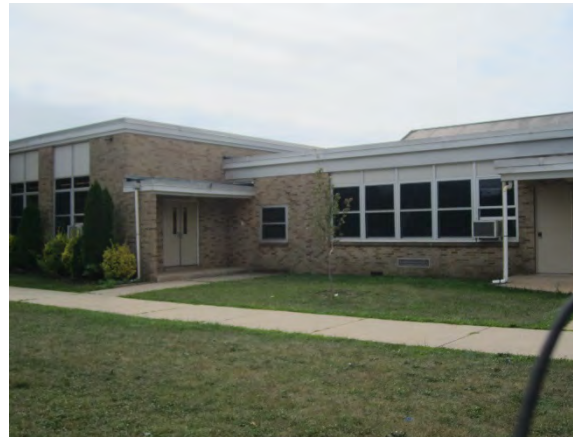
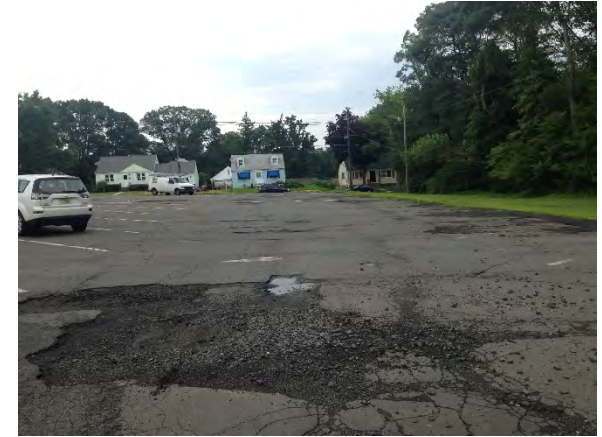
PINE GROVE MANOR SCHOOL

Parking spaces can be replaced with pervious pavement to capture and infiltrate stormwater. A rain garden can be installed in the turfgrass area adjacent to the parking lot to capture and infiltrate additional runoff from the parking lot. Another rain garden can be installed near the main entrance of the school to manage rooftop runoff from the building.

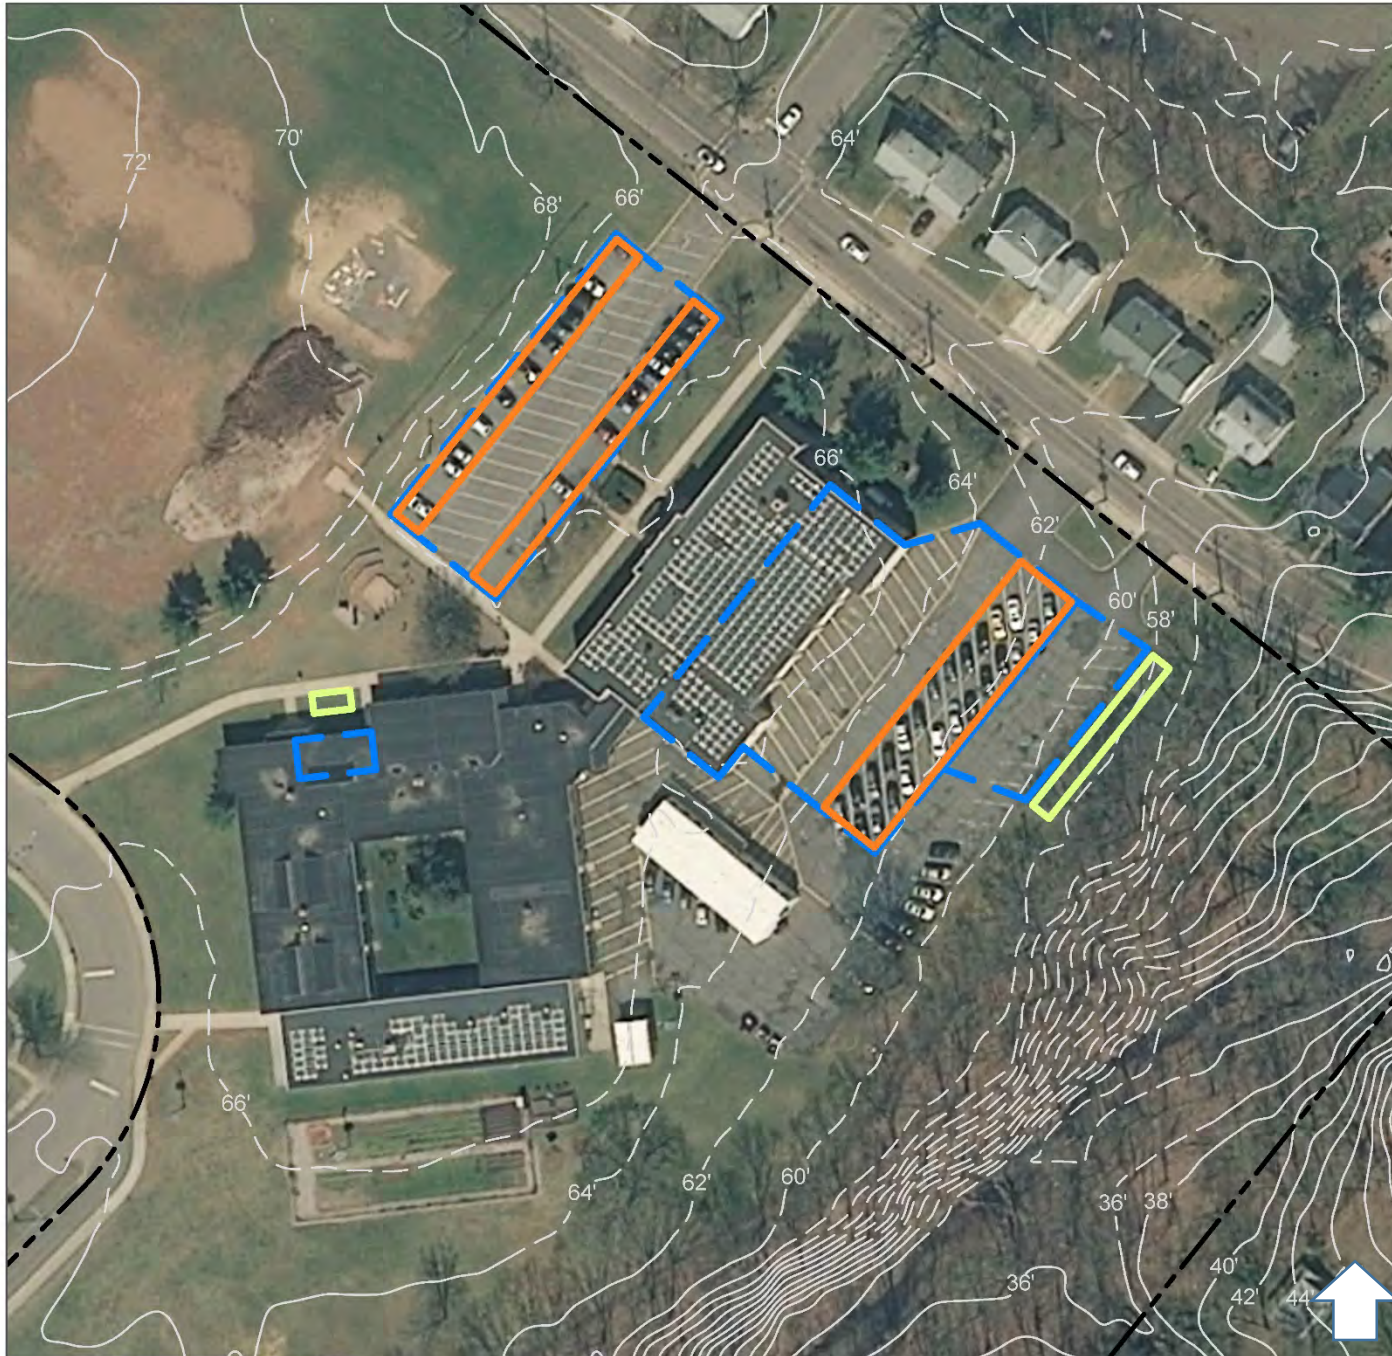
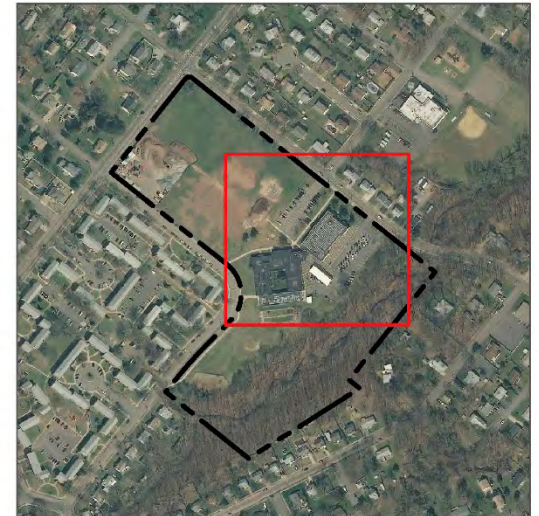
Pine Grove Manor School

pervious pavement
-

bioretention system
-
