**Impervious Cover Assessment
for
Hamilton Township, Atlantic County, New Jersey**

*Prepared for Hamilton Township by the
Rutgers Cooperative Extension Water Resources Program*

February 3, 2021

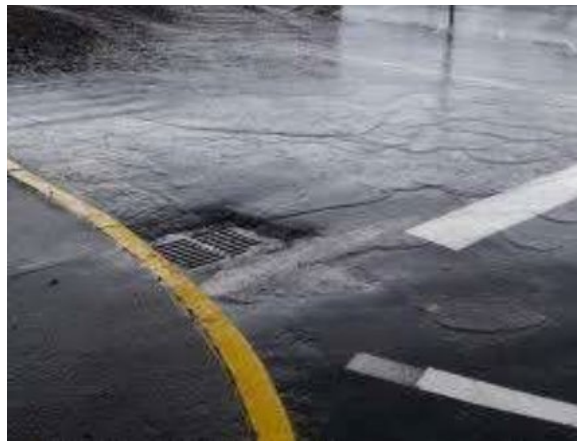
Figure 1: Stormwater draining from a parking lot

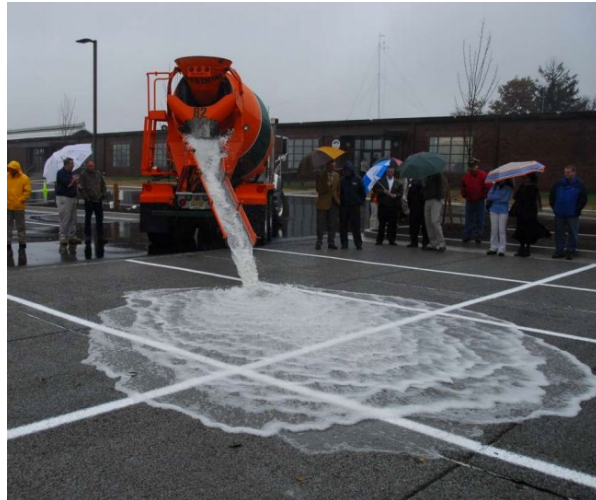
Figure 2: Rapid infiltration of water through porous pavement is demonstrated at the USEPA Edison New Jersey test site

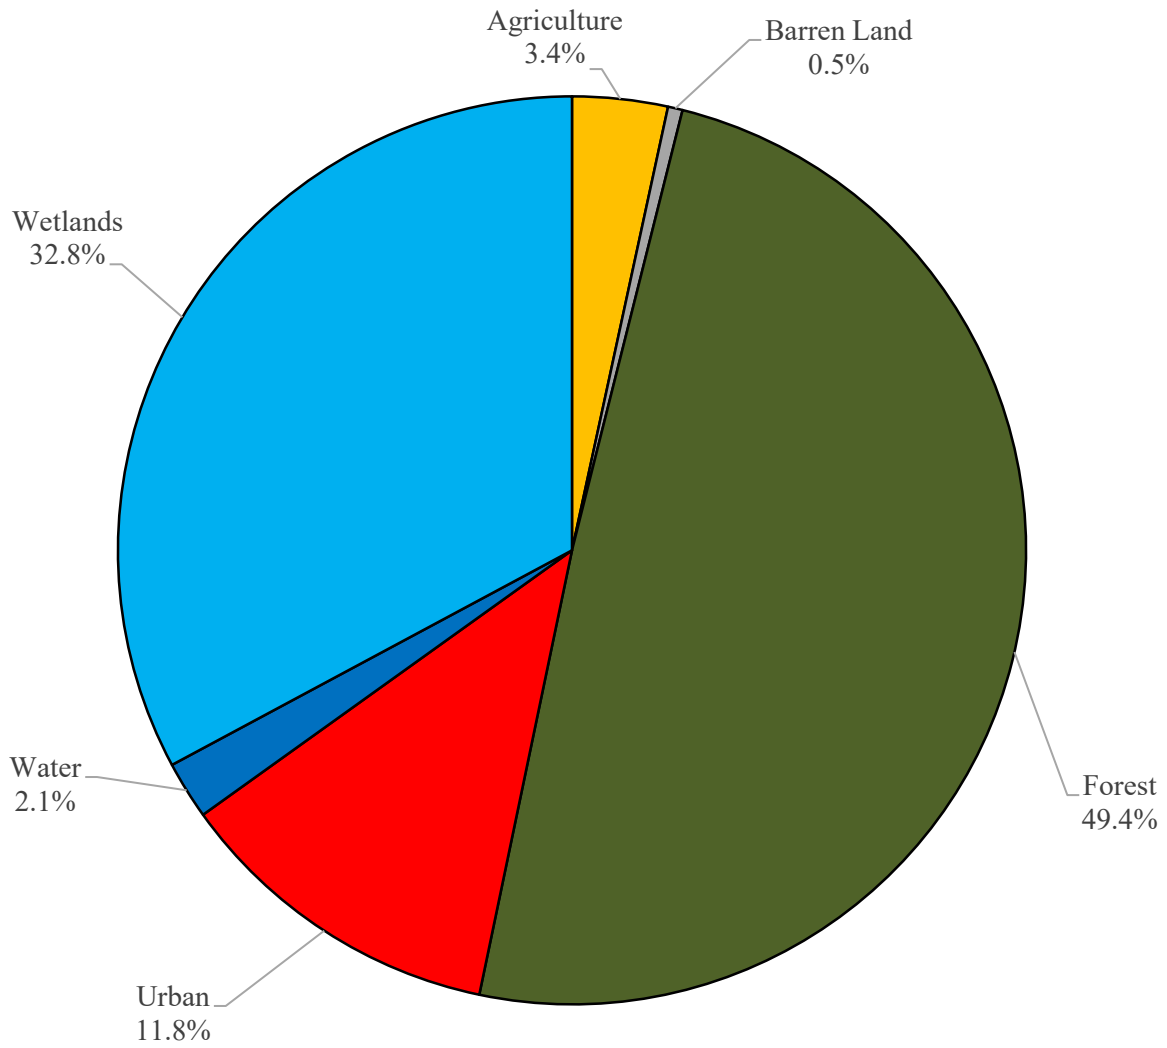
Figure 3: Pie chart illustrating the land use in Hamilton Township

Hamilton Township is located in Atlantic County, New Jersey and covers approximately 112.94 square miles. Figures 3 and 4 illustrate that Hamilton Township is dominated by forest land uses. A total of 11.8% of the municipality's land use is classified as urban. Of the urban land in Hamilton Township, rural residential is the dominant land use (Figure 5).

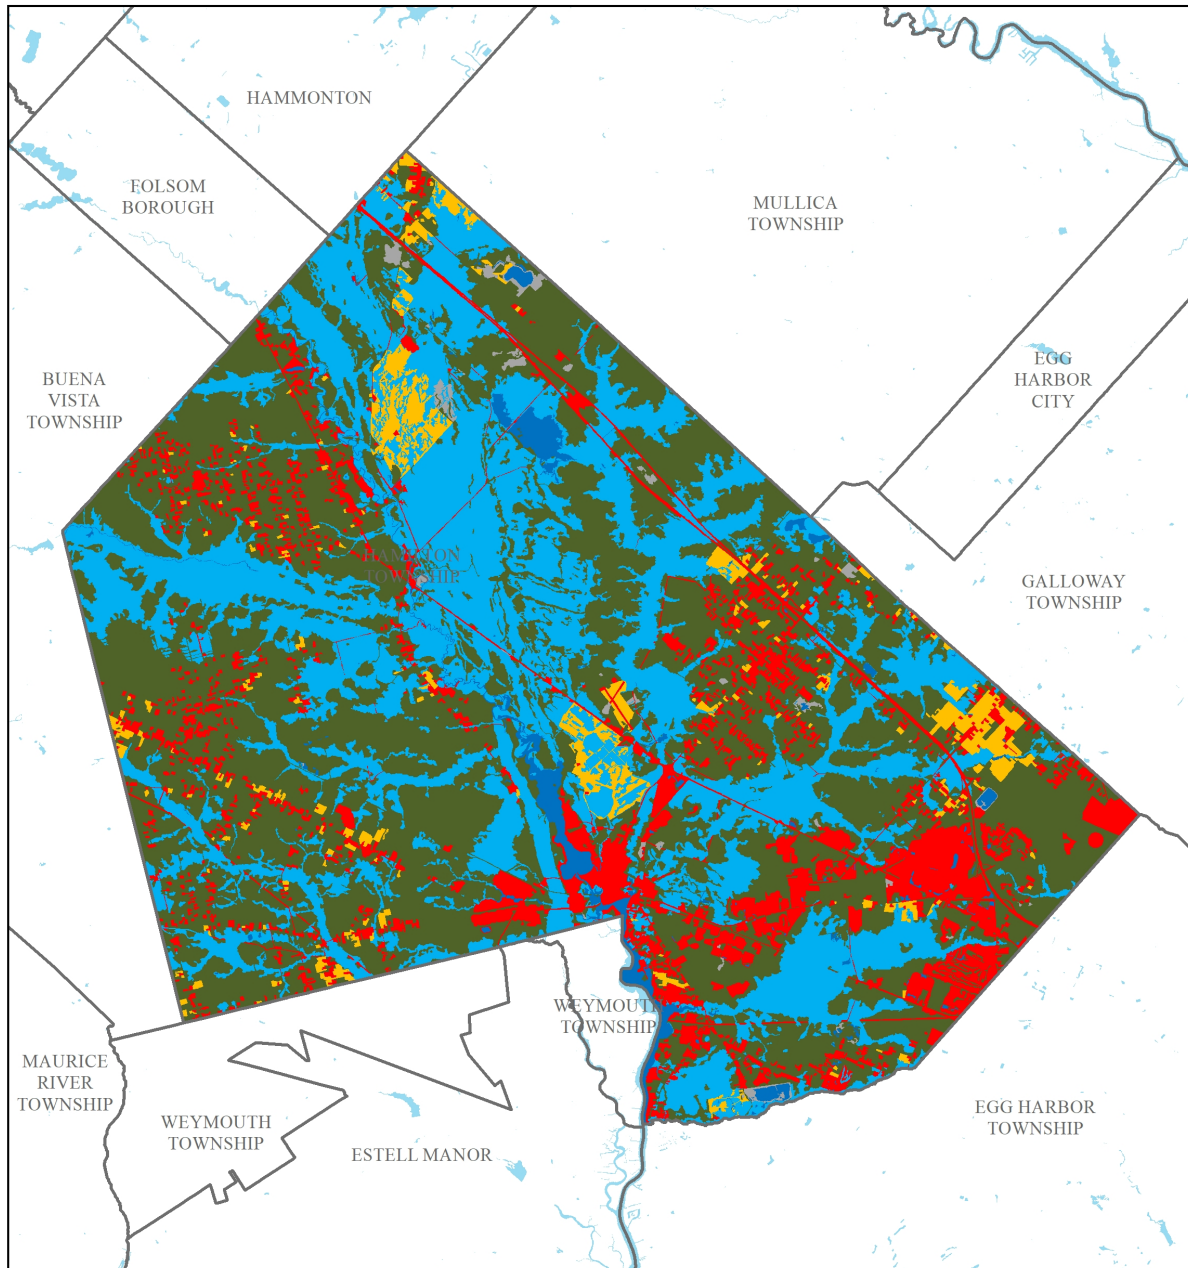
Figure 4: Map illustrating the land use in Hamilton Township

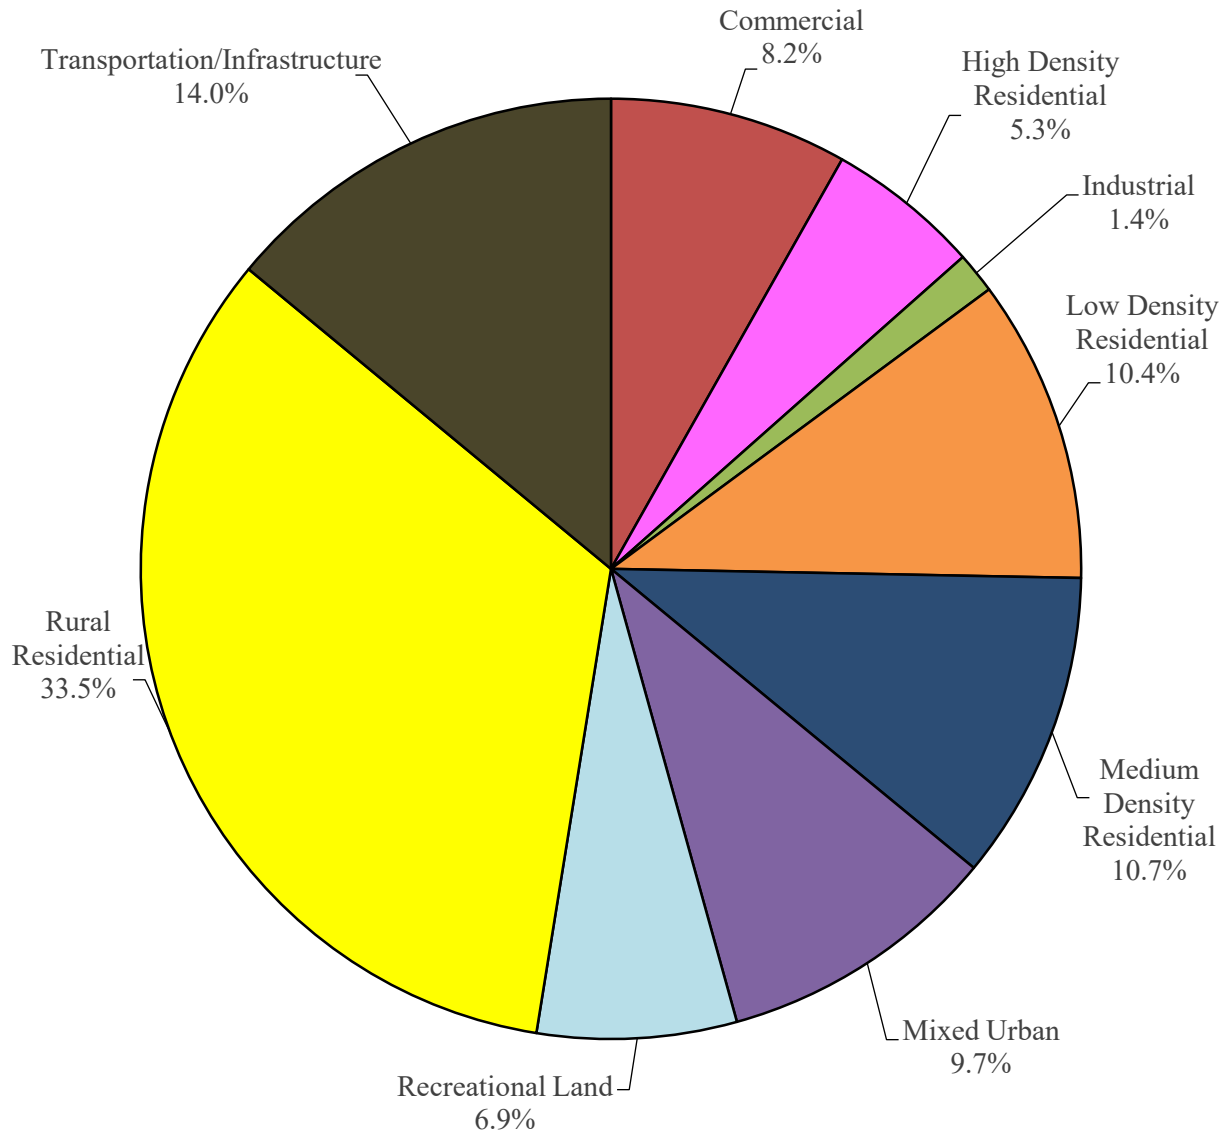
Figure 5: Pie chart illustrating the various types of urban land use in Hamilton Township

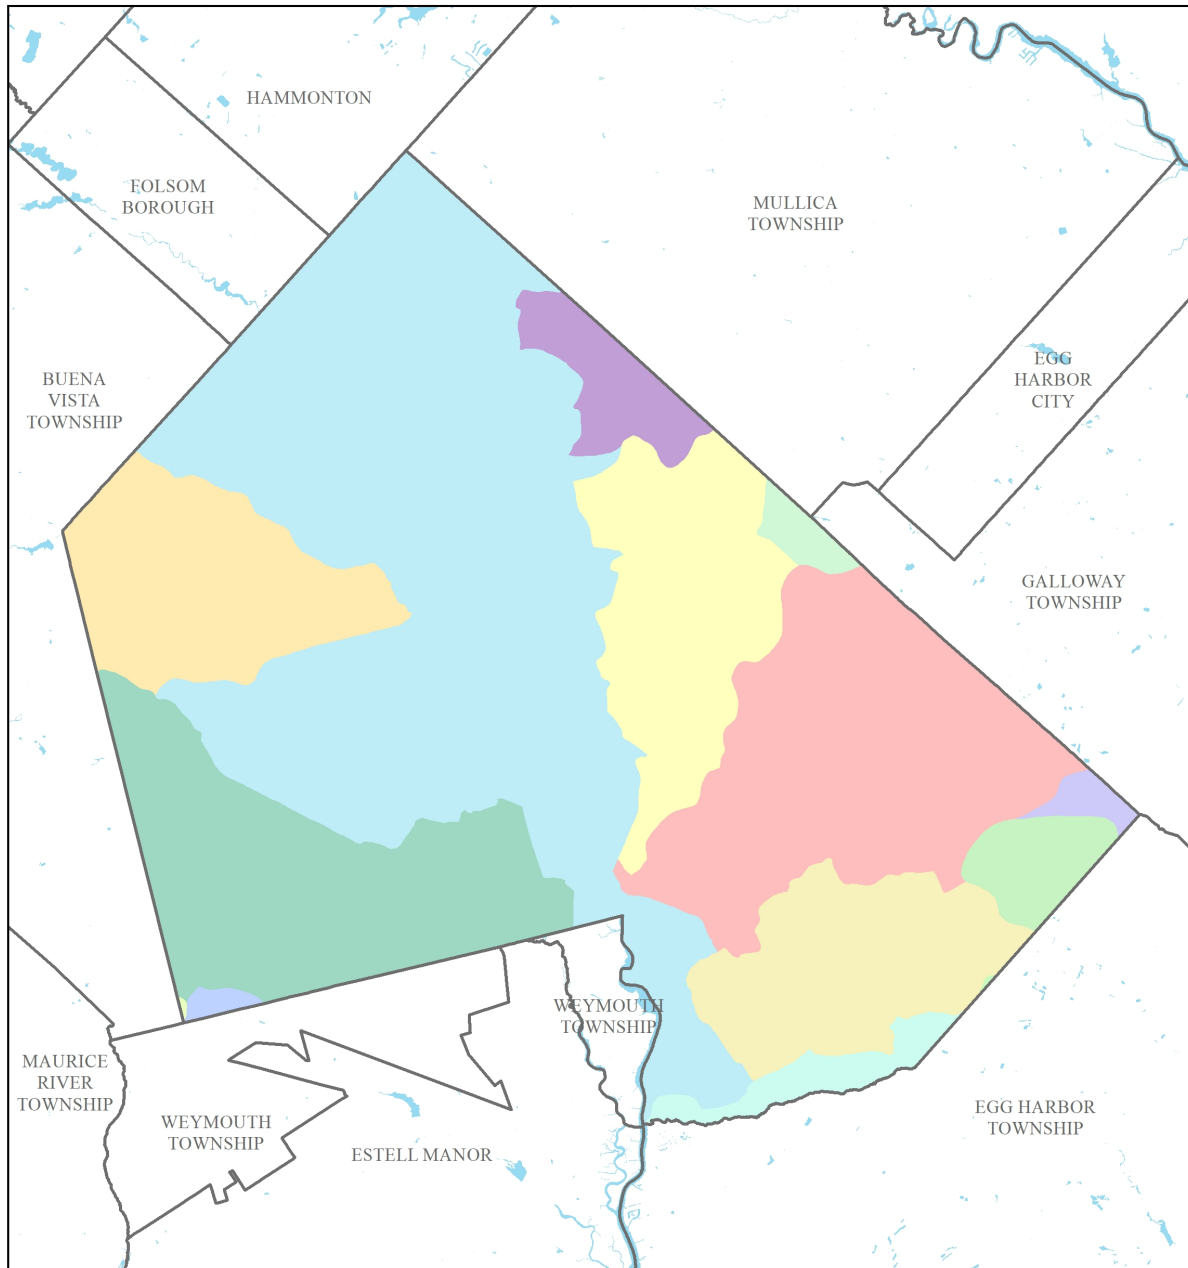
Subwatersheds of Hamilton Township

Figure 6: Map of the subwatersheds in Hamilton Township
 [*Subwatershed area not visible on map]

Water resources are typically managed on a watershed/subwatershed basis; therefore, an impervious cover analysis was performed for each subwatershed within Hamilton Township (Table 1 and Figure 6). On a subwatershed basis, impervious cover ranges from 0.3% in the Tuckahoe River subwatershed to 49.0% in the Mill Branch subwatershed. Evaluating impervious cover on a subwatershed basis allows the municipality to focus impervious cover reduction or disconnection efforts in the subwatersheds where frequent flooding occurs.

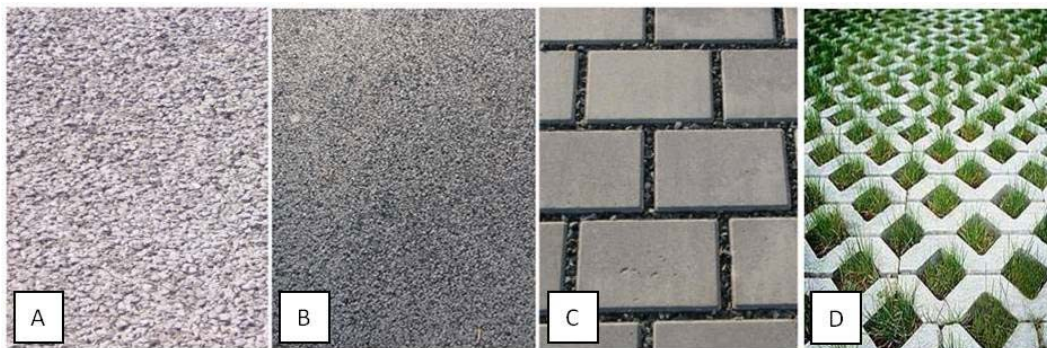
Permeable surfaces: (A) pervious concrete, (B) porous asphalt, (C) interlocking concrete pavers, (D) grid pavers (Rowe, 2012)

Pervious concrete and porous asphalt are the most common of the permeable surfaces. They are similar to regular concrete and asphalt but without the fine materials. This allows water to quickly pass through the material into an underlying layered system of stone that holds the water, allowing it to infiltrate into the underlying uncompacted soil.

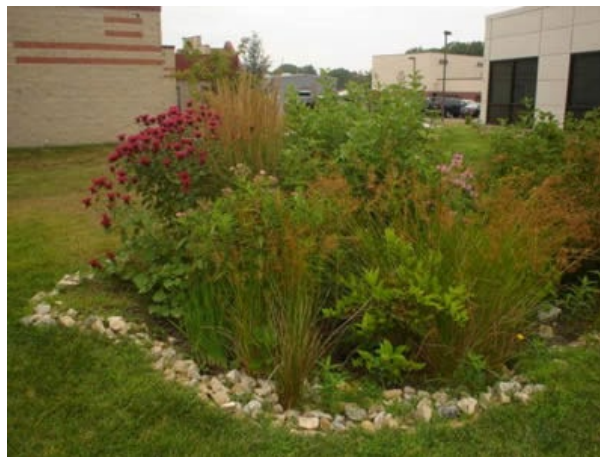
Figure 7: Rain garden outside the RCE of Gloucester County office which was designed to disconnect rooftop runoff from the local storm sewer system

- Rain Gardens: Stormwater can be diverted into shallow landscaped depressed areas (i.e., rain gardens) where the vegetation filters the water, and it is allowed to soak into the ground. Rain gardens, also known as bioretention systems, come in all shapes and sizes and can be designed to disconnect a variety of impervious surfaces (Figure 7).

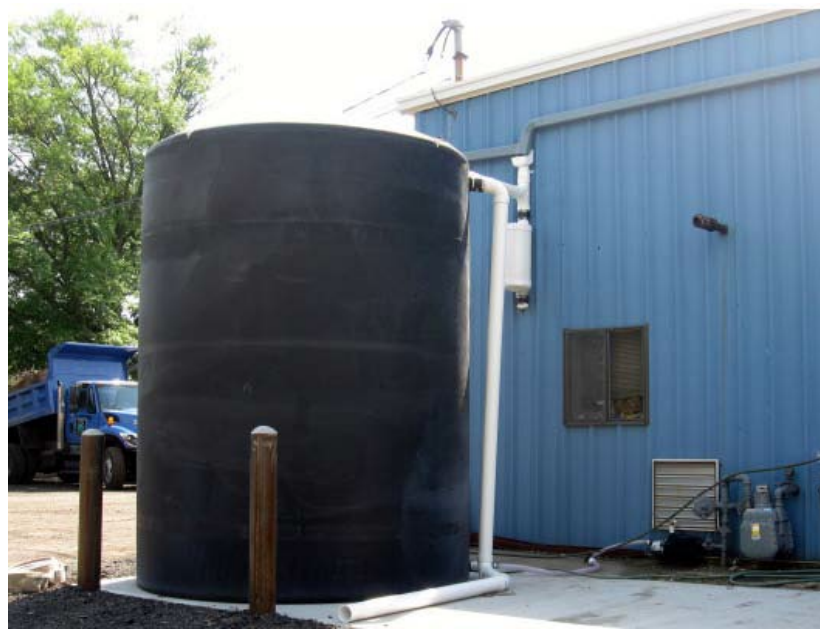
Figure 8b: A 5,000 gallon cistern used to disconnect the rooftop of the Department of Public Works in Clark Township to harvest rainwater for nonprofit car wash events

- Rainwater Harvesting: Rainwater harvesting includes the use of rain barrels and cisterns (Figures 8a and 8b). These can be placed below downspouts to collect rooftop runoff. The collected water has a variety of uses including watering plants and washing cars. This practice also helps cut down on the use of potable water for nondrinking purposes. It is important to divert the overflow from the rainwater harvesting system to a pervious area.

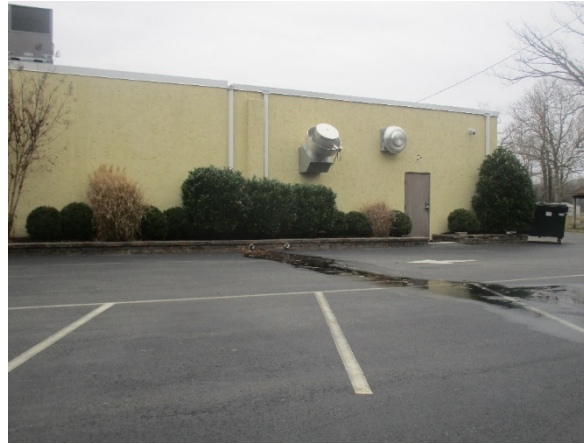
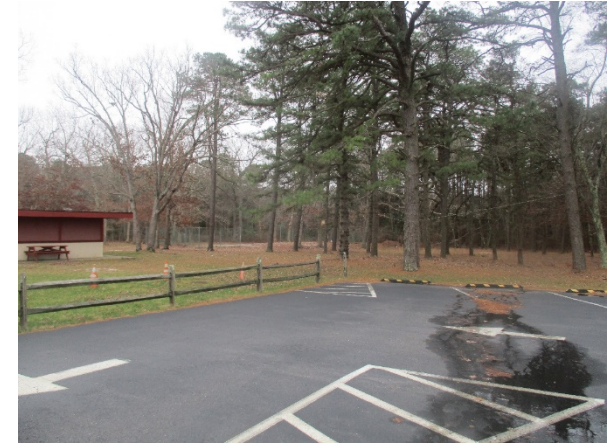
COLOGNE VOLUNTEER FIRE COMPANY: STATION 18-5

Rain gardens can be installed to intercept stormwater coming from the parking areas at the east and south corners of the site. A cistern can be installed to capture stormwater that can be reused for washing firetrucks or for watering existing landscaping.

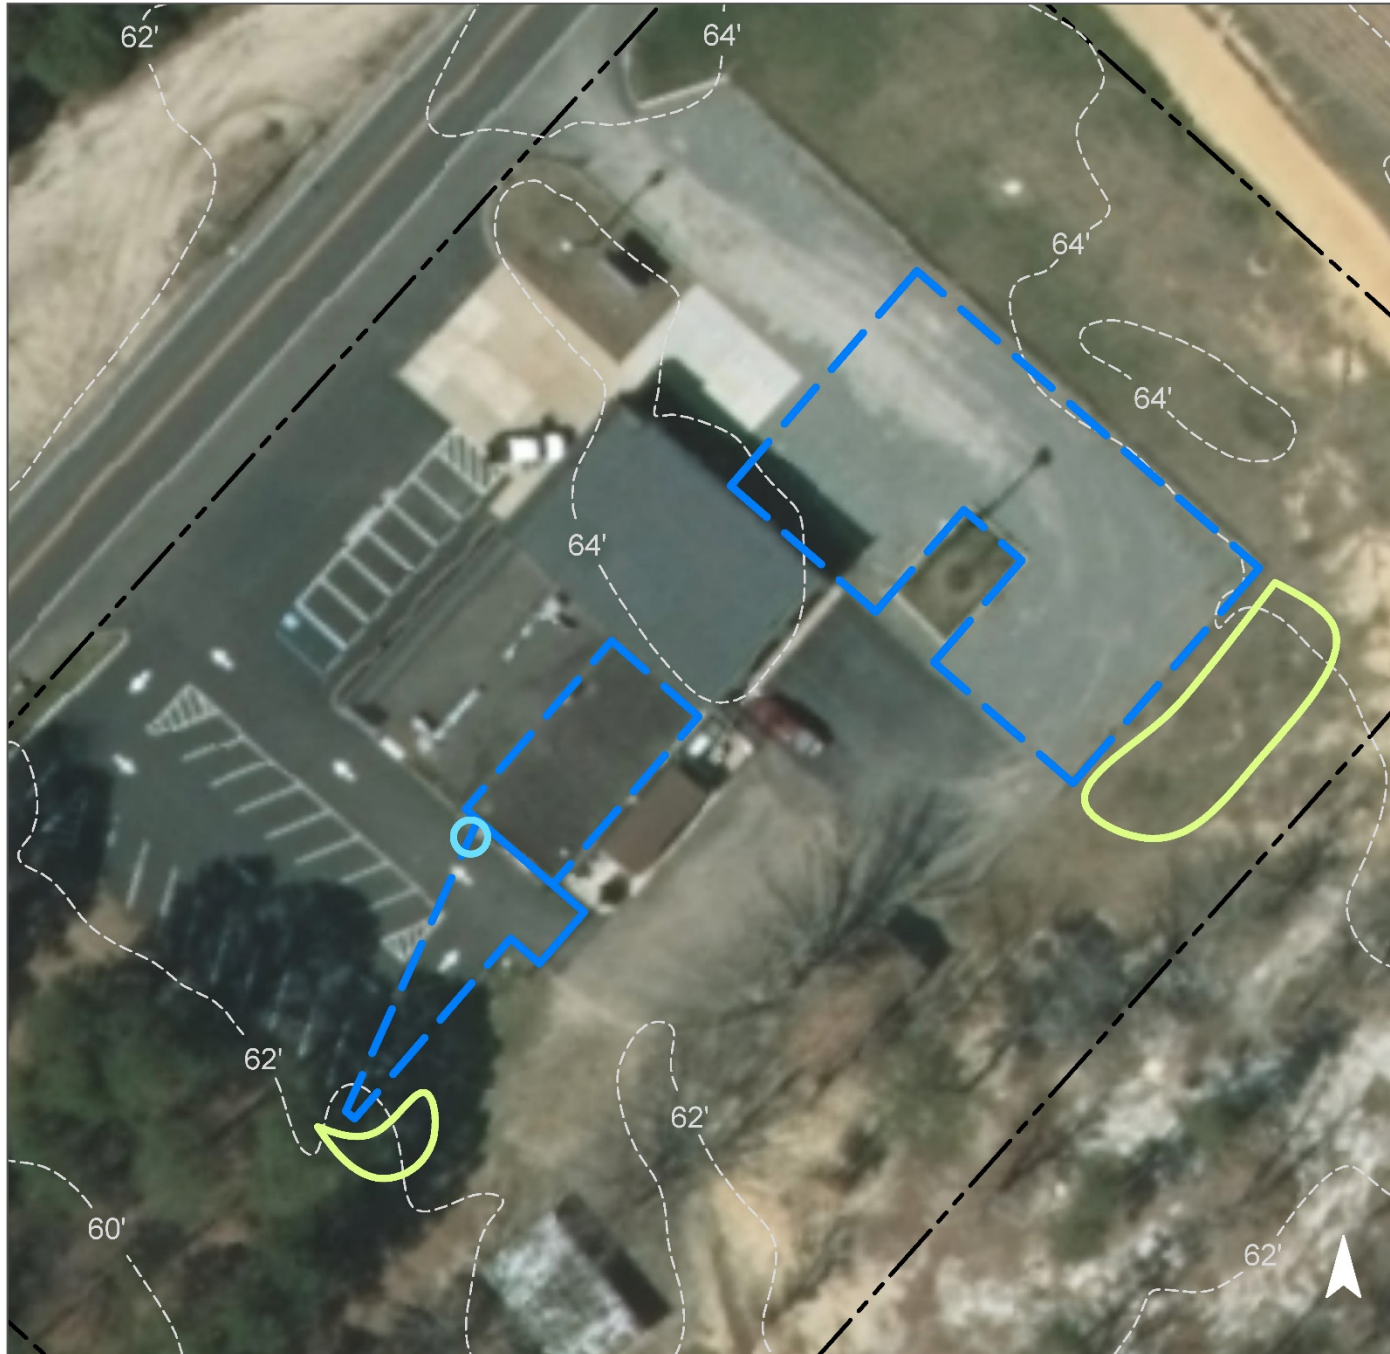
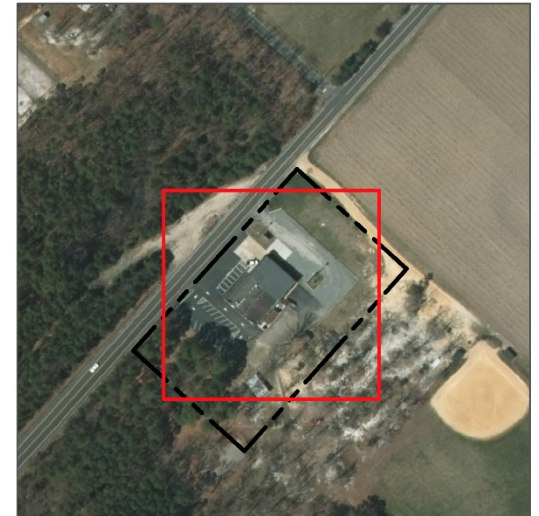
Cologne Volunteer Fire Company: Station 18-5

bioretention system
-

rainwater harvesting
-

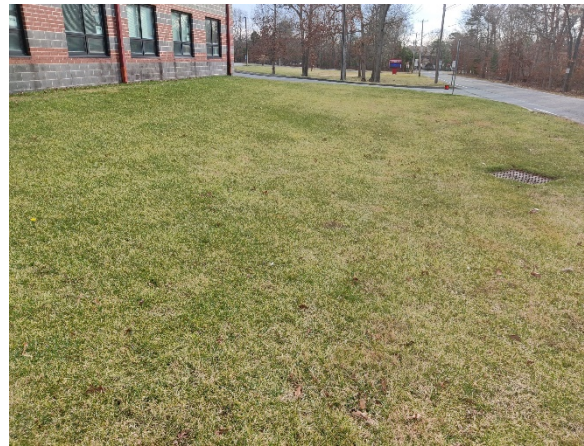
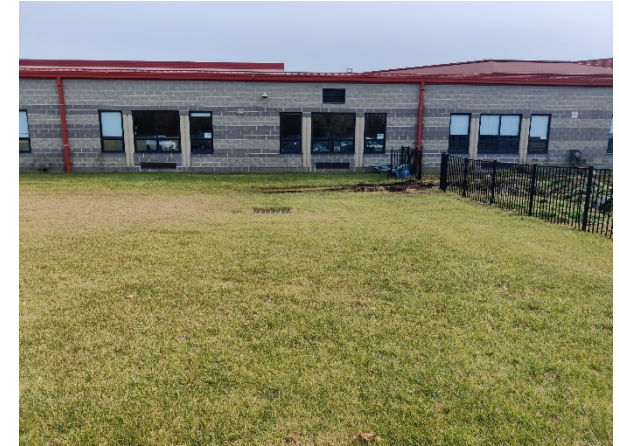
WILLIAM DAVIES MIDDLE SCHOOL

A bioretention system can be installed in the green space to the west of the property. Another system can be installed next to the garden area and the parking lot at the northwestern edge of the school property. Another system can be installed at the east corner of the school property near the transformer. Another system can be installed along the southeast edge of the school property by the main entrances. All of these systems can be installed to capture, treat, and infiltrate, the stormwater runoff from the nearby road and the downspouts to prevent flooding.

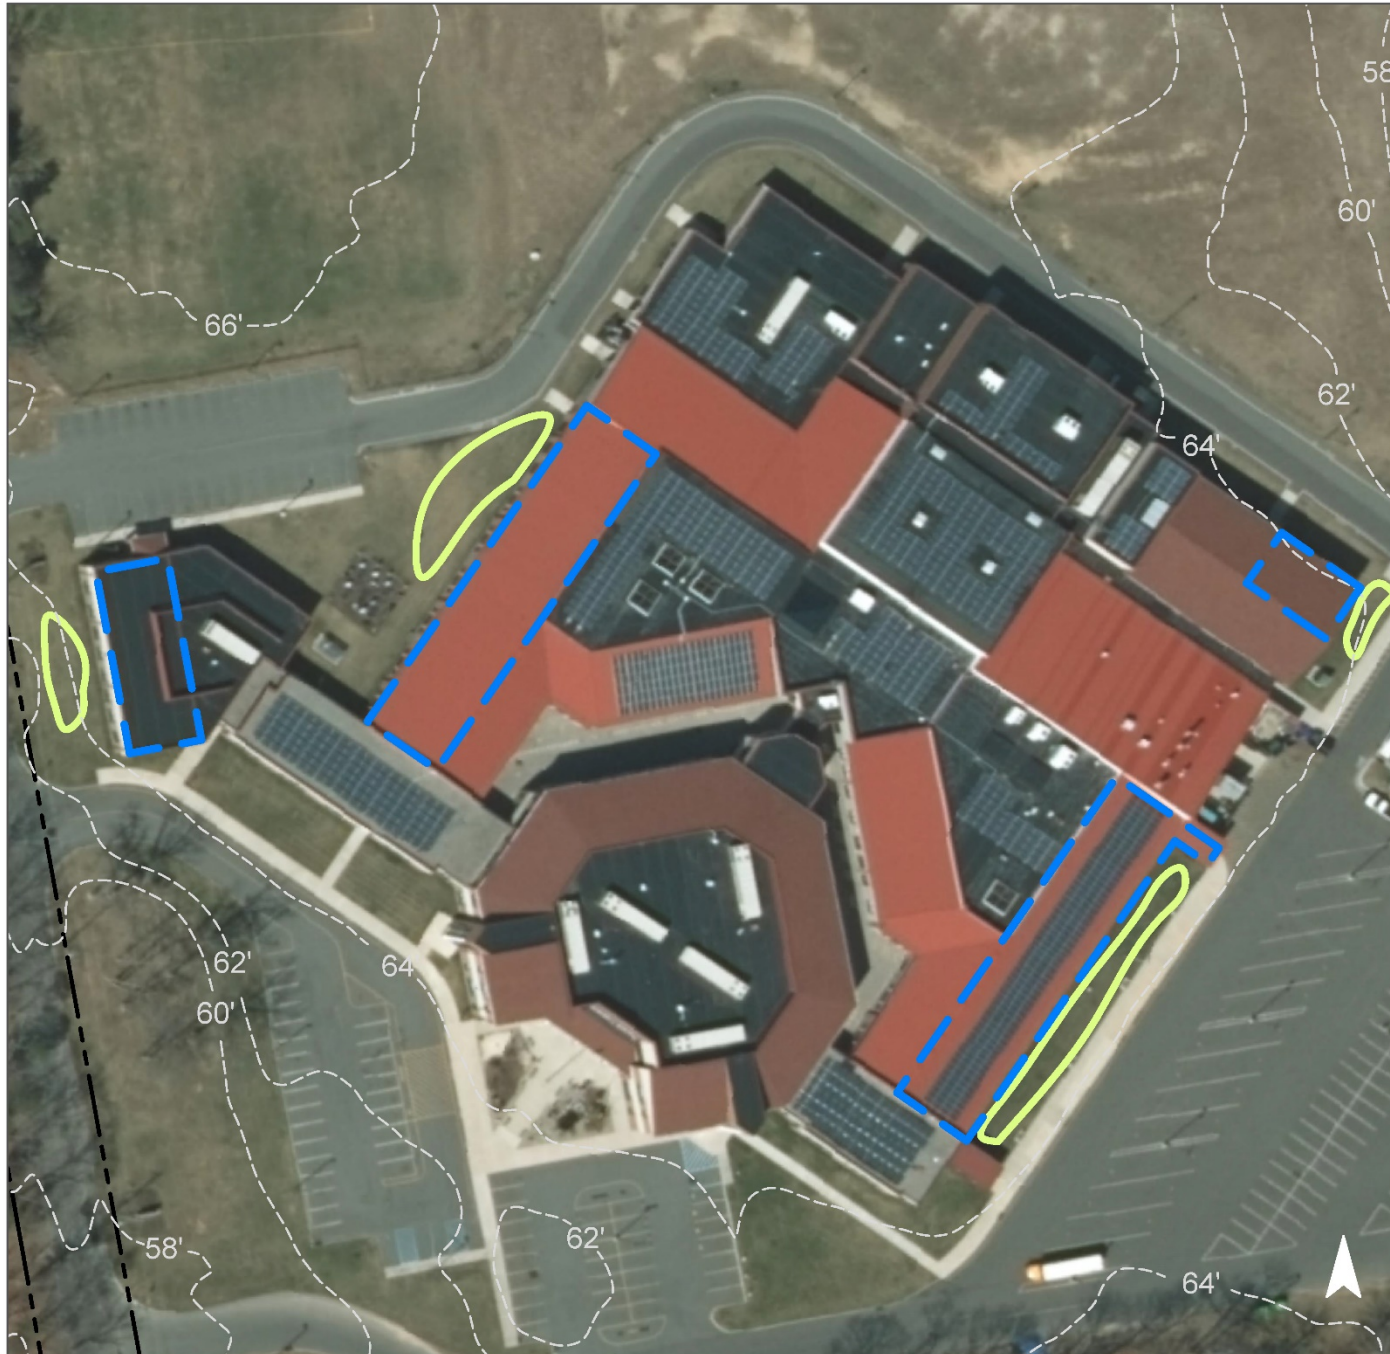
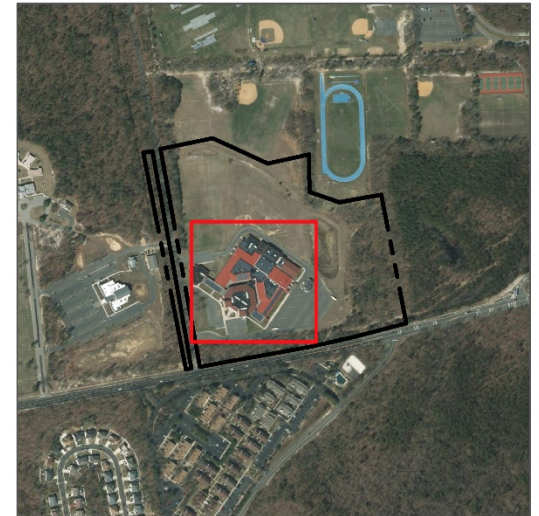
William Davies Middle School

bioretention system
-

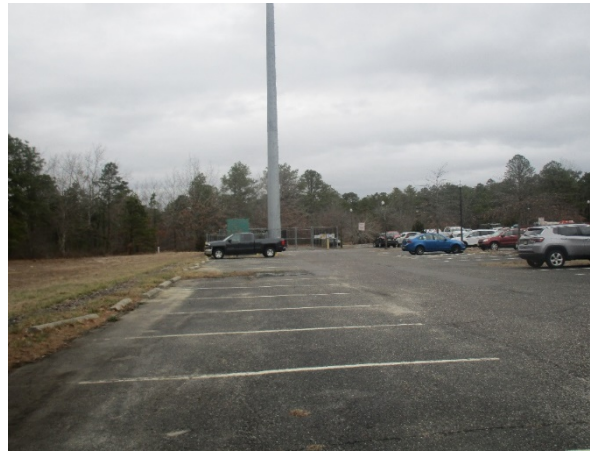
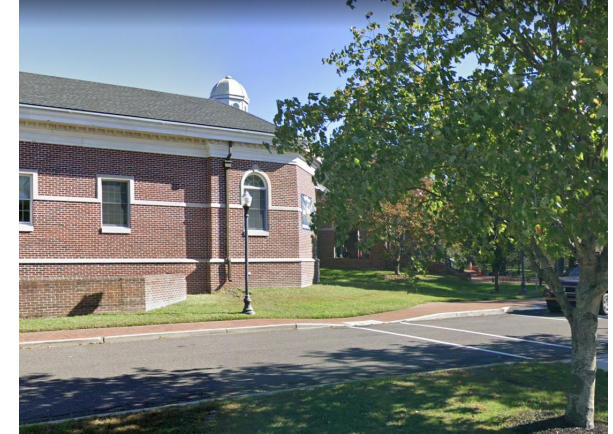
HAMILTON TOWNSHIP MUNICIPAL BUILDING

Parking spaces on the west side of the site can be converted to pervious pavement to capture stormwater from the parking lot. Two rain gardens can be installed along the south end of the building by redirecting downspouts into them to capture stormwater from the rooftop.

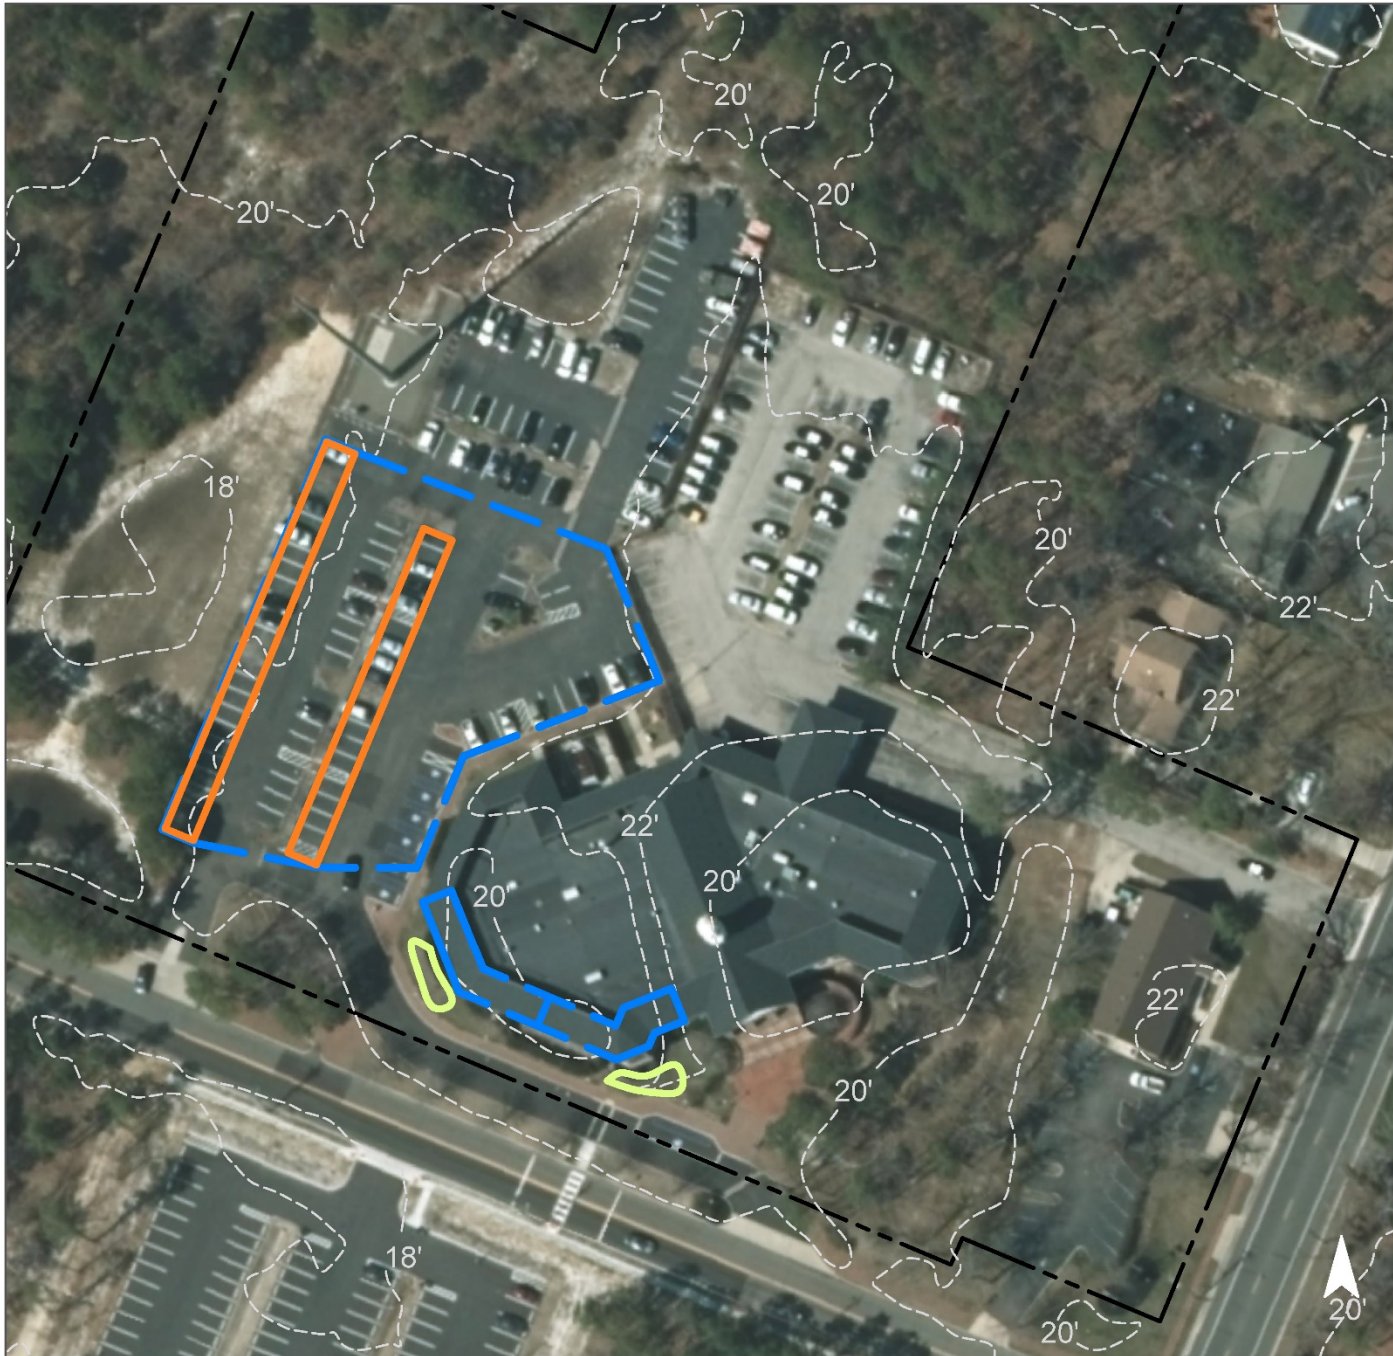
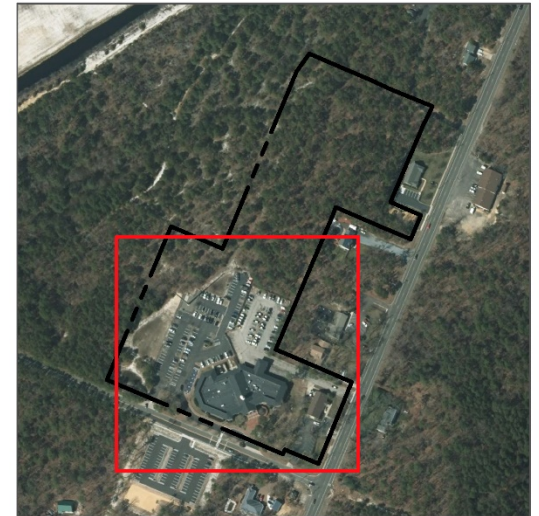
Hamilton Township Municipal Building

bioretention system
-

pervious pavement
-
