**Impervious Cover Assessment
for
Allamuchy Township, Warren County, New Jersey**

*Prepared for Allamuchy Township by the
Rutgers Cooperative Extension Water Resources
Program*

August 6, 2021

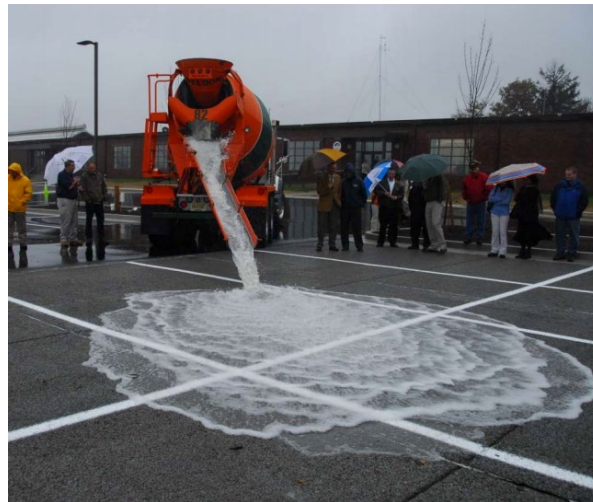
Figure 2: Rapid infiltration of water through porous pavement is demonstrated at the USEPA Edison New Jersey test site

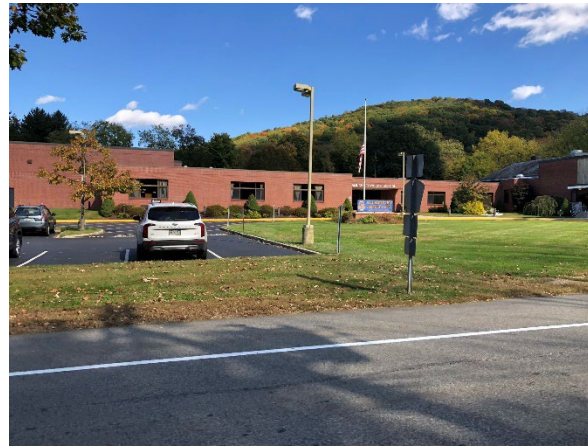
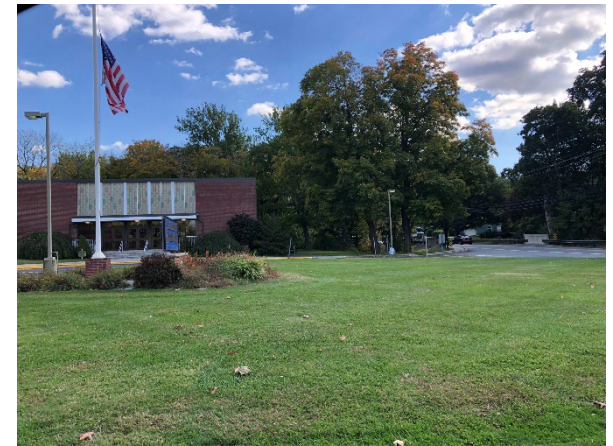
ALLAMUCHY TOWNSHIP BOARD OF EDUCATION

A bioretention system can be installed south of the parking lot to capture, treat, and infiltrate the stormwater runoff from the roadway to the west of the board of education building. Parking spaces on the northwestern area of the parking lot can be converted to pervious pavement to capture and infiltrate the stormwater runoff from the parking lot.

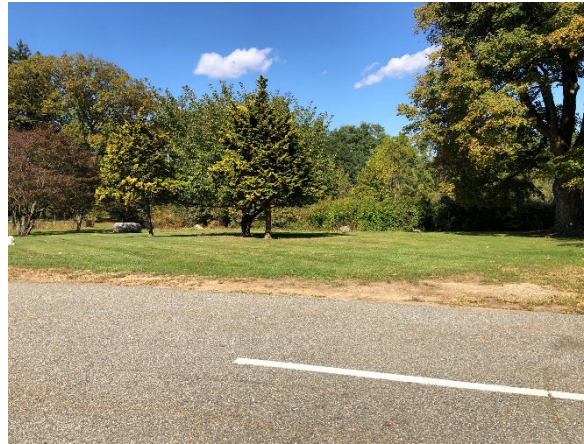
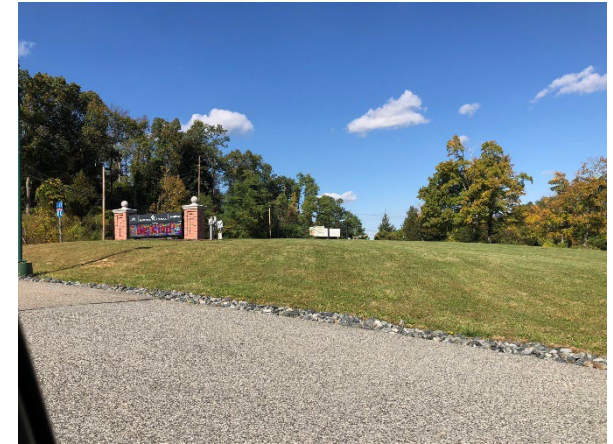
MOUNTAIN VILLA SCHOOL

Bioretention systems can be installed along the roadway leading towards the school to capture, treat, and infiltrate the stormwater runoff from the roadway. The parking spaces in the parking lot north of the building can be converted to pervious pavement to capture and infiltrate the stormwater runoff from the parking lot area.

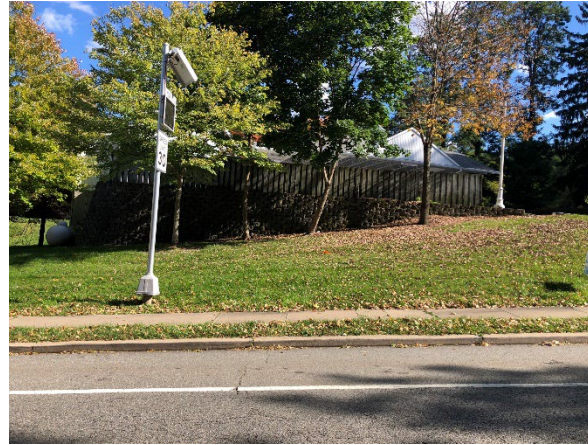
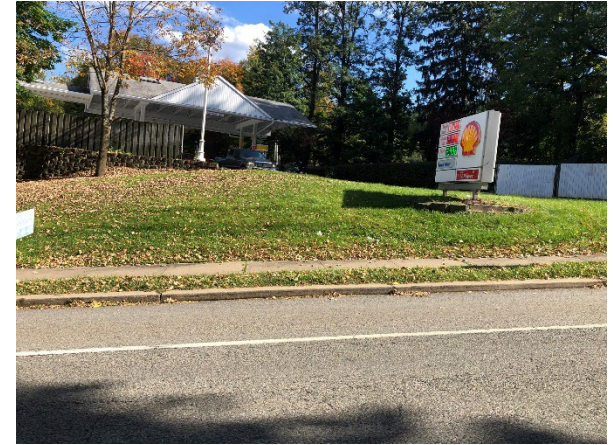
SHELL STATION

A bioretention system can be installed in the turfgrass area alongside the roadway to capture, treat, and infiltrate the stormwater runoff from the roadway. To convey the water into the rain garden, a trench drain through the sidewalk or piping underneath the sidewalk will be required.
