Impervious Cover Assessment for Allamuchy Township, Warren County, New Jersey

Prepared for Allamuchy Township by the Rutgers Cooperative Extension Water Resources Program

August 6, 2021

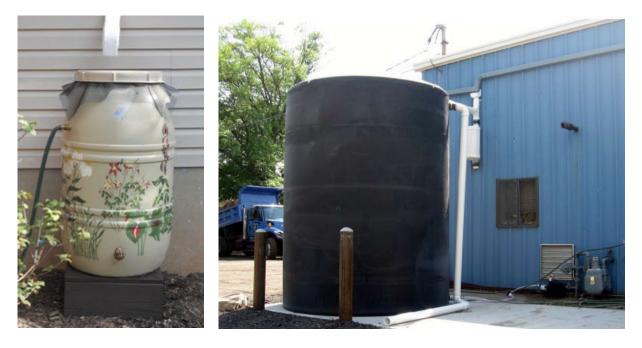
Figure 8a: Rain barrel used to disconnect a downspout with the overflow going to a flower bed

Figure 8b: A 5,000 gallon cistern used to disconnect the rooftop of the Department of Public Works in Clark Township to harvest rainwater for nonprofit car wash events

• <u>Rainwater Harvesting</u>: Rainwater harvesting includes the use of rain barrels and cisterns (Figures 8a and 8b). These can be placed below downspouts to collect rooftop runoff. The collected water has a variety of uses including watering plants and washing cars. This practice also helps cut down on the use of potable water for nondrinking purposes. It is important to divert the overflow from the rainwater harvesting system to a pervious area.

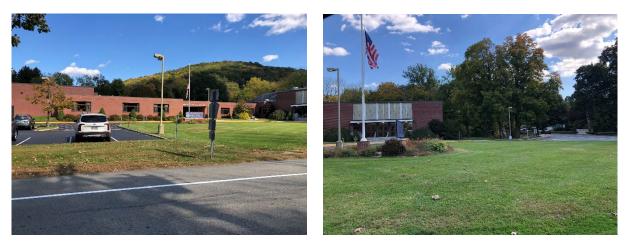
ALLAMUCHY TOWNSHIP BOARD OF EDUCATION

A bioretention system can be installed south of the parking lot to capture, treat, and infiltrate the stormwater runoff from the roadway to the west of the board of education building. Parking spaces on the northwestern area of the parking lot can be converted to pervious pavement to capture and infiltrate the stormwater runoff from the parking lot.

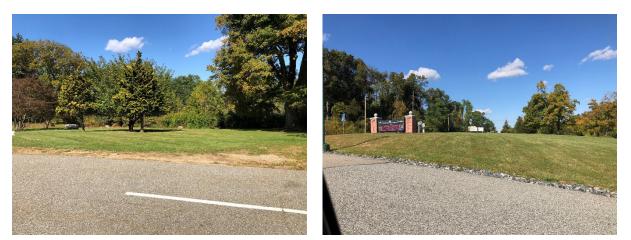
MOUNTAIN VILLA SCHOOL

Bioretention systems can be installed along the roadway leading towards the school to capture, treat, and infiltrate the stormwater runoff from the roadway. The parking spaces in the parking lot north of the building can be converted to pervious pavement to capture and infiltrate the stormwater runoff from the parking lot area.

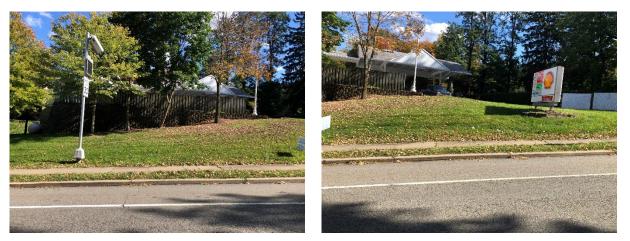
SHELL STATION

A bioretention system can be installed in the turfgrass area alongside the roadway to capture, treat, and infiltrate the stormwater runoff from the roadway. To convey the water into the rain garden, a trench drain through the sidewalk or piping underneath the sidewalk will be required.
