**Impervious Cover Assessment  
for  
Bloomsbury Borough, Hunterdon County, New Jersey**

*Prepared for Bloomsbury Borough by the  
Rutgers Cooperative Extension Water Resources Program*

August 6, 2021

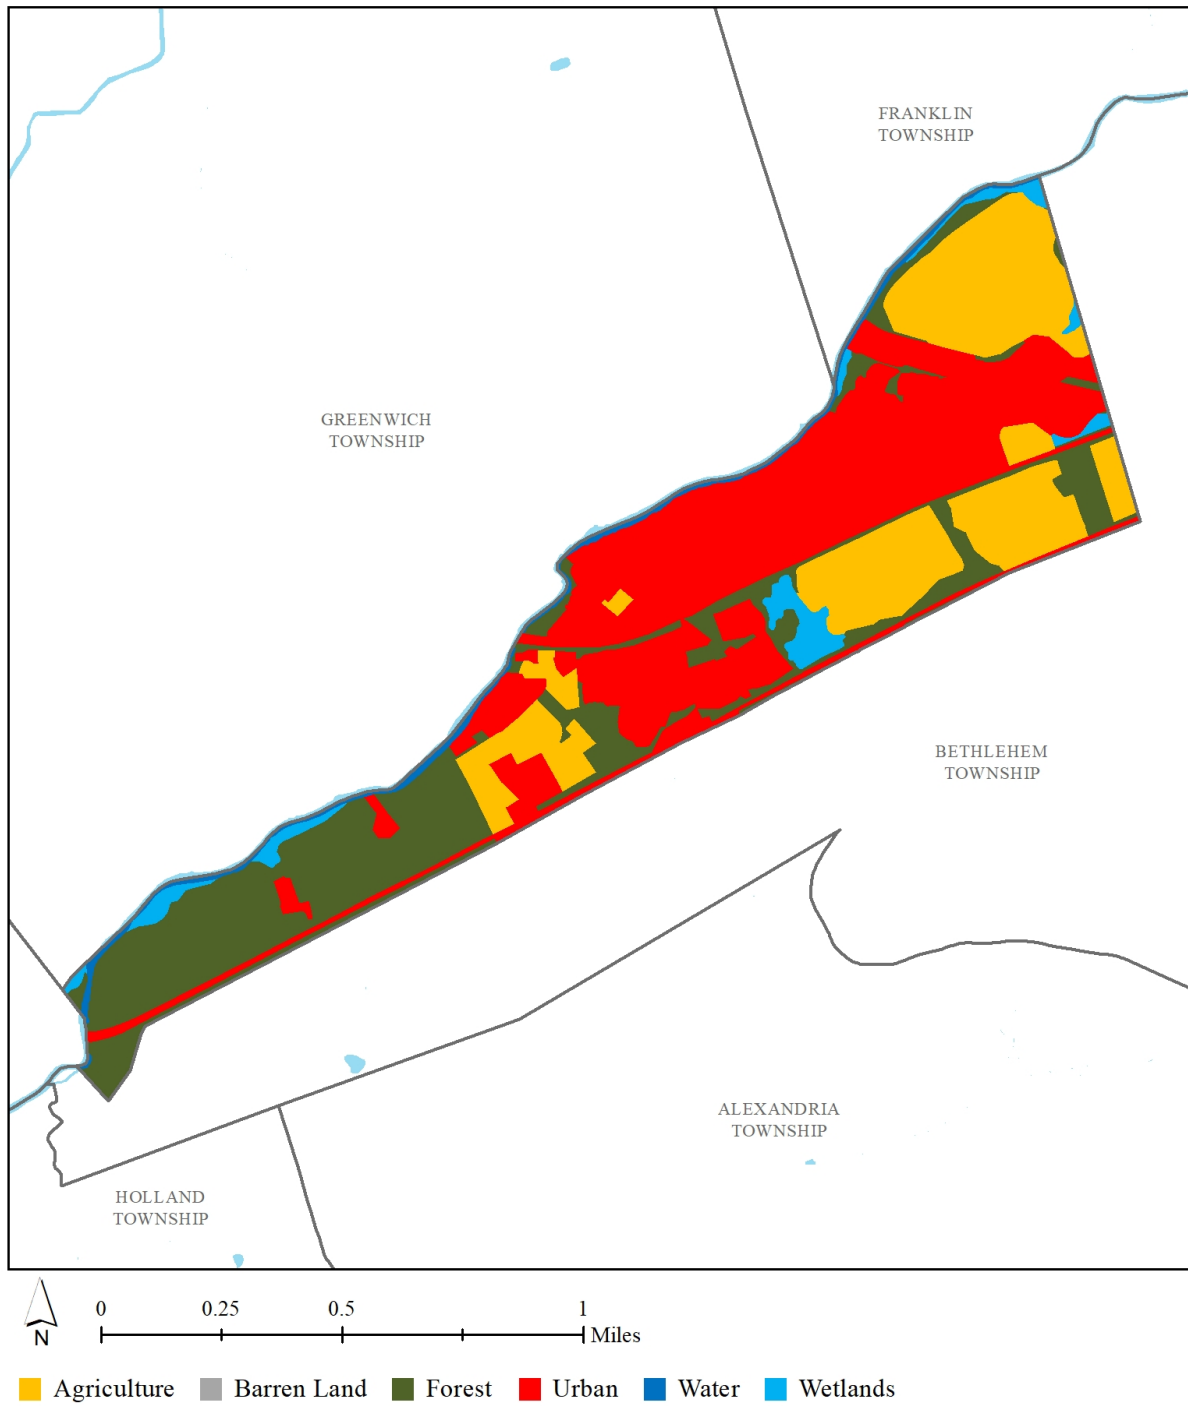
Figure 4: Map illustrating the land use in Bloomsbury Borough

Bloomsbury Borough is located in Hunterdon County, New Jersey and covers approximately 0.96 square miles. Figures 3 and 4 illustrate that Bloomsbury Borough is dominated by urban land uses. A total of 41.7% of the municipality's land use is classified as urban. Of the urban land in Bloomsbury Borough, medium density residential is the dominant land use (Figure 5).

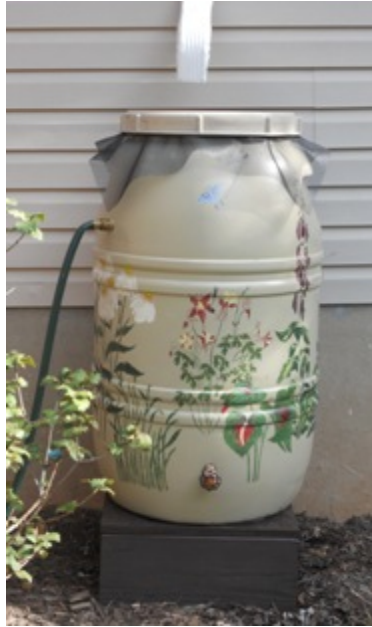
Figure 8a: Rain barrel used to disconnect a downspout with the overflow going to a flower bed

- Rainwater Harvesting: Rainwater harvesting includes the use of rain barrels and cisterns (Figures 8a and 8b). These can be installed below downspouts to collect rooftop runoff. The collected water has a variety of uses including watering plants and washing cars, ultimately reducing the use of potable water for non-drinking purposes. Rain barrels and cisterns must be designed with an overflow valve to allow excess water to be diverted to a nearby pervious area.

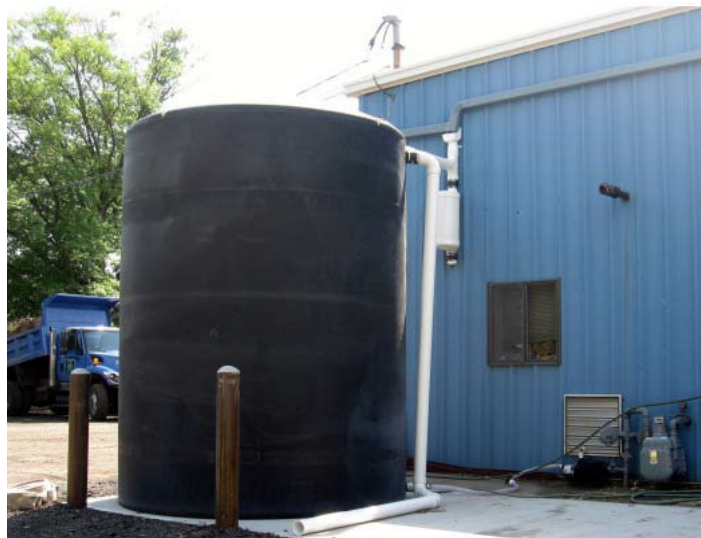
Figure 8b: A 5,000 gallon cistern used to disconnect the rooftop of the Department of Public Works in Clark Township to harvest rainwater for nonprofit car wash events

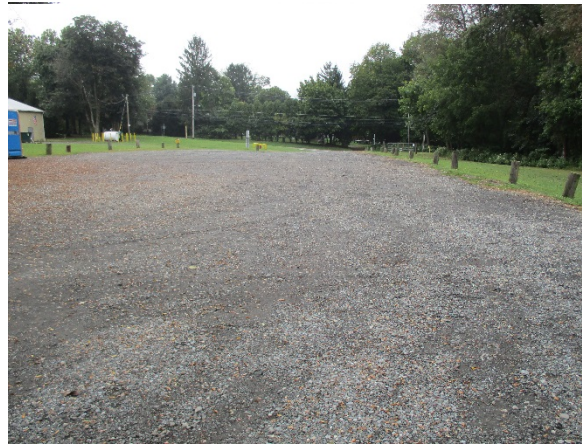
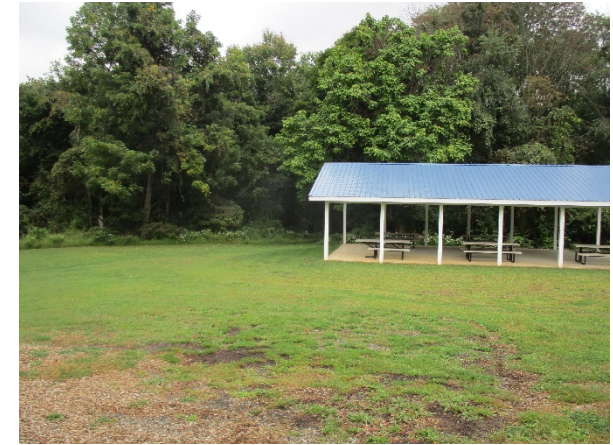
# BLOOMSBURY MUNICIPAL PARK

Parking spaces in the northeast part of the parking lot can be converted to porous pavement to capture and infiltrate stormwater runoff from the parking lot. A rain garden can be installed to the north of the building to capture, treat, and infiltrate stormwater runoff from the roof. A preliminary soil assessment suggests that the soils have suitable drainage characteristics for green infrastructure.

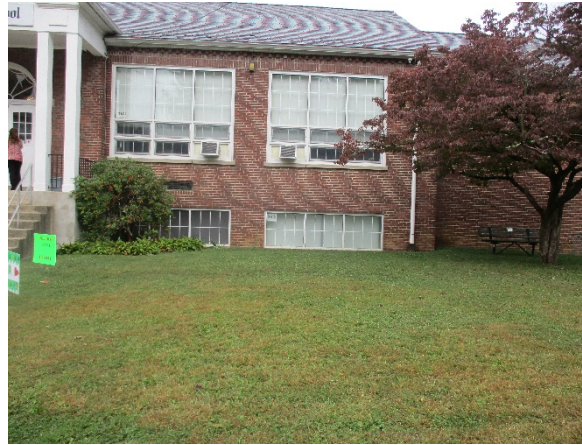
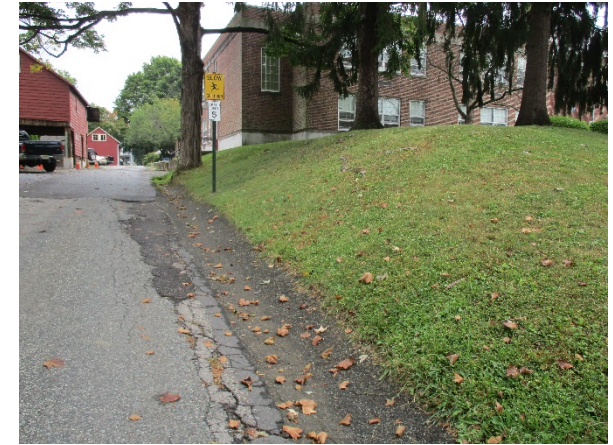
# BLOOMSBURY PUBLIC SCHOOL

A rain garden can be installed in the turfgrass area south of the building to capture, treat, and infiltrate stormwater runoff from the roof. A preliminary soil assessment suggests that the soils have suitable drainage characteristics for green infrastructure.

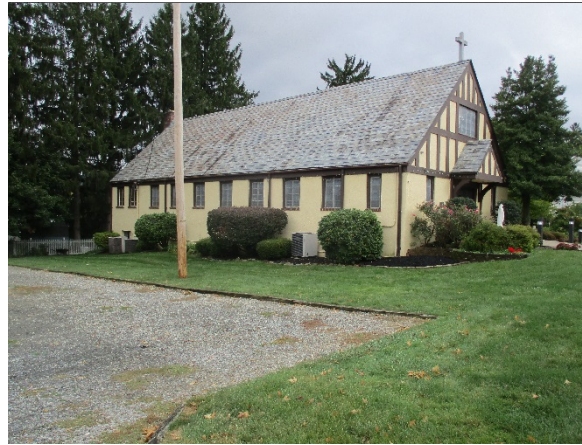
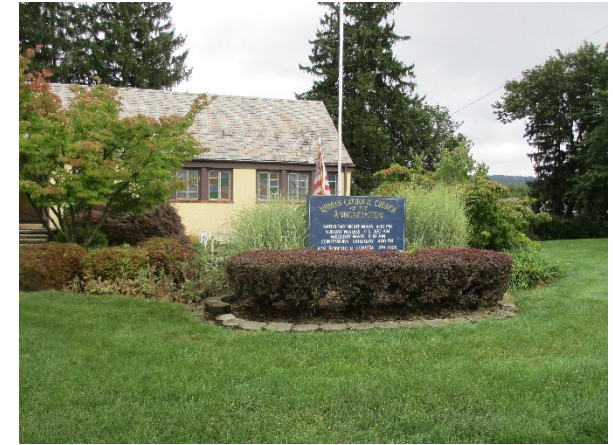
# ROMAN CATHOLIC CHURCH OF THE ANNUNCIATION

Parking spaces in the parking lot to the west of the building can be converted to porous pavement to capture and infiltrate stormwater runoff from the parking lot and the street. Two rain gardens can be installed to the south and west of the building to capture, treat, and infiltrate stormwater runoff from the roof. A preliminary soil assessment suggests that the soils have suitable drainage characteristics for green infrastructure.
