**Impervious Cover Assessment
for
Helmetta Borough, Middlesex County, New Jersey**

*Prepared for Helmetta Borough by the
Rutgers Cooperative Extension Water Resources Program*

February 1, 2015

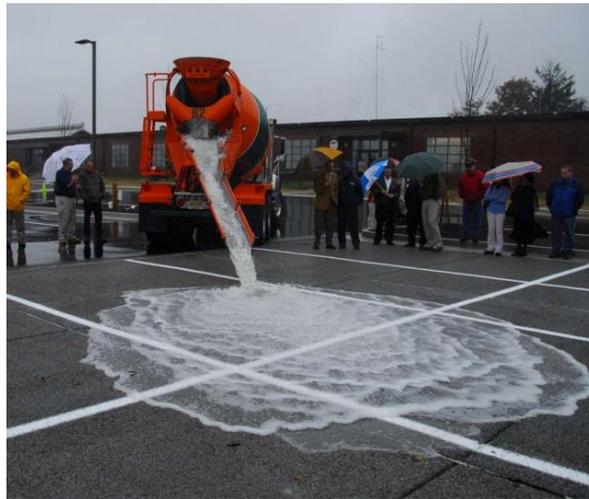
Figure 2: Rapid infiltration of water through porous pavement is demonstrated at the USEPA Edison New Jersey test site

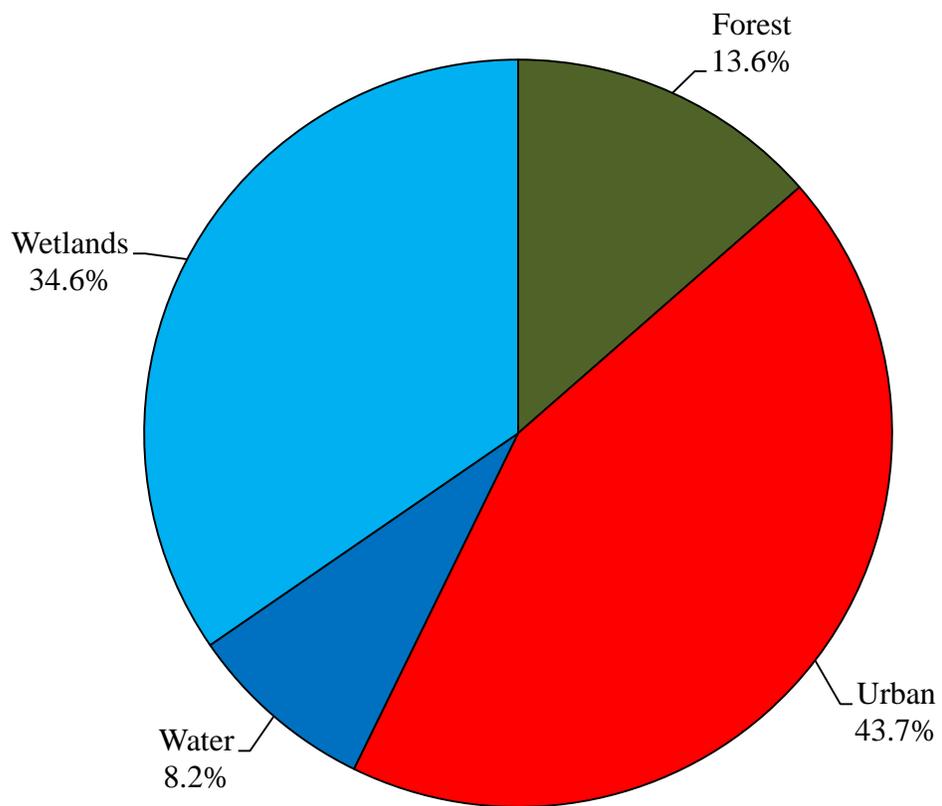
Figure 3: Pie chart illustrating the land use in Helmetta Borough

Located in Middlesex County in central New Jersey, Helmetta Borough covers approximately 0.88 square miles. Figures 3 and 4 illustrate that Helmetta Borough is dominated by urban land uses. A total of 43.7% of the municipality's land use is classified as urban. Of the urban land in Helmetta Borough, medium density residential is the dominant land use (Figure 5).

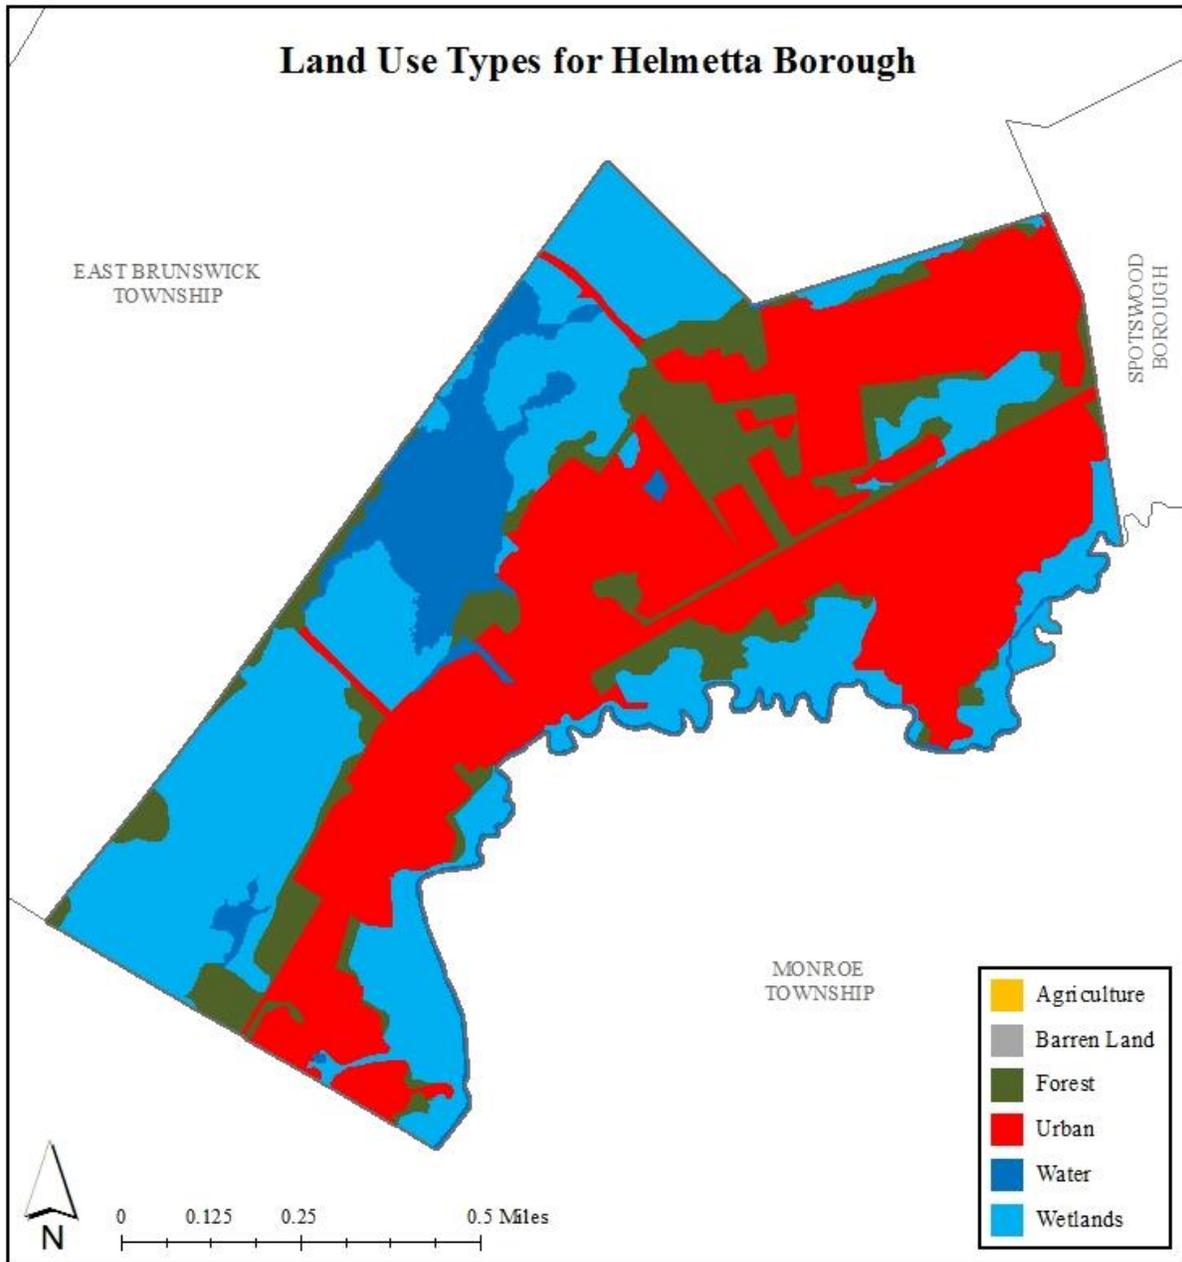
Figure 4: Map illustrating the land use in Helmetta Borough

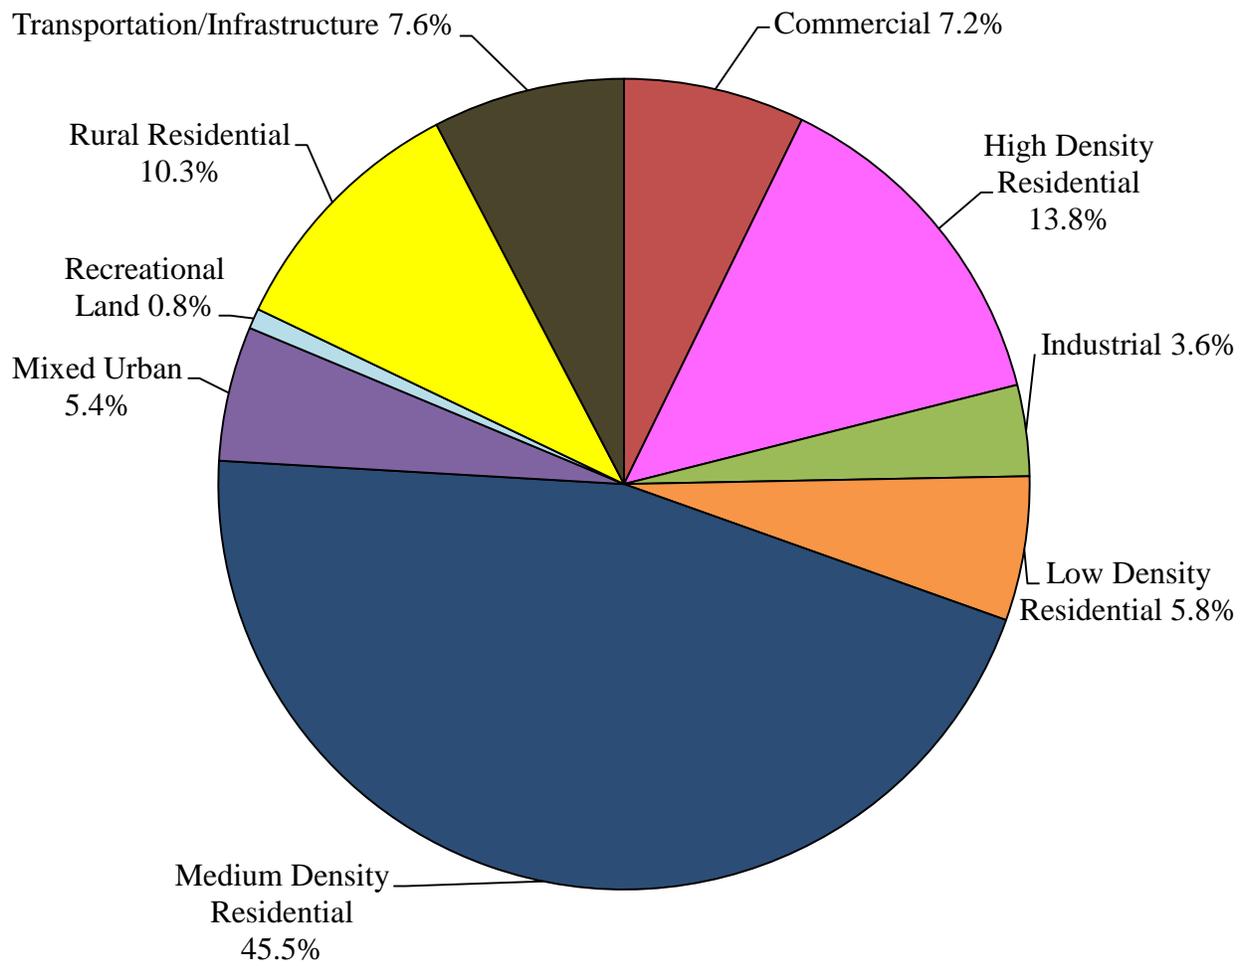
Figure 5: Pie chart illustrating the various types of urban land use in Helmetta Borough

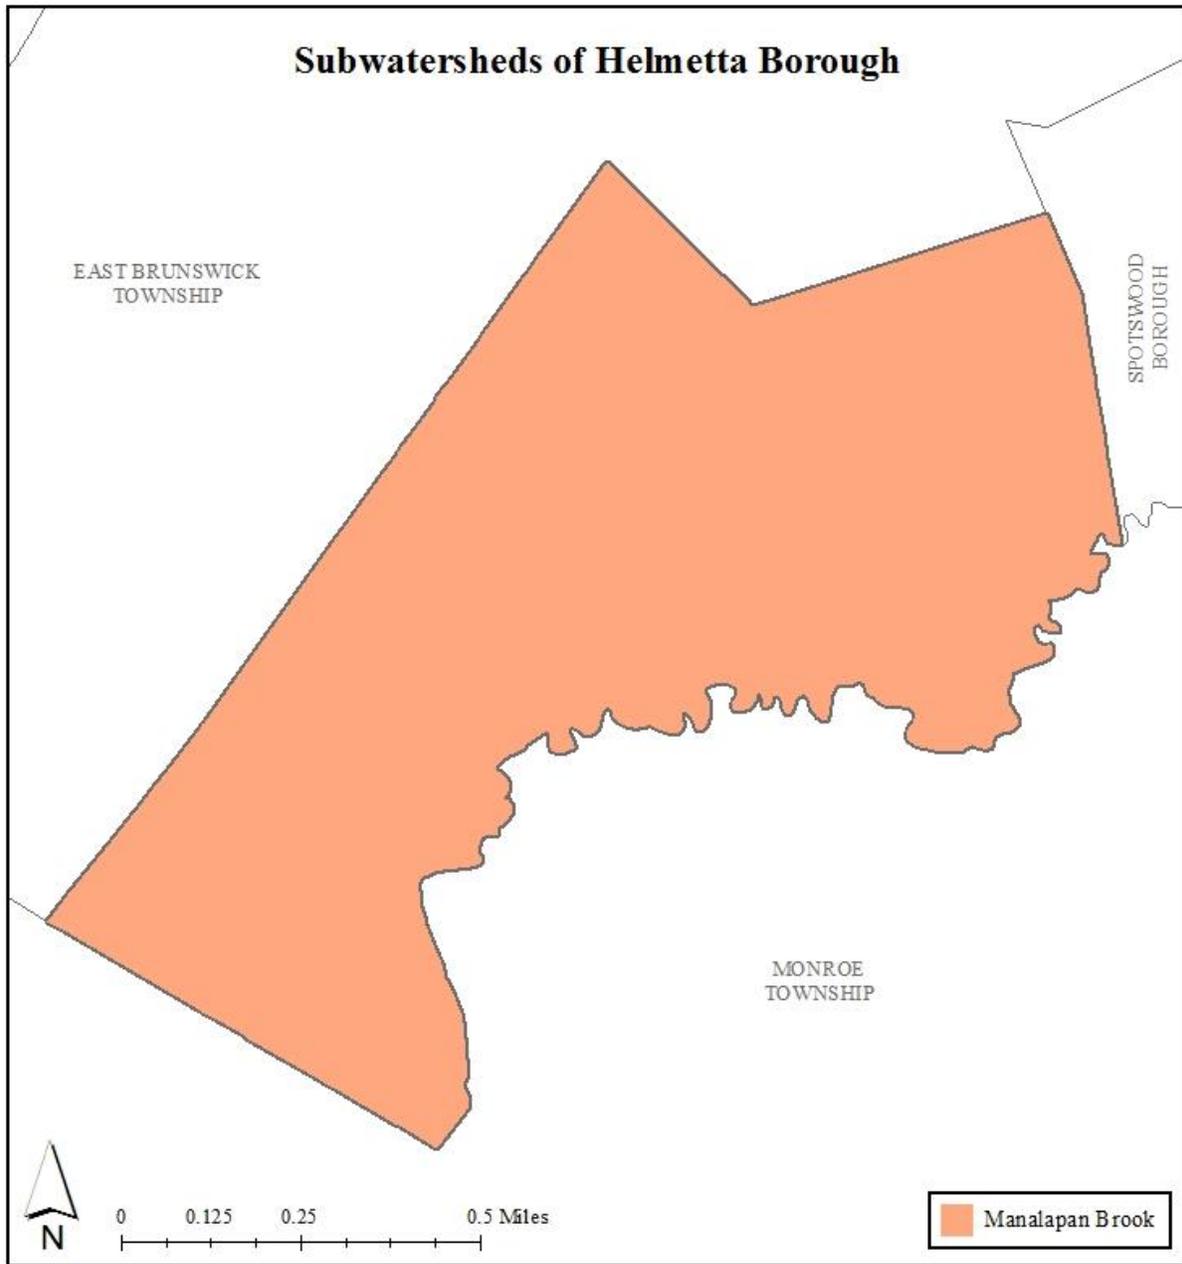
Figure 6: Map of the subwatersheds in Helmetta Borough

Water resources are typically managed on a watershed/subwatershed basis; therefore an impervious cover analysis was performed for the Raritan River subwatershed within Helmetta Borough which is the Manalapan Brook subwatershed (Table 1 and Figure 6). Approximately 17.6%, or 90.5 acres, of the Manalapan Brook subwatershed consists of impervious cover. Evaluating impervious cover on a subwatershed basis allows the municipality to focus impervious cover reduction or disconnection efforts in the subwatersheds where frequent flooding occurs.

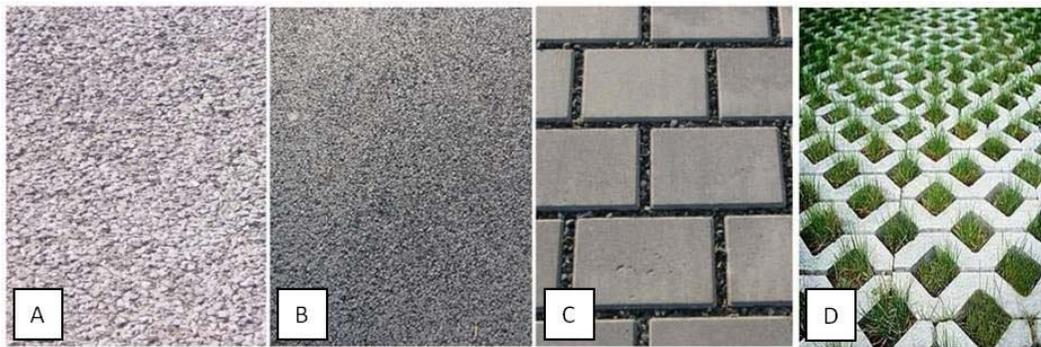
Permeable surfaces: (A) pervious concrete, (B) porous asphalt, (C) interlocking concrete pavers, (D) grid pavers (Rowe, 2012)

Pervious concrete and porous asphalt are the most common of the permeable surfaces. They are similar to regular concrete and asphalt but without the fine materials. This allows water to quickly pass through the material into an underlying layered system of stone that holds the water allowing it to infiltrate into the underlying uncompacted soil.

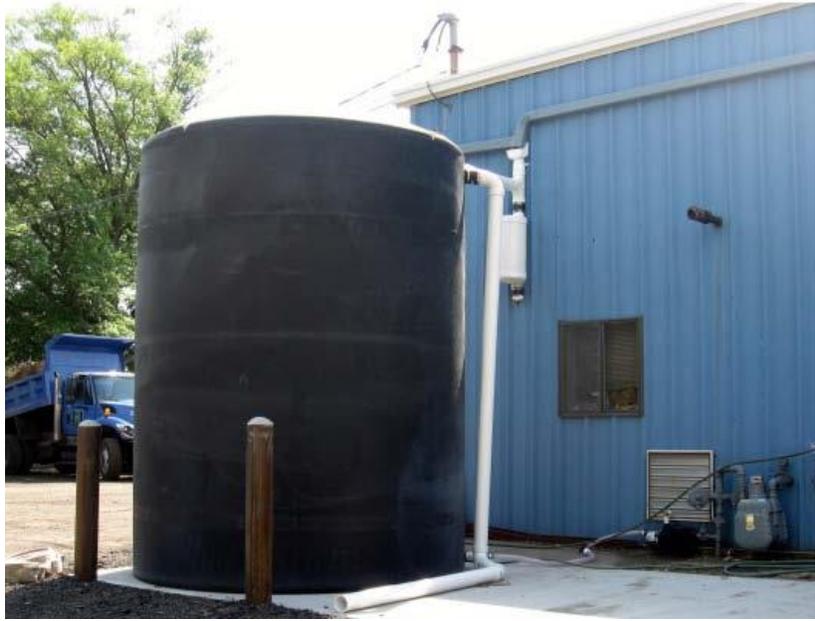
Figure 8b: A 5,000 gallon cistern used to disconnect the rooftop of the Department of Public Works in Clark Township to harvest rainwater for nonprofit car wash events

- Rainwater Harvesting: Rainwater harvesting includes the use of rain barrels and cisterns (Figures 8a and 8b). These can be placed below downspouts to collect rooftop runoff. The collected water has a variety of uses including watering plants and washing cars. This practice also helps cut down on the use of potable water for nondrinking purposes. It is important to divert the overflow from the rainwater harvesting system to a pervious area.

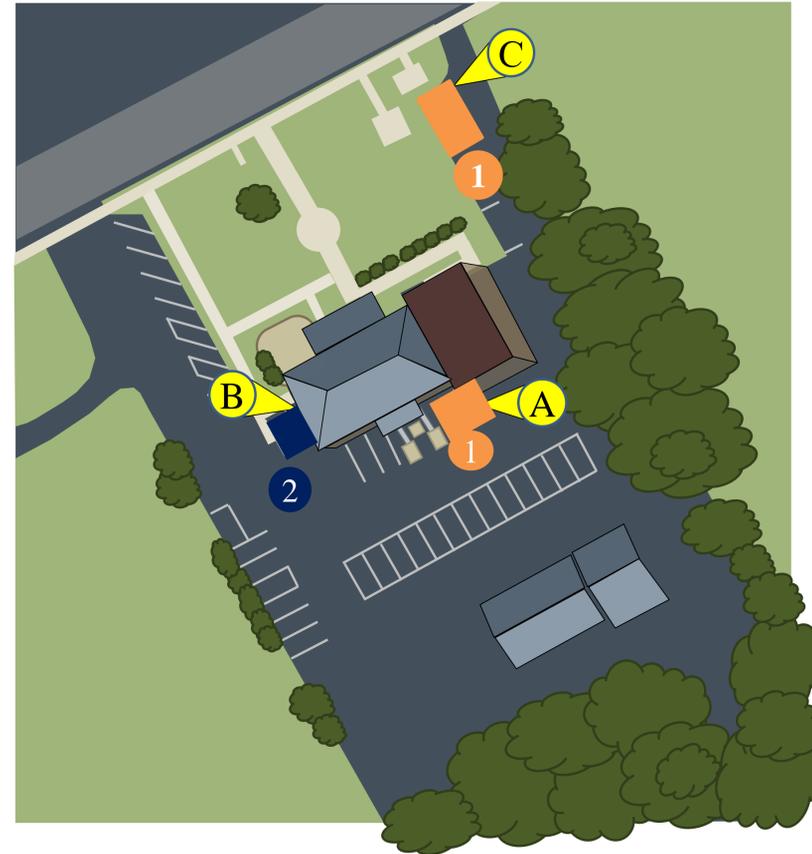
SITE PLAN:

- 1 **POROUS PAVEMENT:** Two parking spaces adjacent to the back of the building, as well as a strip of pavement at the end of the driveway east of the building, could be repaved with porous pavement to capture stormwater runoff from the roof, parking lot and driveway. Porous pavement promotes groundwater recharge and filters stormwater.
- 2 **DOWNSPOUT PLANTER BOX:** Two downspout planter boxes could be installed at the southwest corner of the building to collect water from the nearby downspouts. Planter boxes reduce runoff and allow water to slowly infiltrate while treating it for pollutants.

<p>Proposed Solution(s): The two downspouts at the west side of the building could be disconnected into two downspout planter boxes along the walls to capture, treat, and infiltrate some of the rooftop runoff. Two parking spaces to the east of the back entrance of the site could be converted to porous pavement to capture more roof runoff from the disconnected downspout. A strip of pavement at the end of the driveway on the east could also be converted to porous pavement to capture runoff from the parking lot and driveway. Porous pavement will treat the stormwater runoff and slowly allow it to infiltrate into the ground.</p>	
<p>Anticipated Benefits: Stormwater planters are estimated to achieve a 30% removal rate for TN and a 60% removal rate for TP (NJDEP BMP Manual). If designed to capture and infiltrate runoff from the 2-year design storm (3.3 inches of rain over 24 hours), the planter systems will achieve approximately a 95% pollutant load reduction for TN, TP, and TSS flowing into local waterways. The planter boxes would also aesthetically enhance the site near an entrance. Porous pavement allows stormwater to infiltrate through to soil layers which will promote groundwater recharge as well as intercept and filter stormwater runoff. These systems are expected to achieve a 95% pollutant load reduction for TN, TP, and TSS.</p>

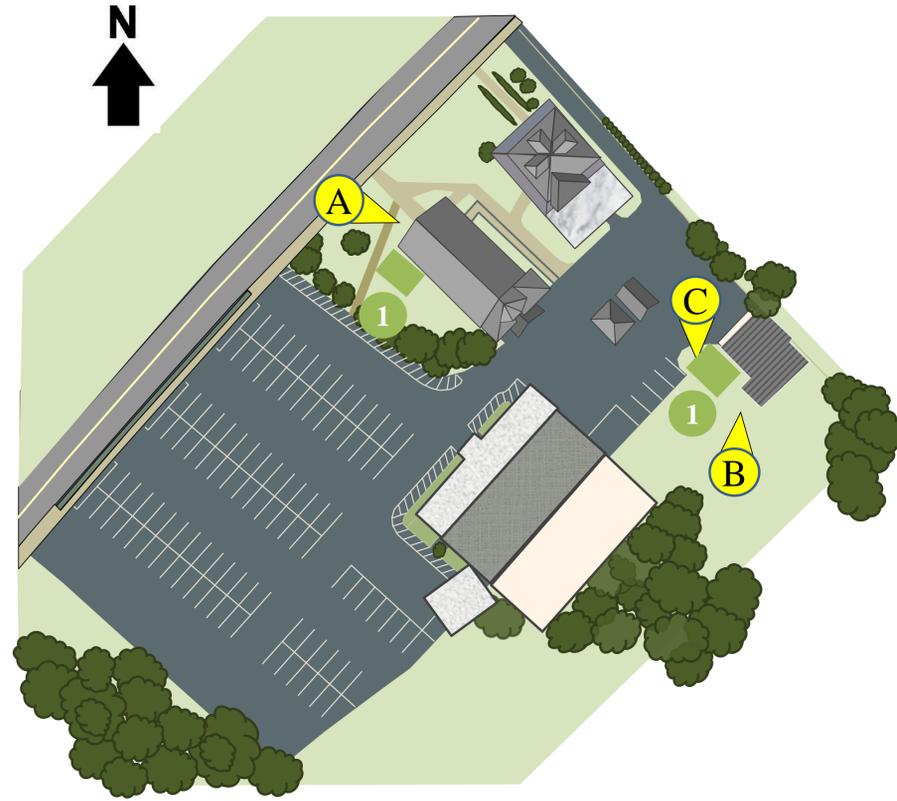
SITE PLAN:

1 BIORETENTION SYSTEM: A bioretention system could be installed along the west side of the church to capture stormwater runoff from the roof, and a second bioretention system could be installed in the turf grass area next to the storage building at the back of the site to capture stormwater runoff from the driveway.

<p>Proposed Solution(s): Two bioretention systems could be installed at this site. A rain garden could be installed in the turf grass area west of the building to treat runoff from the disconnected downspout. A second rain garden could be installed in the turf grass area next to the storage building in the southeast corner of the site. This second rain garden would capture runoff from the driveway and reduce pooling.</p>	
<p>Anticipated Benefits: Since the bioretention systems would be designed to capture, treat, and infiltrate the entire 2-year design storm (3.3 inches of rain over 24 hours), these systems are estimated to achieve a 95% pollutant load reduction for TN, TP, and TSS. A bioretention system would also provide ancillary benefits such as enhanced wildlife habitat and aesthetic appeal.</p>	
<p>Possible Funding Sources: mitigation funds from local developers NJDEP grant programs</p>

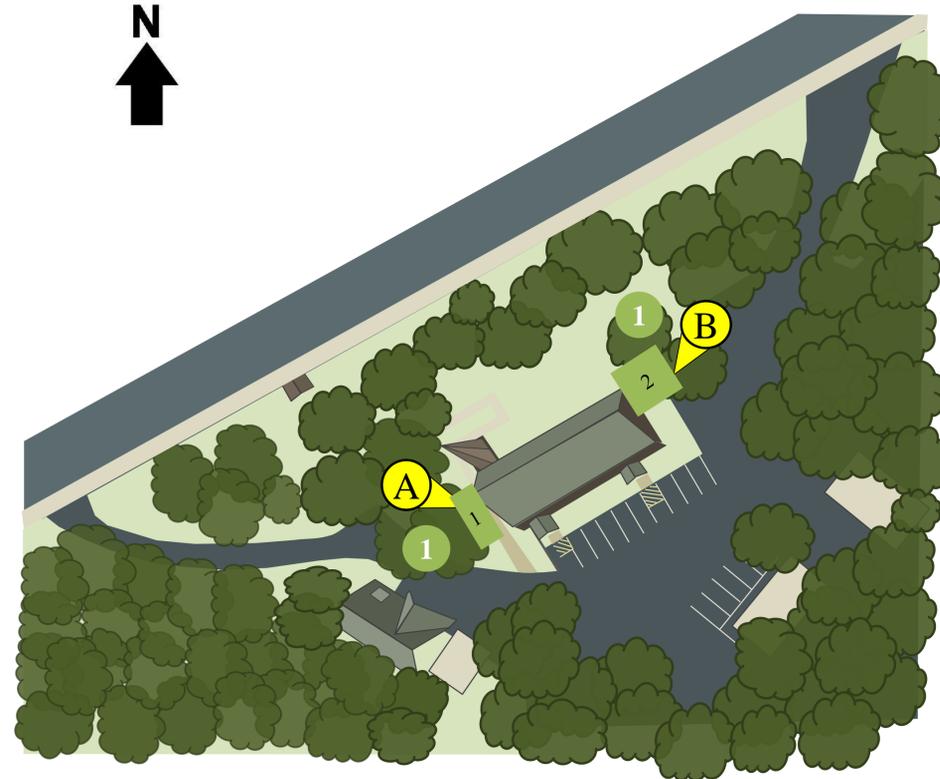
SITE PLAN:

1 BIORETENTION SYSTEM: A bioretention system could be installed at the front of the church off the southwest side of the building to collect runoff from downspouts. Another bioretention system could be installed at the east side of the building to capture roof runoff. Bioretention systems reduce sediment and nutrient loading to local waterways and promote groundwater recharge.

<p>Proposed Solution(s): The two downspouts in the front of the church at the southwest side could be disconnected and redirected into a bioretention system (1). A second rain garden (2) could be installed at the back of the church in the turf grass area where runoff from the roof drains.</p>	
<p>Anticipated Benefits: Since the bioretention systems would be designed to capture, treat, and infiltrate the entire 2-year design storm (3.3 inches of rain over 24 hours), these systems are estimated to achieve a 95% pollutant load reduction for TN, TP, and TSS. A bioretention system would also provide ancillary benefits such as enhanced wildlife habitat and aesthetic appeal.</p>	
<p>Possible Funding Sources: mitigation funds from local developers NJDEP grant programs Saint George's Anglican Church Helmetta Borough</p>	
<p>Partners/Stakeholders: Helmetta Borough residents Saint George's Anglican Church members local community groups (Boy Scouts, Girl Scouts, etc.) Rutgers Cooperative Extension</p>
