**Impervious Cover Assessment
for
Lebanon Township, Hunterdon County, New Jersey**

*Prepared for Lebanon Township by the
Rutgers Cooperative Extension Water Resources Program*

January 7, 2020

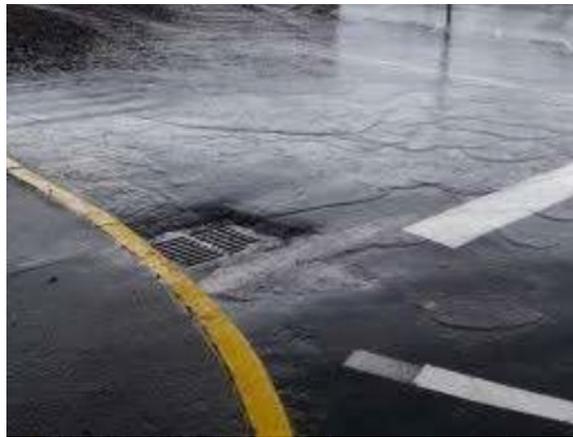
Figure 1: Stormwater draining from a parking lot

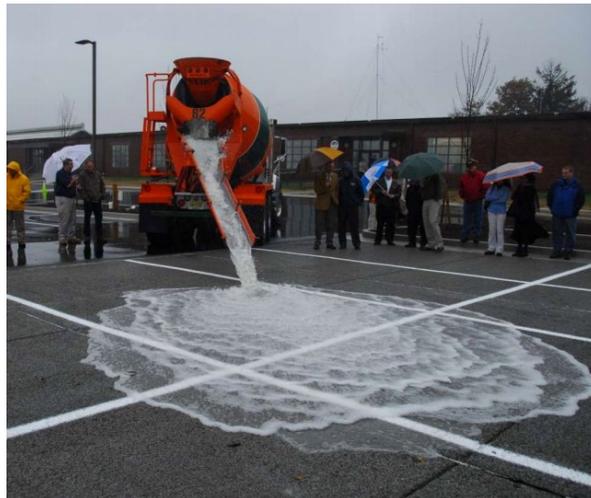
Figure 2: Rapid infiltration of water through porous pavement is demonstrated at the USEPA Edison New Jersey test site

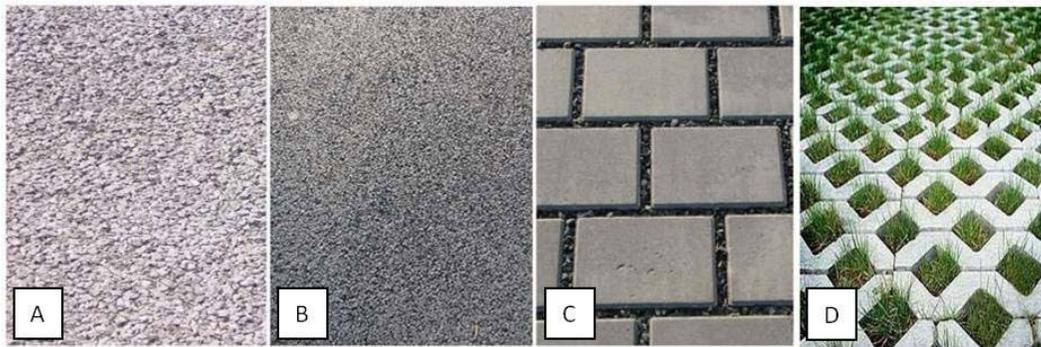
Permeable surfaces: (A) pervious concrete, (B) porous asphalt, (C) interlocking concrete pavers, (D) grid pavers (Rowe, 2012)

Pervious concrete and porous asphalt are the most common of the permeable surfaces. They are similar to regular concrete and asphalt but without the fine materials. This allows water to quickly pass through the material into an underlying layered system of stone that holds the water, allowing it to infiltrate into the underlying uncompacted soil.

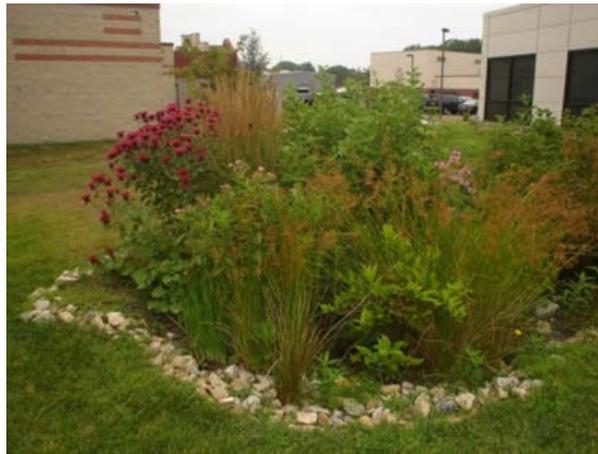
Figure 7: Rain garden outside the RCE of Gloucester County office which was designed to disconnect rooftop runoff from the local storm sewer system

- Rain Gardens: Stormwater can be diverted into shallow landscaped depressed areas (i.e., rain gardens) where the vegetation filters the water, and it is allowed to soak into the ground. Rain gardens, also known as bioretention systems, come in all shapes and sizes and can be designed to disconnect a variety of impervious surfaces (Figure 7).

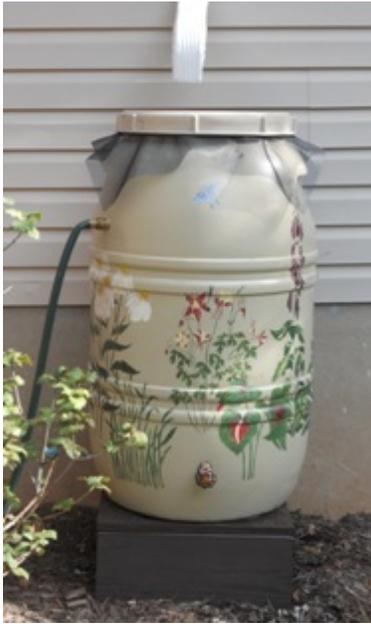
Figure 8a: Rain barrel used to disconnect a downspout with the overflow going to a flower bed

- Rainwater Harvesting: Rainwater harvesting includes the use of rain barrels and cisterns (Figures 8a and 8b). These can be placed below downspouts to collect rooftop runoff. The collected water has a variety of uses including watering plants and washing cars. This practice also helps cut down on the use of potable water for nondrinking purposes. It is important to divert the overflow from the rainwater harvesting system to a pervious area.

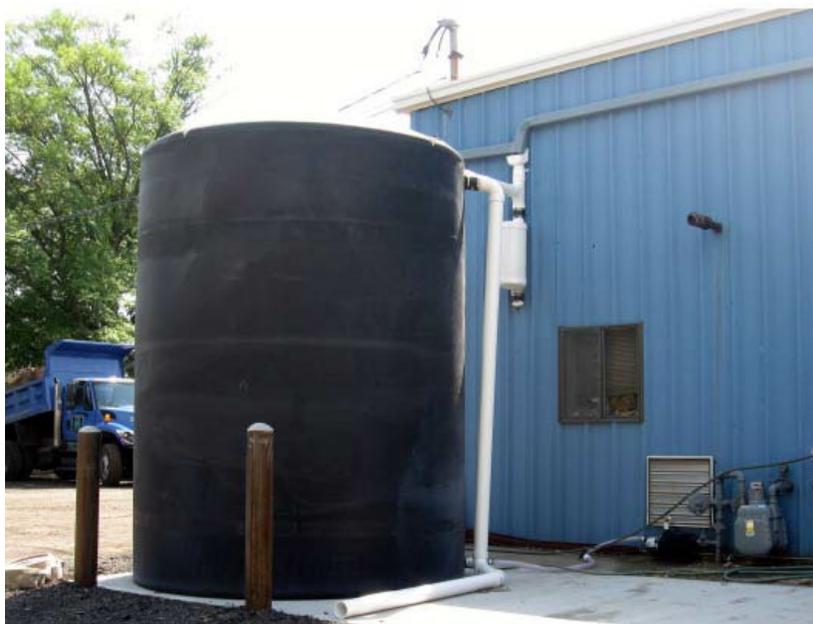
Figure 8b: A 5,000 gallon cistern used to disconnect the rooftop of the Department of Public Works in Clark Township to harvest rainwater for nonprofit car wash events

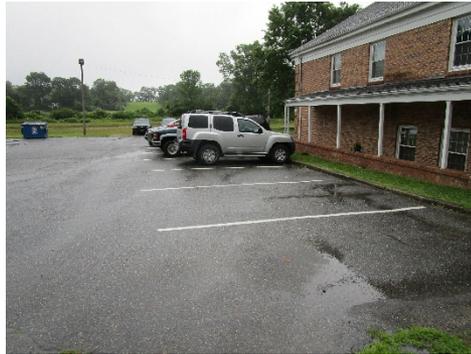
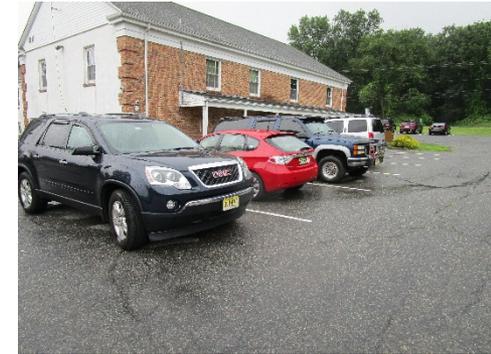
LEBANON TOWNSHIP MUNICIPAL BUILDING

A bioretention system is proposed in the southwest turfgrass area to treat the western strip of the parking lot. Additionally, pervious pavement is proposed on the east side of the building to infiltrate the water from the roof and the downspouts. A downspout planter box is another option to use rooftop runoff.

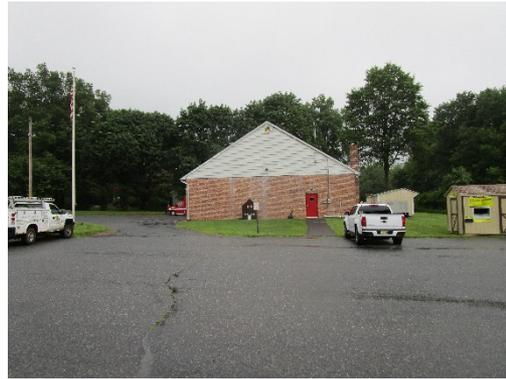
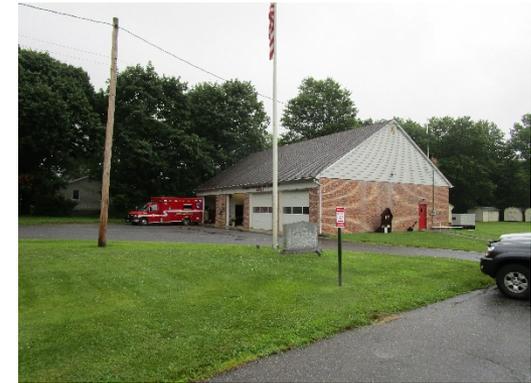
LEBANON TOWNSHIP VOLUNTEER FIRE DEPARTMENT – STATION 3

A cistern can be installed on the front of the firehouse to harvest rainwater. Planter boxes are another option to reuse the rooftop runoff. In addition, a bioretention system can be installed to treat the southern parking lot's drainage area.

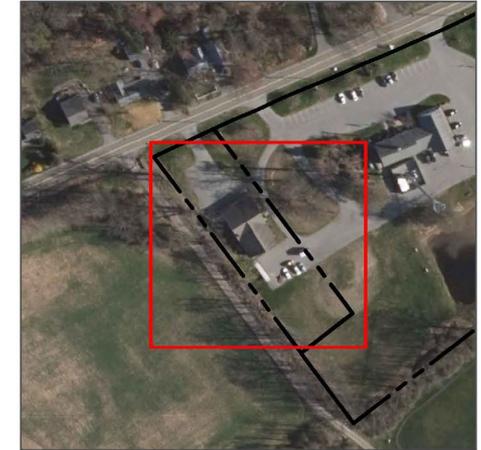
Lebanon Township Volunteer Fire Department - Station 3

bioretention system
-

planter box
-

rainwater harvesting
-

drainage area
-

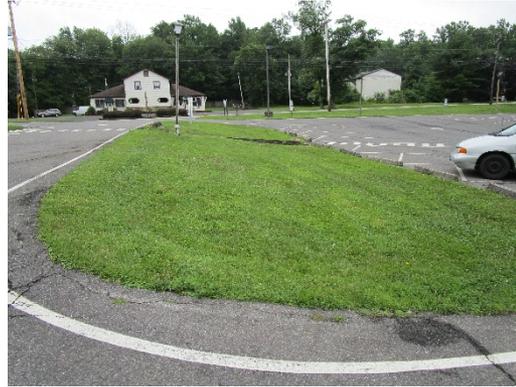
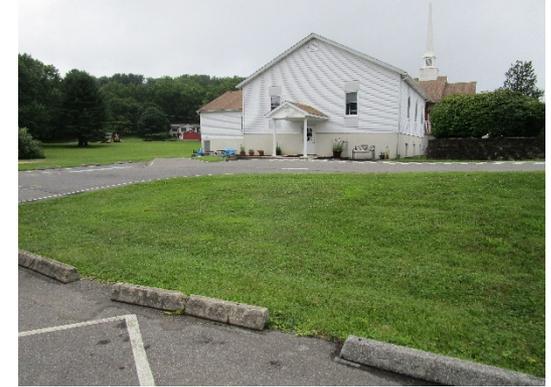
BUNNVALE ASSEMBLY OF GOD

A bioretention system can be installed in the center of the parking lot to infiltrate water from the downspouts as well as the parking lot. It should be noted that the turfgrass area in the center of the lot is divided down the middle by a staircase; two identical bioretention systems can be installed on either side. In addition, pervious pavement can be installed along the northern strip of the parking lot to treat the parking lot's drainage area. Lastly, three planter boxes can be installed at the building to treat the rooftop drainage area.

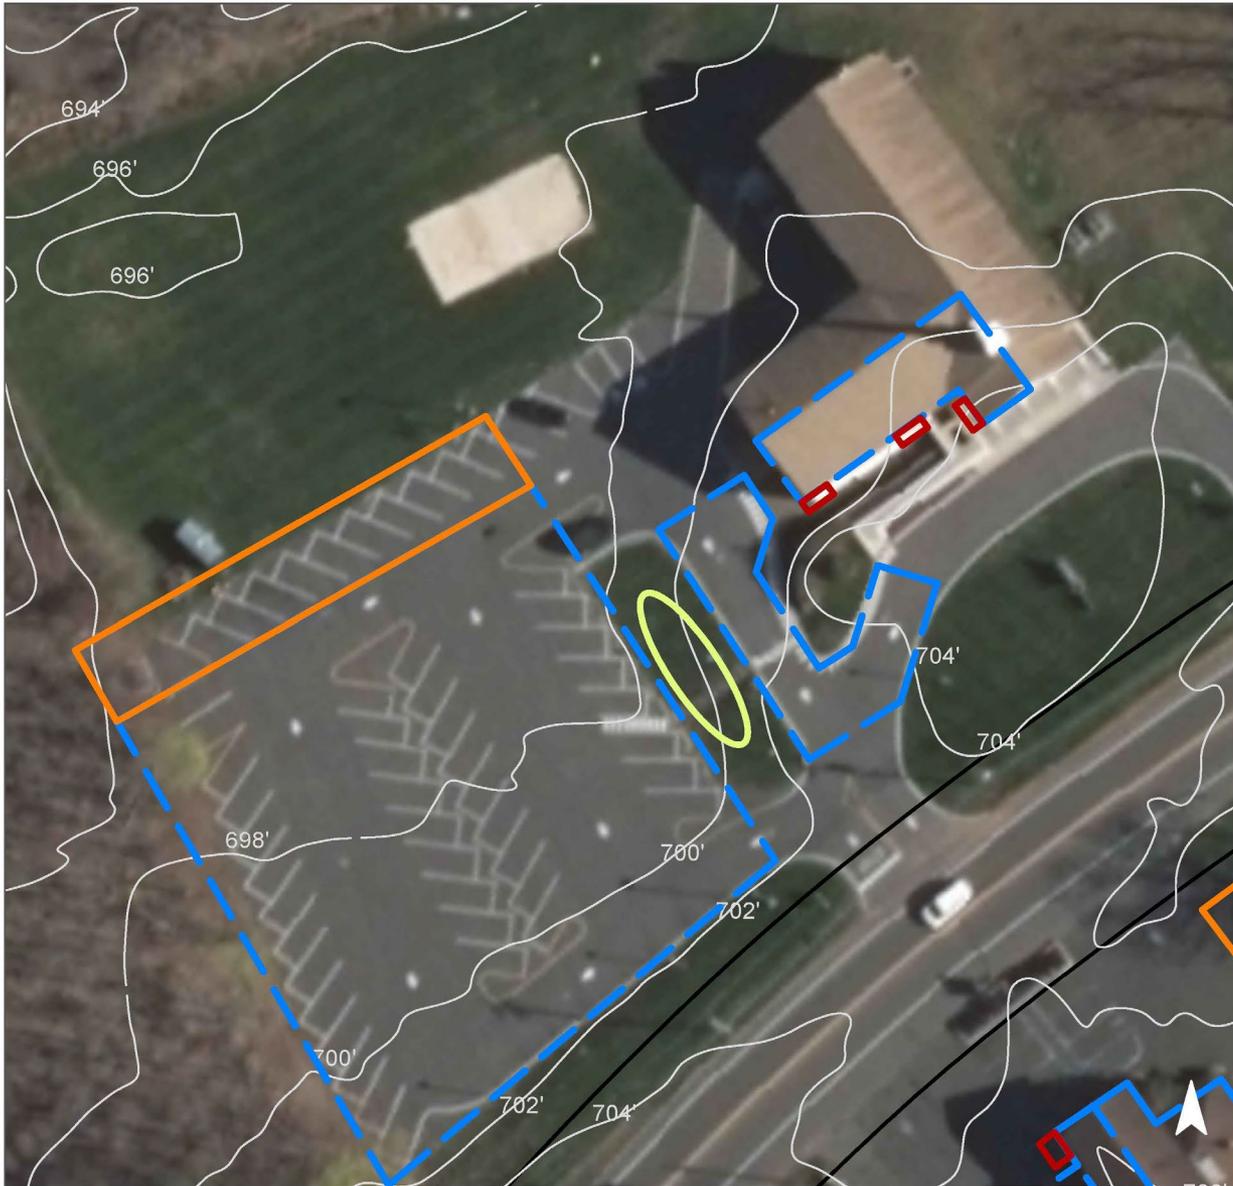
Bunnvale Assembly of God

bioretention system
-

pervious pavement
-

planter box
-

drainage area
-
