**Impervious Cover Assessment  
for  
Washington Township, Morris County, New Jersey**

*Prepared for Washington Township by the  
Rutgers Cooperative Extension Water Resources Program*

January 7, 2020

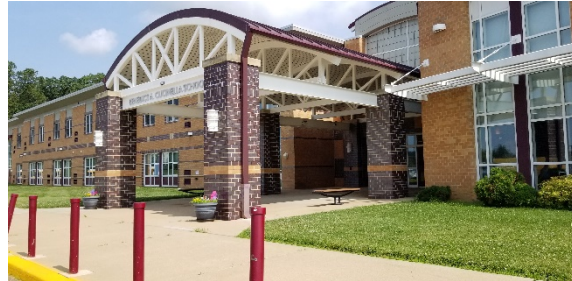
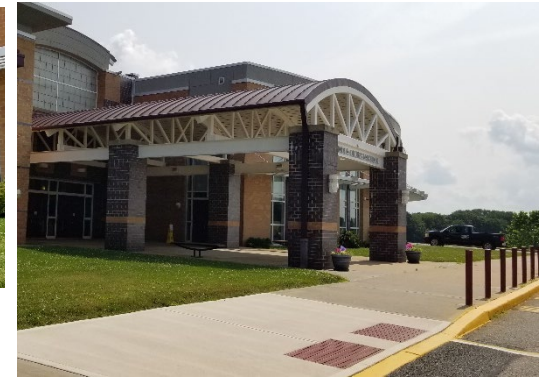
# BENEDICT A. CUCINELLA SCHOOL

Downspout planter boxes are suggested at the entrance of the school to promote green infrastructure awareness. Pervious pavement is proposed along the east edge of the south parking lot to treat the parking lot's drainage area.

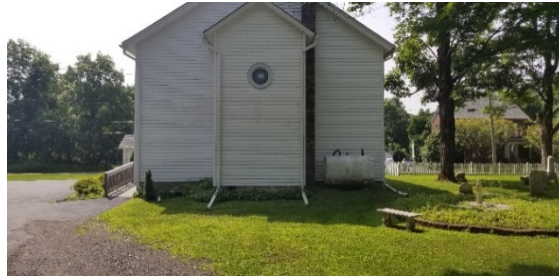
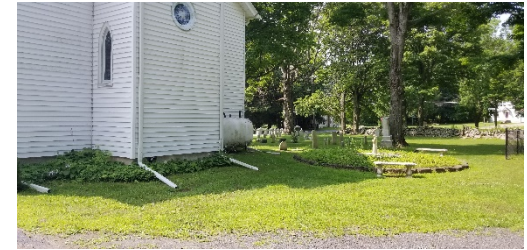
# DRAKESTOWN UNITED METHODIST CHURCH

A bioretention system is proposed to infiltrate the water from disconnected downspouts as well as to prevent the adjacent pavement from eroding further. Downspout planter boxes are another option to treat the same drainage area. In addition, pervious pavement is proposed along the south edge of the parking lot to treat the entire parking lot's drainage area.

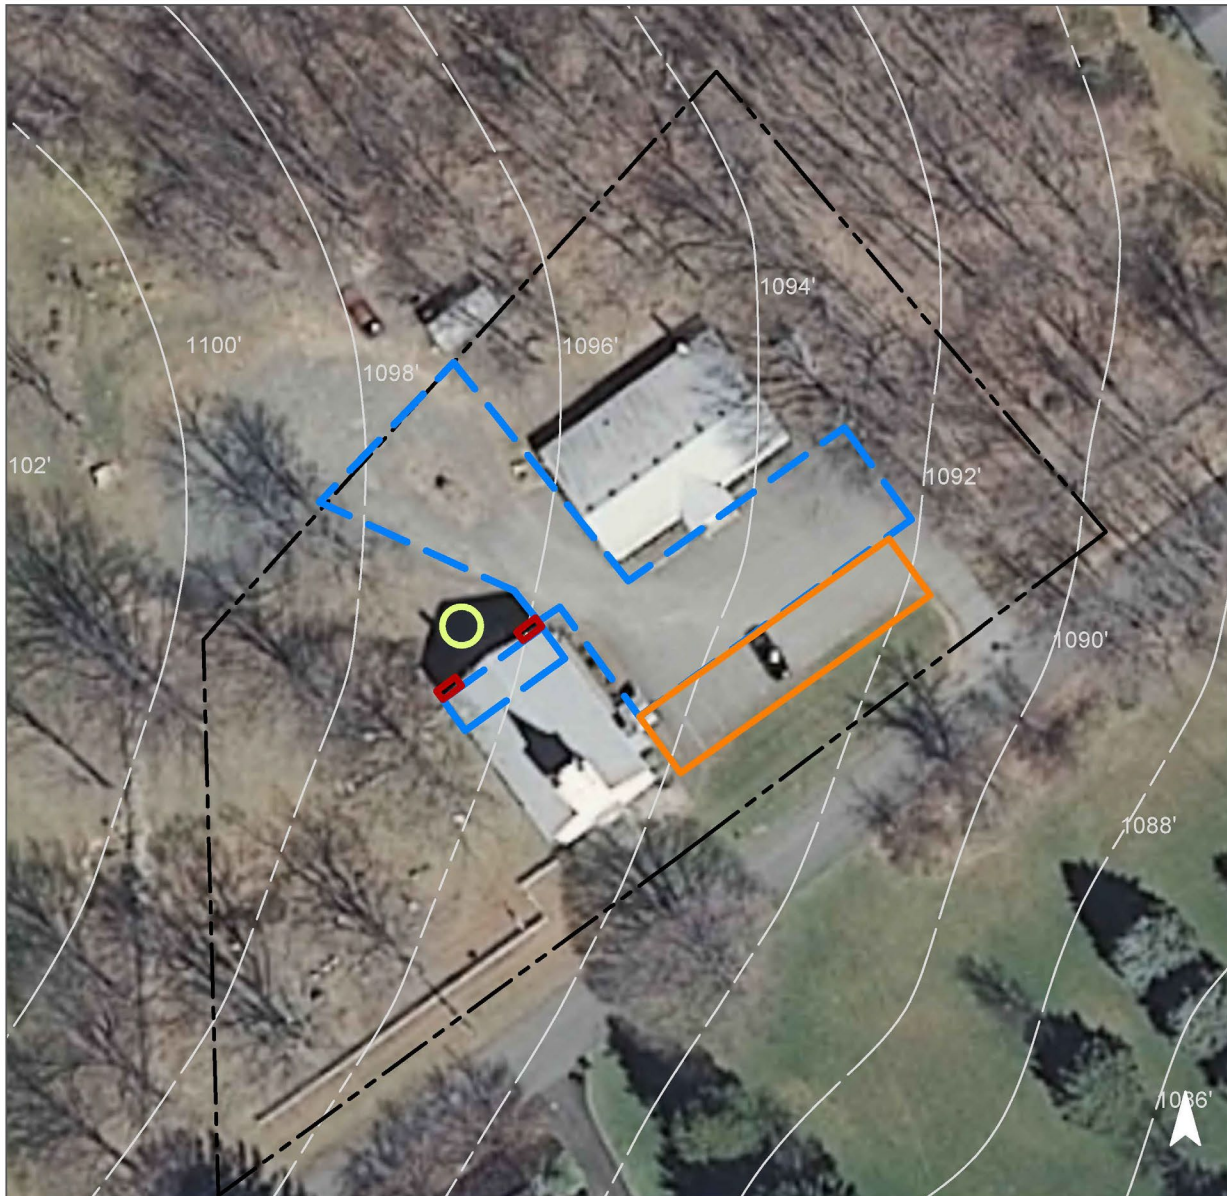
## Drakestown United Methodist Church

bioretention system
-

pervious pavement
-

planter box
-

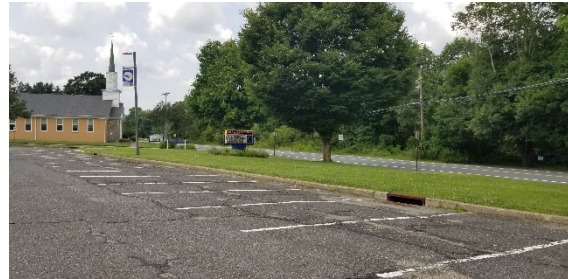
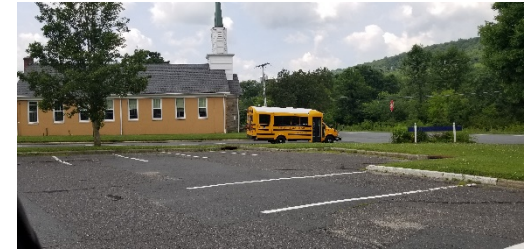
# LONG VALLEY MIDDLE SCHOOL

Pervious pavement is proposed to decrease the amount of surface runoff contamination from the parking lot to the subwatershed as well as to remediate the erosion. A bioretention system is proposed in the north turfgrass area to treat the northwest drainage area of the school. Downspout planter boxes are another option to serve the same purpose.

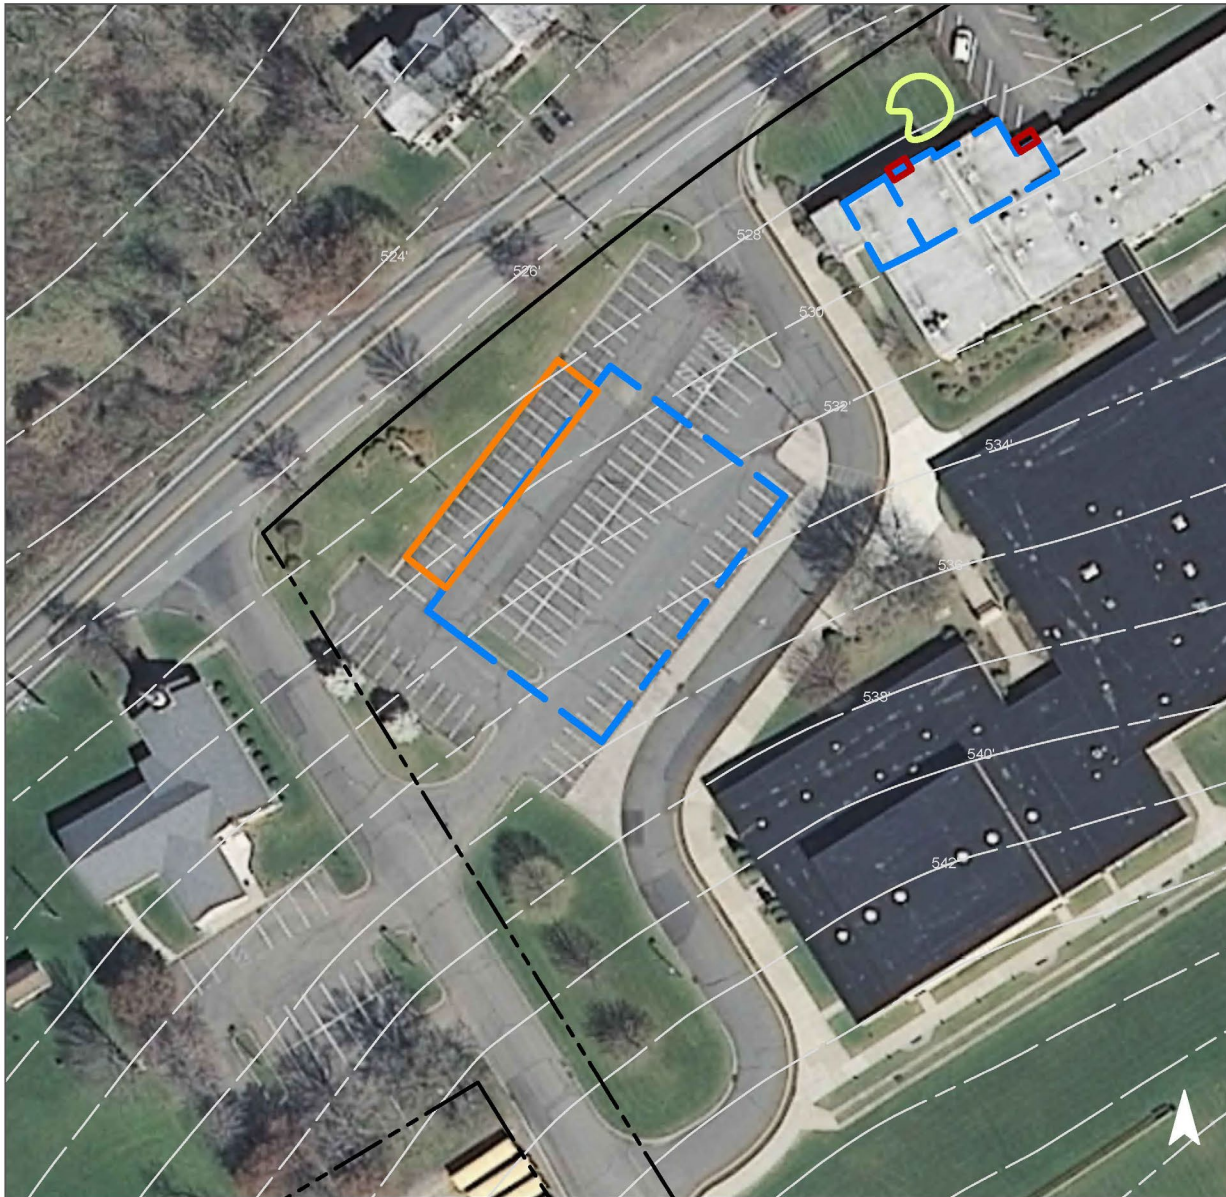
## Long Valley Middle School

bioretention system
-

pervious pavement
-

planter box
-
