## **DRAFT - Roadway Bioswale Stormwater Reduction Action Plan (RAP) for Bernardsville Borough ~ June 2022**

This document will serve as an addendum to the February 10, 2020 impervious cover reduction action plan for Bernardsville Borough prepared with funding and direction from the New Jersey Highlands Water Protection and Planning Council.

# BERNARDSVILLE BOROUGH: GREEN INFRASTRUCTURE ROADWAY STORMWATER MANAGEMENT STRATEGIES

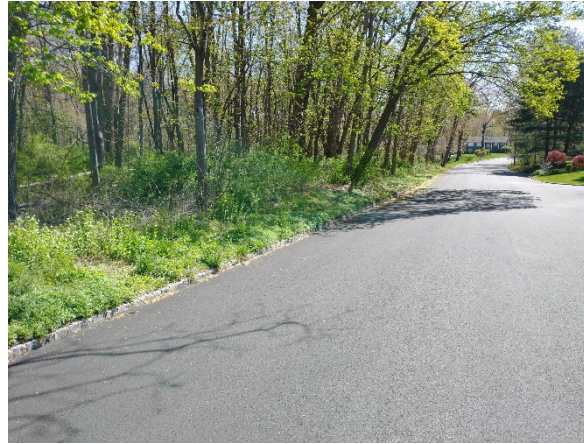
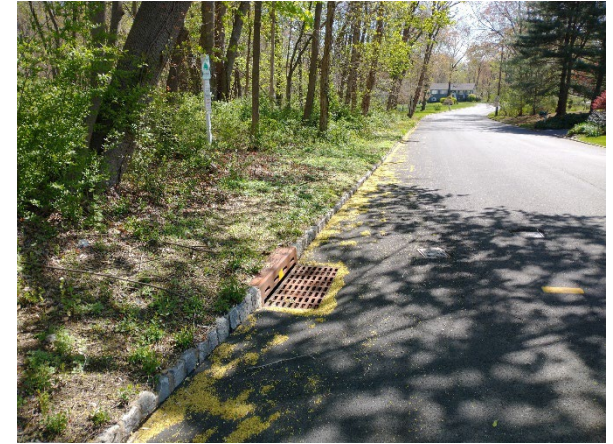
# Oakley Street

A bioswale can be installed west of the existing catch basin in the grassed area between the tree cover. The catch basin had standing water in it so an investigation to the downhill piping could help with water ponding issues in this area. A preliminary soil assessment suggests that the soils have suitable drainage characteristics for green infrastructure.

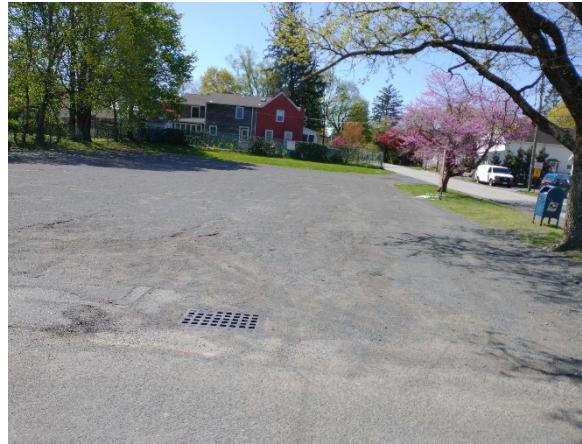
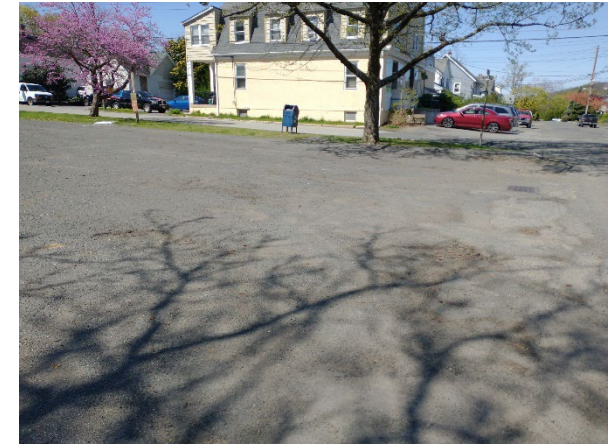
# Bernards Avenue & Maple Street

A stormwater planter can be installed uphill of the catch basin to intercept the stormwater prior it entering the basin. A preliminary soil assessment suggests that the soils have suitable drainage characteristics for green infrastructure.

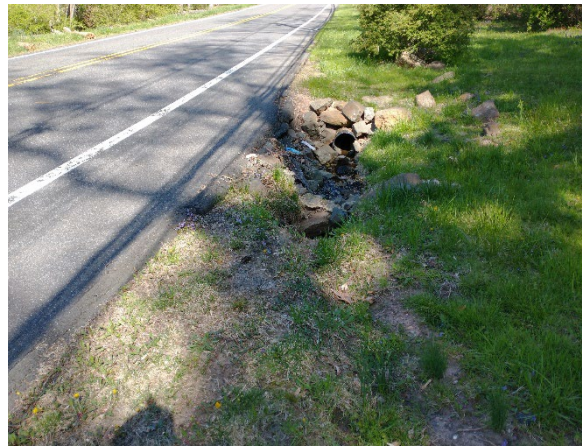
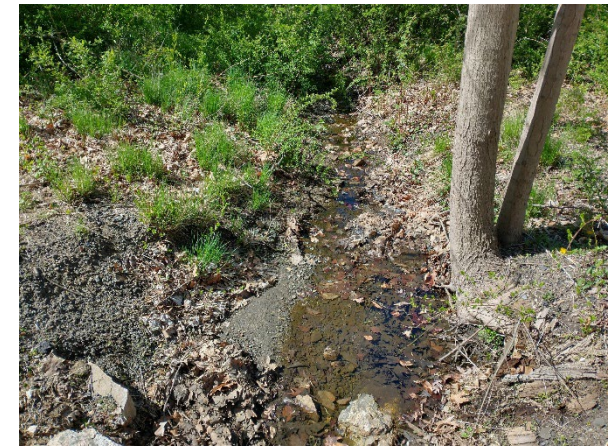
# Claremont Road

Using an existing curb cut and underground piping system, the daylighted areas can be converted to a bioswale to help promote water infiltration. The outfall pipe on the southern section of the roadway can have the channel cleared of debris, regraded, and planted to be converted to a bioswale. A preliminary soil assessment suggests that the soils have suitable drainage characteristics for green infrastructure.

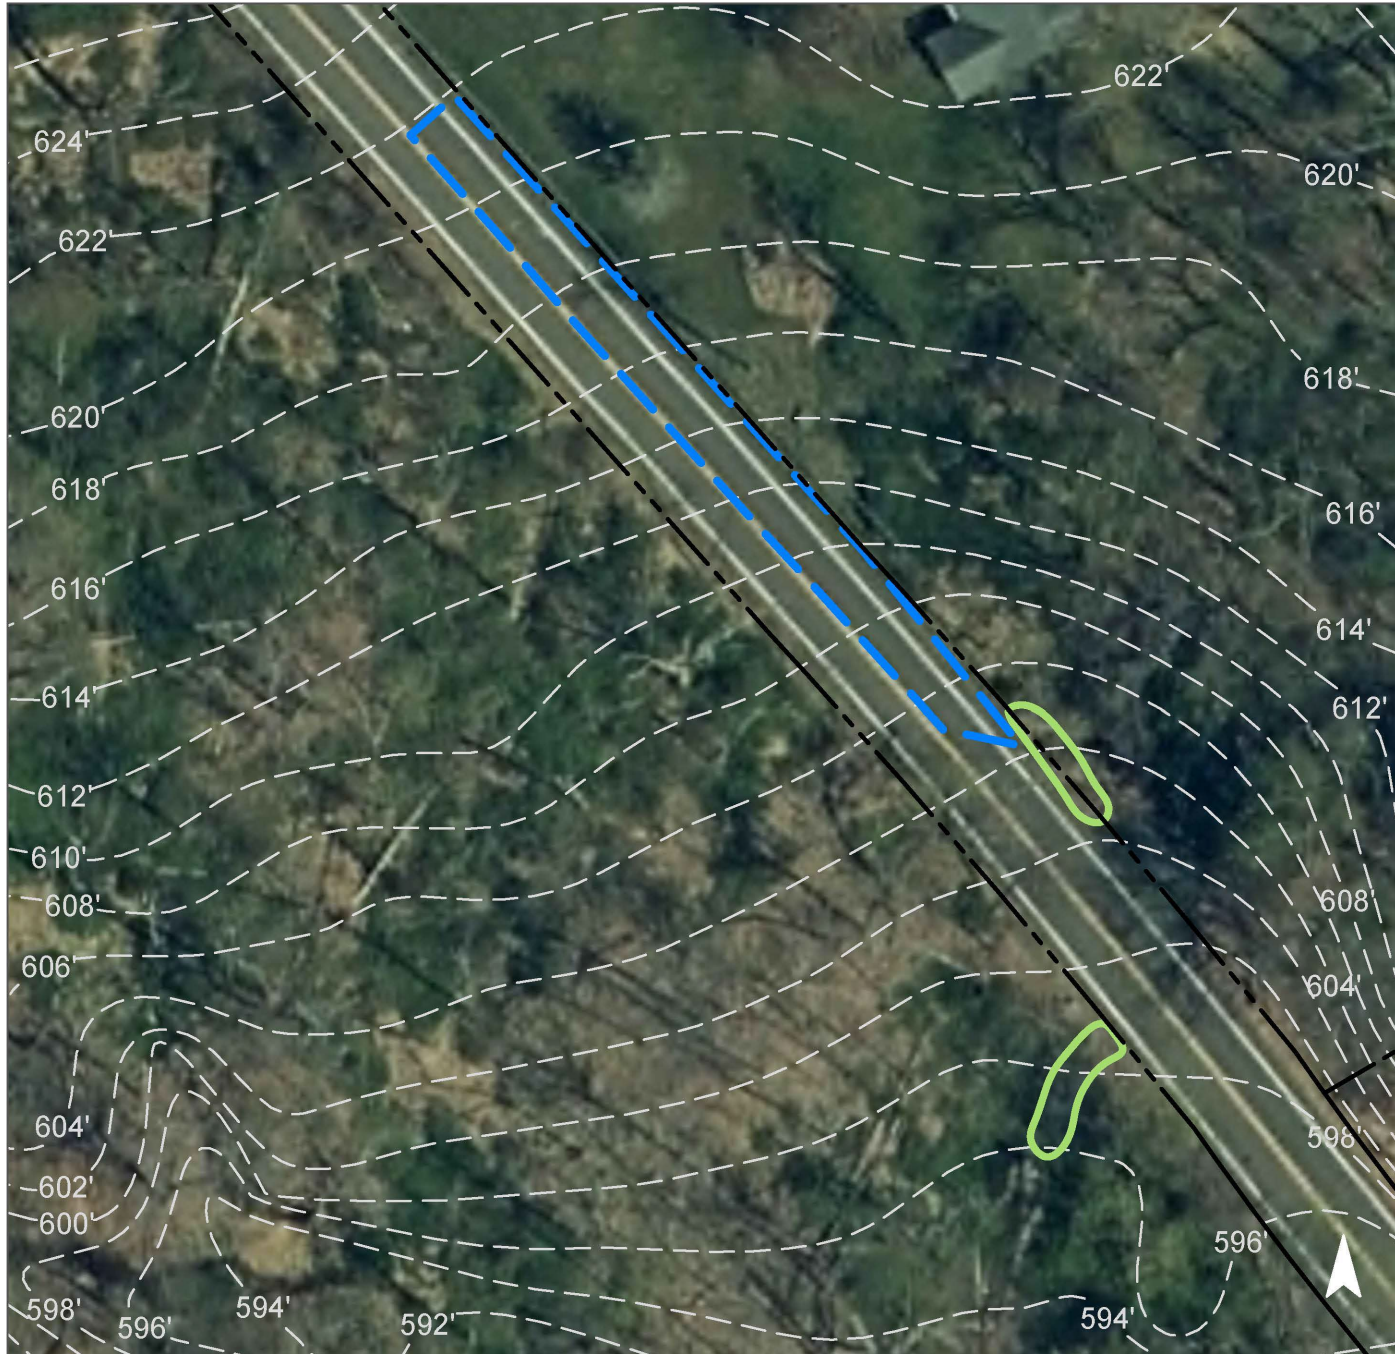
## Claremont Road

bioswale
-

drainage area
-

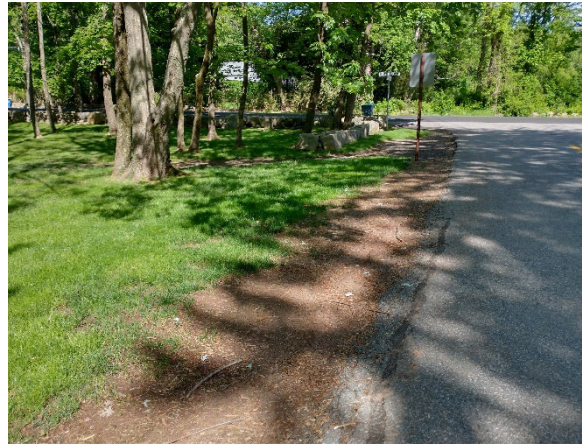
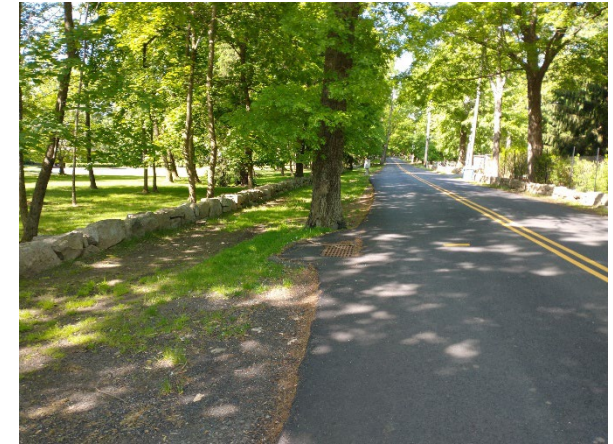
# Mountain Top Road & Overleigh Road

A stone swale can be installed south of Mountain Top Road to help guide the water flow away from the retaining wall toward the catch basin on the corner of the roadway. A bioswale can be installed west of Overleigh Road in the existing eroded area to aid in water conveyance to the nearby catch basins. A preliminary soil assessment suggests that more soil testing would be required before determining the soil's suitability for green infrastructure.

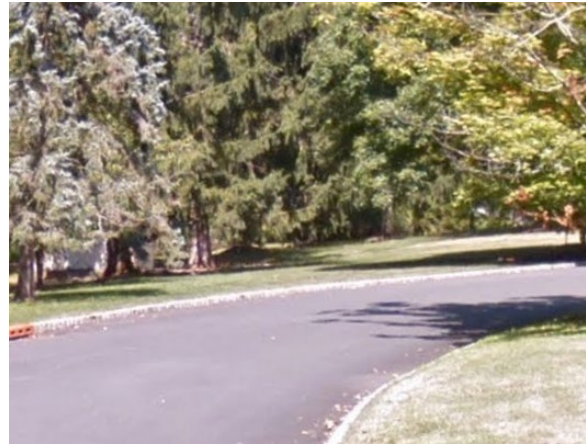
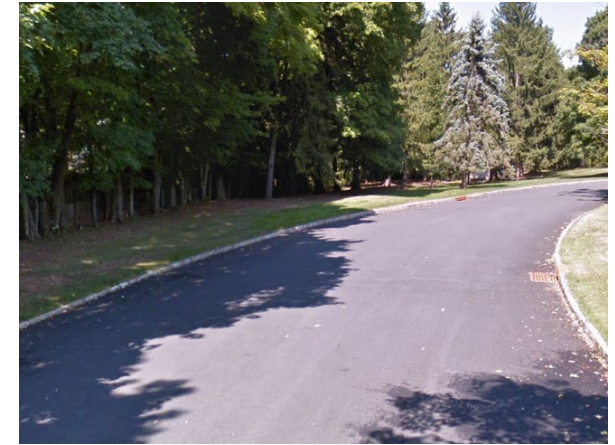
# South Field Drive

A bioswale can be installed on the corner turn of South Field Drive. This will help with water conveyance down the hill and help prevent erosion alongside the roadway. A preliminary soil assessment suggests that more soil testing would be required before determining the soil's suitability for green infrastructure.

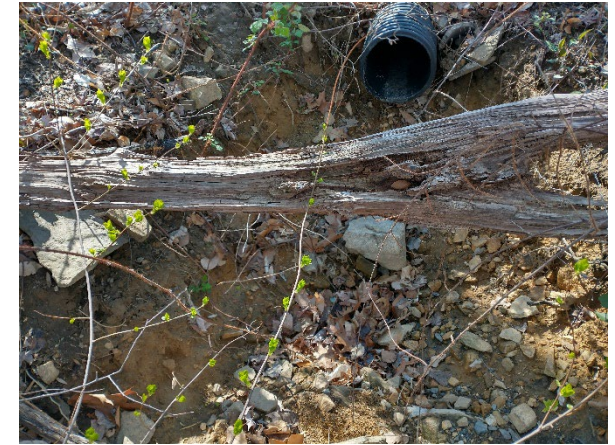
# Locust Drive

The northwestern section of the pavement can be replaced with a rain garden to intercept stormwater prior to it entering the catch basin. The outfall pipe of the catch basin can be armored with rock to prevent erosion, and the channel downhill of it can be cleared of debris and converted to a bioswale to help promote water infiltration. A preliminary soil assessment suggests that the soils have suitable drainage characteristics for green infrastructure.

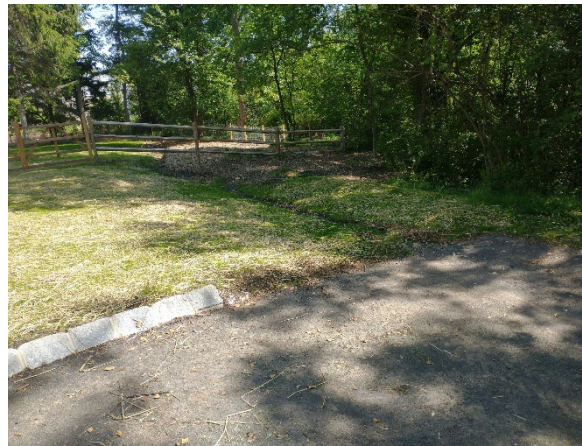
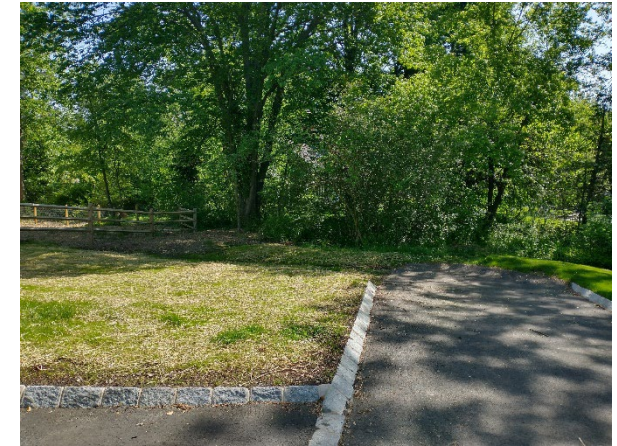
# Prospect Street

A rain garden can be installed at the beginning of the existing drainage channel to promote infiltration. To prevent standing water and further erosion of the drainage channel, the channel can be converted to a bioswale. A preliminary soil assessment suggests that the soils have suitable drainage characteristics for green infrastructure.

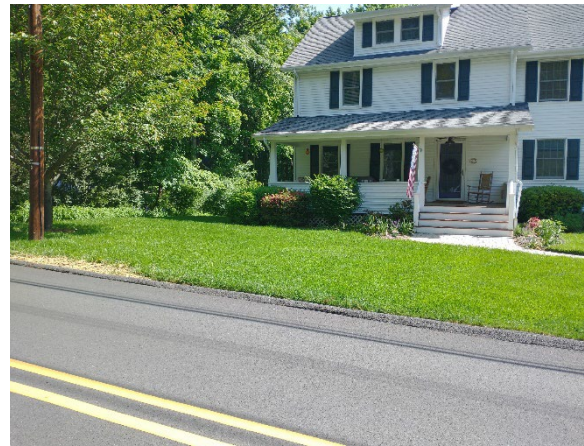
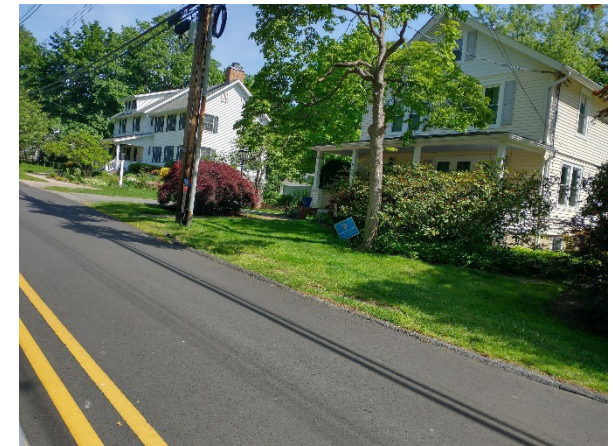
# Washington Street

Bioswales can be installed alongside the northern edge of Washington Street in areas where stormwater creates ruts or dead patches in the turfgrass to help convey the stormwater nondestructively. A preliminary soil assessment suggests that the soils have suitable drainage characteristics for green infrastructure.
