**Impervious Cover Reduction Action Plan
for
Washington Township, Morris County, New Jersey**

*Prepared for Washington Township by the
Rutgers Cooperative Extension Water Resources Program*

June 22, 2020

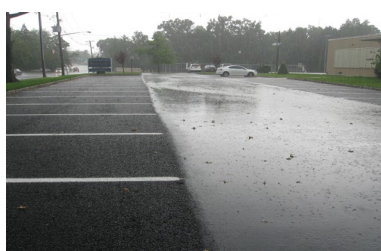
Pervious pavements

There are several types of permeable pavement systems including porous asphalt, pervious concrete, permeable pavers, and grass pavers. These surfaces are hard and support vehicle traffic but also allow water to infiltrate through the surface. They have an underlying stone layer to store stormwater runoff and allow it to slowly seep into the ground.

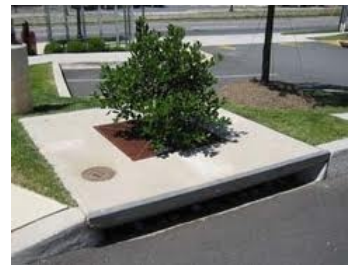
Tree filter boxes

These are pre-manufactured concrete boxes that contain a special soil mix and are planted with a tree or shrub. They filter stormwater runoff but provide little storage capacity. They are typically designed to quickly filter stormwater and then discharge it to the local sewer system.

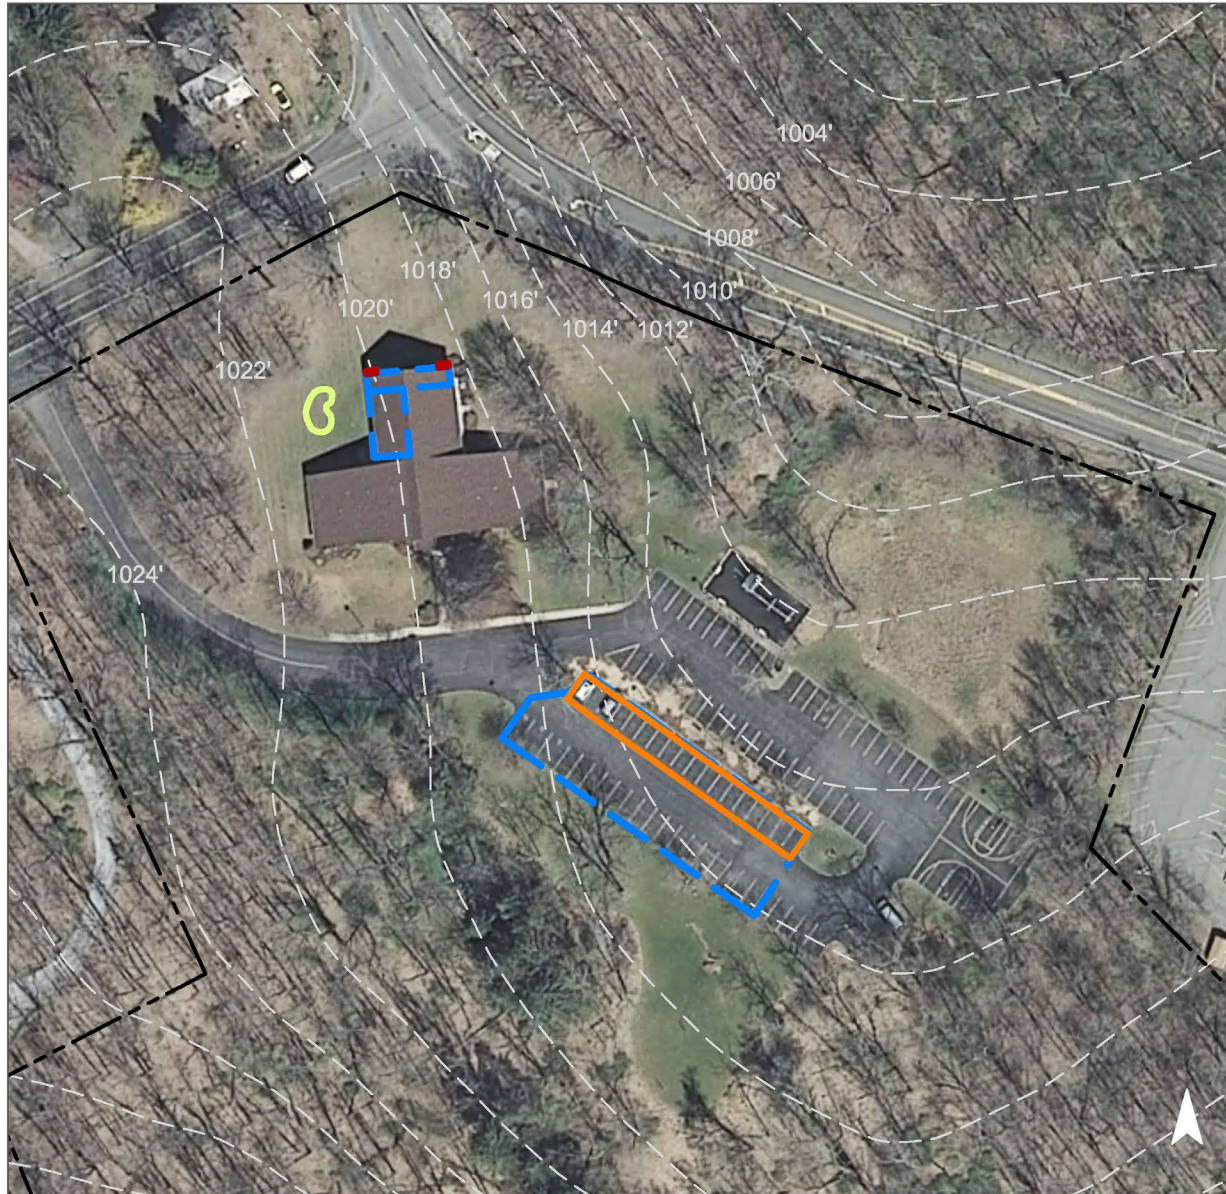
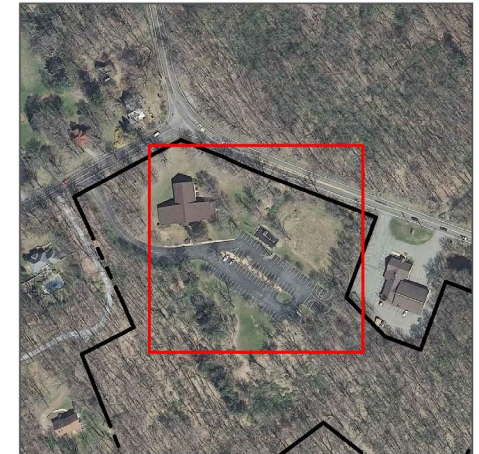
Emmanuel Bible Church

A rain garden and downspout planter boxes can be installed adjacent to the main building to capture, treat, and infiltrate stormwater runoff from the roof. Pervious pavement is proposed to treat runoff in the southeast parking lot. Planter boxes can also be installed to treat the rooftop drainage area. A preliminary soil assessment suggests that more soil testing would be required before determining the soil's suitability for green infrastructure.

Recommended Green Infrastructure Practices	Recharge Potential (Mgal/yr)	TSS Removal Potential (lbs/yr)	Maximum Volume Reduction Potential (gal/storm)	Peak Discharge Reduction Potential (cu. ft./second)	Estimated Size (sq. ft.)	Estimated Cost
Bioretention system	0.021	4	1,670	0.06	205	\$1,025
Pervious pavement	0.269	45	21,030	0.74	1,845	\$46,125
Planter boxes	n/a	2	n/a	n/a	2 (boxes)	\$2,000

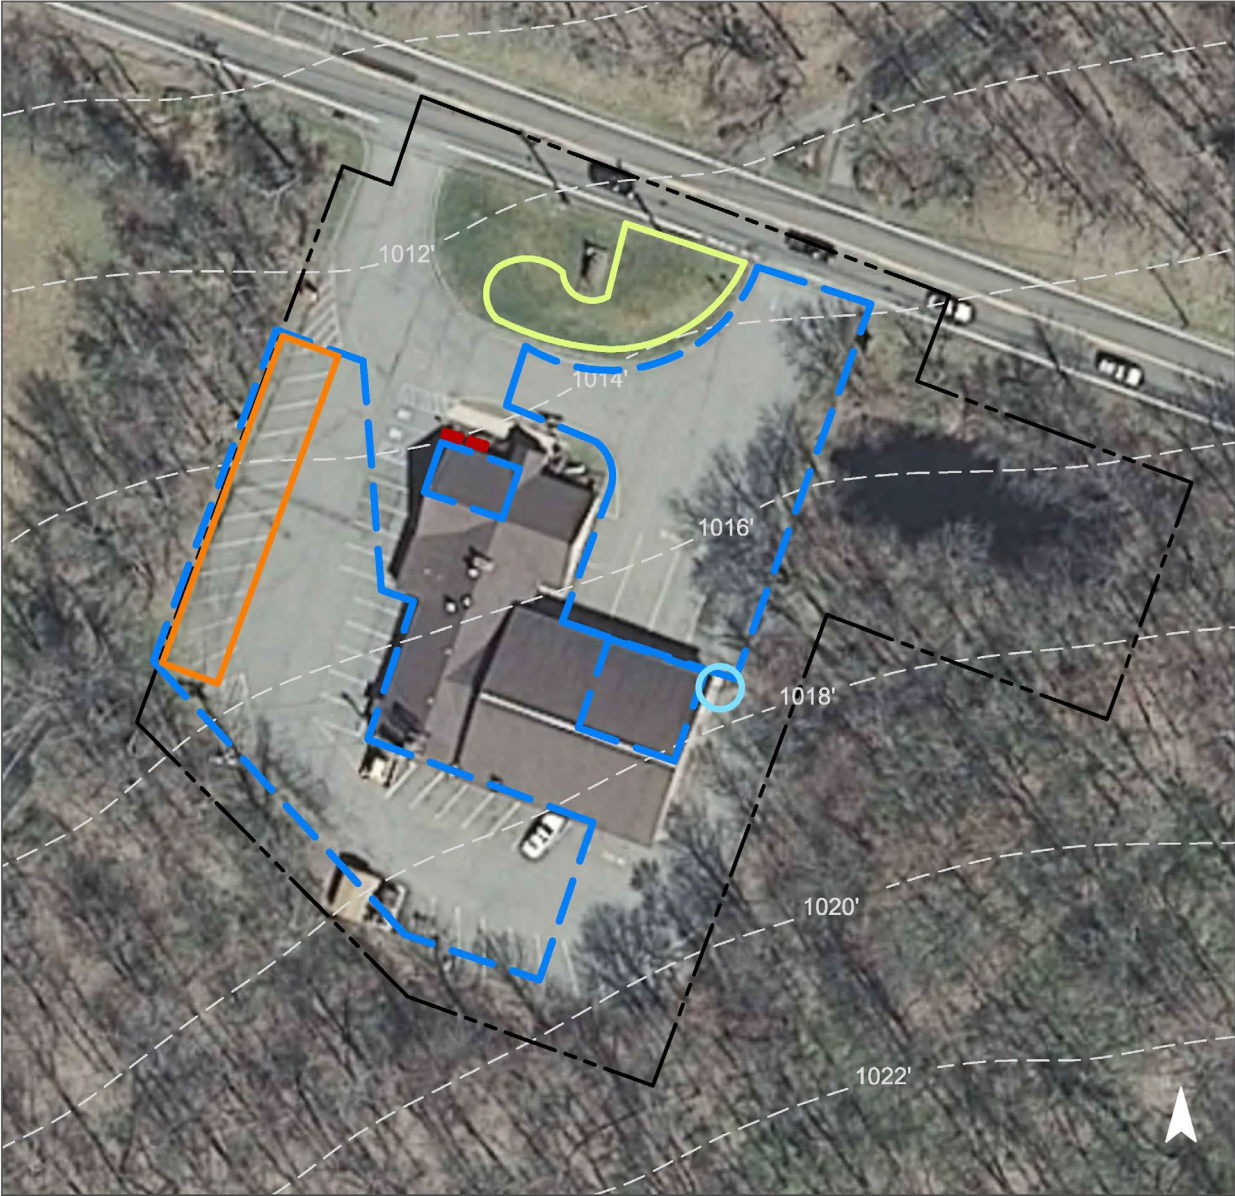
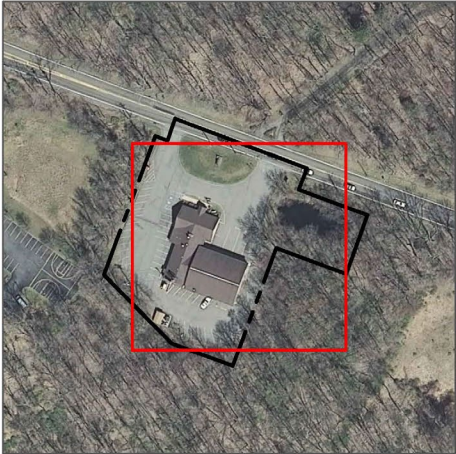
Schooleys Mountain Fire Protection

Runoff from different sections of the parking lot can be treated by a rain garden and also a section of porous parking spaces. A cistern can be installed adjacent to the building to capture runoff from the roof. The water can then be reused for washing vehicles or watering the lawn. Additionally, downspout planters can be installed to treat the northeast rooftop drainage area. Preliminary soil assessment suggests that more soil testing would be required before determining the soil's suitability for green infrastructure.

Recommended Green Infrastructure Practices	Recharge Potential (Mgal/yr)	TSS Removal Potential (lbs/yr)	Maximum Volume Reduction Potential (gal/storm)	Peak Discharge Reduction Potential (cu. ft./second)	Estimated Size (sq. ft.)	Estimated Cost
Bioretention system	0.248	42	20,031	0.88	2,385	\$11,925
Pervious pavement	0.348	58	27,160	1.19	2,570	\$64,250
Planter boxes	n/a	2	n/a	n/a	2 (boxes)	\$2,000
Rainwater harvesting	0.033	6	2,446	0.11	1,000 (gal)	\$2,000

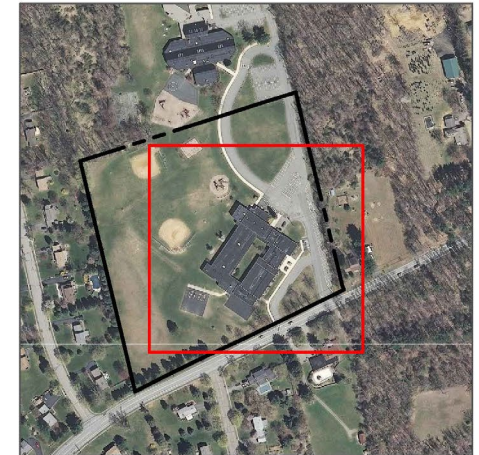
**Walter J. Kossmann
School**

Two rain gardens can be installed to capture, treat, and infiltrate runoff from the roof of the building. A section of parking spaces can be converted to porous pavement to capture and infiltrate runoff from the parking lot. A preliminary soil assessment suggests that more soil testing would be required before determining the soil's suitability for green infrastructure.

Recommended Green Infrastructure Practices	Recharge Potential (Mgal/yr)	TSS Removal Potential (lbs/yr)	Maximum Volume Reduction Potential (gal/storm)	Peak Discharge Reduction Potential (cu. ft./second)	Estimated Size (sq. ft.)	Estimated Cost
Bioretention systems	0.238	40	18,570	0.66	2,280	\$11,400
Pervious pavement	0.466	78	36,430	1.29	3,195	\$79,875

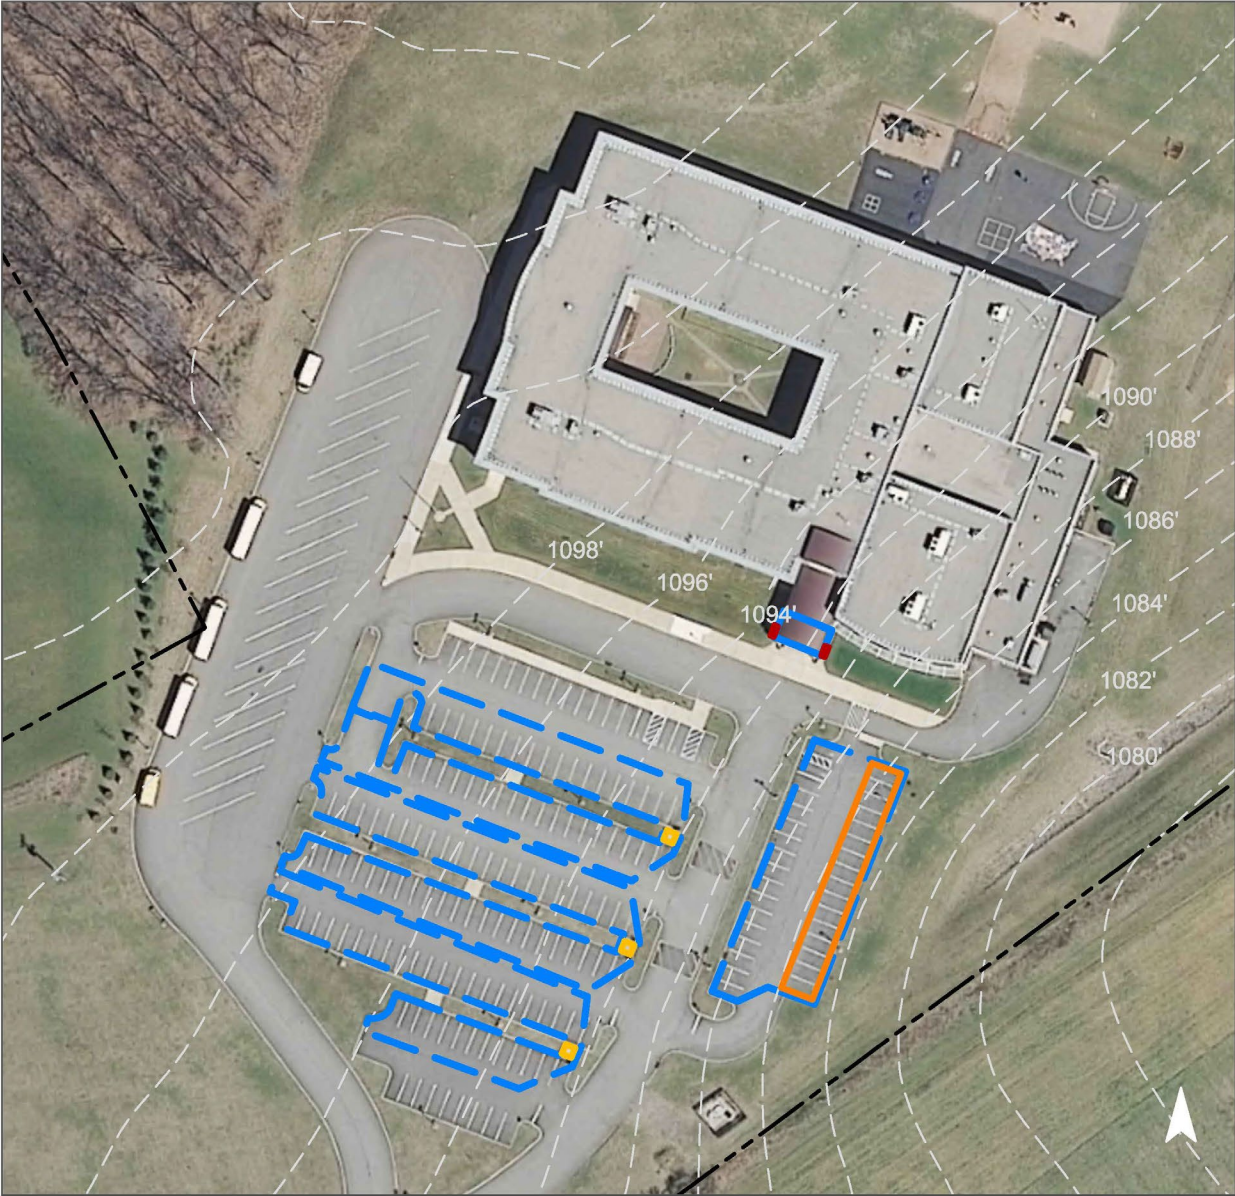
**Benedict A.
Cucinella School**

Downspout planter boxes are suggested at the entrance of the school to promote green infrastructure awareness. A section of parking spaces can be converted to pervious pavement to capture and infiltrate runoff from the parking lot. Tree filter boxes can be installed in islands in the parking lot to capture runoff from other spaces in the parking lot. A preliminary soil assessment suggests that more soil testing would be required before determining the soil's suitability for green infrastructure.

Recommended Green Infrastructure Practices	Recharge Potential (Mgal/yr)	TSS Removal Potential (lbs/yr)	Maximum Volume Reduction Potential (gal/storm)	Peak Discharge Reduction Potential (cu. ft./second)	Estimated Size (sq. ft.)	Estimated Cost
Pervious pavement	0.230	38	17,960	0.63	2,715	\$67,875
Planter boxes	n/a	2	n/a	n/a	2 (boxes)	\$2,000
Tree filter boxes	n/a	116	n/a	n/a	3 (boxes)	\$30,000

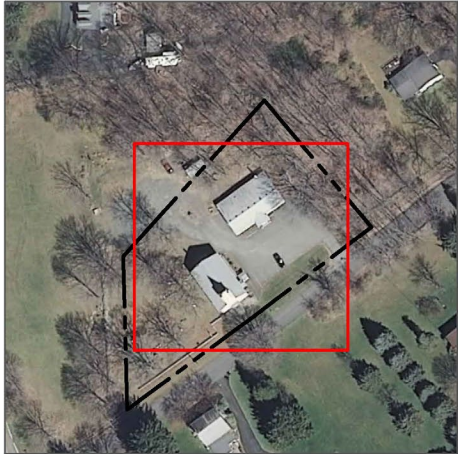
Drakestown United Methodist Church

Downspout planter boxes can be installed to capture and retain runoff from the rooftop. Pervious pavement is proposed along the south edge of the parking lot to treat the entire parking lot's drainage area. A preliminary soil assessment suggests that more soil testing would be required before determining the soil's suitability for green infrastructure.

Recommended Green Infrastructure Practices	Recharge Potential (Mgal/yr)	TSS Removal Potential (lbs/yr)	Maximum Volume Reduction Potential (gal/storm)	Peak Discharge Reduction Potential (cu. ft./second)	Estimated Size (sq. ft.)	Estimated Cost
Pervious pavement	0.168	28	13,090	0.46	1,630	\$40,750
Planter boxes	n/a	1	n/a	n/a	2 (boxes)	\$2,000

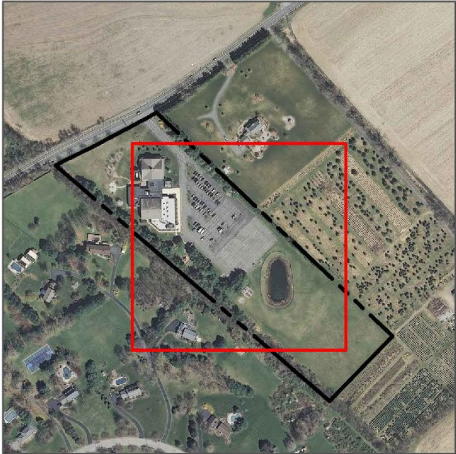
St. Luke Parish

A bioretention system can be installed to infiltrate the water from three disconnected downspouts on the west side of the building. In addition, pervious pavement is proposed along the southeast corner of the parking lot to the parking lot's drainage area. A preliminary soil assessment suggests that the soils have suitable drainage characteristics for green infrastructure.

Recommended Green Infrastructure Practices	Recharge Potential (Mgal/yr)	TSS Removal Potential (lbs/yr)	Maximum Volume Reduction Potential (gal/storm)	Peak Discharge Reduction Potential (cu. ft./second)	Estimated Size (sq. ft.)	Estimated Cost
Bioretention system	0.060	10	4,710	0.17	580	\$2,900
Pervious pavement	0.700	117	54,730	1.93	4,800	\$120,000

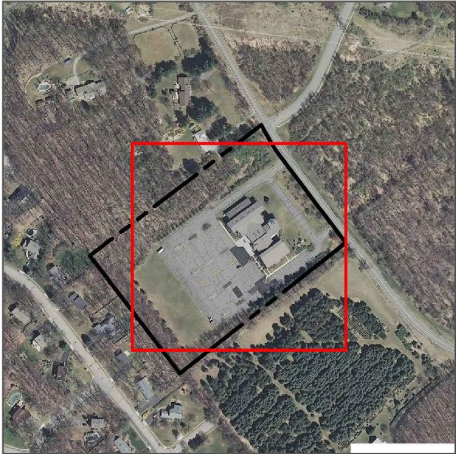
St. Mark the Evangelist Roman Catholic Church

A bioretention system can be installed in the southeast corner of the property to mitigate flooding. Additionally, pervious pavement is suggested adjacent to the southwest edge of the building to capture and infiltrate stormwater runoff from the parking lot. A preliminary soil assessment suggests that more soil testing would be required before determining the soil's suitability for green infrastructure.

Recommended Green Infrastructure Practices	Recharge Potential (Mgal/yr)	TSS Removal Potential (lbs/yr)	Maximum Volume Reduction Potential (gal/storm)	Peak Discharge Reduction Potential (cu. ft./second)	Estimated Size (sq. ft.)	Estimated Cost
Bioretention system	0.159	27	12,420	0.44	1,525	\$7,625
Pervious pavement	1.473	247	115,100	4.06	8,910	\$222,750

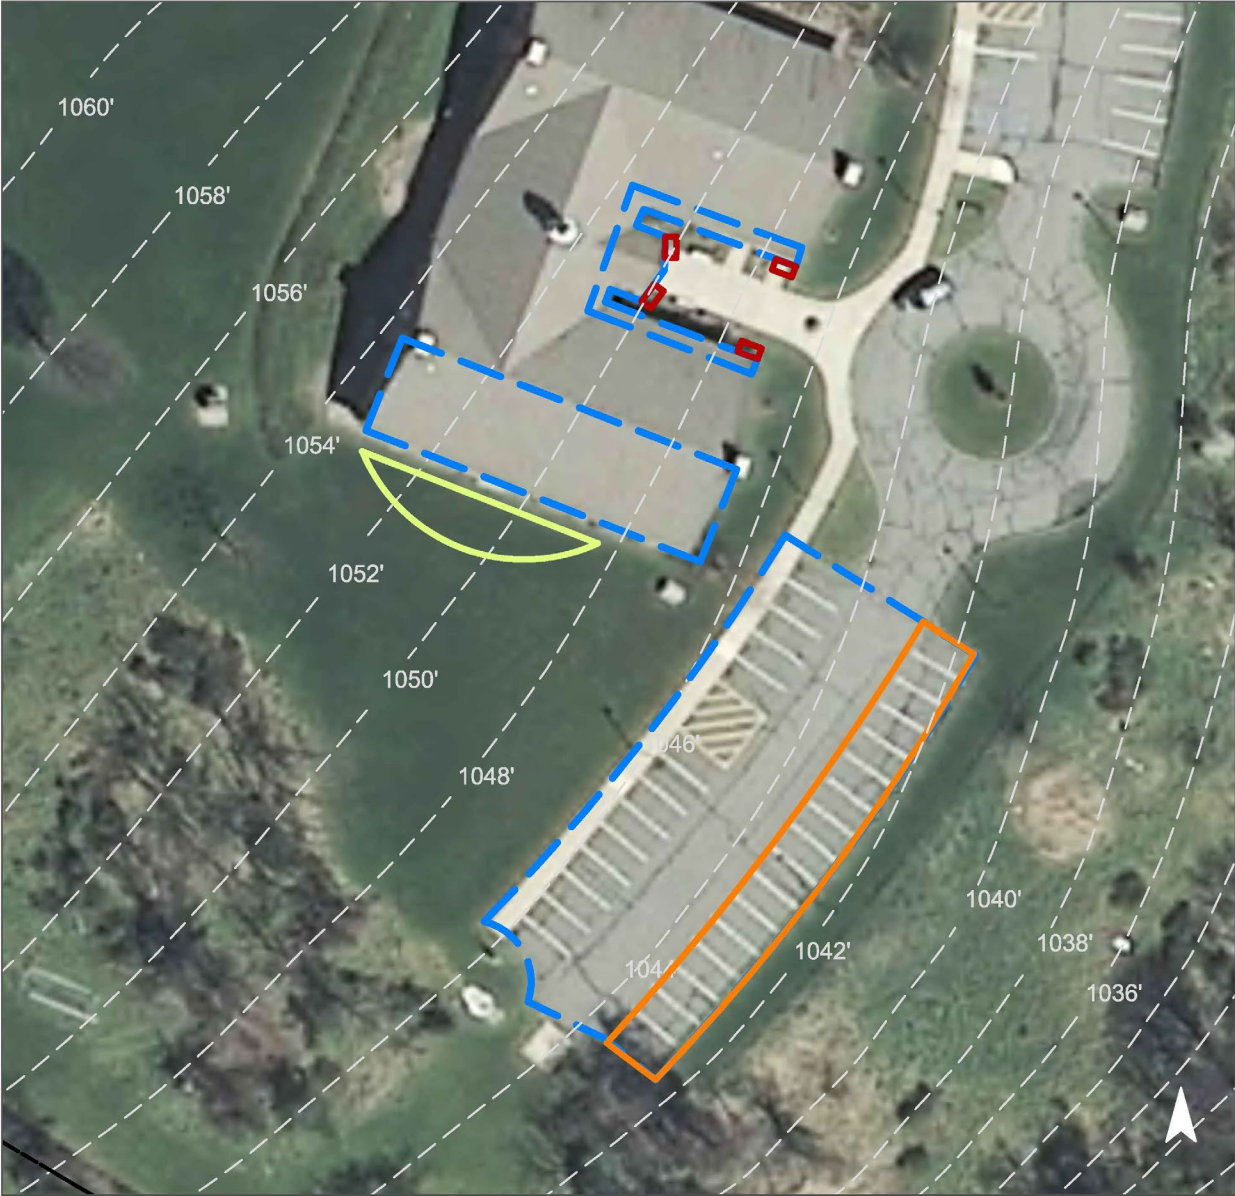
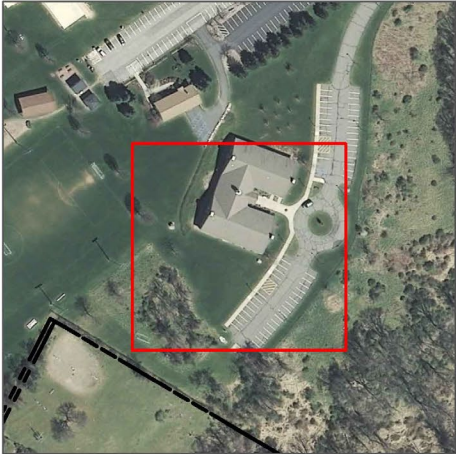
**Washington Township
Public Library**

A bioretention system can be installed to infiltrate the water from four disconnected downspouts. Parking spaces can be converted to porous pavement to capture and infiltrate runoff from the parking lot. Four downspout planter boxes are proposed near the entrance of the building to treat the rooftop drainage area. A preliminary soil assessment suggests that more soil testing would be required before determining the soil's suitability for green infrastructure.

Recommended Green Infrastructure Practices	Recharge Potential (Mgal/yr)	TSS Removal Potential (lbs/yr)	Maximum Volume Reduction Potential (gal/storm)	Peak Discharge Reduction Potential (cu. ft./second)	Estimated Size (sq. ft.)	Estimated Cost
Bioretention system	0.081	14	6,310	0.22	775	\$3,875
Pervious pavement	0.269	45	21,060	0.74	2,880	\$72,000
Planter boxes	n/a	3	n/a	n/a	4 (boxes)	\$4,000
