**Impervious Cover Assessment
for
Holmdel Township, Monmouth County, New Jersey**

*Prepared for Holmdel Township by the
Rutgers Cooperative Extension Water Resources Program*

January 12, 2021

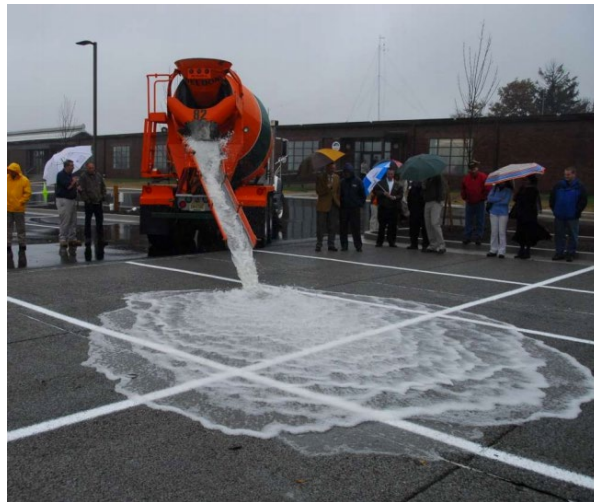
Figure 2: Rapid infiltration of water through porous pavement is demonstrated at the USEPA Edison New Jersey test site

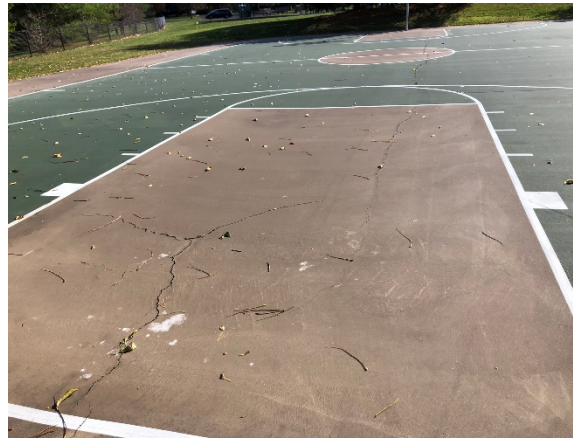
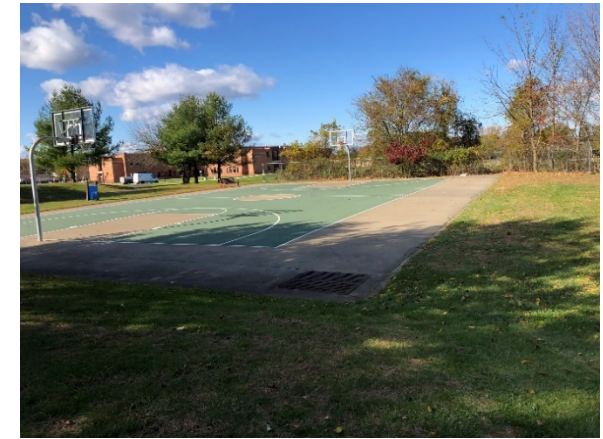
ACKERSON PARK

A rain garden can be installed near the playground area to capture, treat, and infiltrate stormwater runoff and also serve as an educational demonstration. Pervious pavement can be installed to treat the drainage area of the basketball court and also improve the structure of the existing cracked pavement.

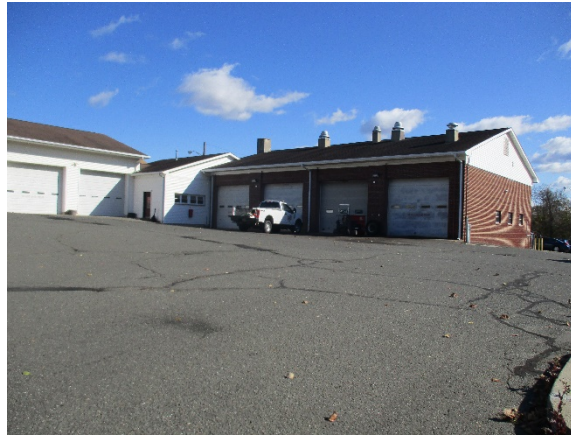
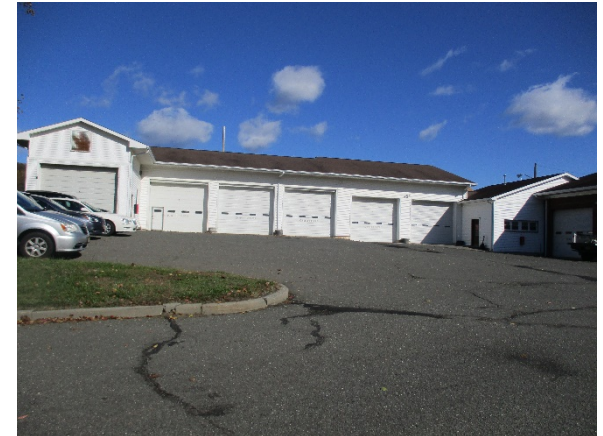
HOLMDEL FIRST AID SQUAD

Three cisterns can be installed to capture runoff from the rooftops. The water can then be reused to provide a source of non-potable water for the first aid squad to wash vehicles.

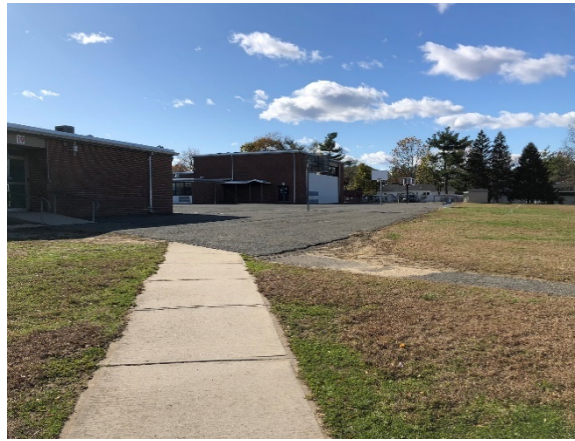
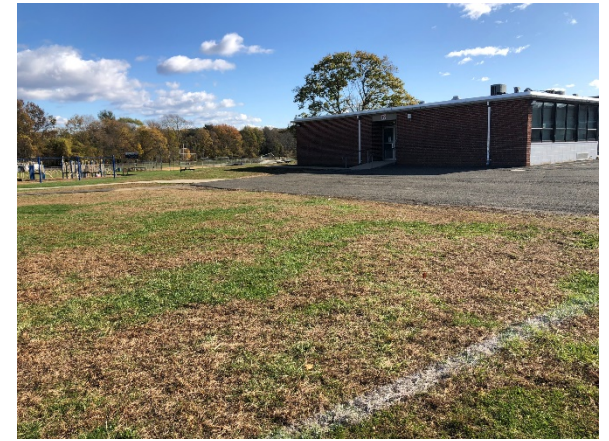
INDIAN HILL SCHOOL

A rain garden can be installed adjacent to the northeast corner of the parking lot to capture, treat, and infiltrate runoff from the parking lot. Additionally, two raingardens can be installed to treat the rooftops of the adjacent buildings.
