**Impervious Cover Reduction Action Plan
for
Middletown Township, Monmouth County, New Jersey**

*Prepared for Middletown Township by the
Rutgers Cooperative Extension Water Resources Program*

January 15, 2021

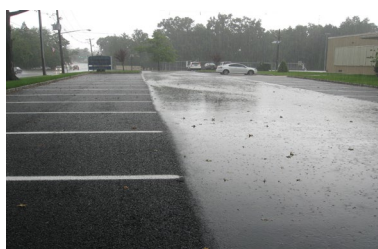
Pervious pavements

There are several types of permeable pavement systems including porous asphalt, pervious concrete, permeable pavers, and grass pavers. These surfaces are hard and support vehicle traffic but also allow water to infiltrate through the surface. They have an underlying stone layer to store stormwater runoff and allow it to slowly seep into the ground.

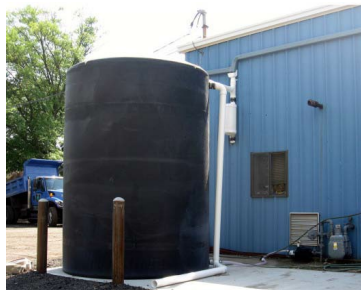
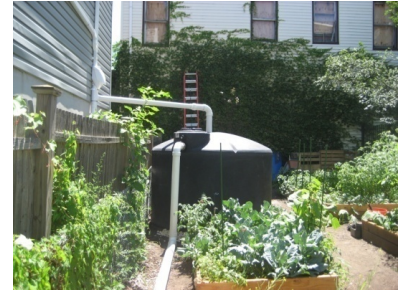
Rainwater harvesting systems (cistern or rain barrel)

These systems capture rainwater, mainly from rooftops, in cisterns or rain barrels. The water can then be used for watering gardens, washing vehicles, or for other non-potable uses.

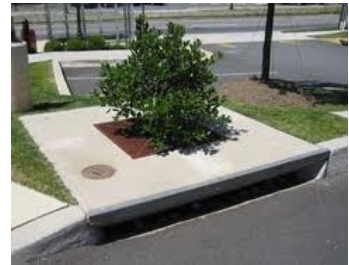
Tree filter boxes

These are pre-manufactured concrete boxes that contain a special soil mix and are planted with a tree or shrub. They filter stormwater runoff but provide little storage capacity. They are typically designed to quickly filter stormwater and then discharge it to the local sewer system.

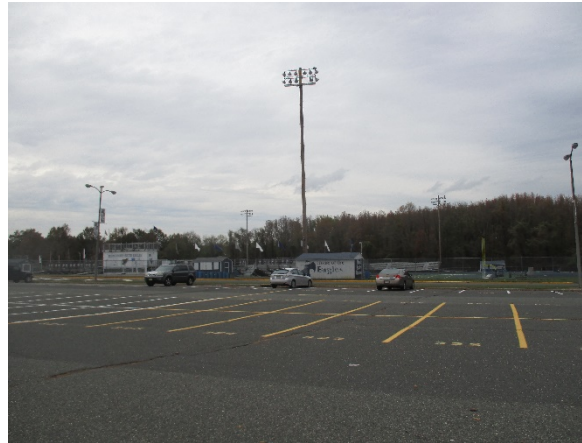
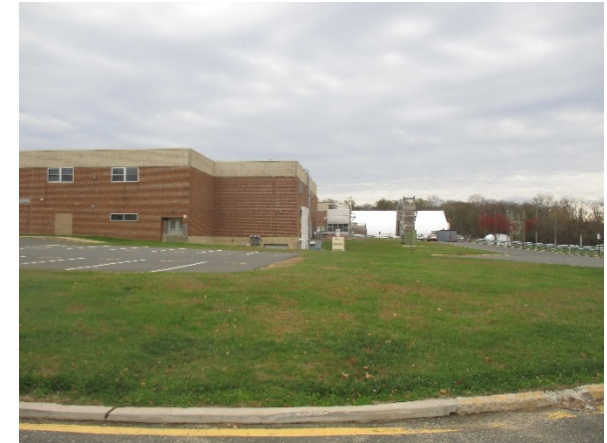
Block and Lot: Block 998, Lot 10

Parking spaces can be converted to porous pavement to capture and infiltrate stormwater runoff from the parking lot. Rain gardens can be installed to capture, treat, and infiltrate stormwater runoff from the rooftops and a section of roadway. A preliminary soil assessment suggests that the soils have suitable drainage characteristics for green infrastructure.

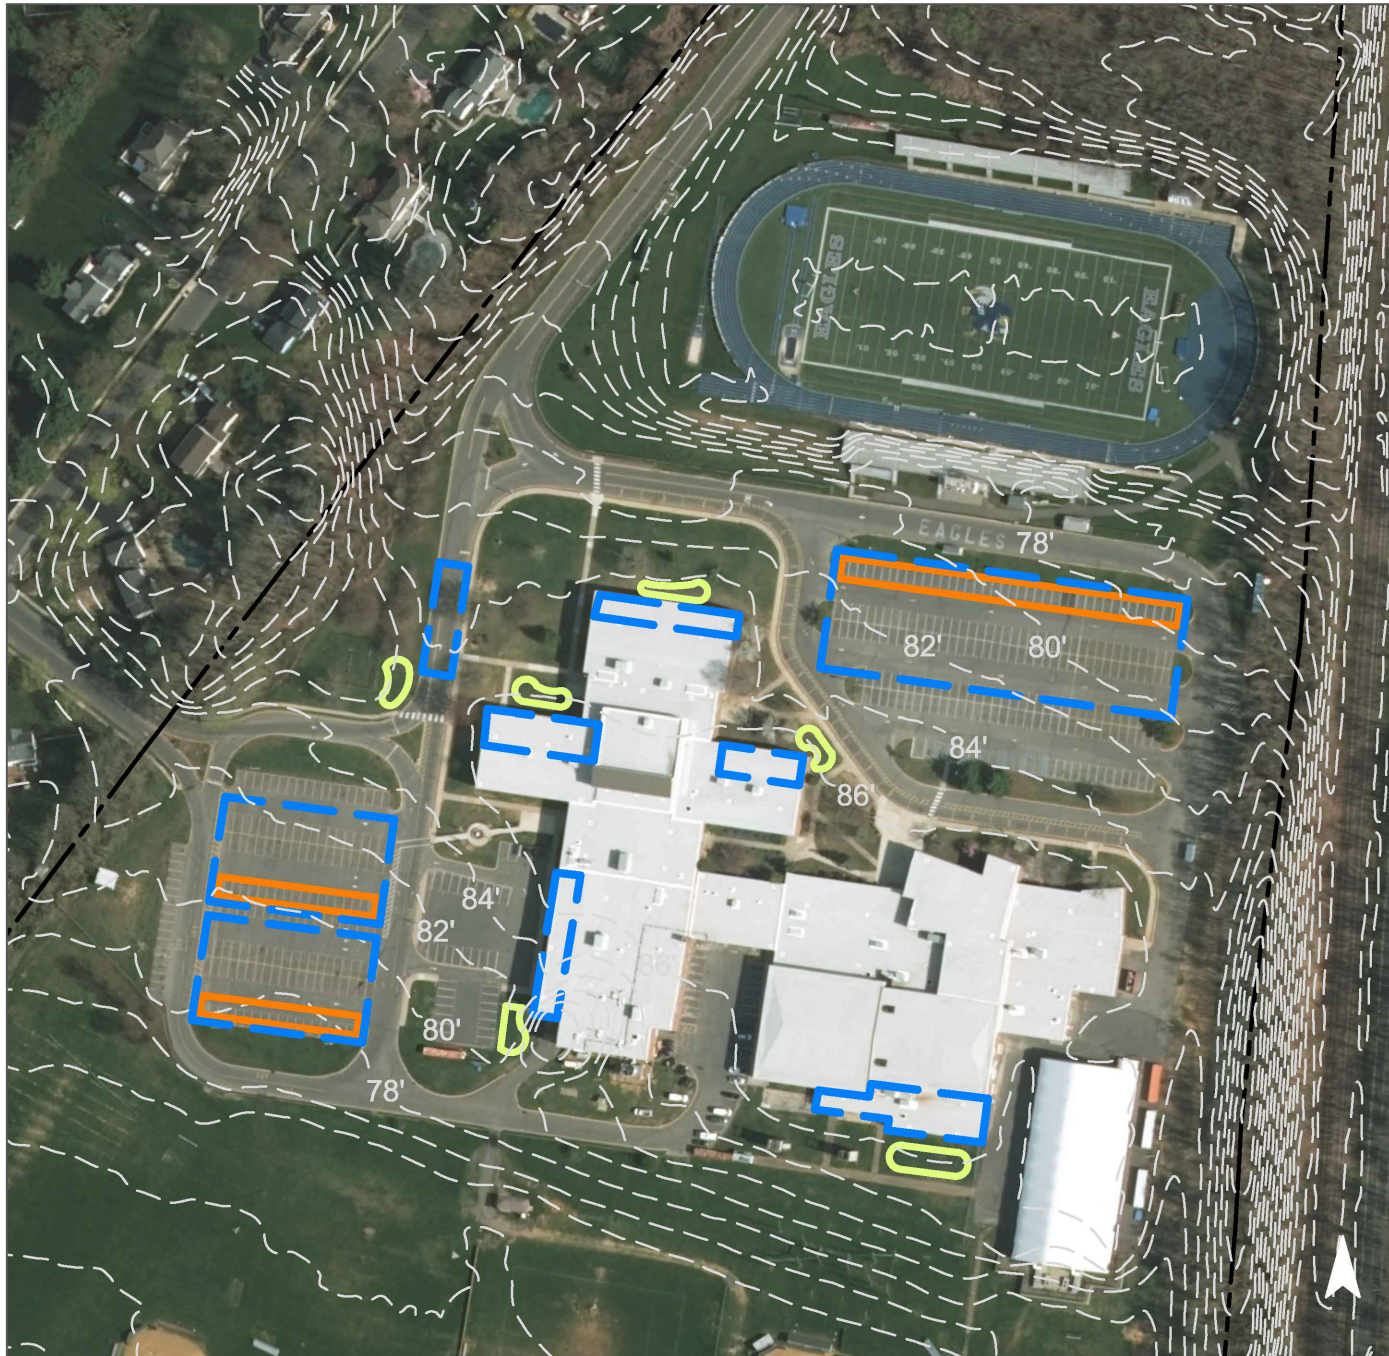
GREEN INFRASTRUCTURE RECOMMENDATIONS

Recommended Green Infrastructure Practices	Recharge Potential (Mgal/yr)	TSS Removal Potential (lbs/yr)	Maximum Volume Reduction Potential (gal/storm)	Peak Discharge Reduction Potential (cu. ft./second)	Estimated Size (sq. ft.)	Estimated Cost
Bioretention systems	0.633	106	46,420	1.74	6,070	\$30,350
Pervious pavement	2.125	356	155,890	5.86	14,560	\$364,000

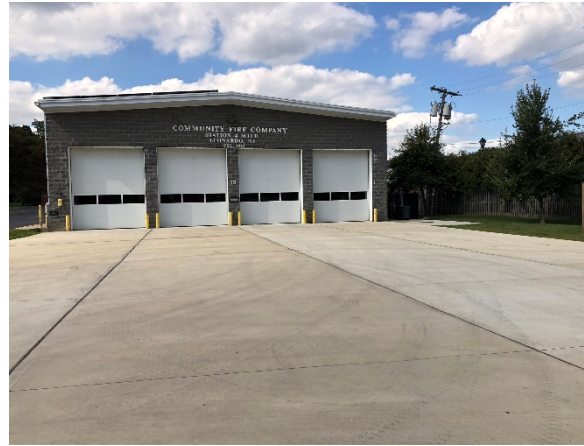
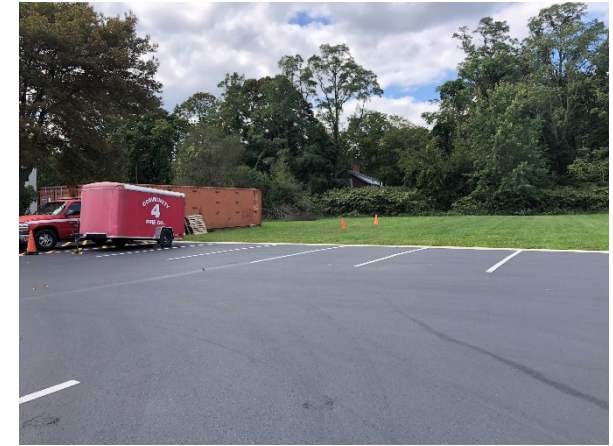
Subwatershed: Pews Creek to Shrewsbury River
Site Area: 199,761 sq. ft.
Address: 85 Appleton Avenue Leonardo, NJ 07737
Block and Lot: Block 451, Lots 4, 5

Parking spaces can be converted to porous pavement to capture and infiltrate stormwater runoff from the parking lot. A rain garden can be installed in the turfgrass area near the entrance of the building to capture, treat, and infiltrate stormwater runoff from the roof. A preliminary soil assessment suggests that more soil testing would be required before determining the soil's suitability for green infrastructure.

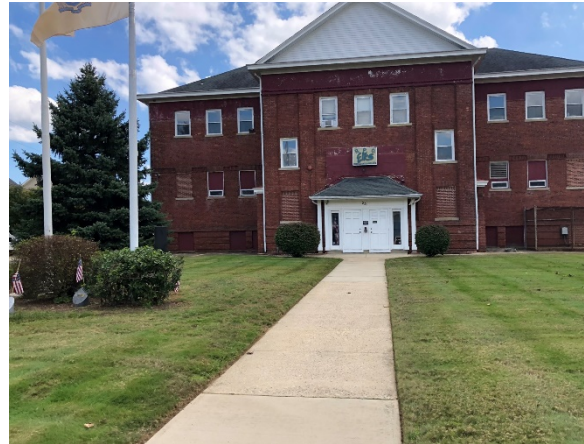
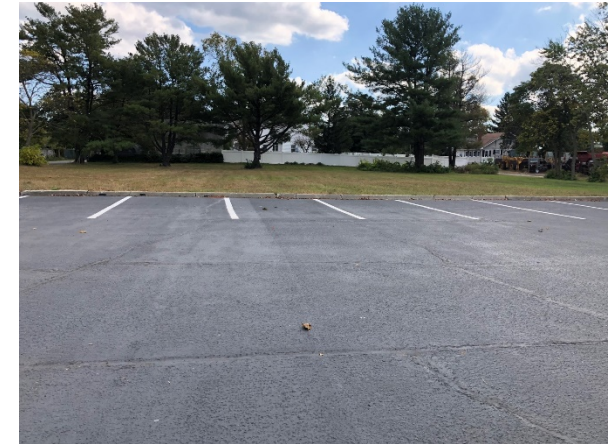
Subwatershed: Pews Creek to Shrewsbury River
Site Area: 82,064 sq. ft.
Address: 251 Church Street
 Belford, NJ 07718
Block and Lot: Block 296, Lot 7

Parking spaces in the parking lot to the east of the building can be converted to porous pavement to capture and infiltrate stormwater runoff from the parking lot. Rain gardens can be installed in the turfgrass at the entrance and rear of the building to capture, treat, and infiltrate stormwater runoff from the roof. A preliminary soil assessment suggests that more soil testing would be required before determining the soil's suitability for green infrastructure.

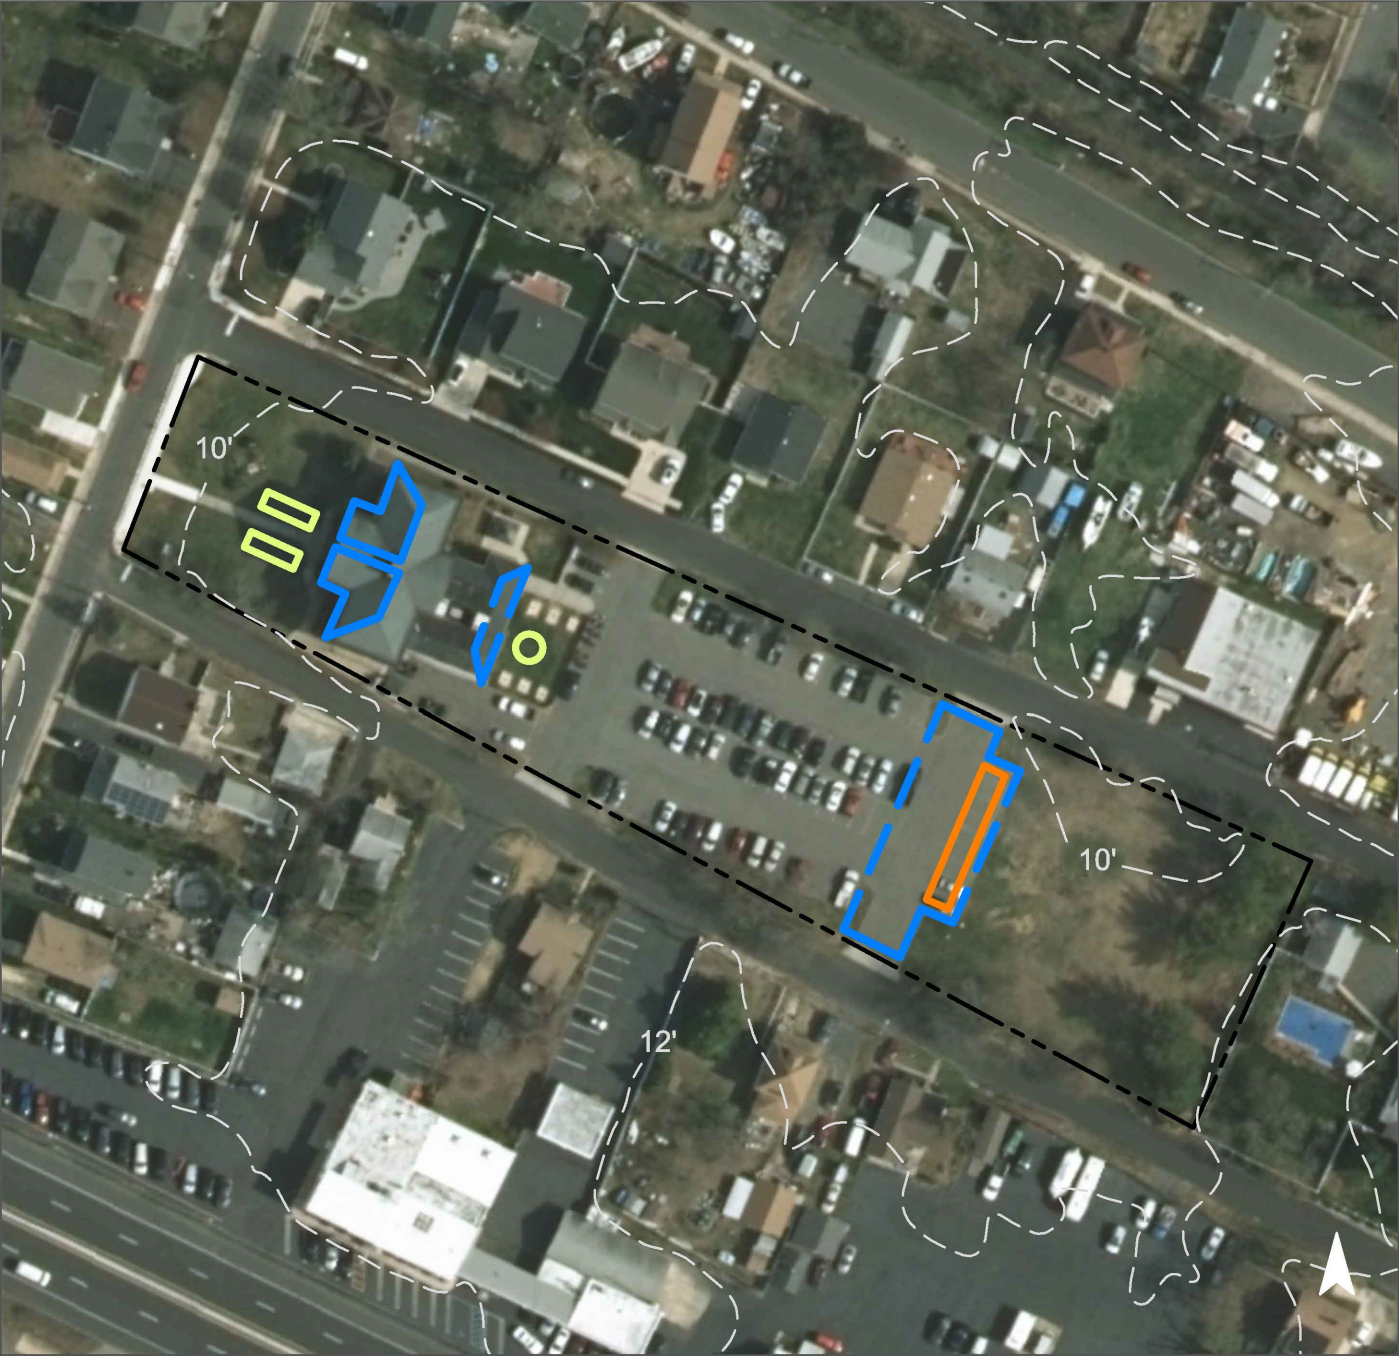
GREEN INFRASTRUCTURE RECOMMENDATIONS

Recommended Green Infrastructure Practices	Recharge Potential (Mgal/yr)	TSS Removal Potential (lbs/yr)	Maximum Volume Reduction Potential (gal/storm)	Peak Discharge Reduction Potential (cu. ft./second)	Estimated Size (sq. ft.)	Estimated Cost
Bioretention systems	0.067	11	4,910	0.18	650	\$3,250
Pervious pavement	0.134	22	9,840	0.37	920	\$23,000

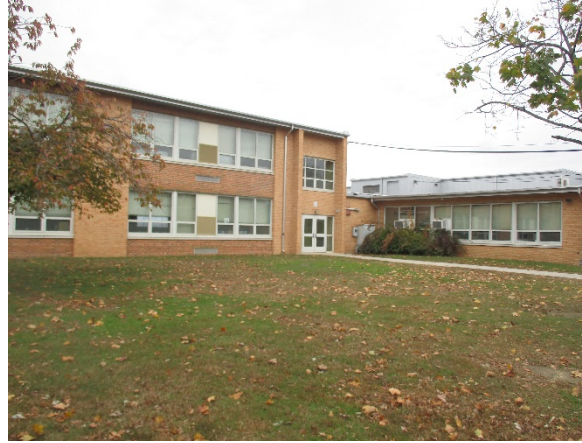
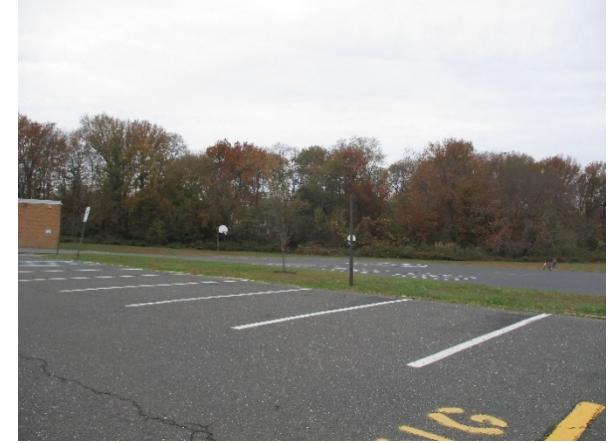
Block and Lot: Block 572, Lots 33, 34

Parking spaces can be converted to porous pavement to capture and infiltrate stormwater runoff from the parking lot. Rain gardens can be installed in the turfgrass areas around the school to capture, treat, and infiltrate stormwater runoff from the roof. A preliminary soil assessment suggests that more soil testing would be required before determining the soil's suitability for green infrastructure.

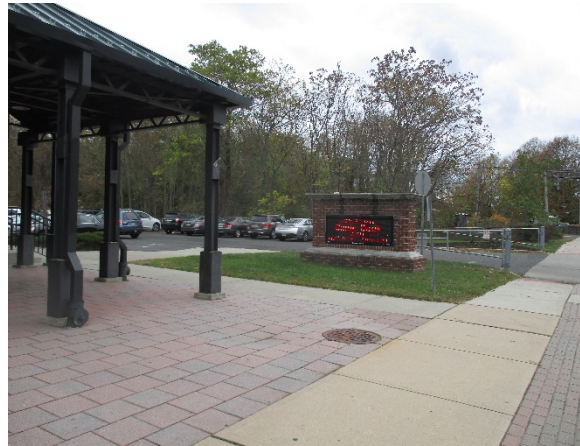
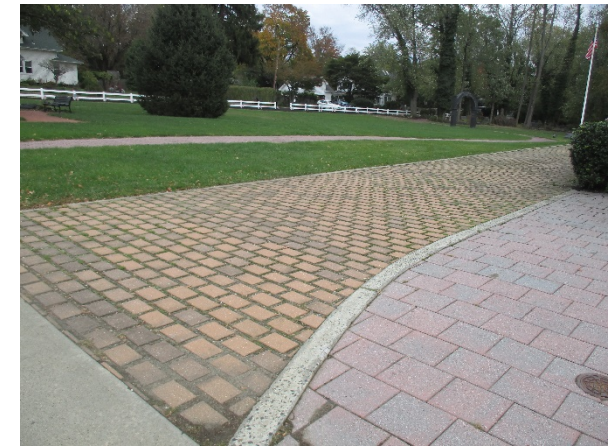
Subwatershed: Pews Creek to Shrewsbury River
Site Area: 638,061 sq. ft.
Address: 36 Church Street
 Middletown, NJ 07748
Block and Lot: Block 859, Lot 25.01

Rain gardens can be installed in the turfgrass area near the rear of the building to capture, treat, and infiltrate stormwater runoff from the roof. A preliminary soil assessment suggests that more soil testing would be required before determining the soil's suitability for green infrastructure.

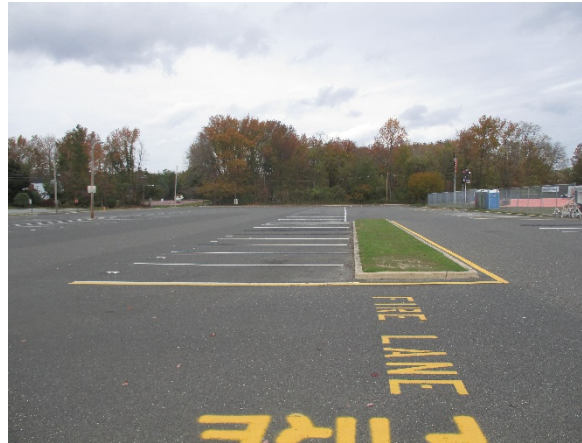
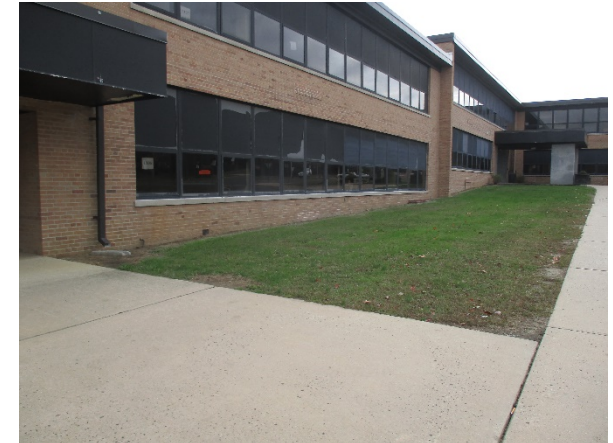
Subwatershed: Pews Creek to Shrewsbury River
Site Area: 2,111,770 sq. ft.
Address: 63 Tindall Road
 Middletown, NJ 07748
Block and Lot: Block 640, Lots 20,23,35

Parking spaces in the parking lot to the north of the building can be converted to porous pavement to capture and infiltrate stormwater runoff from the parking lot. Rain gardens can be installed at several locations to capture, treat, and infiltrate stormwater runoff from the rooftops. A preliminary soil assessment suggests that the soils have suitable drainage characteristics for green infrastructure.

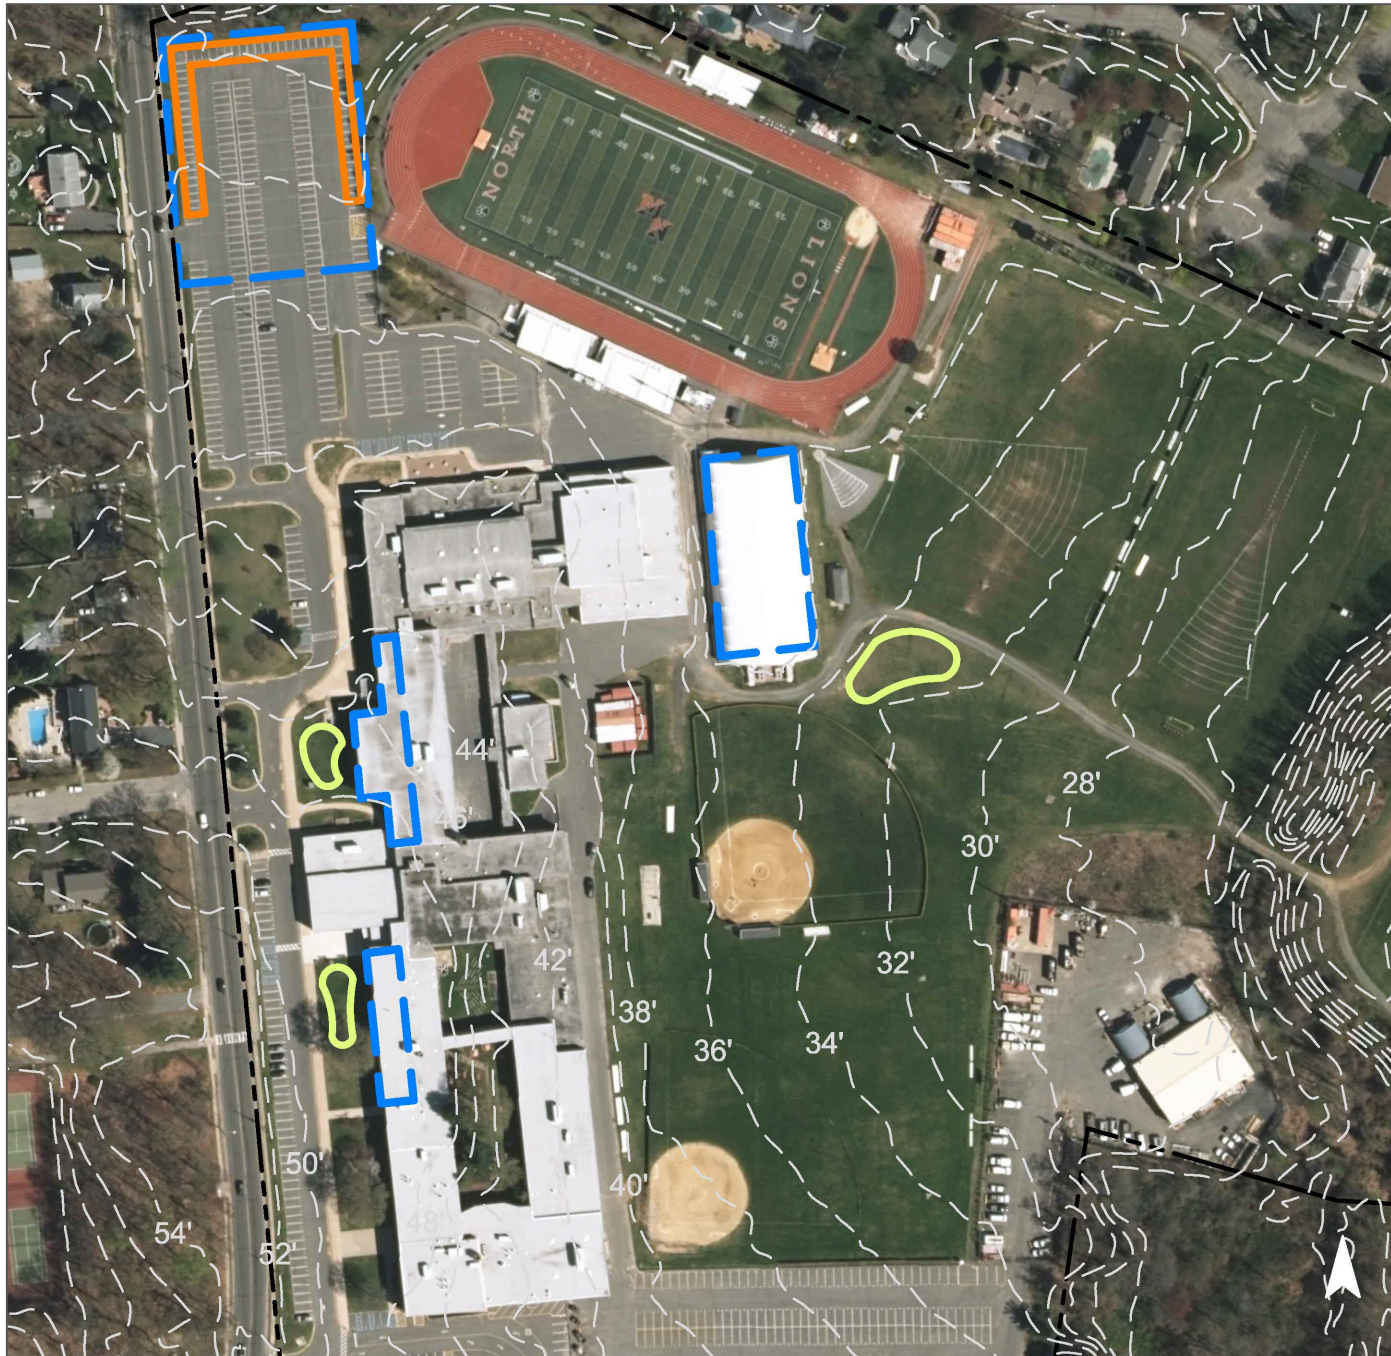
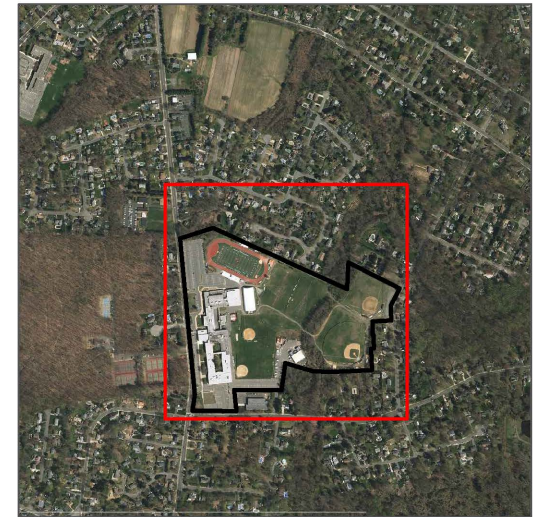
GREEN INFRASTRUCTURE RECOMMENDATIONS

Recommended Green Infrastructure Practices	Recharge Potential (Mgal/yr)	TSS Removal Potential (lbs/yr)	Maximum Volume Reduction Potential (gal/storm)	Peak Discharge Reduction Potential (cu. ft./second)	Estimated Size (sq. ft.)	Estimated Cost
Bioretention systems	0.879	147	64,520	2.42	8,440	\$42,200
Pervious pavement	1.285	215	94,320	3.54	8,810	\$220,250

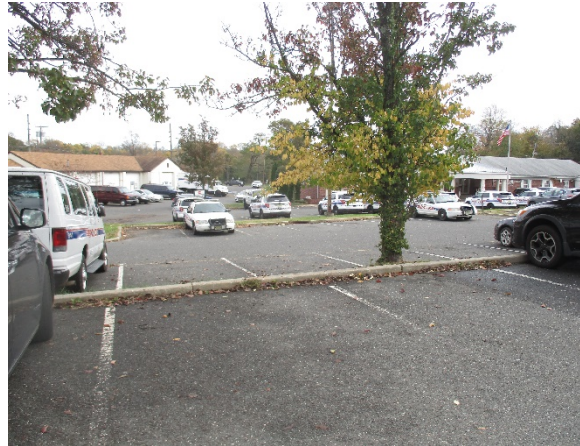
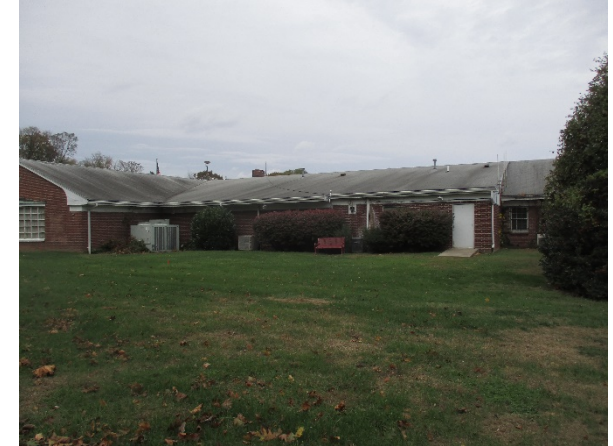
Subwatershed: Pews Creek to Shrewsbury River
Site Area: 445,415 sq. ft.
Address: 1 Kings Highway
 Middletown, NJ 07748
Block and Lot: Block 815, Lots 1.01,5,6,7

A section of parking spaces can be converted to porous pavement to capture and infiltrate stormwater runoff from the parking lot. Rain gardens can be installed in various locations to capture, treat, and infiltrate stormwater runoff from the rooftops. Three tree filter boxes can be installed to capture and filter runoff from the parking lot. A preliminary soil assessment suggests that the soils have suitable drainage characteristics for green infrastructure.

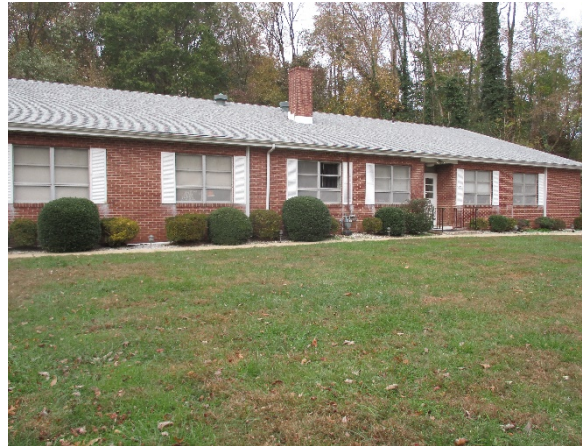
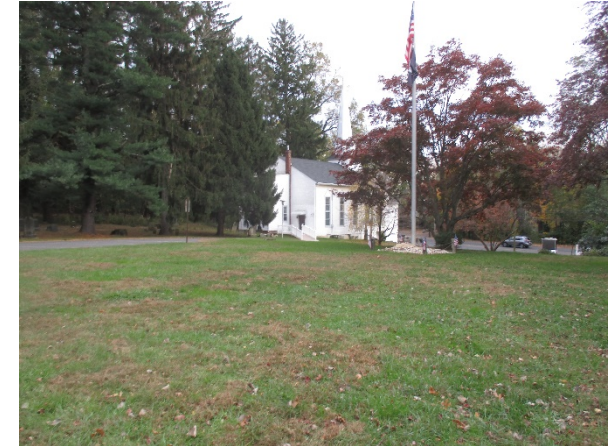
Block and Lot: Block 805, Lots 29,30

A rain garden can be installed at the entrance of the building to capture, treat, and infiltrate stormwater runoff from the roof. A preliminary soil assessment suggests that the soils have suitable drainage characteristics for green infrastructure.

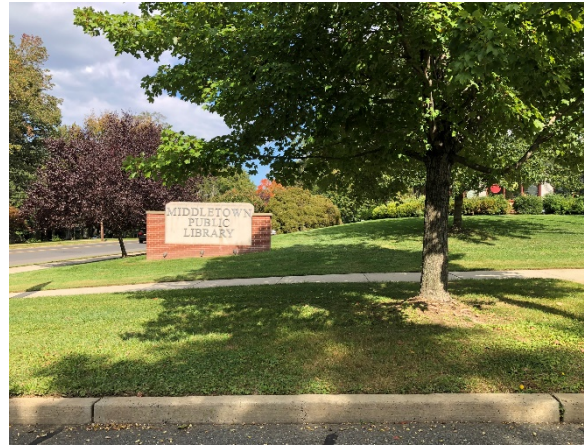
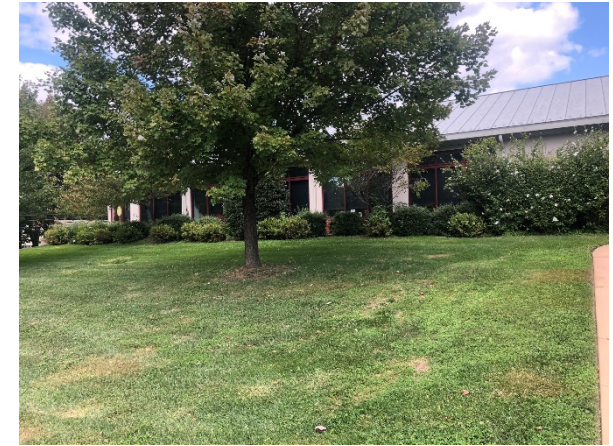
Block and Lot: Block 632, Lots 183,184

A section of parking spaces can be converted to porous pavement to capture and infiltrate stormwater runoff from the parking lot. Rain gardens can be installed at various locations of the building to capture, treat, and infiltrate stormwater runoff from the roof. A preliminary soil assessment suggests that more soil testing would be required before determining the soil's suitability for green infrastructure.

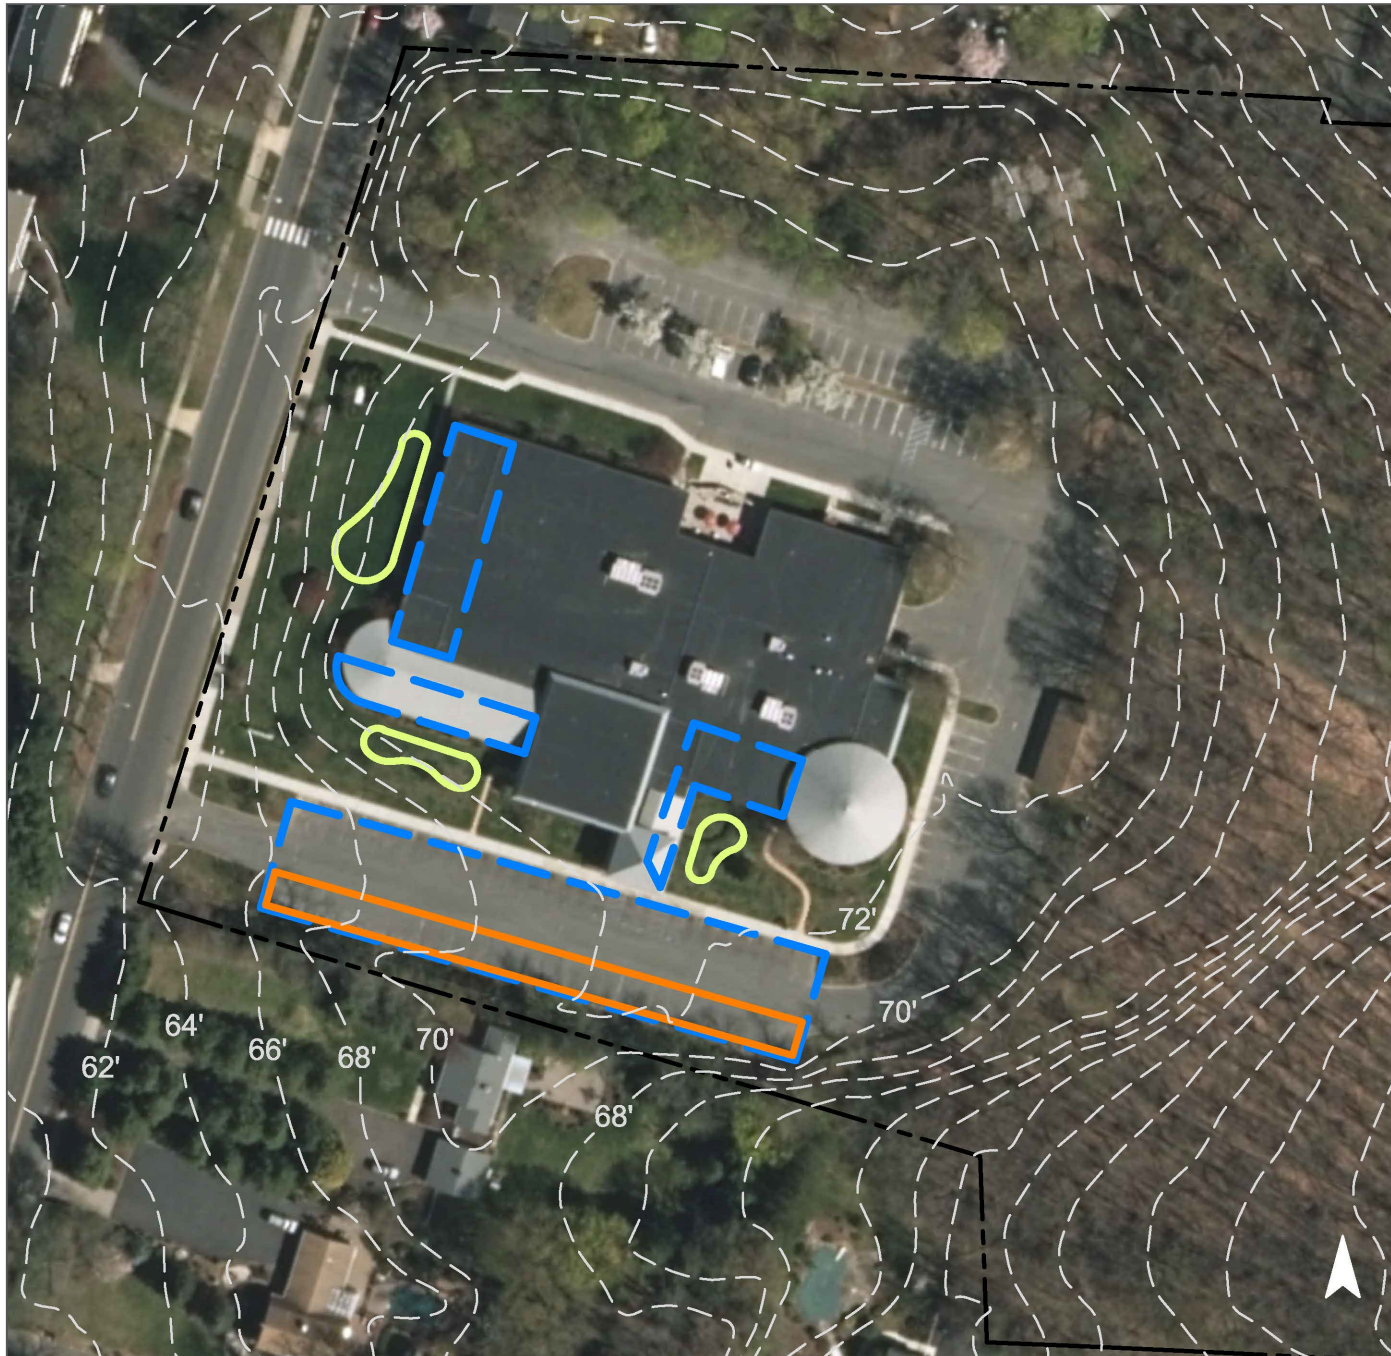
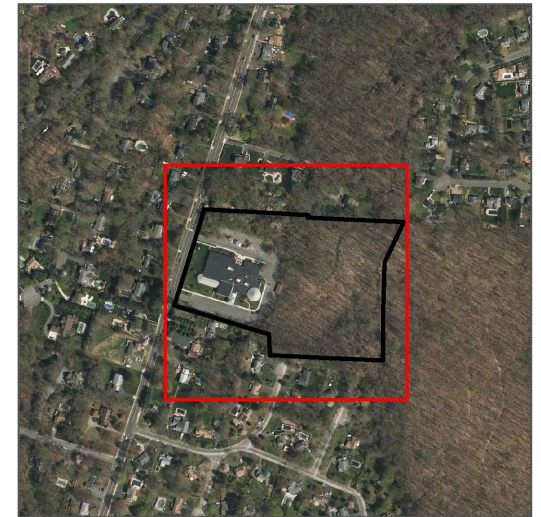
GREEN INFRASTRUCTURE RECOMMENDATIONS

Recommended Green Infrastructure Practices	Recharge Potential (Mgal/yr)	TSS Removal Potential (lbs/yr)	Maximum Volume Reduction Potential (gal/storm)	Peak Discharge Reduction Potential (cu. ft./second)	Estimated Size (sq. ft.)	Estimated Cost
Bioretention systems	0.202	34	14,820	0.56	1,940	\$9,700
Pervious pavement	0.433	72	31,740	1.19	5,140	\$128,500

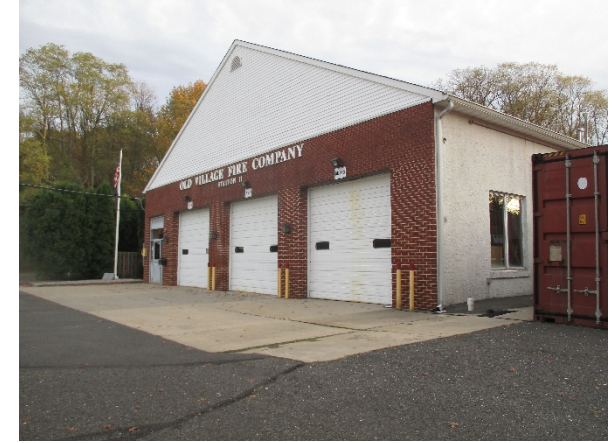
Subwatershed: Pews Creek to Shrewsbury River
Site Area: 48,278 sq. ft.
Address: 1340 NJ-35
 Middletown, NJ 07748
Block and Lot: Block 805, Lot 22

A rain garden can be installed in the turfgrass area in the rear of the building to capture, treat, and infiltrate stormwater runoff from the roof. A preliminary soil assessment suggests that the soils have suitable drainage characteristics for green infrastructure.

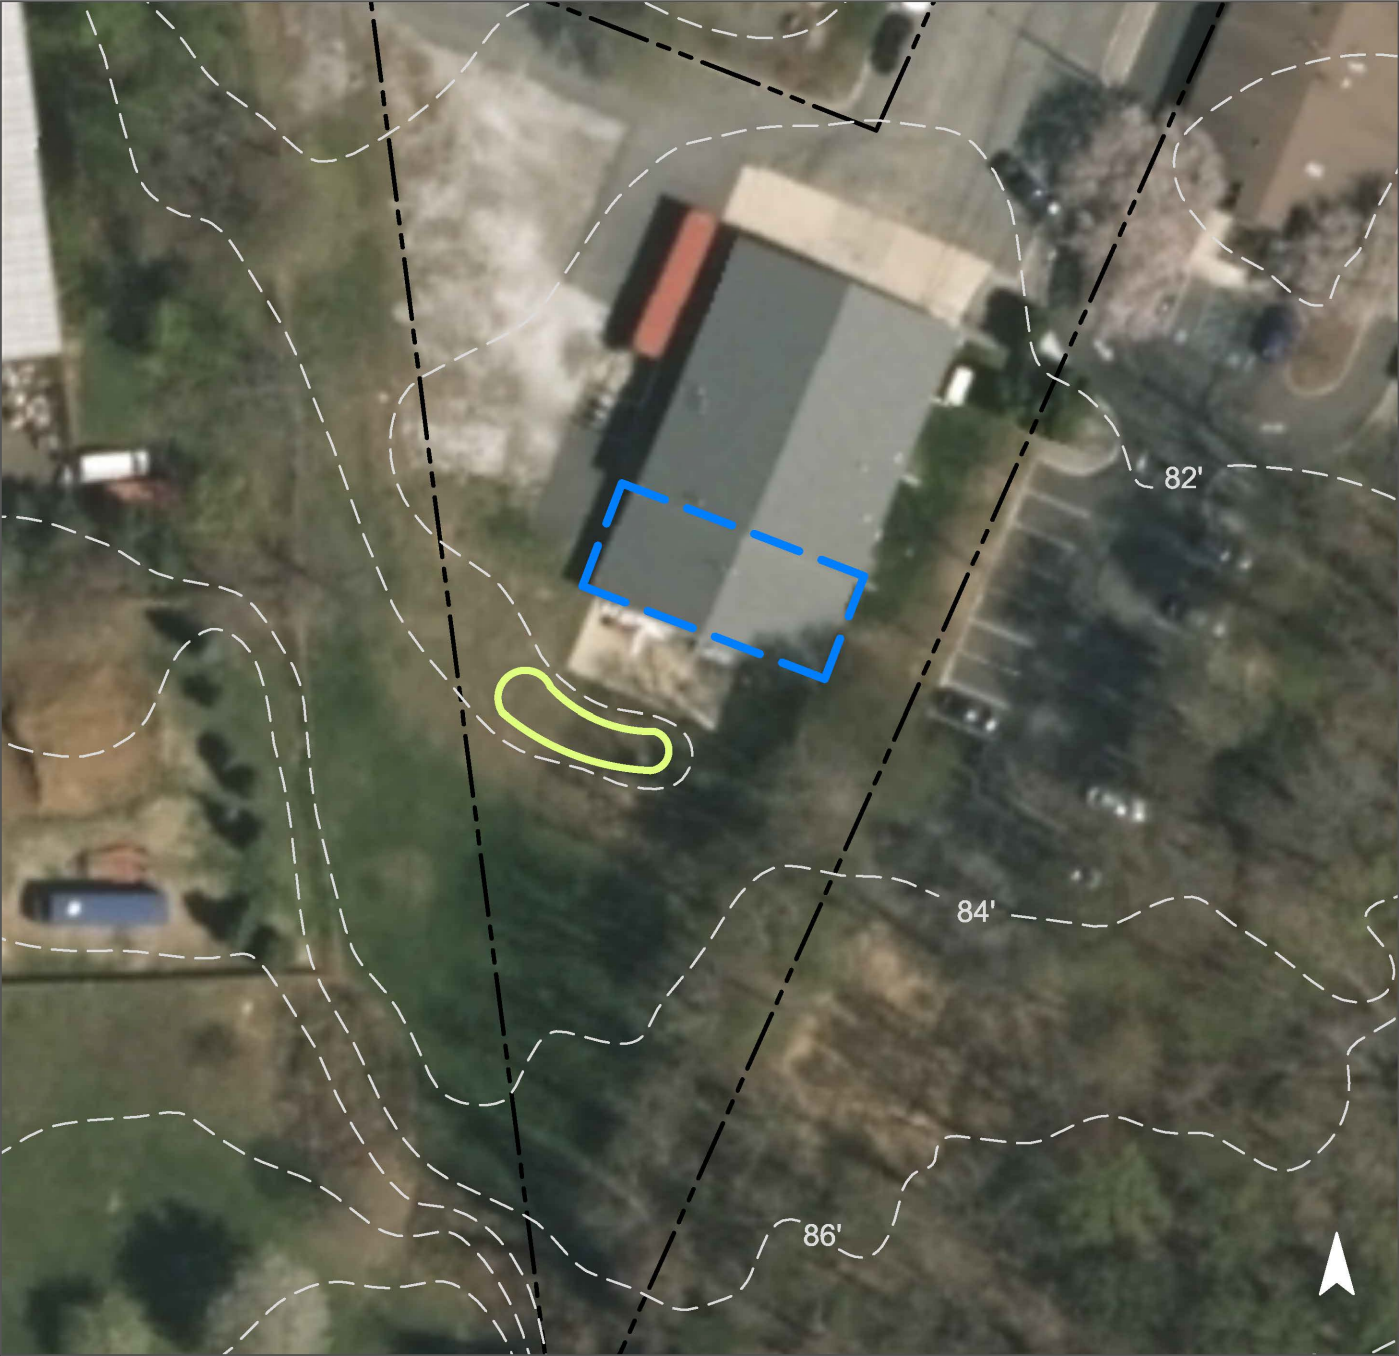
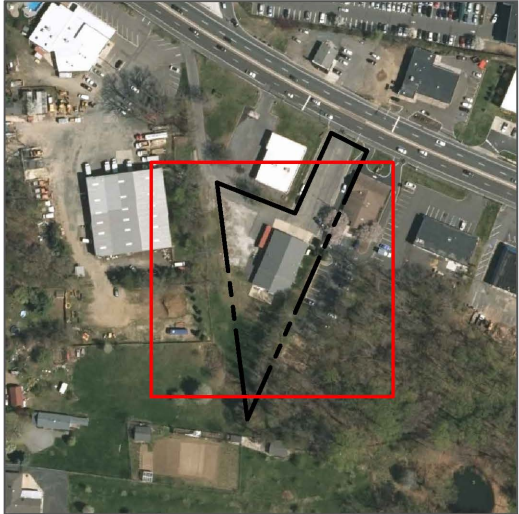
GREEN INFRASTRUCTURE RECOMMENDATIONS

Recommended Green Infrastructure Practices	Recharge Potential (Mgal/yr)	TSS Removal Potential (lbs/yr)	Maximum Volume Reduction Potential (gal/storm)	Peak Discharge Reduction Potential (cu. ft./second)	Estimated Size (sq. ft.)	Estimated Cost
Bioretention system	0.050	8	3,700	0.14	517	\$2,585

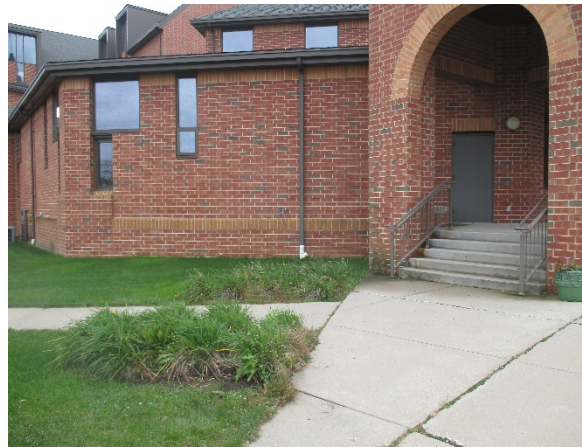
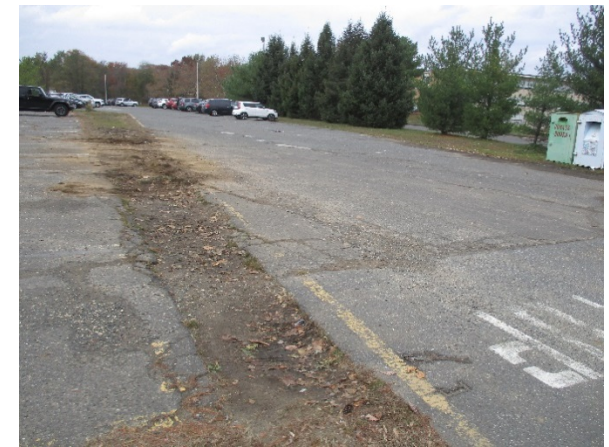
Block and Lot: Block 524, Lots 84,98,101

A row of parking spaces to the north of the main building can be converted to porous pavement to capture and infiltrate stormwater runoff from the parking lot and roof. Rain gardens can be installed at various locations to capture, treat, and infiltrate stormwater runoff from the roof. A preliminary soil assessment suggests that the soils have suitable drainage characteristics for green infrastructure.

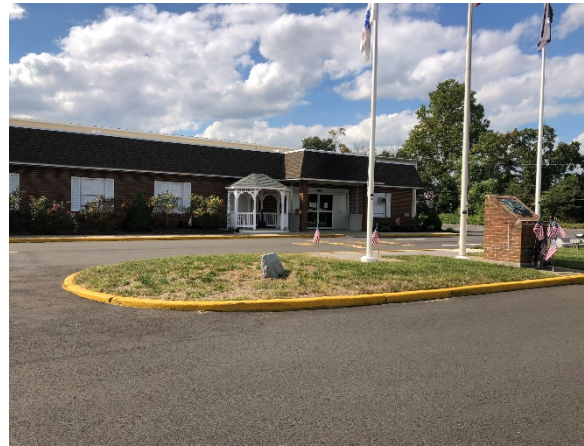
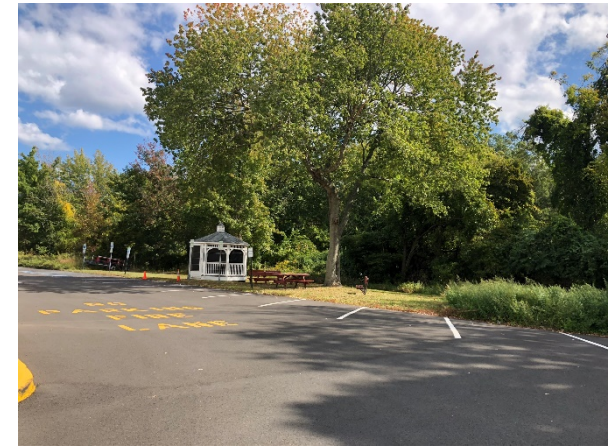
Subwatershed: Pews Creek to Shrewsbury River
Site Area: 163,915 sq. ft.
Address: 1 Veterans Lane
 Port Monmouth, NJ 07758
Block and Lot: Block 532, Lot 40

Two sections of parking spaces can be converted to porous pavement to capture and infiltrate stormwater runoff from the parking lot. A preliminary soil assessment suggests that more soil testing would be required before determining the soil's suitability for green infrastructure.

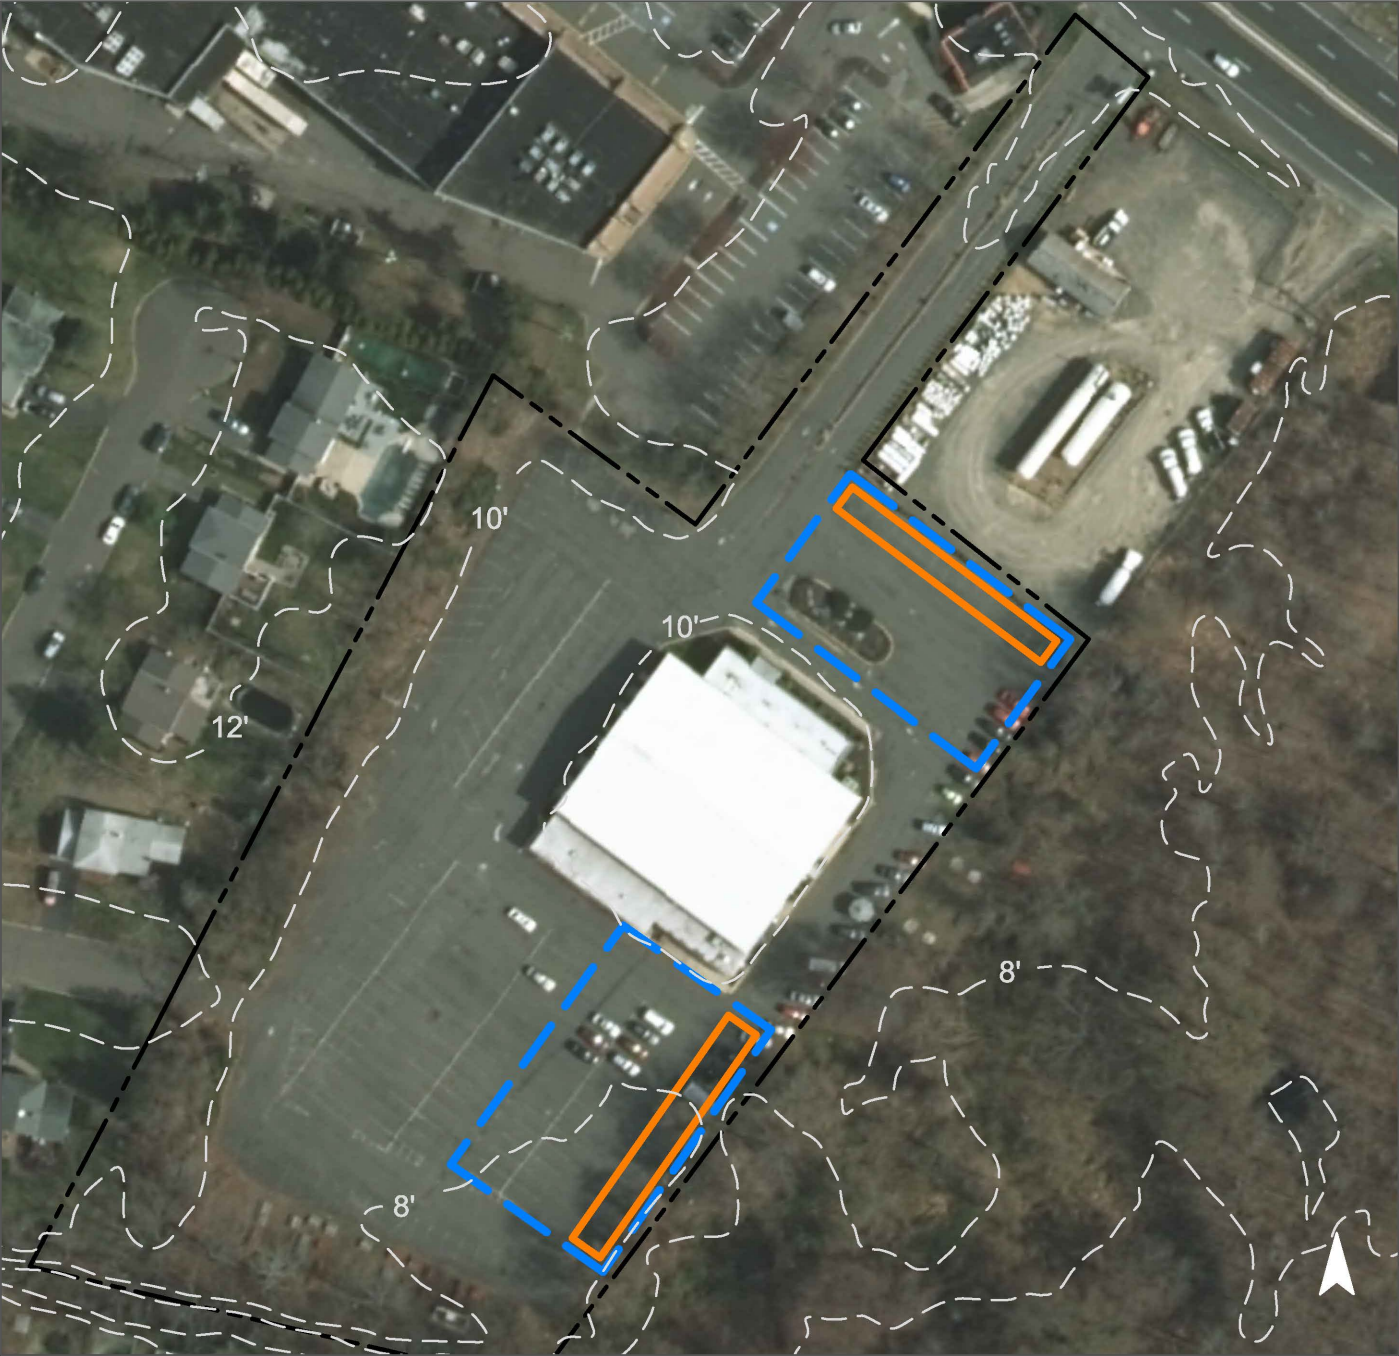
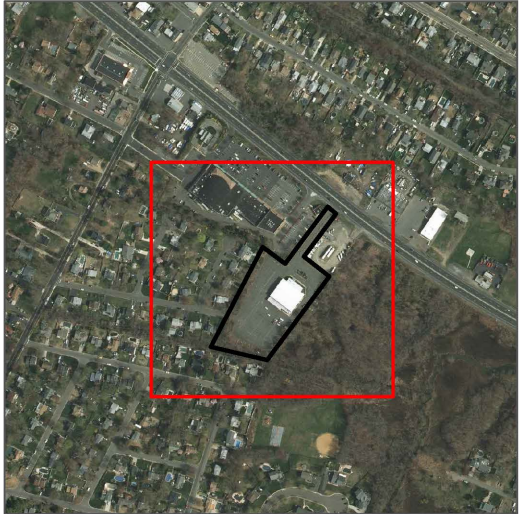
GREEN INFRASTRUCTURE RECOMMENDATIONS

Recommended Green Infrastructure Practices	Recharge Potential (Mgal/yr)	TSS Removal Potential (lbs/yr)	Maximum Volume Reduction Potential (gal/storm)	Peak Discharge Reduction Potential (cu. ft./second)	Estimated Size (sq. ft.)	Estimated Cost
Pervious pavement	0.635	106	46,570	1.75	4,350	\$108,750

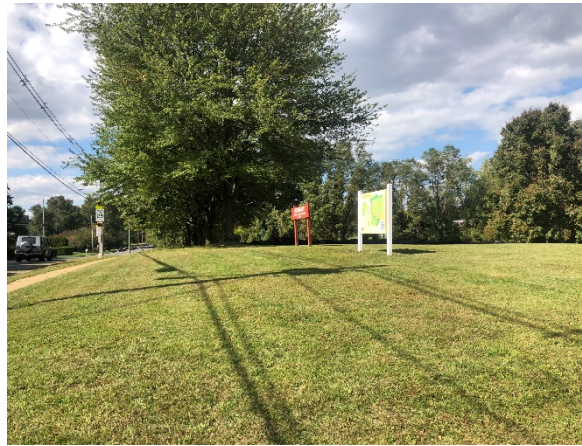
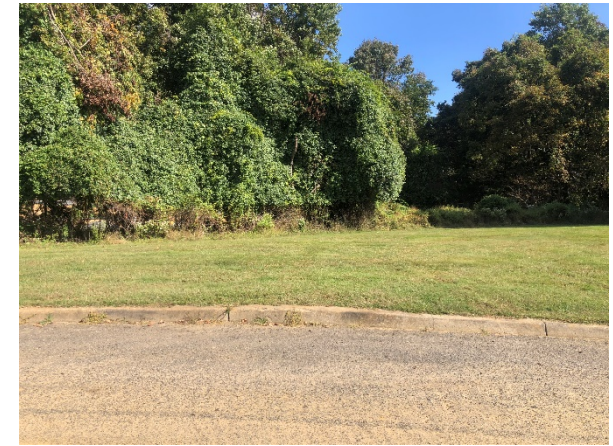
Block and Lot: Block 901, Lot 3

A rain garden can be installed in the turfgrass area near the main building to capture, treat, and infiltrate runoff from the roof. A preliminary soil assessment suggests that more soil testing would be required before determining the soil's suitability for green infrastructure.
