**Impervious Cover Reduction Action Plan
for
Middletown Township, Monmouth County, New Jersey**

*Prepared for Middletown Township by the
Rutgers Cooperative Extension Water Resources Program*

January 15, 2021

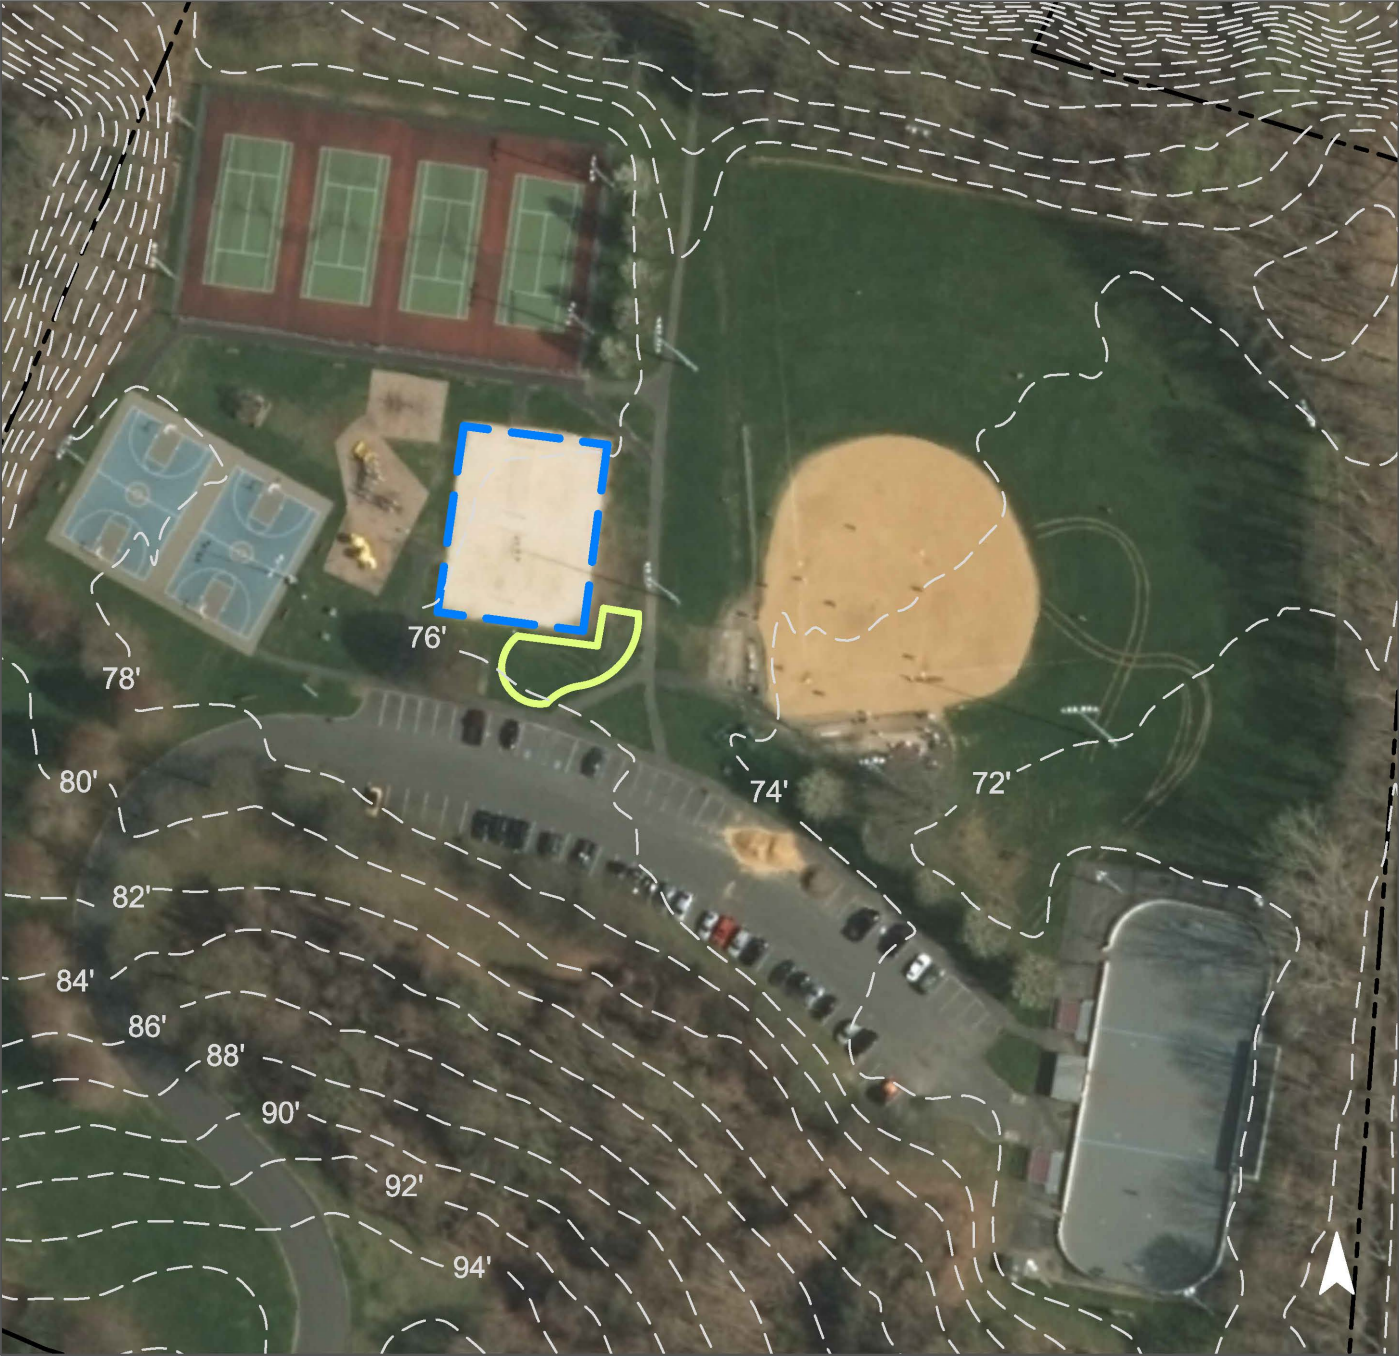
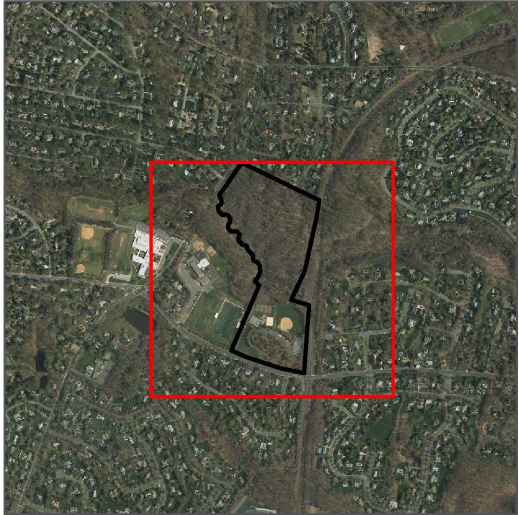
GREEN INFRASTRUCTURE RECOMMENDATIONS

A rain garden can be installed in the turfgrass area near the main building to capture, treat, and infiltrate runoff from the roof. A preliminary soil assessment suggests that more soil testing would be required before determining the soil's suitability for green infrastructure.

Recommended Green Infrastructure Practices	Recharge Potential (Mgal/yr)	TSS Removal Potential (lbs/yr)	Maximum Volume Reduction Potential (gal/storm)	Peak Discharge Reduction Potential (cu. ft./second)	Estimated Size (sq. ft.)	Estimated Cost
Bioretention system	0.193	32	14,200	0.53	1,855	\$9,275

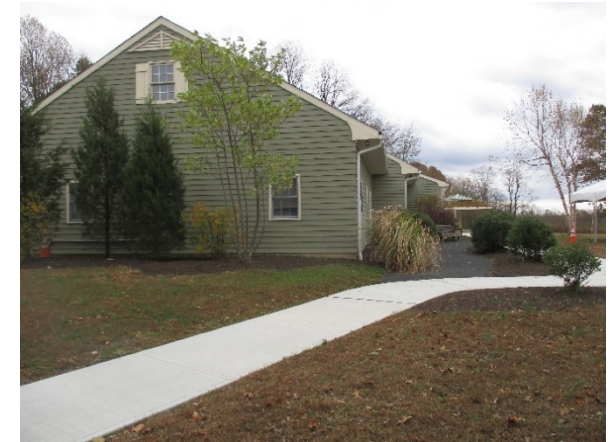
Block and Lot: Blocks 913,3001
Lots 55,136;3,6

Rain gardens can be installed at various locations to capture, treat, and infiltrate stormwater runoff from the parking lot and from the rooftops. A preliminary soil assessment suggests that the soils have suitable drainage characteristics for green infrastructure.

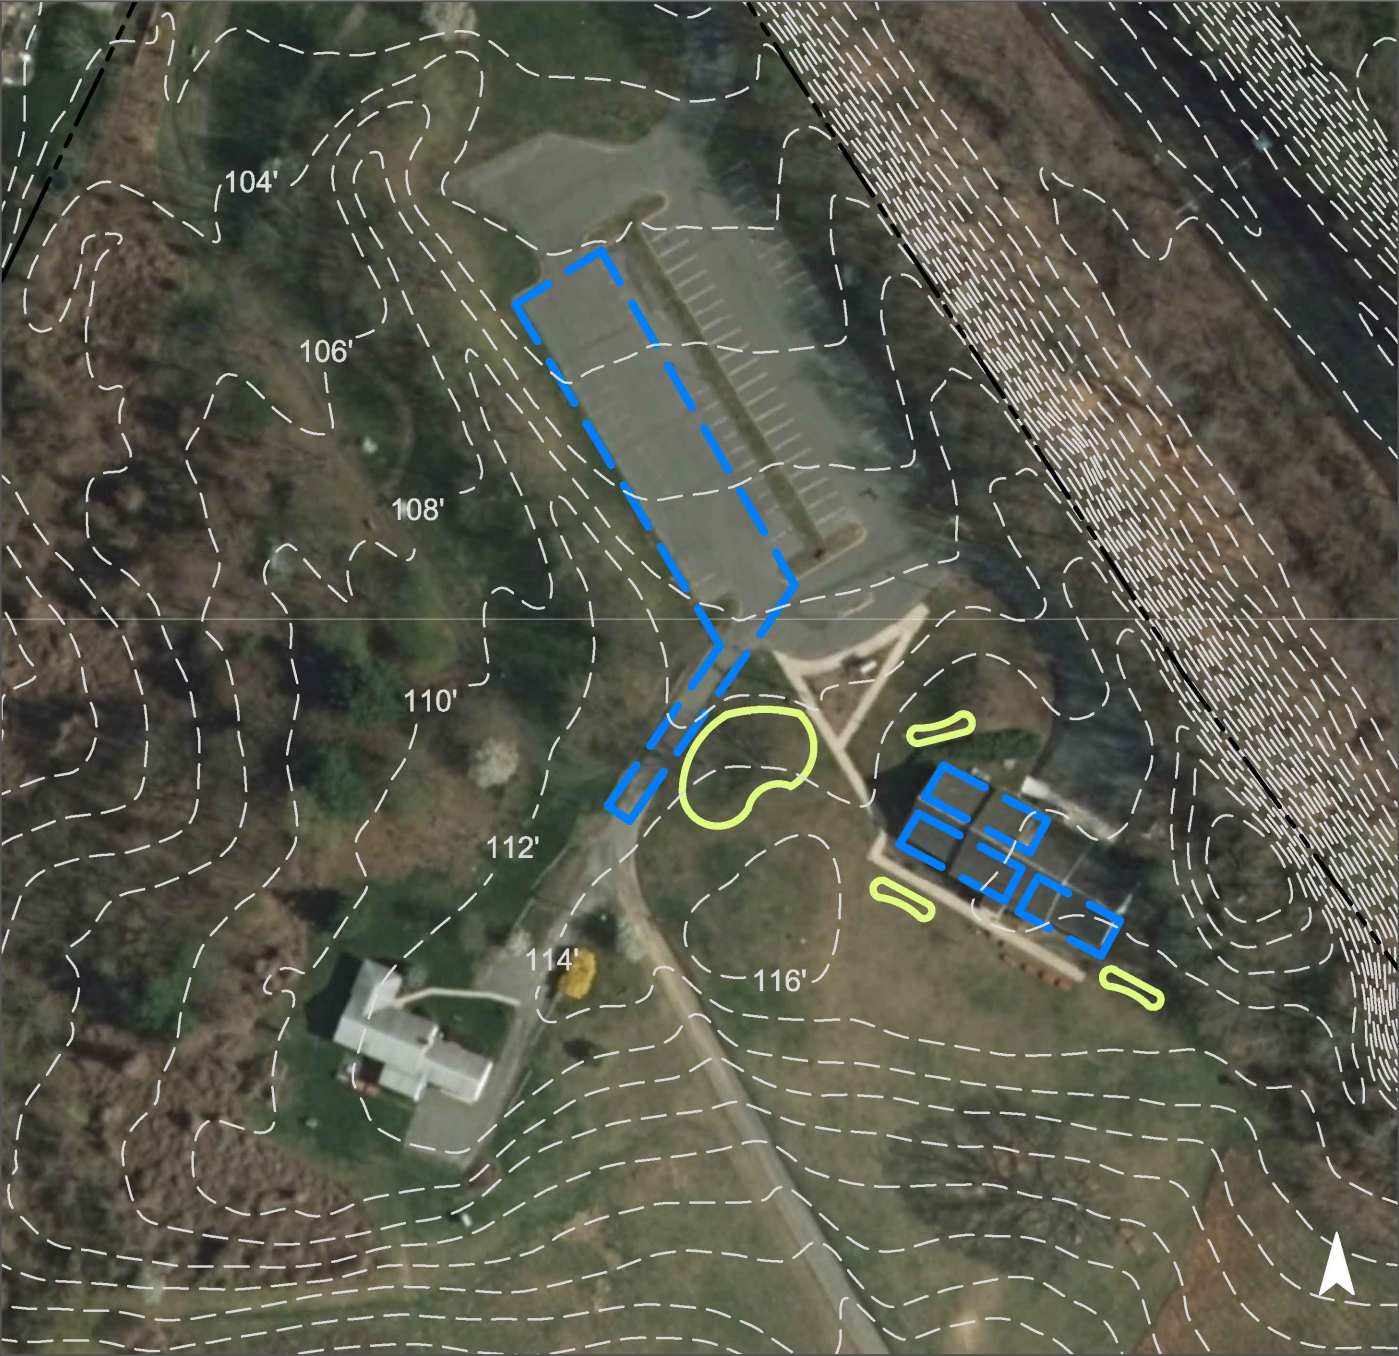
GREEN INFRASTRUCTURE RECOMMENDATIONS

Recommended Green Infrastructure Practices	Recharge Potential (Mgal/yr)	TSS Removal Potential (lbs/yr)	Maximum Volume Reduction Potential (gal/storm)	Peak Discharge Reduction Potential (cu. ft./second)	Estimated Size (sq. ft.)	Estimated Cost
Bioretention systems	0.404	68	29,640	1.11	3,875	\$19,375

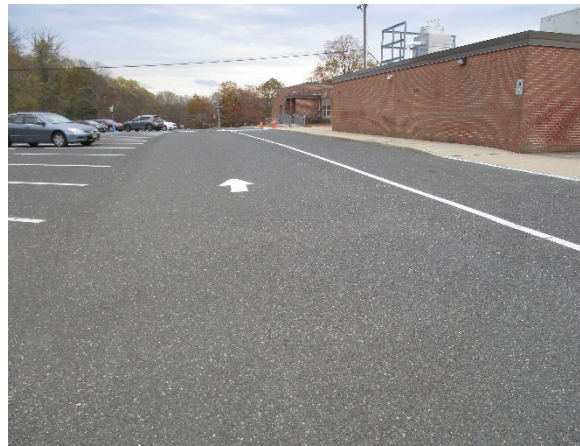
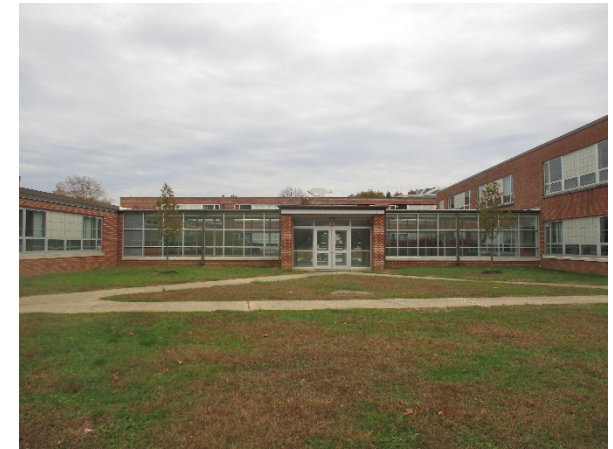
Subwatershed: Poricy Brook/Swimming River
Site Area: 1,310,440 sq. ft.
Address: 1001 Middletown-Lincroft Road
 Middletown, NJ 07748
Block and Lot: Block 898, Lot 39

A row of parking spaces in the parking lot to the north of the building can be converted to porous pavement to capture and infiltrate stormwater runoff from the parking lot. Rain gardens can be installed throughout the property to capture, treat, and infiltrate stormwater runoff from the rooftops and paved areas. A preliminary soil assessment suggests that the soils have suitable drainage characteristics for green infrastructure.

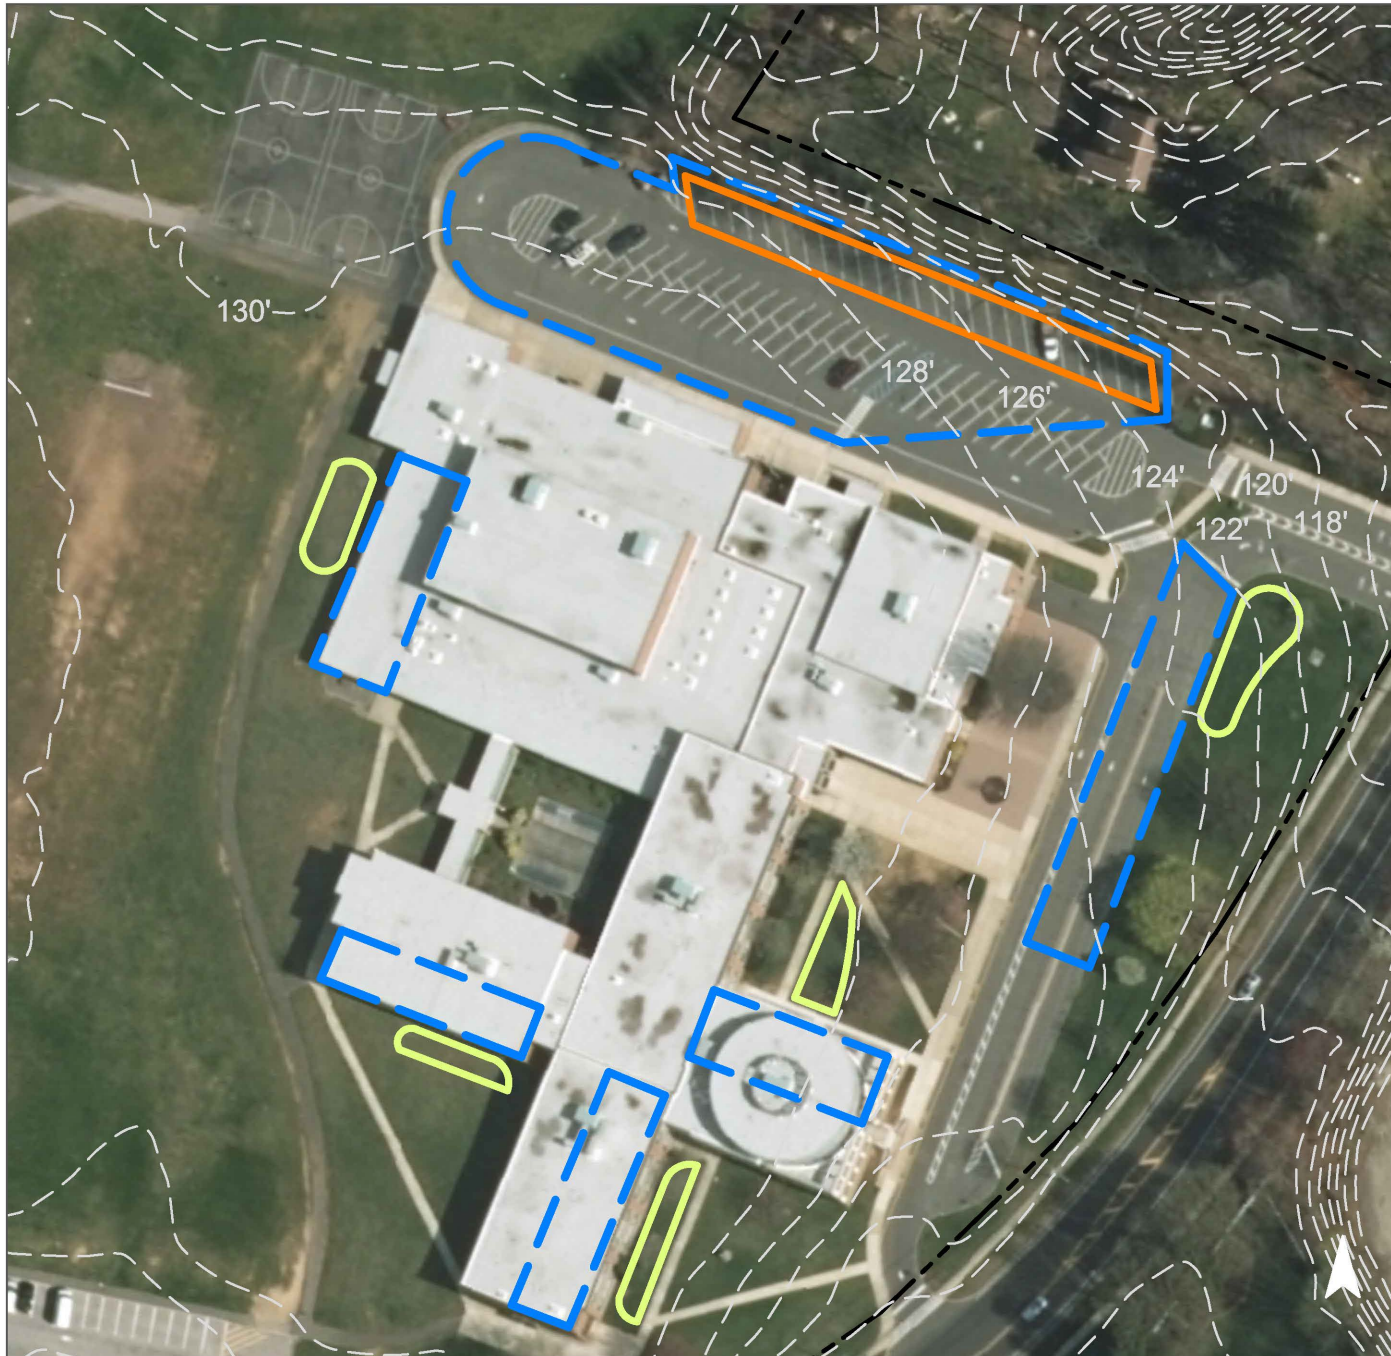
GREEN INFRASTRUCTURE RECOMMENDATIONS

Recommended Green Infrastructure Practices	Recharge Potential (Mgal/yr)	TSS Removal Potential (lbs/yr)	Maximum Volume Reduction Potential (gal/storm)	Peak Discharge Reduction Potential (cu. ft./second)	Estimated Size (sq. ft.)	Estimated Cost
Bioretention systems	0.594	99	43,550	1.64	5,705	\$28,525
Pervious pavement	0.844	141	61,930	2.33	5,785	\$144,625

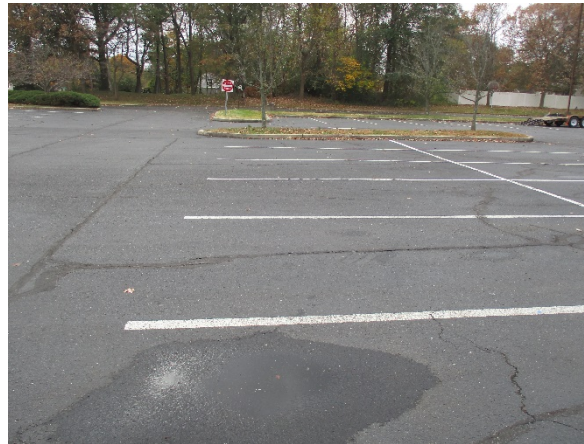
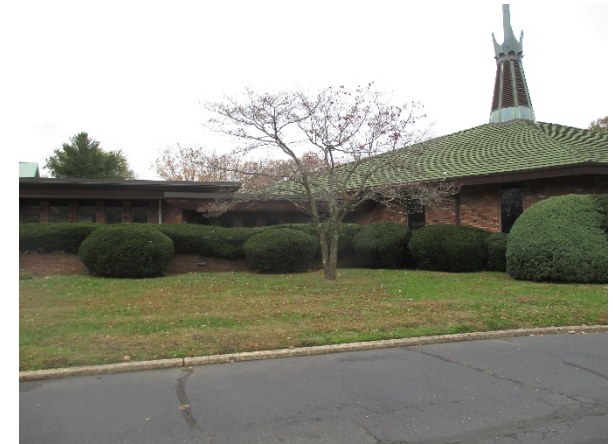
Subwatershed: Waackaack Creek
Site Area: 153,968 sq. ft.
Address: 250 Harmony Road
Middletown, NJ 07748
Block and Lot: Block 611, Lot 10

Parking spaces in the parking lot to the south of the building can be converted to porous pavement to capture and infiltrate stormwater runoff from the parking lot. Rain gardens can be installed in the turfgrass areas around the building and near a section of parking spaces to capture, treat, and infiltrate stormwater runoff from the roof and parking lot. A preliminary soil assessment suggests that the soils have suitable drainage characteristics for green infrastructure.

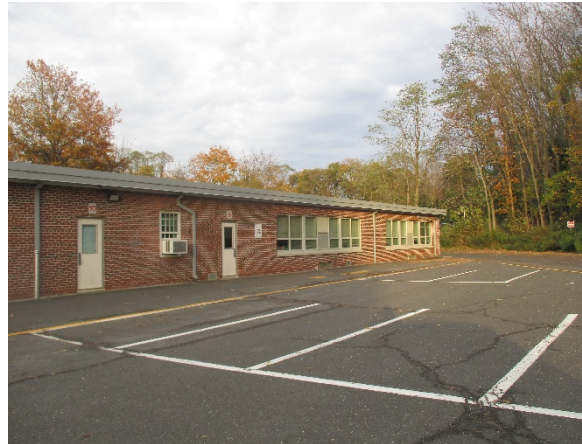
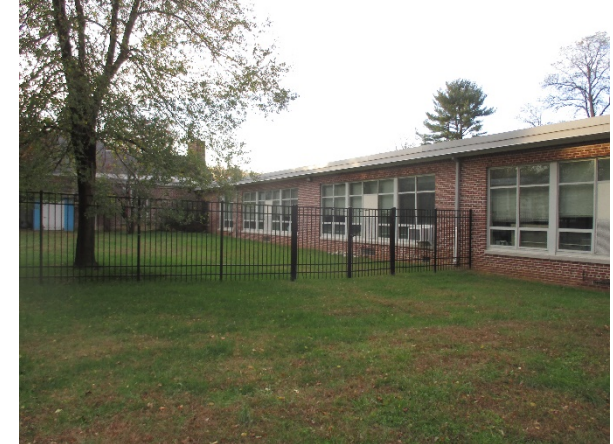
Block and Lot: Block 805, Lot 3

Parking spaces in the parking lot to the east of the building can be converted to porous pavement to capture and infiltrate stormwater runoff from the parking lot. Rain gardens can be installed to capture, treat, and infiltrate stormwater runoff from the roof. A preliminary soil assessment suggests that the soils have suitable drainage characteristics for green infrastructure.

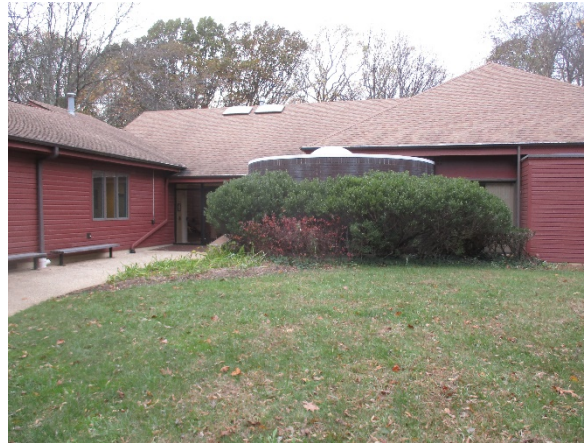
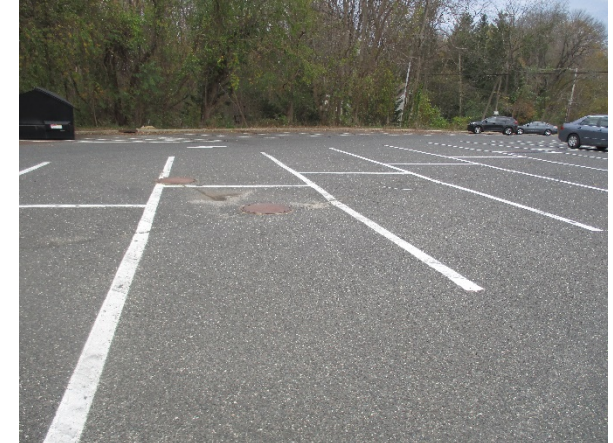
Block and Lot: Block 796, Lot 8

Rain gardens can be installed around the activity center building to capture, treat, and infiltrate stormwater runoff from the roof. A preliminary soil assessment suggests that the soils have suitable drainage characteristics for green infrastructure.
