Bethel Holy Temple Church of God in Christ

Address: 533 8th Street
Newtonville, NJ 08346

GREEN INFRASTRUCTURE RECOMMENDATIONS

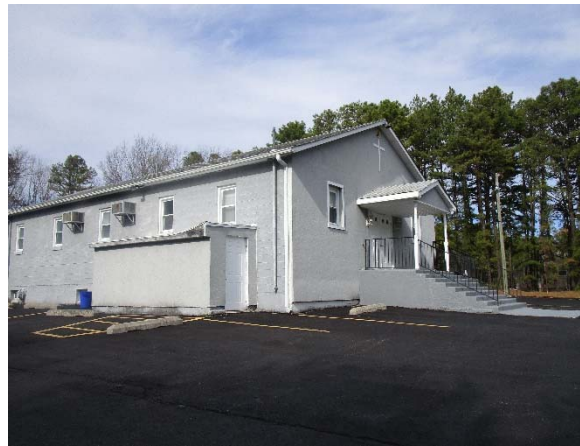
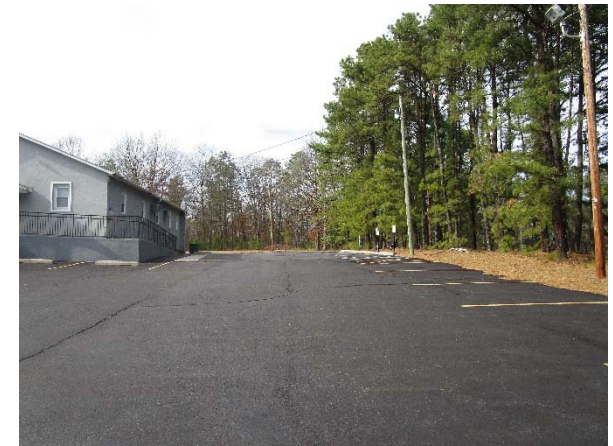
The southern half of parking spaces northeast of the building can be replaced with pervious pavement to capture and infiltrate stormwater. A preliminary soil assessment suggests that the soils have suitable drainage characteristics for green infrastructure.

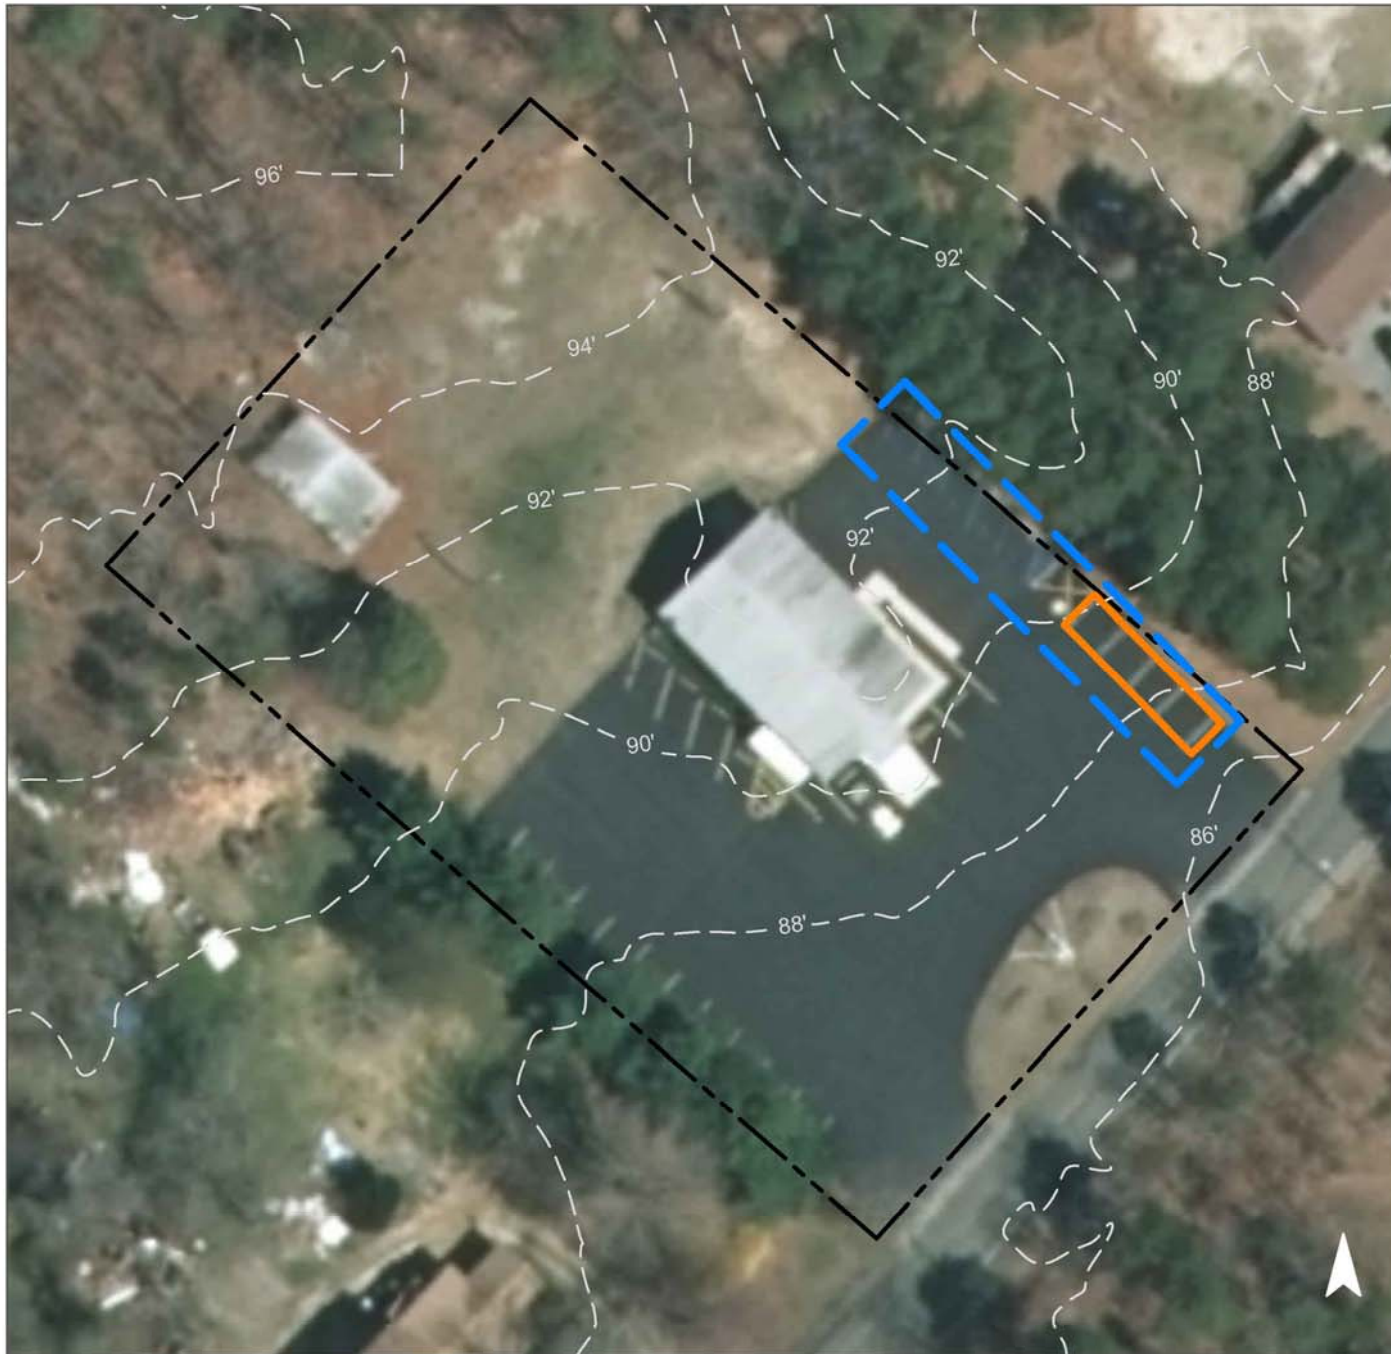
Bethel Holy Temple Church of God in Christ

pervious pavement
-

drainage area
-

property line
-

Recommended Green Infrastructure Practices	Recharge Potential (Mgal/yr)	TSS Removal Potential (lbs/yr)	Maximum Volume Reduction Potential (gal/storm)	Peak Discharge Reduction Potential (cu. ft./second)	Estimated Size (sq. ft.)	Estimated Cost
Pervious pavement	0.075	13	5,510	0.21	515	\$12,875
