**Impervious Cover Assessment
for
Hopatcong Borough, Sussex County, New Jersey**

*Prepared for the town of Hopatcong Borough by the
Rutgers Cooperative Extension Water Resources Program*

February 27, 2017

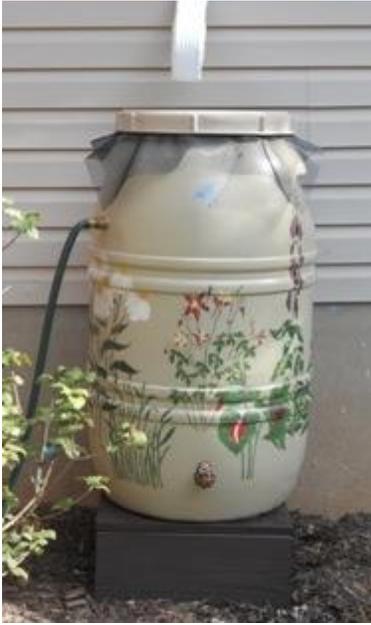
Figure 8a: Rain barrel used to disconnect a downspout with the overflow going to a flower bed

- Rainwater Harvesting: Rainwater harvesting includes the use of rain barrels and cisterns (Figures 8a and 8b). These can be placed below downspouts to collect rooftop runoff. The collected water has a variety of uses including watering plants and washing cars. This practice also helps cut down on the use of potable water for nondrinking purposes. It is important to divert the overflow from the rainwater harvesting system to a pervious area.

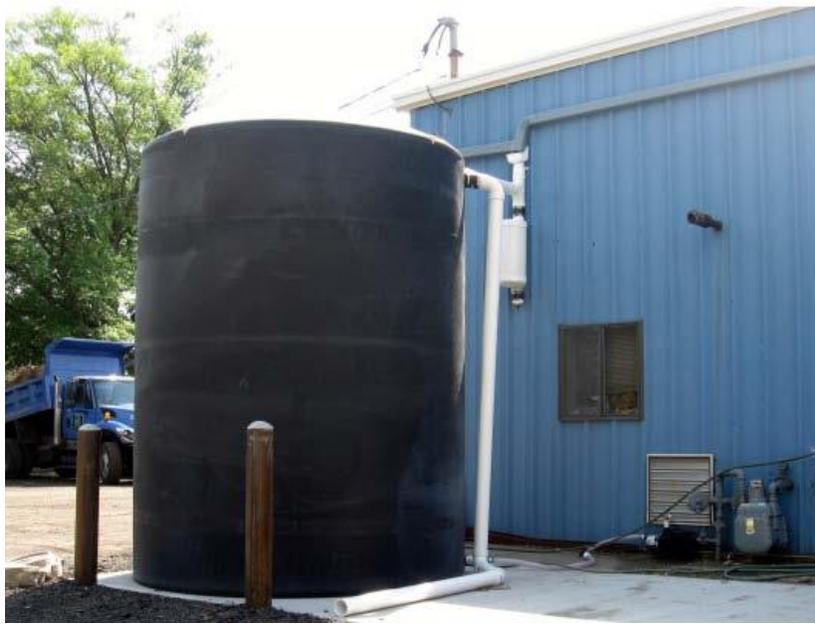
Figure 8b: A 5,000 gallon cistern used to disconnect the rooftop of the Department of Public Works in Clark Township to harvest rainwater for nonprofit car wash events
