**Hamilton Township (Mercer County)
Stormwater Basin Assessment Summary
Past Priority Addendum (Year 5B)**

Developed by the Rutgers Cooperative Extension Water Resources Program
Funded by Hamilton Township, Mercer County, New Jersey

November 27, 2019

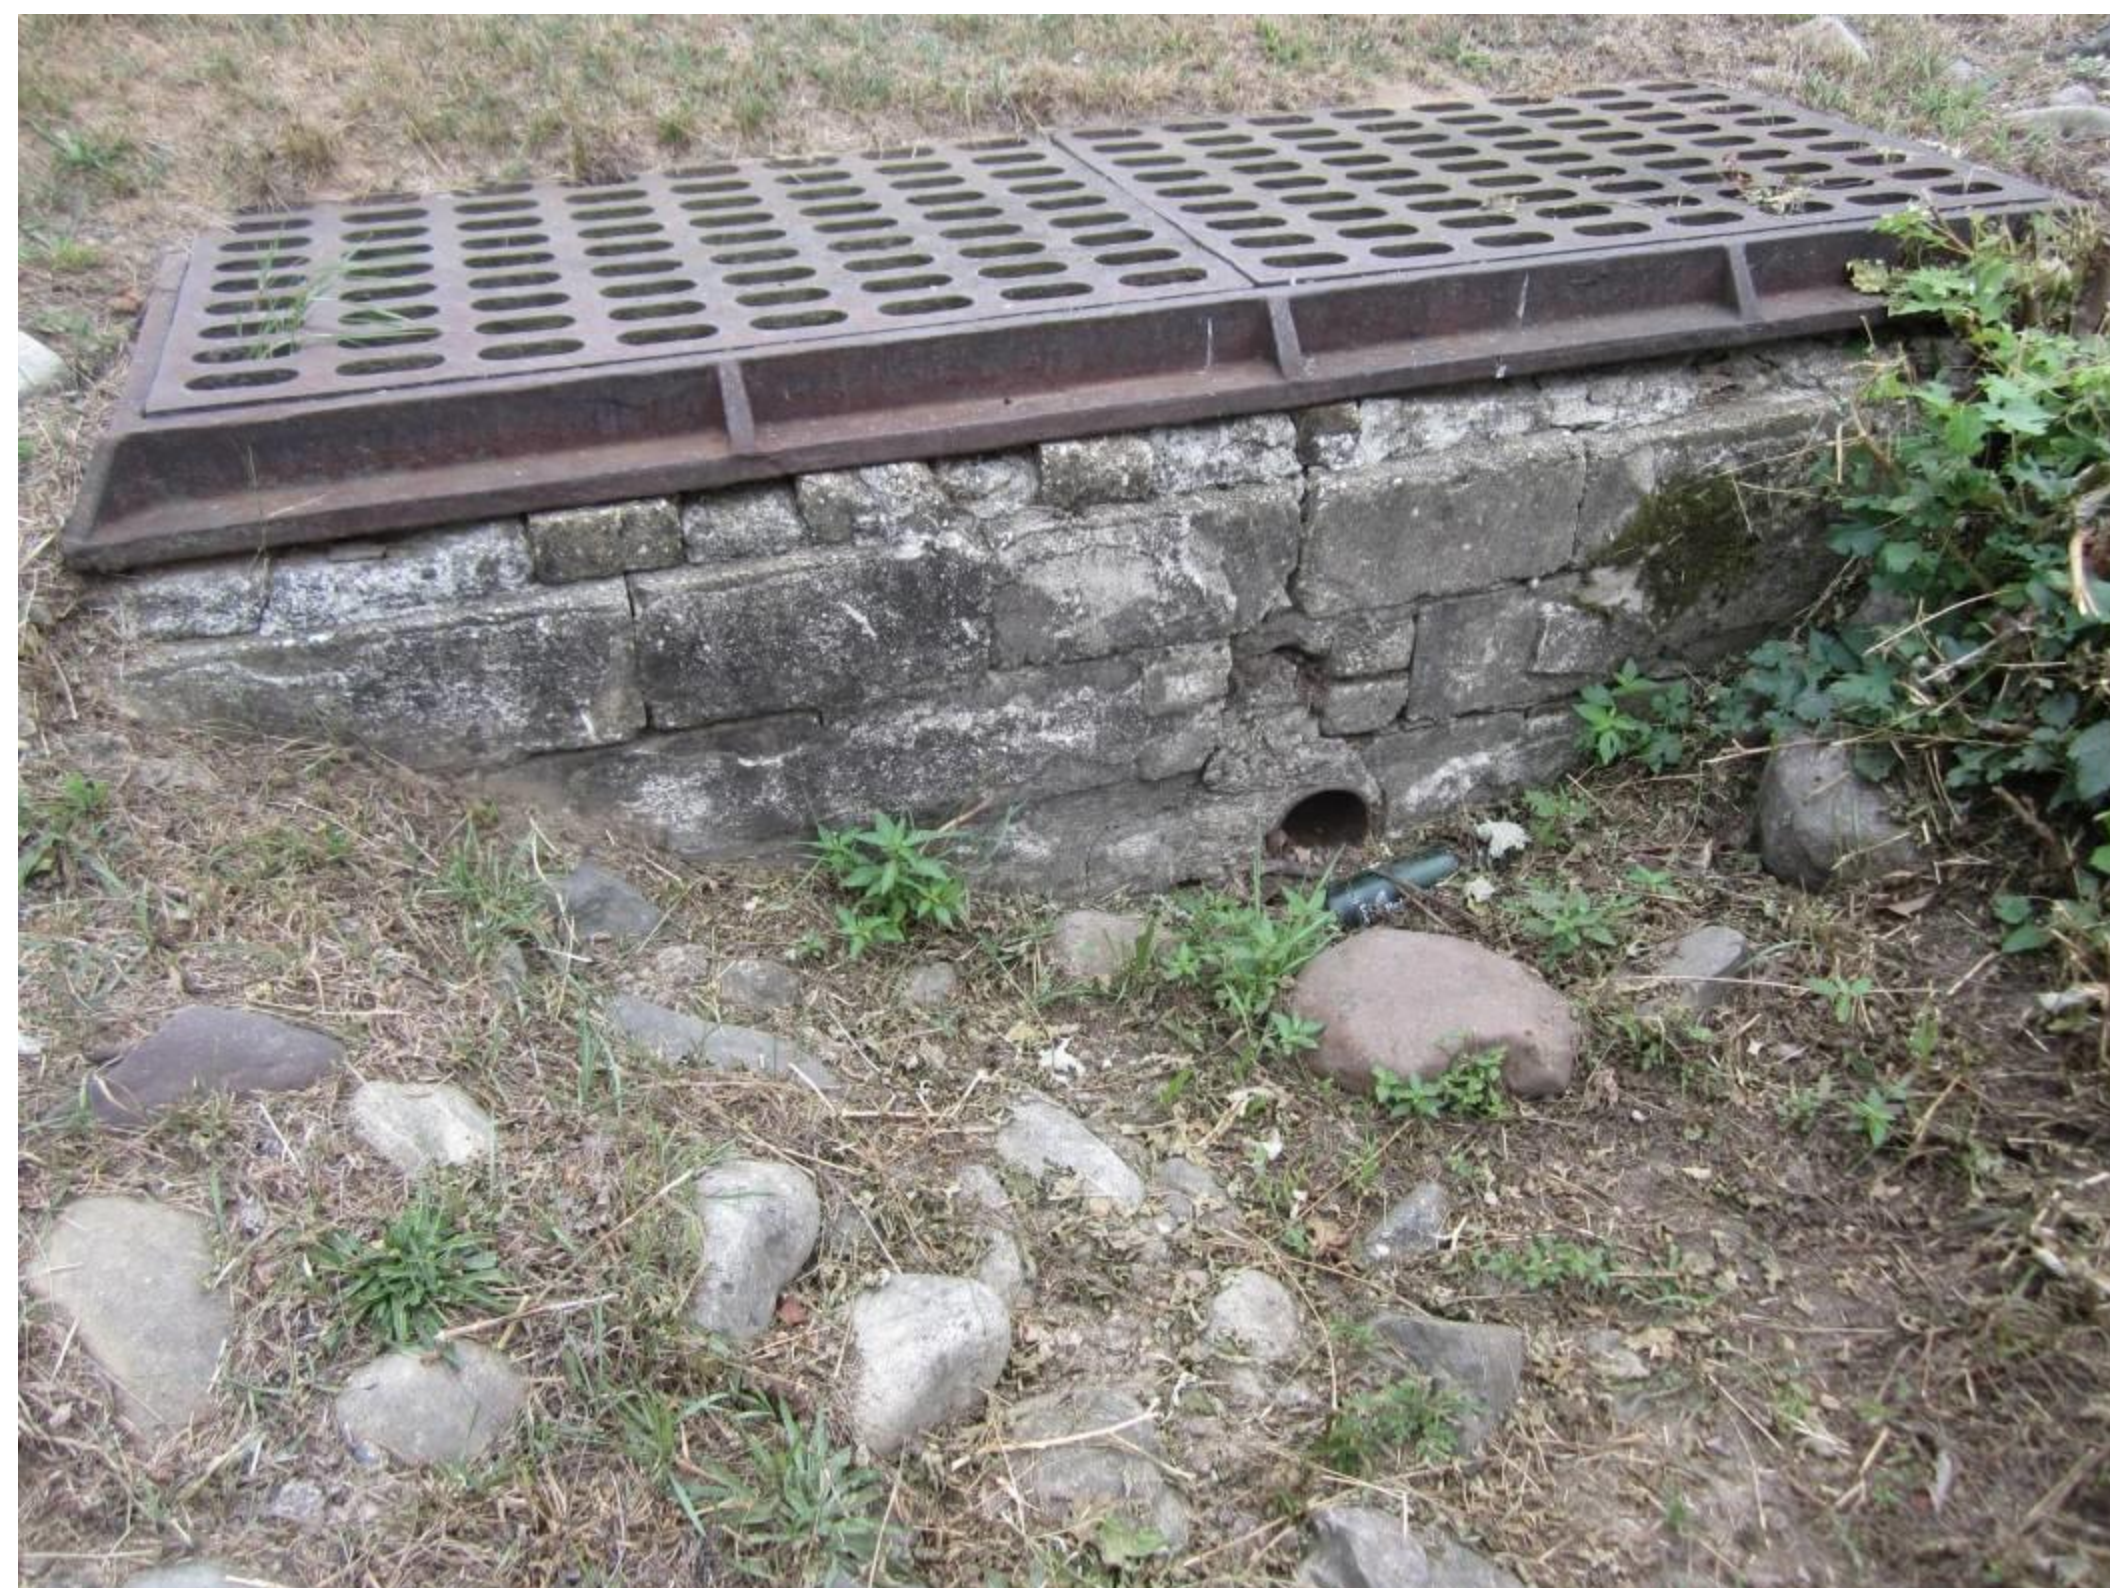
Outlet structure

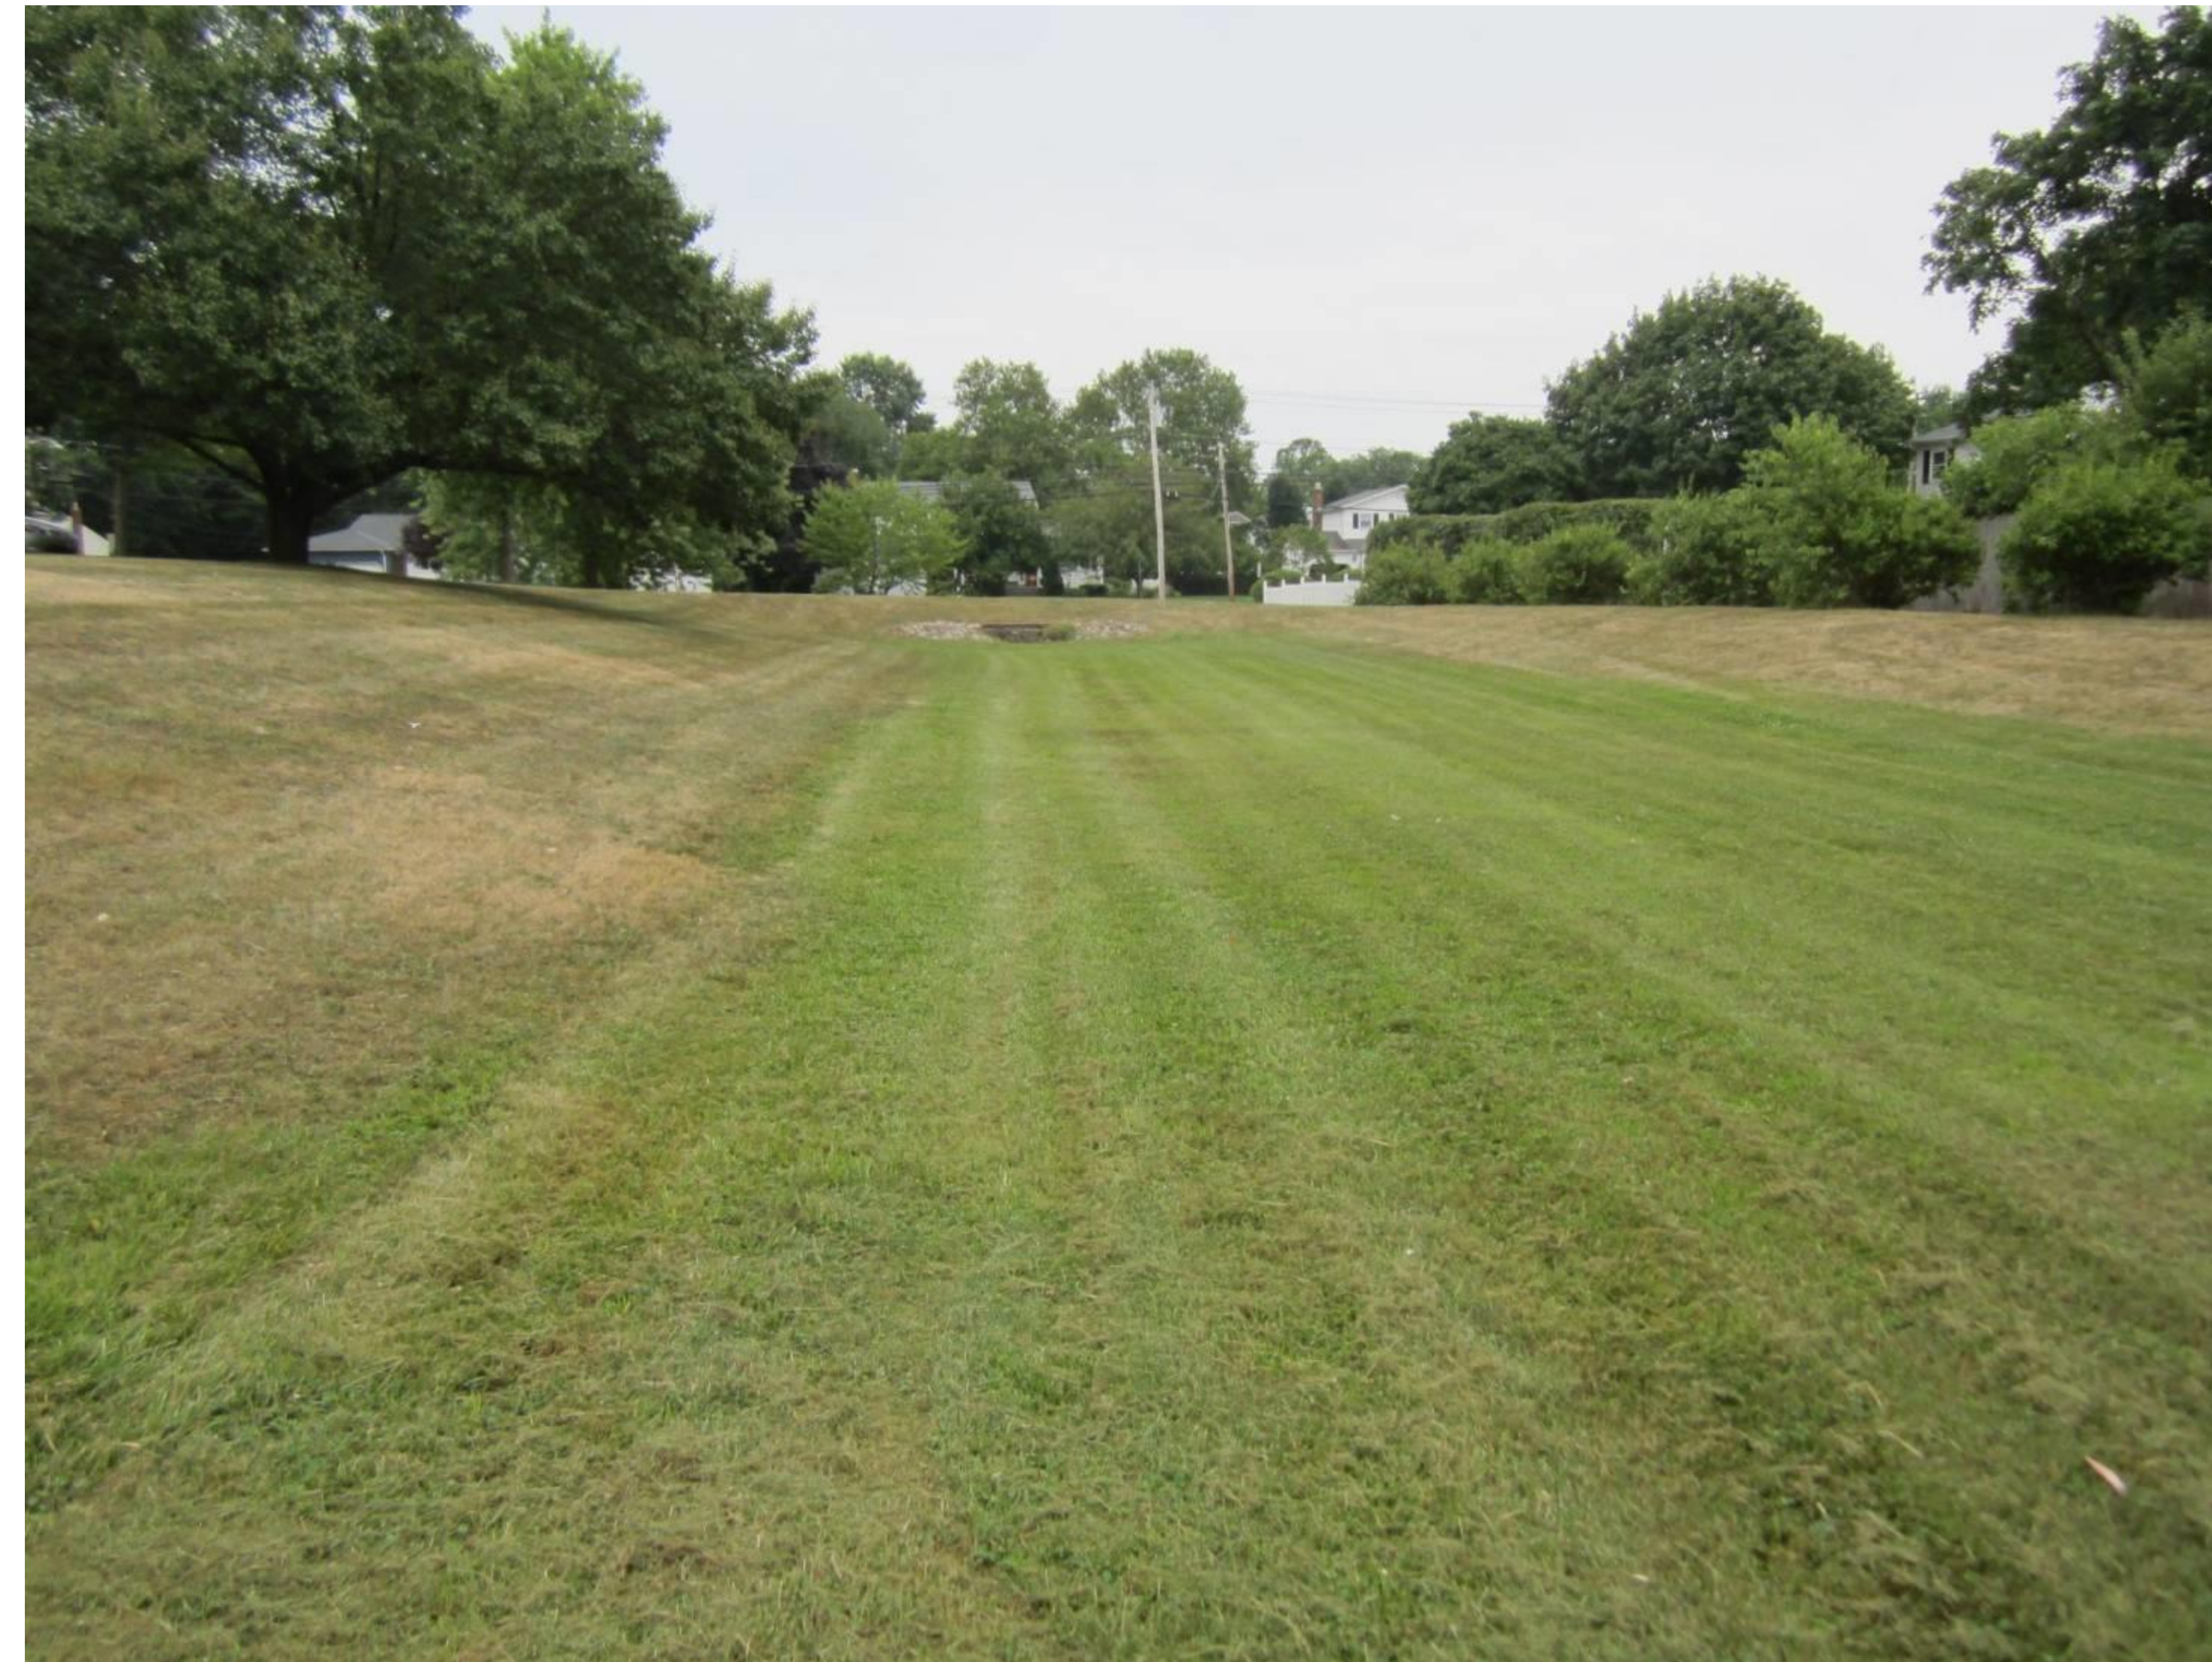
Looking north along basin bottom

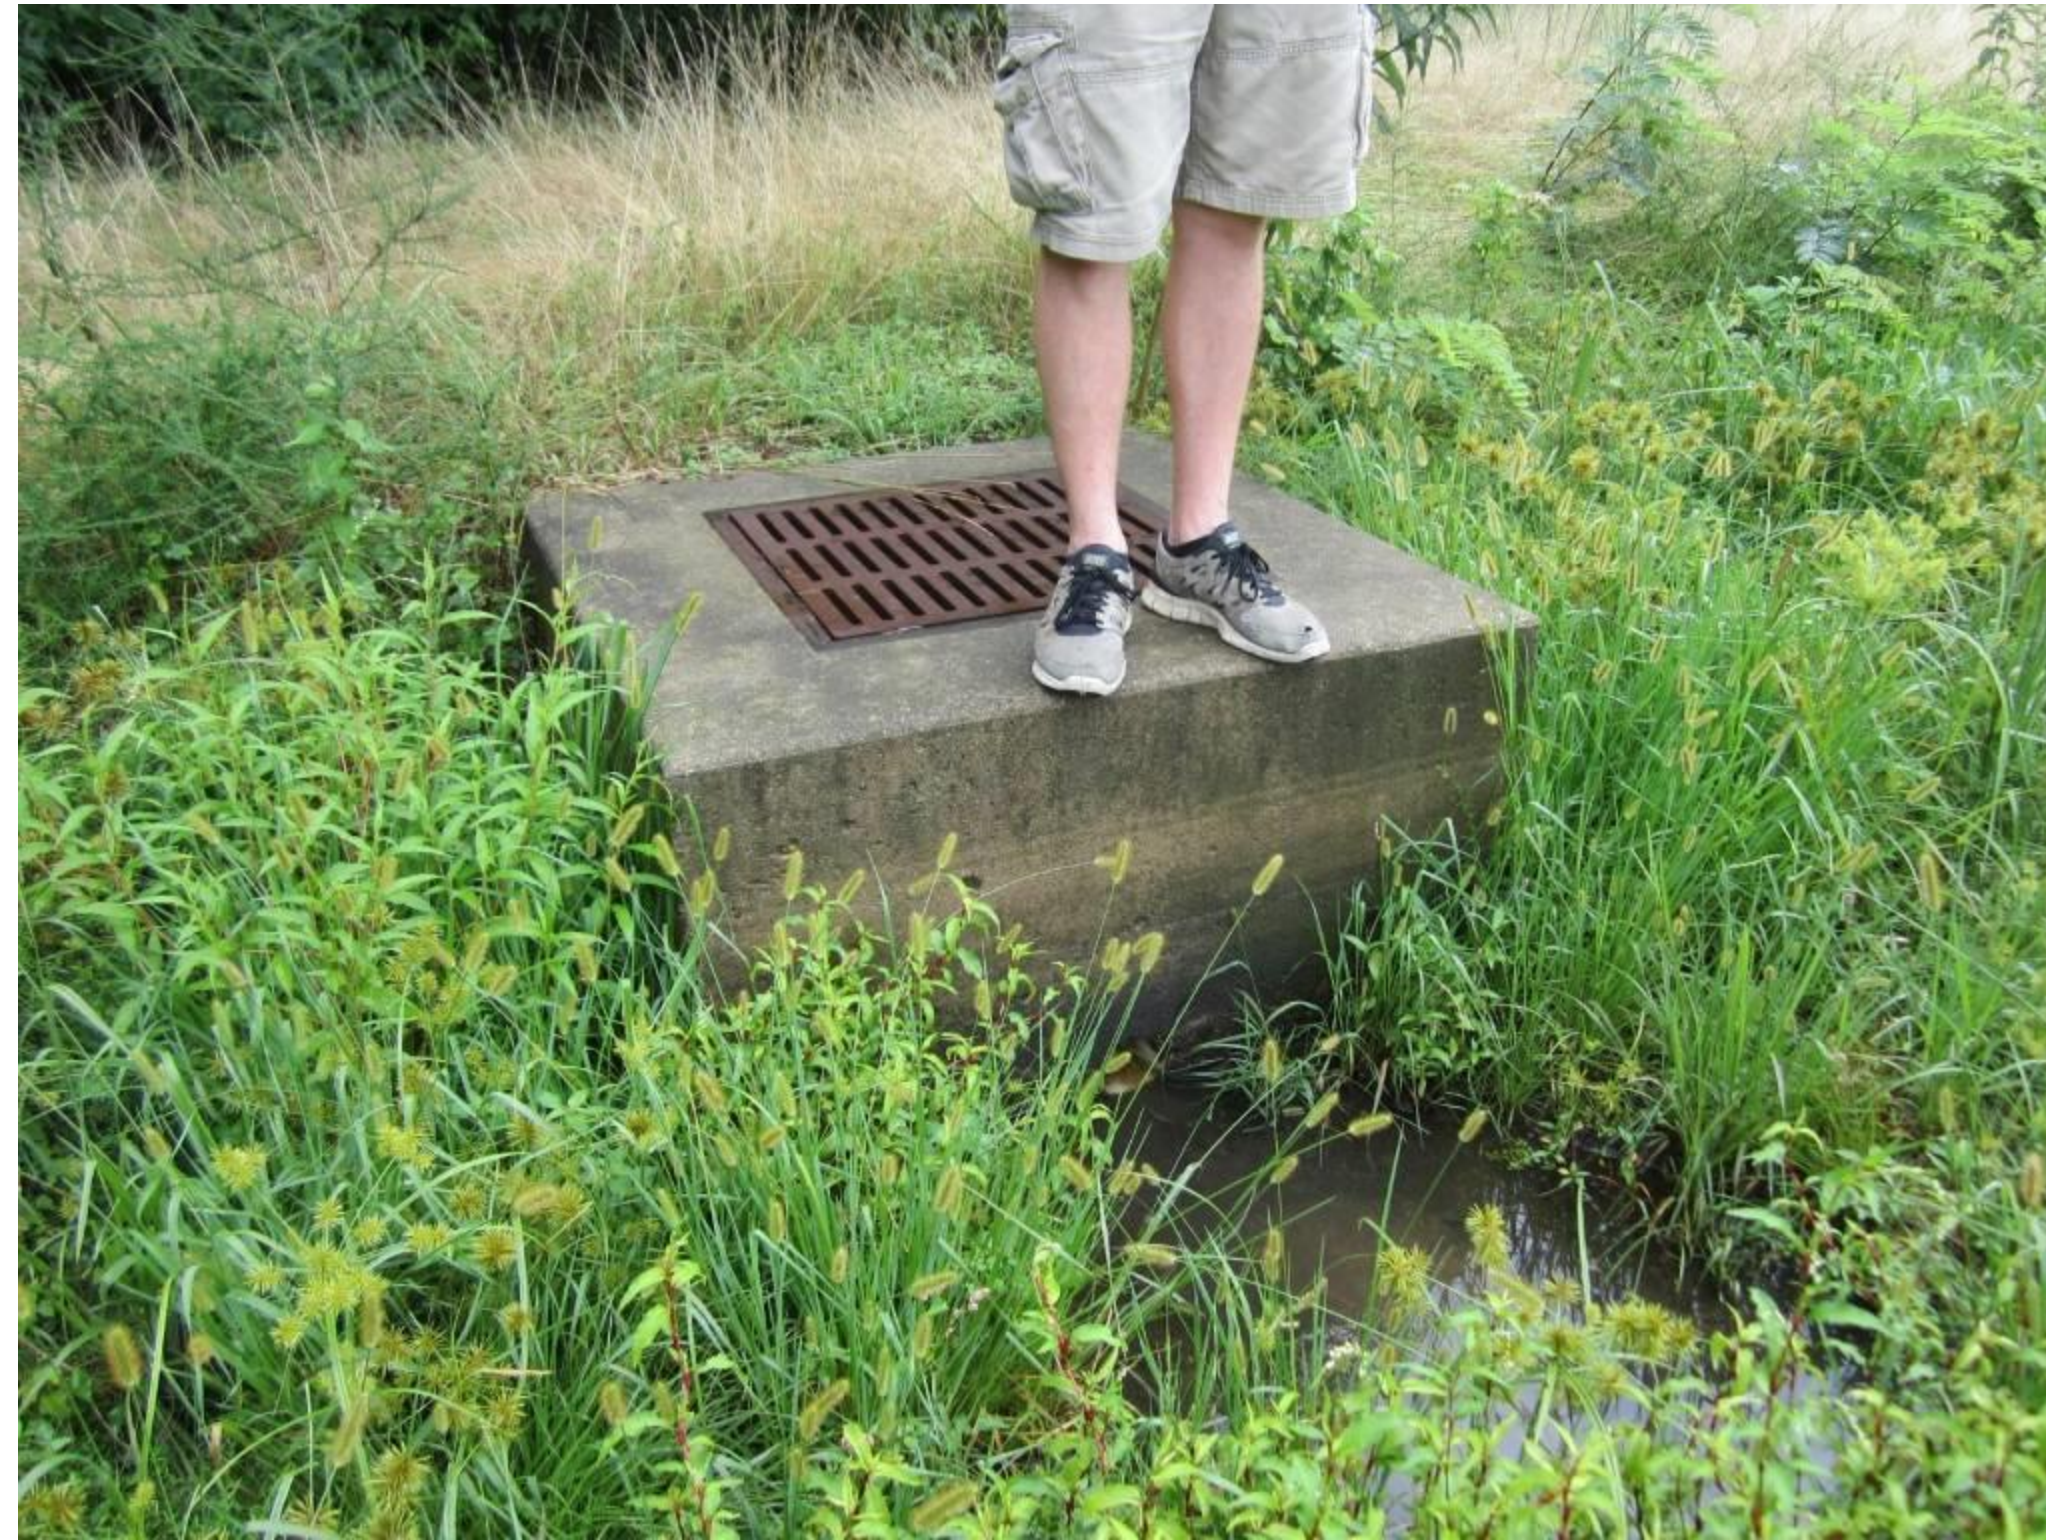
Outlet structure

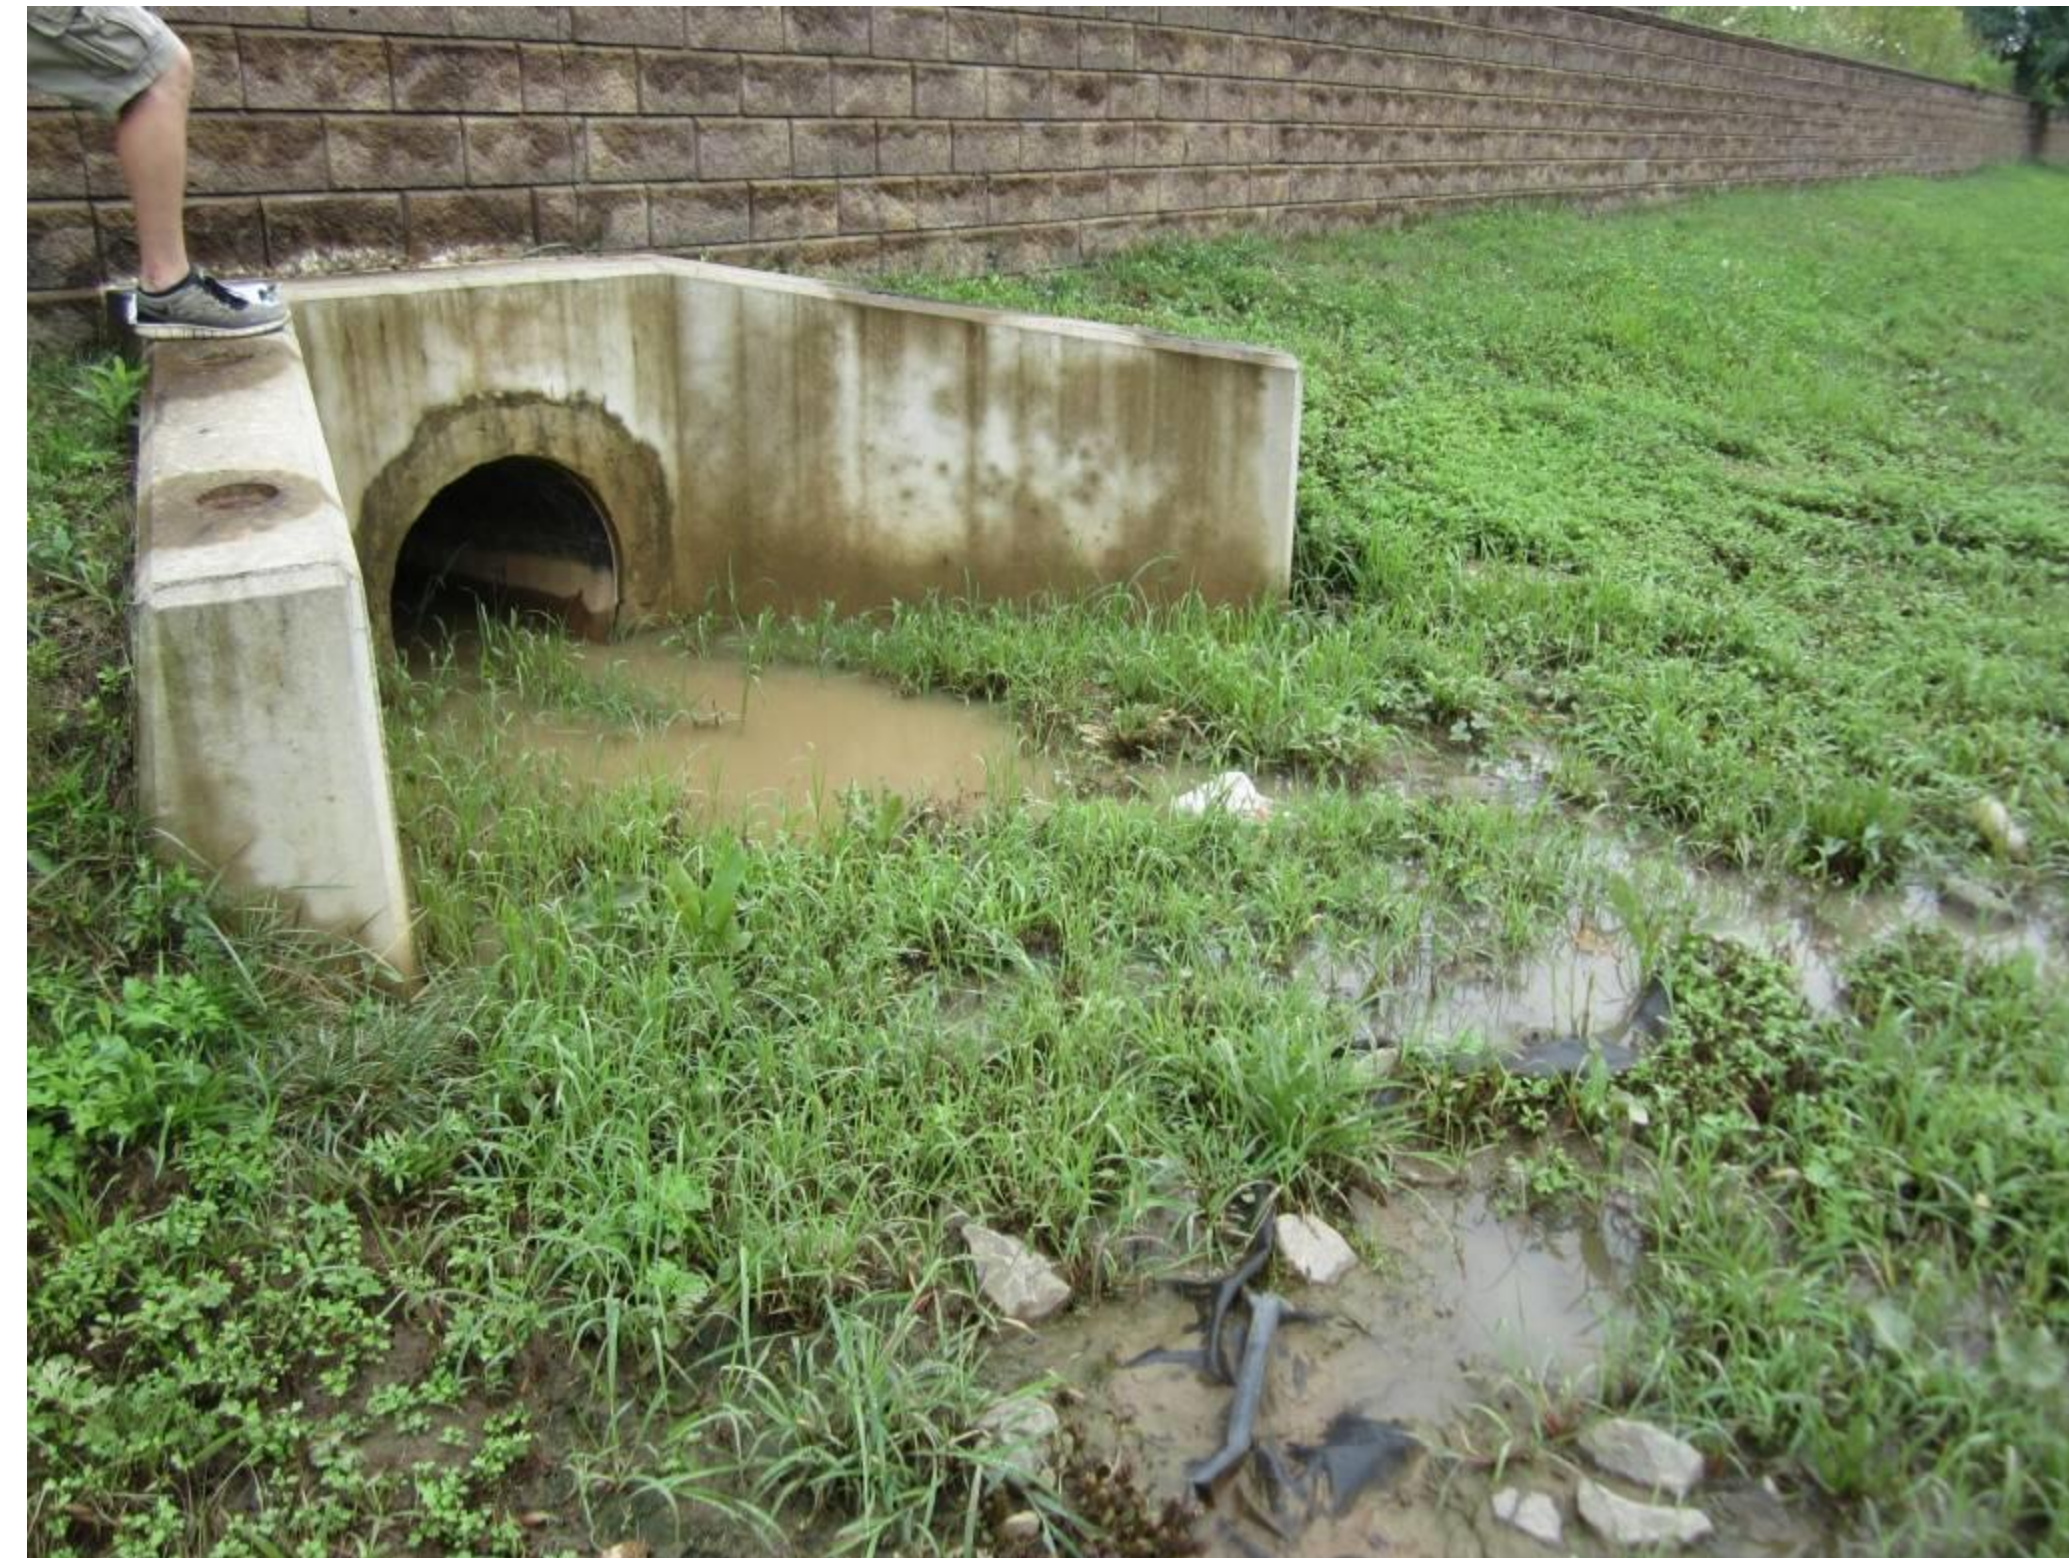
Inlet

- Inlets and outlet have excess sediment accumulation obstructing flow
- Standing water in low flow channel and basin bottom
- Outlet has structural damage and missing grate

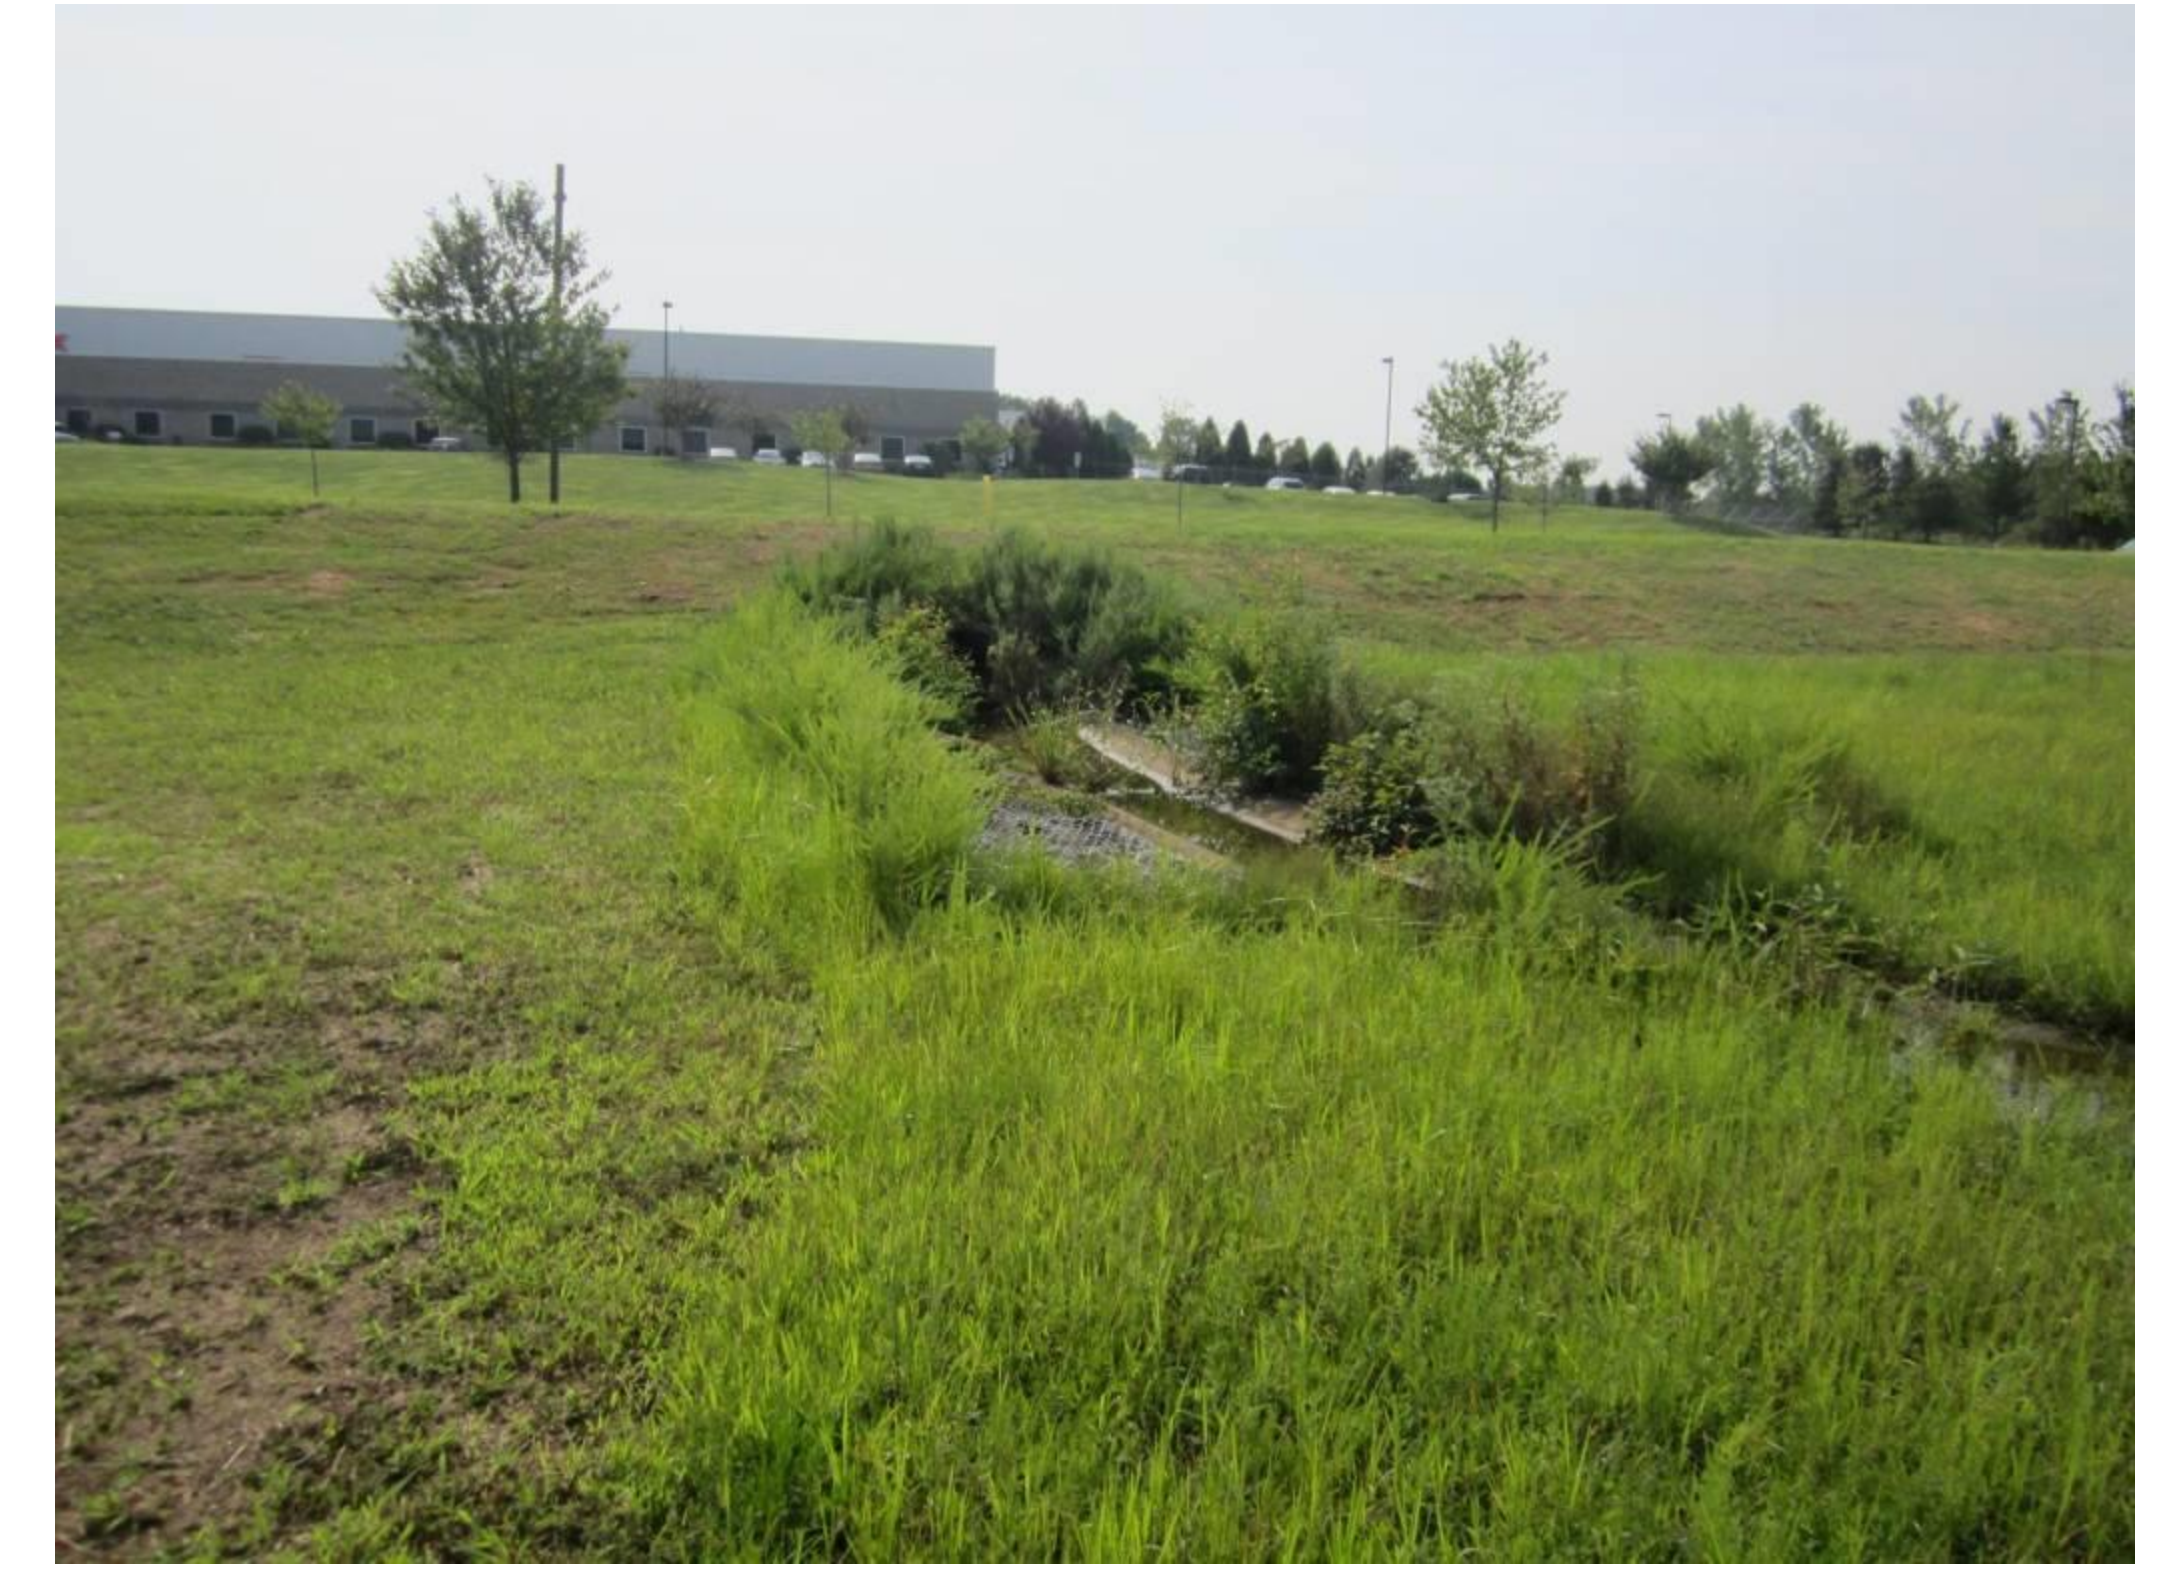
Inlet

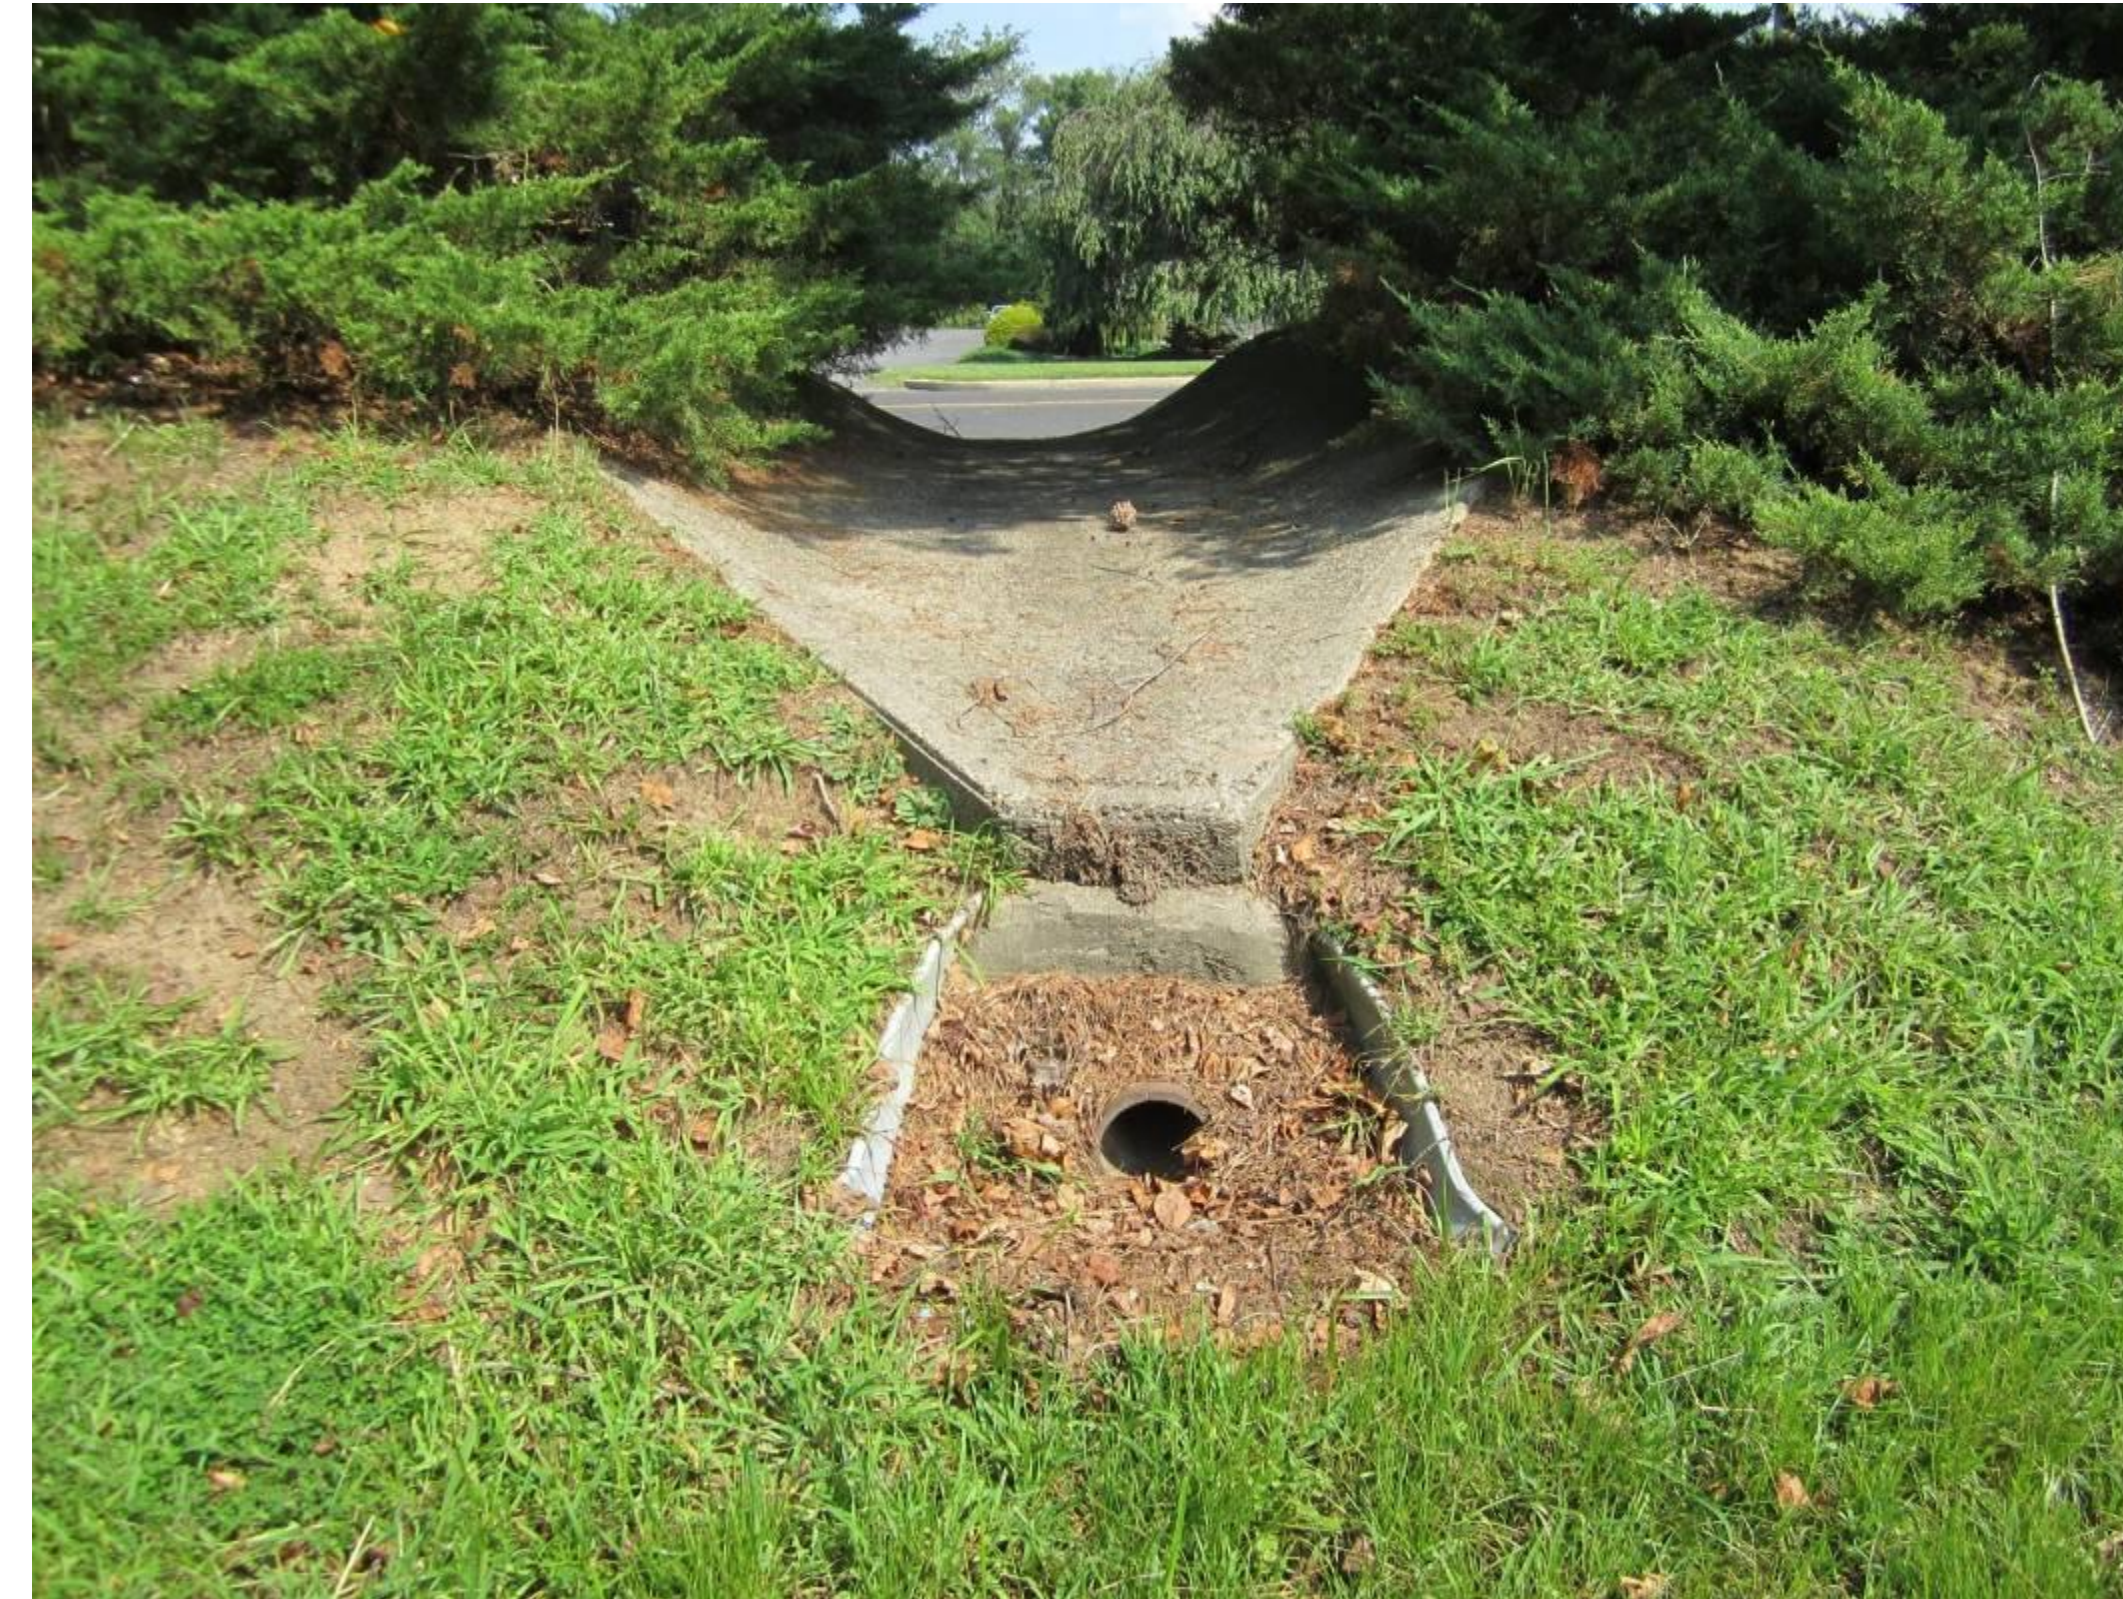
Outlet structure
