**Hamilton Township (Mercer County)
Stormwater Basin Assessment Summary
Past Priority Addendum (Year 5B)**

Developed by the Rutgers Cooperative Extension Water Resources Program
Funded by Hamilton Township, Mercer County, New Jersey

November 27, 2019

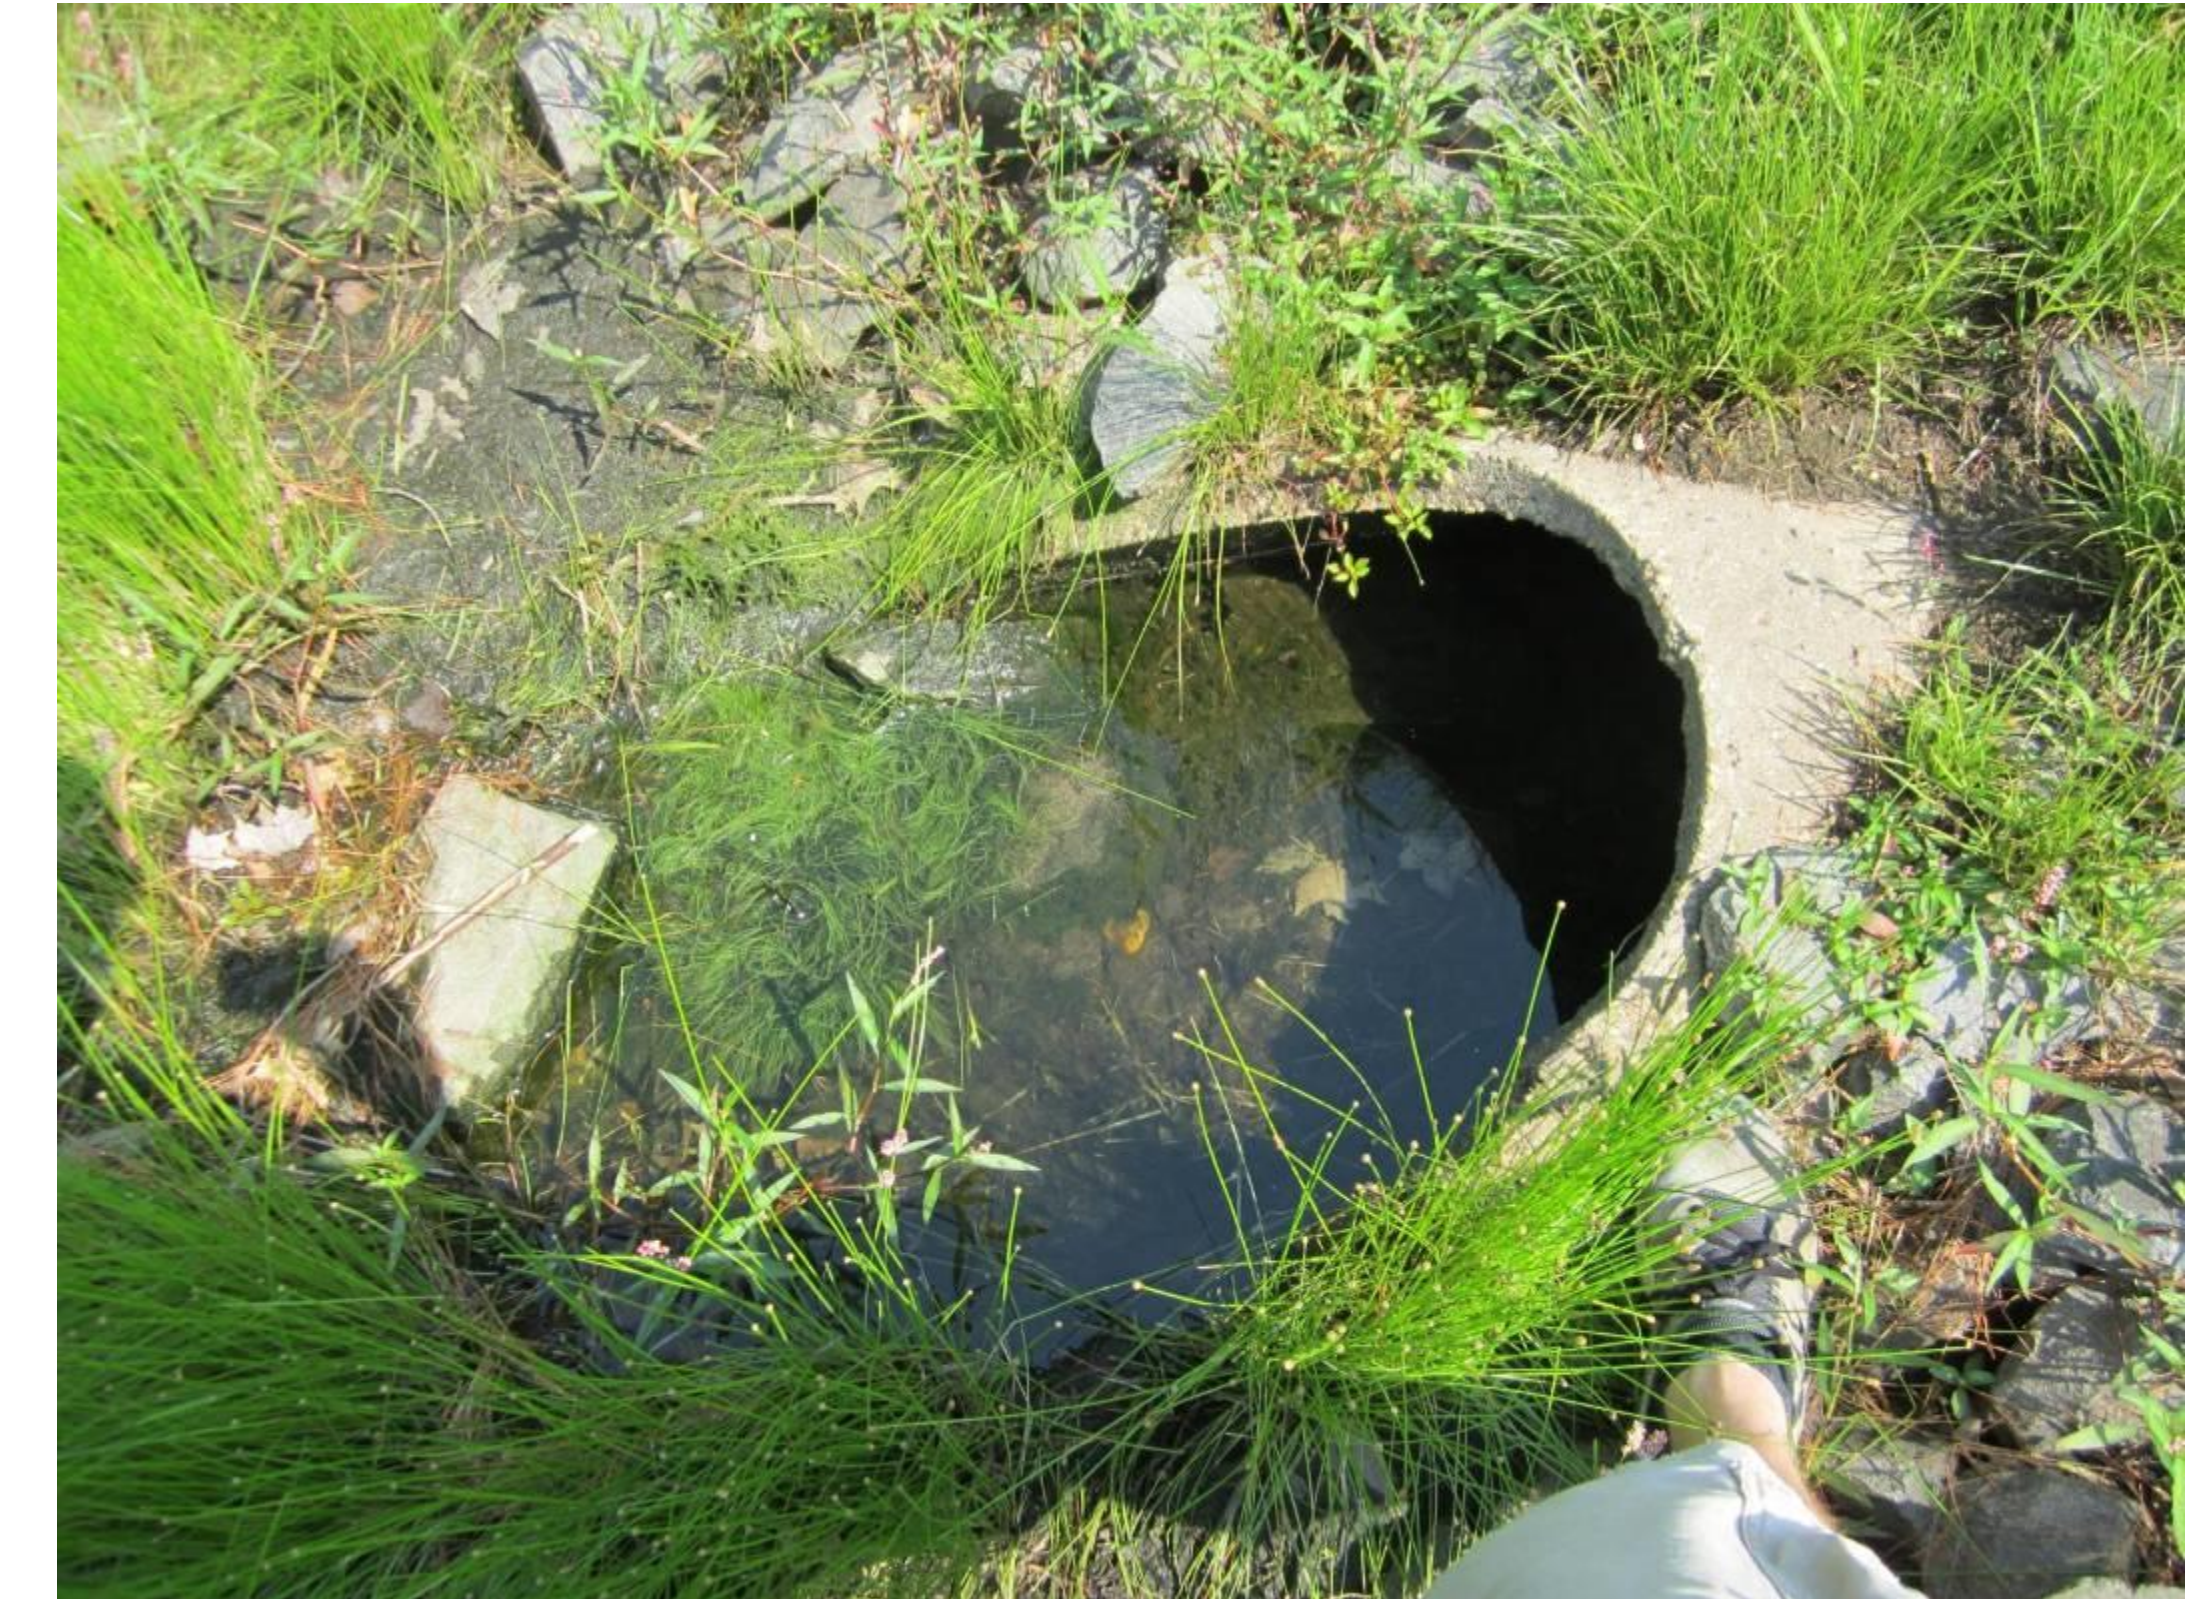
Clogged inlet

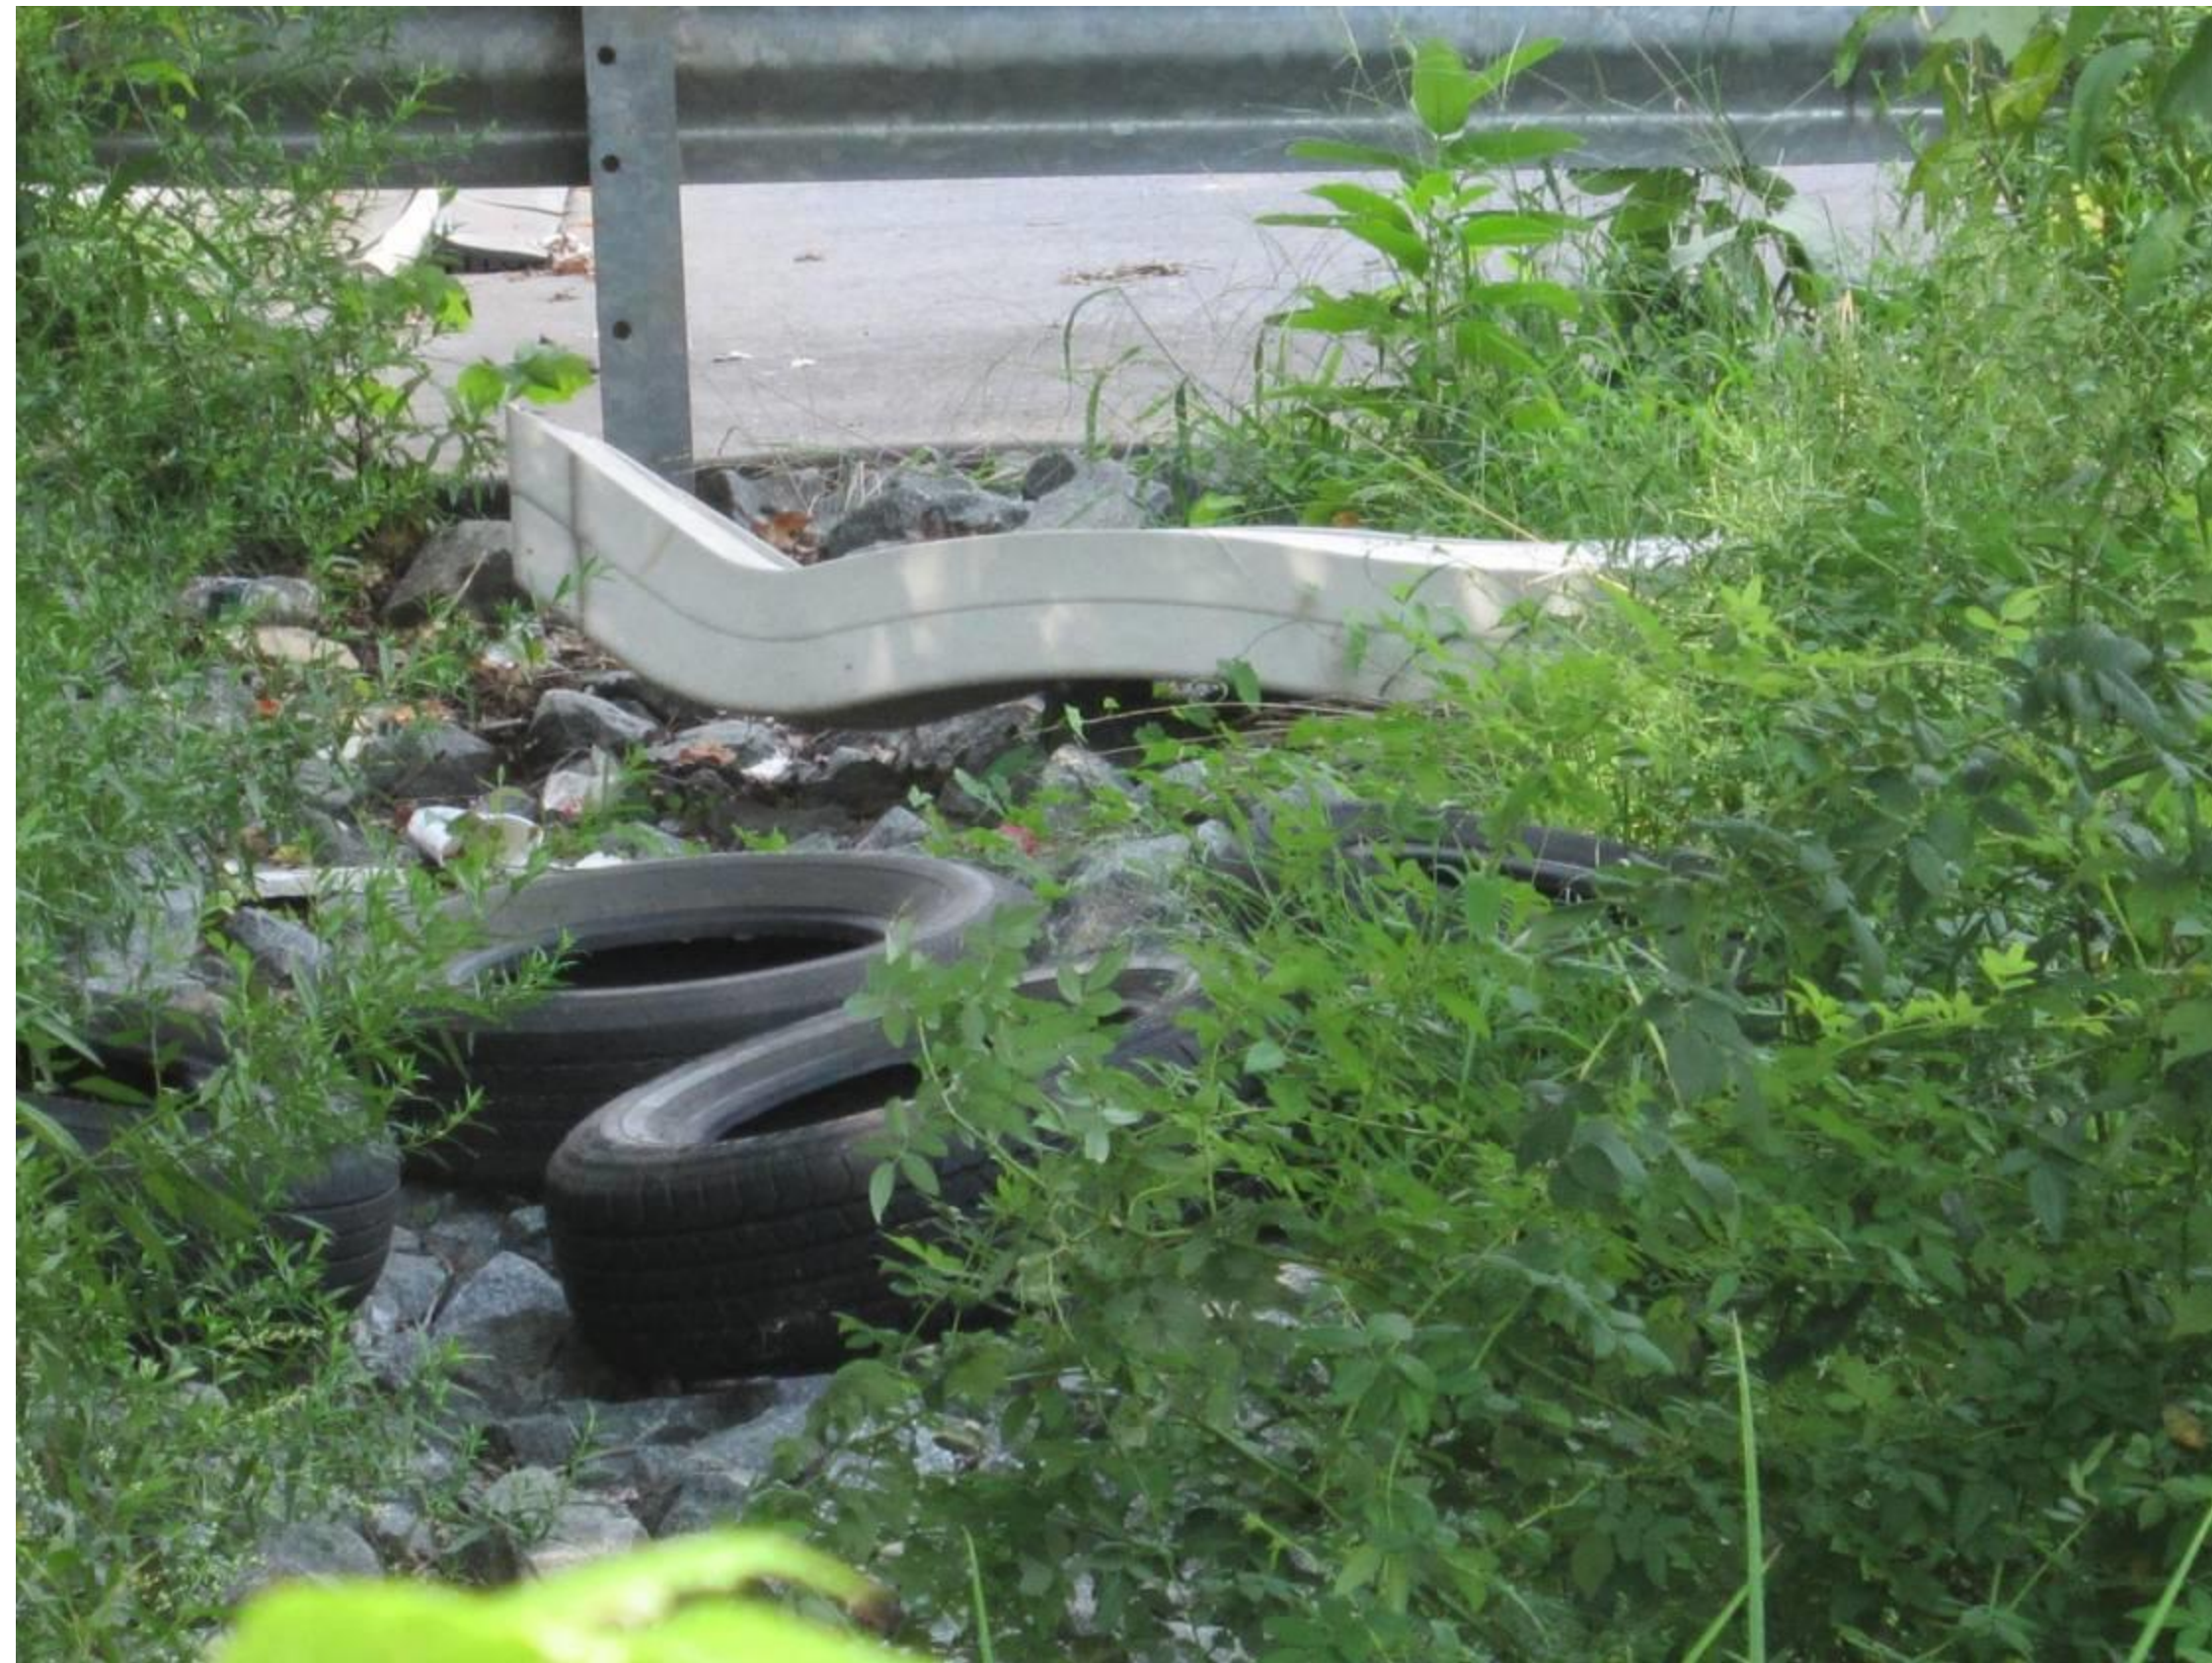
Rip rap and trash at dead end leading to basin

- Basin behind the building leading into a wooden area
- Recommend cleaning out location

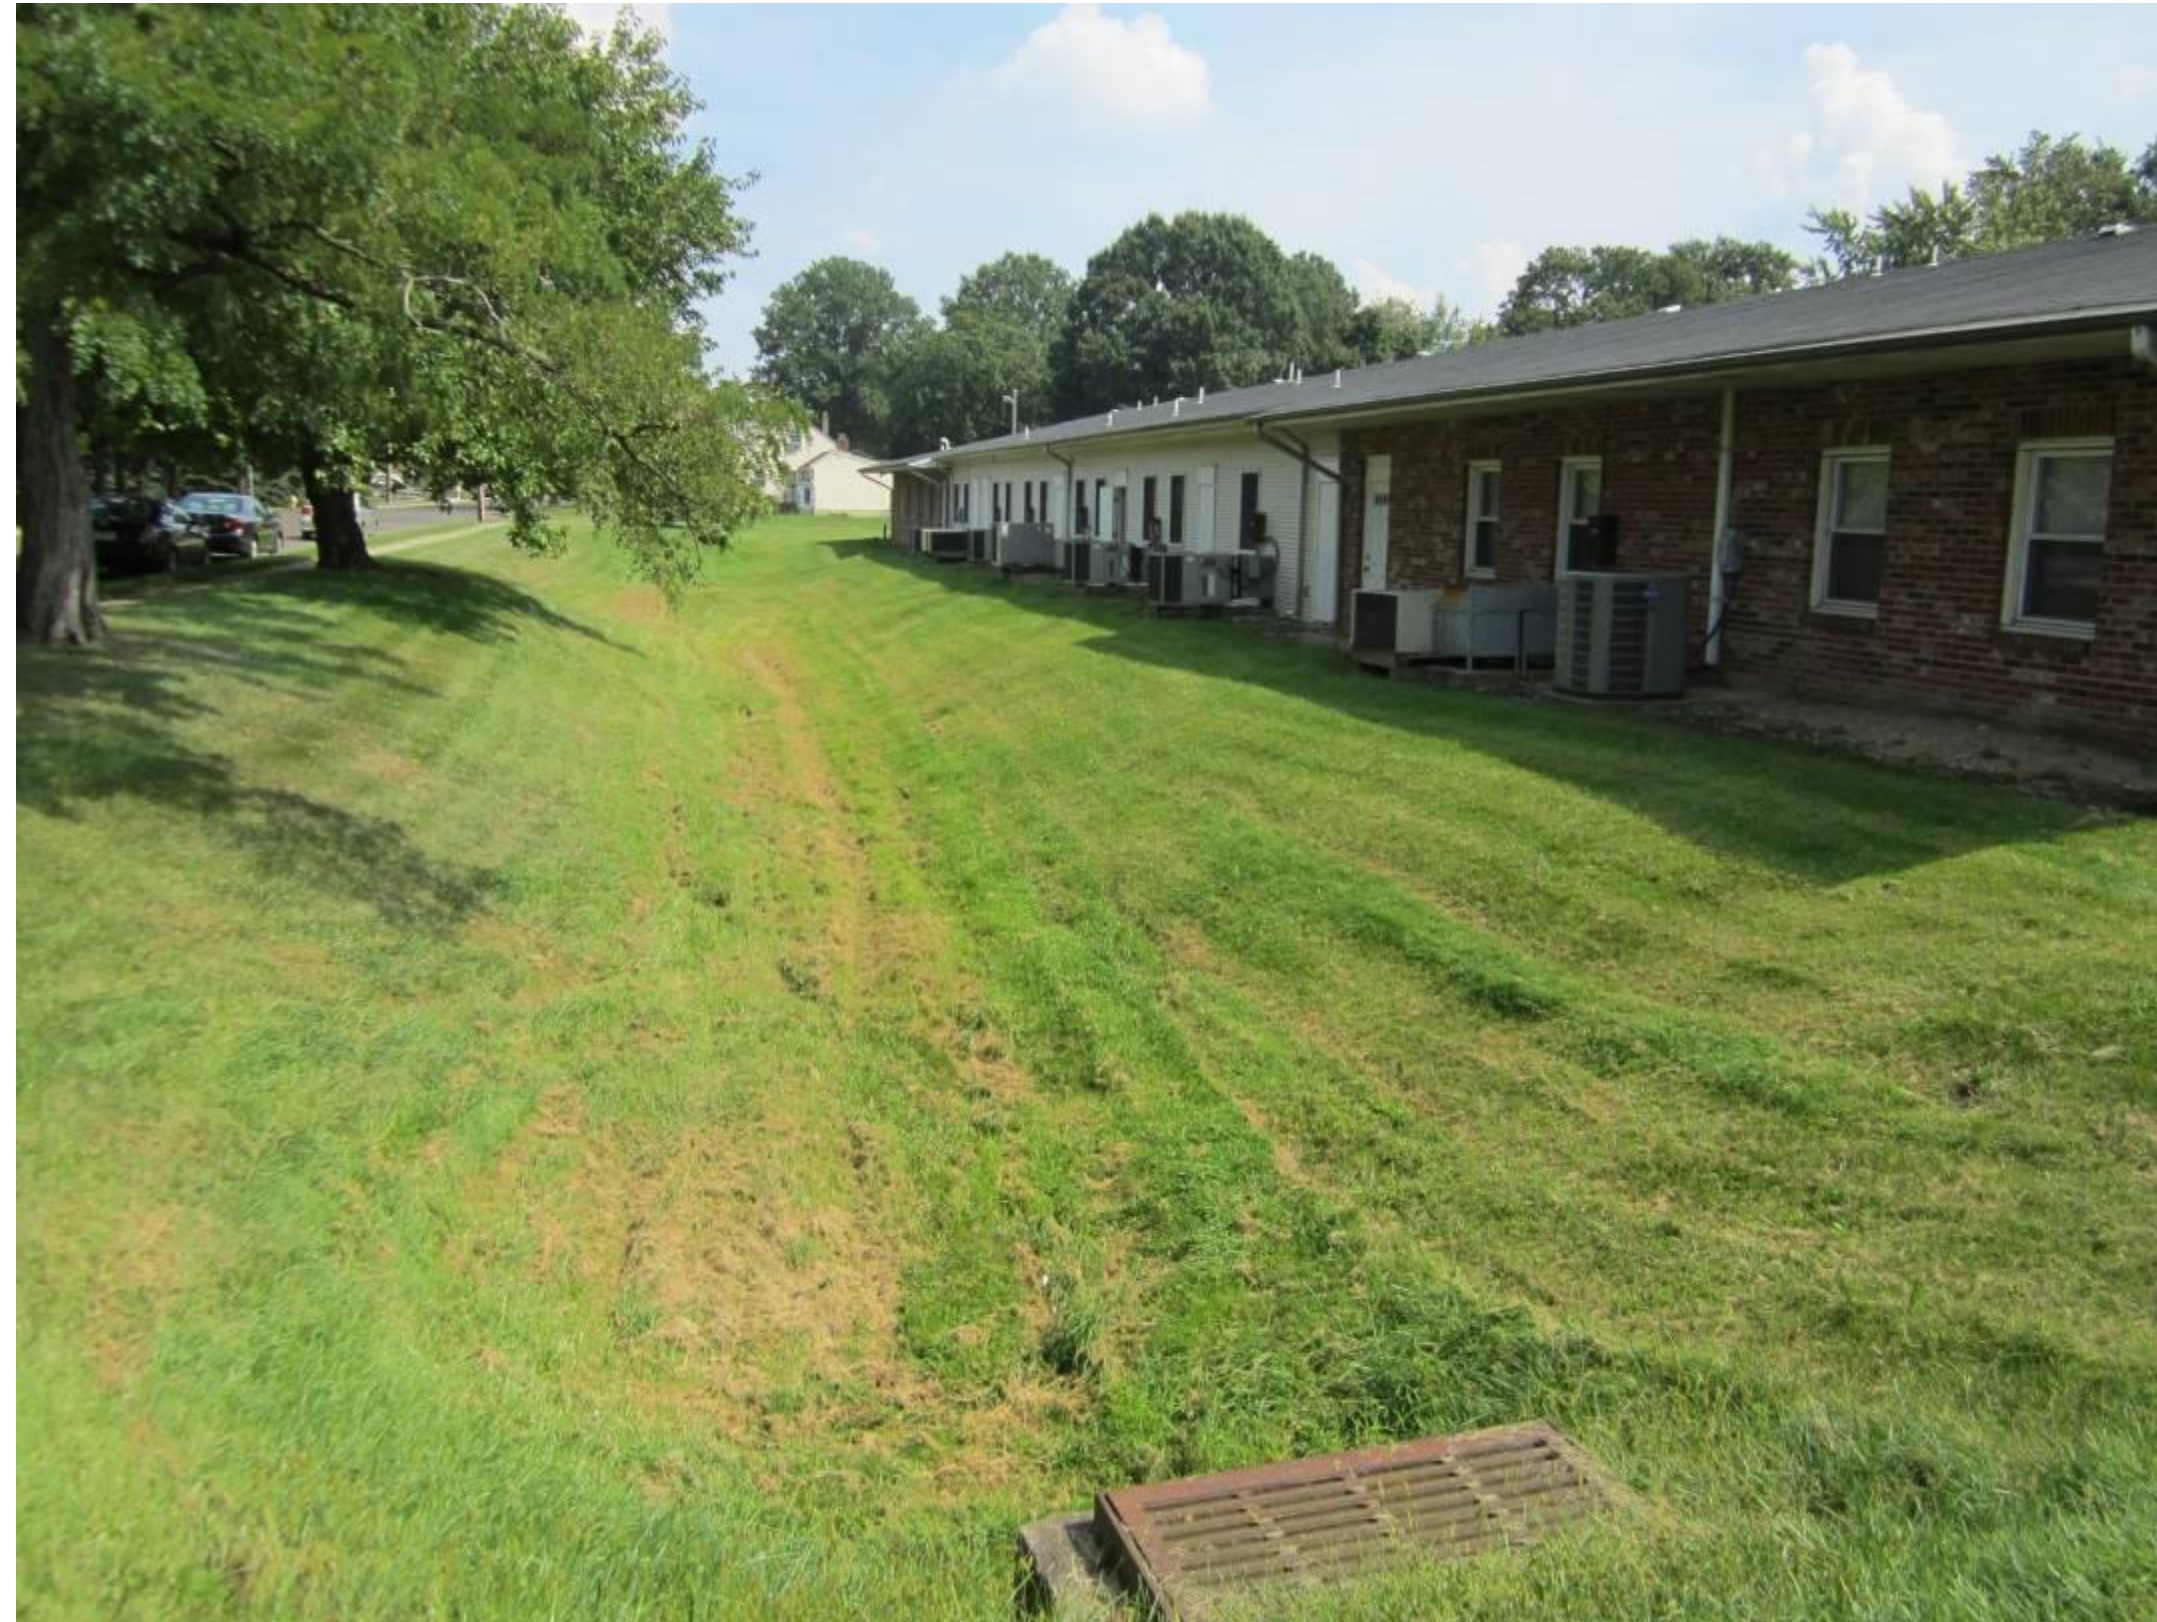
Eastern basin bottom

- Sediment accumulation at inlet and outlet
- Exposed soil in basin bottom
- Outlet has structural damage

- Basin has 2 inlets, some erosion appears to be caused by them
- Naturalize with herbaceous plants and add stone near inlets to control erosion

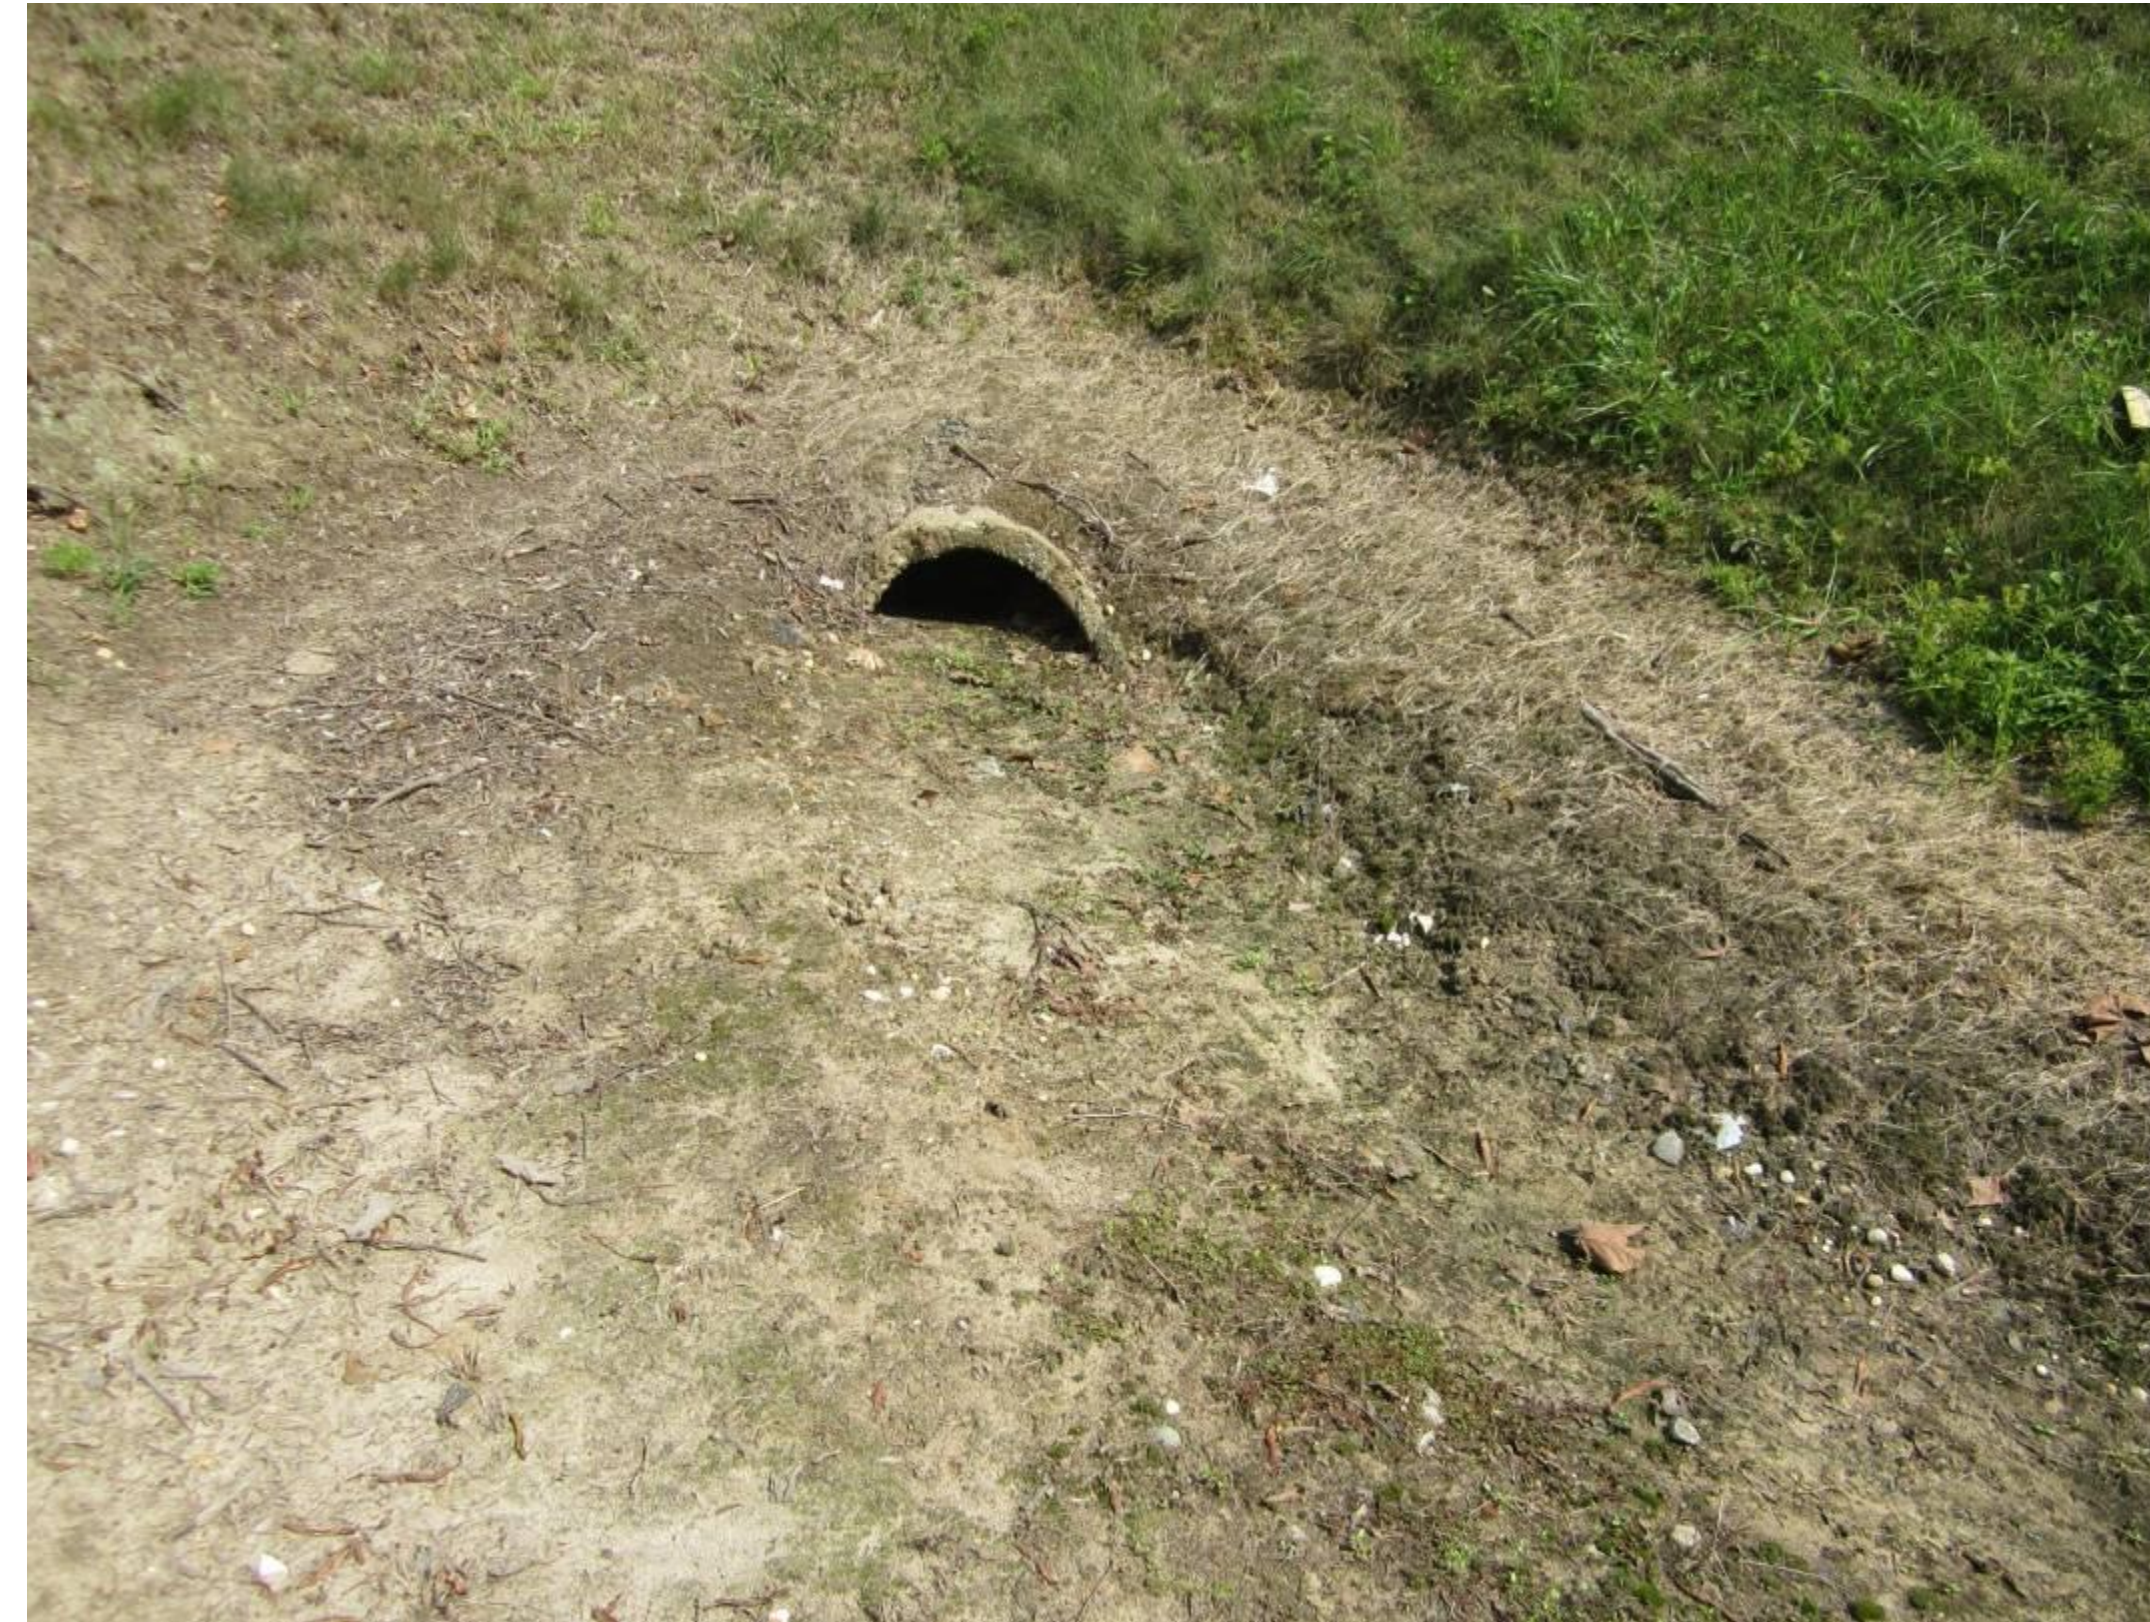
Clogged inlet

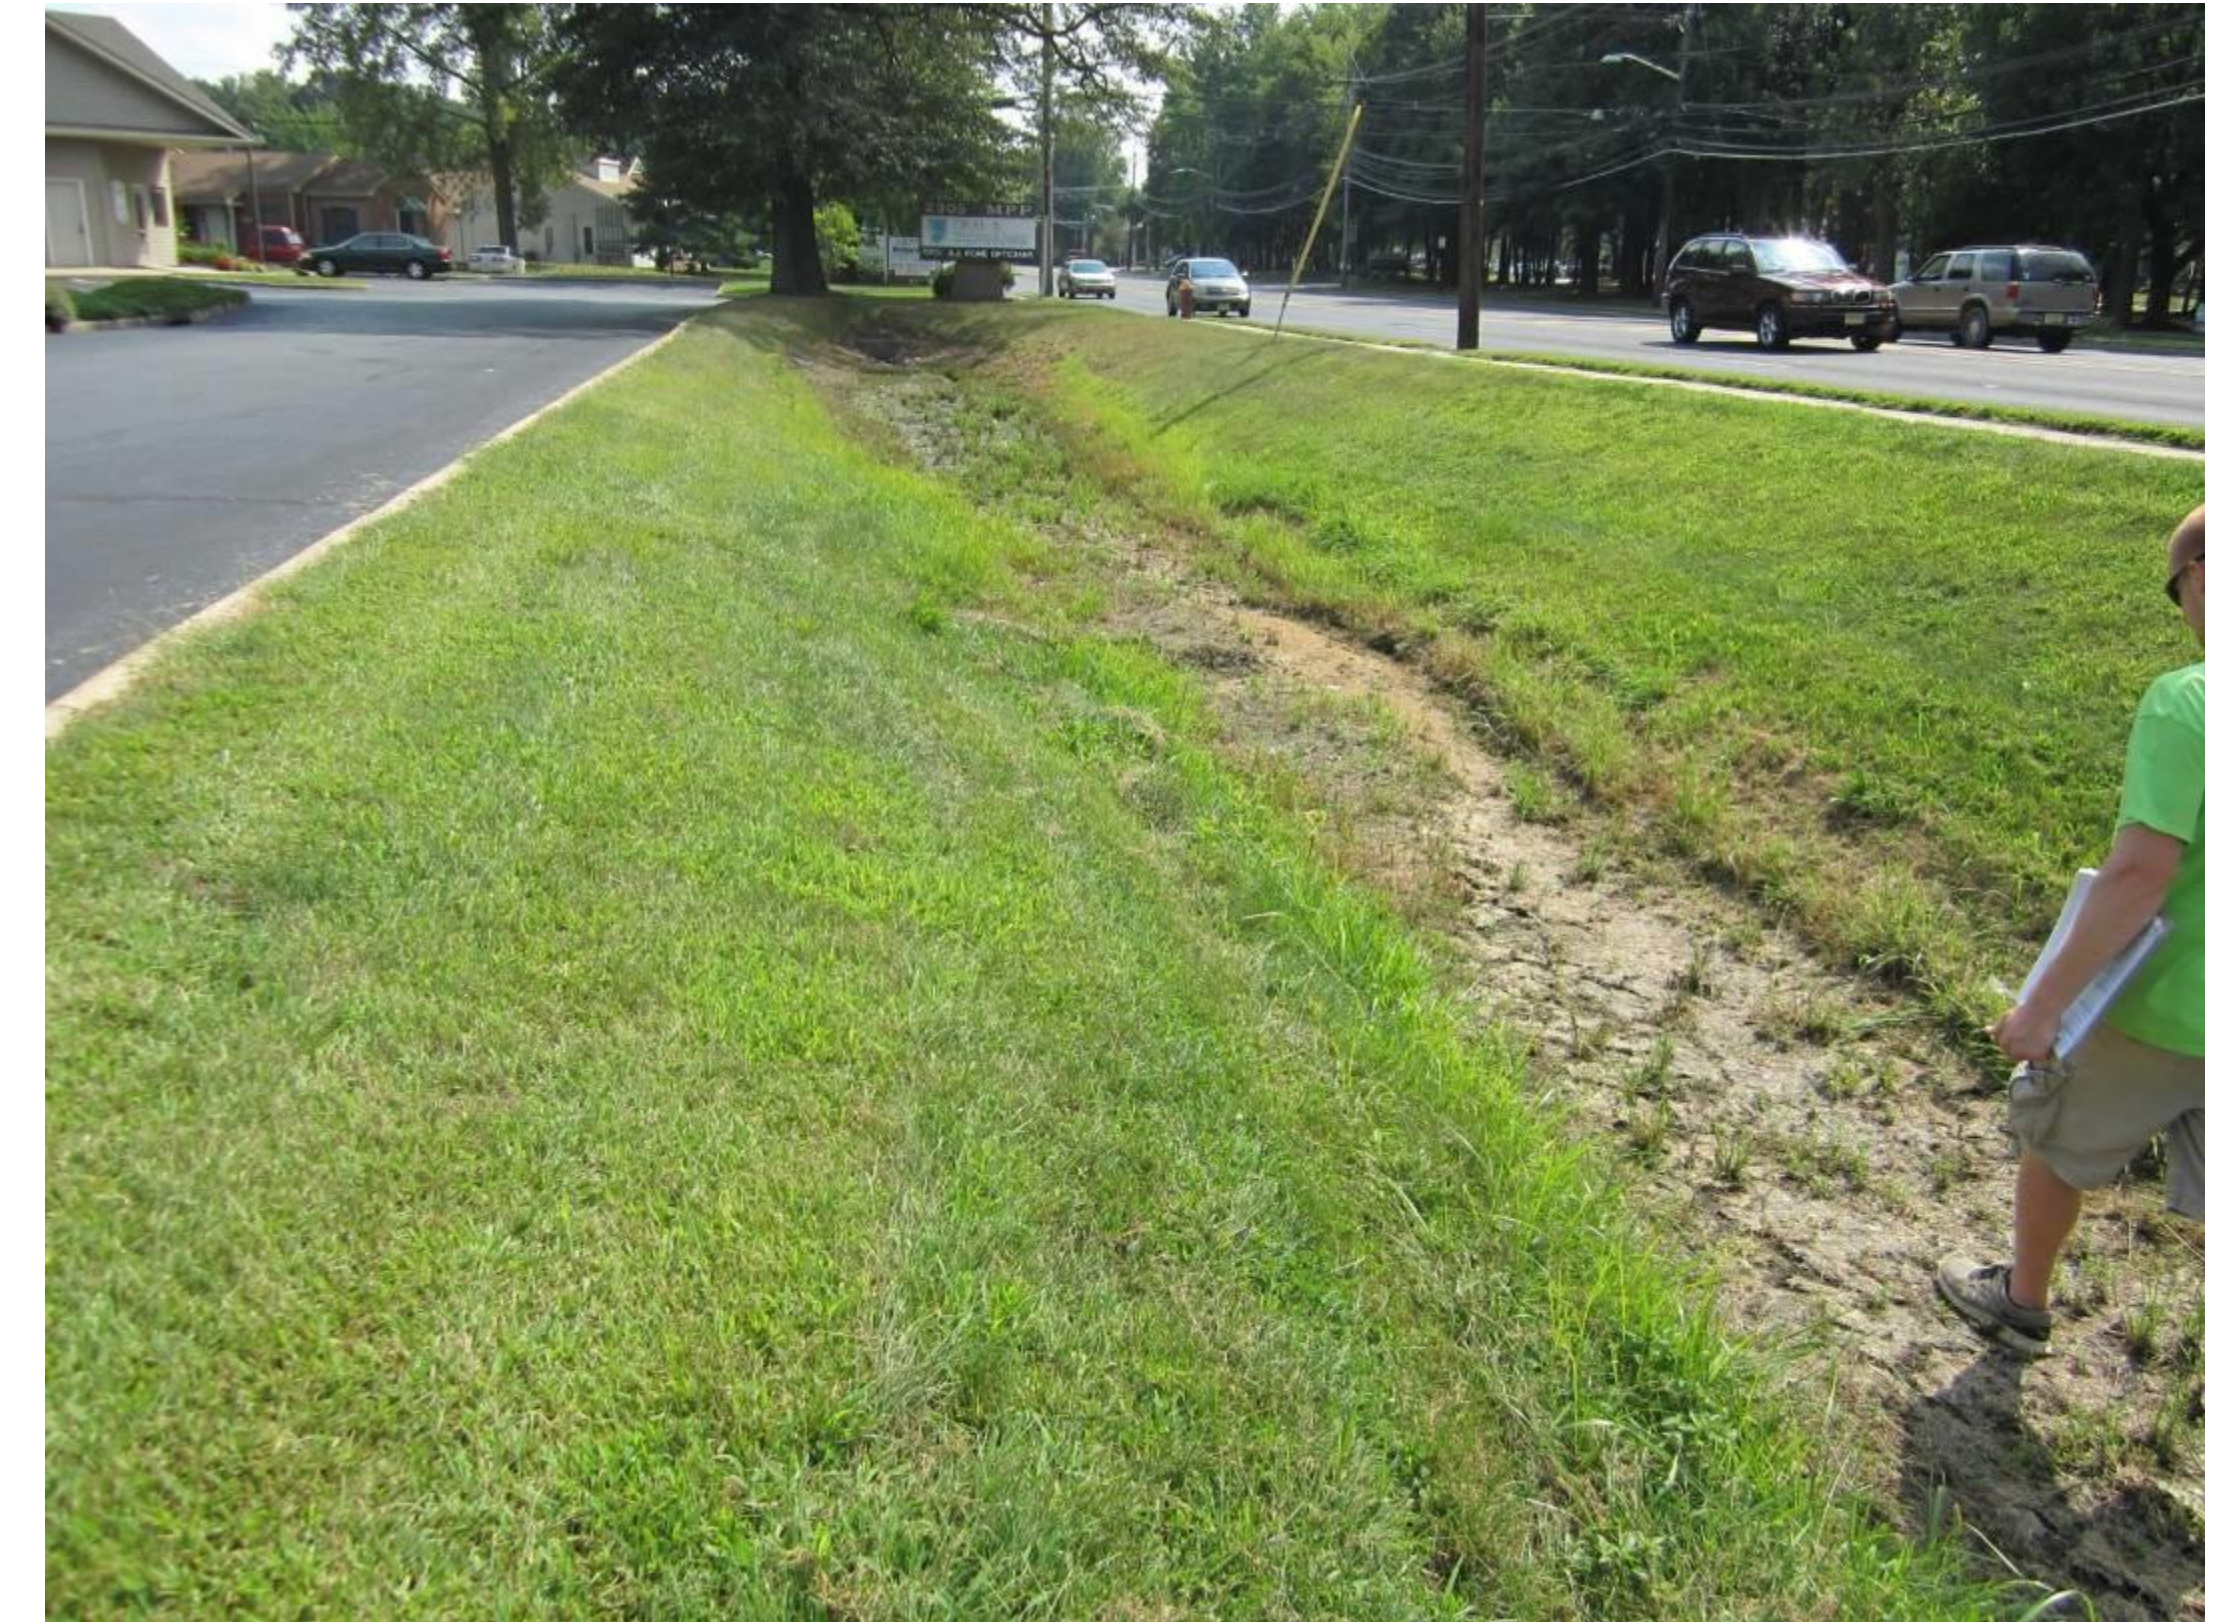
Western basin bottom

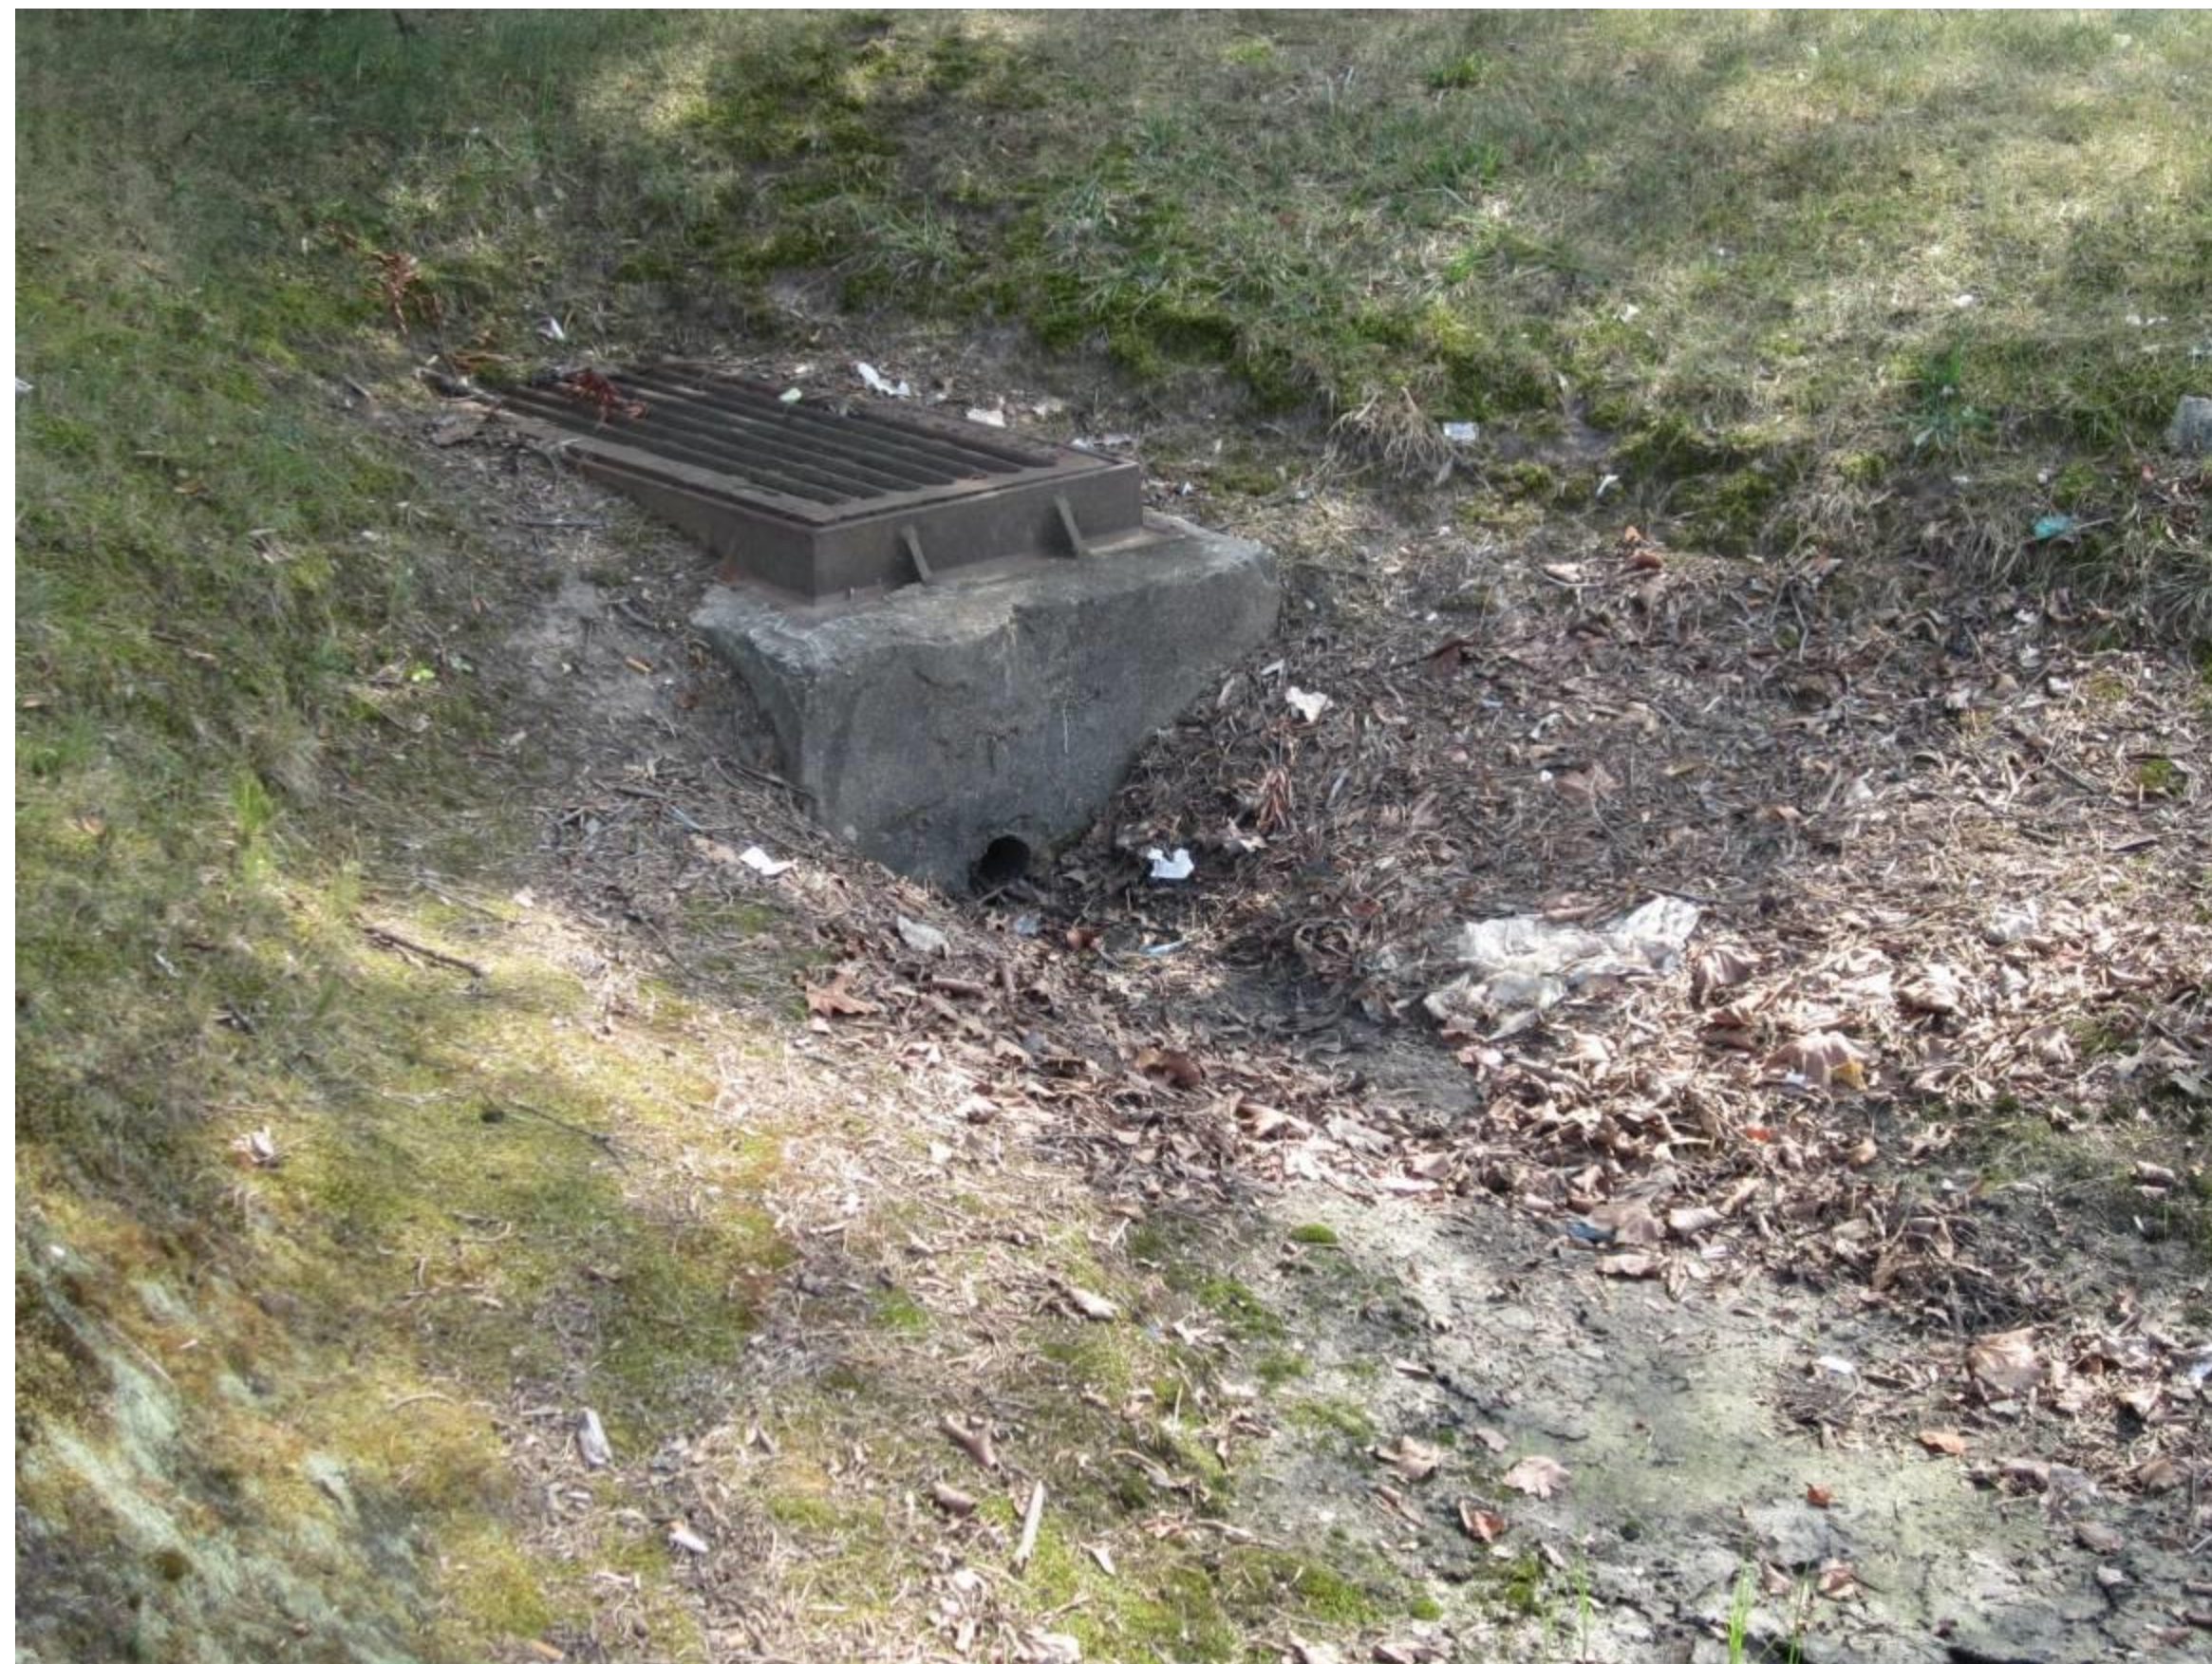
Outlet
