**Hamilton Township (Mercer County)
Stormwater Basin Assessment Summary
Past Priority Addendum (Year 5B)**

Developed by the Rutgers Cooperative Extension Water Resources Program
Funded by Hamilton Township, Mercer County, New Jersey

November 27, 2019

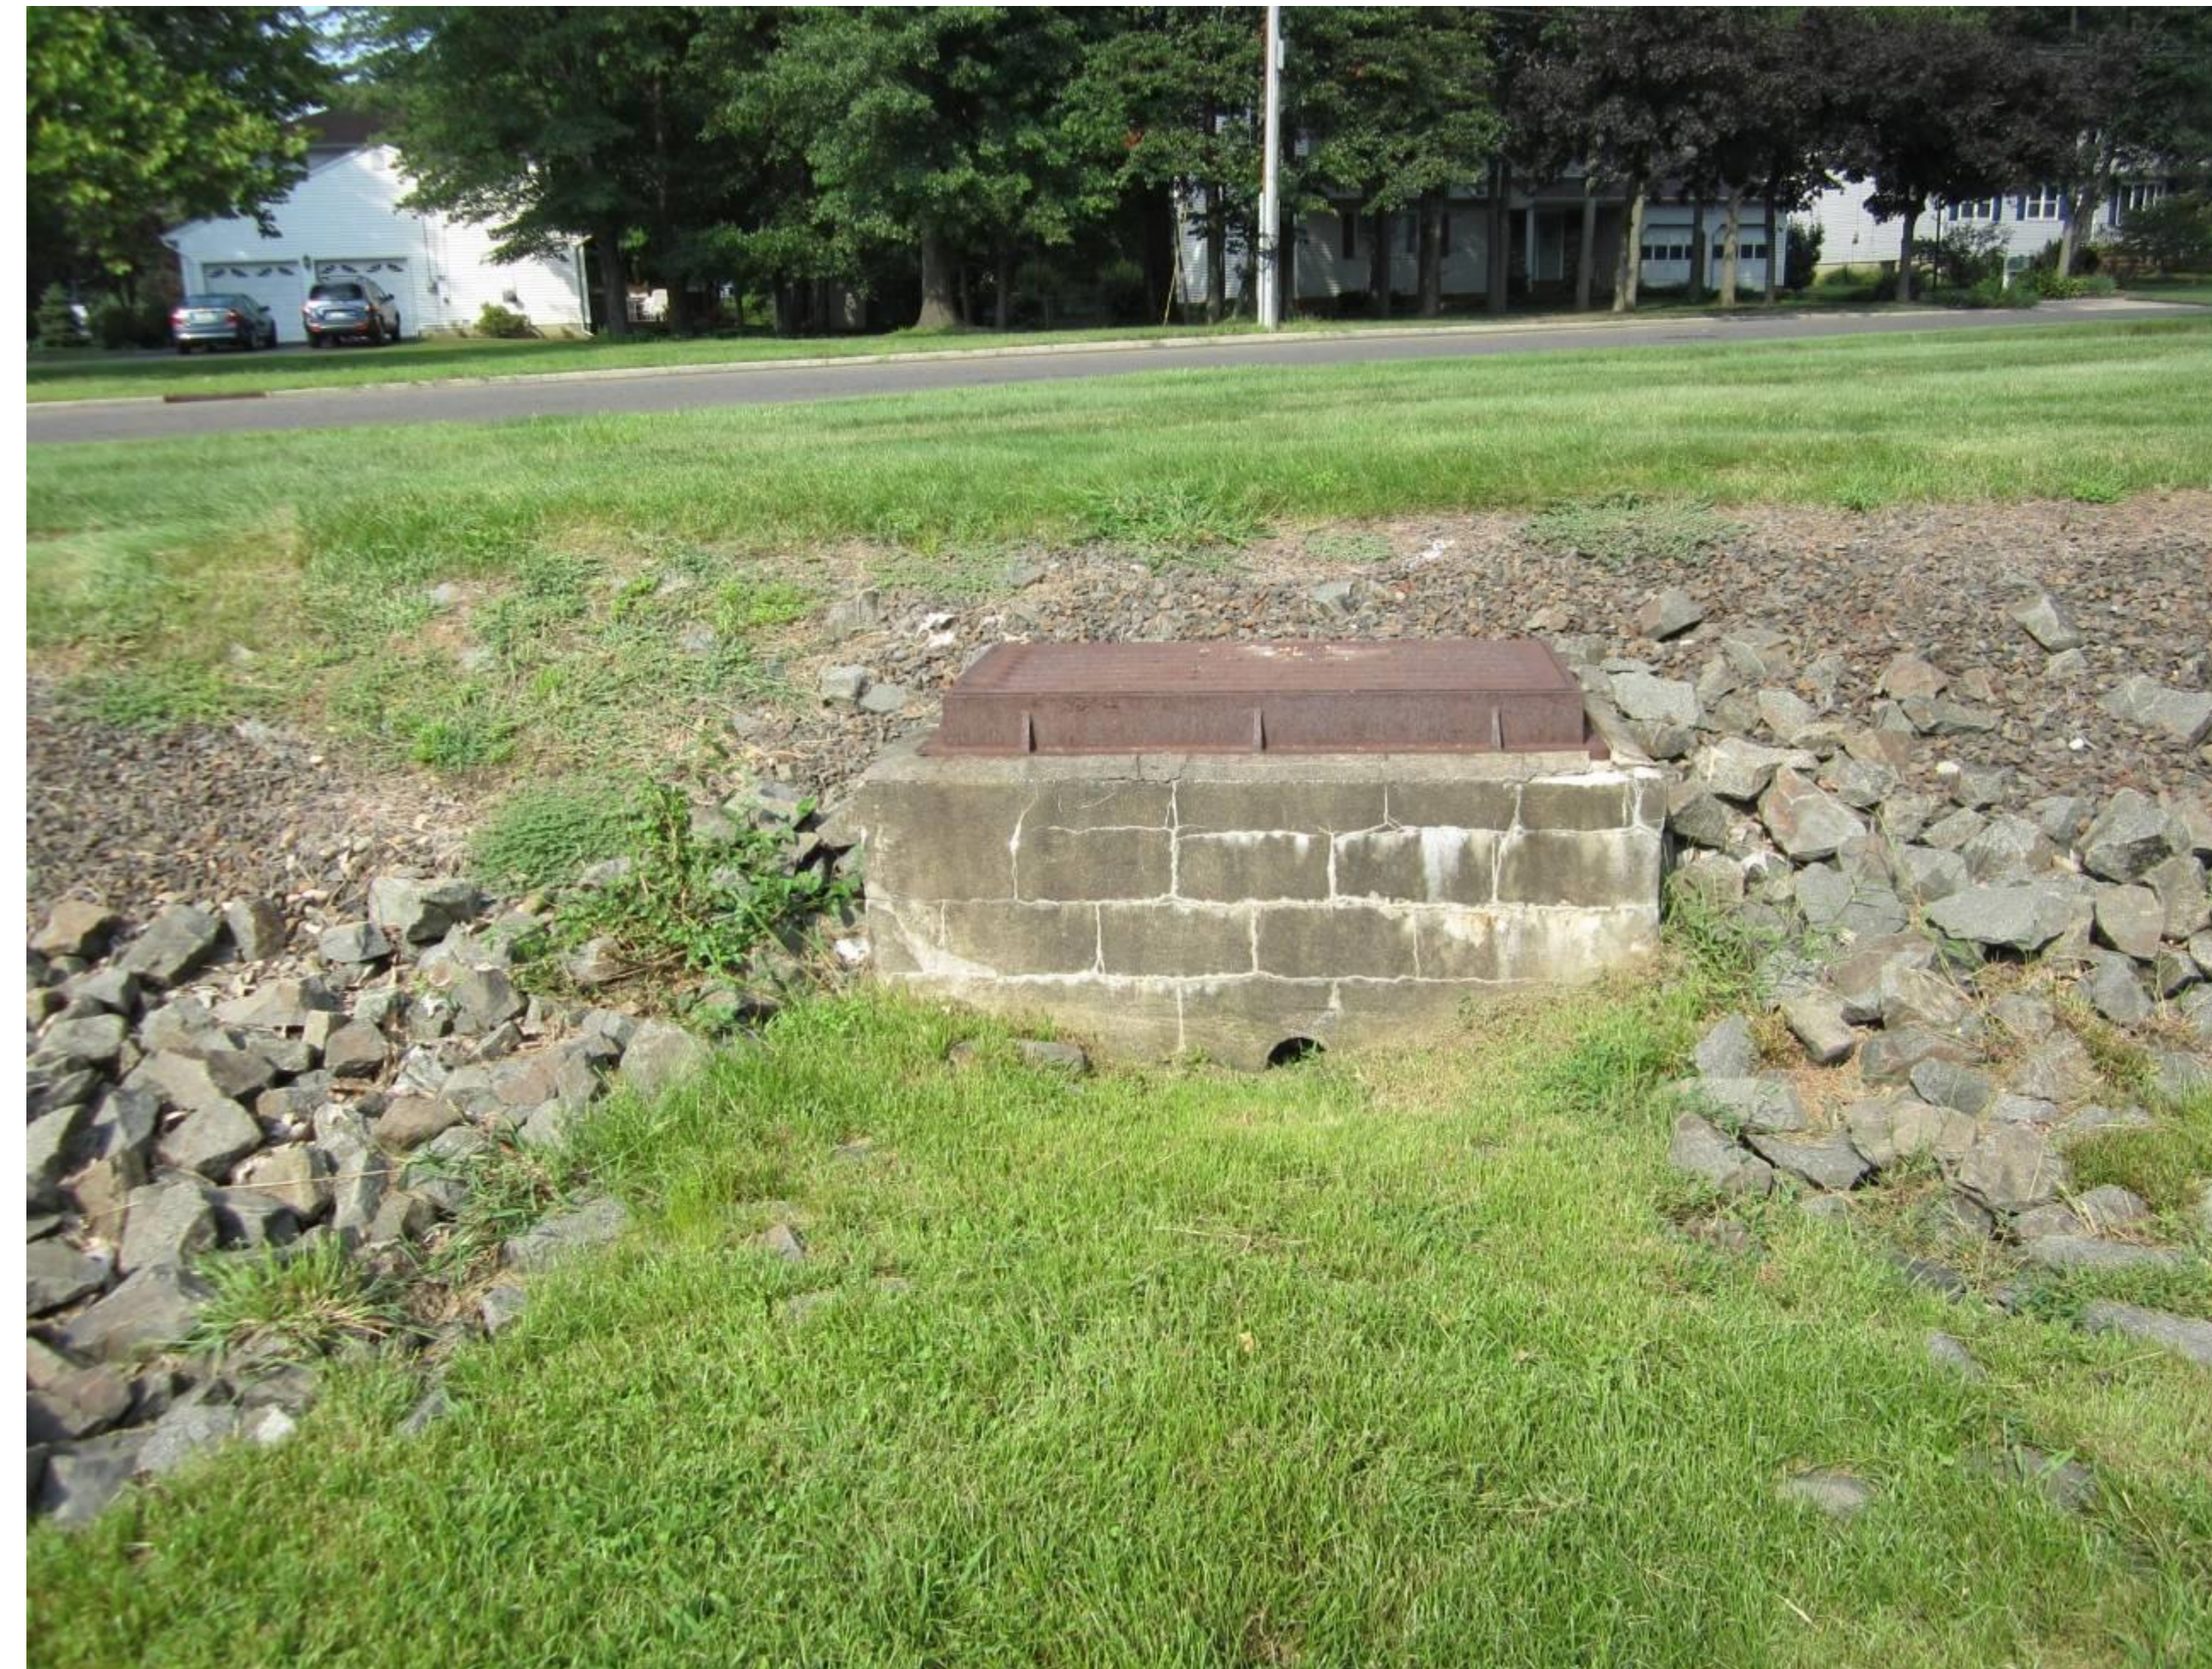
Outlet structure

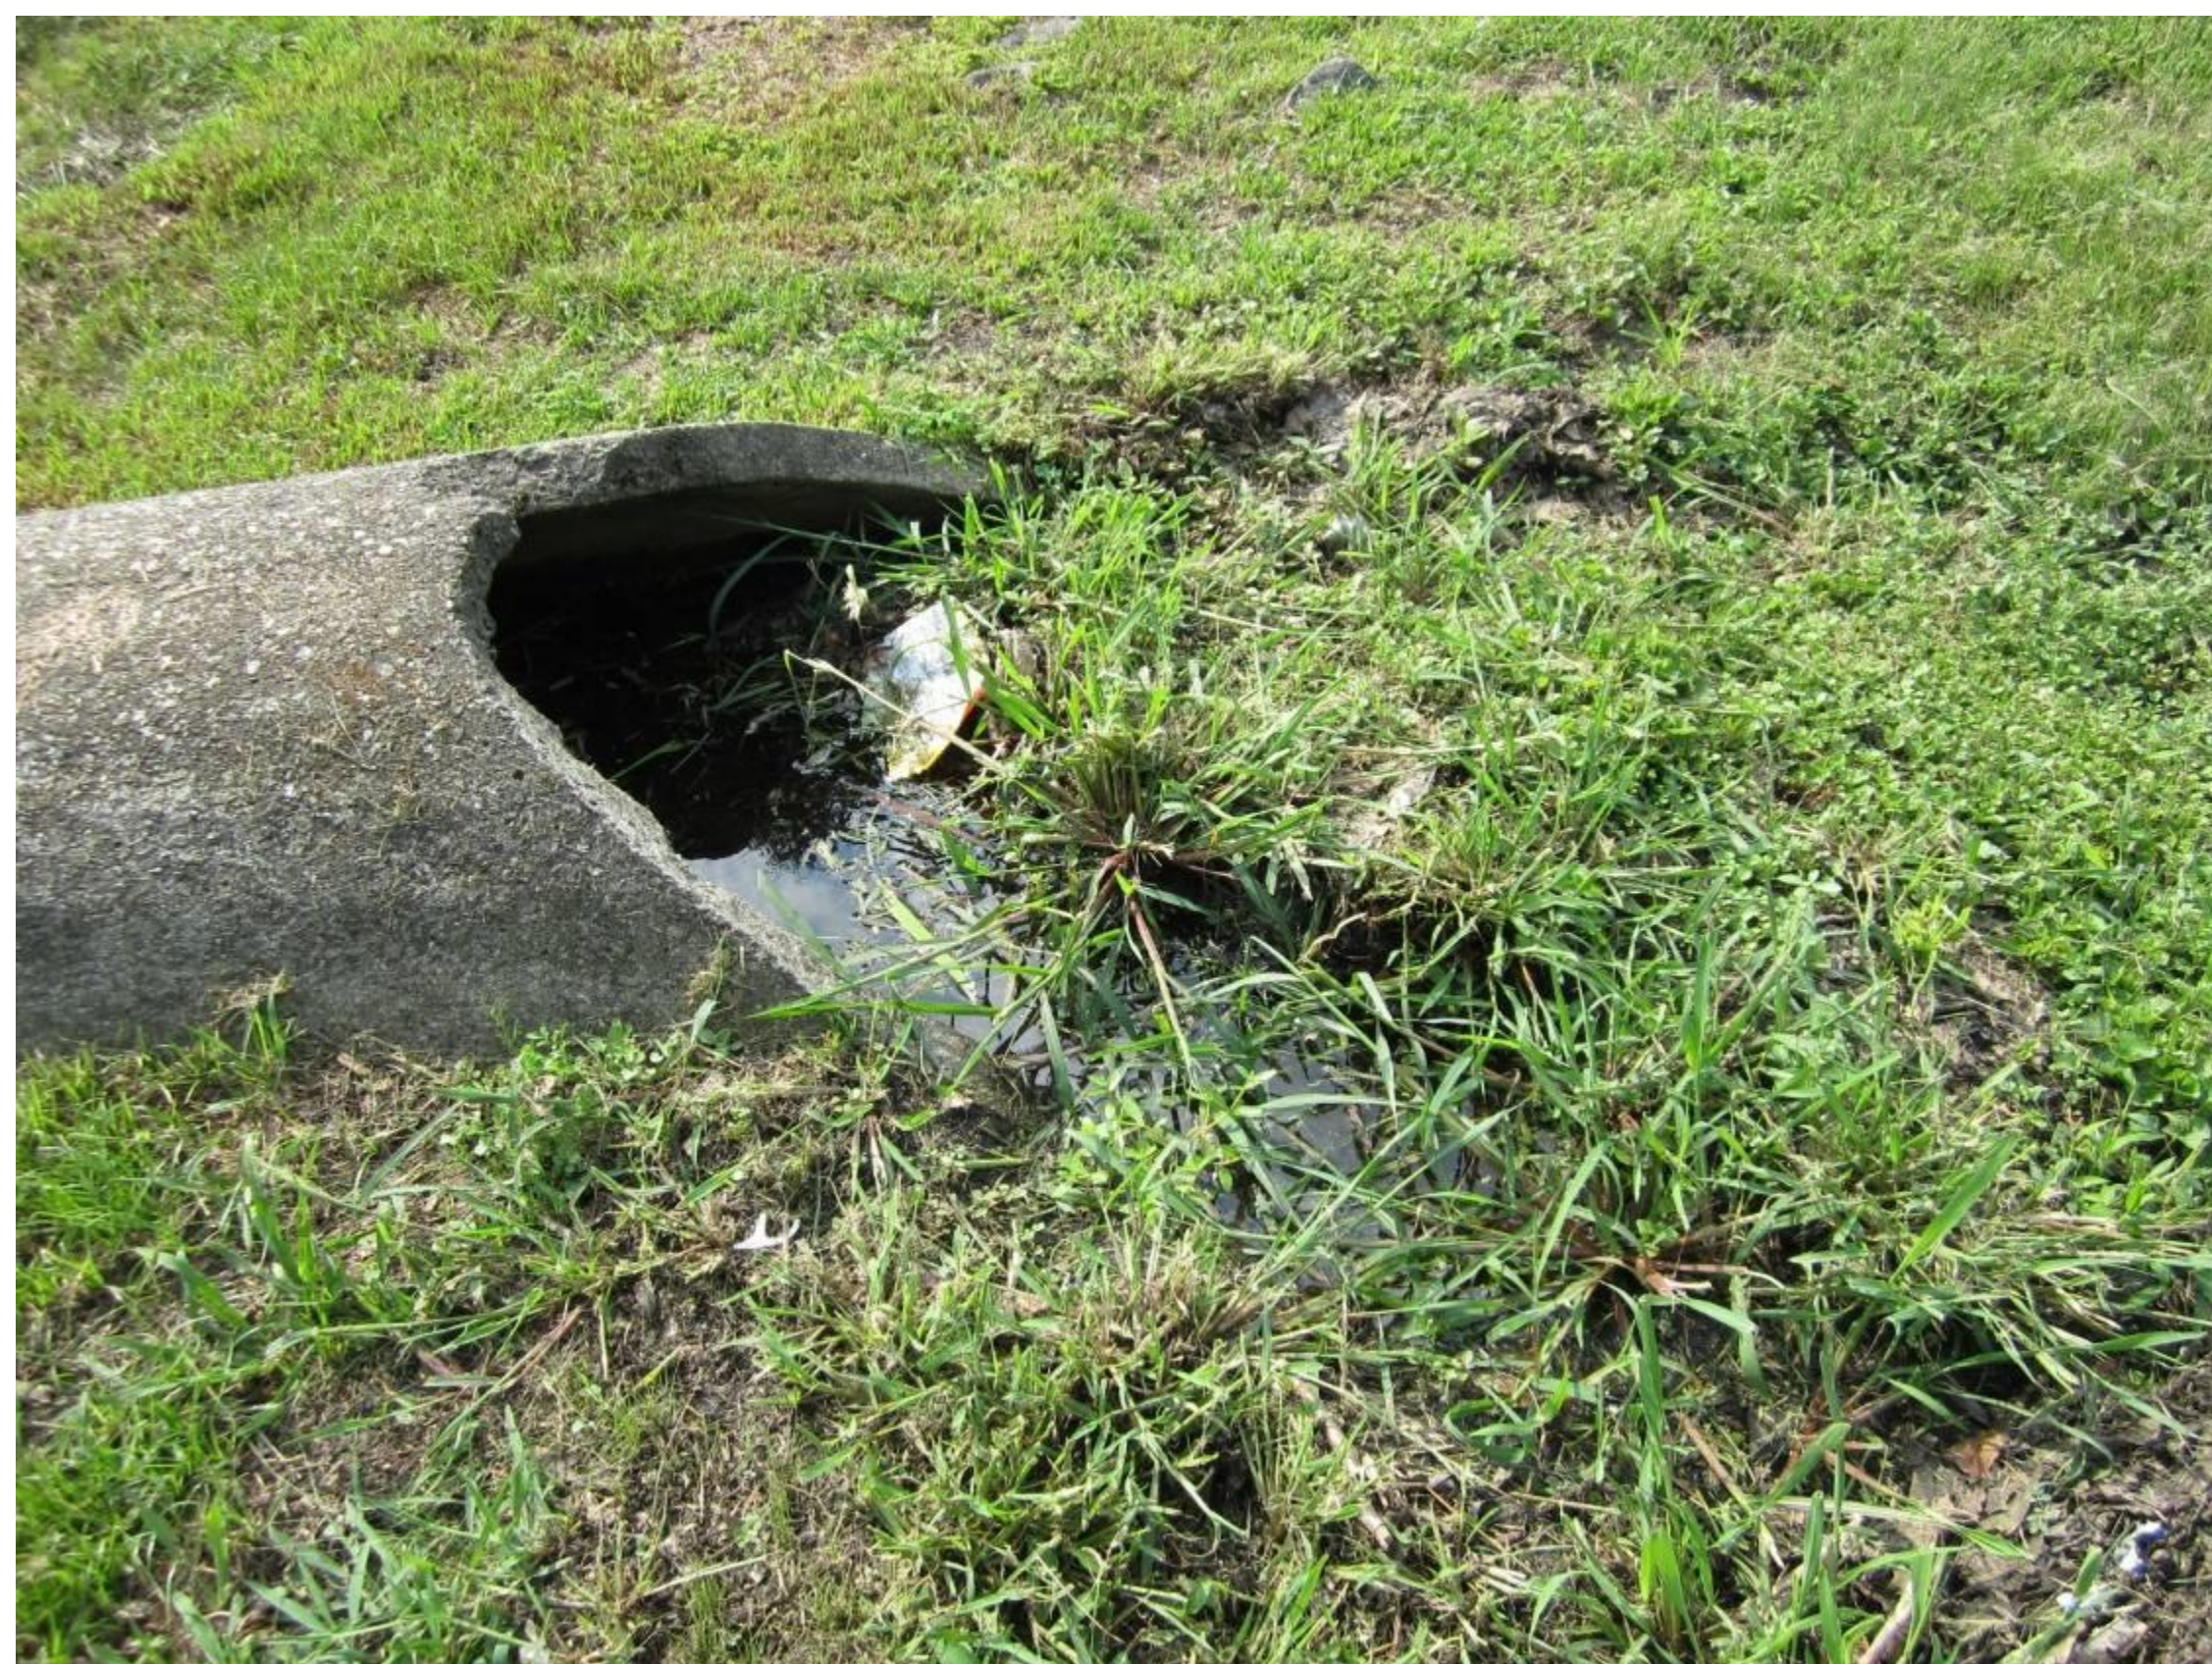
Inlet pipe

- Standing water in inlet
- Accumulation of litter, sediment and debris AT outlet, inlet and basin bottom
- Exposed soil in basin bottom
- Evidence of erosion in front of inlet
- Inlet shows evidence of deterioration

- Small basin with one inlet
- Inlet still appears damaged and may need repair
- Naturalize basin with herbaceous plants

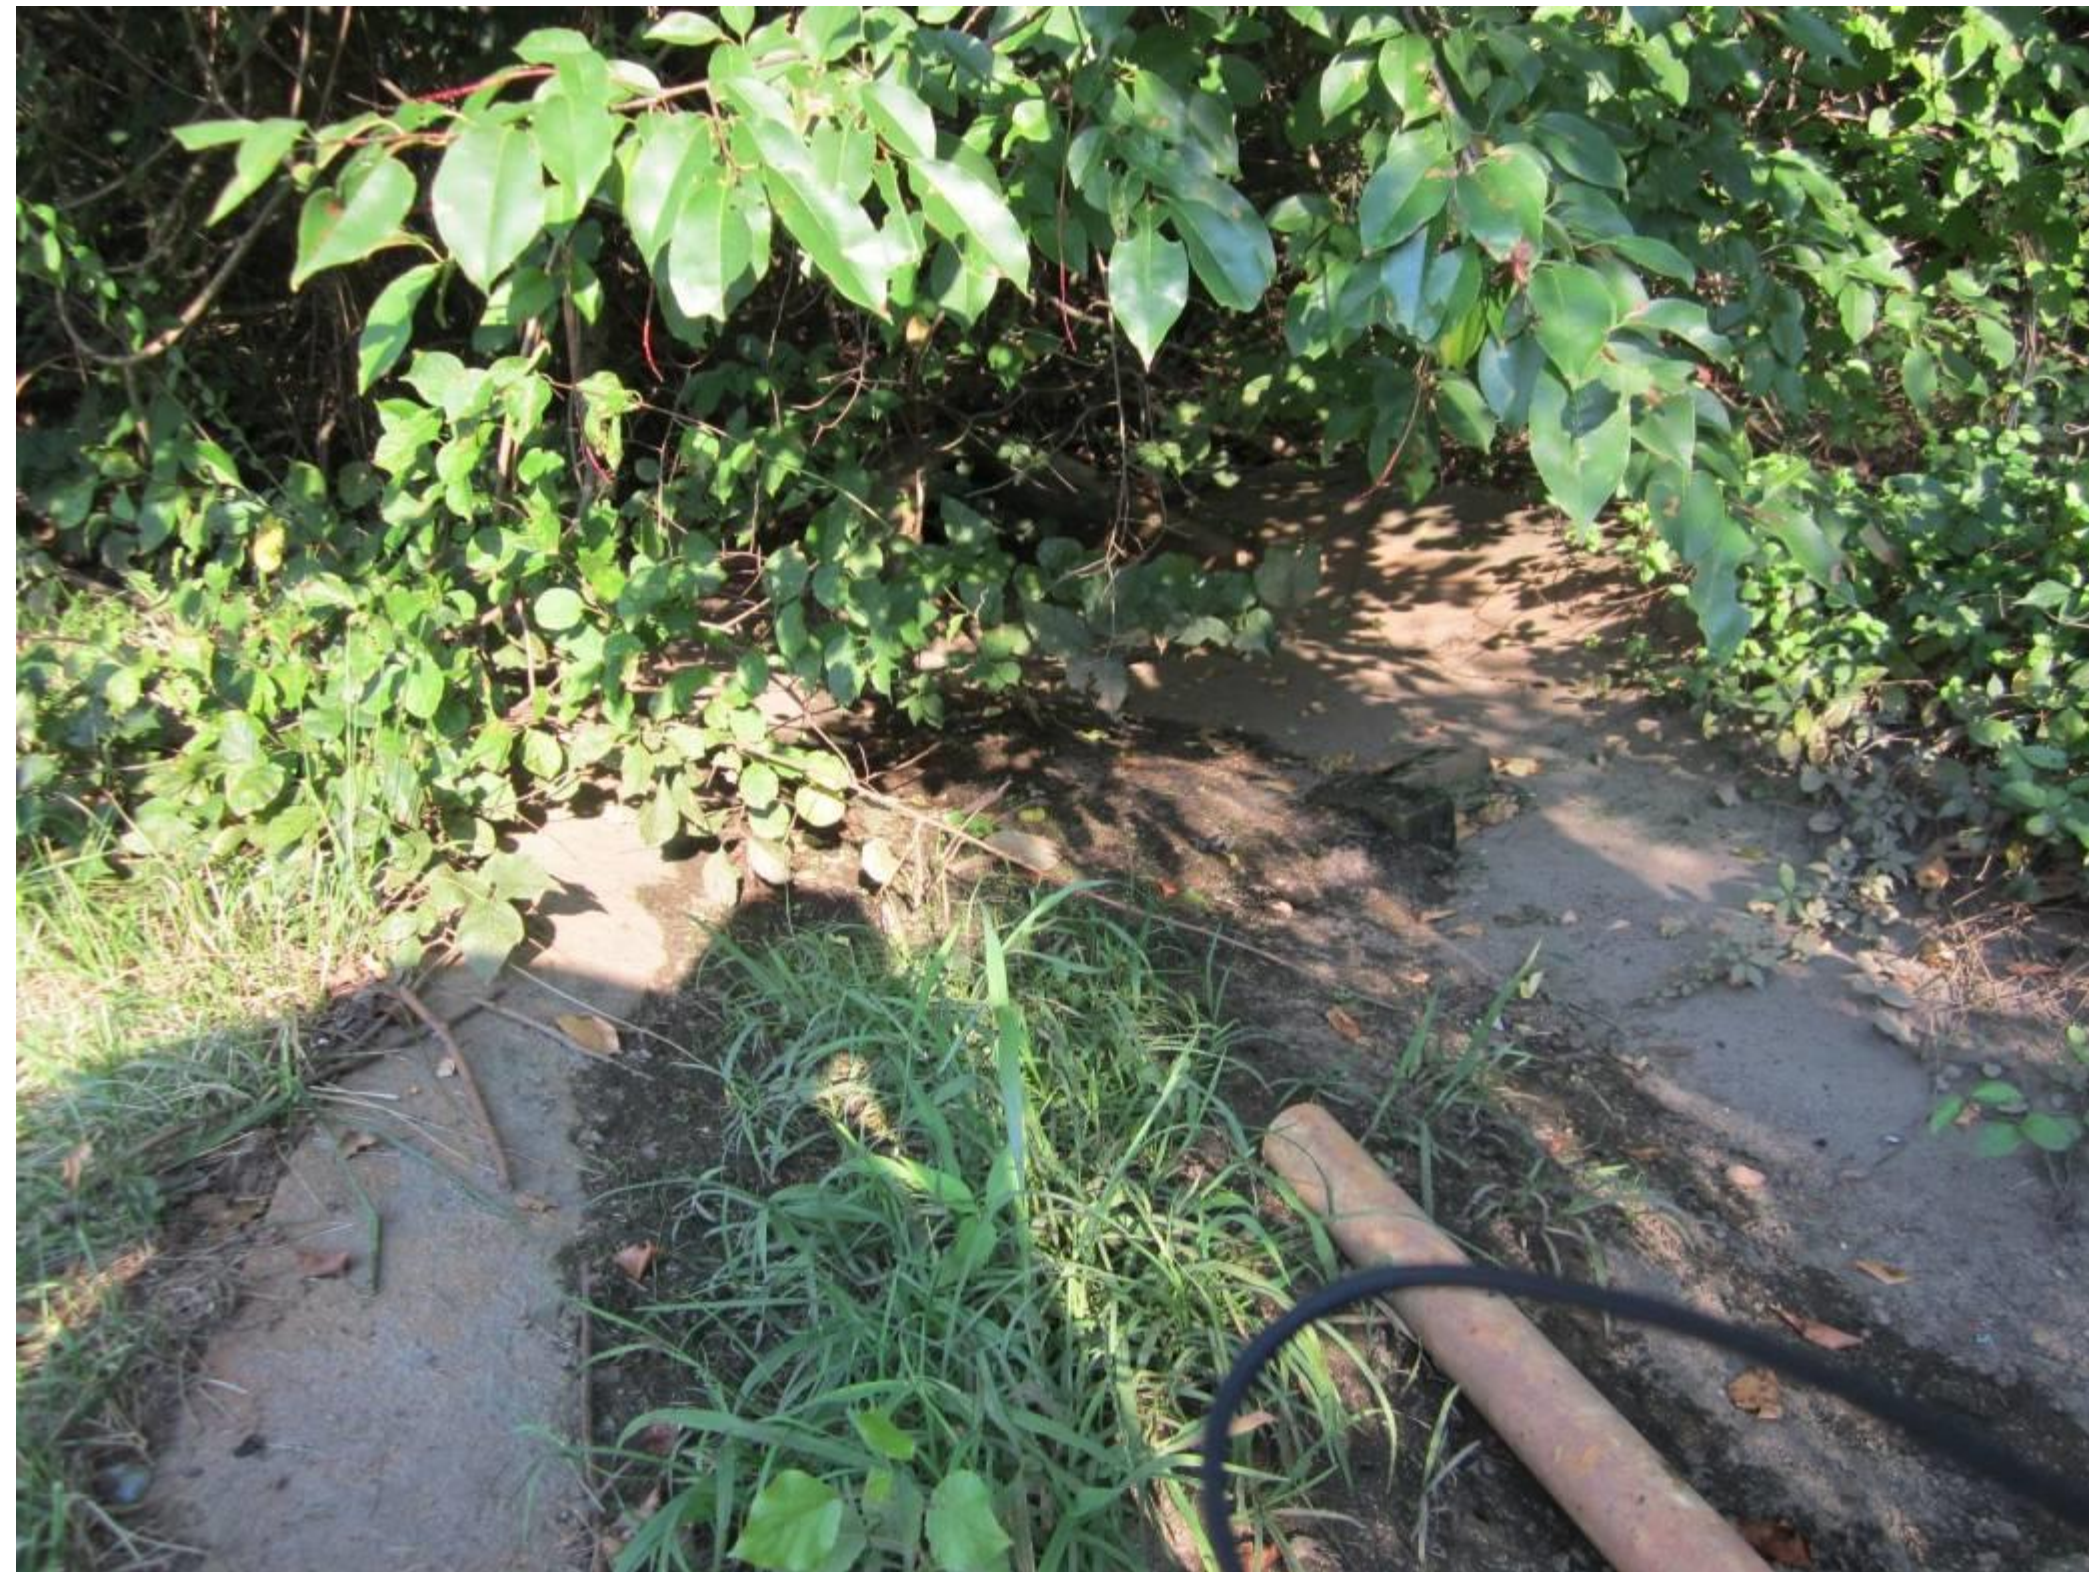
Inlet covered by plant growth

- Sediment, debris and litter accumulation at inlets and outlet
- Excess sediment accumulation and standing water in low flow channel with algae growth
- Northwestern basin embankment slumping/failing
- Evidence of deterioration at inlets
- Woody vegetation growth around outlet
- Basin outfall area shows evidence of erosion

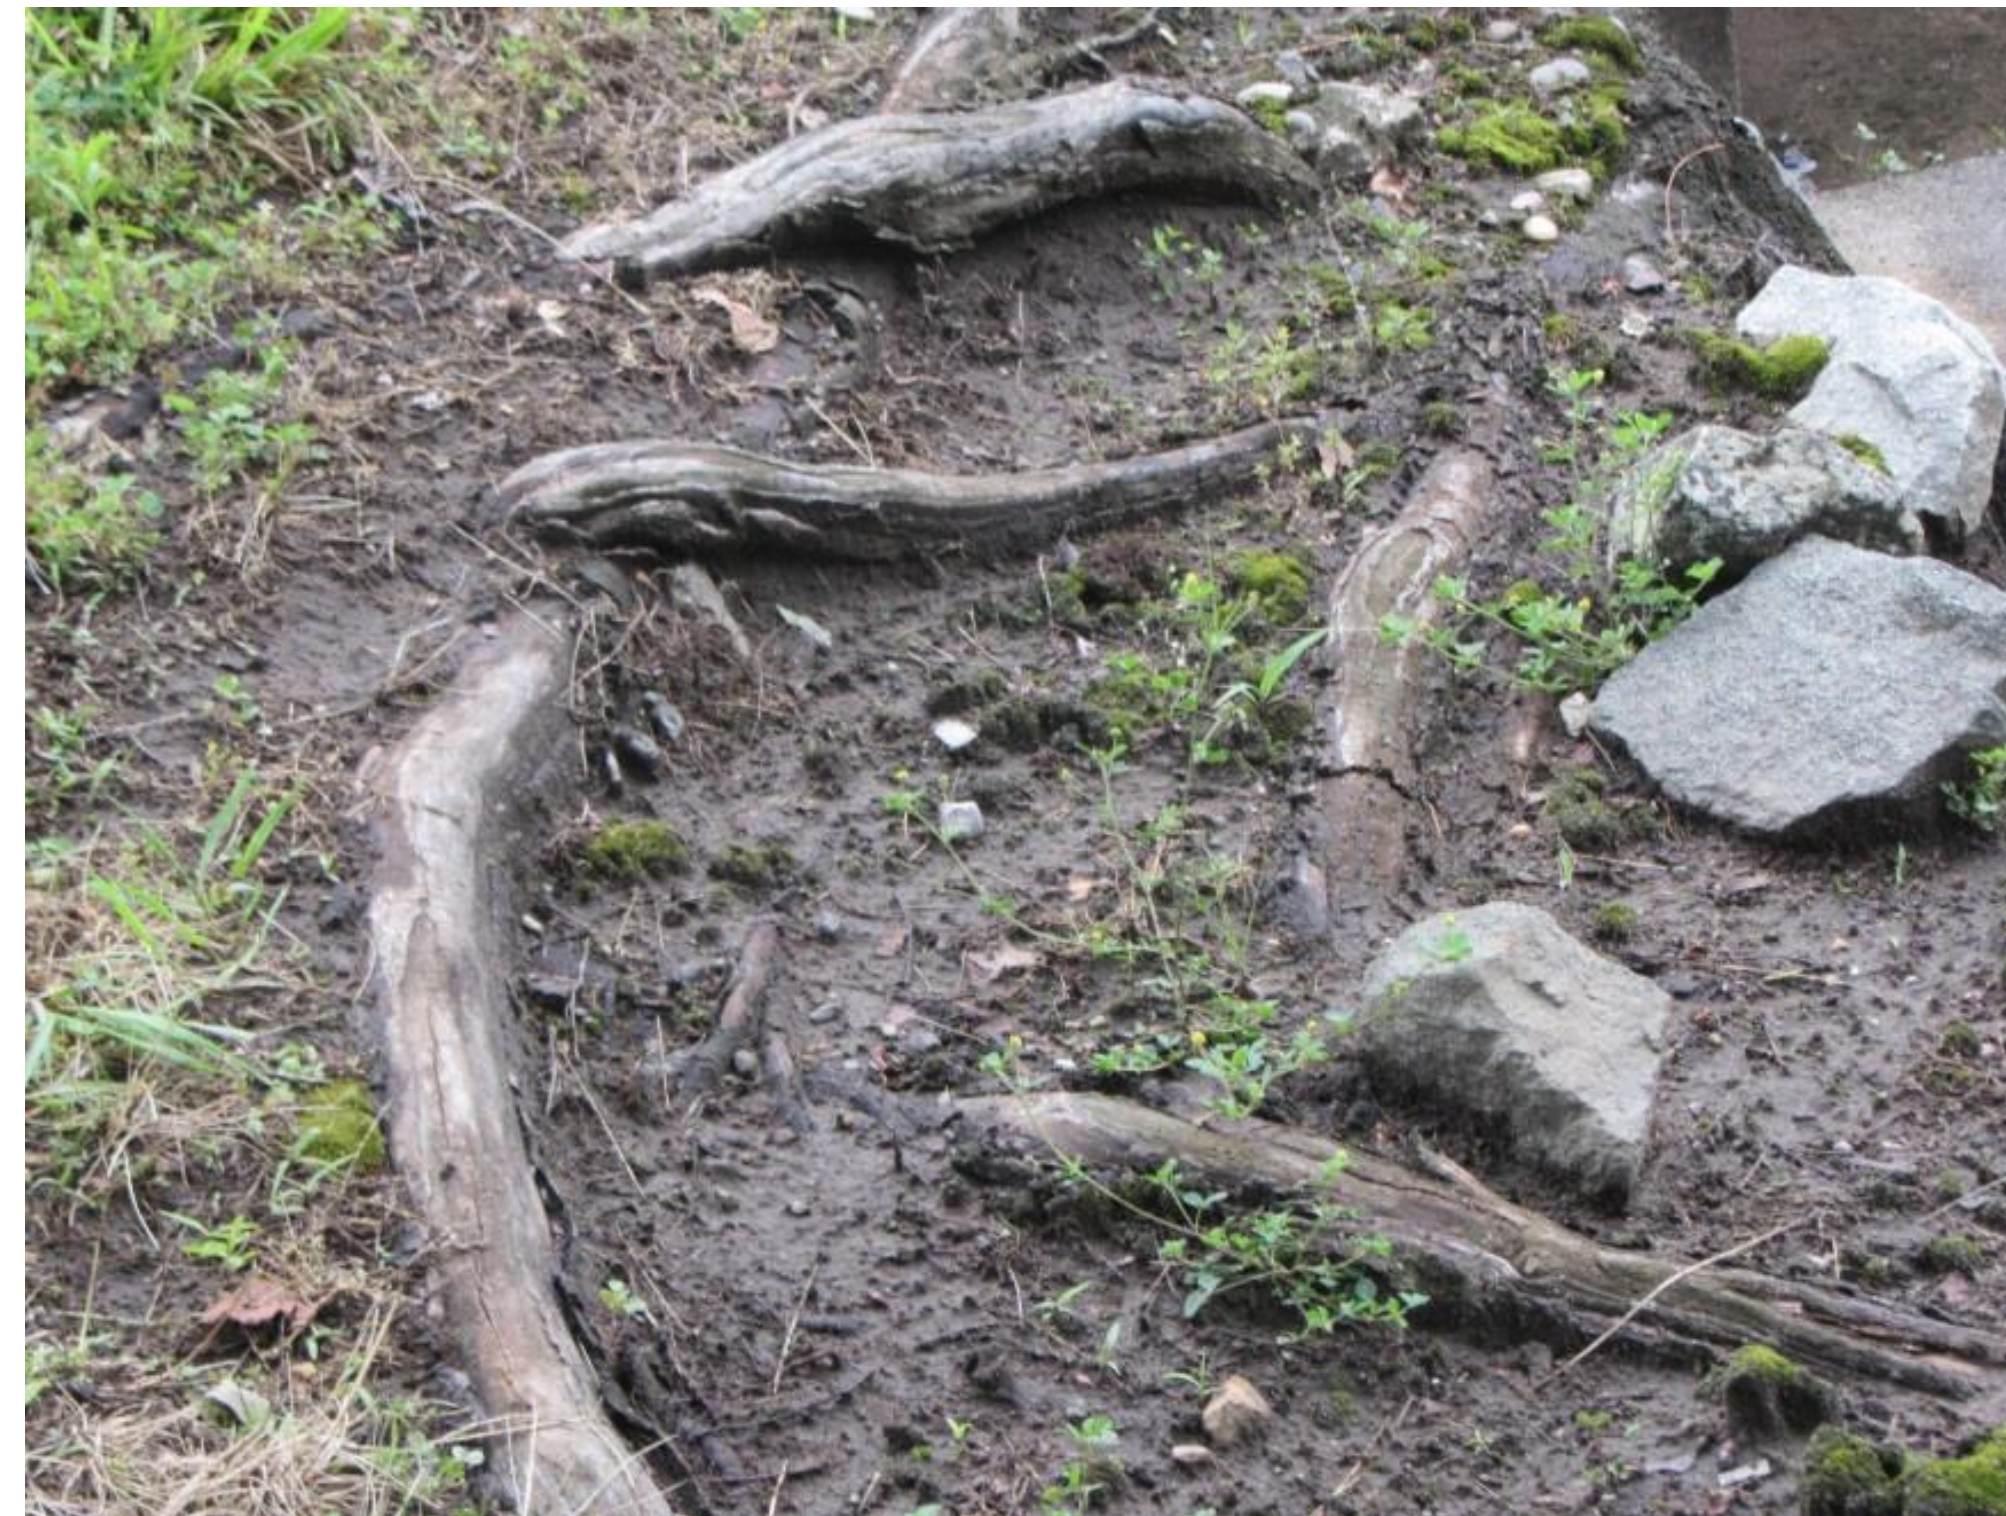
Exposed roots near eastern inlet

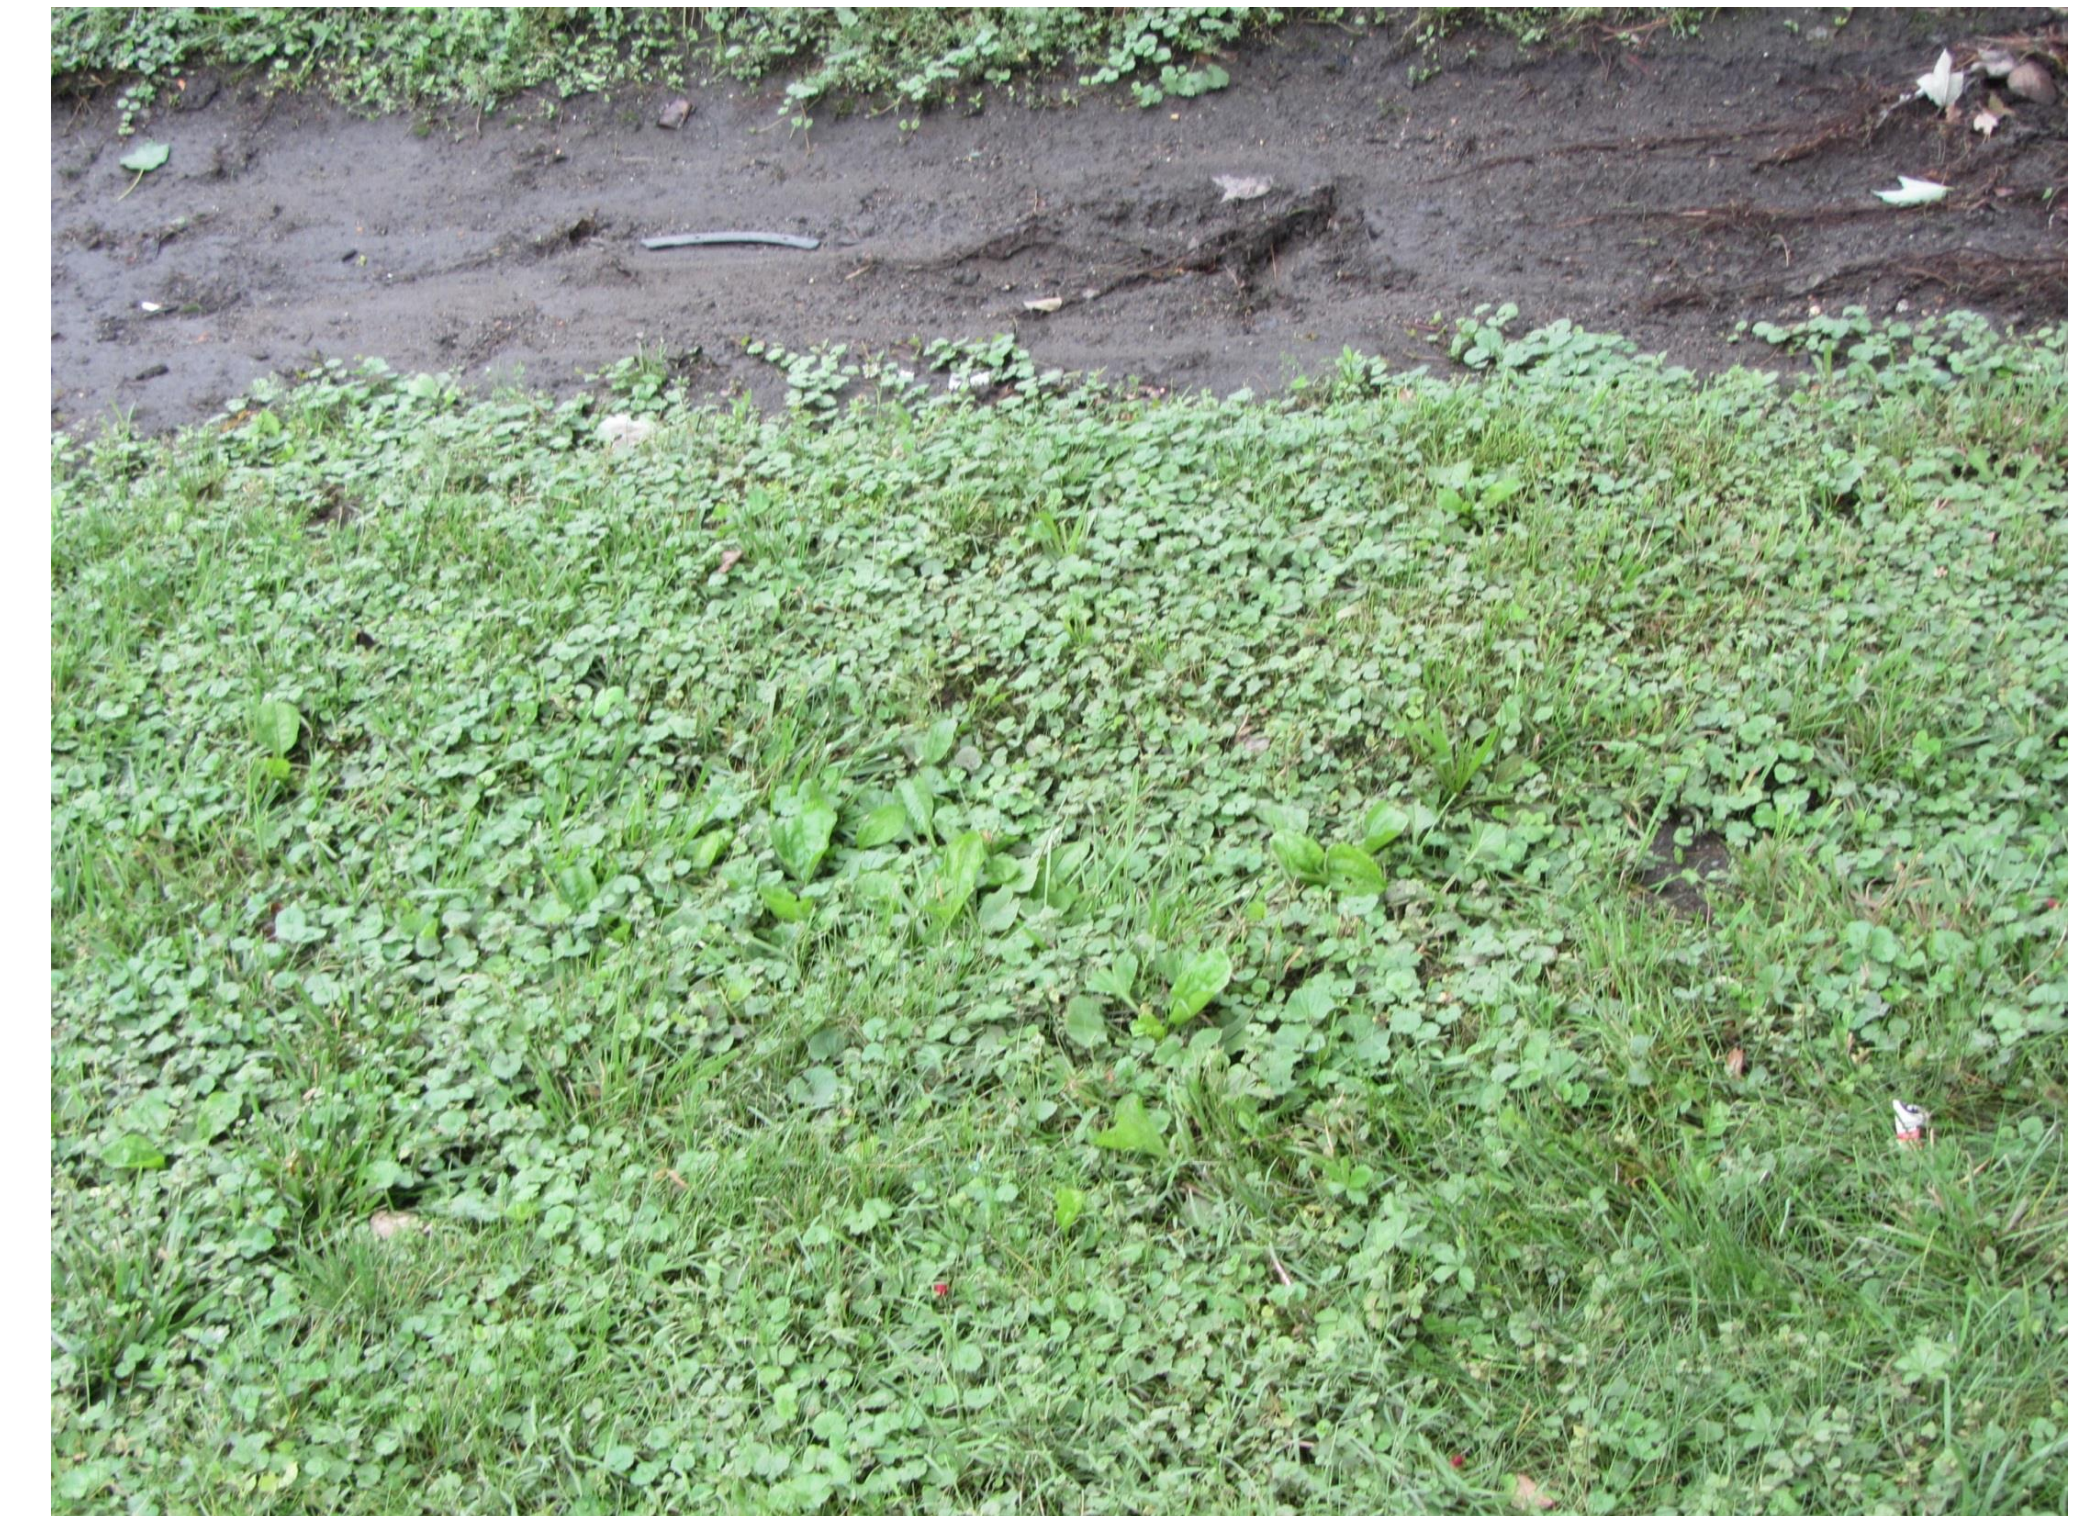
Invasive ground cover

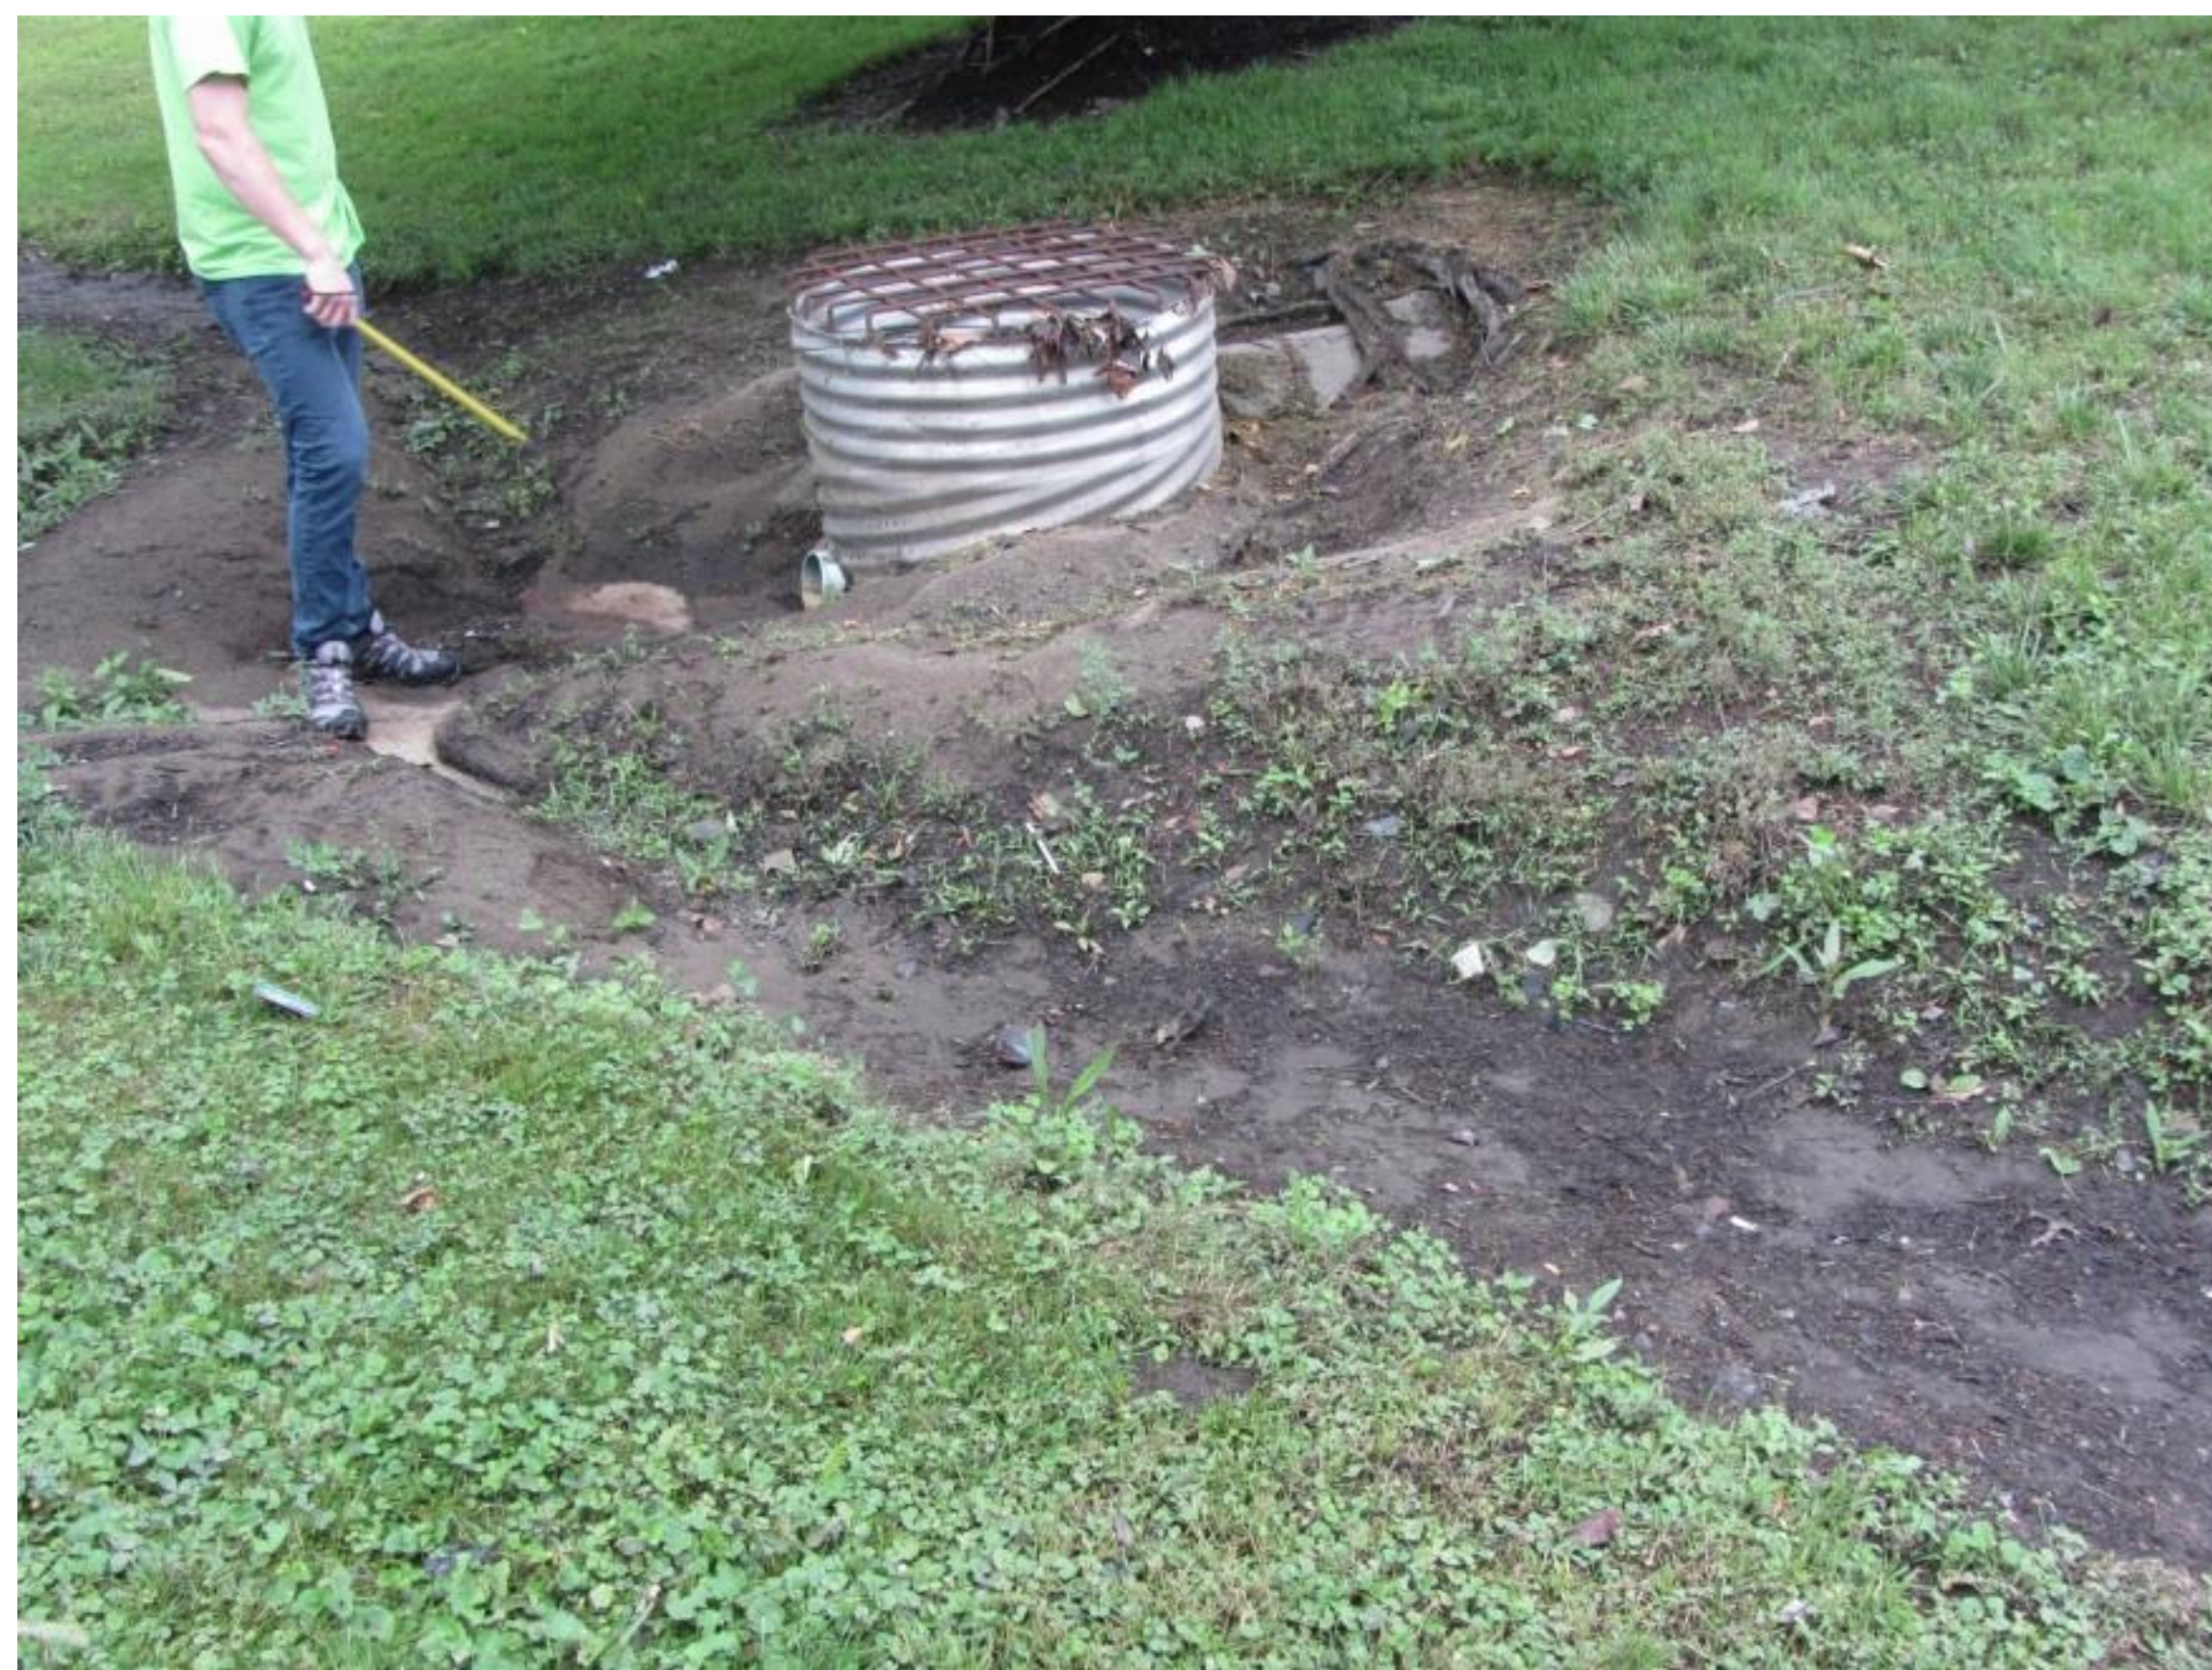
Outlet structure

- Sediment buildup and soil erosion present in basin especially near outlet structure
- Outlet appear to be of old design, could be replaced for better management
- Low flow channels could be removed to promote more infiltration
