**Hamilton Township (Mercer County)
Stormwater Basin Assessment Summary
Past Priority Addendum (Year 5B)**

Developed by the Rutgers Cooperative Extension Water Resources Program
Funded by Hamilton Township, Mercer County, New Jersey

November 27, 2019

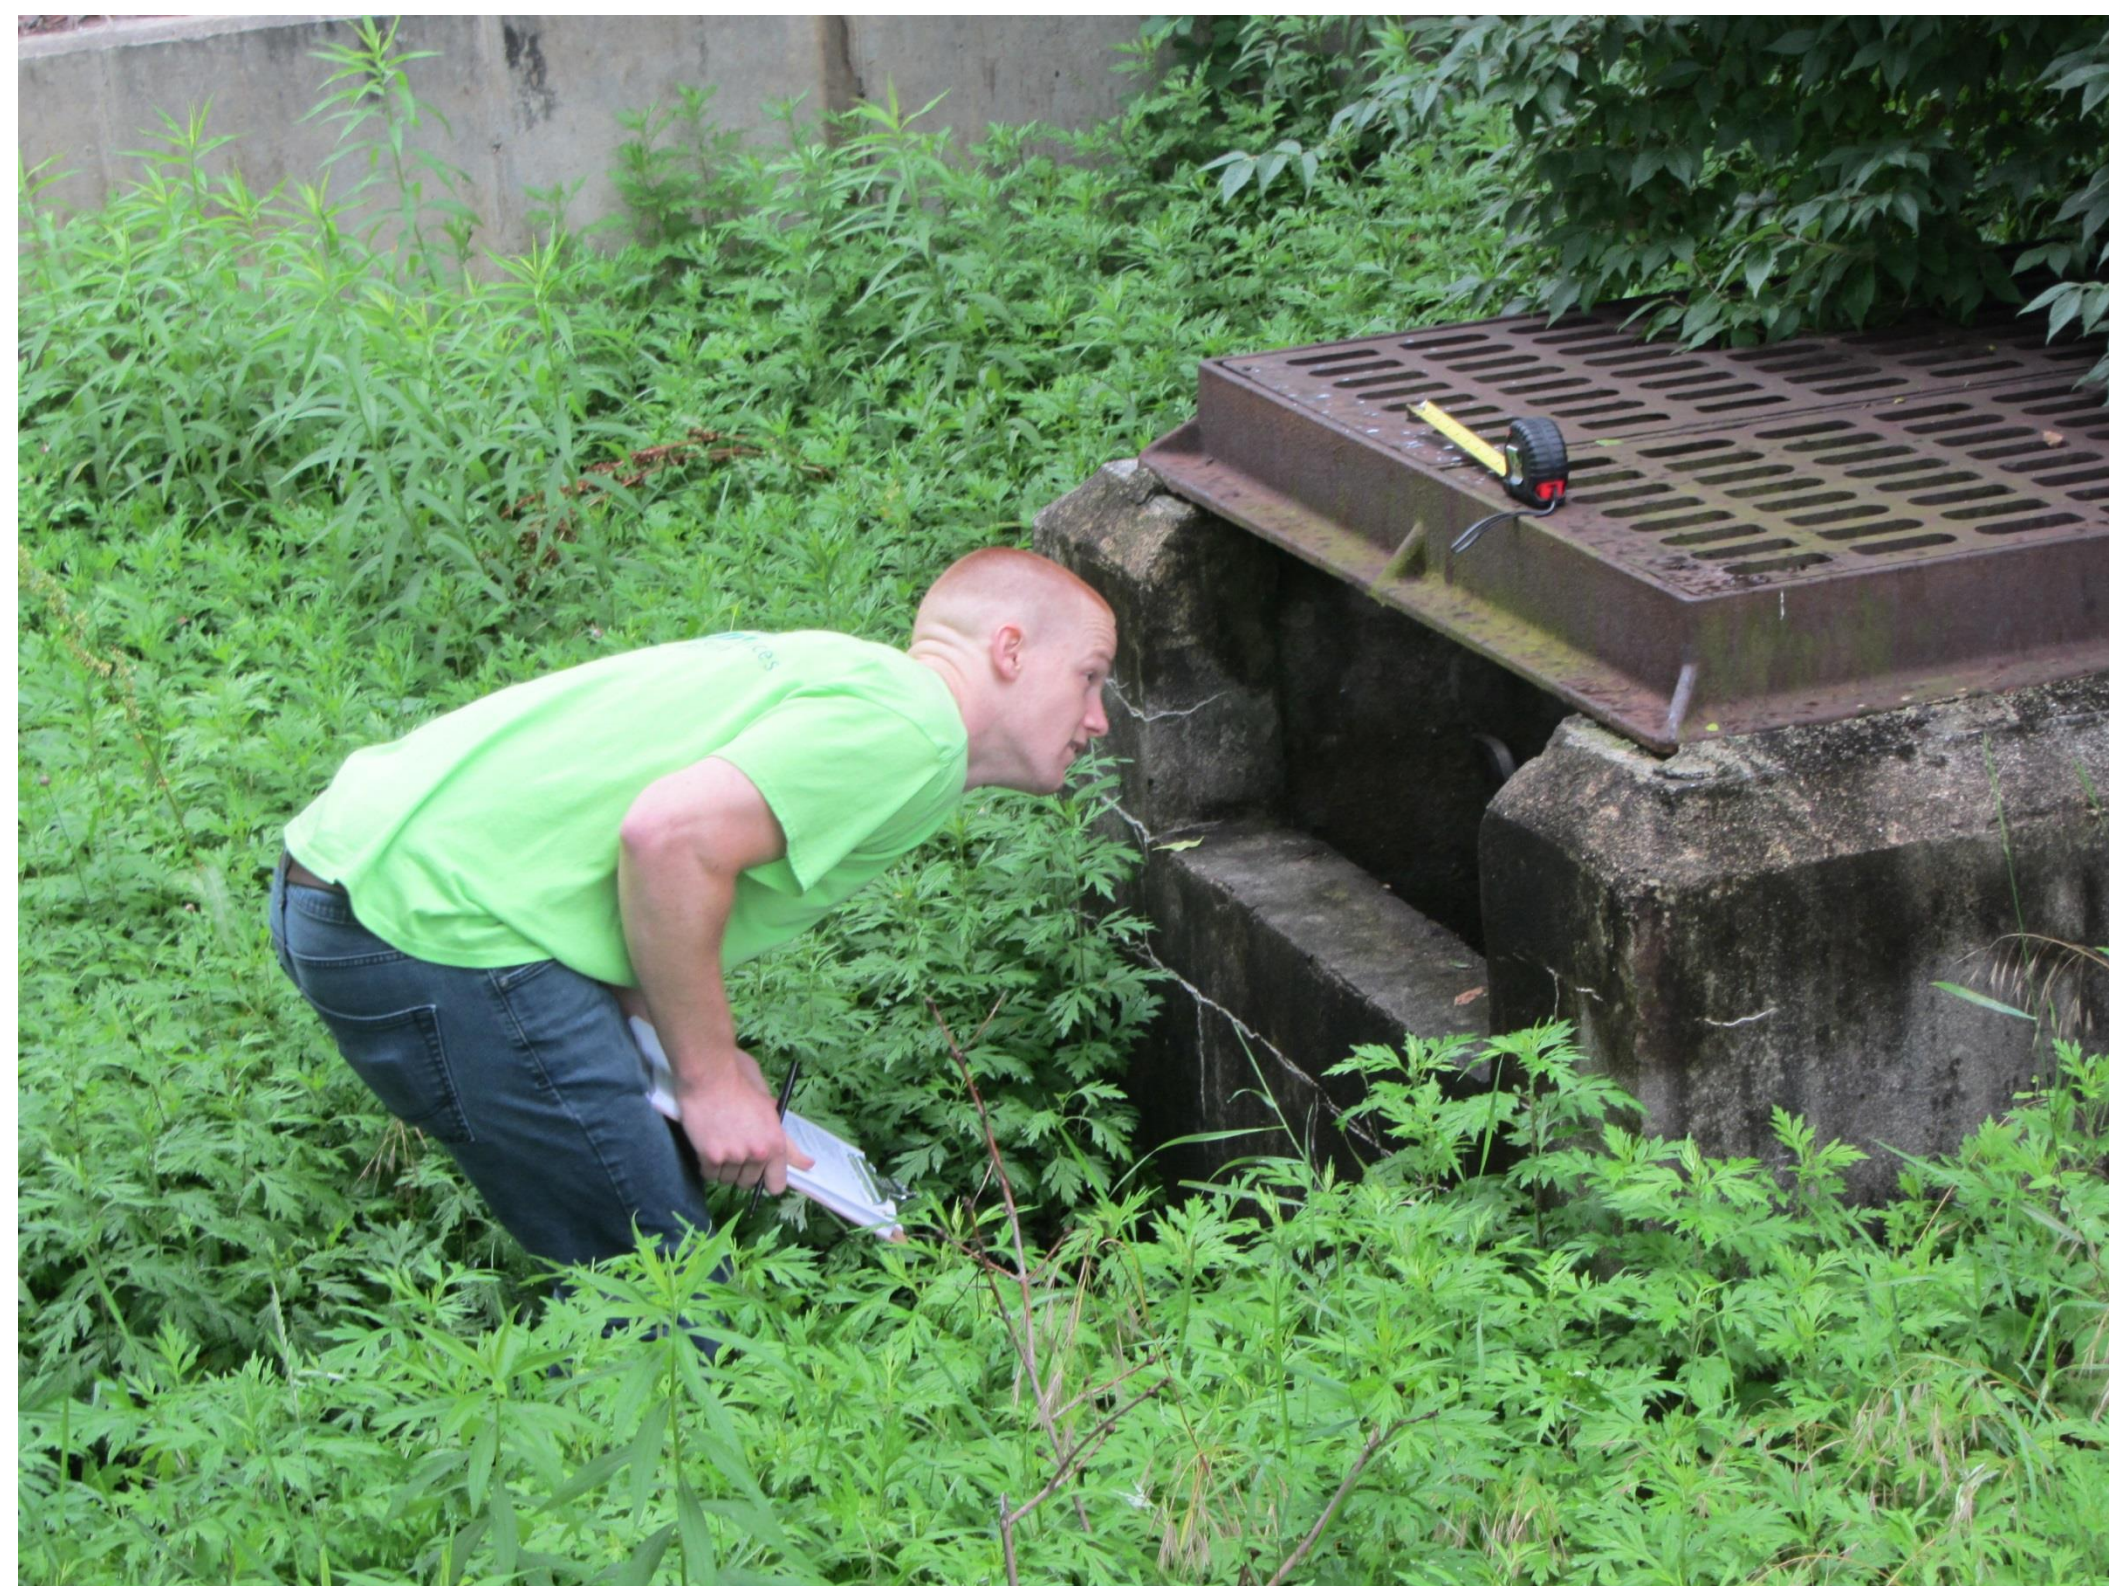
Outlet structure

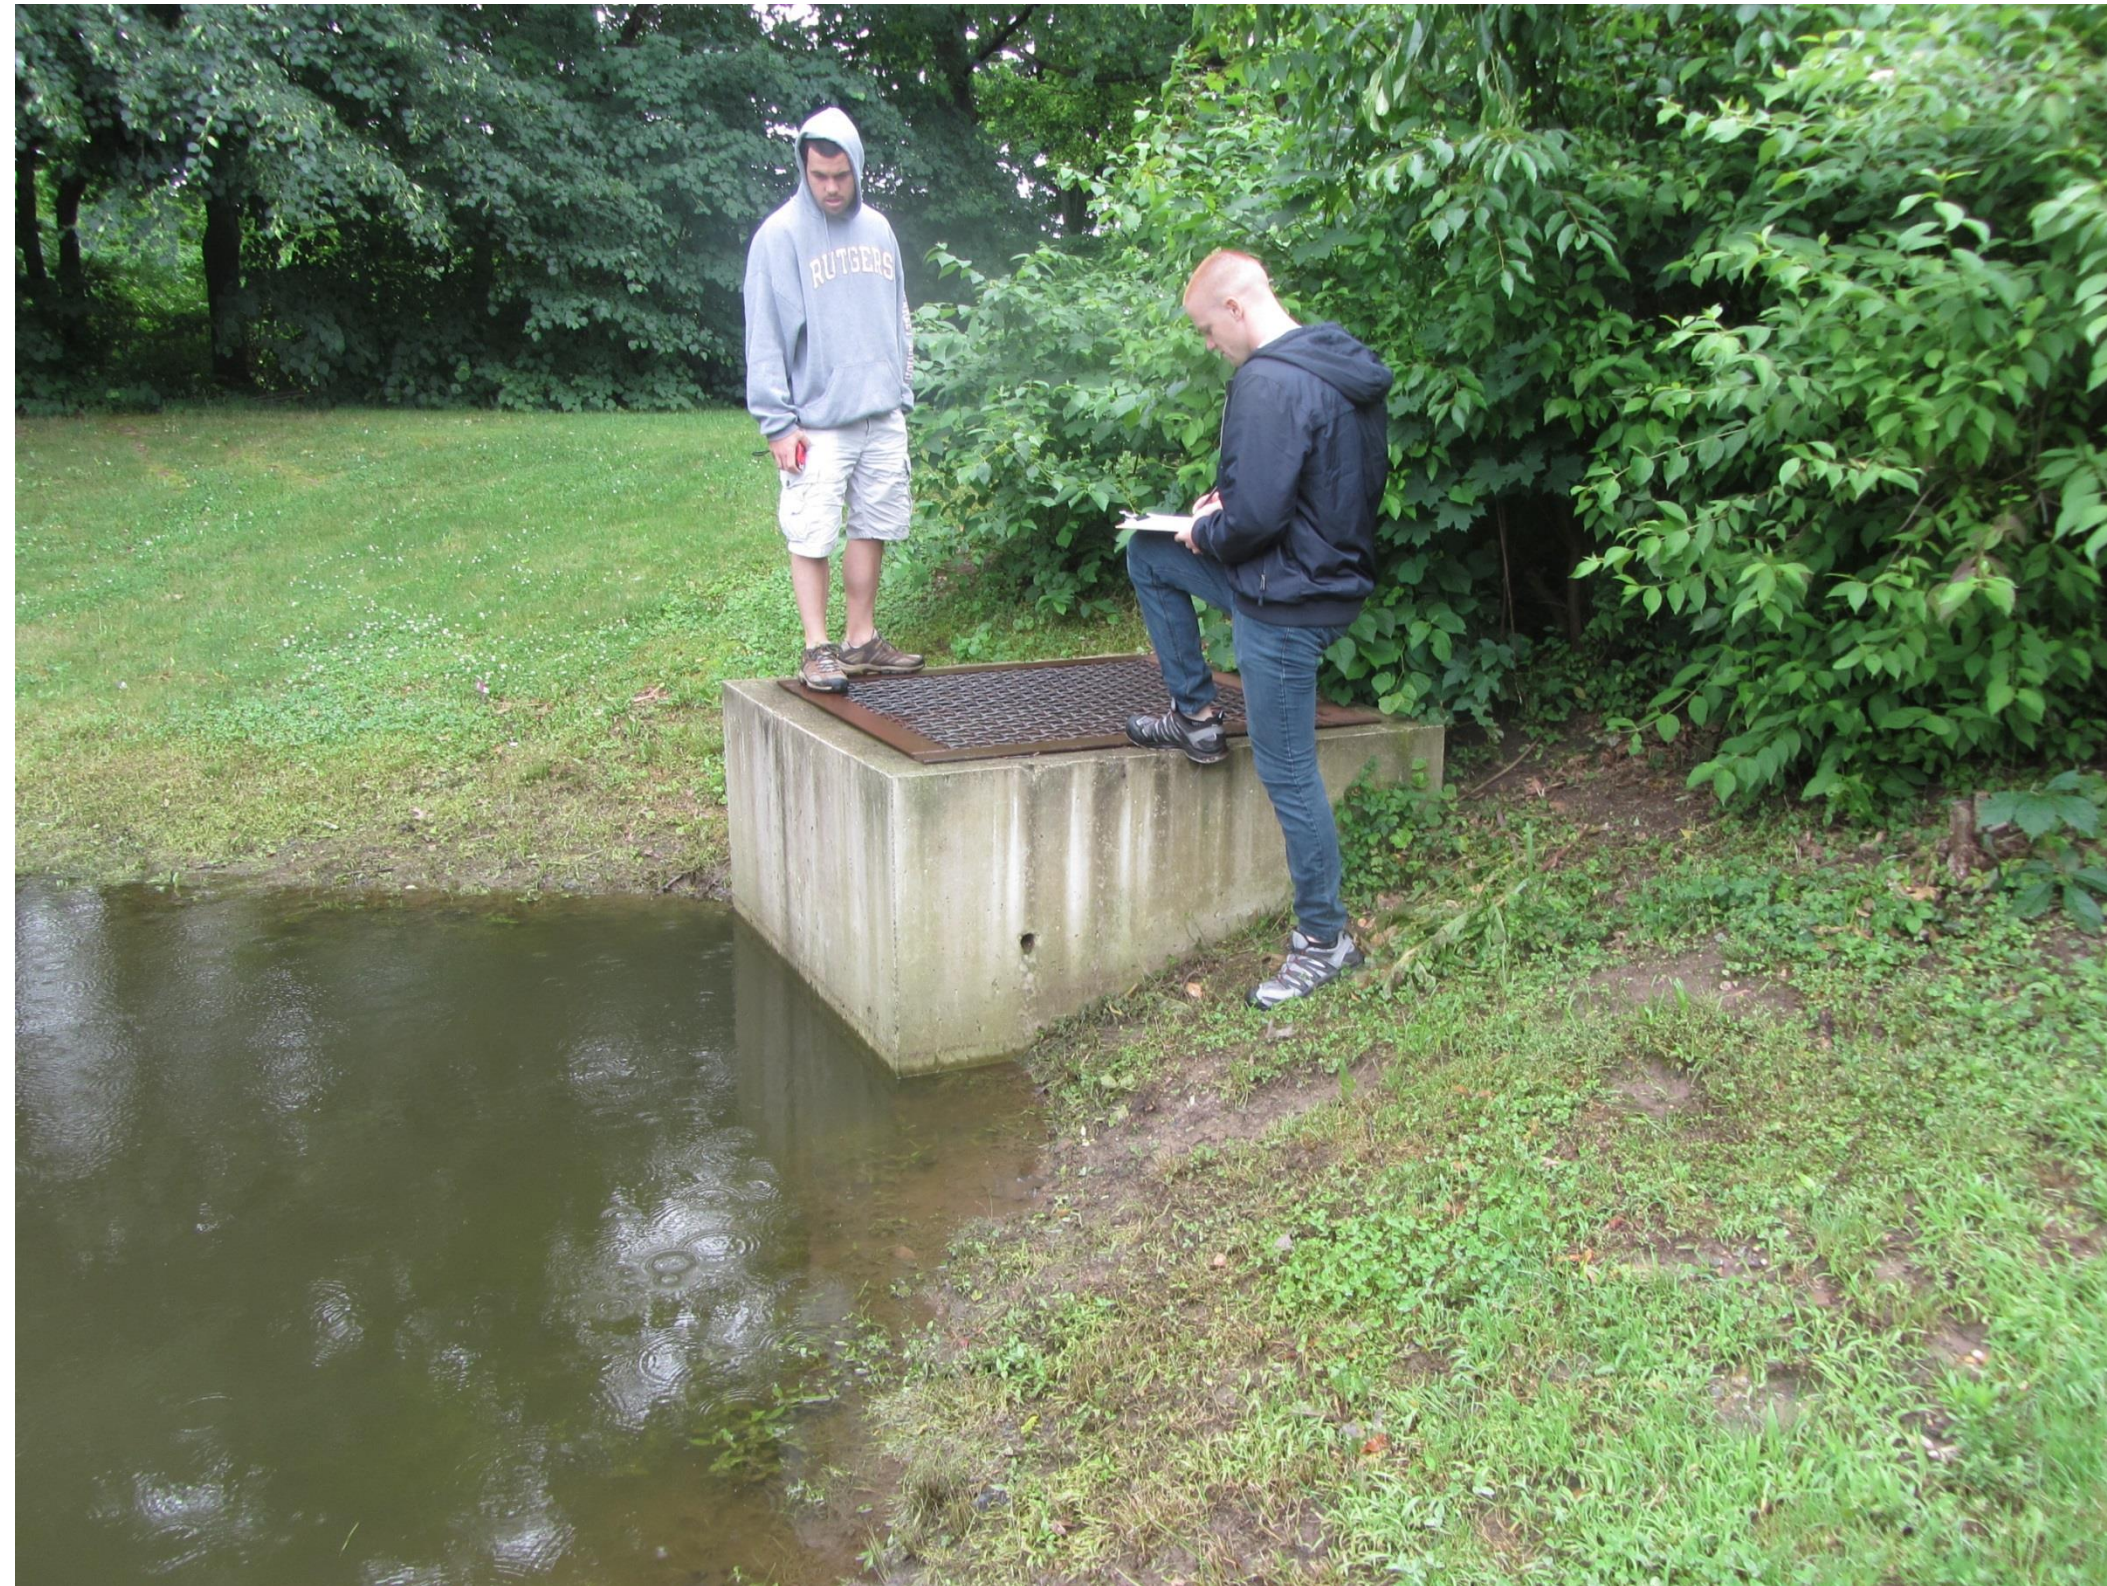
Outlet structure

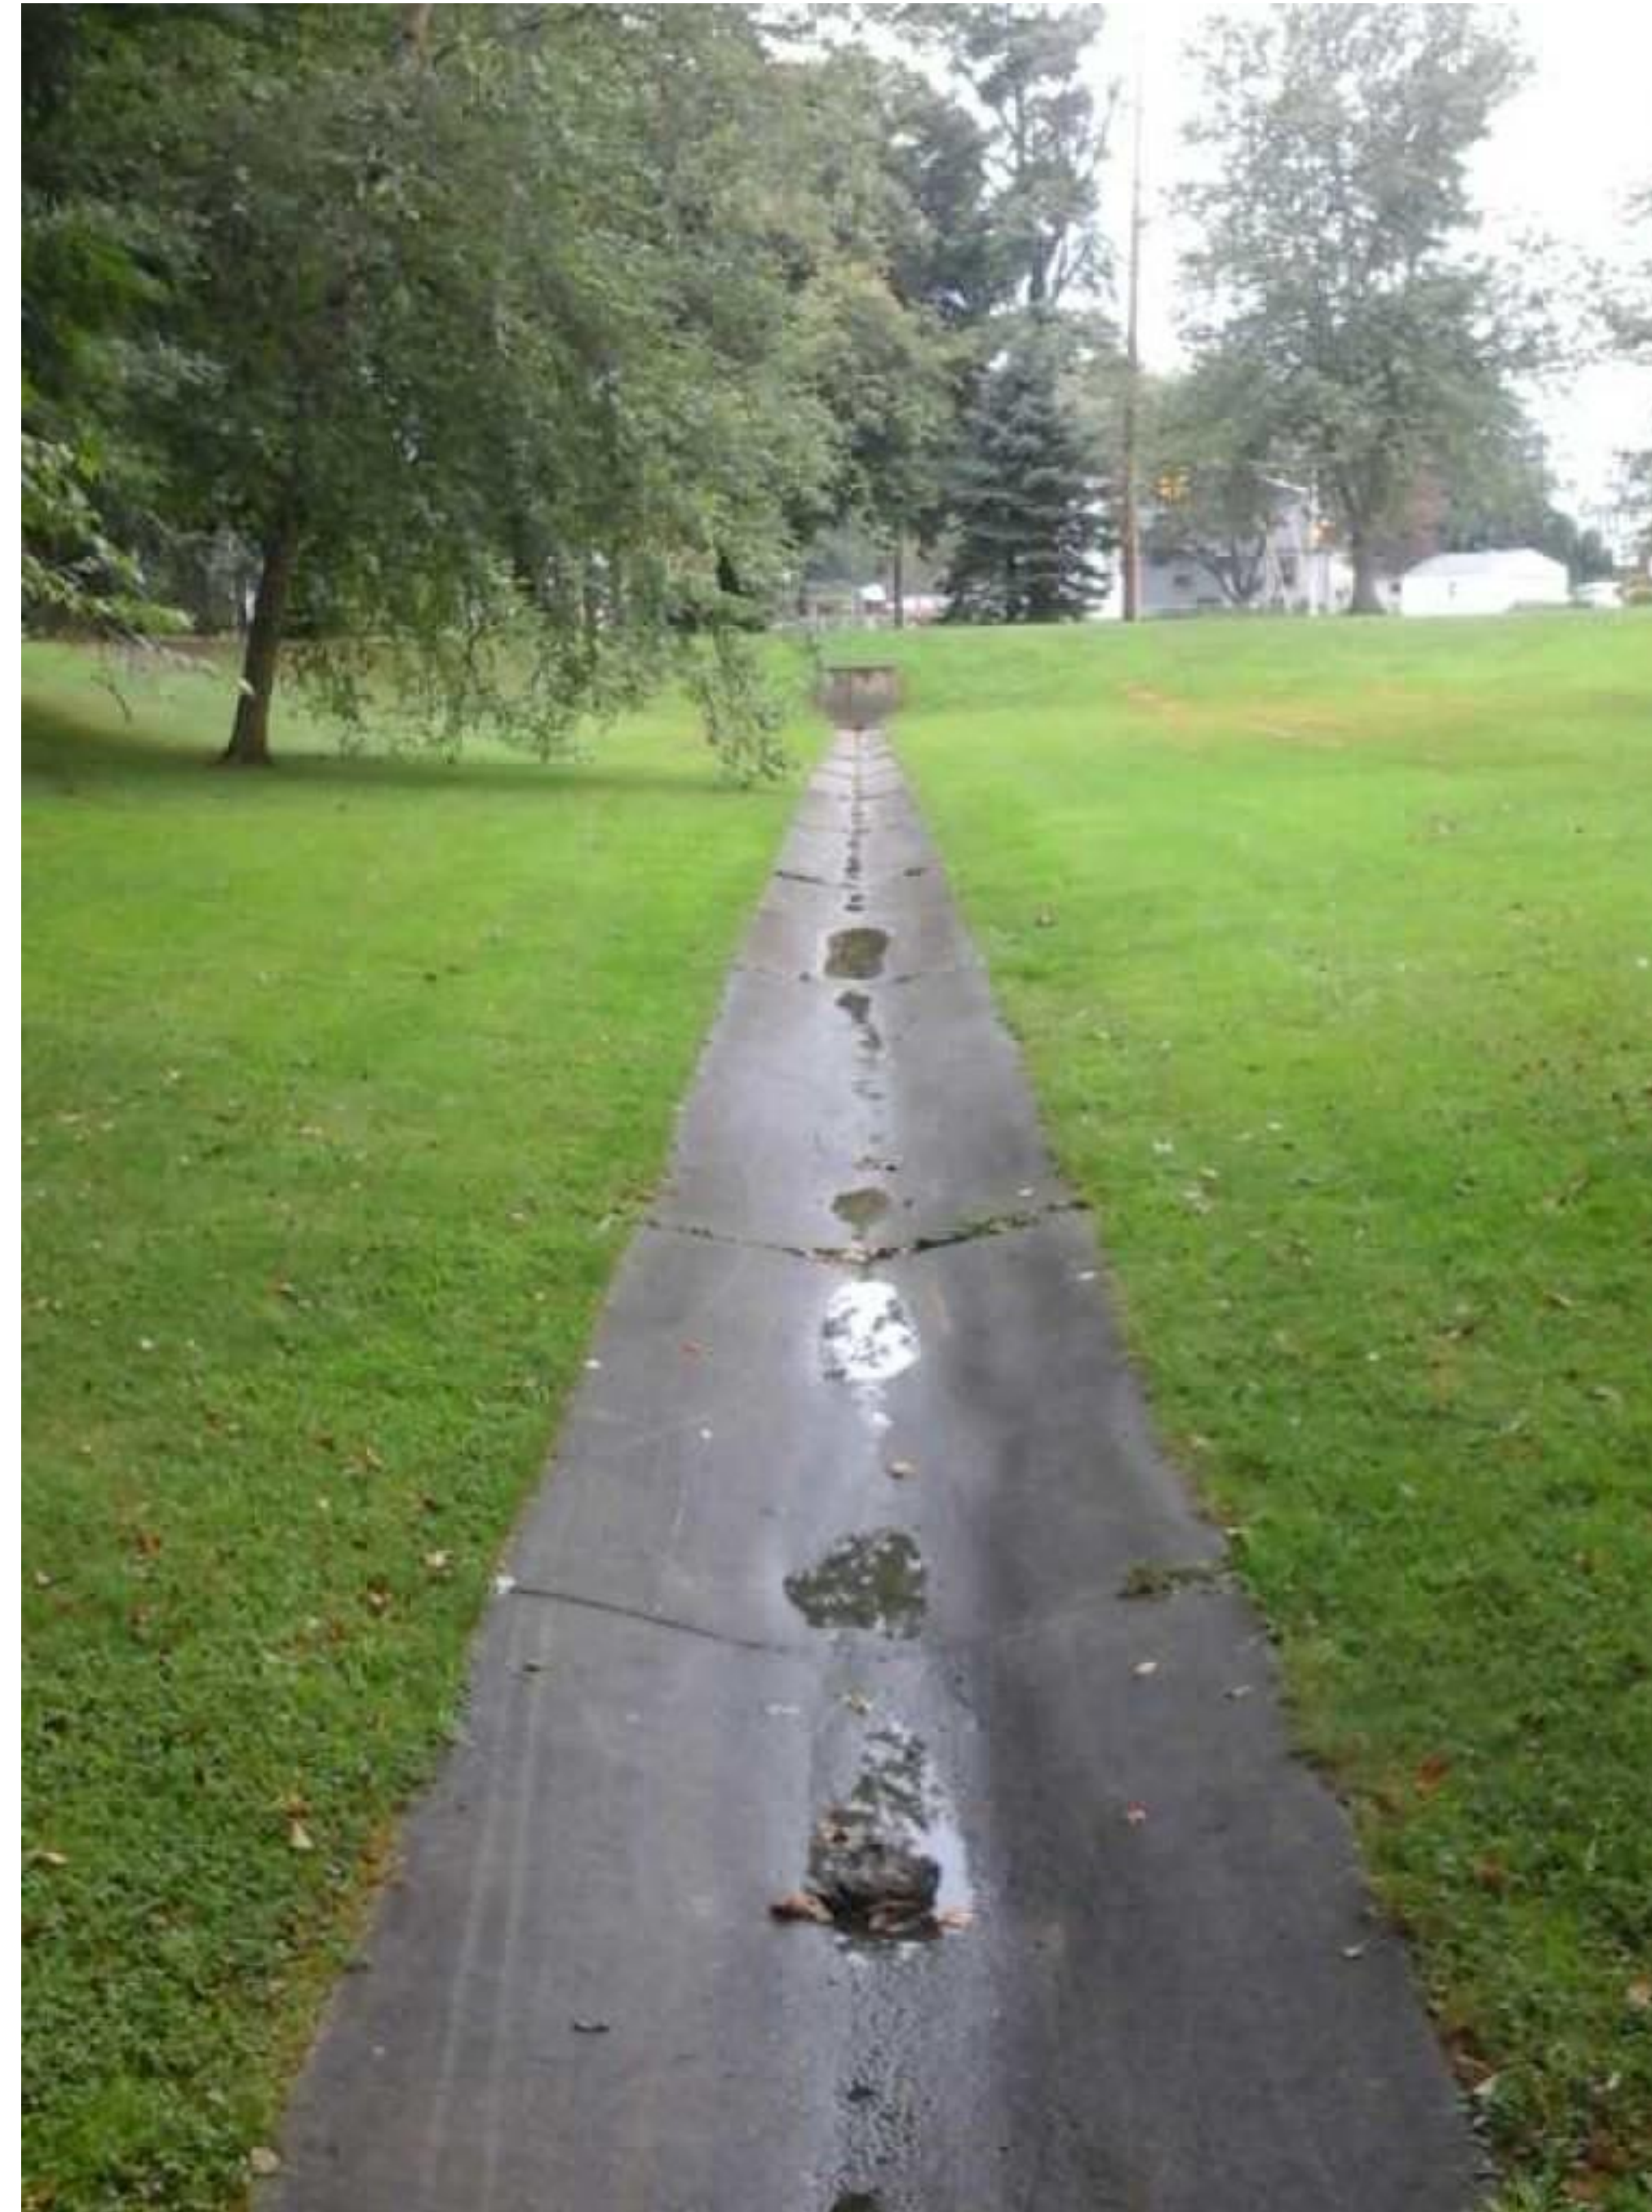
- Basin is well maintained
- No signs of standing water or sediment accumulation seen in previous assessment
- Low flow channel could be removed to manage stormwater better in smaller storms

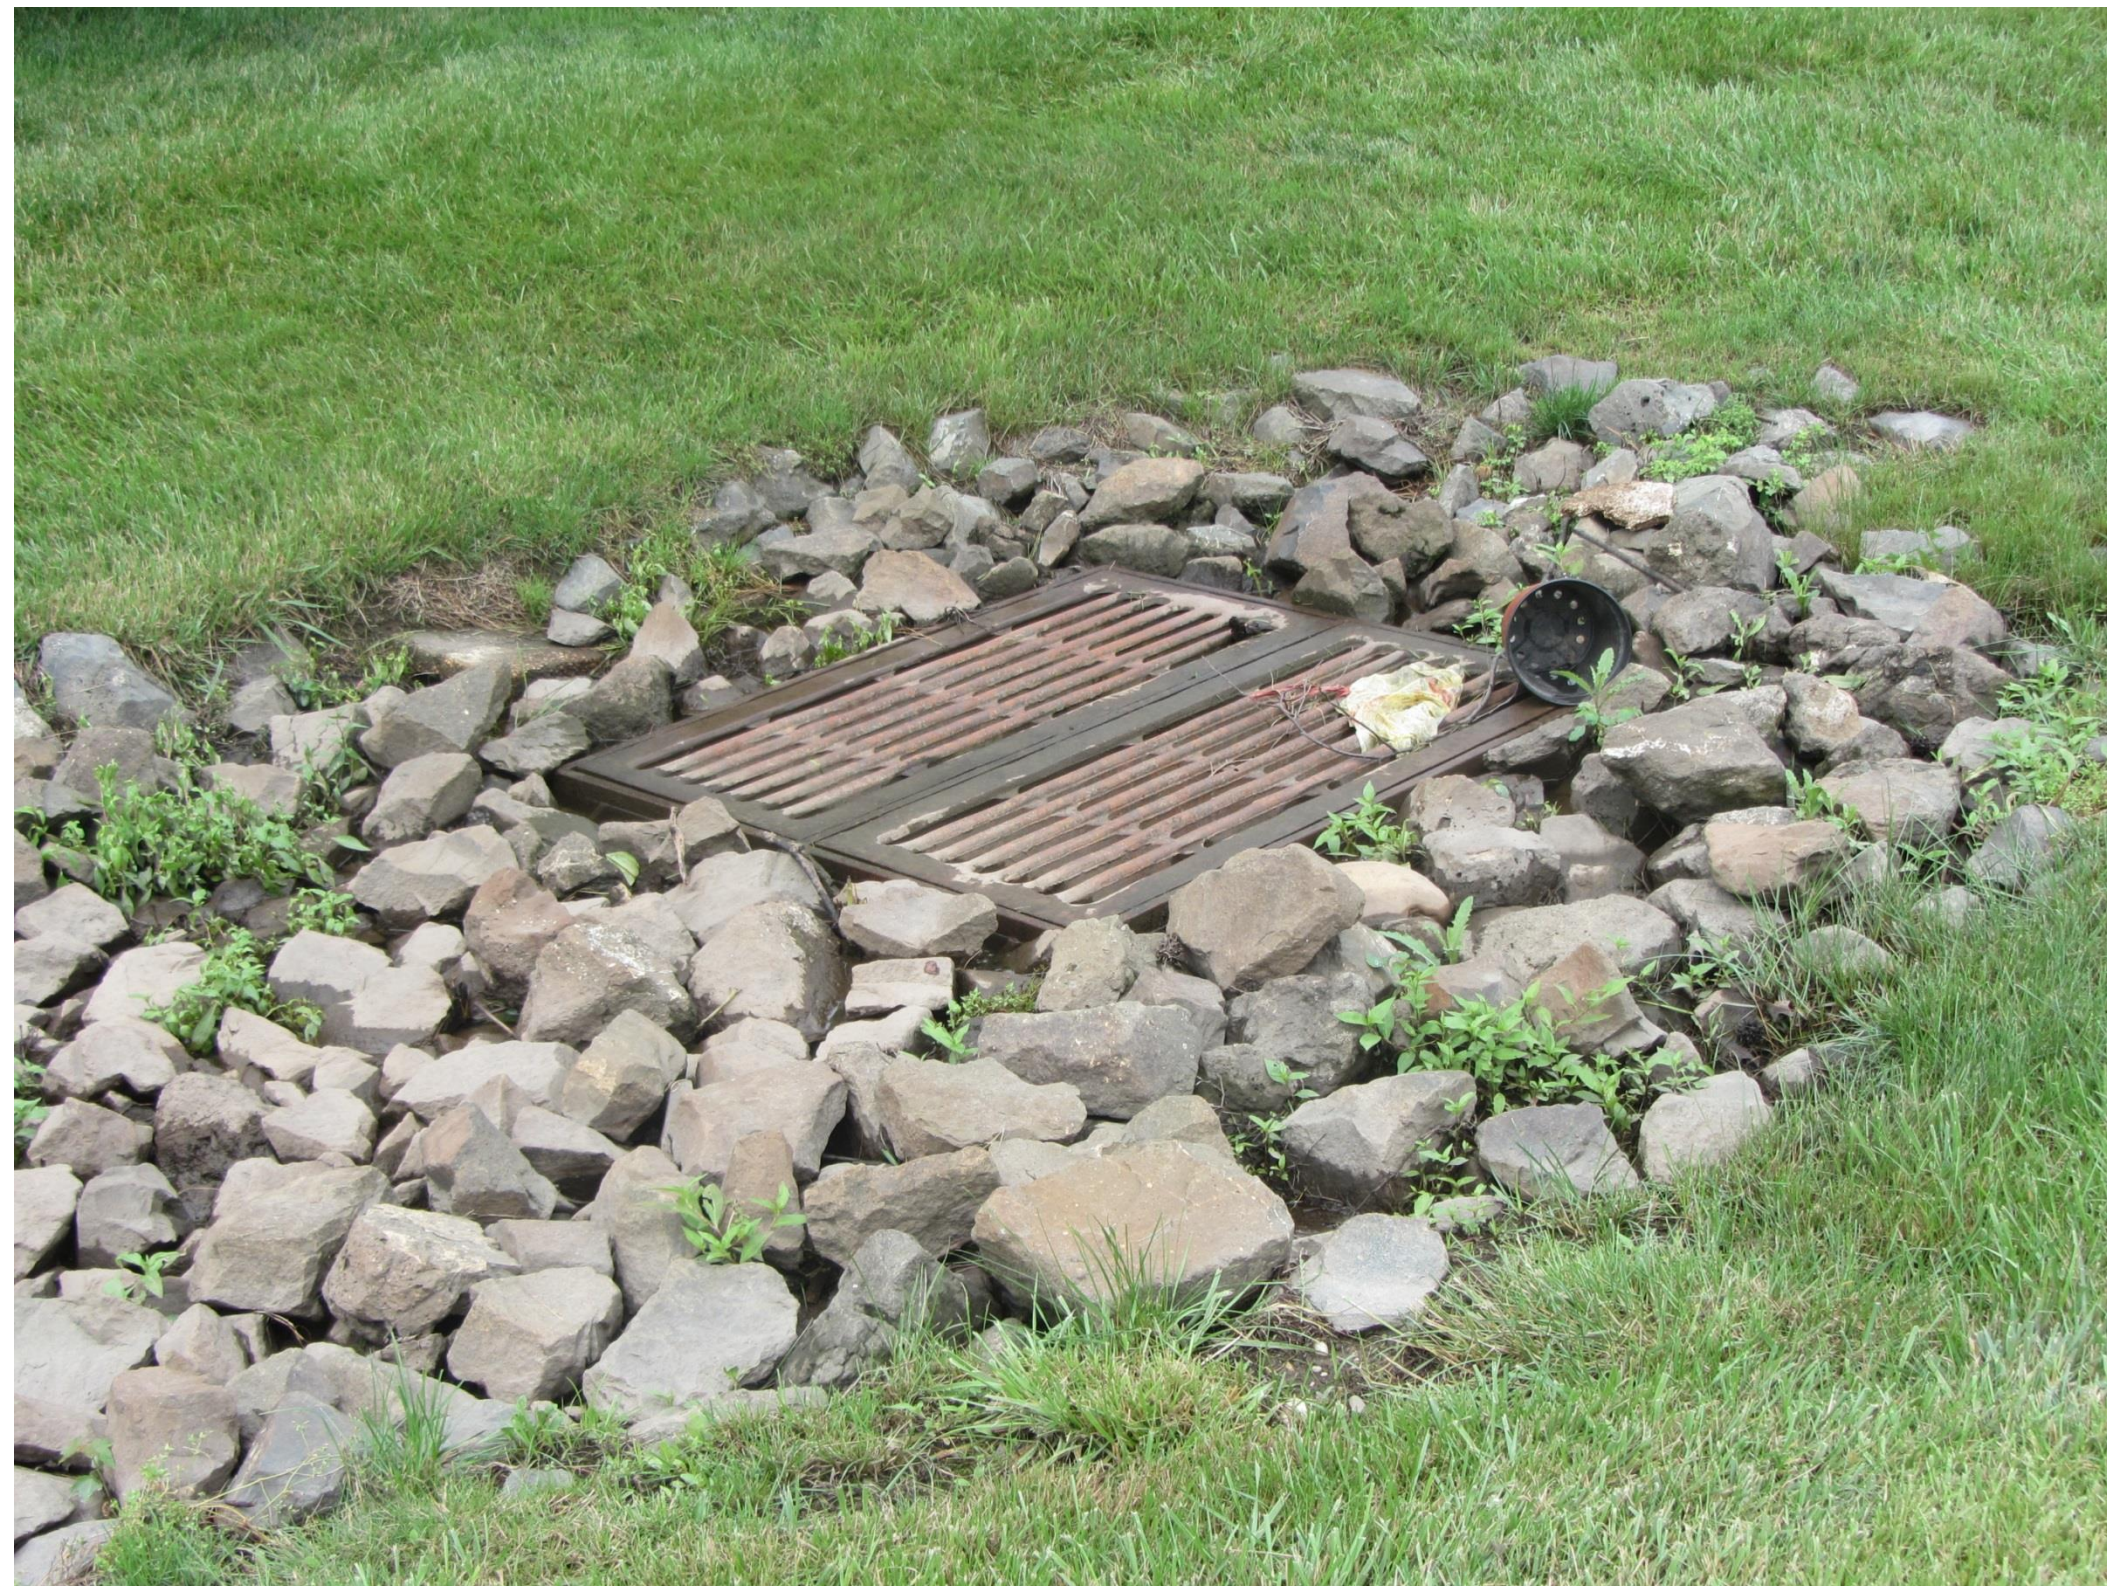
Outlet grate

- Basin intercepts a natural stream
- Water is exiting through cracks in the sides of the outlet rather than the grate
- Water is exiting through a hole in the ground before reaching the outlet

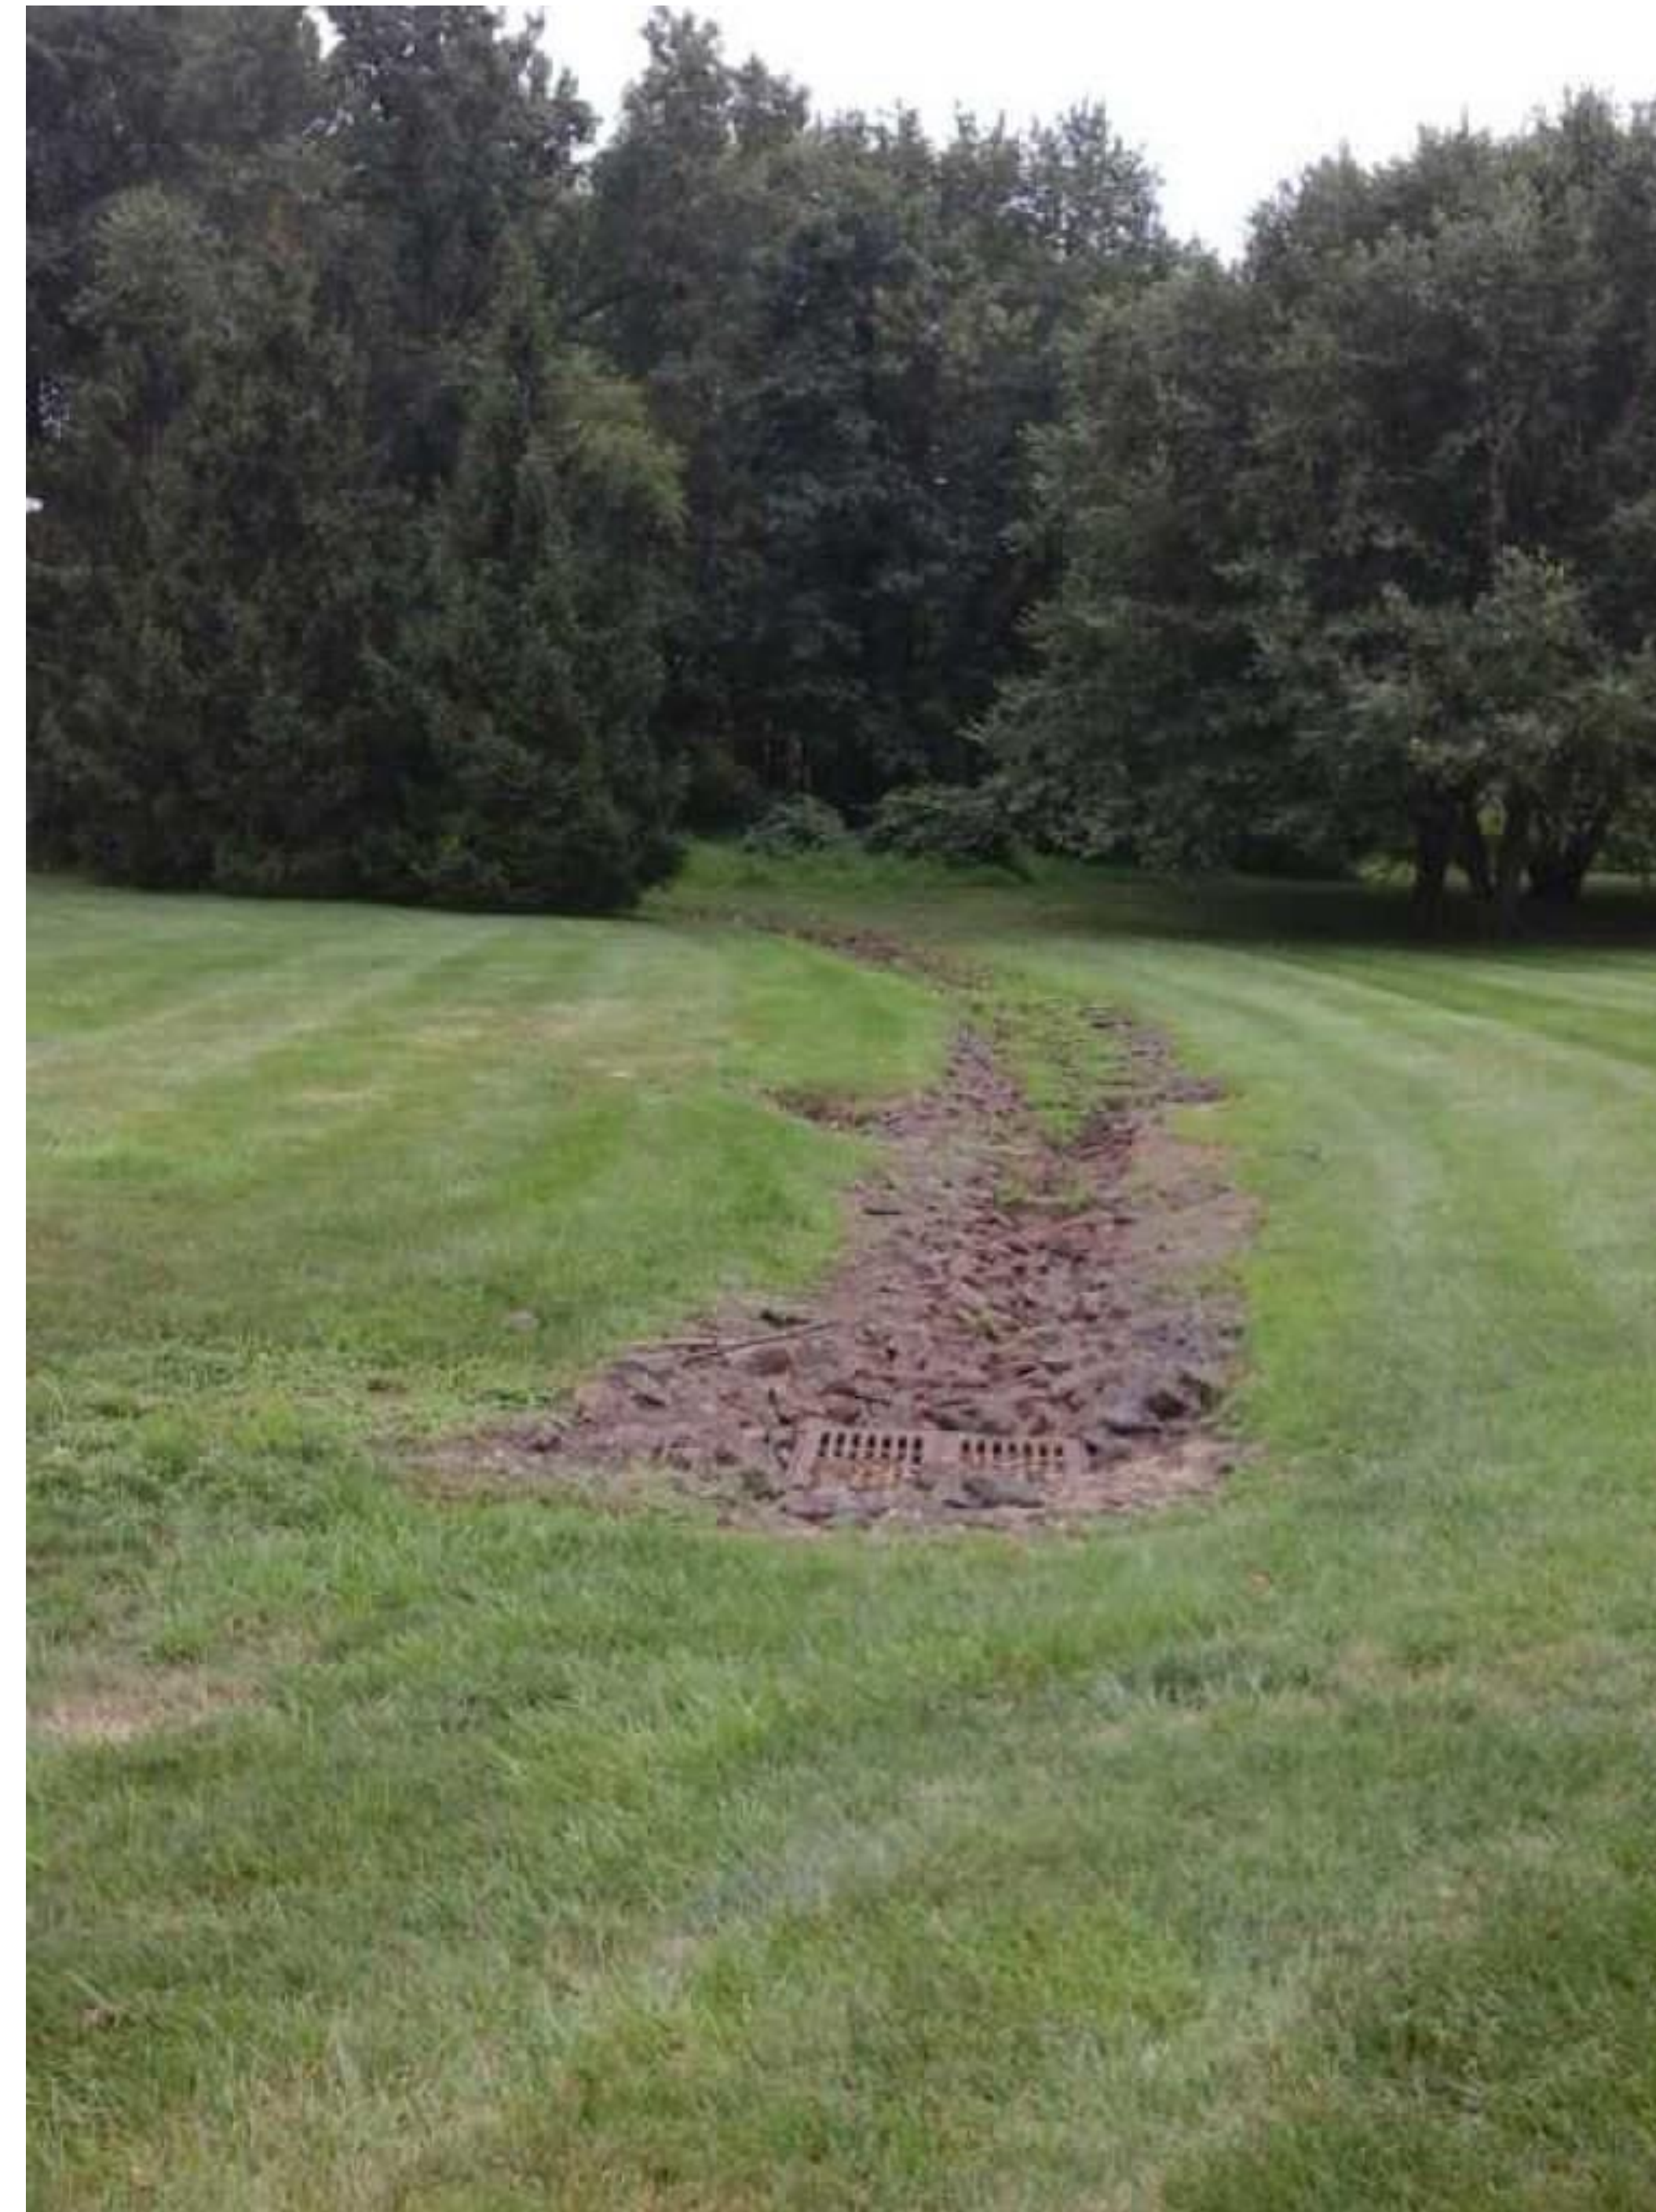
- Rock channel has a small amount of sediment and erosion that could be cleaned up
- Vegetation should be removed from rough channel
- Area around channel can be naturalized with herbaceous plants

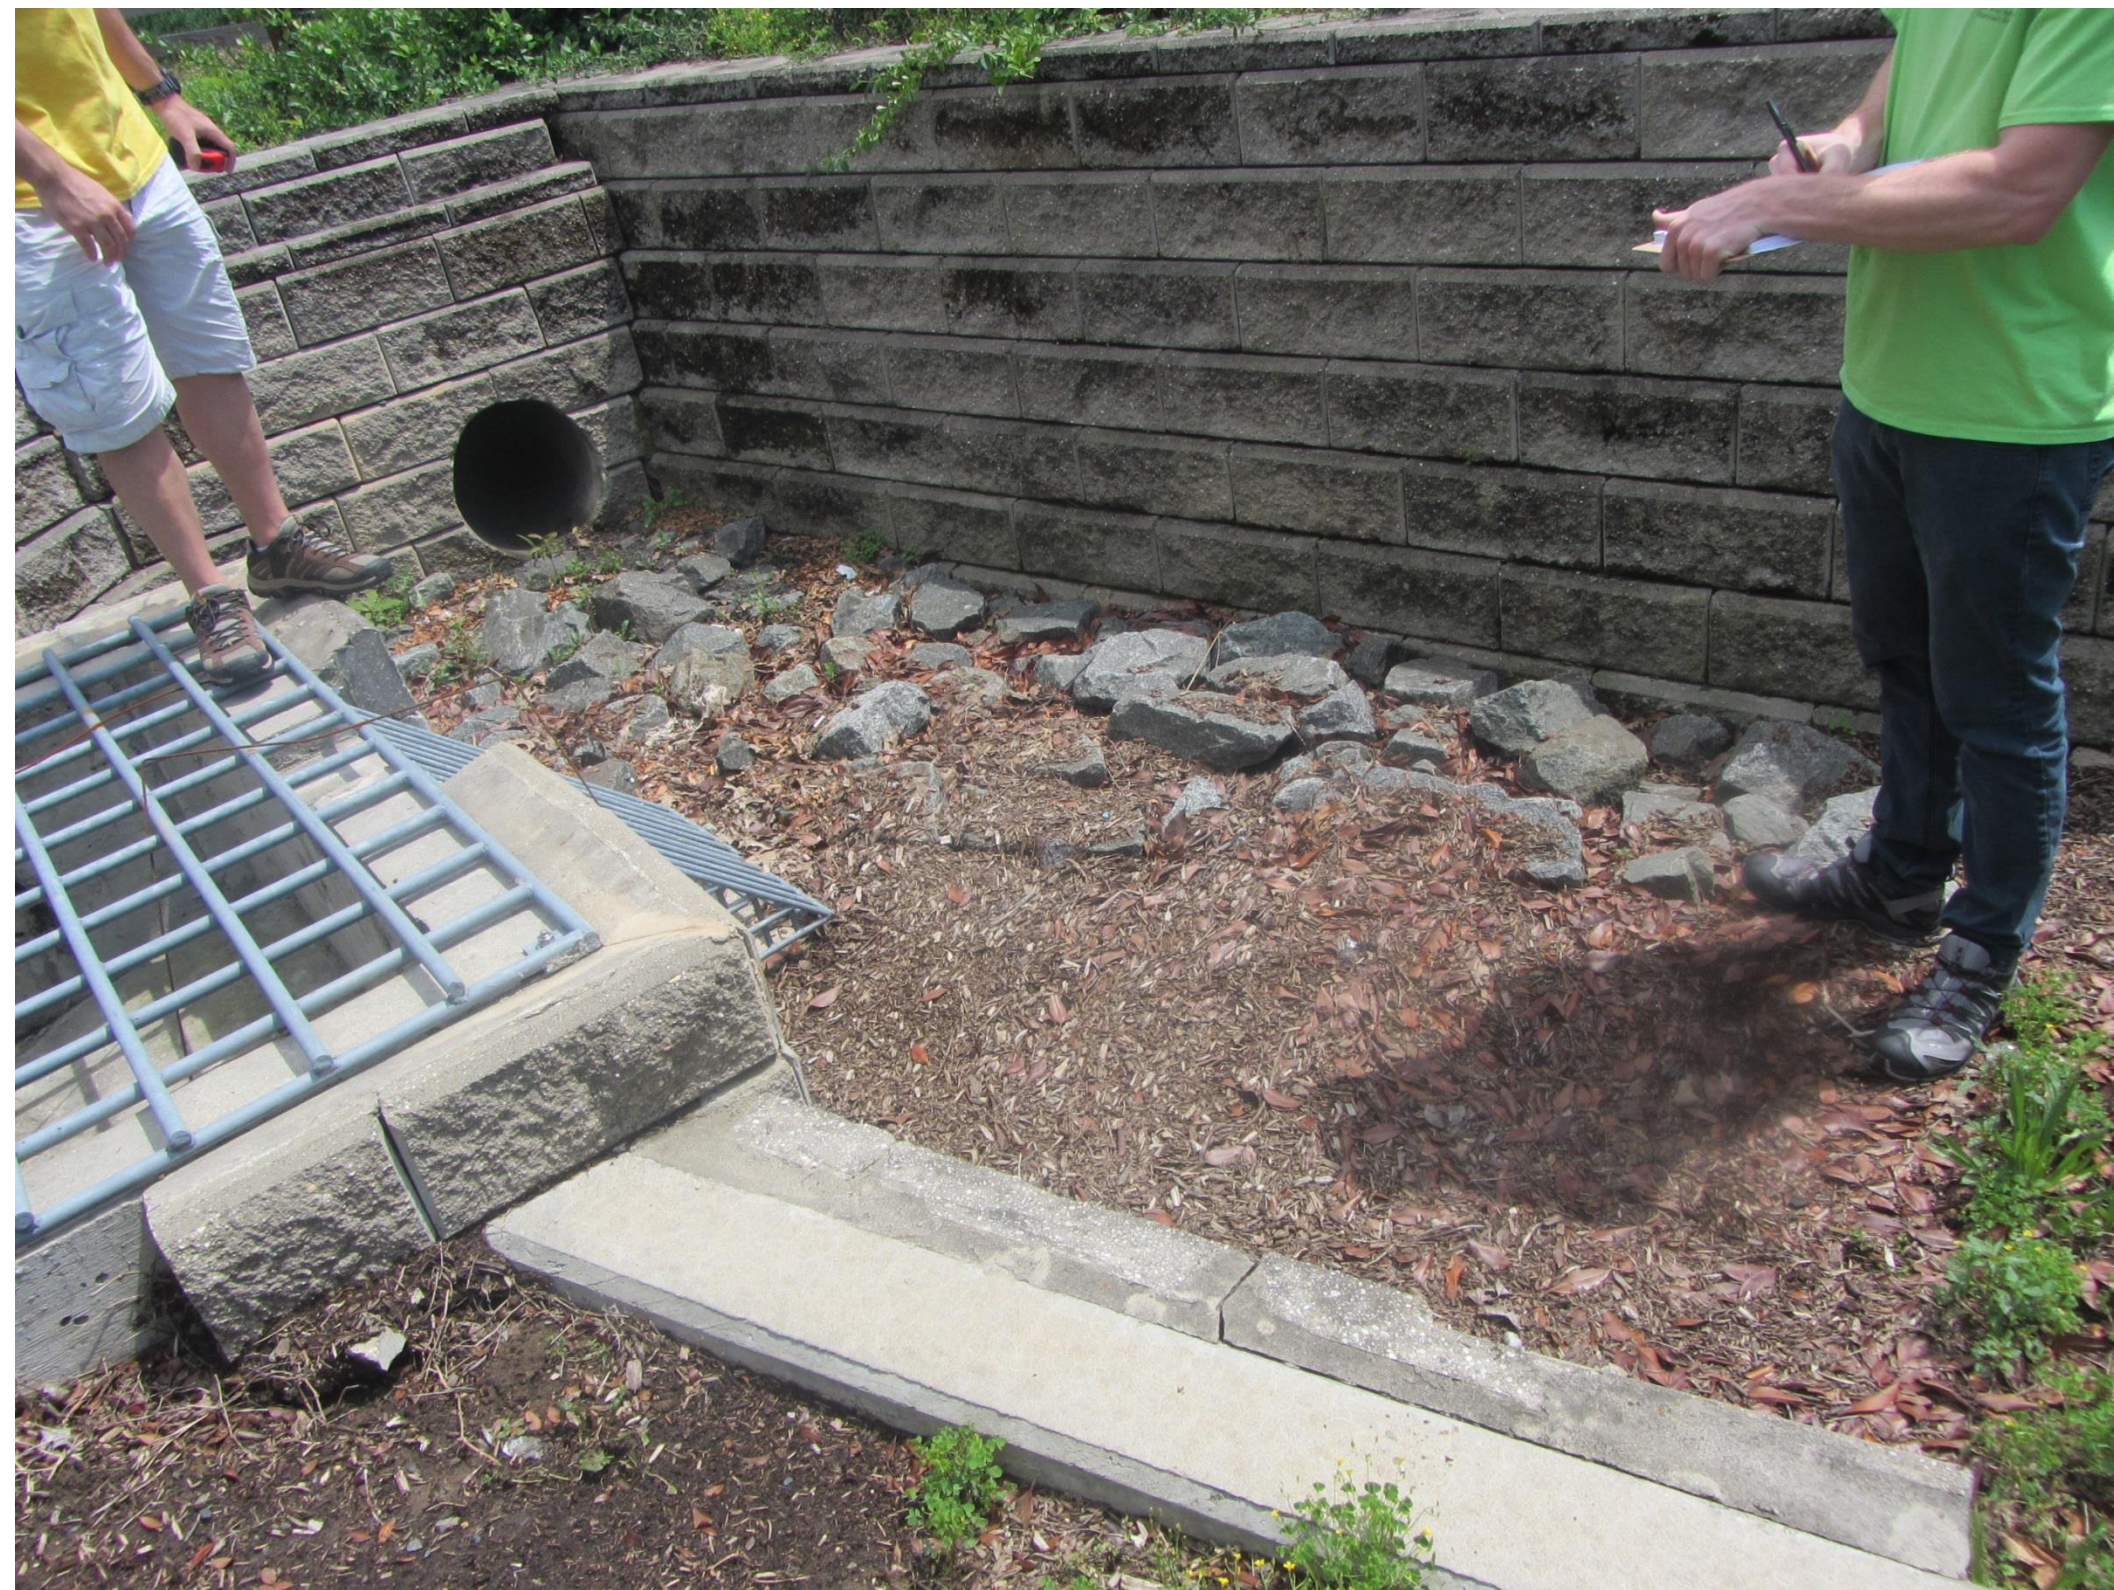
Outlet with excess mulch
