**Hamilton Township (Mercer County)
Stormwater Basin Assessment Summary
Past Priority Addendum (Year 5B)**

Developed by the Rutgers Cooperative Extension Water Resources Program
Funded by Hamilton Township, Mercer County, New Jersey

November 27, 2019

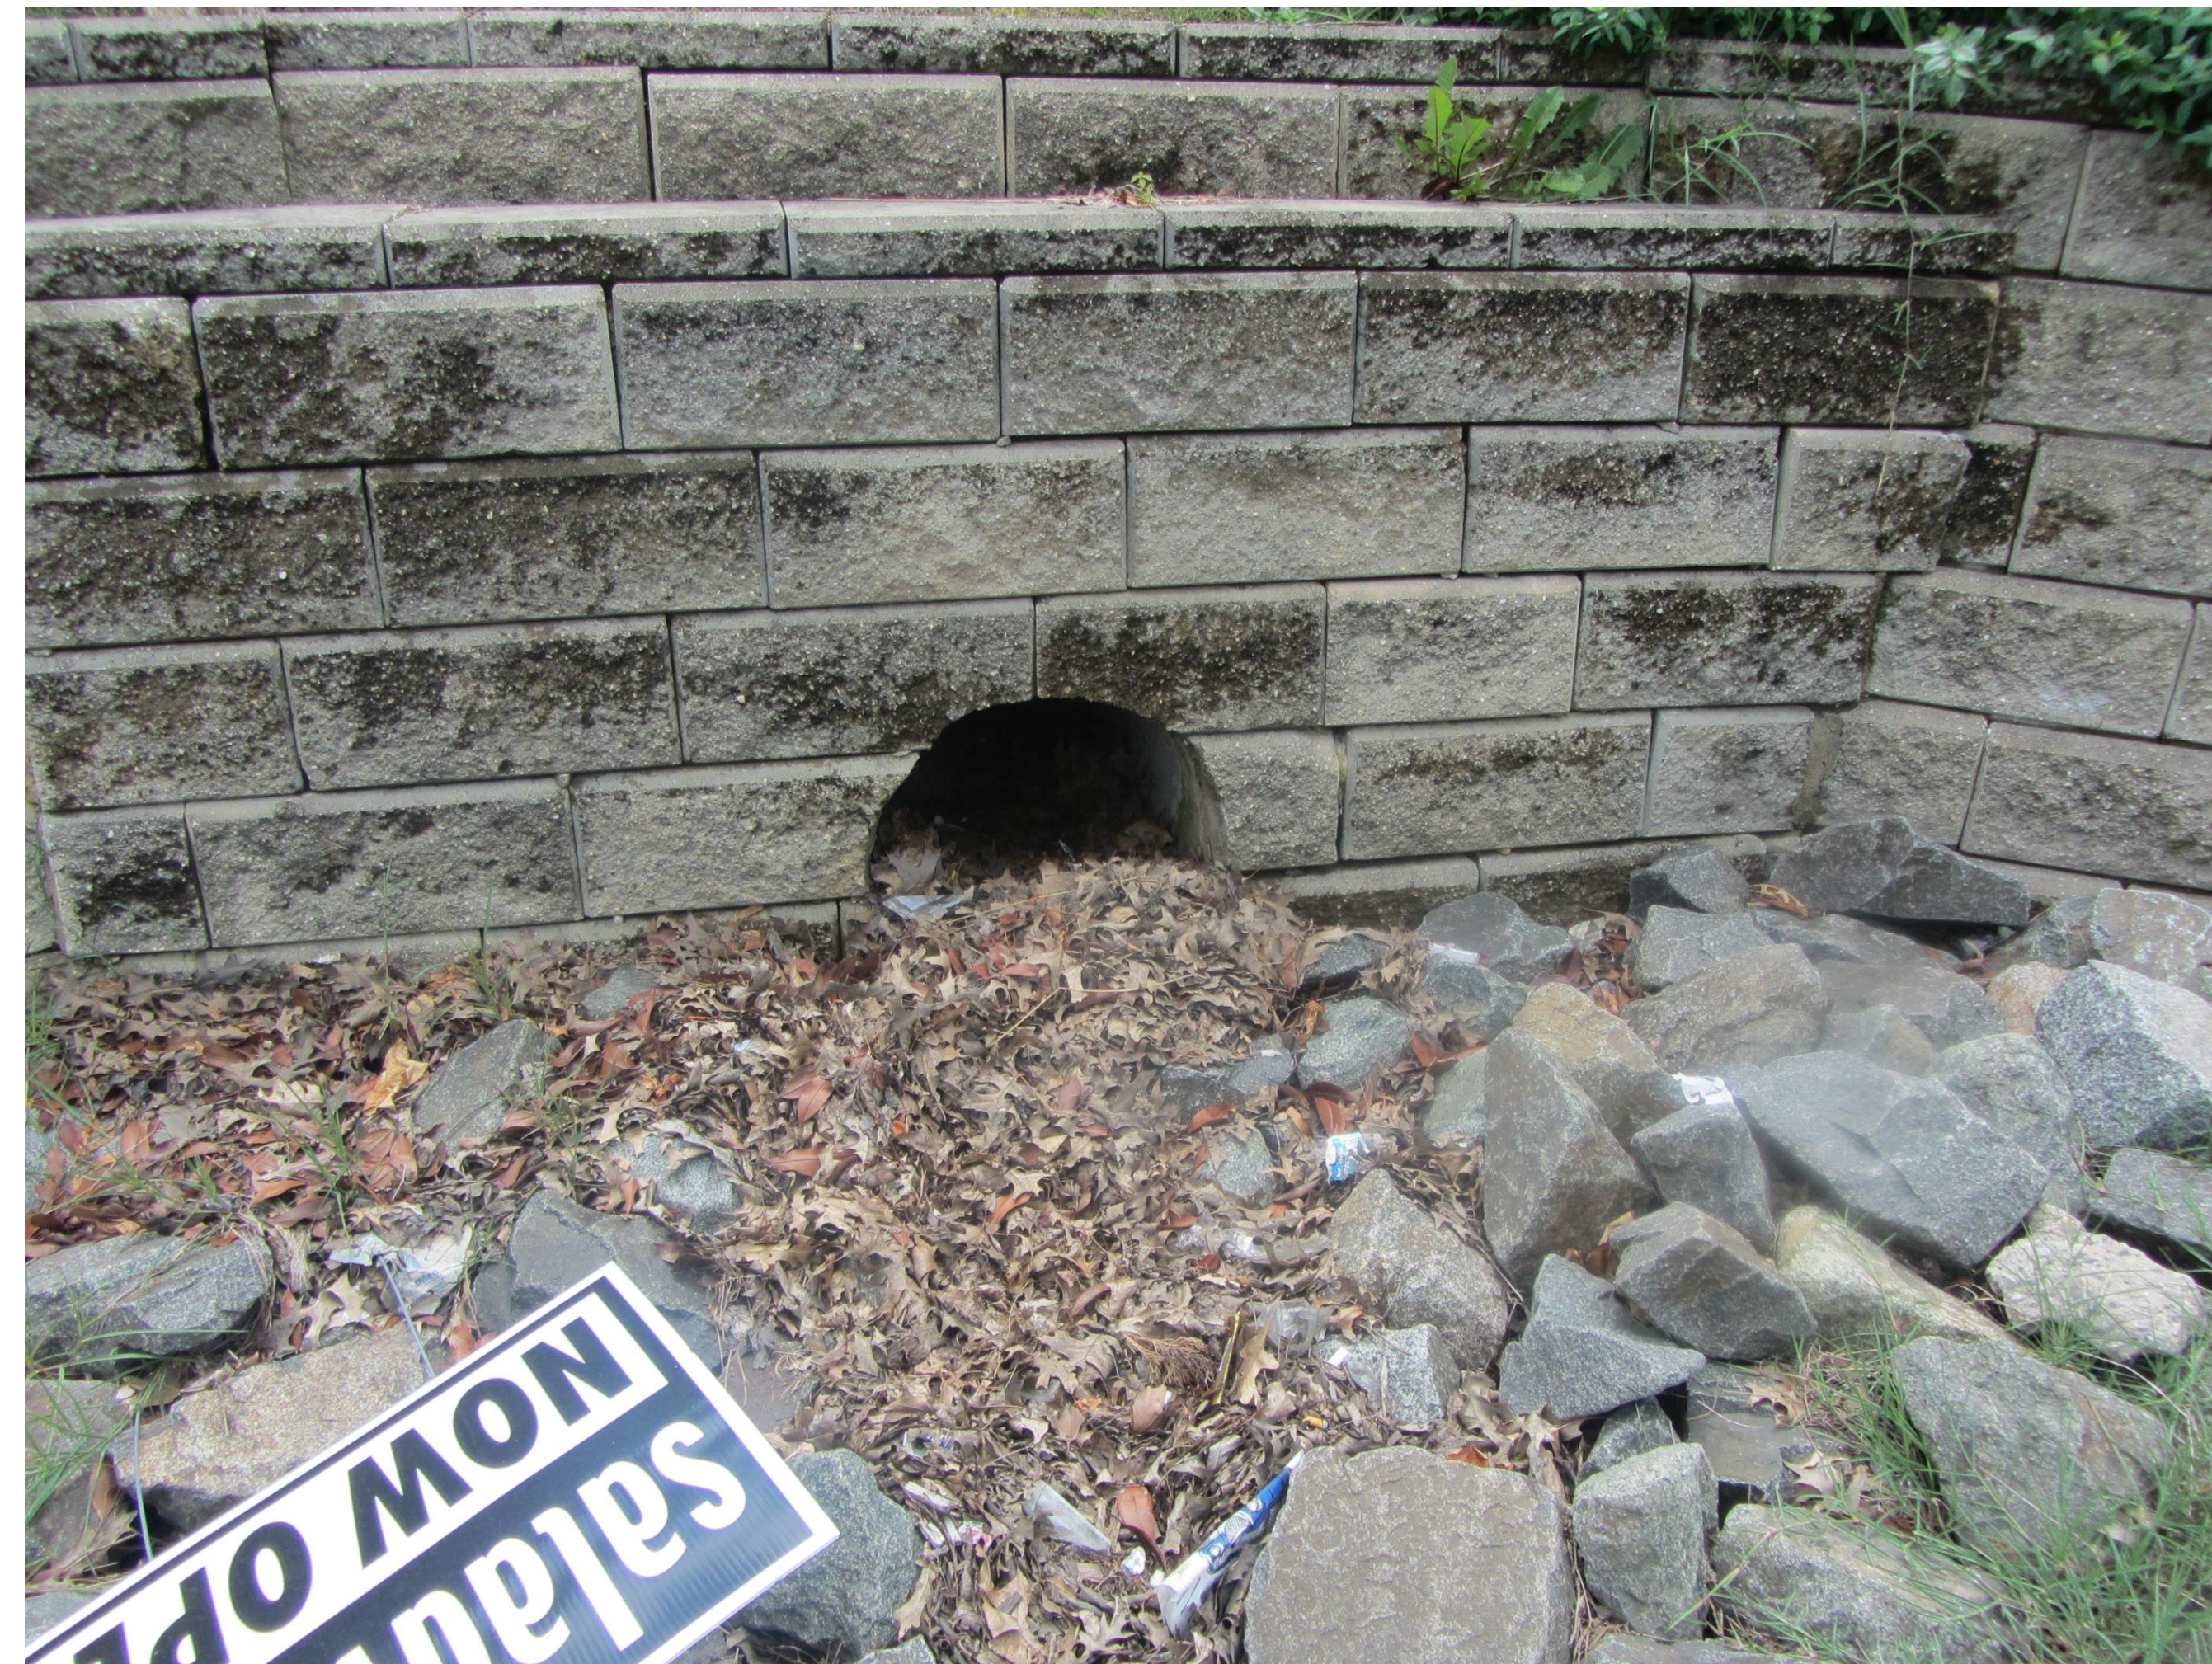
Western inlet clogged with leaves

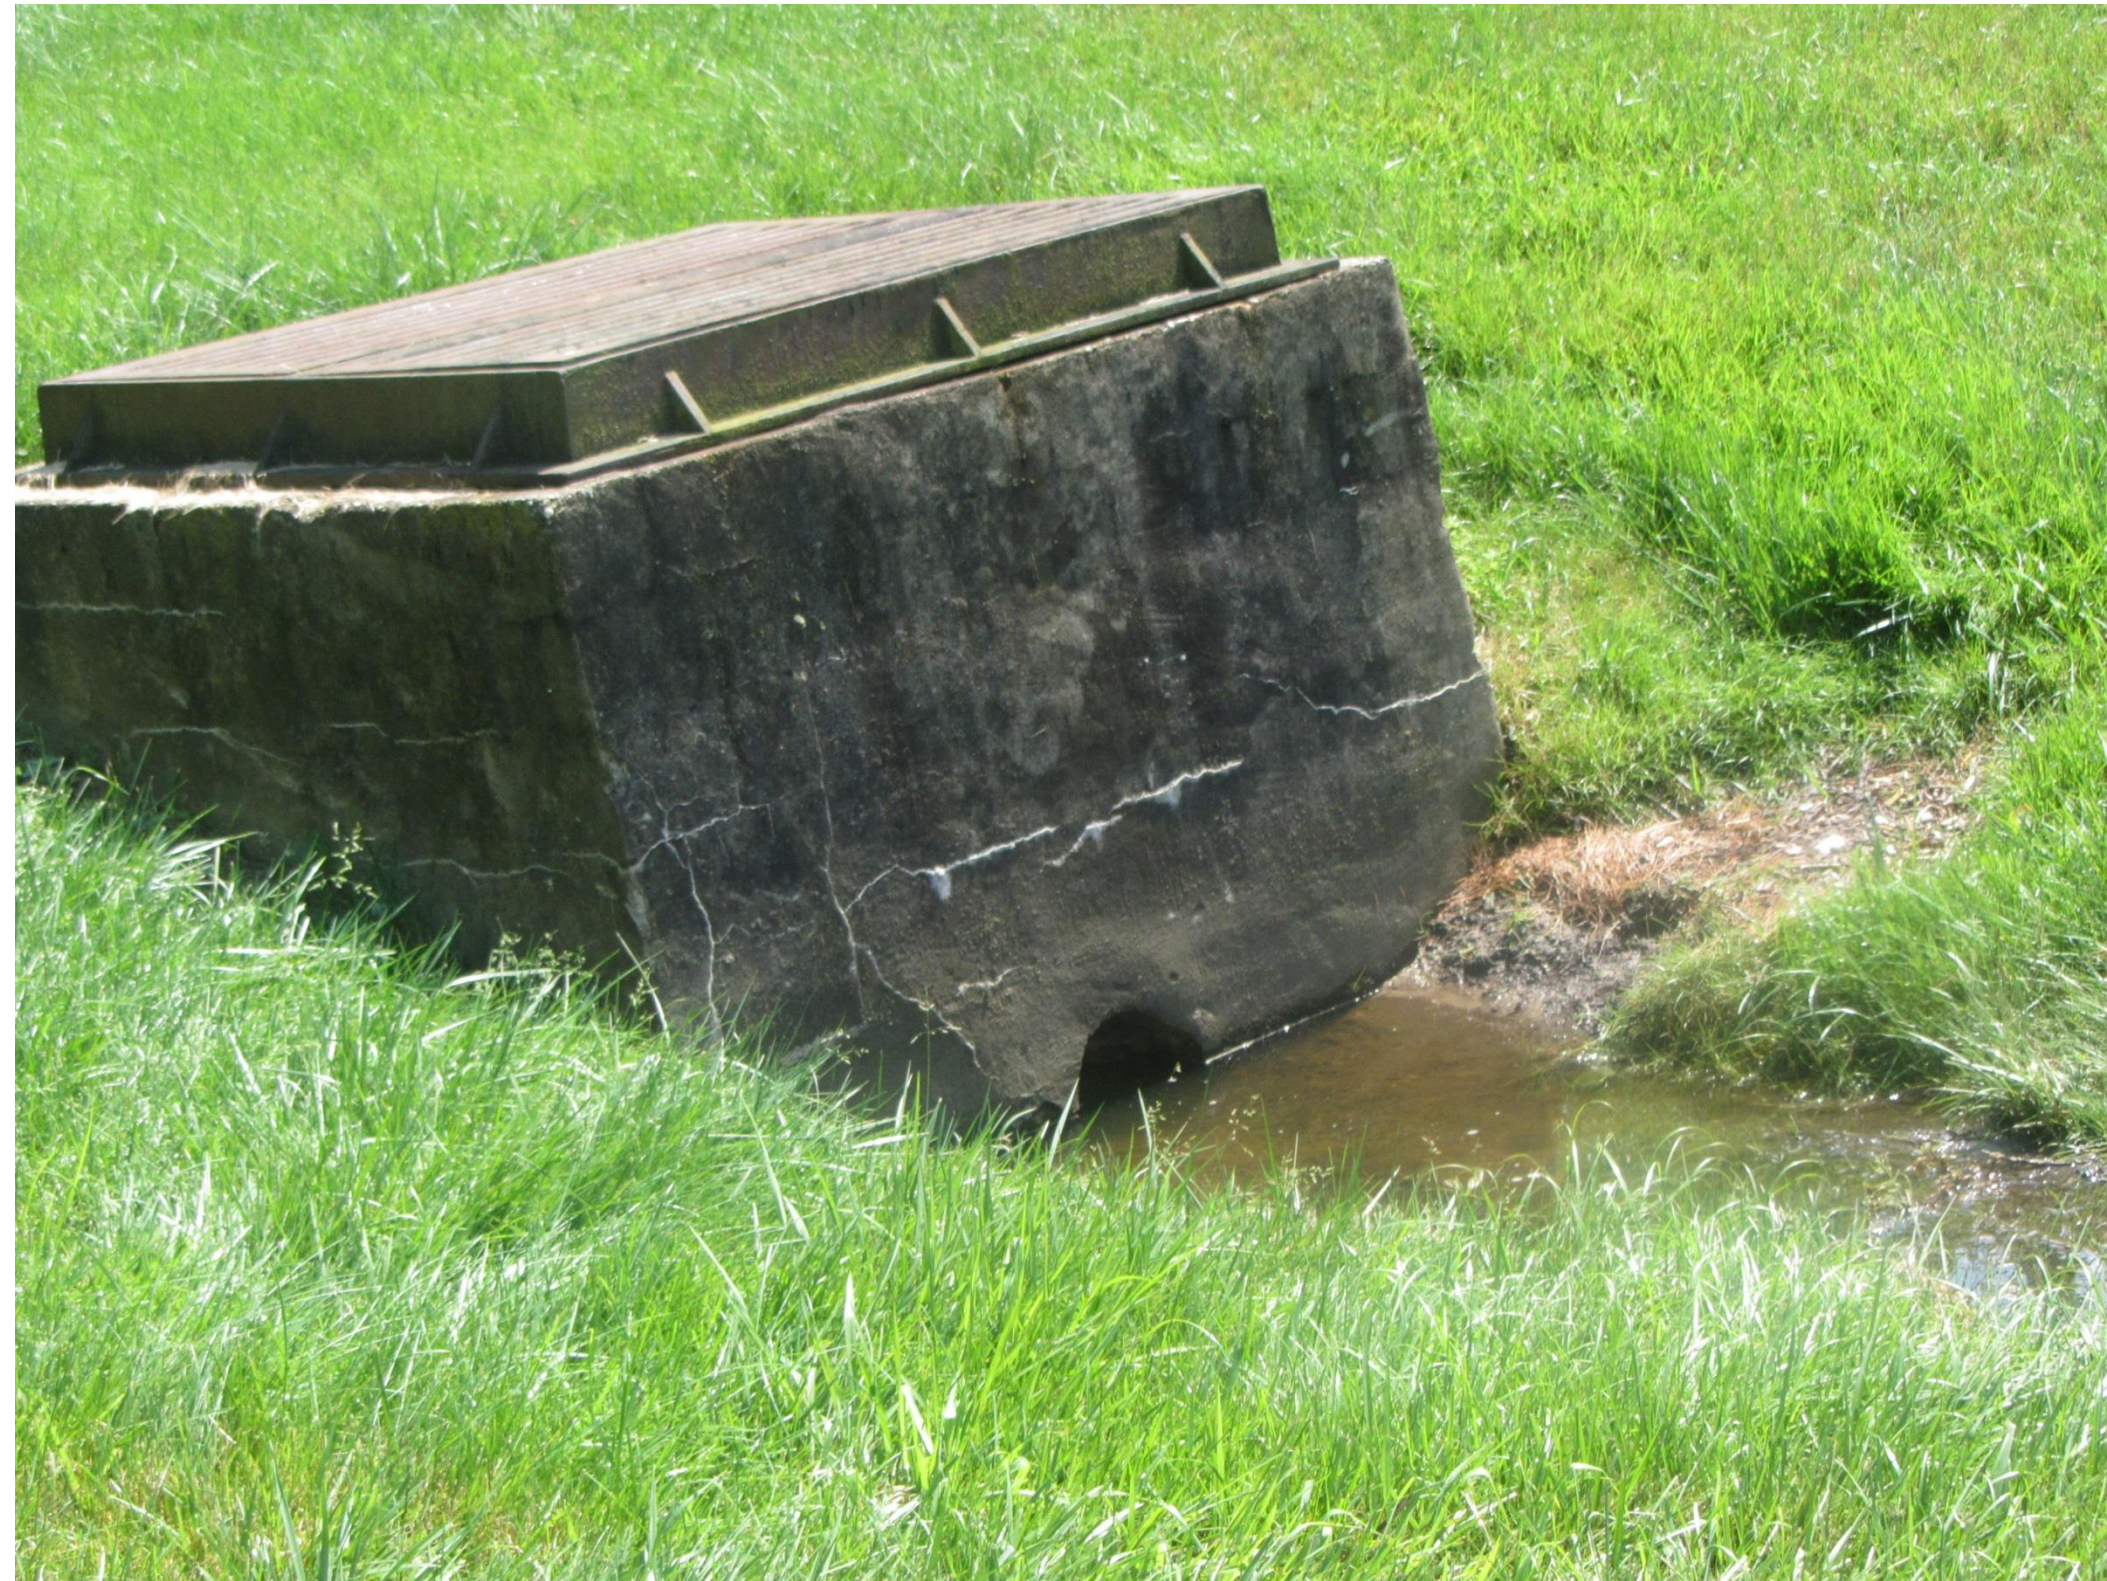
Outlet structure

- Outlet has minor cracks
- There is excess sediment accumulated and standing water in the low flow channel
- There is excess sediment accumulated in the outlet low flow orifice
- Eastern embankment has a large bare spot

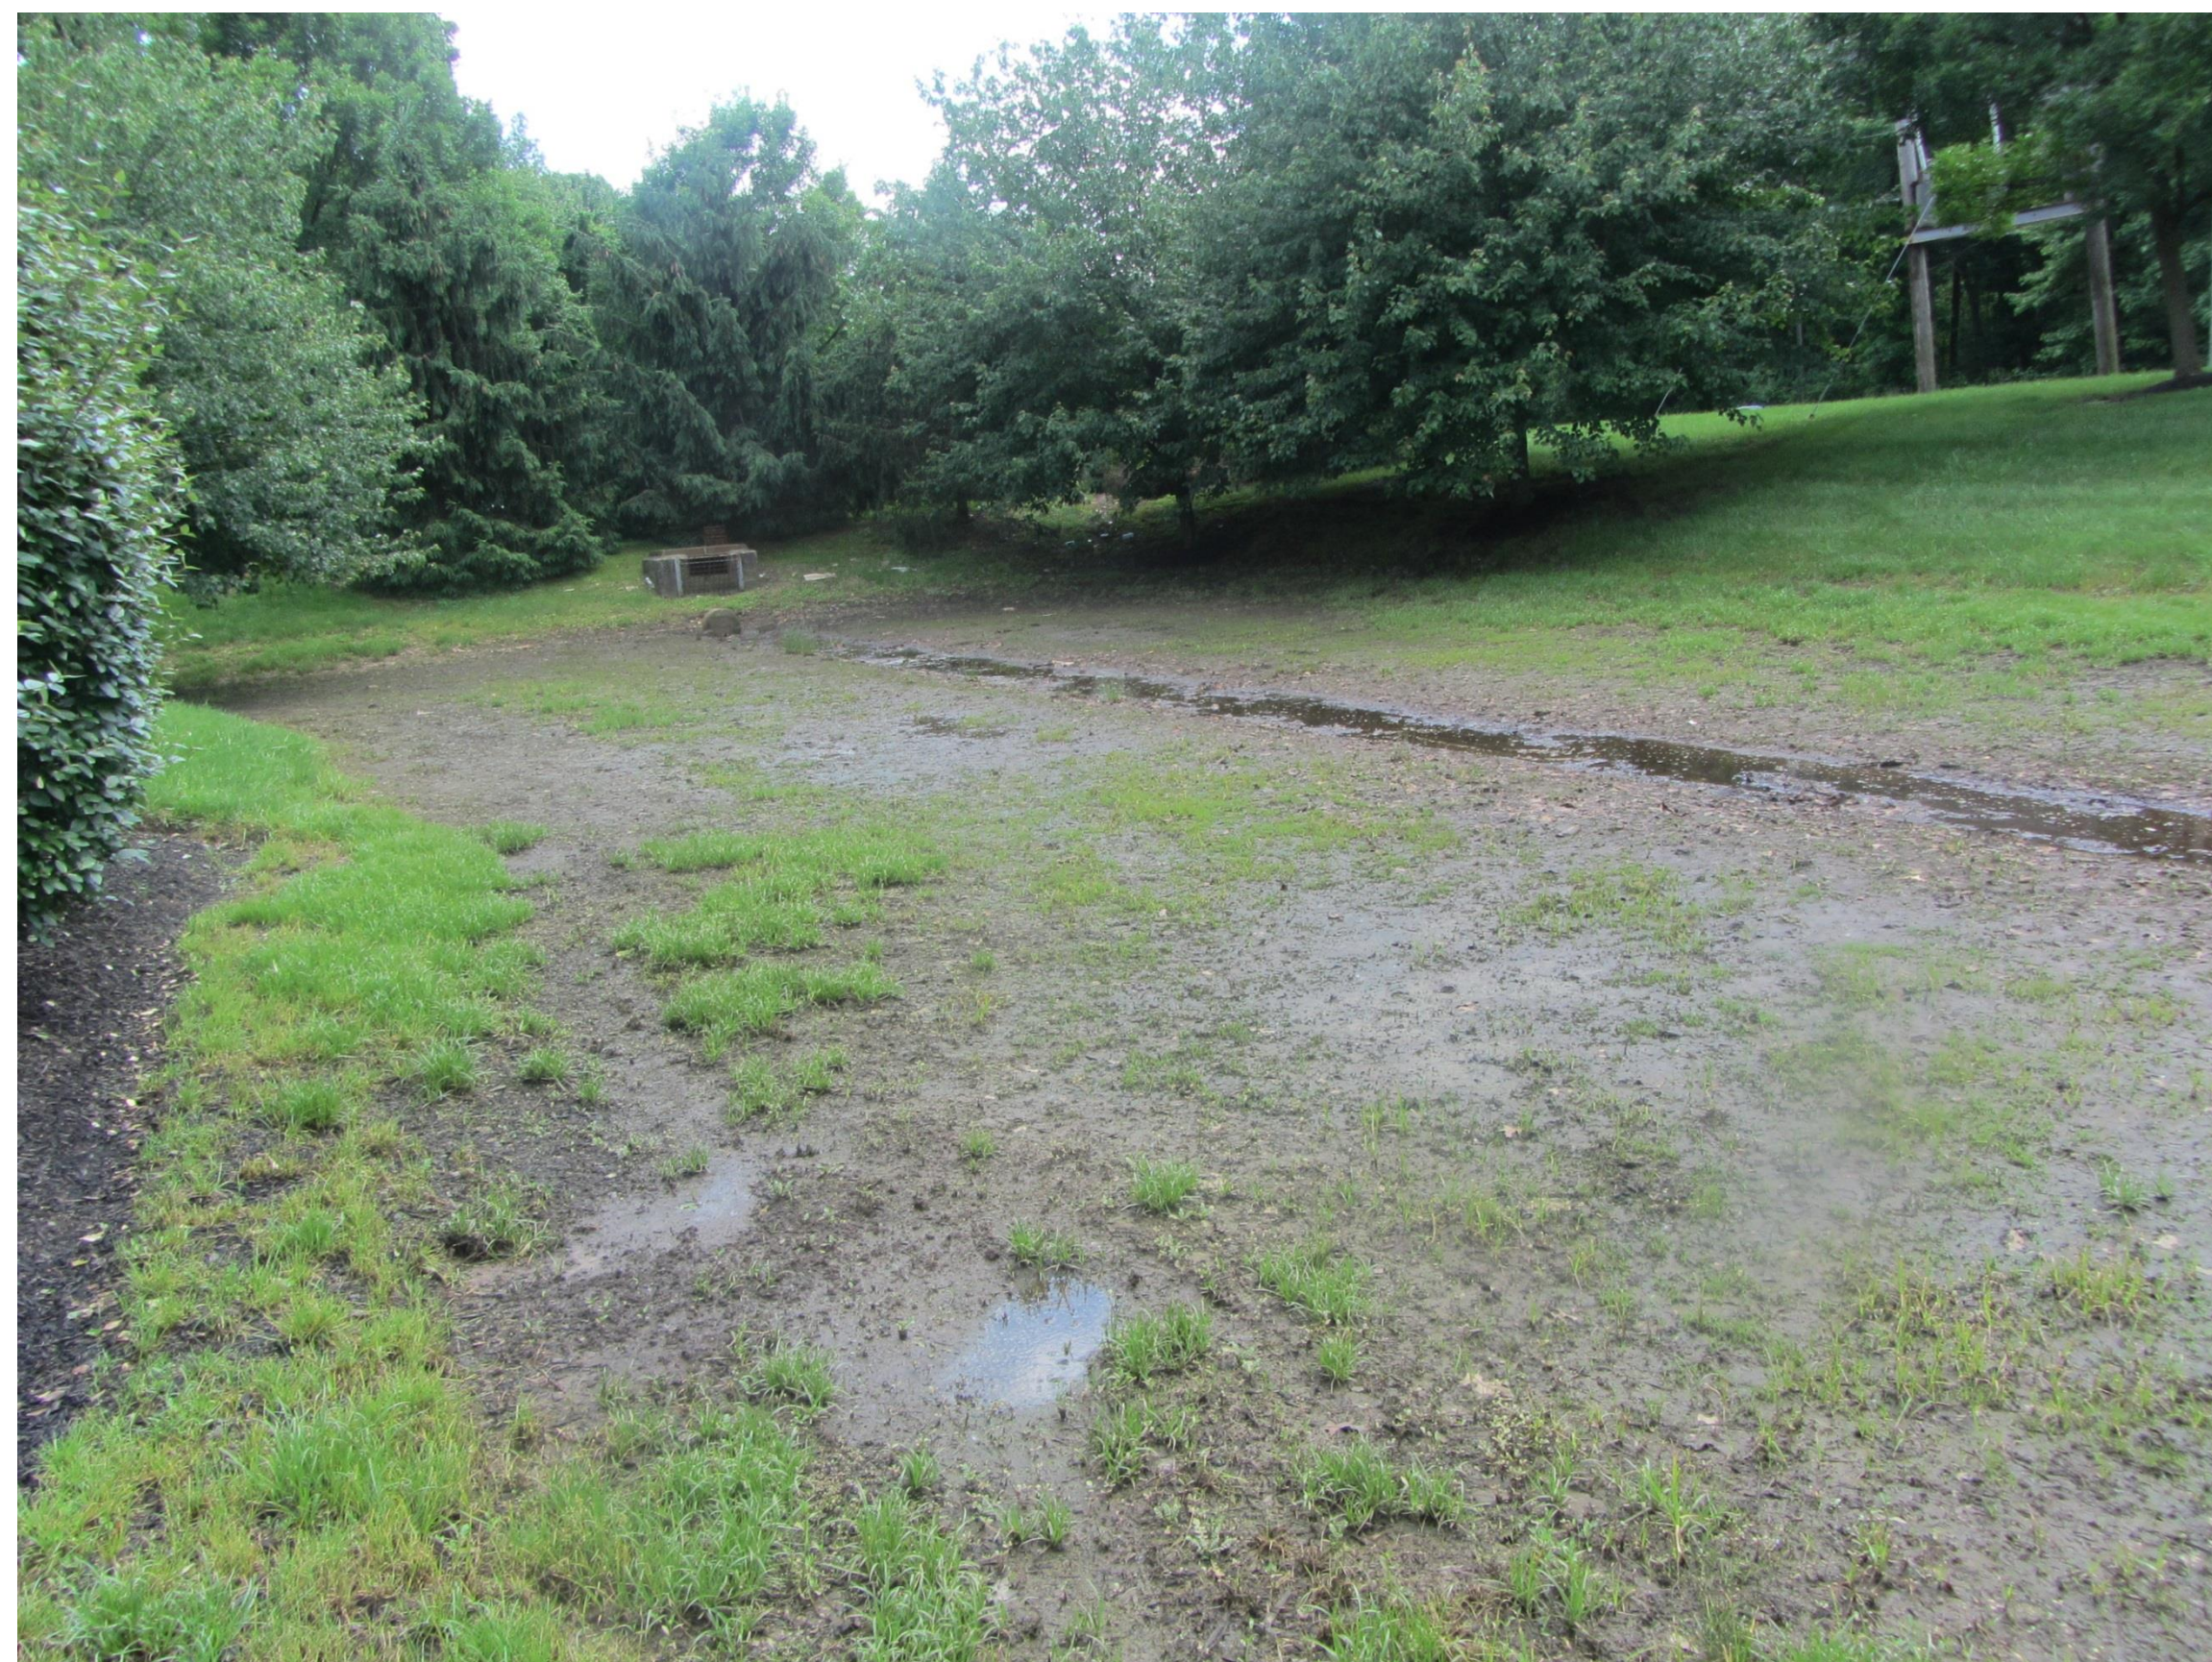
Bare and muddy southern section of basin

- Most eastern inlet has concrete deterioration with reinforcement showing
- There is excess sediment and leaves accumulated in the low flow channel and outlet orifice causing excessive ponding
- Southern end is primarily bare and muddy

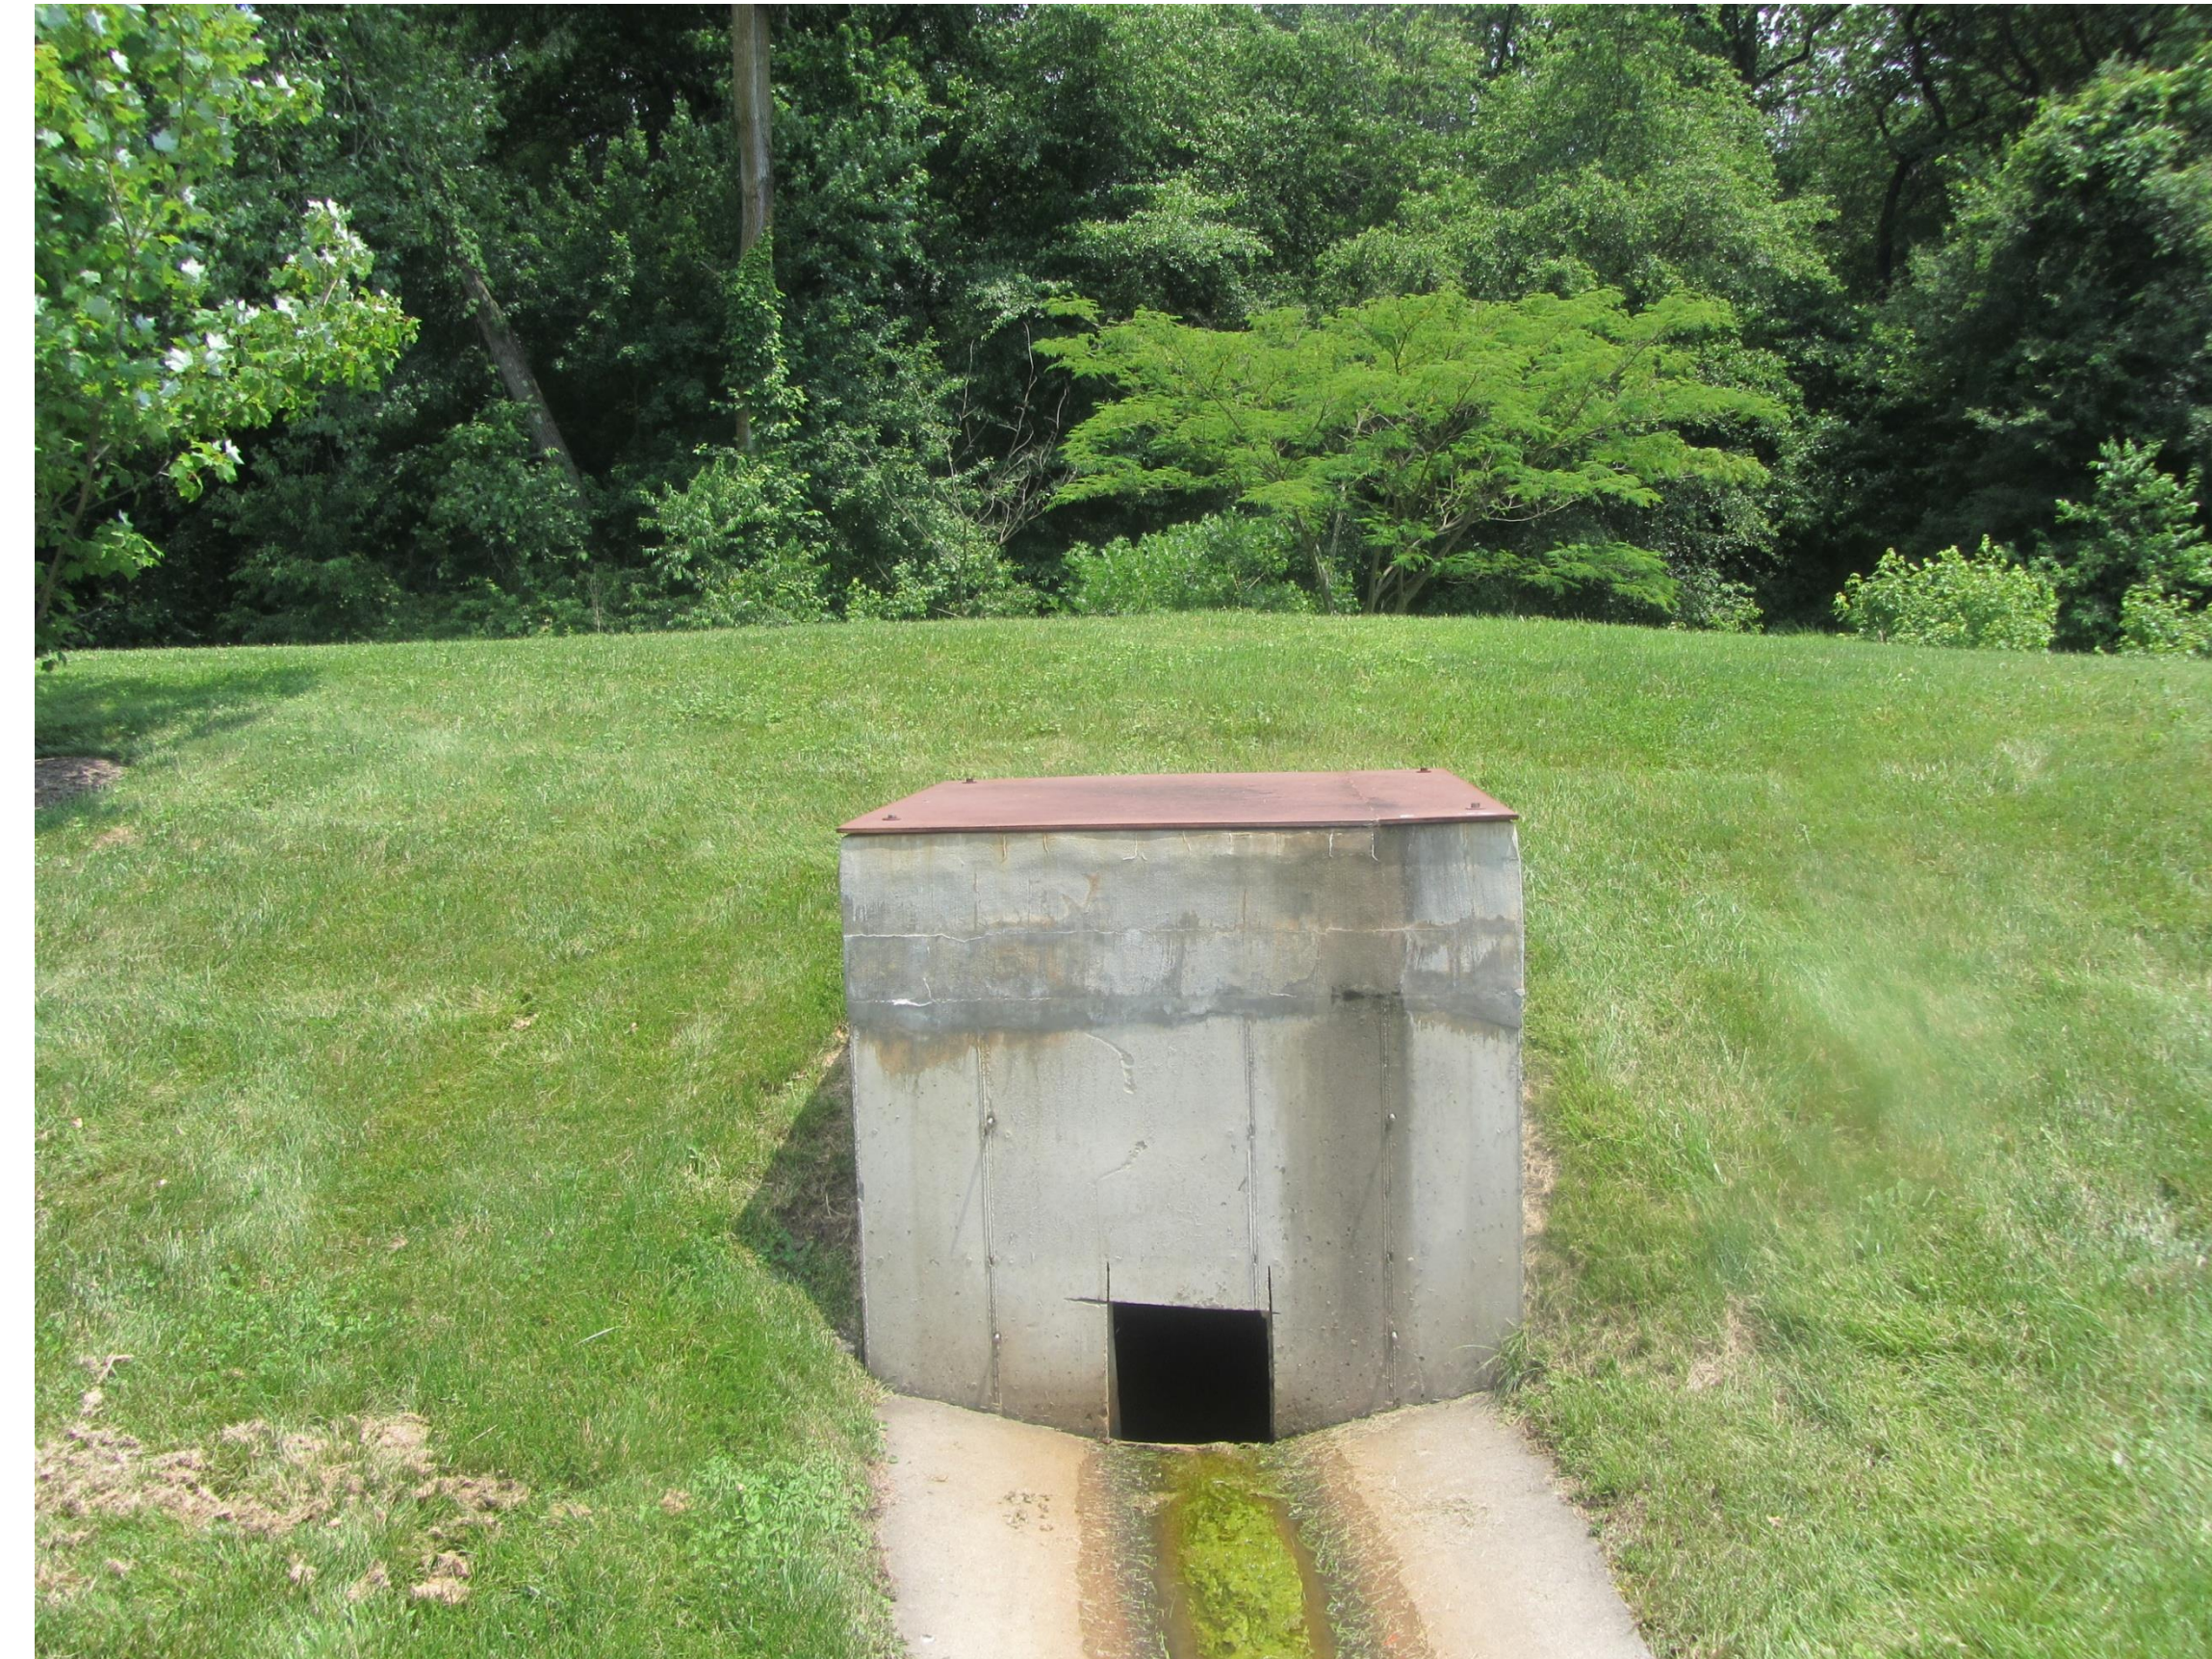
Outlet structure

- Standing water with algal growth in low flow channel
- Outlet has some breakage and the low flow orifice is crudely cut out, needs a restrictor plate
- Outlet has a metal plate bolted on top of the emergency overflow, this should be replaced with a grate

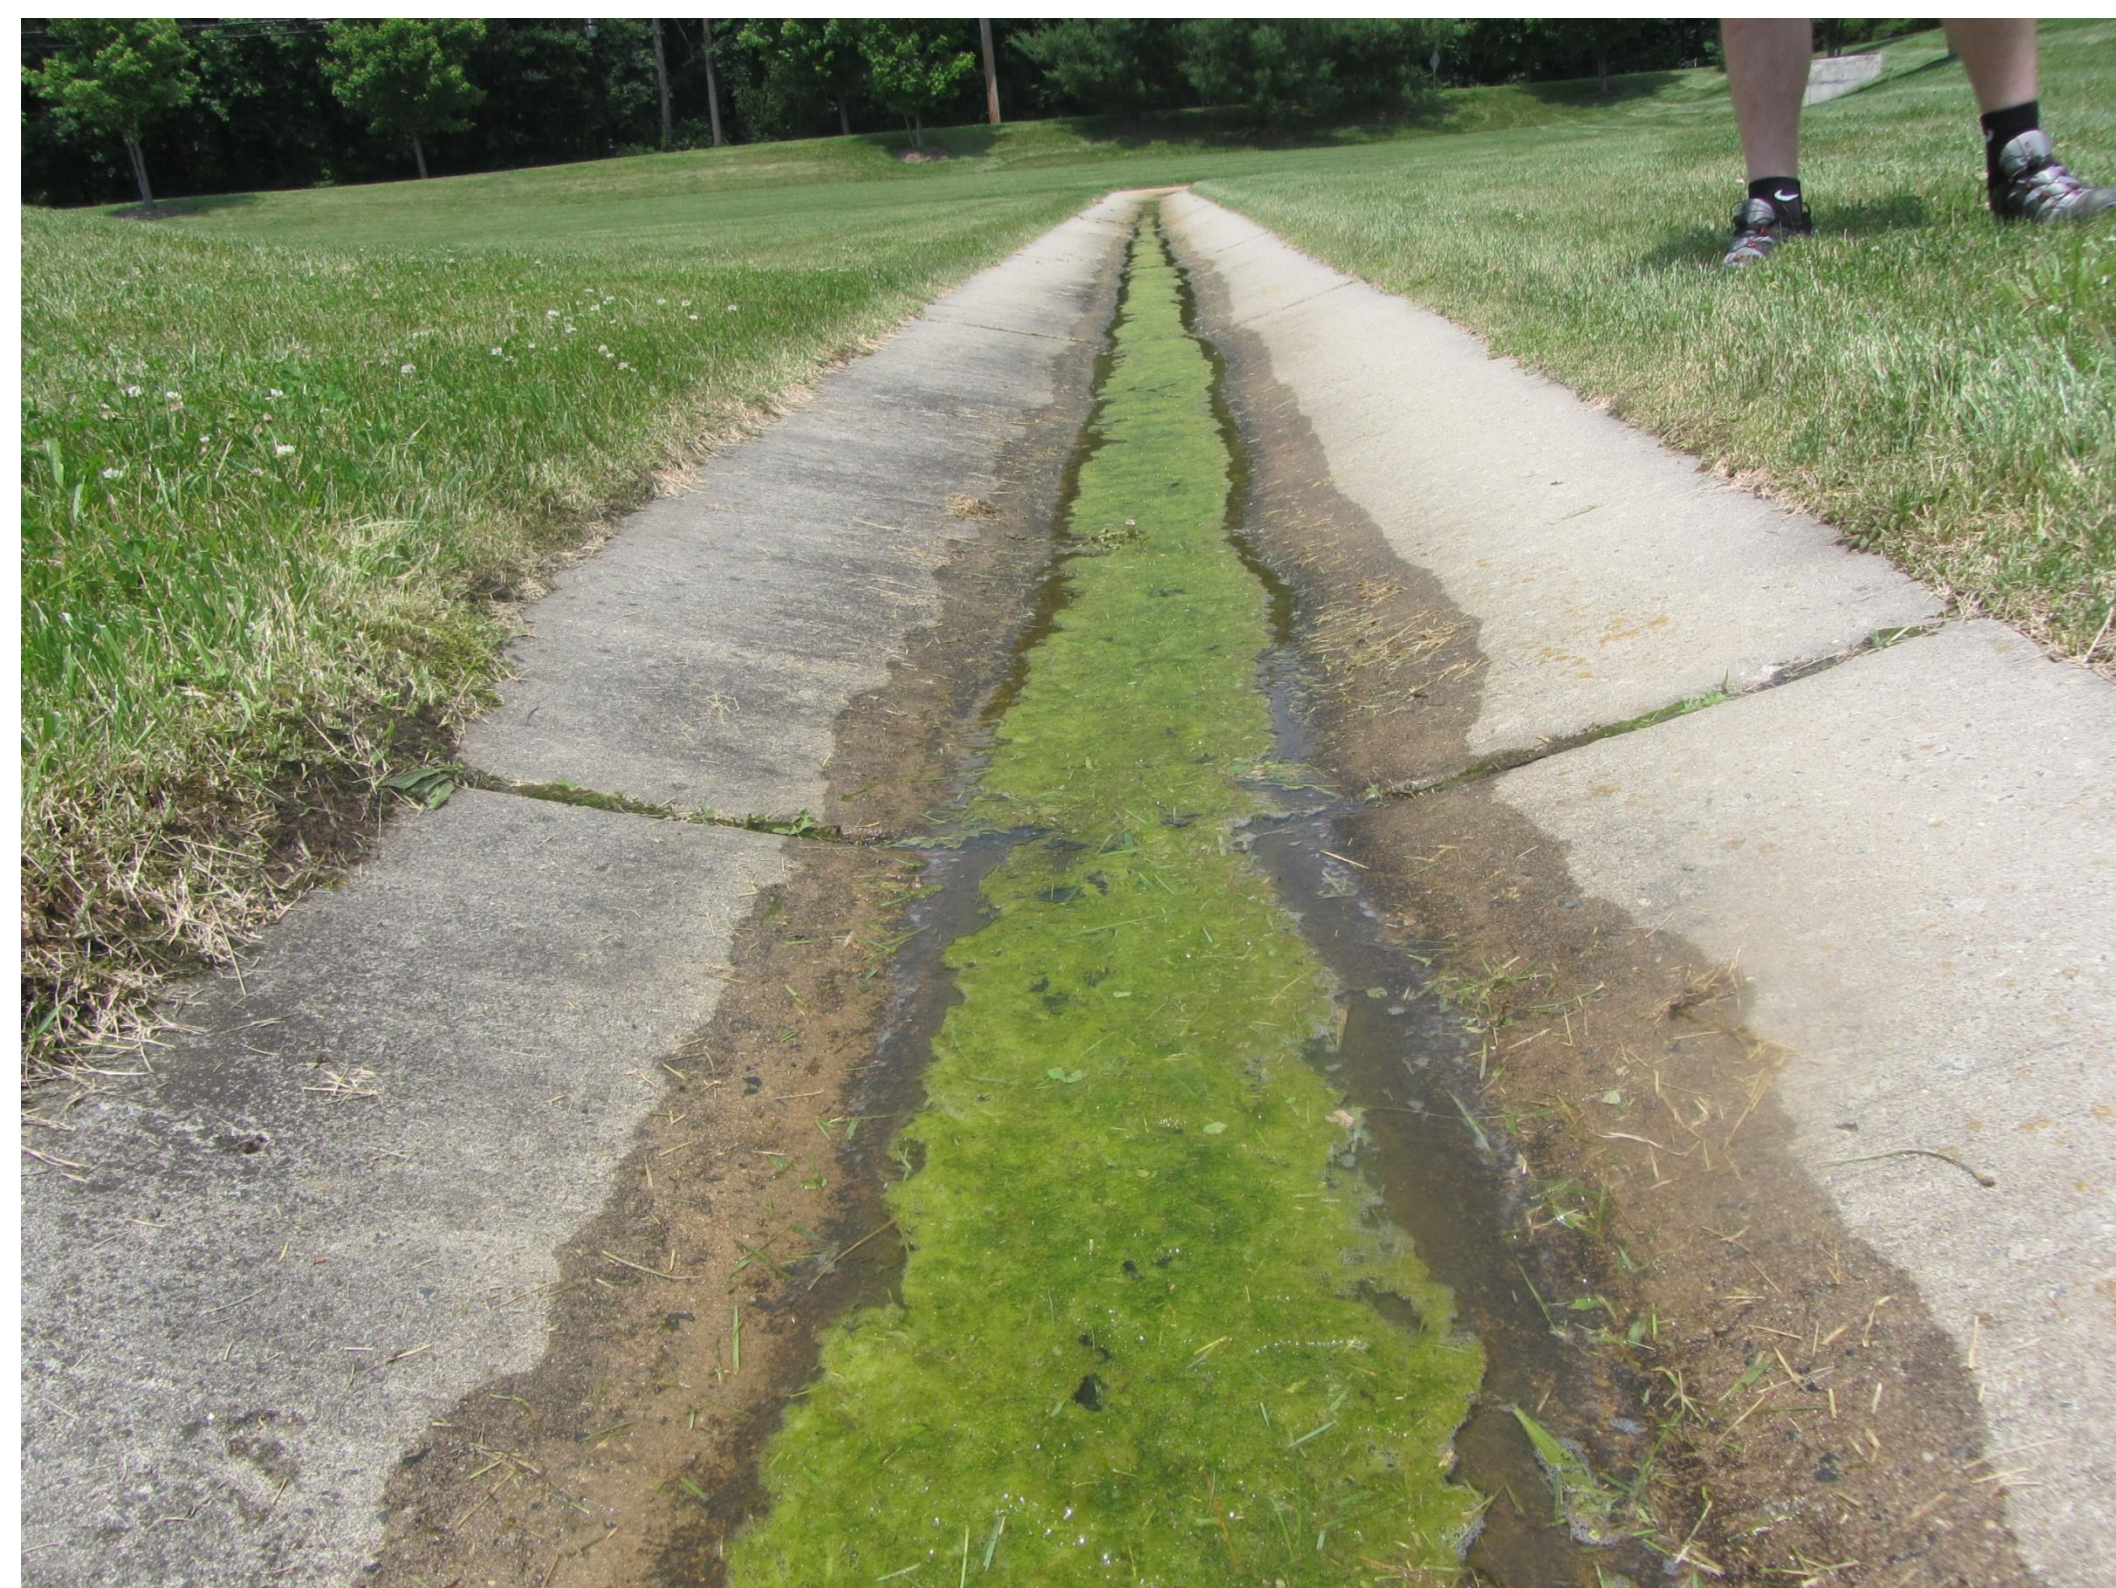
Algal growth in low flow channel

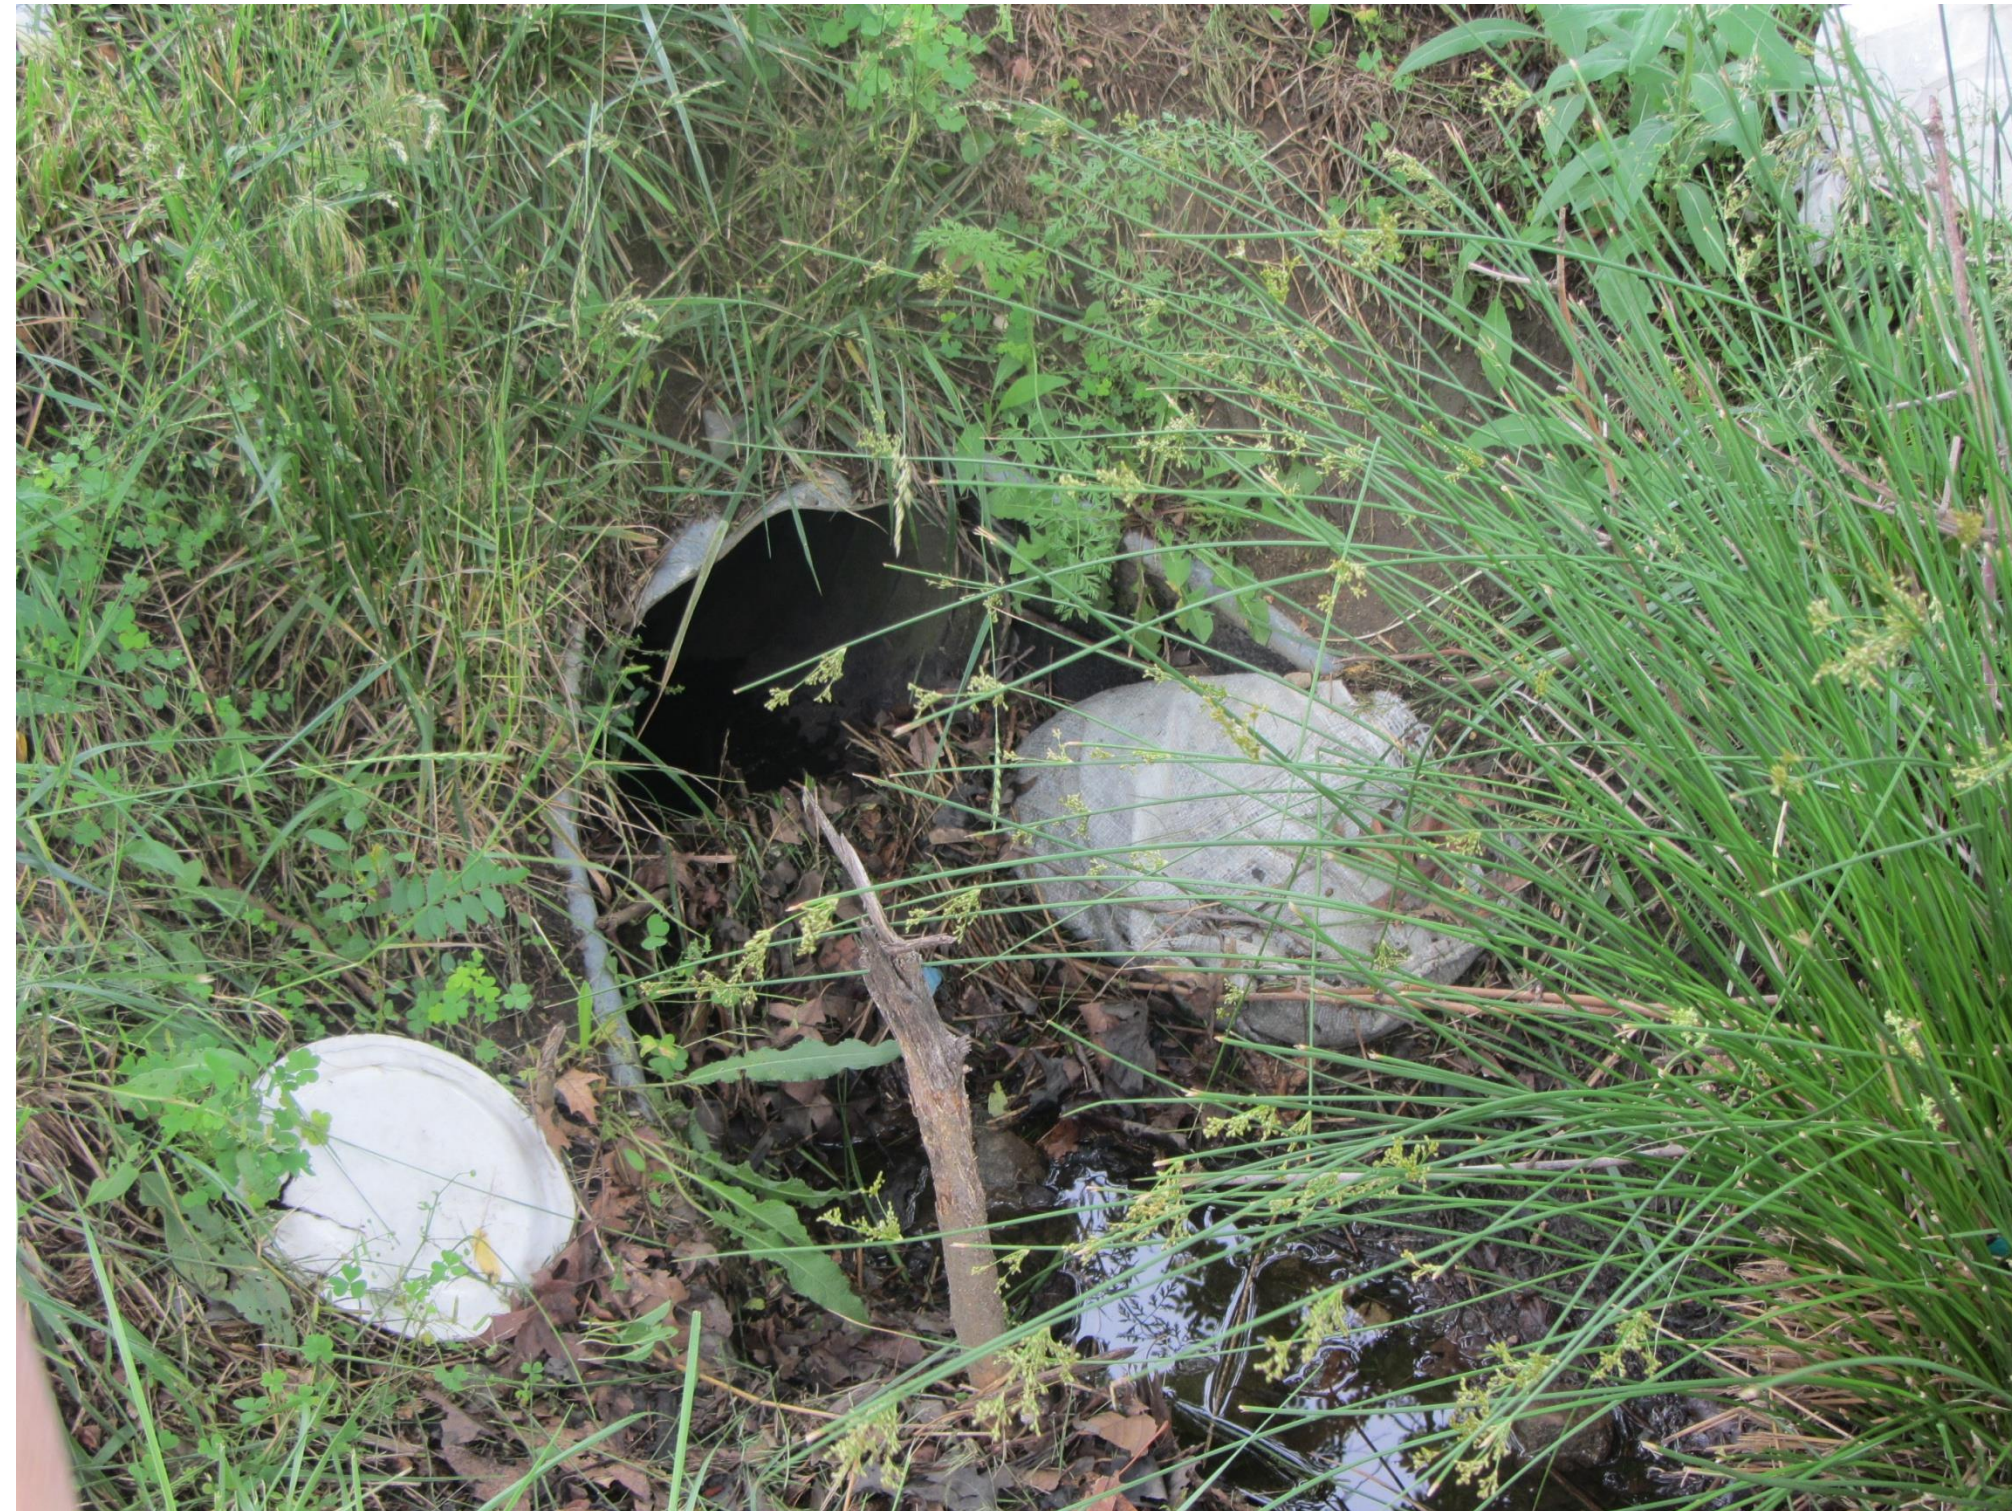
Overgrown outlet
