**Hamilton Township (Mercer County)
Stormwater Basin Assessment Summary
Past Priority Addendum (Year 5B)**

Developed by the Rutgers Cooperative Extension Water Resources Program
Funded by Hamilton Township, Mercer County, New Jersey

November 27, 2019

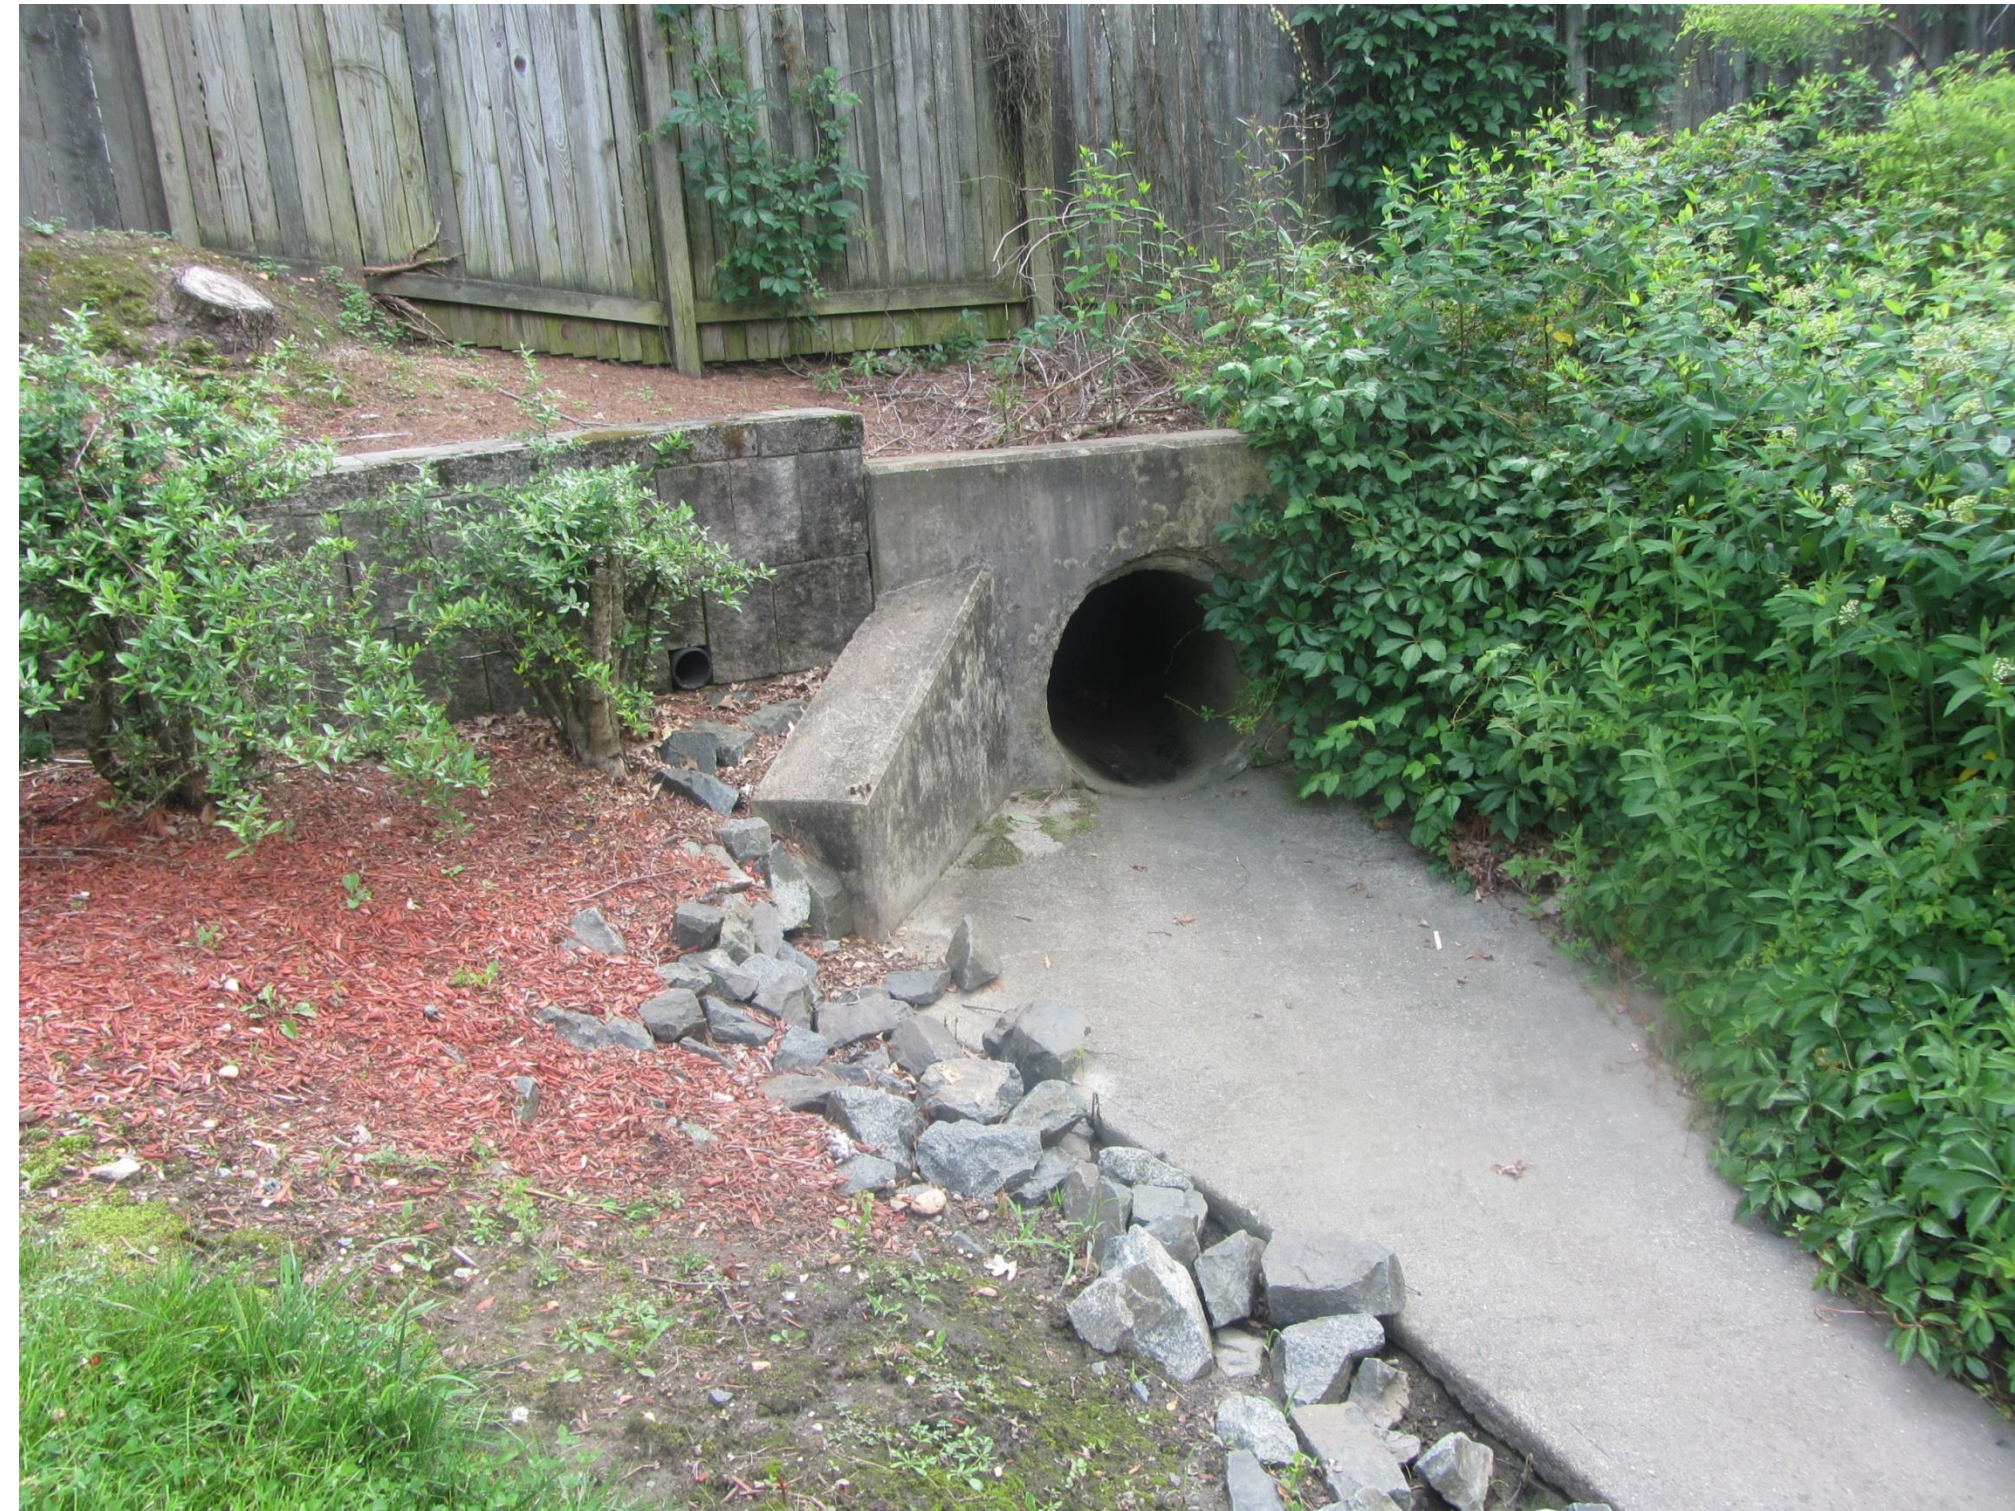
Overgrown southern inlet

- There is excess sediment accumulated in the low flow channel
- Southern inlet has erosion in surrounding rip rap and is overgrown on the west side
- The northeastern inlet has concrete deterioration on its Flared End Section (FES) and the northwestern inlet has rip rap restricting the flow of water
- The outlet low flow orifice is clogged with sediment, the primary weir could use a trash rack to prevent failures

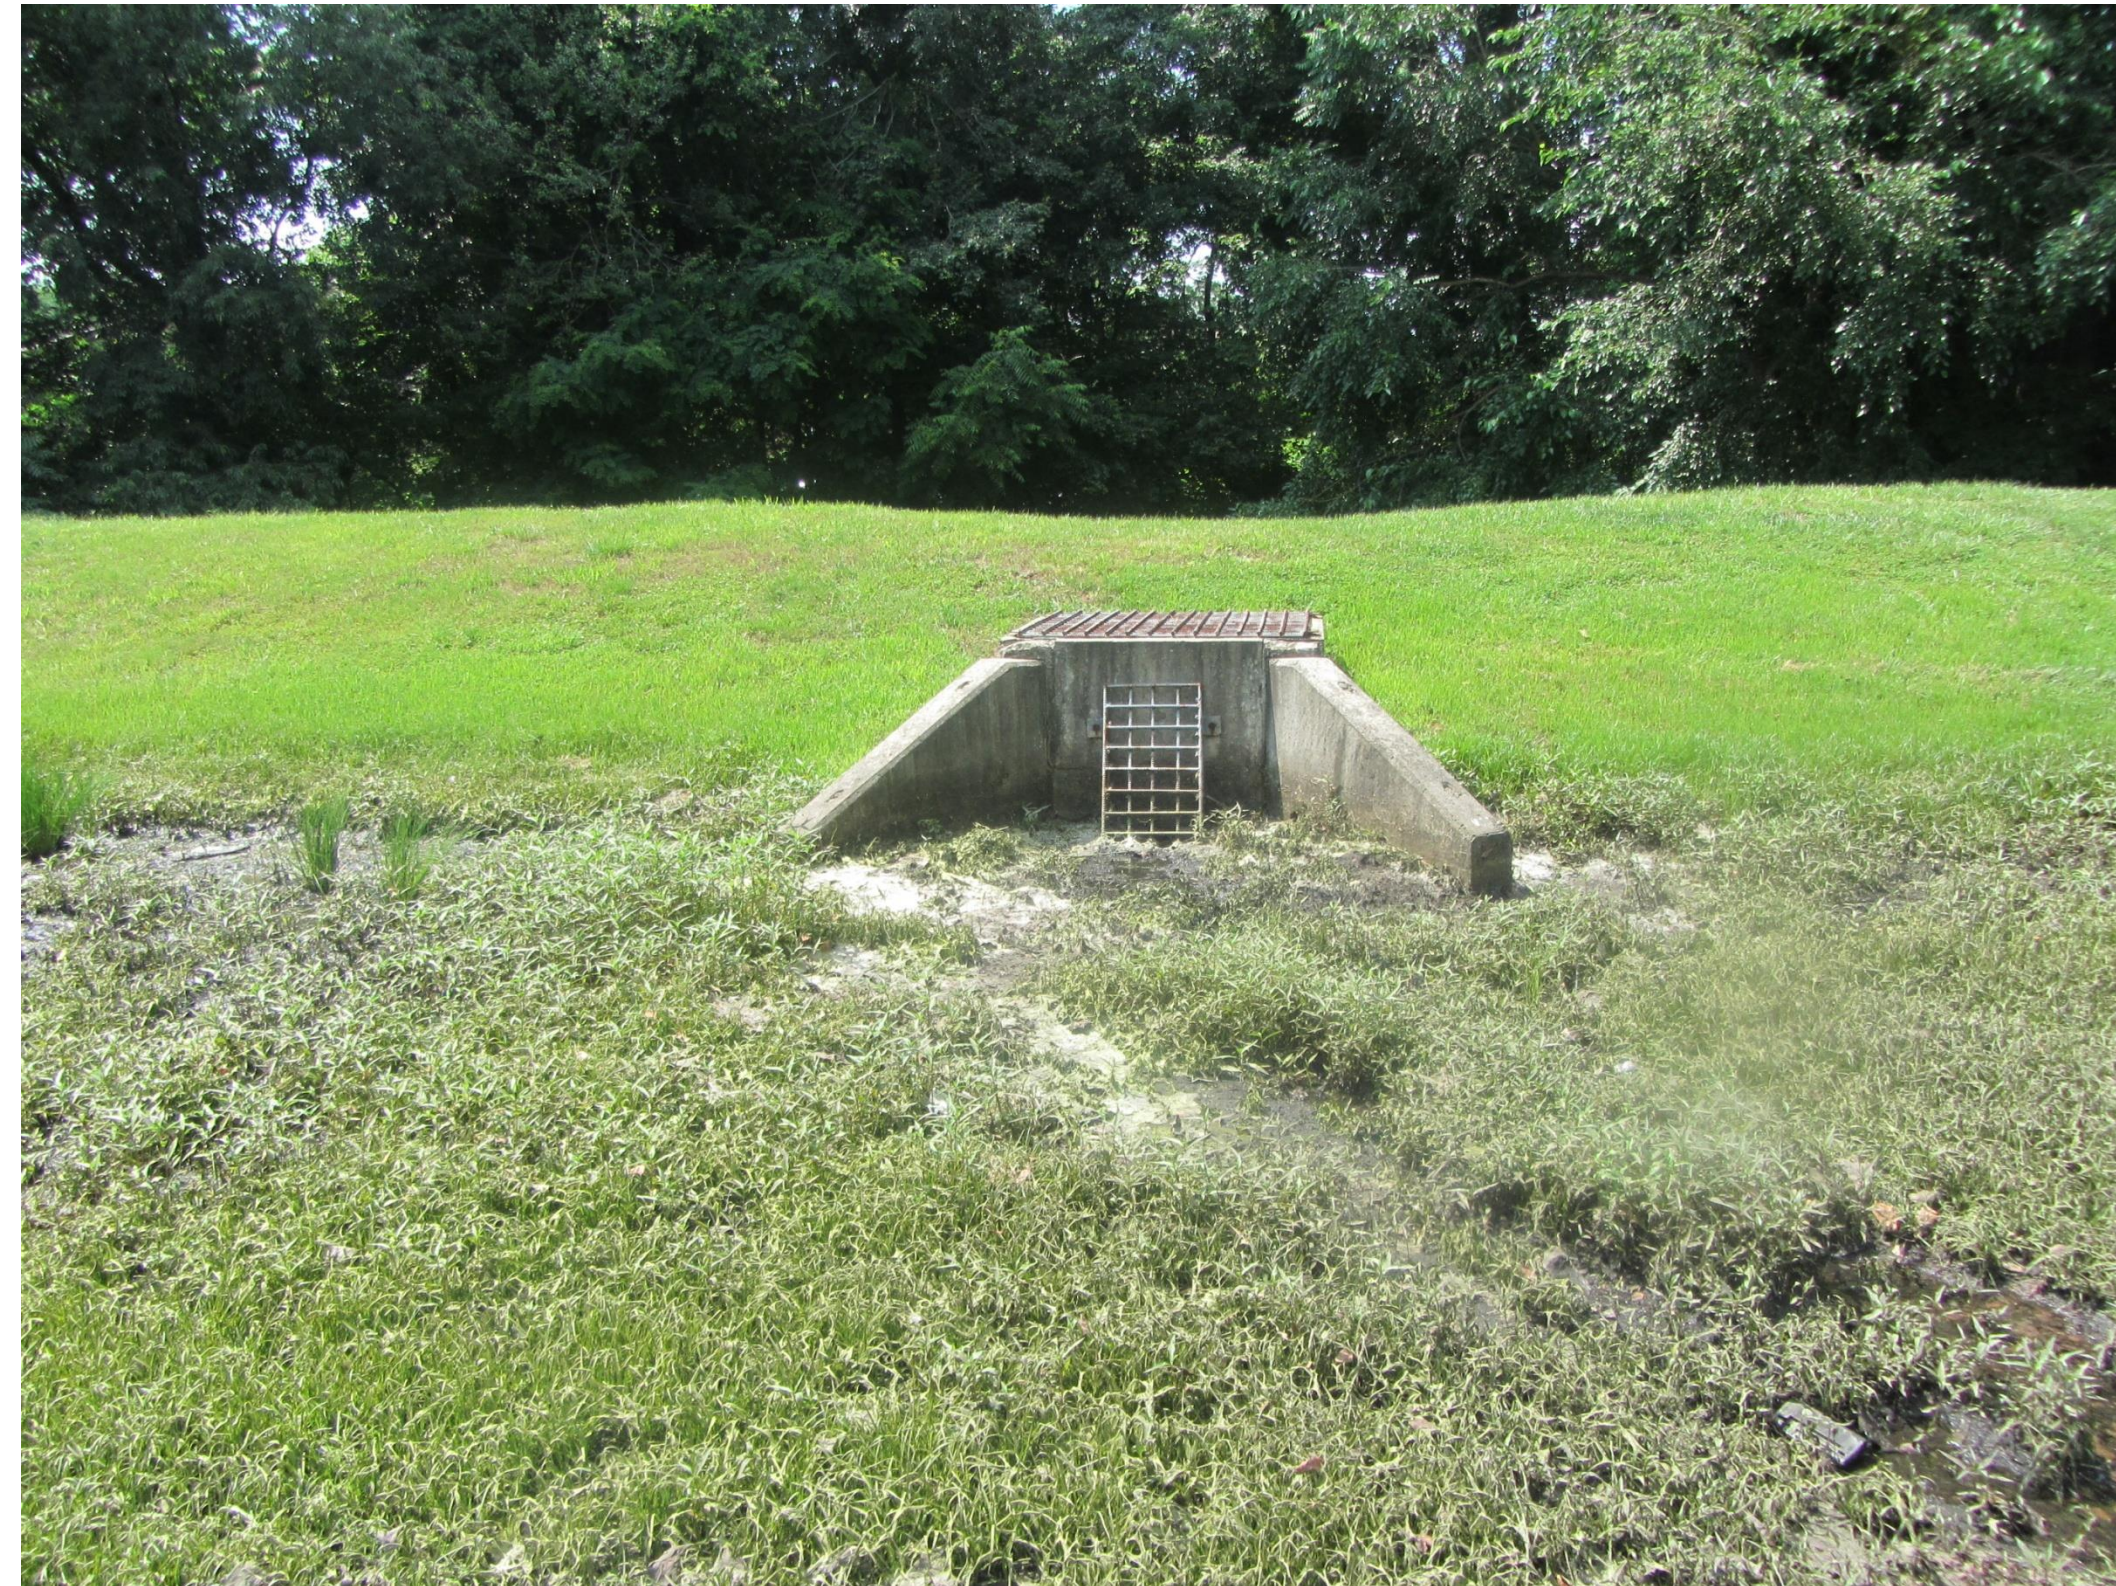
Outlet structure

- Grass clippings in basin clogging low flow orifice
- Naturalize with herbaceous plants

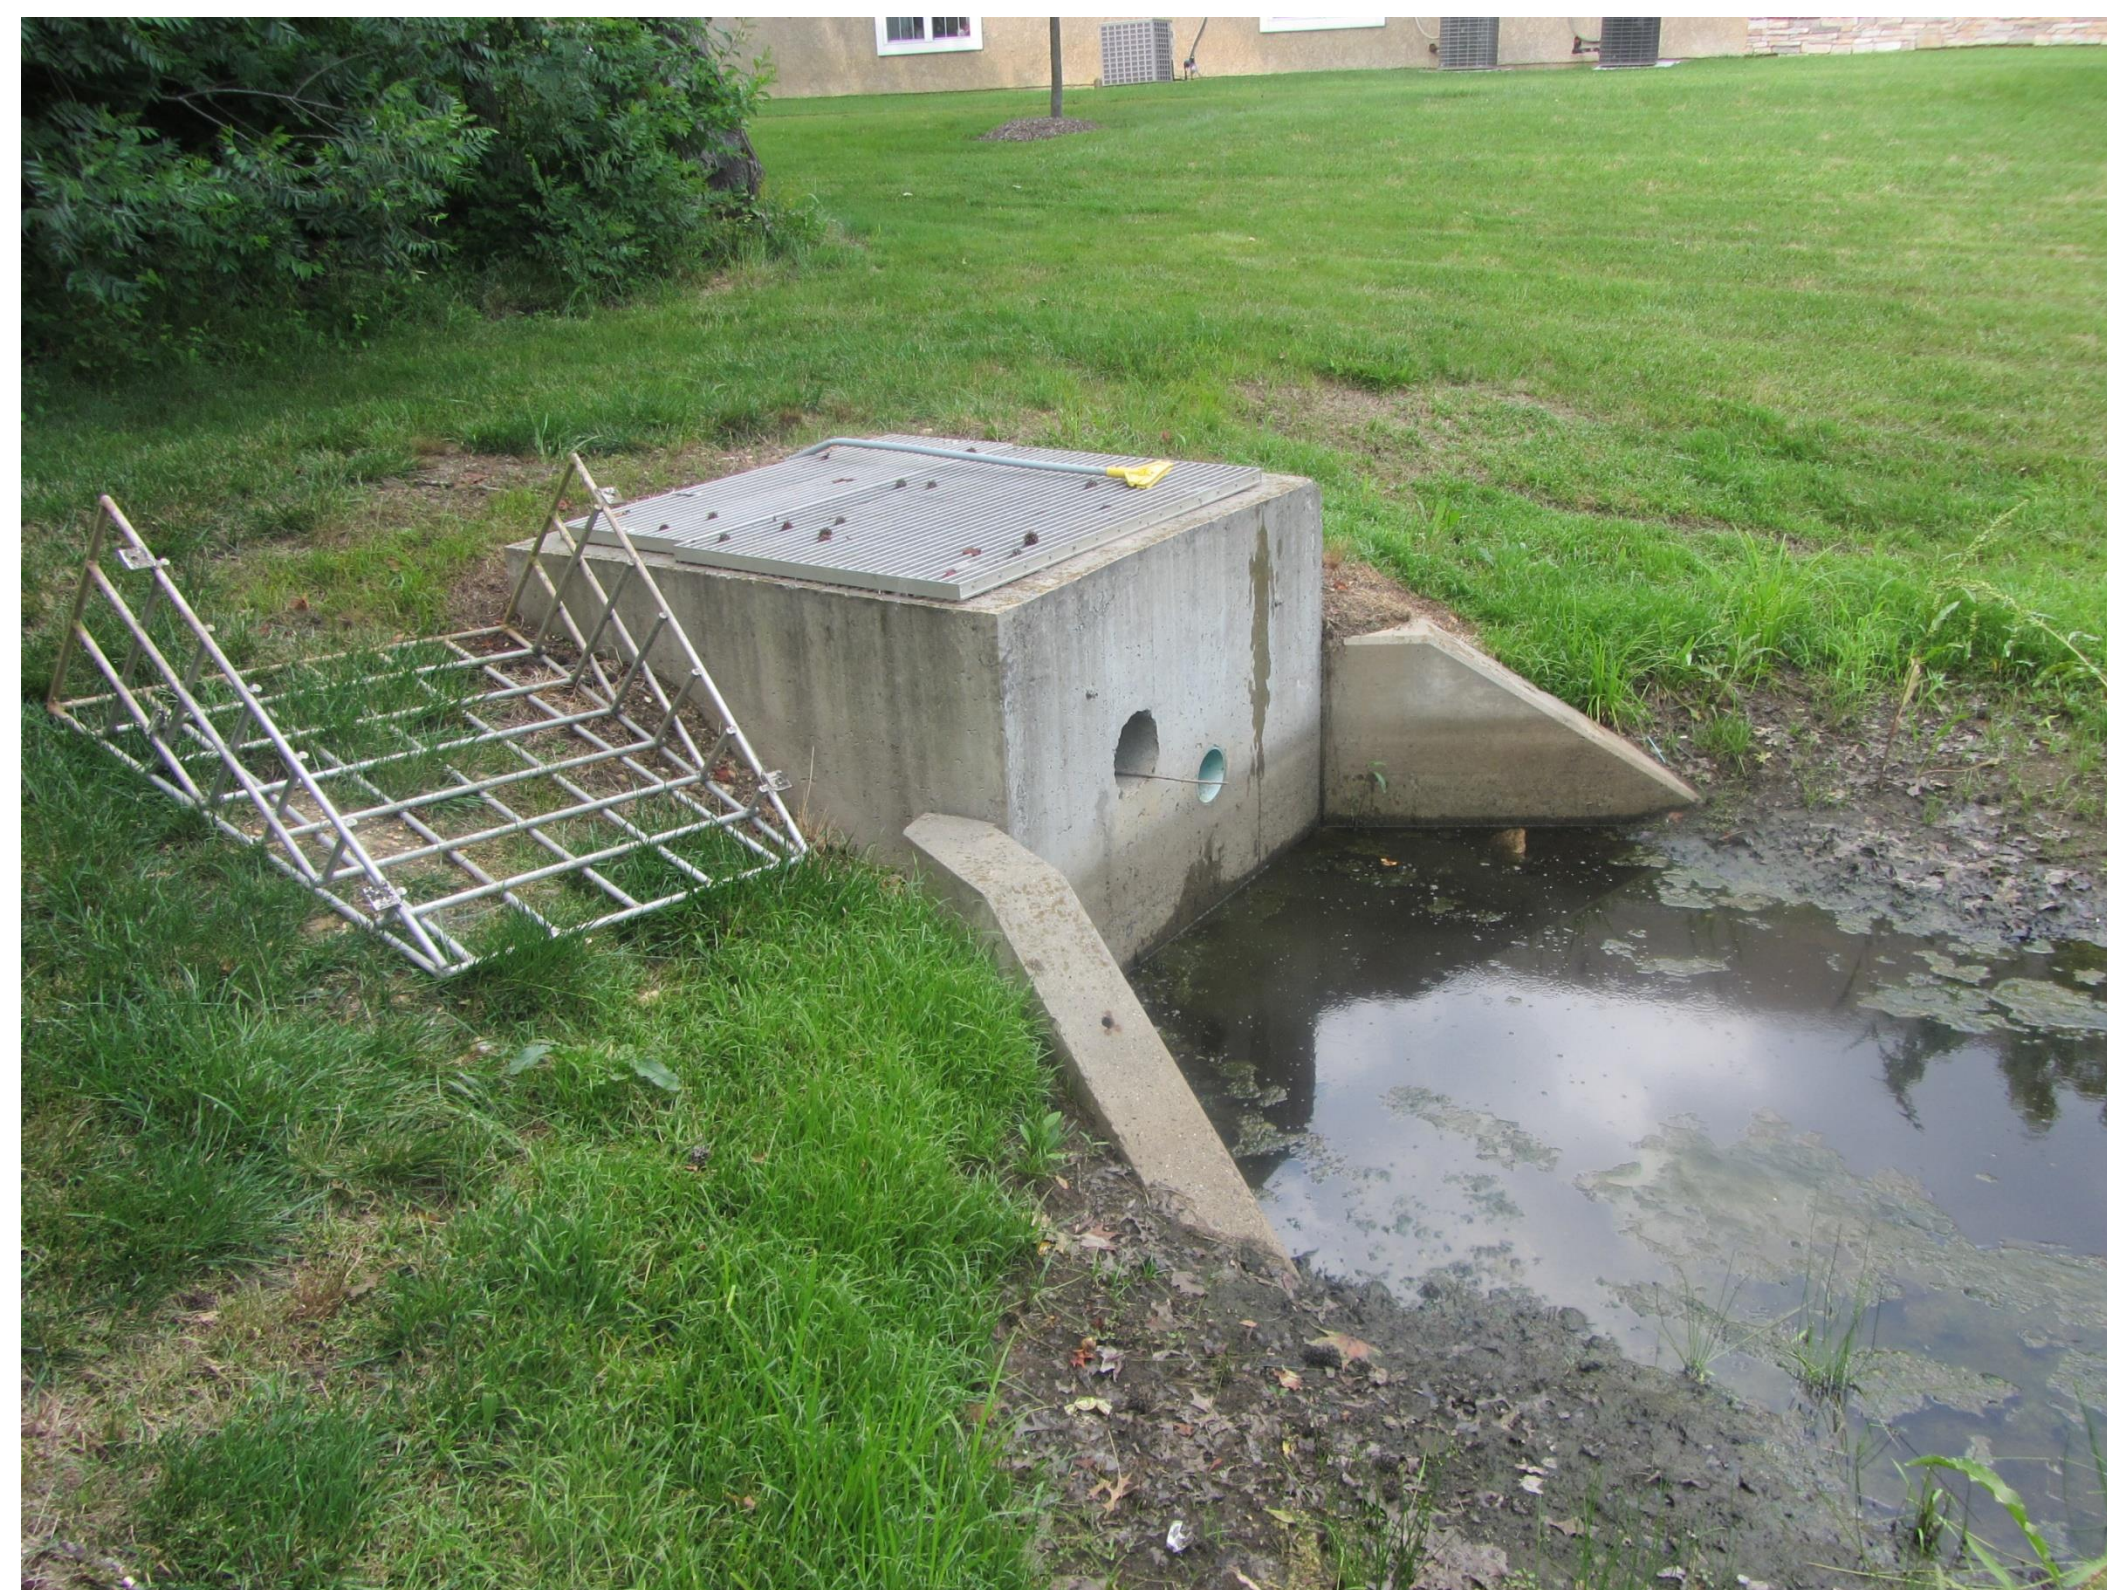
Outlet structure

- Standing water in basin bottom with algal growth
- Trash rack for outlet structure is broken off
- Outlet low flow orifice is clogged with sediment and leaves, restricting the flow of water
- The inlets have some breakage and debris accumulation restricting the flow of water

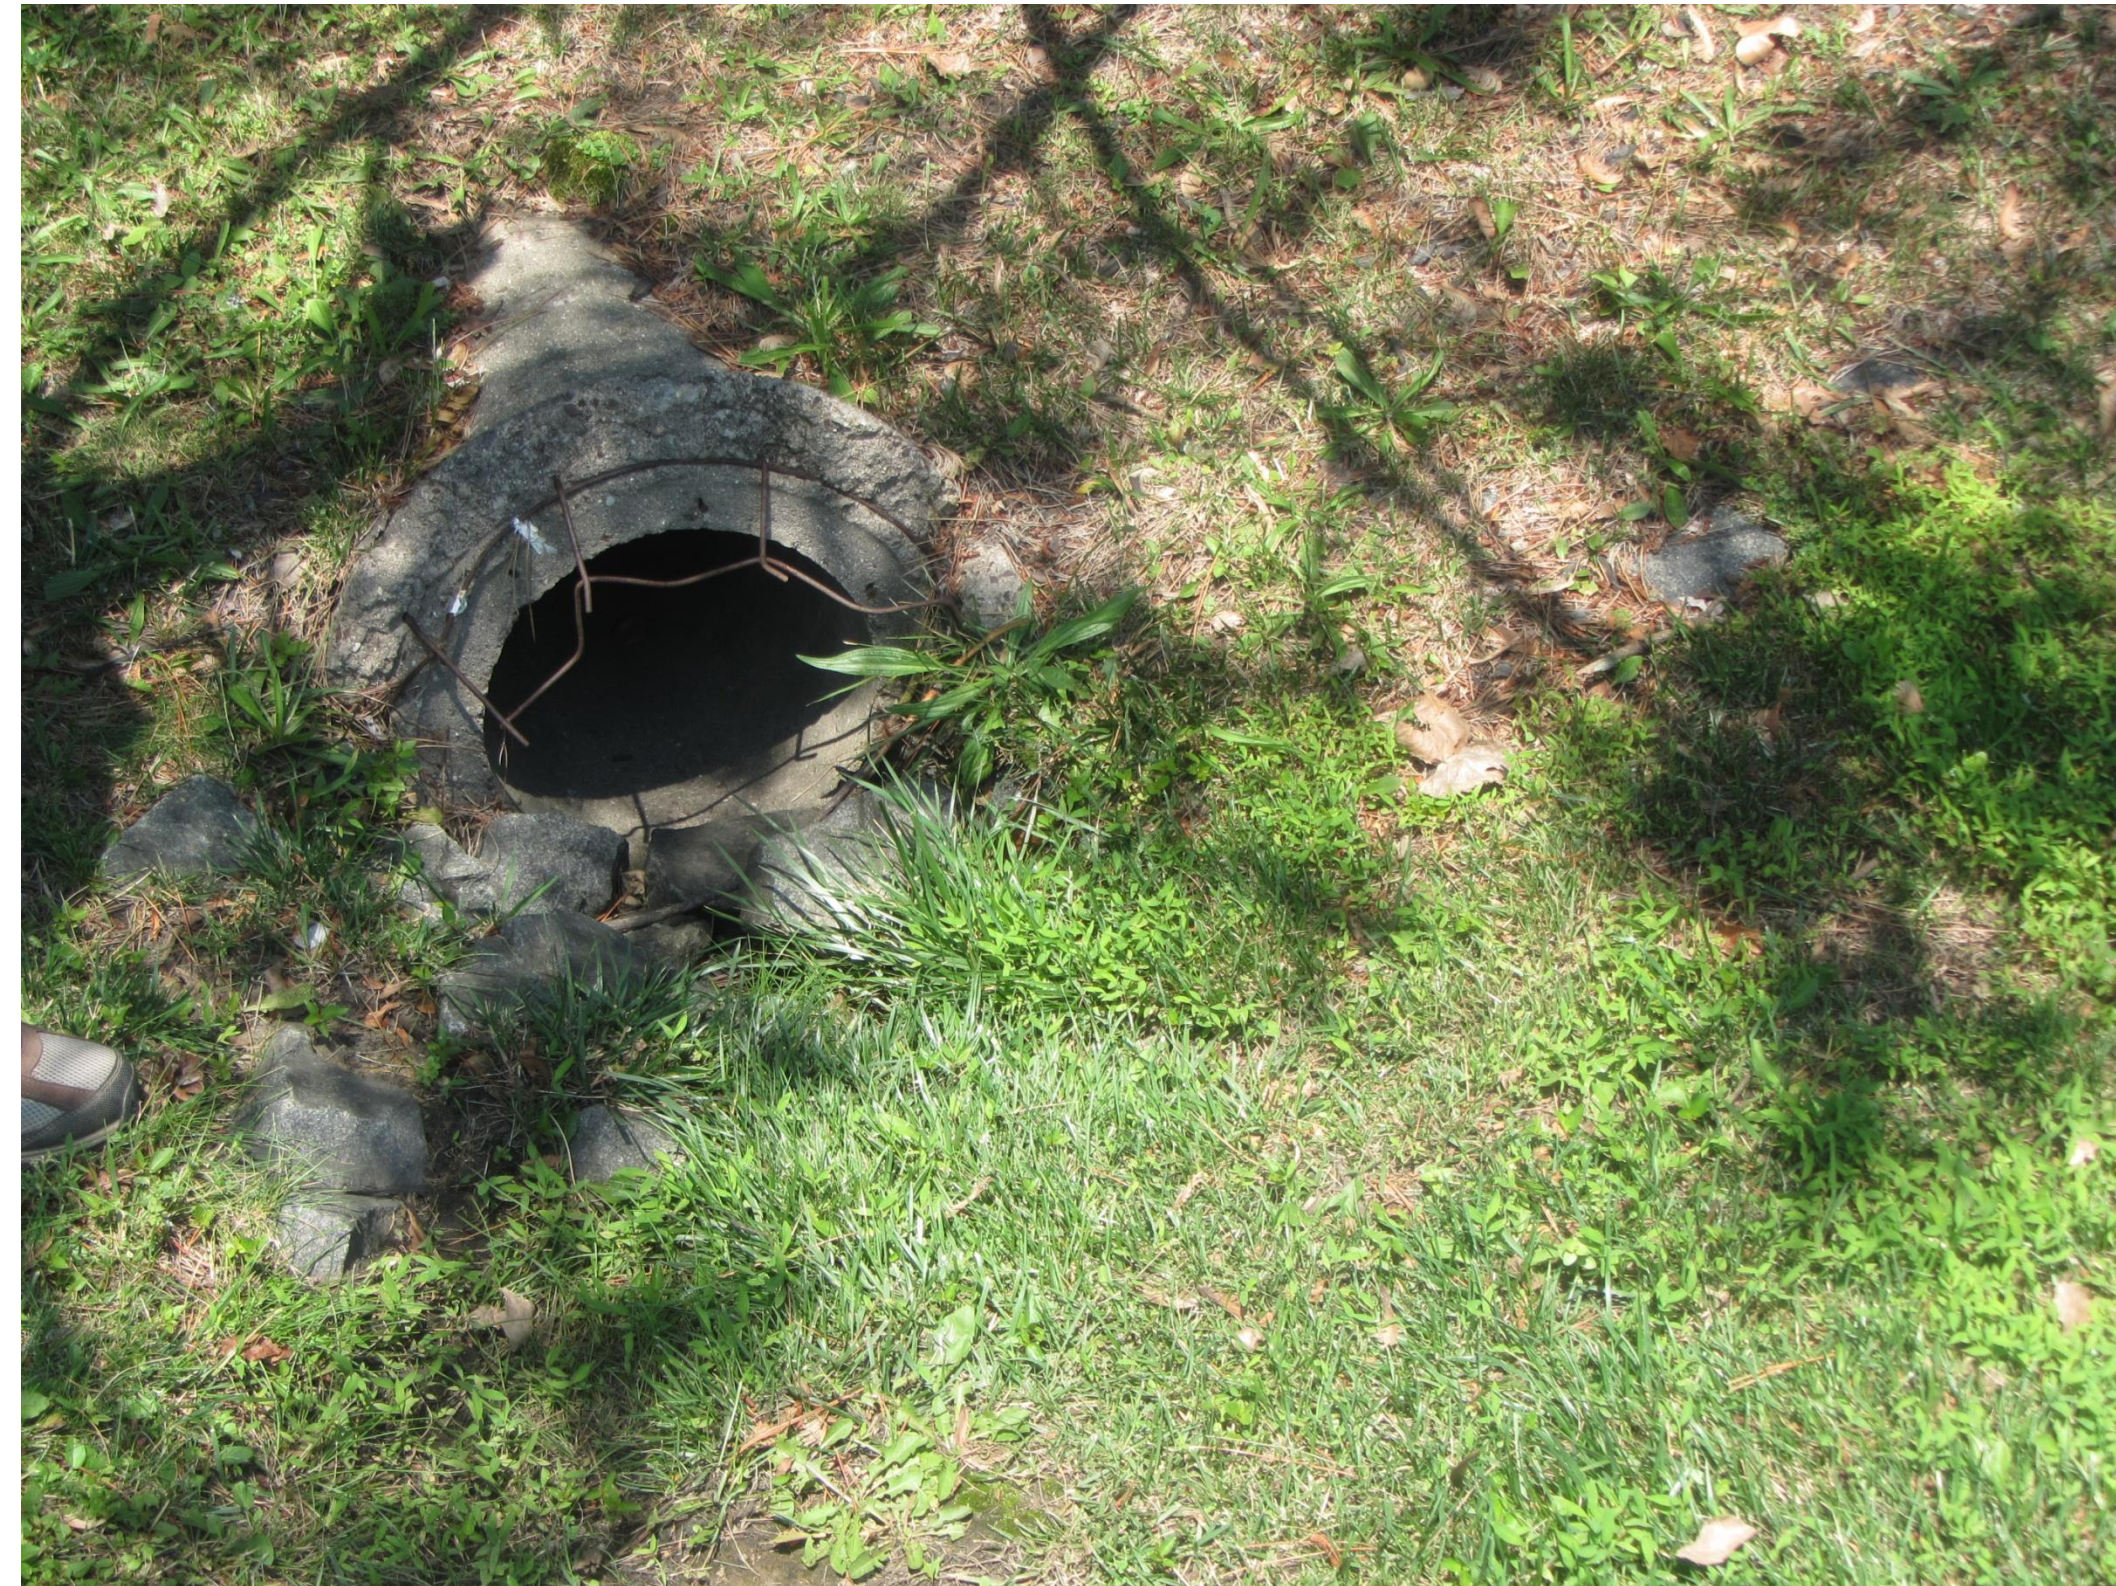
- The basin allows infiltration of stormwater
- Curb cut inlet has severe erosion and breakage
- Outlet pipe has breakage, there is debris and rip rap restricting the flow of water and woody tree growth in proximity of outlet

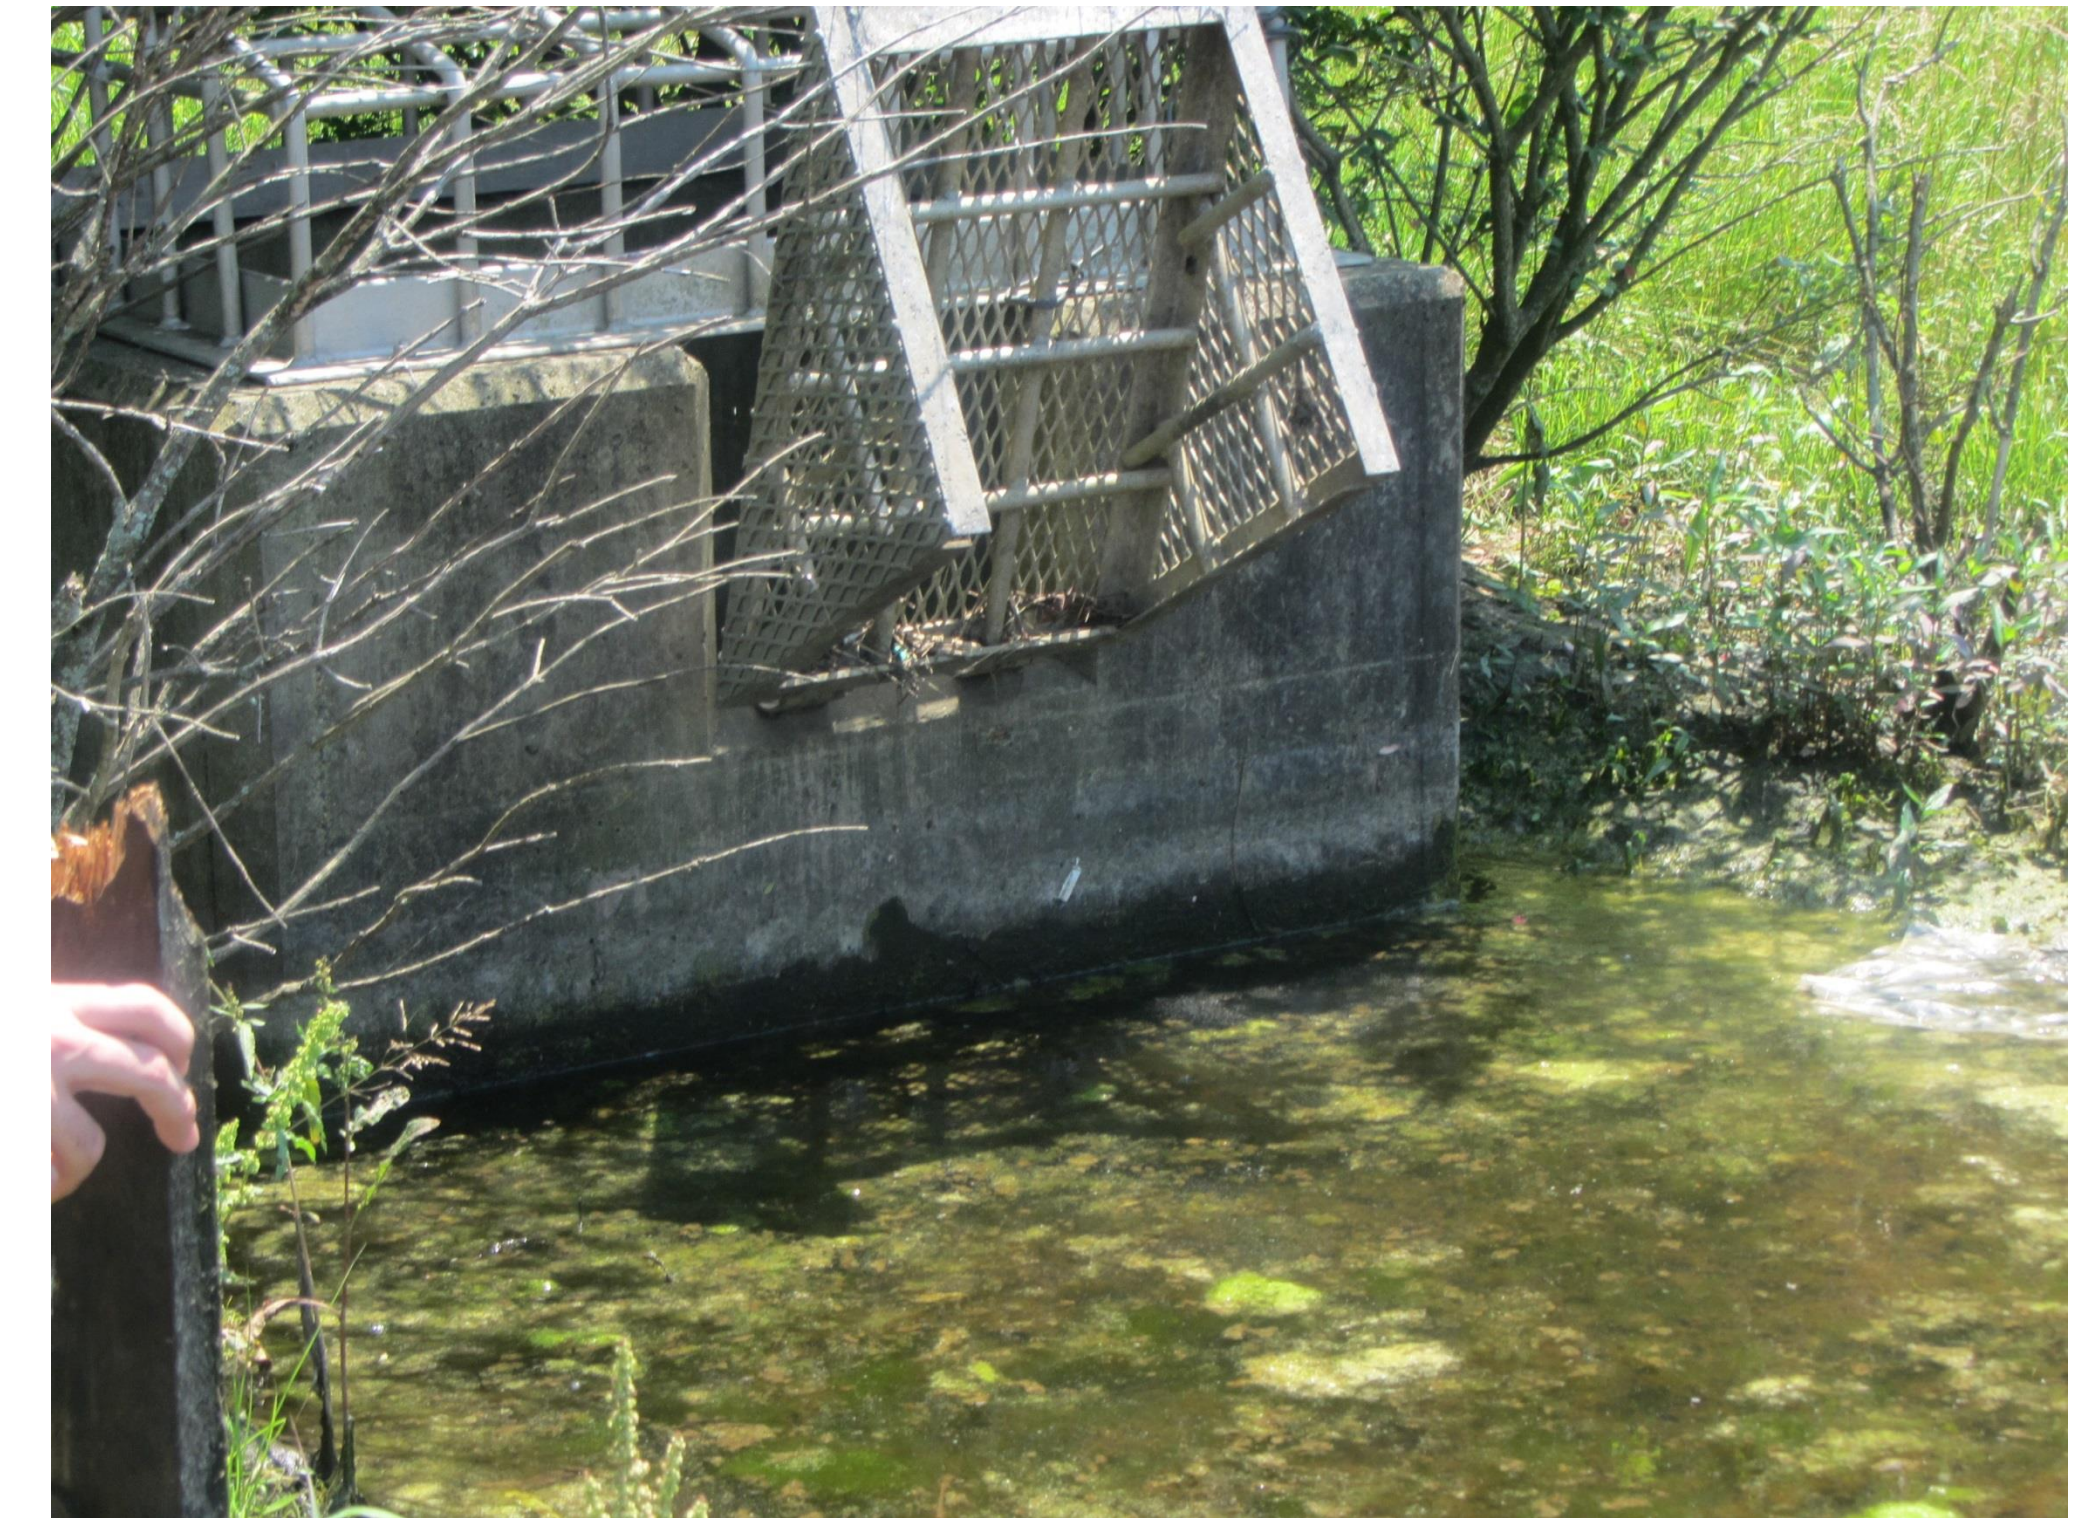
Outlet structure

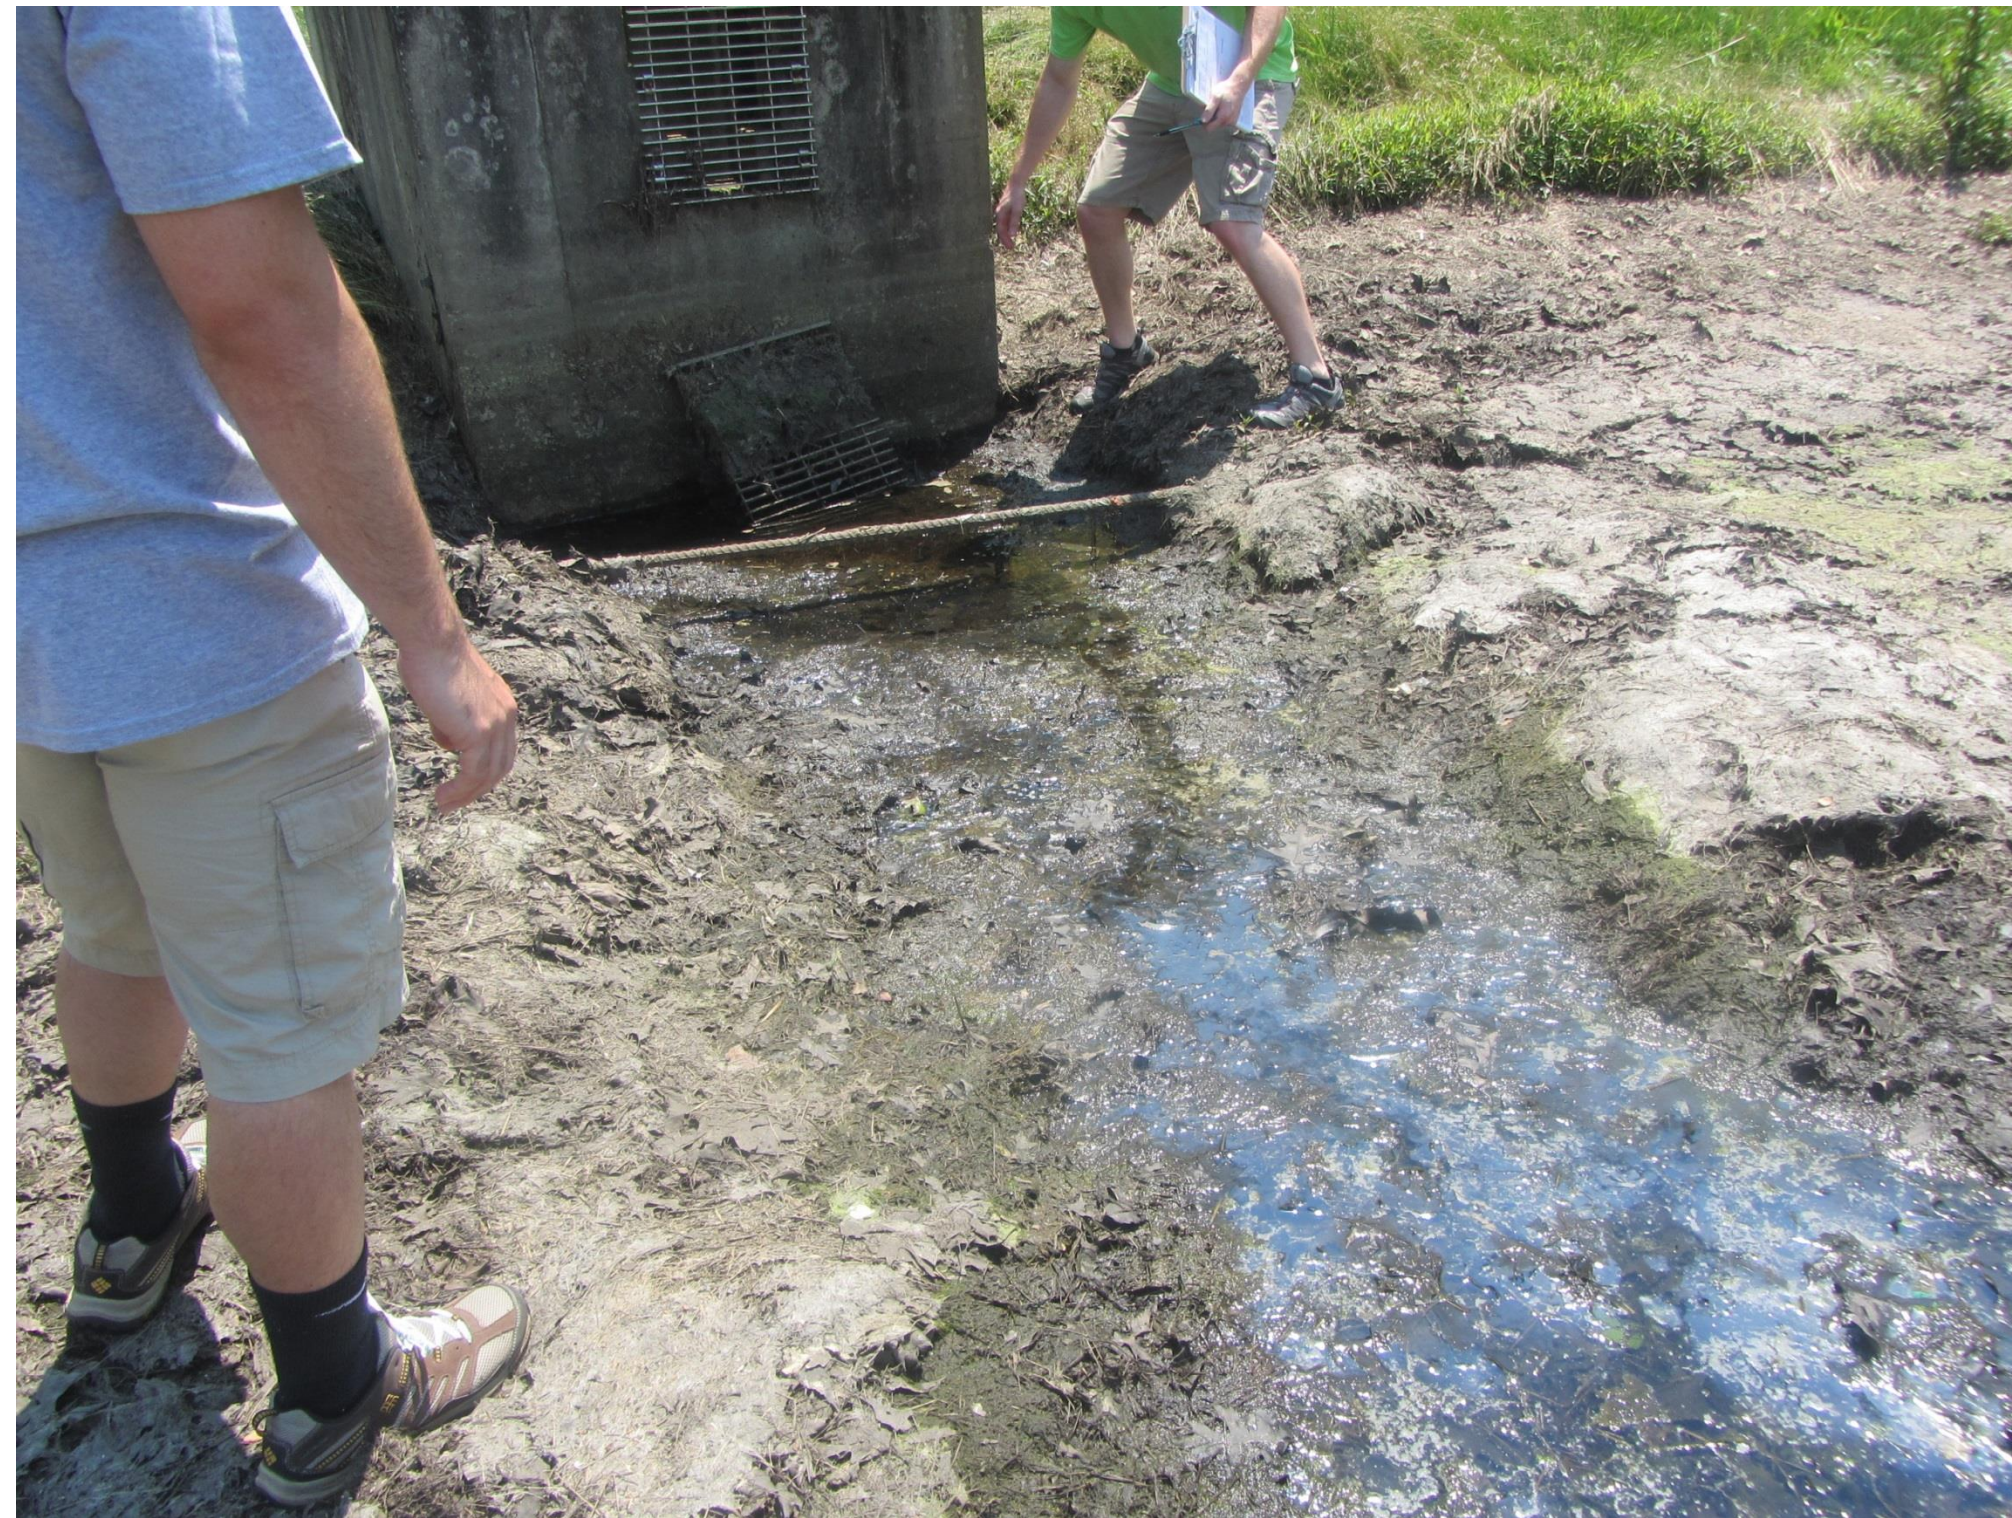
Outlet structure

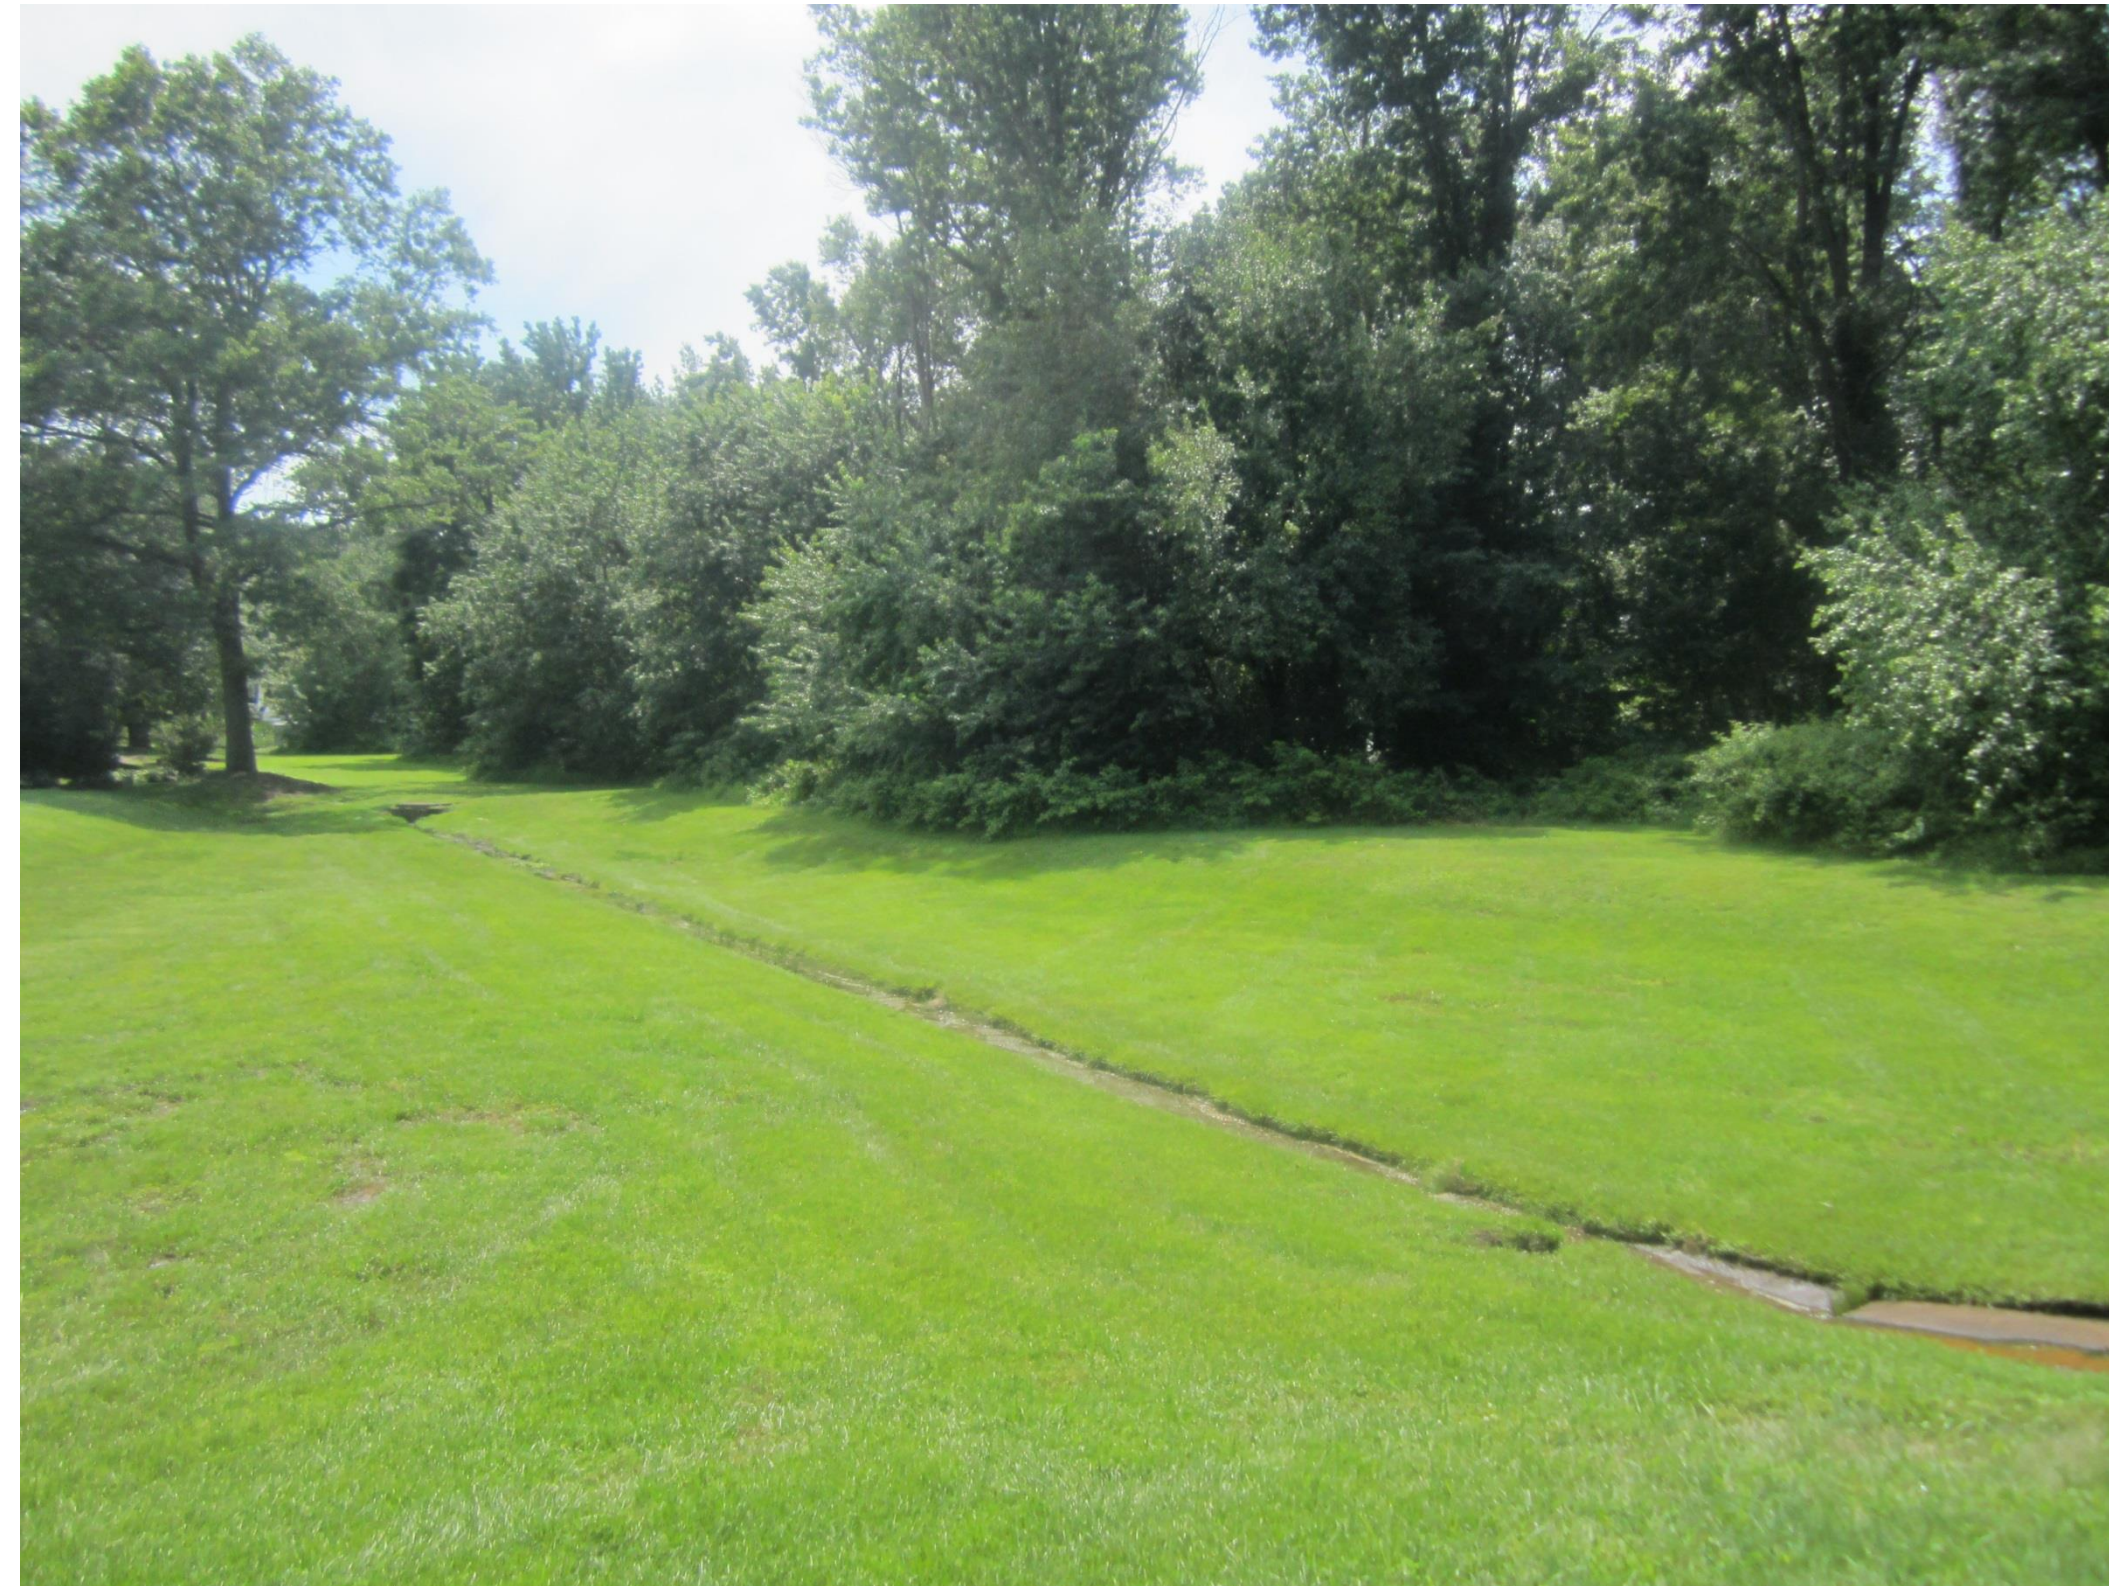
Basin bottom looking south
